**CALIFORNIA UNDERGROUND FACILITIES SAFE EXCAVATION BOARD
INVESTIGATION DIVISION
INCIDENT INVESTIGATION REPORT COVER SHEET**

Case Number: 20SA1040	Report Date: 5/01/2020
Subject Name: PG&E	Notification Date: 4/6/2020

Location of the Incident: Agricultural field bordering 10 1/2 Ave and Nevada Ave, Northwest of Corcoran, CA

Facility Type Damaged: 5" gray PVC conduit with a 440v electrical line running inside

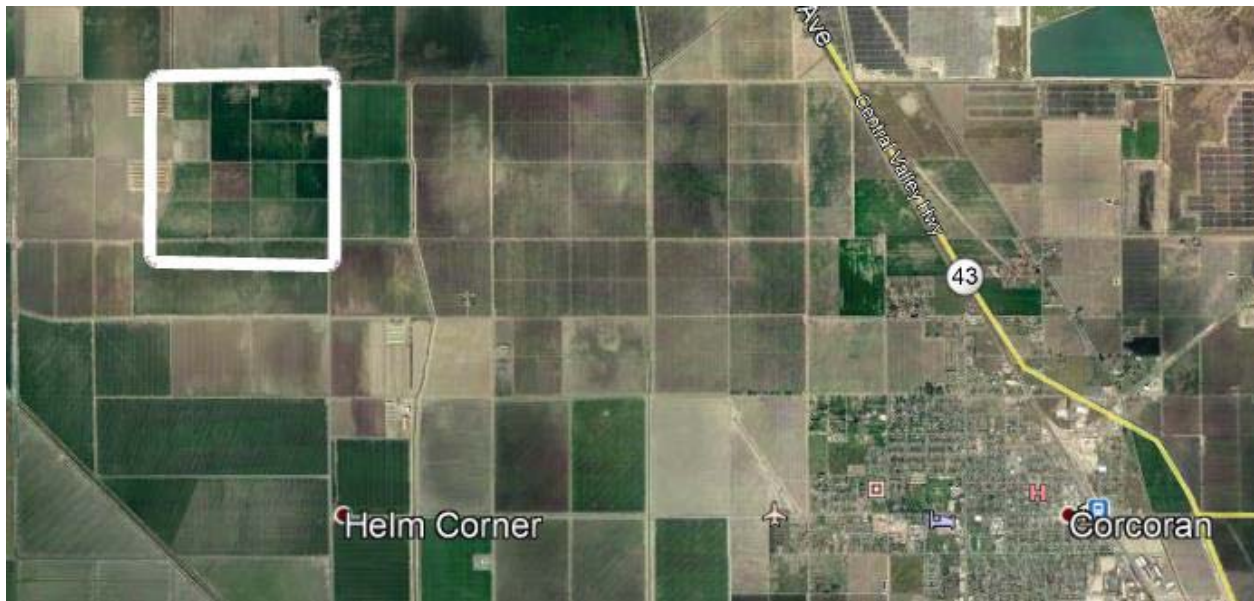
The incident scene is a large agricultural plot Northwest of Corcoran in Kings County. The excavator was performing “deep ripping” to a depth of five and a half feet using a Caterpillar D10 tractor outfitted with a ripping shank.

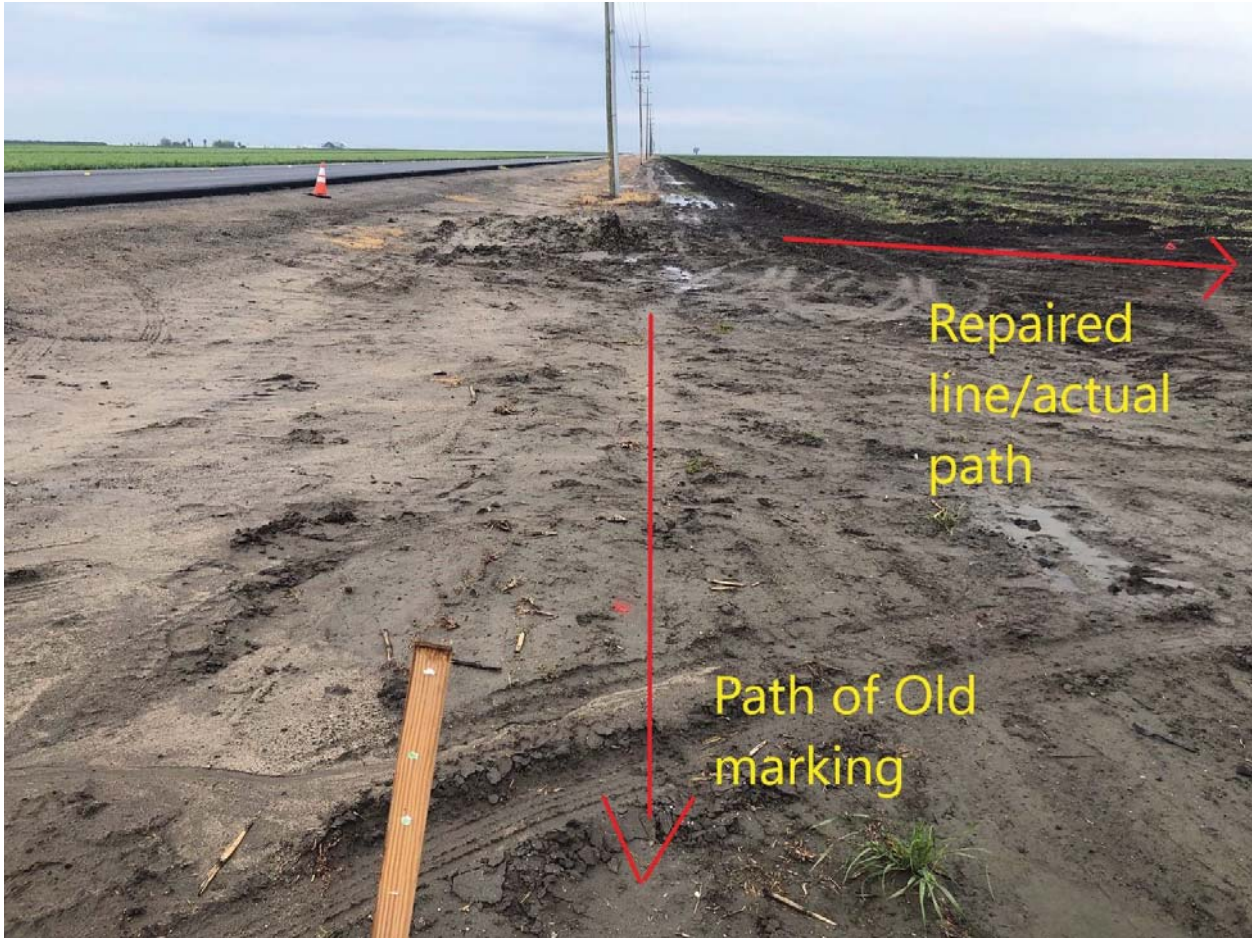
The PG&E locator did not hook up the locate equipment to the meter directly. When the locator was unable to open the metal meter box, he hooked up to the box directly and received a false positive signal leading to the inaccurate marks, off by approximately 20 feet per the excavator and confirmed by the utility operator. The locator failed to communicate with the excavator that he was unable to hook up to the facility directly. Following the investigation, I concluded that PG&E violated GC 4216.3 (a)(1)(A)(ii) by not providing information of a buried facility’s location to the extent and accuracy that was available and violated GC 4216.4(d) by not communicating with the excavator on the inability to access the facility directly when said communication could have mitigated the locator’s lack of access to the facility, resulted in accurate markings, and potentially avoided the incident.
