NOD_ MJ4_ PGE_ 20211203_ 01

NOTICE OF DEFECT

Energy Safety Inspection Report

On December 3, 2021, Energy Safety inspector Mahdi Jahami performed a walking inspection in Grass Valley in Nevada County. The goal of this inspection was to verify 1.3-line miles of covered conductor installed as part of PG&E’s system hardening initiative (2021 WMP initiative 7.3.3.17.1). Detailed findings from this field inspection are laid out in Section II below.

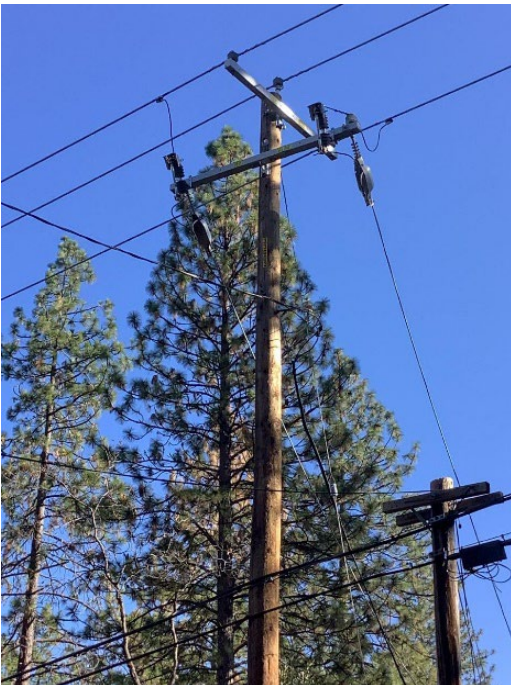
Photo 2: Picture of the entire pole

1. Defect 1: Structures 120768666, 120798920, and 120851082 had vegetation contacting guy wires above the insulator. Guy wires can become energized and pose an increased ignition risk if in contact with vegetation. Energy Safety considers this defect to be in the Minor Risk category. Energy Safety inspector found three (3) defects of this type.
