NOV_SCE_EDC_ 20211207-01

NOTICE OF VIOLATION

Energy Safety Inspection Report

Report Name: SCE_EDC_20211207-01

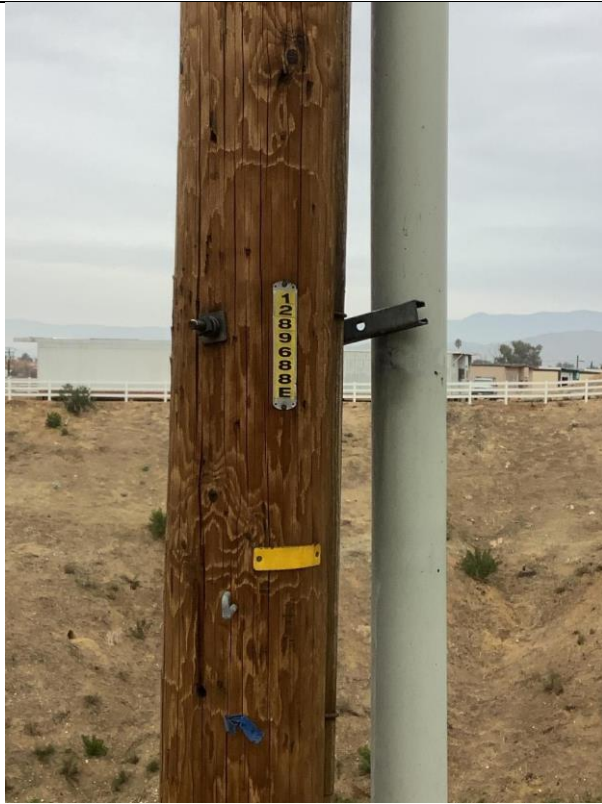
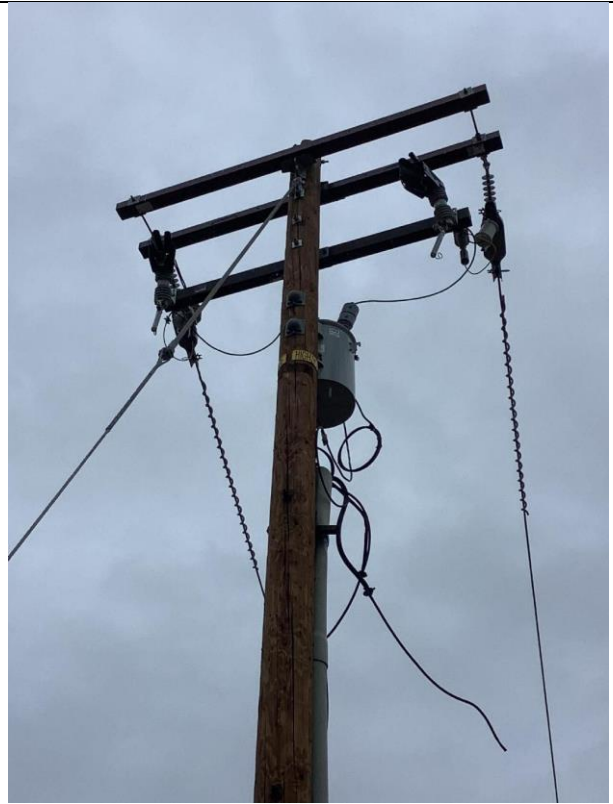
Structure ID: 1289688E

construction. Pole numbered 1289688E did not have a cover on the surge arrester clamp. Energy Safety considers this a violation for failure of adhering to protocol and in the Minor risk category.

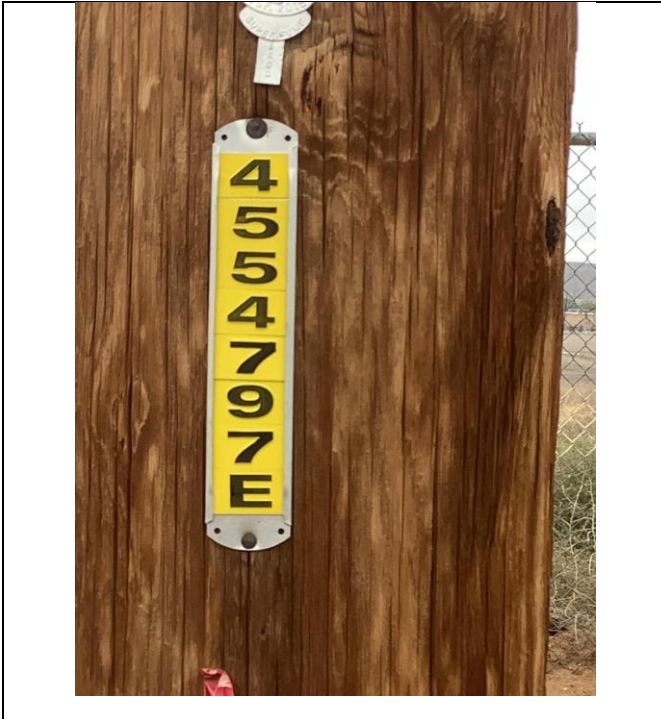
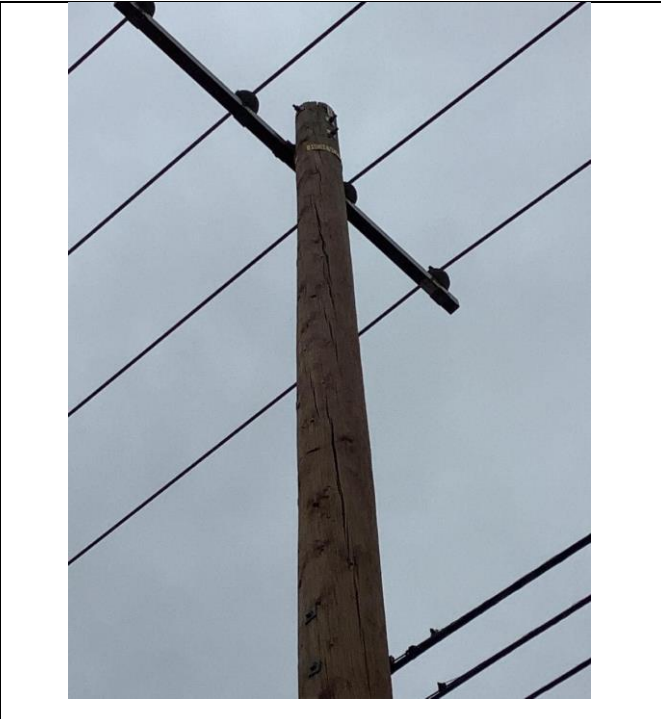
Structure ID: 4554797E

7	4554797E	Tier 2	7.3.3.3.1	Adherence to Protocol	Minor	Failure to install vibration dampers on a span
8	4554795	Tier 2	7.3.3.3.1	Adherence to Protocol	Minor	Failure to install vibration dampers on a span
9	4554793E	Tier 2	7.3.3.3.1	Adherence to Protocol	Minor	Failure to install vibration dampers on a span
10	4554792E	Tier 2	7.3.3.3.1	Adherence to Protocol	Minor	Failure to install vibration dampers on a span
11	4554791E	Tier 2	7.3.3.3.1	Adherence to Protocol	Minor	Failure to install vibration dampers on a span

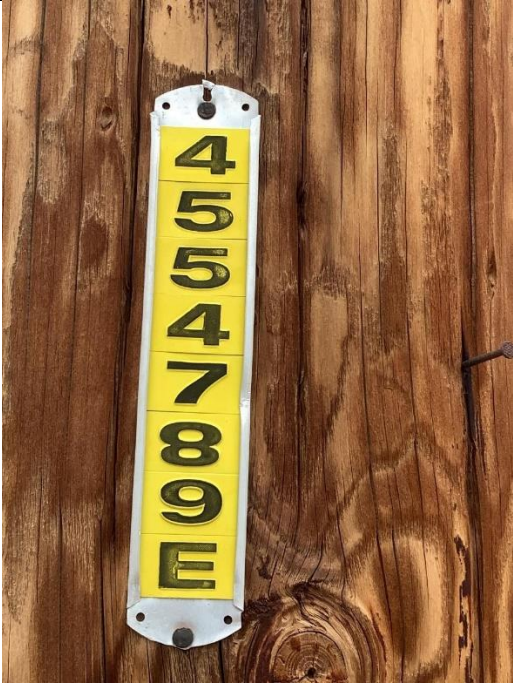
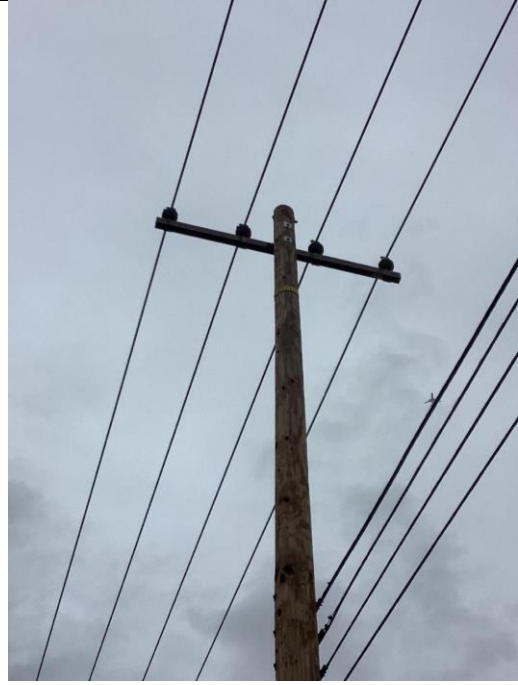
Structure ID: 4554789E

Line Item	Structure ID	HFTD	Initiative Number	Violation Type	Severity	Violation Description
12	4554789E	Tier 2	7.3.3.3.1	Adherence to Protocol	Minor	Failure to install vibration dampers on a span
13	4554786E	Tier 2	7.3.3.3.1	Adherence to Protocol	Minor	Failure to install vibration dampers on a span
14	276507E	Non-HFTD	7.3.3.3.1	Adherence to Protocol	Minor	Failure to install vibration dampers on a span
15	4494709E	Non-HFTD	7.3.3.3.1	Adherence to Protocol	Minor	Failure to install vibration dampers on a span
16	4415240E	Non-HFTD	7.3.3.3.1	Adherence to Protocol	Minor	Failure to install vibration dampers on a span
17	4415240E	Non-HFTD	7.3.3.3.1	Adherence to Protocol	Minor	Failure to install bolted wedge connector covers at double dead end
18	4415240E	Non-HFTD	7.3.3.3.1	Completeness	Minor	Failure to remove guy anchor
19	4775180E	Tier 2	7.3.3.3.1	Adherence to Protocol	Minor	Failure to install vibration dampers on a span

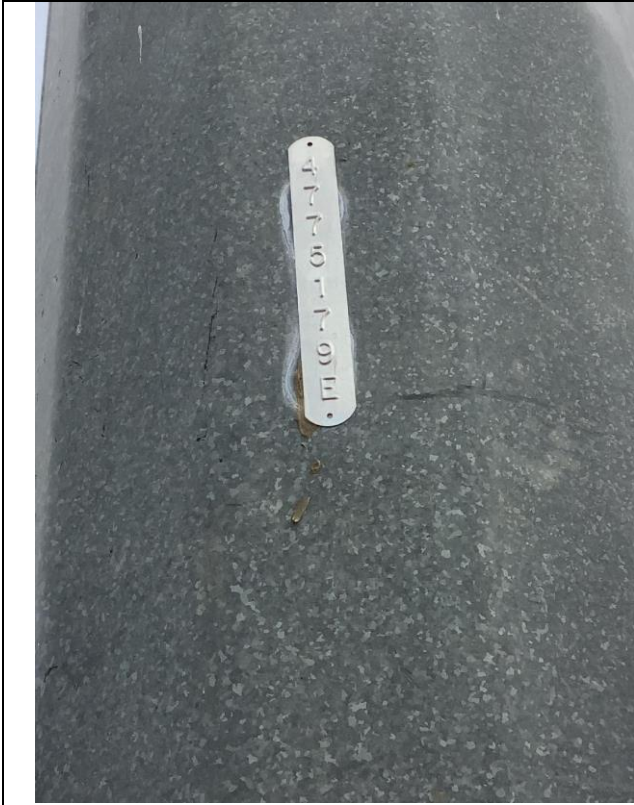
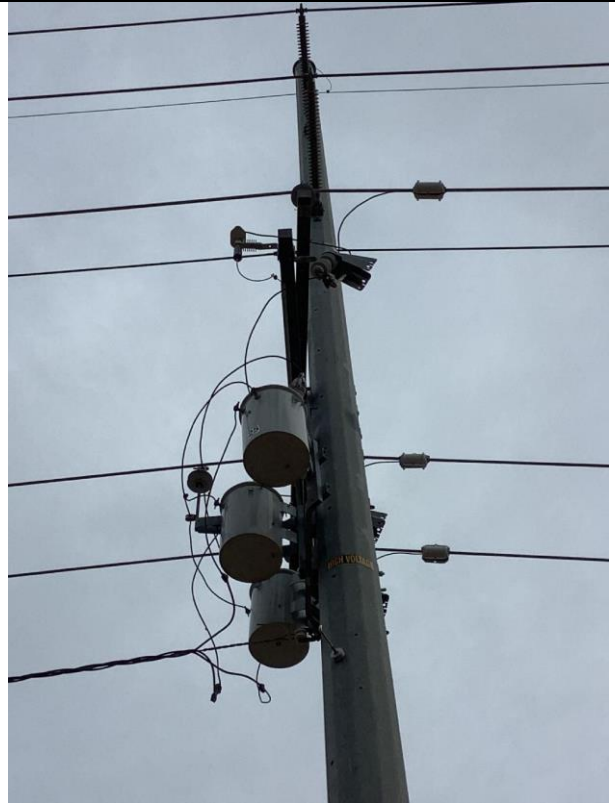
Structure ID: 4775179E

20	4775179E	Non-HFTD	7.3.3.3.1	Adherence to Protocol	Minor	Failure to install vibration dampers on a span
21	4775178E	Non-HFTD	7.3.3.3.1	Adherence to Protocol	Minor	Failure to install vibration dampers on a span
22	4775176E	Non-HFTD	7.3.3.3.1	Adherence to Protocol	Minor	Failure to install vibration dampers on a span
