NOV_SCE_ATJ_ 20211202-01

NOTICE OF VIOLATION

Energy Safety Inspection Report

Report Name: ATJ_SCE_20221202-01

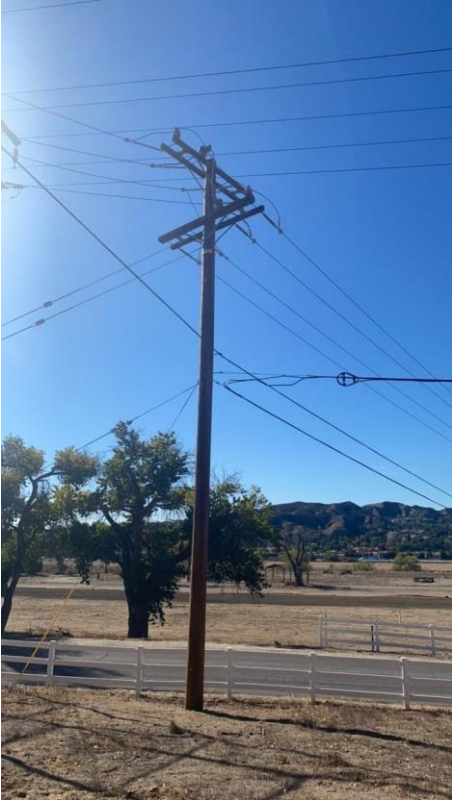
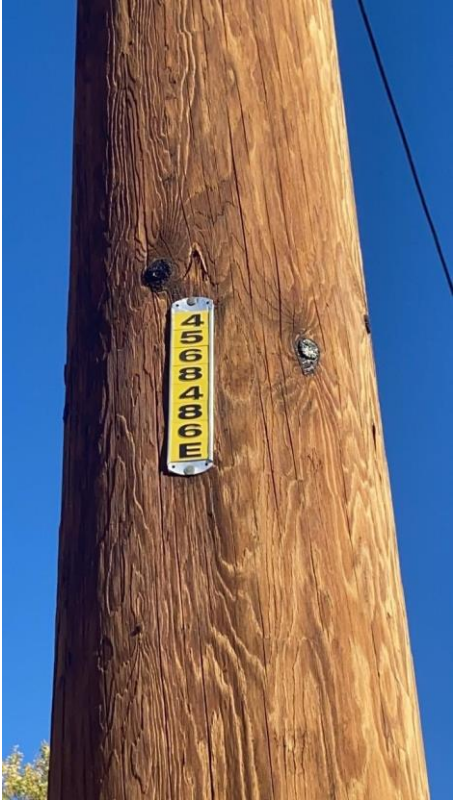
Structure ID: 4568486E

Item	Structure ID	HFTD	Defect Type	Severity	Defect Description
1	4568486E	Tier 3	Conductor evidence of bird caging	Minor	Conductor shows evidence of bird caging

In addition to the violations discovered during WMP inspections of SCE's covered conductor installations, Energy Safety discovered one conductor that showed evidence of bird caging. Energy Safety considers bird caging as a condition that increases an electrical corporation's ignition risk because bird caging is a potential indicator of degradation in a conductor and compromises its structural integrity. Bird caging on a supply conductor can weaken its strength and lead to a wire down event and ignition, thus increasing the risk of conductor failure and potential ignition. The span where bird caging was observed is identified in Table 3.

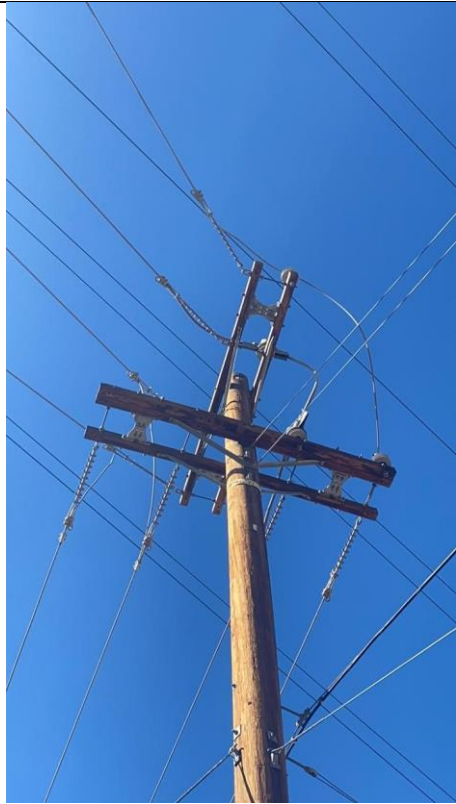
Item15IA1img2: Overall pole

Item15IA1img1: Bare conductor

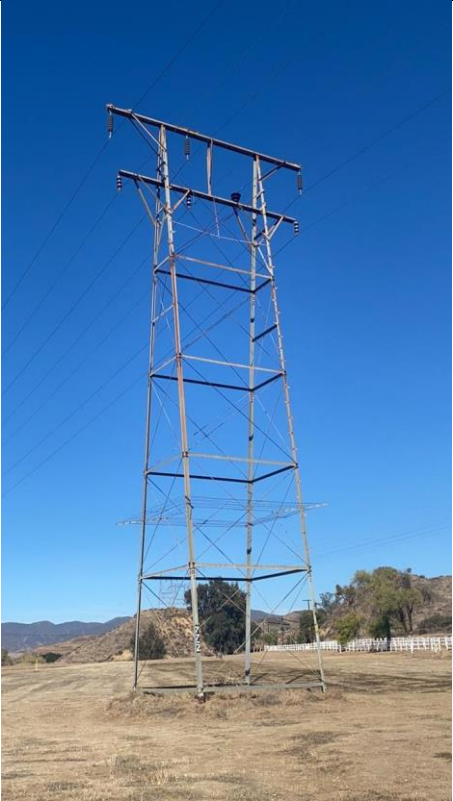
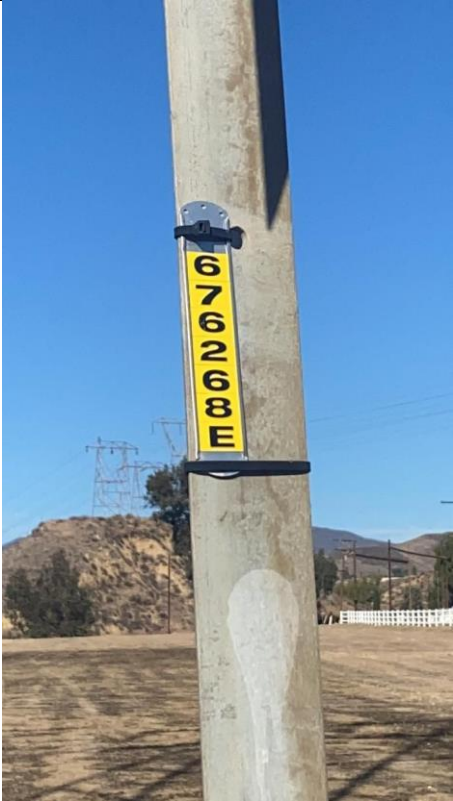
Structure ID: OH-7017637

2. Violation 2: Per SCE’s 2021-Q2 QDR, covered conductor was installed on poles numbered 45377945E, 4568486E, OH-7017637, and OH-7017636. Upon inspection, Energy Safety staff found no covered conductor installed at the above-mentioned structures. Given SCE’s focus on covered conductor as one of its flagship wildfire mitigation programs and the scope of this mitigation program, Energy Safety is greatly concerned about how much covered conductor work is completed and how prevalent this issue may be. Energy Safety

23	4308817E	Tier 3	7.3.3.3.1	Adherence to Protocol	Minor	Failure to install fiberglass guy strain insulator
24	4789750E	Tier 3	7.3.3.3.1	Adherence to Protocol	Minor	Failure to install vibration dampers
25	4789750E	Tier 3	7.3.3.3.1	Adherence to Protocol	Minor	Failure to install fiberglass guy strain insulators on two guys
26	4568486E	Tier 3	7.3.3.3.1	Data Accuracy	Moderate	Covered conductor reported as completed, and has not started
27	4568486E	Tier 3	7.3.3.3.1	Completeness	Moderate	Failure to install covered conductor
28	OH-7017637	Tier 3	7.3.3.3.1	Data Accuracy	Moderate	Covered conductor reported as completed, and has not started
29	OH-7017637	Tier 3	7.3.3.3.1	Completeness	Moderate	Failure to install covered conductor
30	OH-7017637	Tier 3	7.3.3.3.1	Data Accuracy	Minor	Wrong pole ID provided. Provided pole ID is OH-7017637. Actual pole ID is 676268E

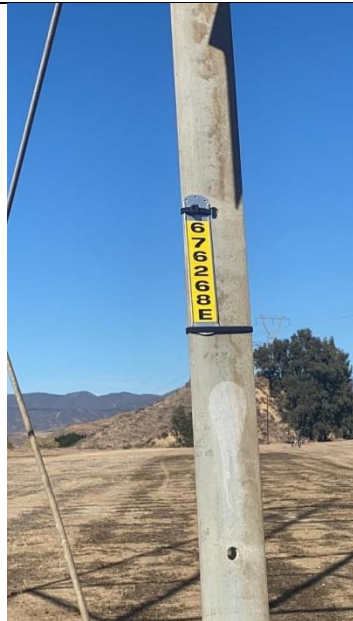
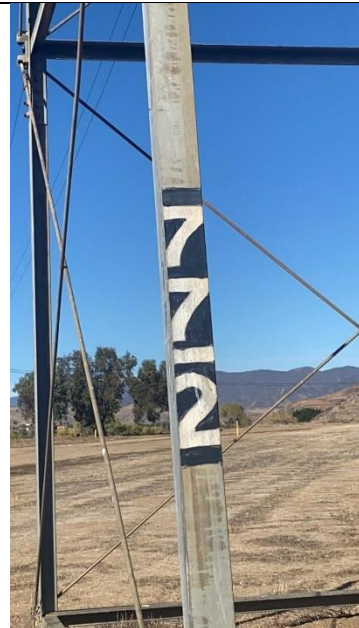
During inspections, Energy Safety found three structures where the structure ID provided by SCE did not match the structure ID observed in the field. Structures where Energy Safety observed this data accuracy violation are noted in Table 2 above.

Item16IA2Img1: Correct structure ID

Item16IA2Img2: Other structure ID

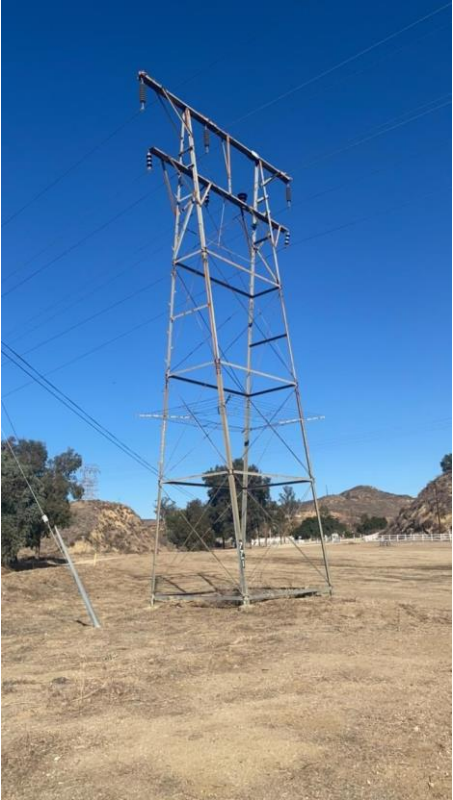
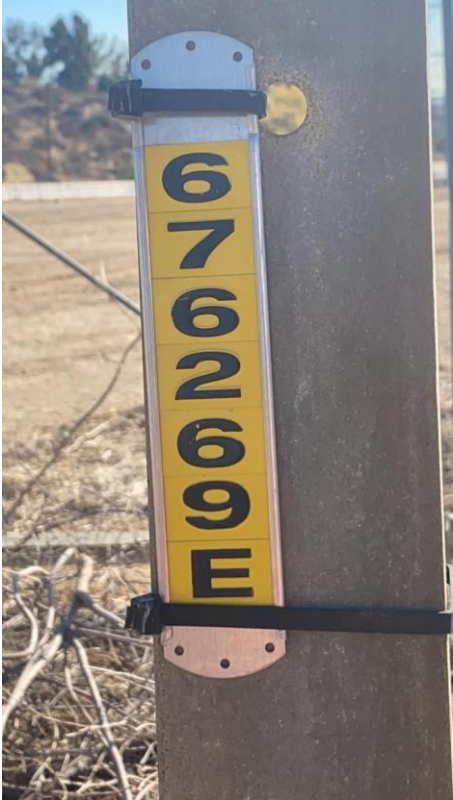
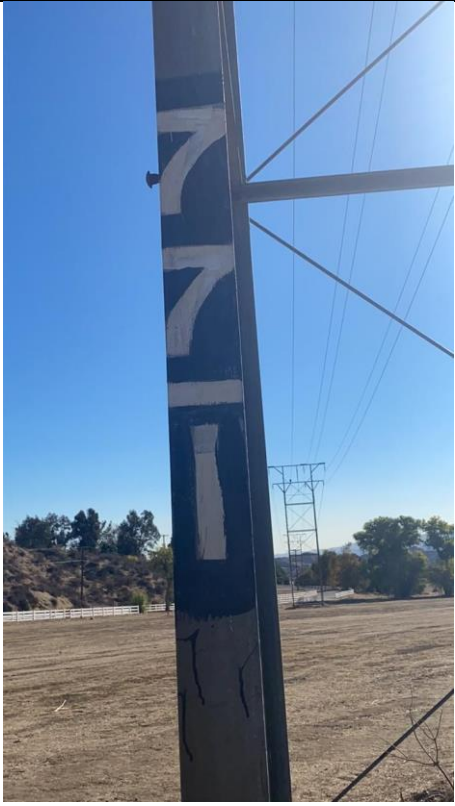
Structure ID: OH-7017636

Item	Structure ID	HFTD	Initiative Number	Violation Type	Severity	Violation Description
31	OH-7017636	Tier 3	7.3.3.3.1	Data Accuracy	Moderate	Covered conductor reported as completed, and has not started
32	OH-7017636	Tier 3	7.3.3.3.1	Completeness	Moderate	Failure to install covered conductor
33	OH-7017636	Tier 3	7.3.3.3.1	Data Accuracy	Minor	Wrong pole ID provided. Provided pole ID is OH-7017636. Structure ID is 676269E

Item17GImg3: Other structure ID
