NOD_SCE_ATJ_20211202-01

NOTICE OF DEFECT

Energy Safety Inspection Report

Report Name: ATJ_SCE_20221202-01

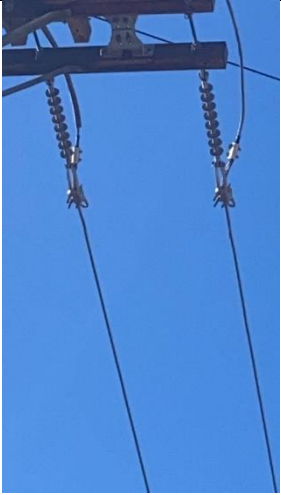
1. Defect 1: Pole numbered 4568486E showed evidence of bird caging on one conductor. Bird-caging refers to the separation of the wires of a stranded conductor. When a conductor is not clamped, tensioned, or terminated properly, the outer wires can open spirally away from the center. Bird-caging on a supply conductor can weaken its strength and lead to a wire down event and ignition. Energy Safety considers this defect to be in the Minor risk category.

Item	Structure ID	HFTD	Defect Type	Severity	Defect Description
1	4568486E	Tier 3	Conductor evidence of bird caging	Minor	Conductor shows evidence of bird caging

In addition to the violations discovered during WMP inspections of SCE's covered conductor installations, Energy Safety discovered one conductor that showed evidence of bird caging. Energy Safety considers bird caging as a condition that increases an electrical corporation's ignition risk because bird caging is a potential indicator of degradation in a conductor and compromises its structural integrity. Bird caging on a supply conductor can weaken its strength and lead to a wire down event and ignition, thus increasing the risk of conductor failure and potential ignition. The span where bird caging was observed is identified in Table 3.

Item15GImg3: Bare wire on all phases closeup
