NOV\_SCE\_ATJ\_ 20211116-01

# NOTICE OF VIOLATION

# Energy Safety Inspection Report

Report Name: ATJ\_SCE\_20211116

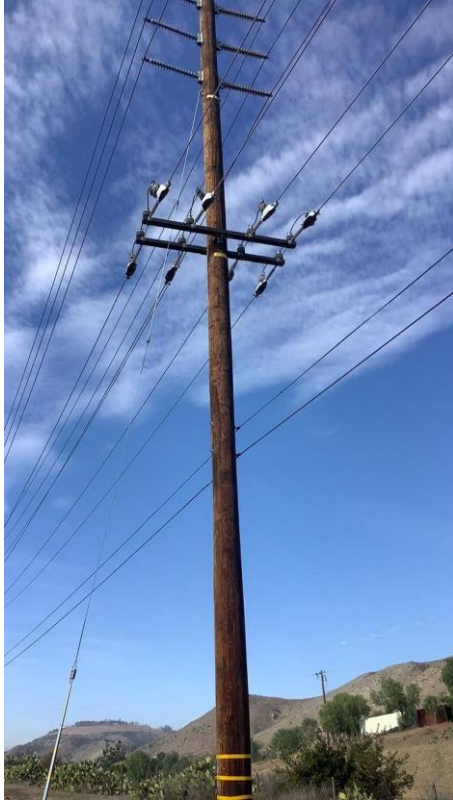
Item1GImg1: Overall photo

Item	Structure ID	HFTD	Initiative Number	Violation Type	Severity	Violation Description
1	1922866E	Tier 3	7.3.3.3.1	Adherence to Protocol	Minor	Failed to install vibration dampers
2	1922670E	Tier 3	7.3.3.3.1	Adherence to Protocol	Minor	Failed to install vibration dampers
3	4477226E	Tier 3	7.3.3.3.1	Adherence to Protocol	Minor	Failed to install vibration dampers
4	1922666E	Tier 3	7.3.3.3.1	Adherence to Protocol	Minor	Failed to install vibration dampers
5	4477224E	Tier 3	7.3.3.3.1	Adherence to Protocol	Minor	Failed to install vibration dampers
6	1922663E	Tier 3	7.3.3.3.1	Adherence to Protocol	Minor	Failed to install vibration dampers
7	4477219E	Tier 3	7.3.3.3.1	Adherence to Protocol	Minor	Failed to install vibration dampers
8	4477216E	Tier 3	7.3.3.3.1	Adherence to Protocol	Minor	Failed to install vibration dampers
9	1922903	Tier 3	7.3.3.3.1	Adherence to Protocol	Minor	Failed to install vibration dampers

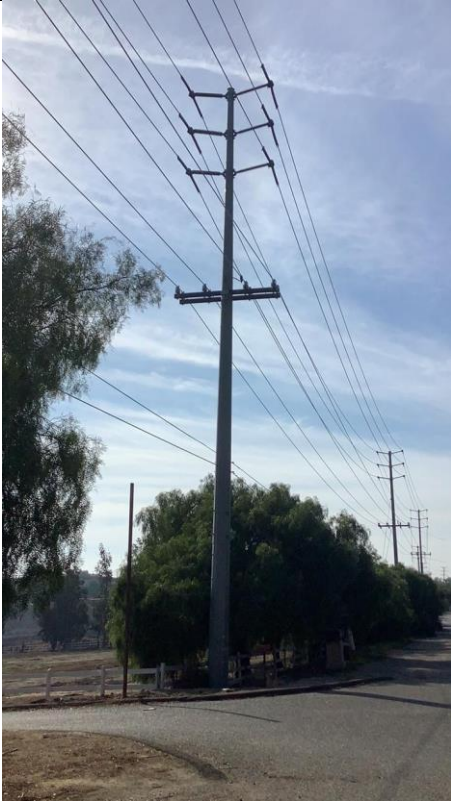
**Item10GImg1:** Overall Pole

10	4476903E	Tier 3	7.3.3.3.1	Adherence to Protocol	Minor	Failure to install vibration dampers
11	4429437E	Tier 3	7.3.3.3.1	Adherence to Protocol	Minor	Failure to install vibration dampers
12	1922649E	Tier 3	7.3.3.3.1	Adherence to Protocol	Minor	Failure to install vibration dampers
