NOV_SCE_EDC_ 20211207-01_Revised

NOTICE OF VIOLATION

Energy Safety Inspection Report

Report Name: SCE_EDC_20211207-01_Revised

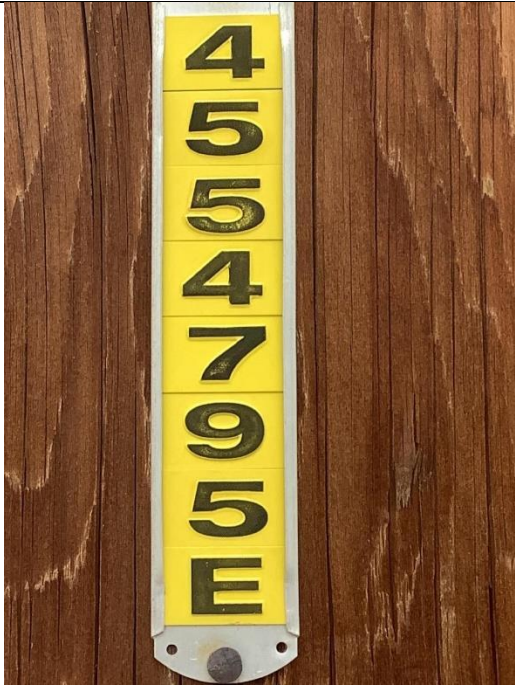
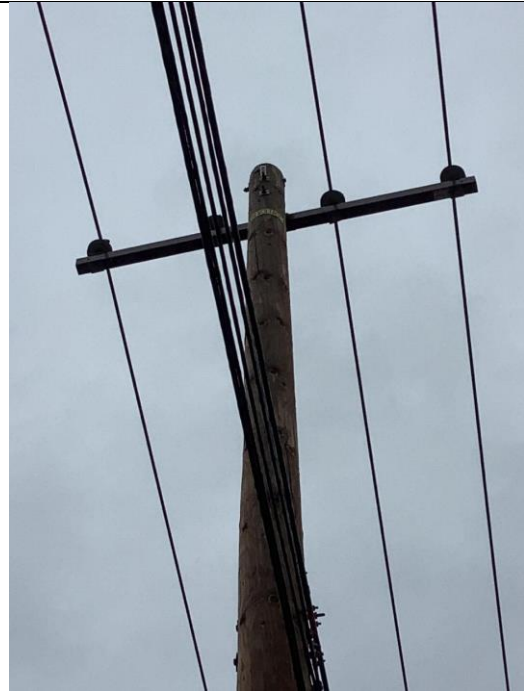
Structure ID: 4554795

7	4554795	Tier 2	7.3.3.3.1	Adherence to Protocol	Minor	Failure to install vibration dampers on a span
8	4554793E	Tier 2	7.3.3.3.1	Adherence to Protocol	Minor	Failure to install vibration dampers on a span
9	4554792E	Tier 2	7.3.3.3.1	Adherence to Protocol	Minor	Failure to install vibration dampers on a span
10	4554791E	Tier 2	7.3.3.3.1	Adherence to Protocol	Minor	Failure to install vibration dampers on a span
Line Item	Structure ID	HFTD	Initiative Number	Violation Type	Severity	Violation Description

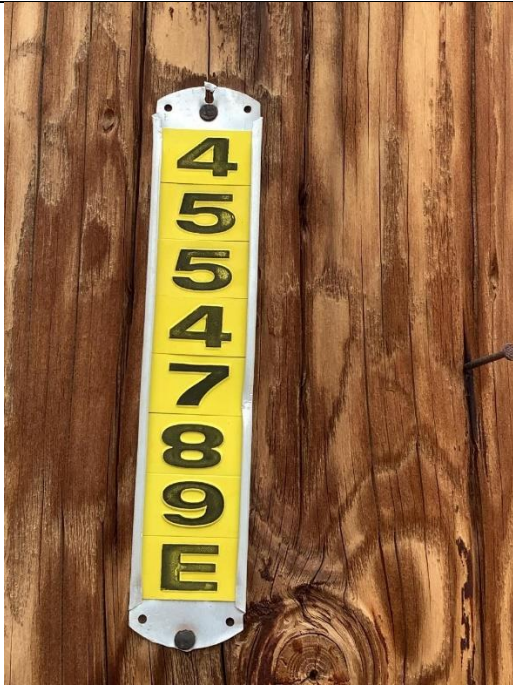
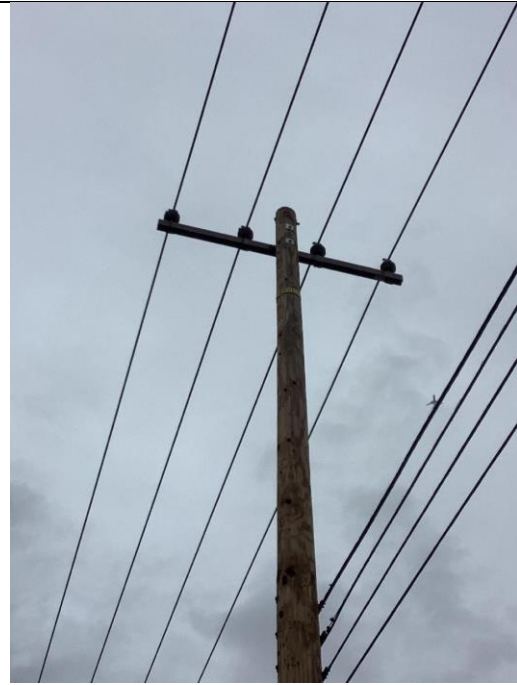
Structure ID: 4554789E

11	4554789E	Tier 2	7.3.3.3.1	Adherence to Protocol	Minor	Failure to install vibration dampers on a span
12	4554786E	Tier 2	7.3.3.3.1	Adherence to Protocol	Minor	Failure to install vibration dampers on a span
13	276507E	Non-HFTD	7.3.3.3.1	Adherence to Protocol	Minor	Failure to install vibration dampers on a span
14	4494709E	Non-HFTD	7.3.3.3.1	Adherence to Protocol	Minor	Failure to install vibration dampers on a span
15	4415240E	Non-HFTD	7.3.3.3.1	Adherence to Protocol	Minor	Failure to install vibration dampers on a span
16	4415240E	Non-HFTD	7.3.3.3.1	Adherence to Protocol	Minor	Failure to install bolted wedge connector covers at double dead end
17	4415240E	Non-HFTD	7.3.3.3.1	Completeness	Minor	Failure to remove guy anchor
18	4775180E	Tier 2	7.3.3.3.1	Adherence to Protocol	Minor	Failure to install vibration dampers on a span
19	4775179E	Non-HFTD	7.3.3.3.1	Adherence to Protocol	Minor	Failure to install vibration dampers on a span

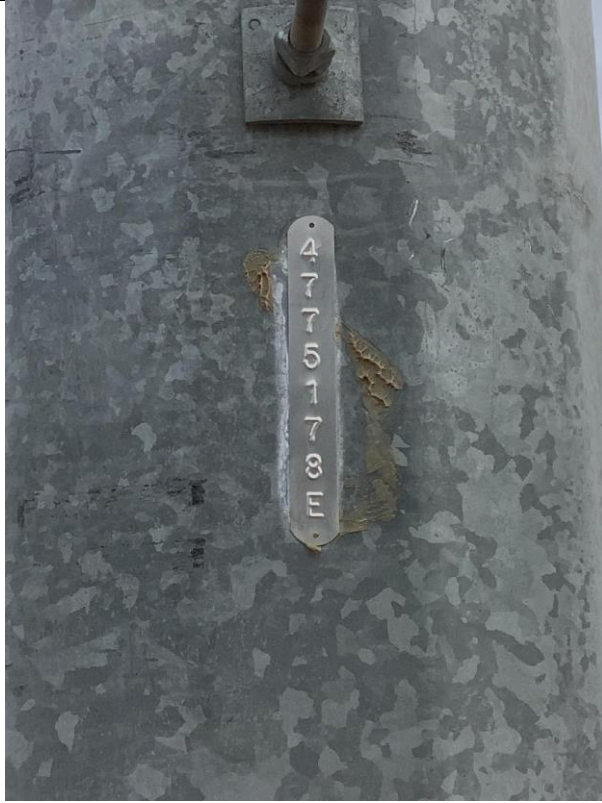
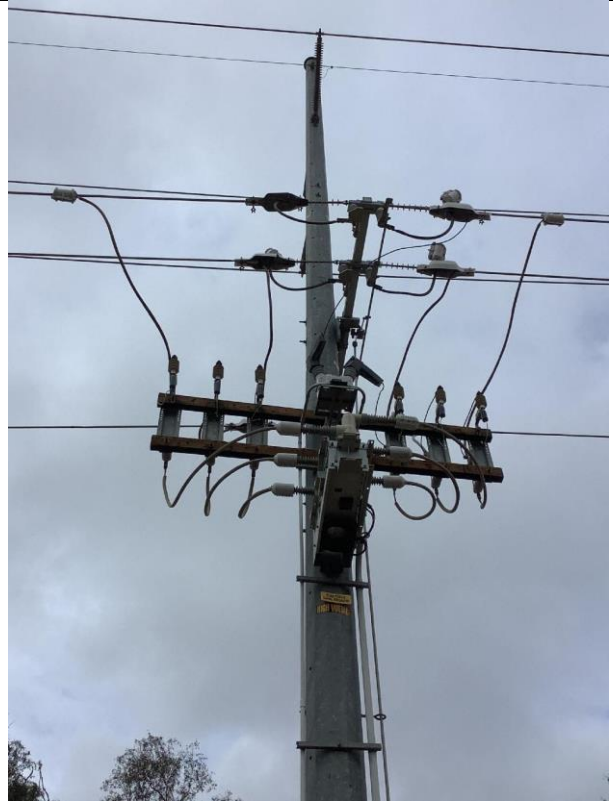
Structure ID: 4775178E

20	4775178E	Non-HFTD	7.3.3.3.1	Adherence to Protocol	Minor	Failure to install vibration dampers on a span
21	4775176E	Non-HFTD	7.3.3.3.1	Adherence to Protocol	Minor	Failure to install vibration dampers on a span
