NOV_SCE_EDC_ 20211208-01

NOTICE OF VIOLATION

Energy Safety Inspection Report

Report Name: SCE_EDC_20211208

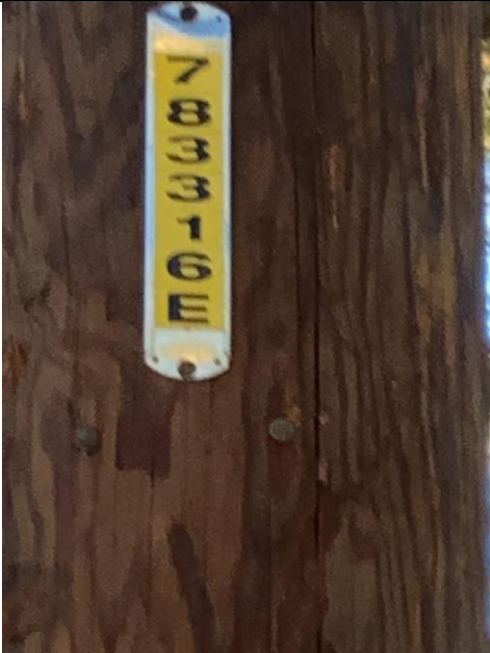
Item3G1mg1: Pole ID

Structure ID: 783316E

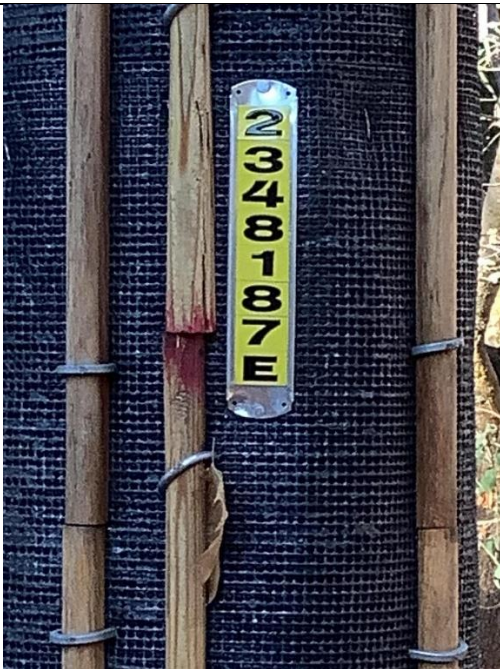
Item4Gimg1: Pole id

Structure ID: 2348187E

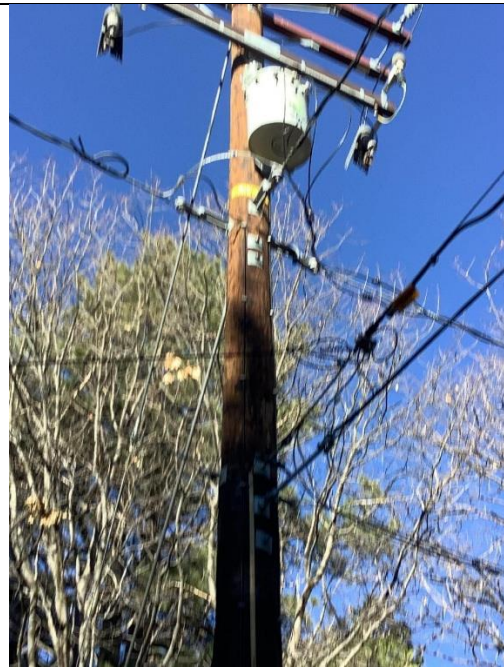
Item4Gimg2: Overall photo

1. Violation 1: Per SCE’s 2021-Q1 Quarterly Data Report (QDR), covered conductor was installed on pole numbered 2348187E. This structure reported a covered conductor initiative (2021 WMP initiative number 7.3.3.3.1) with a status of “complete.” However, upon inspection, SCE has not even begun covered conductor installation at any of these locations. Energy Safety considers this data accuracy violation to be in the Moderate Risk category.
2. Violation 2: Per SCE’s 2021-Q1 QDR, covered conductor was installed on pole numbered 2348187E. Upon inspection, Energy Safety staff found no covered conductor installed at the above-mentioned structures. Given SCE’s focus on covered conductor as one of its flagship wildfire mitigation programs and the scope of this mitigation program, Energy Safety is greatly concerned about how much covered conductor work is completed and

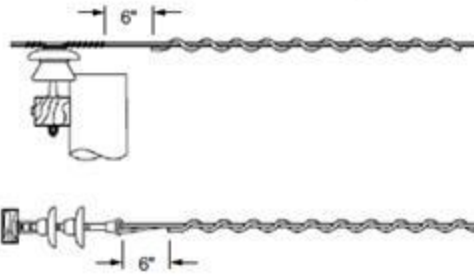
Figure CC 190-5: Installation of Spiral Vibration Dampers on Covered Conductor

Per SCE's Distribution Overhead Standards (DOH), Section CC 190, page 3 of 11, the vibration damper must be installed to maintain a minimum of 6 inches away from the splice on the opposite side to the structure, or on the other end of the span.¹ These structures are noted in table 2 above.
