To: The Public, Local and State Agencies, and Stakeholders for San Diego Gas and Electric's 2021 Wildfire Mitigation Plan Independent Evaluator Annual Report on Compliance

July 15, 2022

FINAL INDEPENDENT EVALUATOR ANNUAL REPORT ON COMPLIANCE

SDG&E

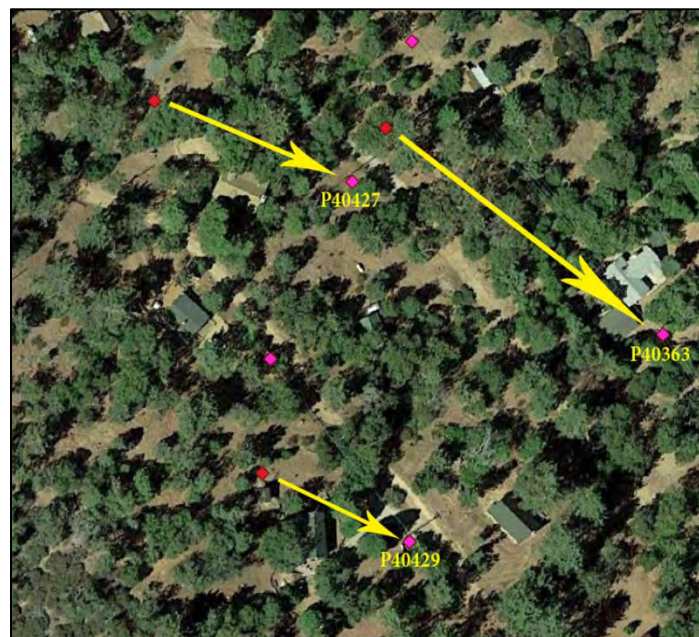
Image 1: Level of mismatch between reported work locations (red) and actual poles (purple)

Inaccurate GIS data – Continuing the theme of data challenges, the IE also found that points would fall between two or more poles; without reliable Pole IDs, it was impossible to know which pole to inspect. This data was partially solved by requesting that SDG&E provide all poles in given locations and then assign poles to the work on the proximity basis. The better solution was found when the cleaned data was supplied by SDG&E, but this was not readily available for the IE and did not occur until well into the verification period, which meant that less time remained available for field inspections. The permanent solution to these issues of data imprecision is to increase accuracy of the GPS data and assign any field work to the point through Pole IDs.

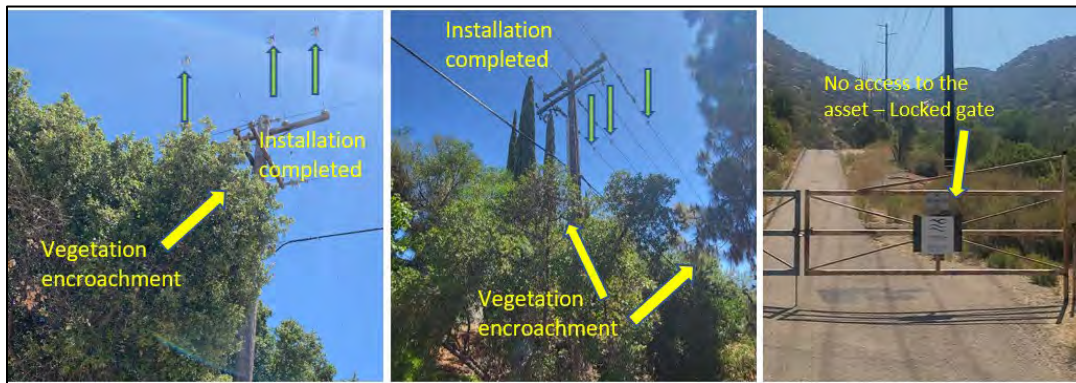
*Image 4: Wireless fault Indicators installation findings*

The IE was successful at securing a statistically valid sample of 35 for this initiative, which enables the findings of these inspections to be extrapolated across the population of 544 wireless fault indicators installed in 2021. Installations could be verified in 100% of the accessible installations, although 15% of the sample showed vegetation encroachment around the poles. 33% of the sample was inaccessible, however, behind gates similar to those shown.

The sizable inaccessible fraction, 33%, places the balance of the sample at risk. 33% of the total of 544 wireless fault indicators equates to 179 indicators in which neither the completeness nor quality of the installation can be verified. To extract this fraction decreases the extrapolated verifiable total to 365 wireless fault indicators, significantly below SDG&E's 2021 target of 500. Based on the inspection results and analysis summarized above, the IE is not able to verify that SDG&E met its objective for this initiative.

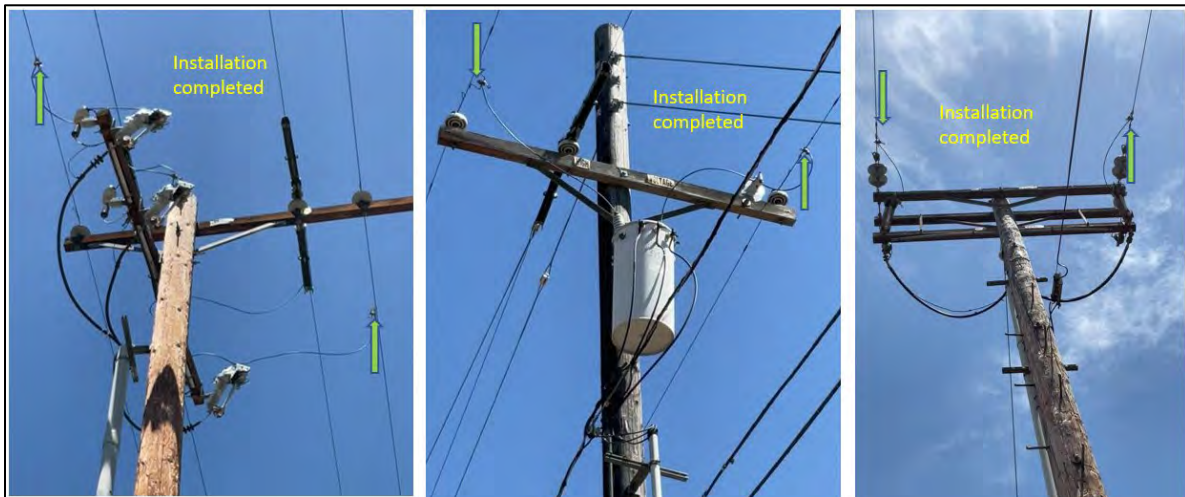
Image 10: Hotline clamps with no observations.

Findings reported by the inspectors fell into the two primary categories above. “No significant findings” means that the inspector was able to observe the hotline clamp in place and saw no quality issues in that installation. Inspector comments on hotline clamp inspections referred primarily to vegetation encroachment, as shown in the second set of images below.

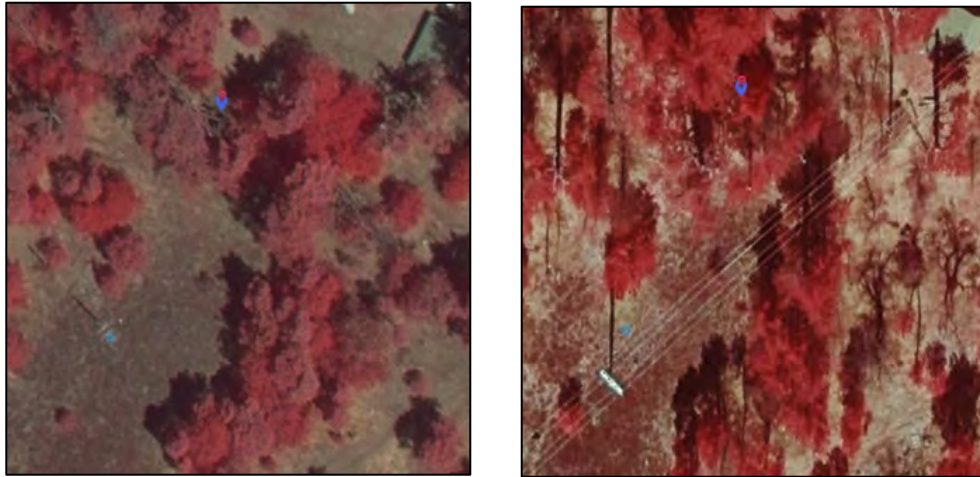
Image 18: Pole 40150 – 2018 (L) vs 2022(R)

Verification via Image Pairs – To verify hardening work performed in the CNF, the location, placement, and potential absence of poles was compared with older images. Image sets 2 - 21 show these comparisons of pole locations by comparing “then” with “now.” These images were analyzed in CIR format to highlight vegetation. See Image 18 below as an example of this comparison.

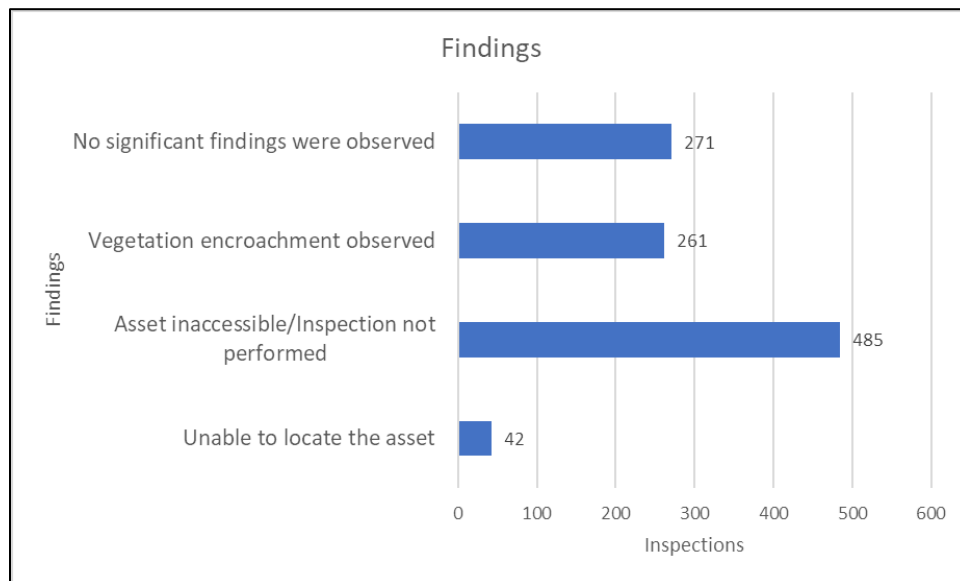
Image 22: Findings for initiative 7.3.5.2 - Detailed inspections of Vegetation.

- In multiple locations vegetation is encroaching communication wires mainly.
- In one location trees are pulling communication the wires down
- o In one location a dead tree is laying across a feeder line
- o In one location the pole shows signs of physical deterioration
- o In one location cleared branches were on the ground below lines adding to fuel source
- Asset inaccessible/Inspection not performed
 - o - Assets were behind lock gates
- Unable to locate the asset
 - o Asset were unable to locate by the given coordinates

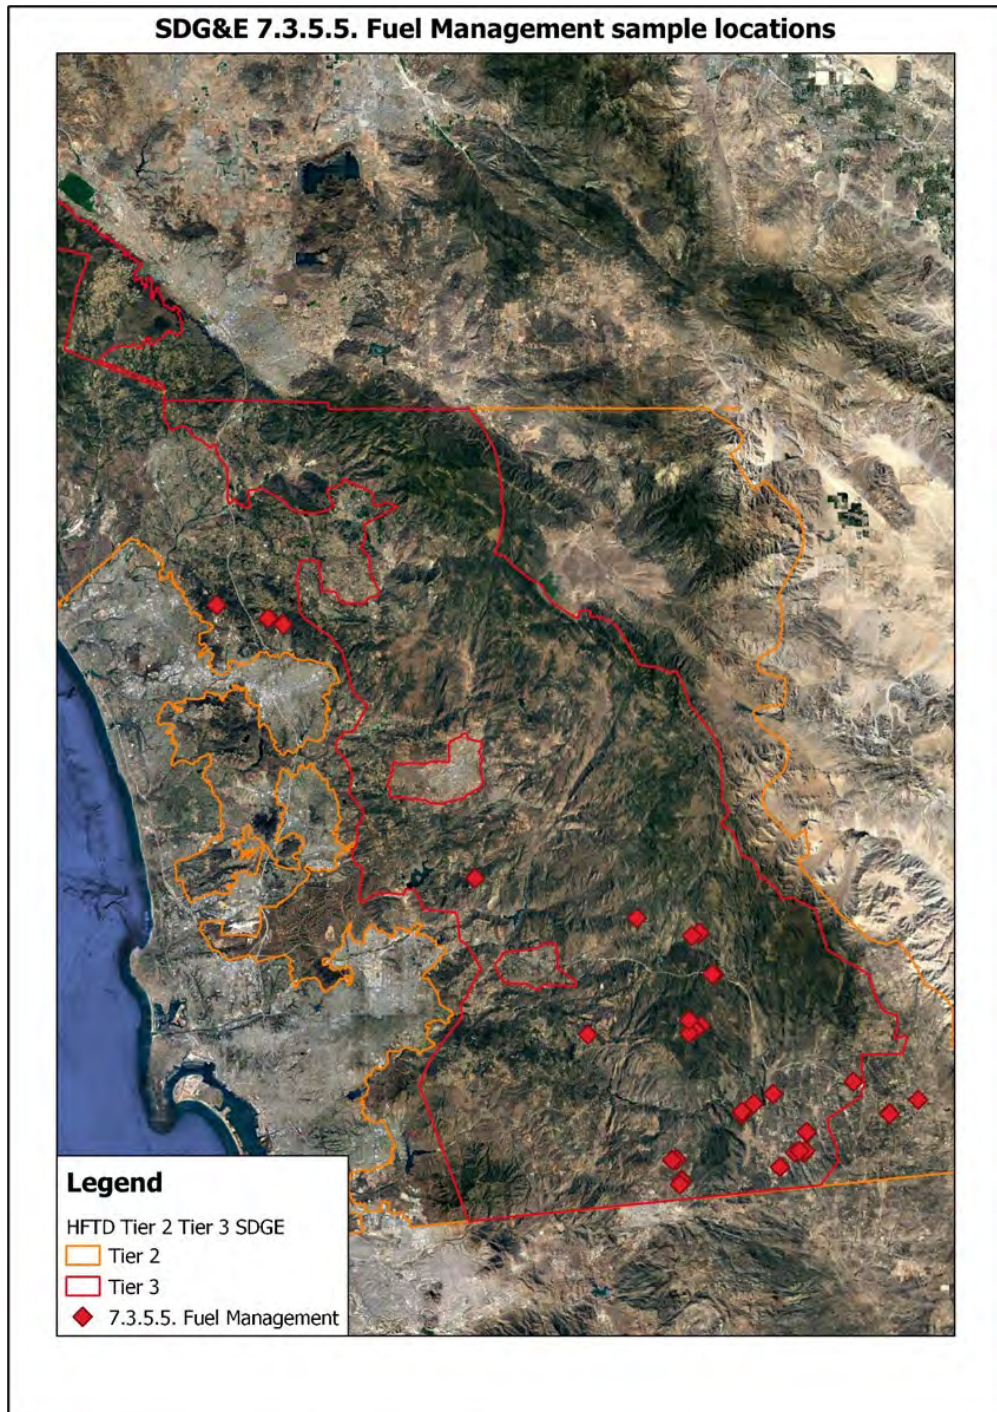
Image 25: Aerial assessment of fuels management.³⁹

- The IE sought a sample of 29 locations and was able to achieve 34 sample locations (out of 38 sampled location) that through the locations, image pairs and drone images assessed in the Analysis Report prepared for this initiative.
- 31 of the 34 image pairs inspected show clean clearance around the poles. In most cases, this reflects 30 - 40-foot clearance around the poles.

- 4 images caught the IE's attention due to the following possible issues (please refer to 7.3.5.5 - Aerial assessment of fuel management):
 - Image 1. showed a canopy of trees very close to the pole.
 - Image 12. showed potential low vegetation growth in the base of the pole.
 - Image 21. showed dead trunks and branches of trees no further than 12-15 feet from the pole.
 - Image 30. showed canopies surrounding the pole in close proximity.
- Additional issues were noticed on images 32 - 35 in the Analysis Report. On these images, a high level of inaccuracy of GPS positioning of poles was noticed.

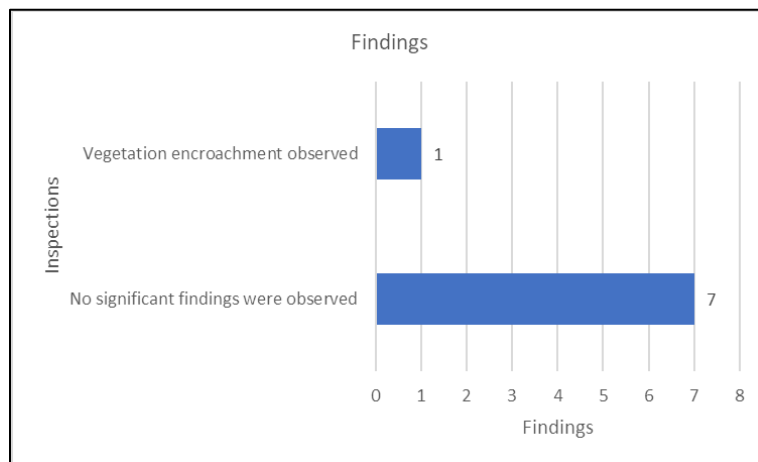
Image 29: Findings for initiative 7.3.5.9 - Discretionary Field Inspections of Distribution Equipment.

The main findings from the eight completed inspections are still instructive, if not statistically valid. In 88% (7) of the sample, locations were accessed, and inspections completed without major issues. One inspection refers to vegetation encroachment. In terms of the quality assessment, 22% showed an acceptable quality and the remaining inspection sites were all categorized as “Exceptional.”

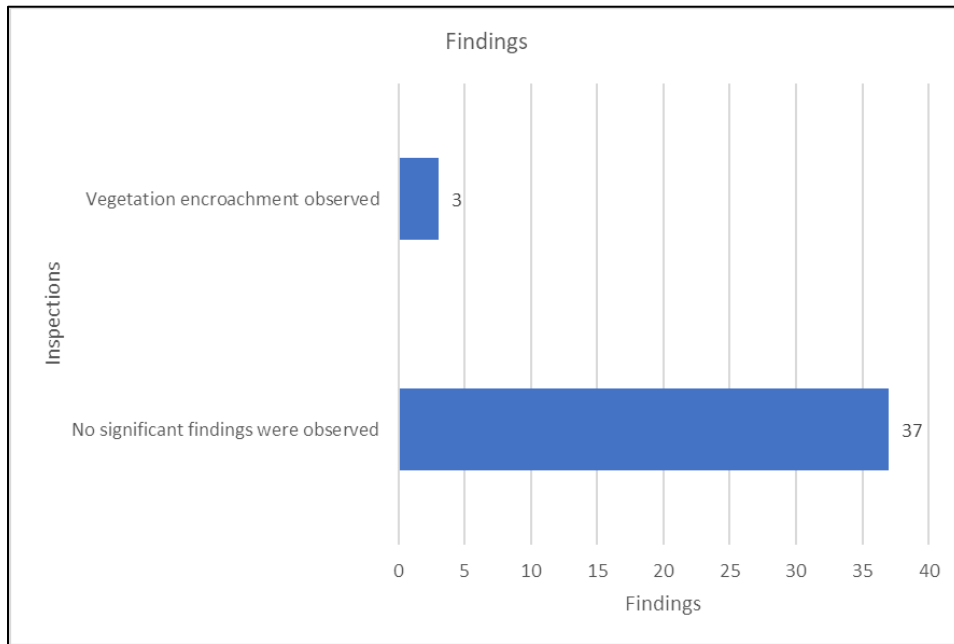
Image 32: Findings for Initiative 7.3.5.20 Pole Brushing.

In 33% of the sample locations, pole brushing was completed without issues according to the clearance protocols. The IE defines this as no vegetation growing at the base of the pole nor any vegetation encroachment discovered on the asset within a 10-foot radius from the pole and 8 feet above the ground.

However, it was observed that 3% of inspected brushed poles was completed but had vegetation encroaching 8 feet above the ground.

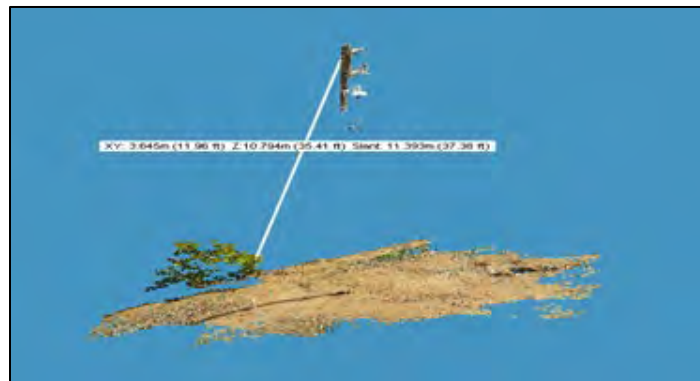
Image 37: 3D-Model Into 2D-Plane.

Image 35: 3D-Model Into 2D-Plane: A second tool to precisely evaluate, store and monitor over time the physical attributes associated with any of SDG&E's system assets is represented by the image below; again, the caveat: this example was created using the 19 SDG&E images of that same pole; however, images with 90% overlap are required for better modeling. For this specific case, a 3D model was projected into a 2D-plane, in order to measure the distance of 11.393m (37.38 feet) from the top of a nearby bush to critical hardware on the pole.

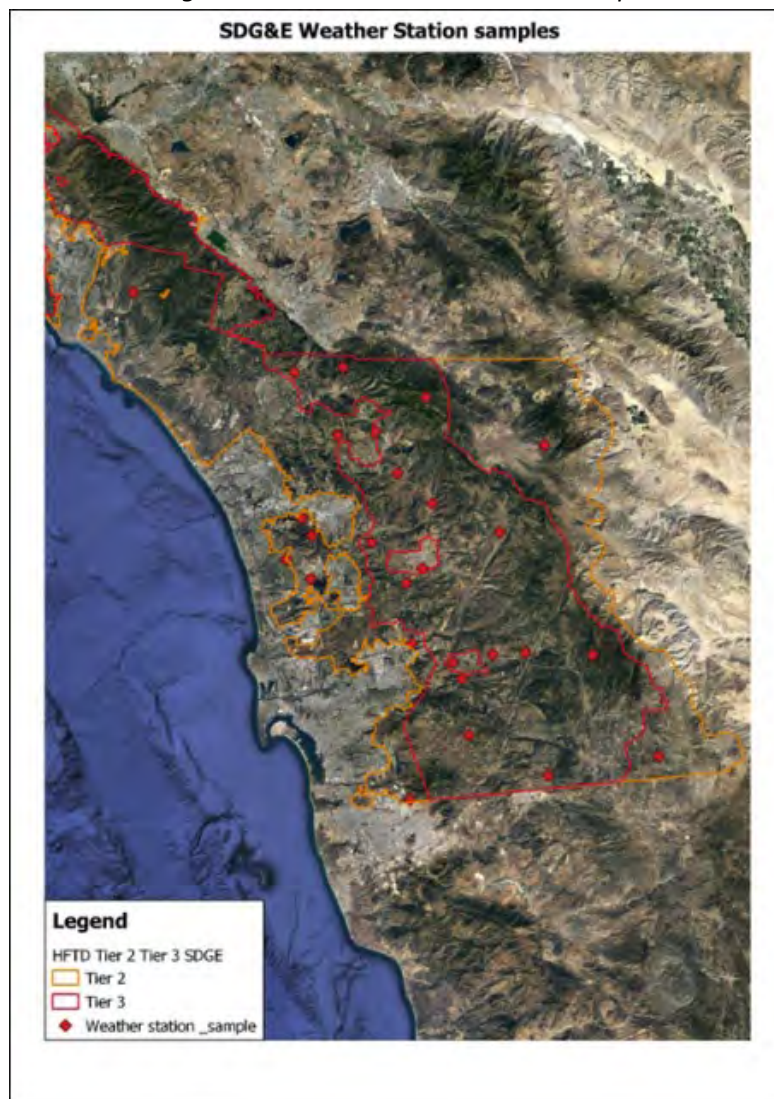
Image 40: SDG&E Weather Stations Sample.

The IE requested and received information on the pool of 46 weather stations upgraded in 2021. 27 of these were chosen as a sample to review the physical locations and operational status of these units. Image 40 shows the sampled locations. The IE's analysis⁹⁶ examined data from the aerial images, excerpts of the images, and screenshots of streamed data from the weather stations. Alongside this primary data, secondary data included the information on poles/weather station surroundings.

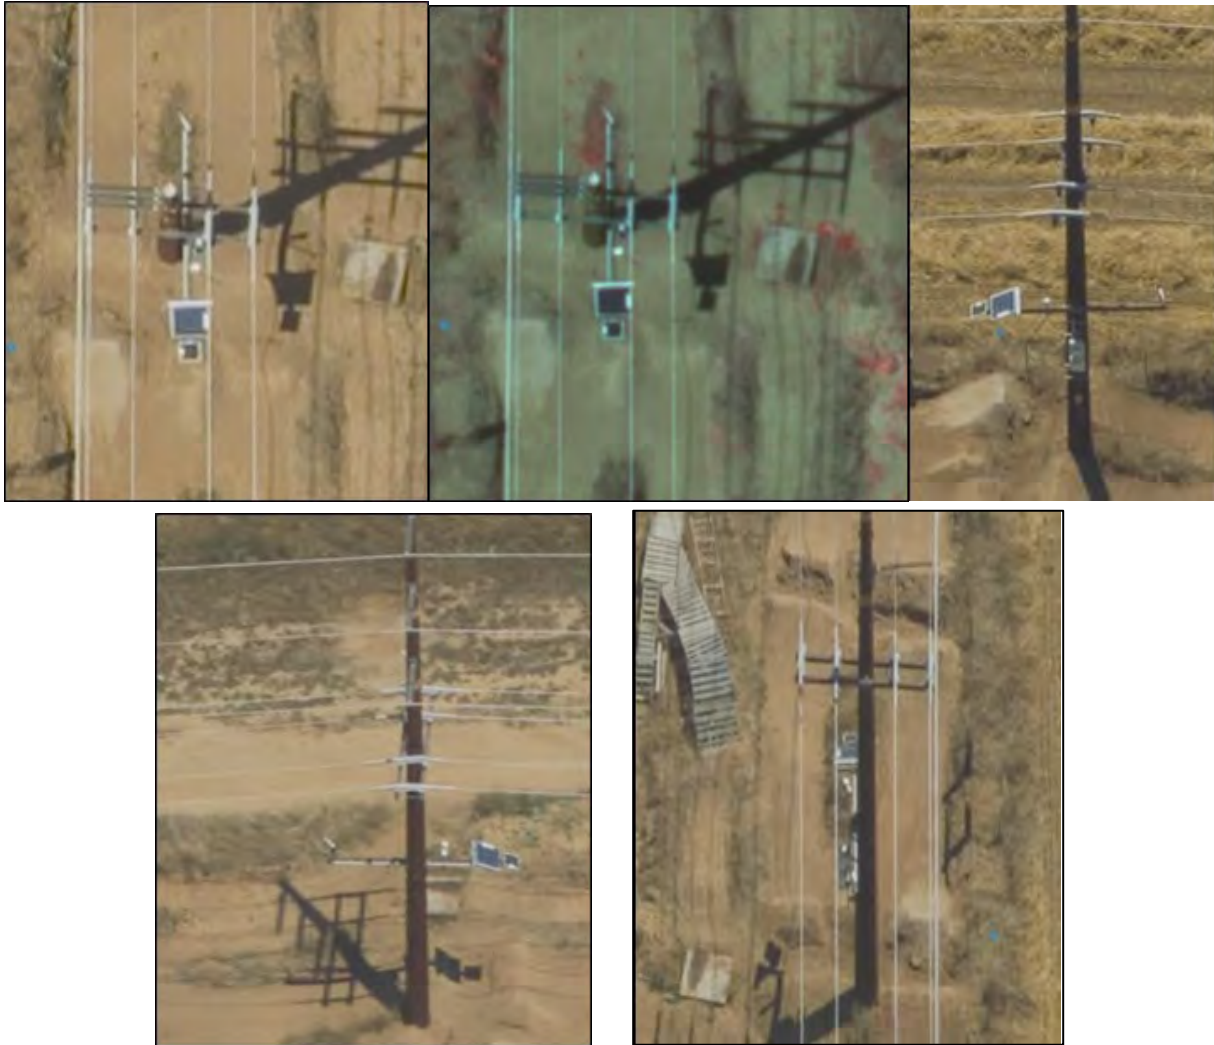
Images 41: Collection of high-resolution aerial images.

As discussed in detail in the analysis, this review was performed through inspection of high-resolution aerial images (See Image 35) and review of streamed data from sampled weather stations. Based on the data streamed from the weather station and the available images, we see that a weather station consists of a solar panel as a power source and equipment to measure wind speed and direction, air humidity, and temperature.

- All sampled weather stations are operational and providing live stream data. The analysis also includes comments on environments of poles on which are weather station mounted.
- The weather stations are in various environments. All checked stations are mounted between 5 and 6 meters above the ground. Some poles have adequate vegetation clearance, (for example Bell Canyon), while others (such as Highland Valley West) have high vegetation in the immediate vicinity of the pole and weather station. The IE expresses concern about the effect of close vegetation on the changing microclimate near

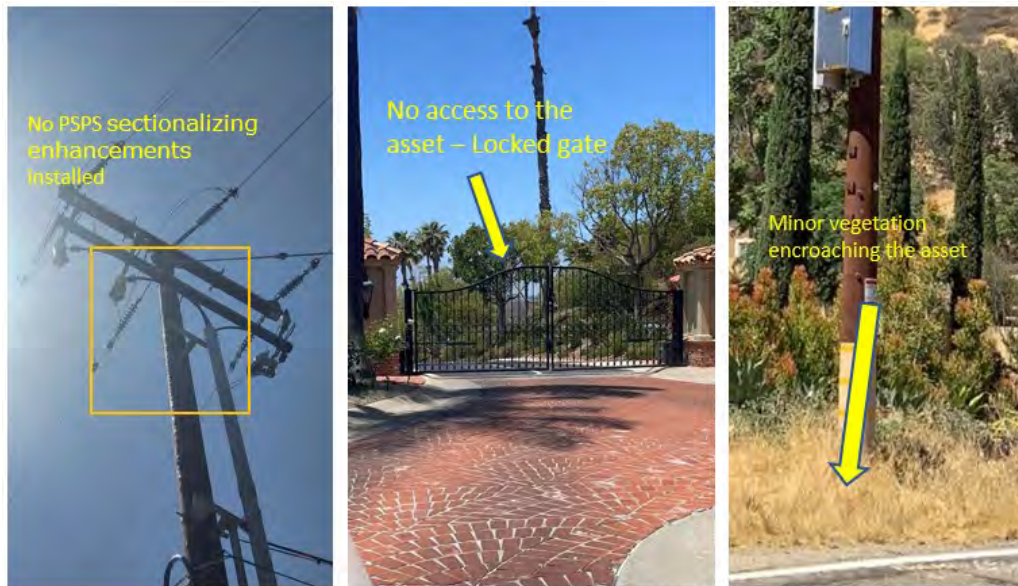
Image 45: Sectionalizing Enhancements with issues.

- No installation issues observed/Other issues observed
 - The device installation was good but minor vegetation encroachment was observed at the base of the pole.
- Installation issues observed
 - No sectionalizing device installed on the pole at two locations
- Unable to access and inspect the asset
 - Assets were behind locked gates at three inspection sites

SDG&E exceeded their 2021 installation target for P5PS sectionalizing enhancements by installing 13 units rather than the ten planned. Based on the small population of units installed in 2021, a statistically valid sample consists of 9 inspections. The IE completed a total of 10 inspections.

Following analysis of the inspection results, however, it can be seen that 30% of the sample showed installation quality issues, including absence of the unit to be verified. Another 30% of the sample was not accessible so no inspection could be conducted.

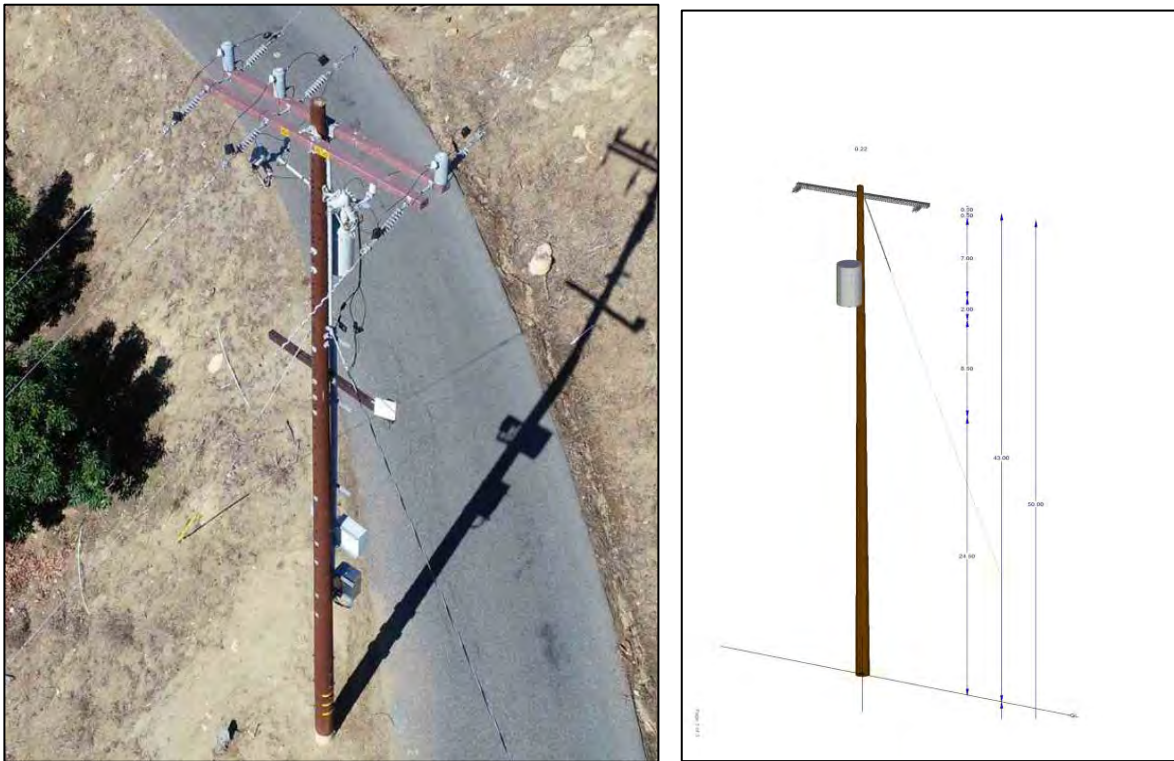
Image 47: PLS-CADD

In addition to the details of the circuit, the analytical information and structural details contained in this PLS-CADD report, each report also includes high-resolution images of the asset in situ (see Image 46) and PLS-CADD drawings of the asset (see image 47).

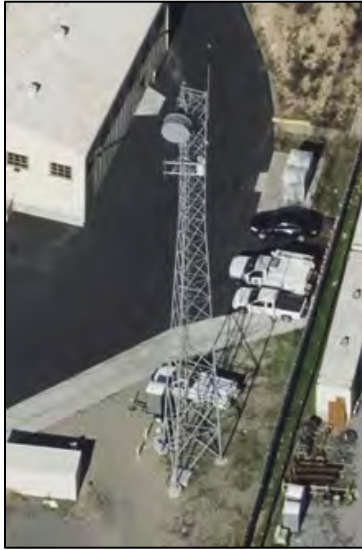
Image 48: DCRI-000003 with 1 antenna.

The IE verified this initiative through aerial means. Based on locations provided by SDG&E, IE concludes that the wireless network relies on using antennas mounted on towers or roofs. Even though there are places with 1 or 2 antennas (Images 45 and 46), there are some locations with multiple towers and multiple antennas in a single location.

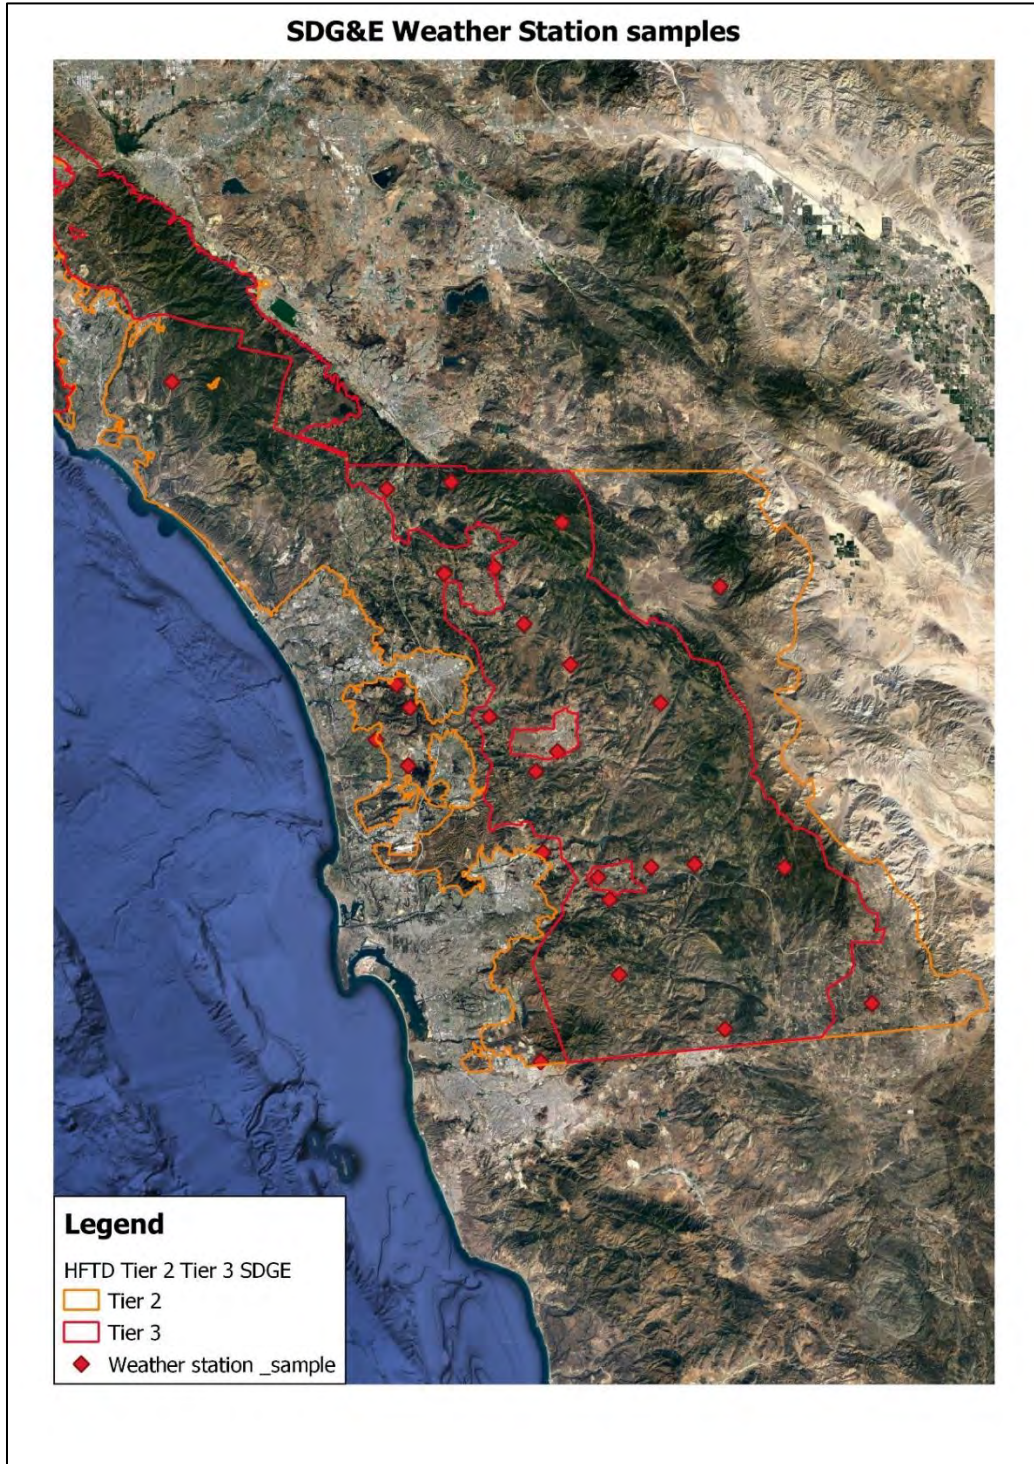
Image 3. SDG&E Weather Stations sample

Out of 195 weather stations in total, 27 were chosen as a sample to review the physical locations and operational status of weather stations in the SDG&E network. A map of the sampled locations is shown in Image 3.

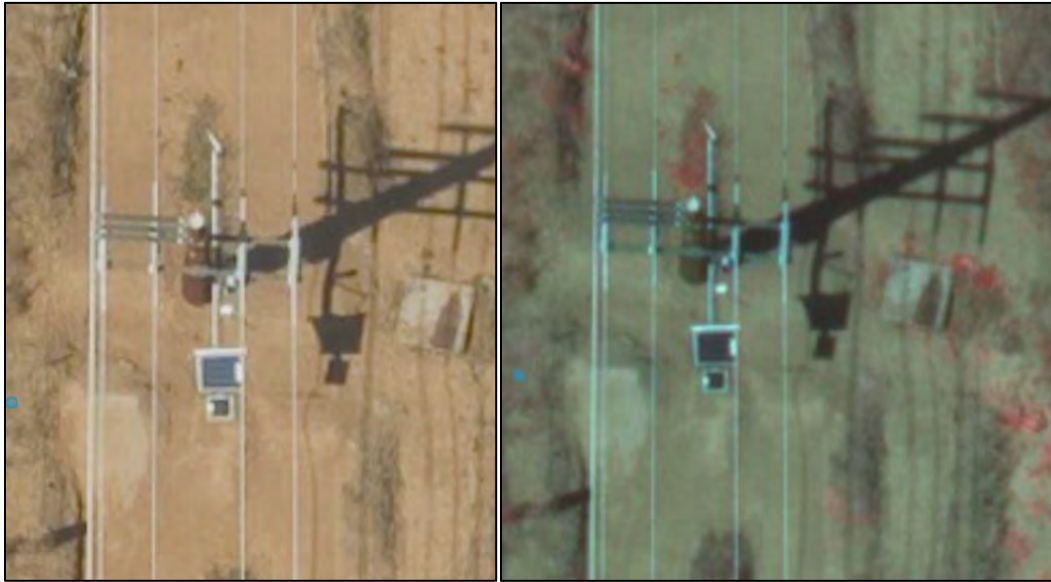
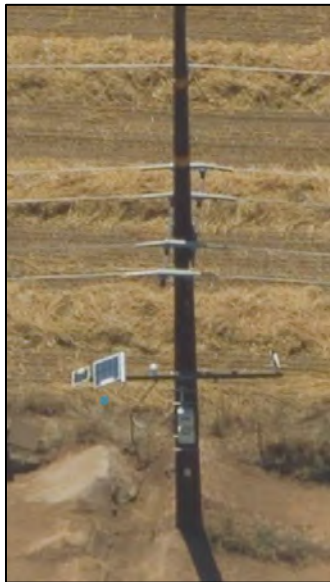
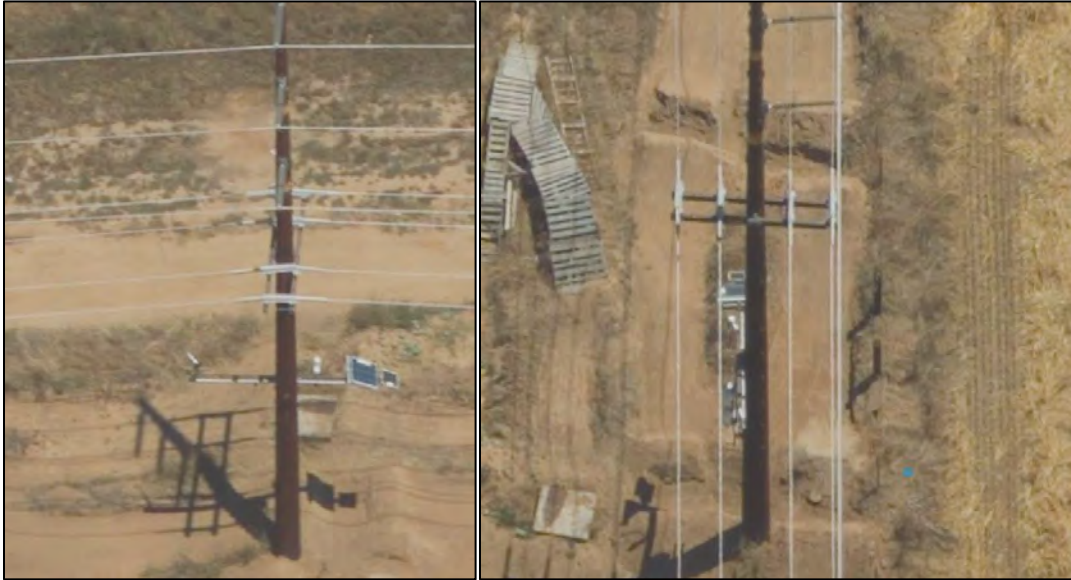
Images 4 – 8. Collection of high-resolution aerial images

The IE's review was performed through inspection of high-resolution aerial images (images 4 – 8) and review of streamed data from the sampled weather stations (<https://weather.sdgeweather.com/>).

Based on data streamed from weather station and the images retrieved, a weather station consists of a small solar panel as a power source and equipment for measurement for wind speed and direction, air humidity, and temperature.

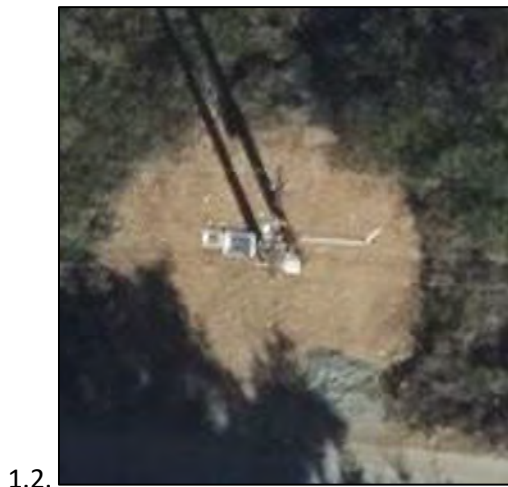
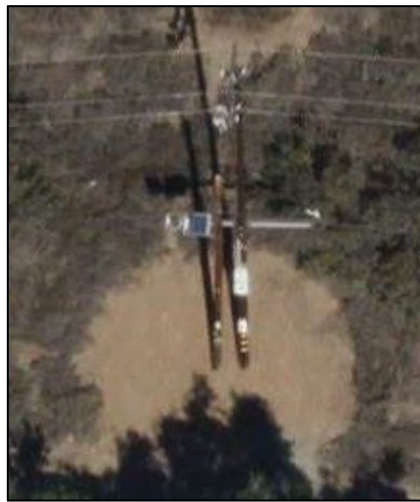
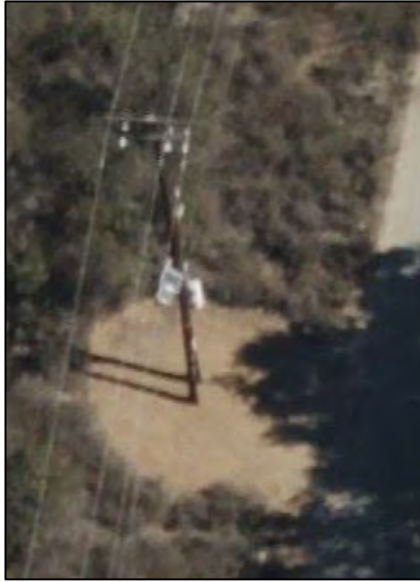
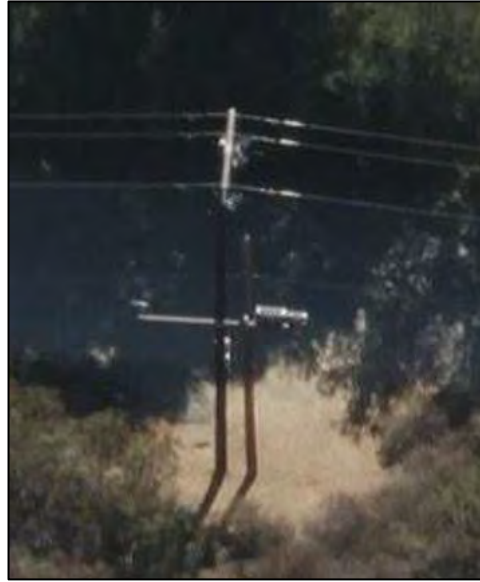
Station id	Station name	Imagery Date	Installation date	Latitude	Longitude	Status
CAP	Bell Canyon	NOV-DEC 2021	2009/08/01	33.557510375976563	-117.547416687011719	Operational

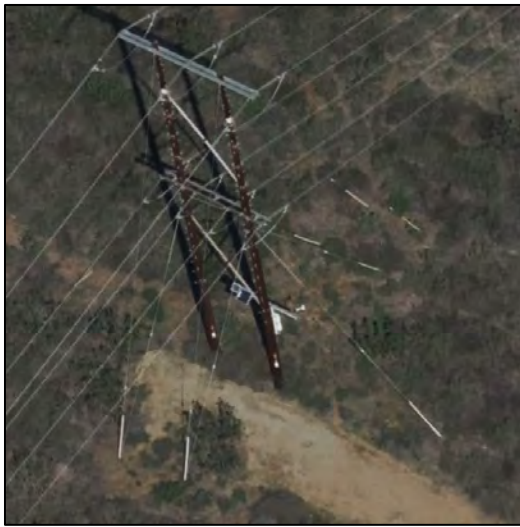
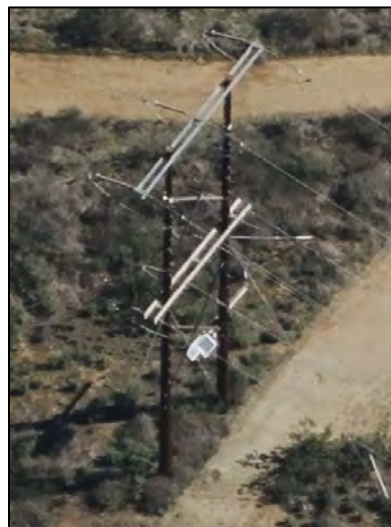
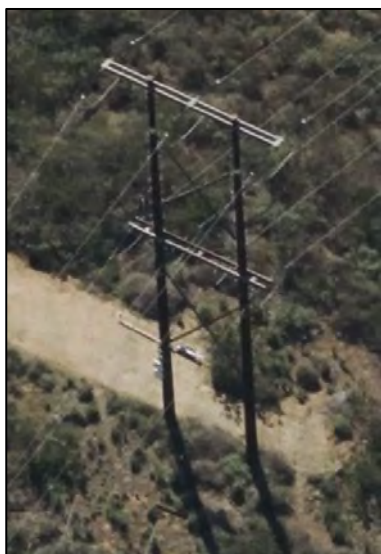
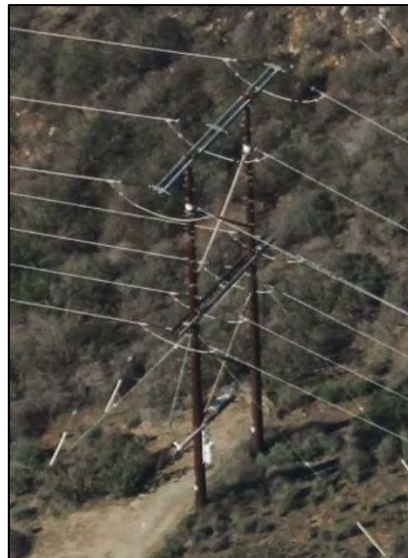
Station id	Station name	Imagery Date	Installation date	Latitude	Longitude	Status
ESC	Escondido	January 2022	2018/12/17	33.171571	-117.051485	Operational

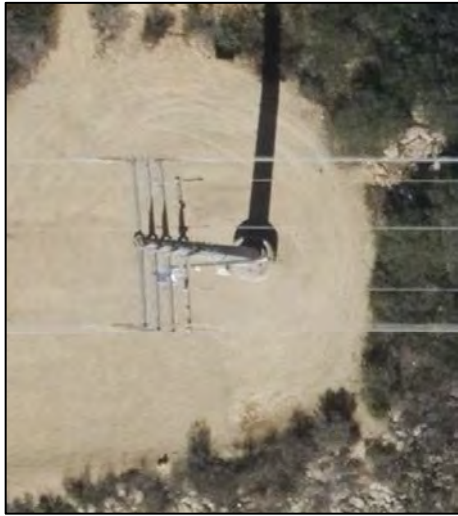
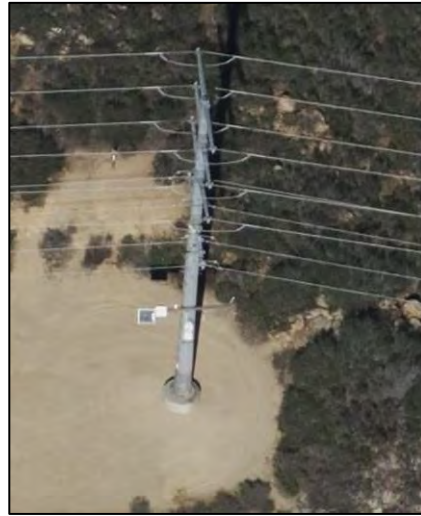
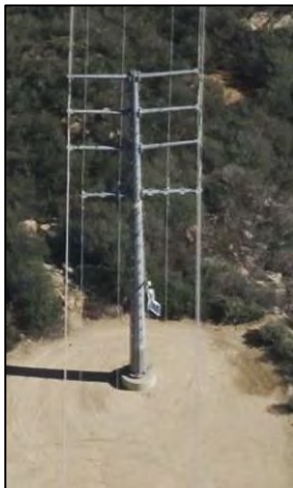
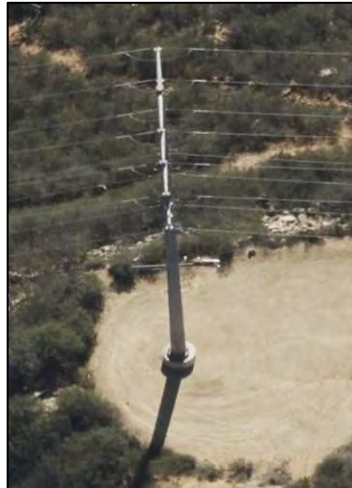
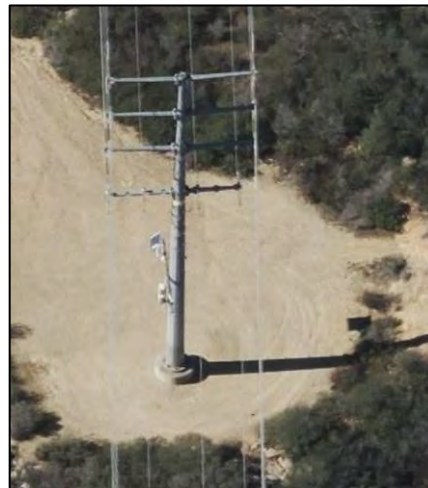
Station id	Station name	Imagery Date	Installation date	Latitude	Longitude	Status
OLV	Olivenhain	January 9 2022	2011/07/28	33.0801010131835	-117.129600524902	Operational

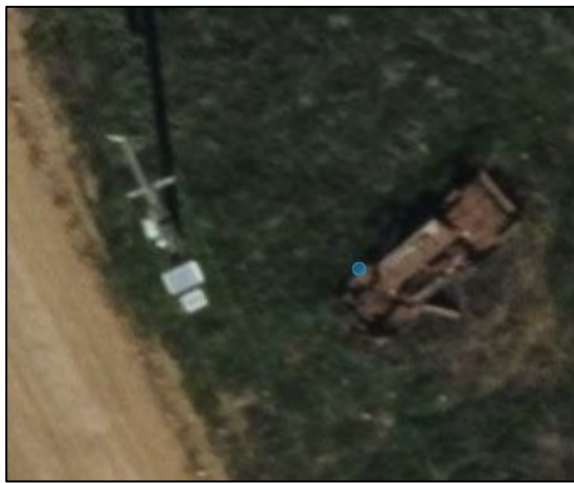
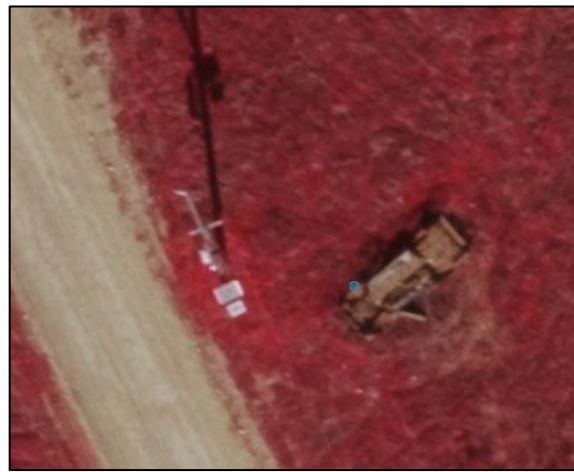
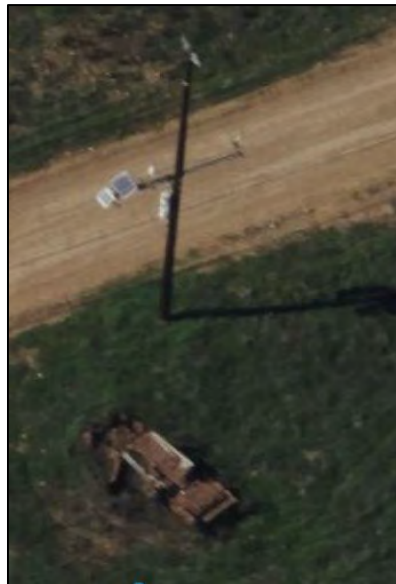
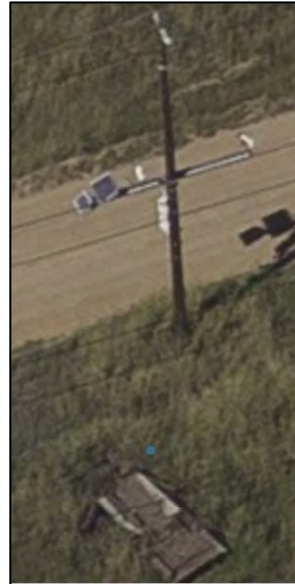
Station id	Station name	Imagery Date	Installation date	Latitude	Longitude	Status
OMB	Otay Mesa Border	January_9_2022	2012/09/08	32.558135986328125	-116.9004516601562	Operational

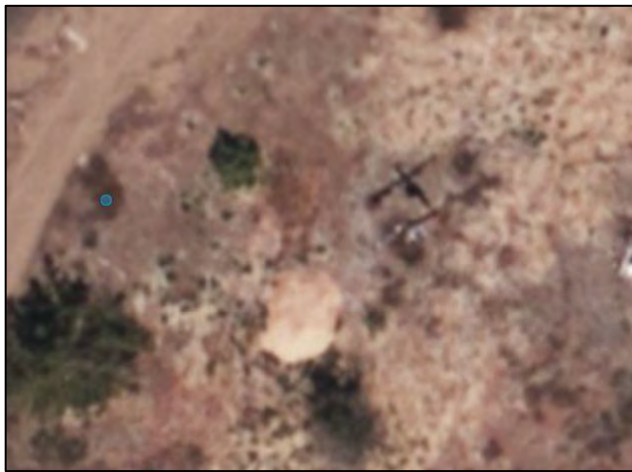
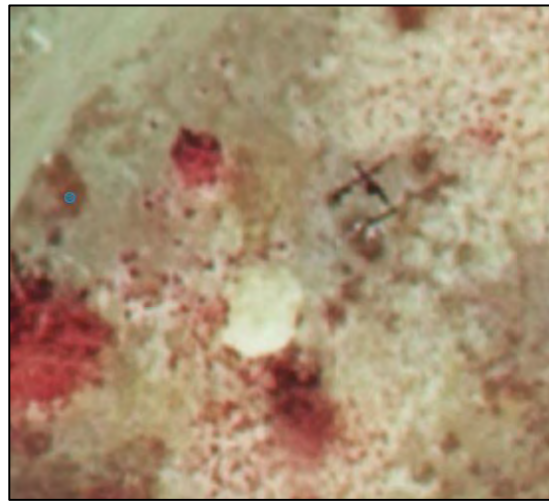
Station id	Station name	Imagery Date	Installation date	Latitude	Longitude	Status
PAM	Palomar	April 19 2021	2009/08/29	33.352138519287109	-116.86286163330078	Operational

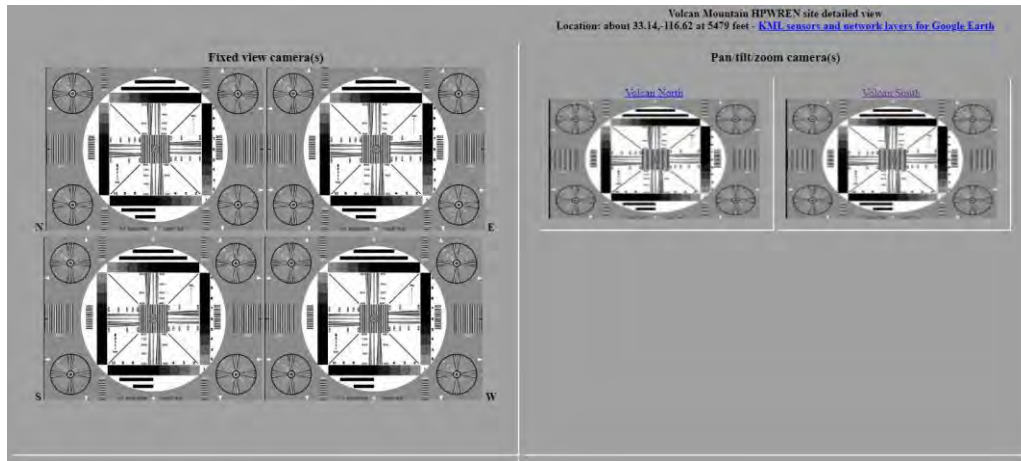
During the IE's inspection period, the cameras located on Volcan Mountain had no feed to inspect (image 6). On June 5th 2022, this was reported to SDG&E. On June 6th, the location at Volcan Mountain had recorded images and current feed available (image 7) .

Image 6. Volcan Mountain Static and PTZ cameras without feed (*source: <http://hpwren.ucsd.edu/cameras/>*)

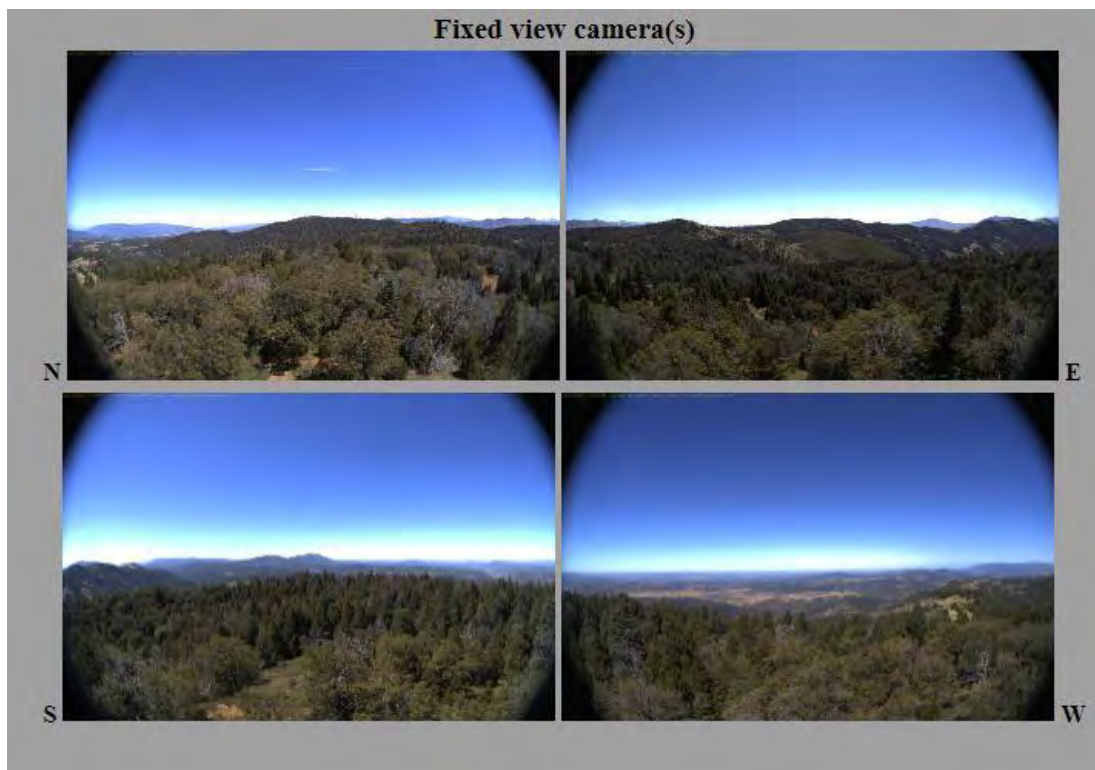
Image 7. Volcan Mountain static cameras with feed (*source: <http://hpwren.ucsd.edu/cameras/>*)

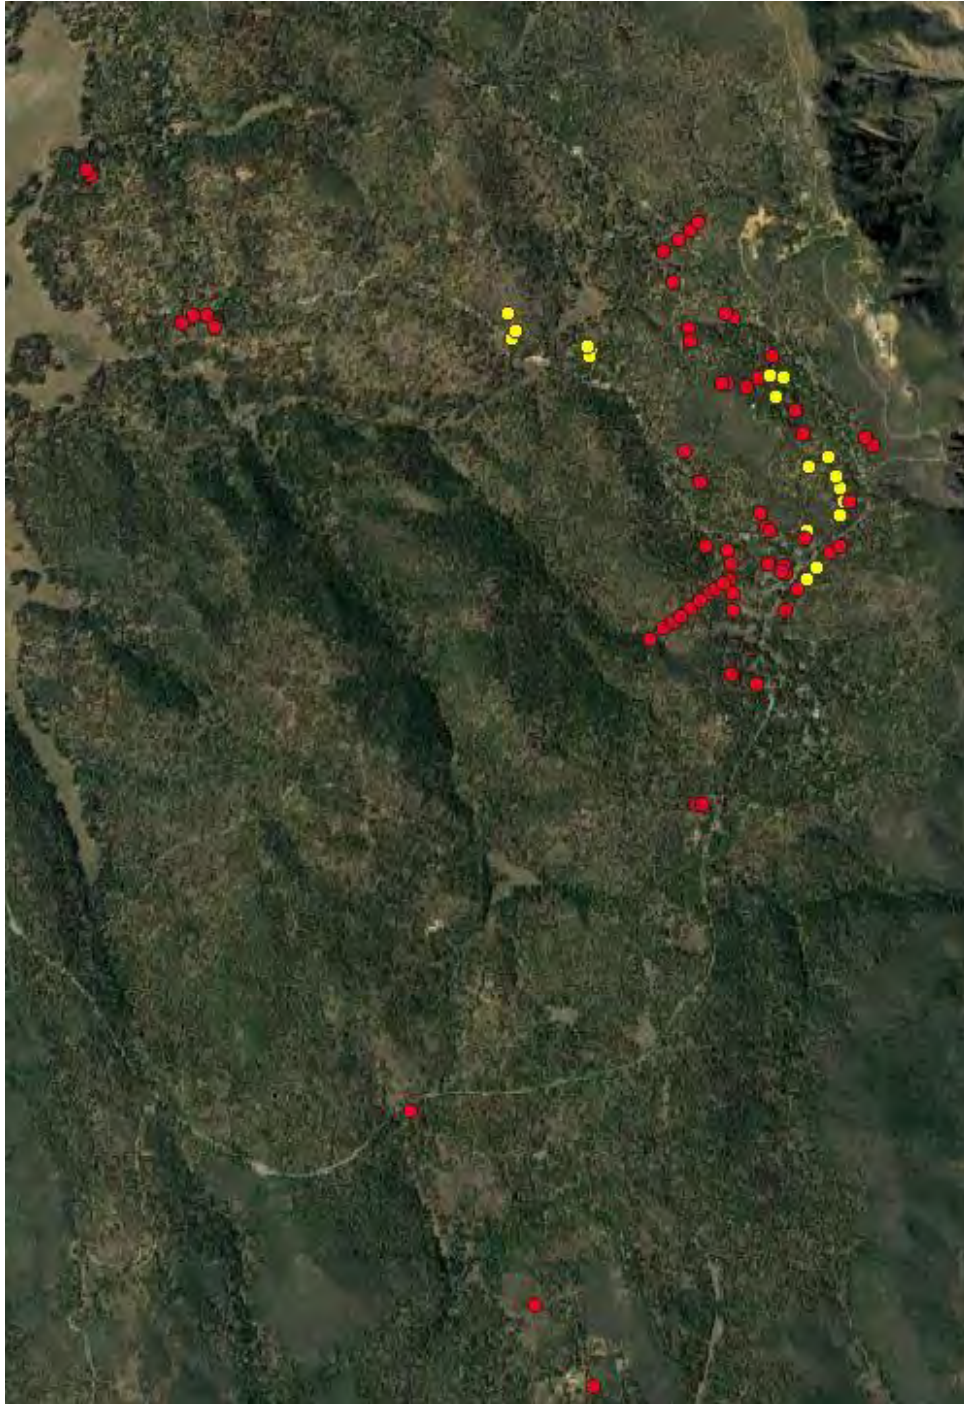
Image 1. Location of sampled points

Three (3) poles, P40427, P40429, and P40363 which were tested for precision showed a very high mismatch between the position of the presented work and the position of the actual poles. In Image 2 red diamonds are positions of work reported in DR15, while purple diamonds represent the actual position of poles. Both GPS locations were provided by SDG&E. This level of error in a forested area could potentially mean loss of time and inaccuracy of fieldwork. Images 3 and 4 show poles P40427 and P40429 in CIR taken in spring 2022. In image 3 pole P40427 is presented by a lower blue dot, while the red dot placed among high vegetation should present the location of P40363. The upper blue dot in image 3 represents pole P40426.
