To: The Public, Local and State Agencies, and Stakeholders for San Diego Gas and Electric's 2021 Wildfire Mitigation Plan Independent Evaluator Annual Report on Compliance

July 15, 2022

FINAL INDEPENDENT EVALUATOR ANNUAL REPORT ON COMPLIANCE

SDG&E

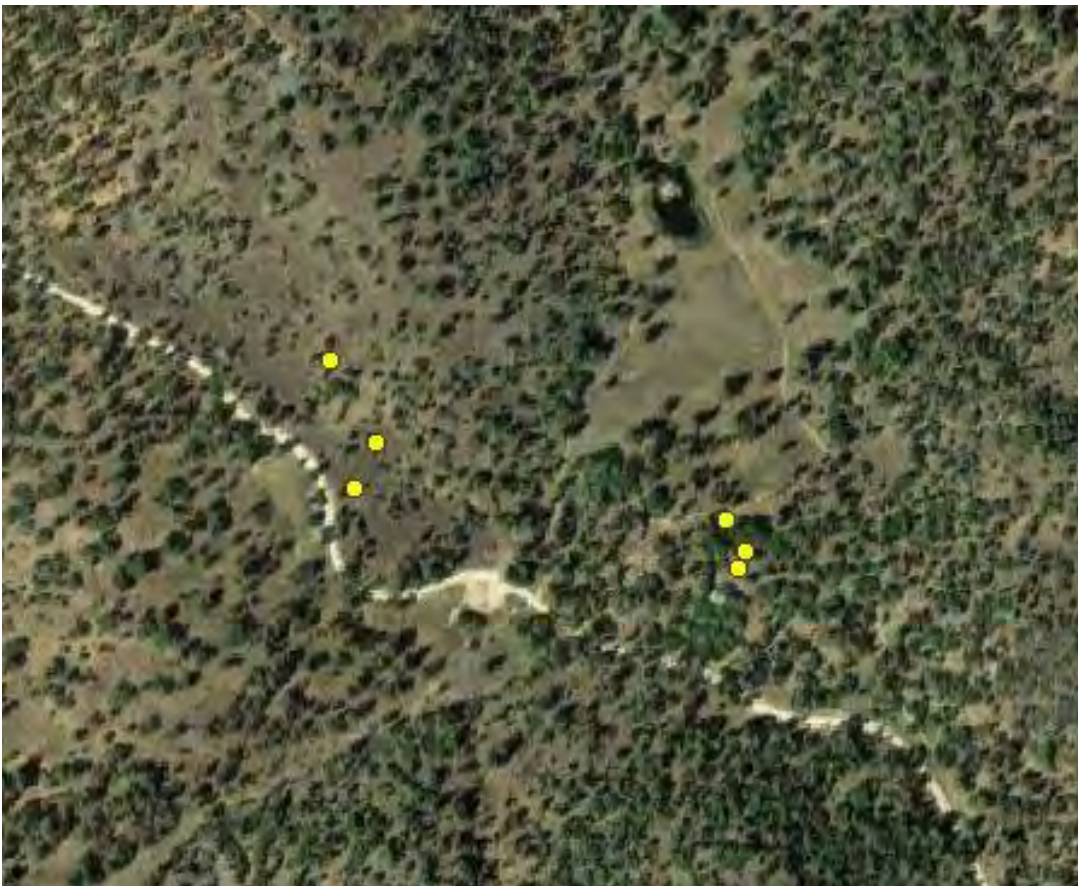
The next set of points of represented work consisted of six points - P40324, P40325, P40326, P40327, P260529, P40328. The location and spatial distribution of these points are shown in Image 5.

There was no mismatch of positions between reported work locations and pole locations. However, in these locations, there were no poles to locate. Neither in imagery from 2018 (images 6 and 7) nor in imagery from spring 2022 (image 8). However, image 8 shows the visible new line of the conductor (yellow line in image) with 2 new poles that can be connected with poles with no work reported (existing poles).

Image 5. Positions of 6 sample poles - P40324, P40325, P40326, P40327, P260529, P40328

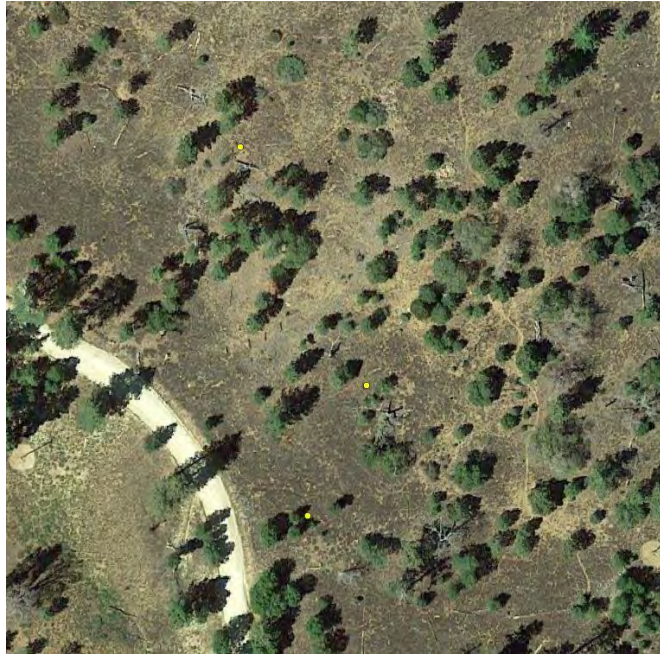
Image 6, even though there are 2 new poles visible, could not be tied to the work presented due to the mismatch of locations.

Image 6. Yellow points representing the positions of poles – no poles visible

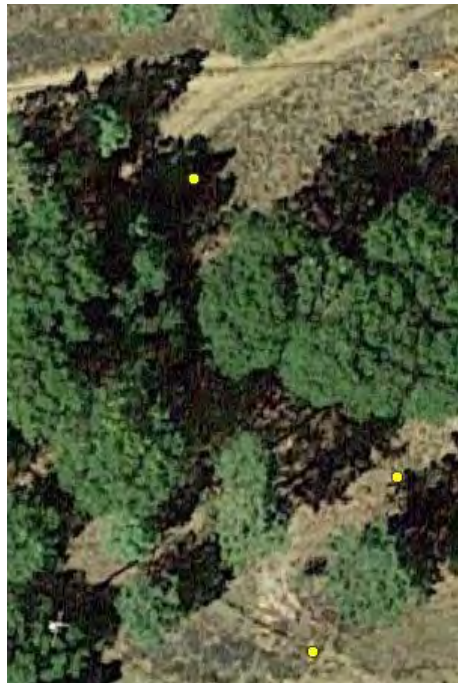
Image 7. Yellow points representing the positions of poles – no poles visible

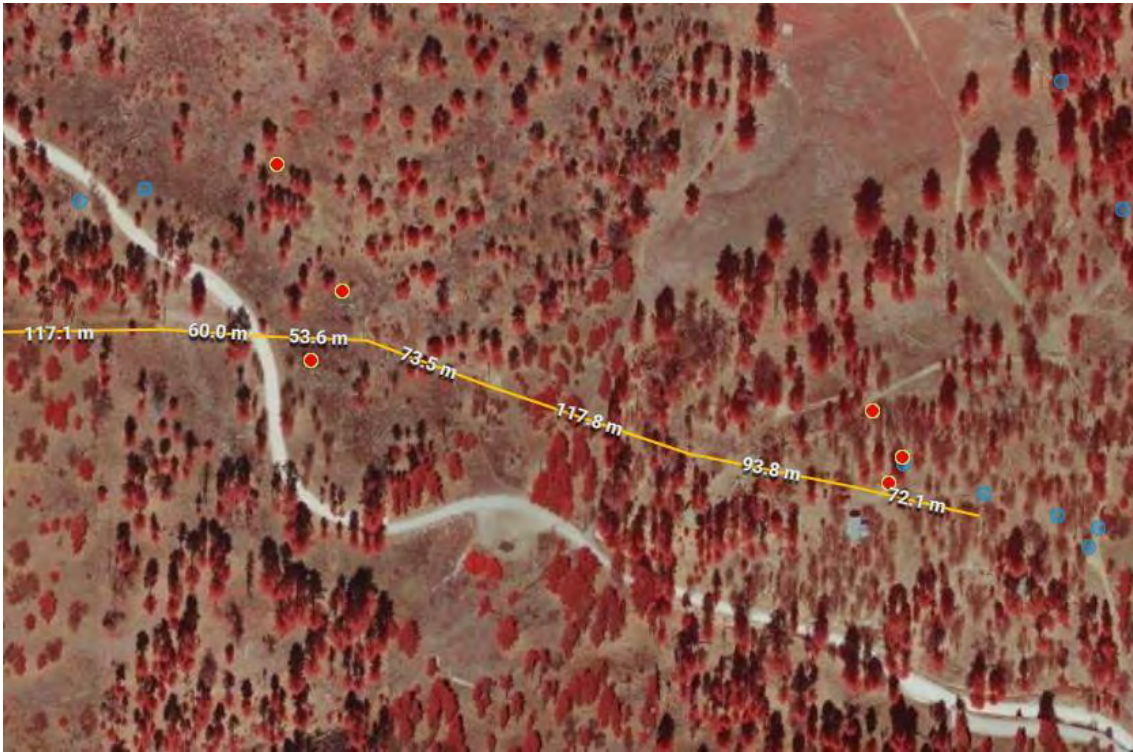
Image 8. Yellow line representing visible new conductor

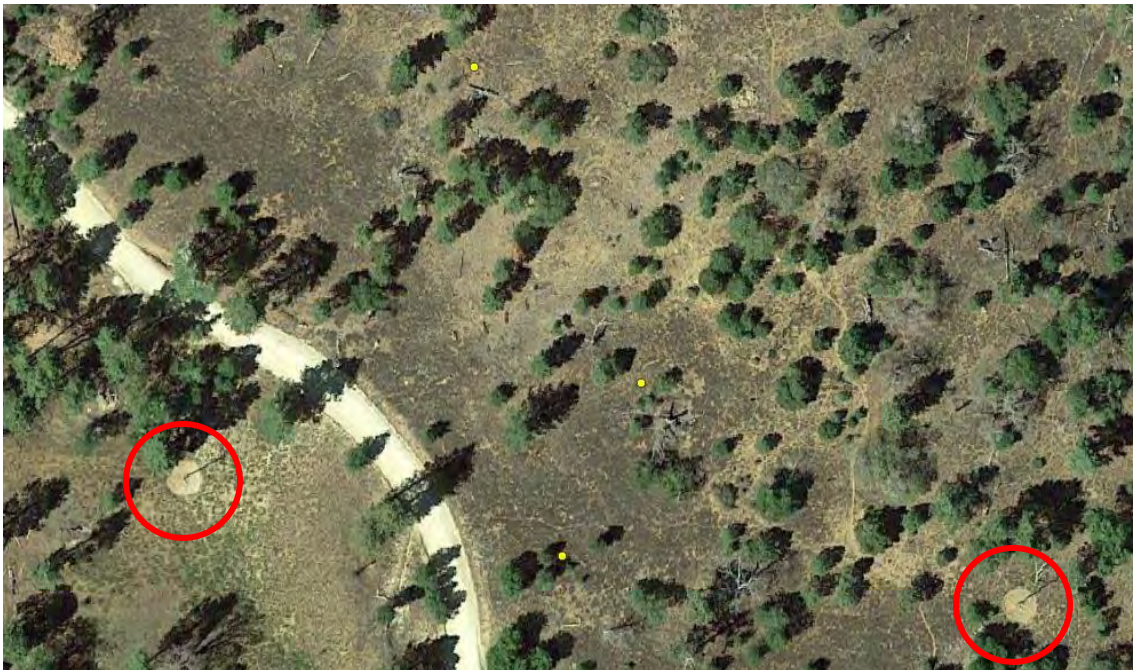
In image 9. Red circles point to two existing poles in the image from 2018. Image 10 in CIR shows those existing poles (red circles) with new poles (green circles) and new conductors between them. The pale blue line and points represent the poles and power lines which are not visible on maps.

Image 9. Existing poles presented by red circles

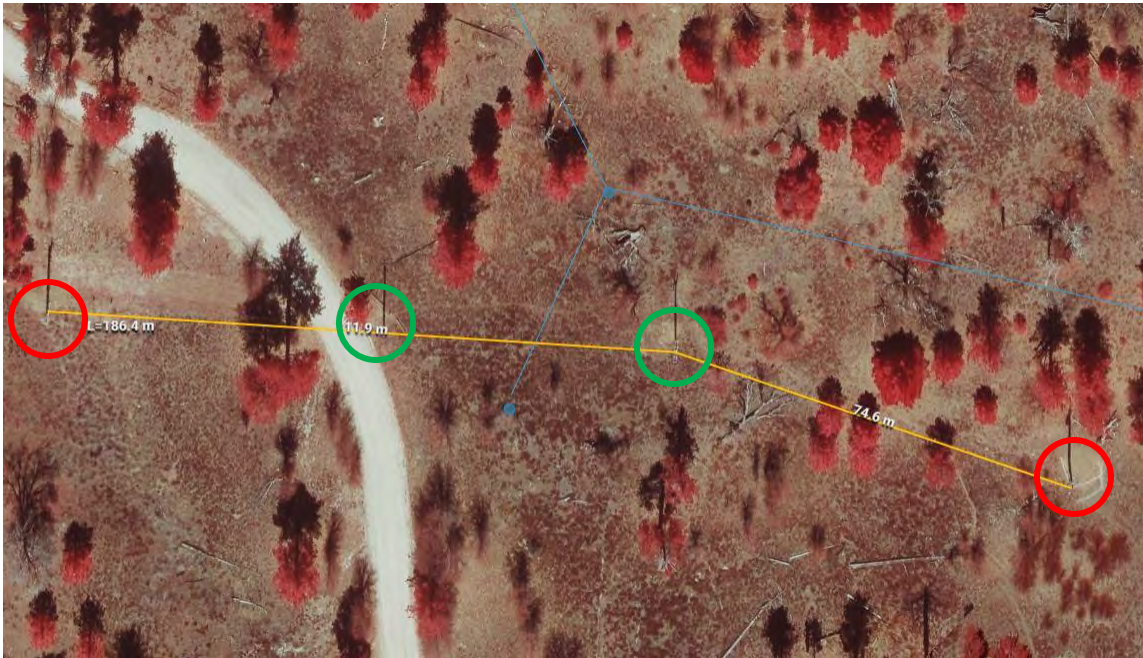
Image 10. Red circles representing existing poles, green circle representing new poles

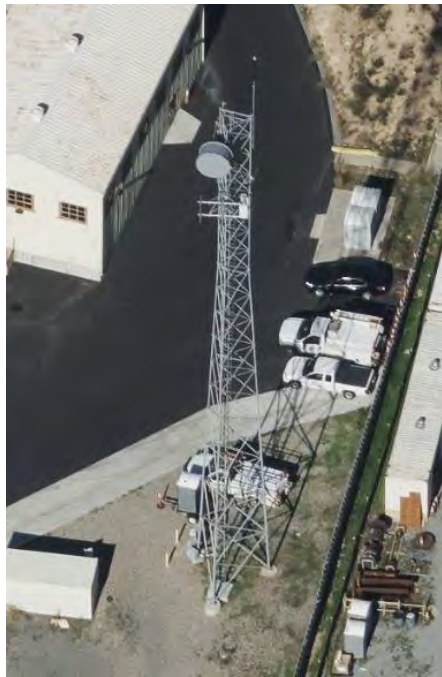
Image 1. DCRI-000003 with 1 antenna

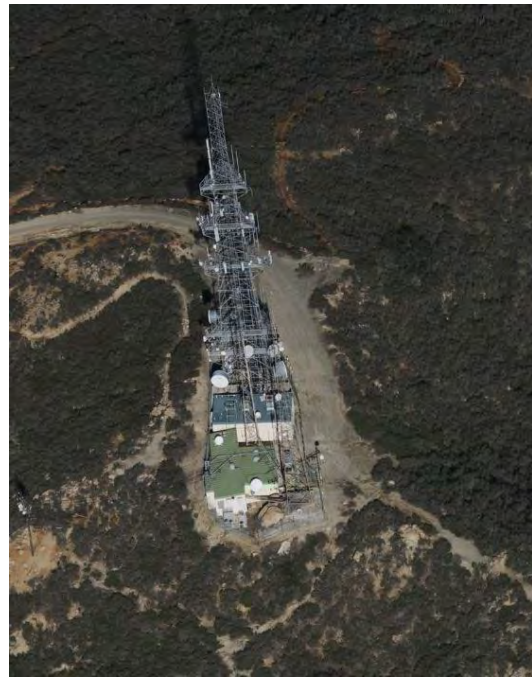
Image 2. DCRI - 000005 with multiple antenna

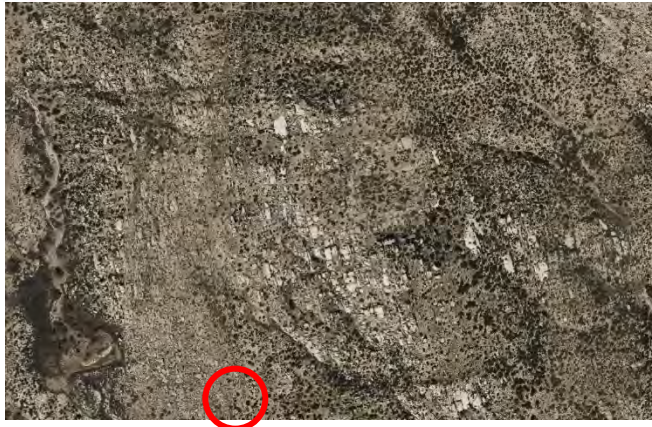
The IE managed to verify the locations of eight towers and antennas. In two locations, however, DCRI- 00001 and DCRI-00009, in the locations provided through GPS (lat/long) there was nothing like a tower structure within the area 150 – 500 yards in diameter around the reported position (images 4 and 5). In images 4 and 5, the red circle indicates the location where base station should have been found.

Other than through locating the base stations, the IE did not see a possible way to verify the fulfillment of work performed for initiative 7.3.3.18.1. The IE chose all ten locations as a sample; of these, two could not be found, while one could not be confirmed as an antenna on the roof (image 6). The IE did notice the trend inaccuracy in the provided GPS locations for infrastructure. The IE also observed that two antennas share the same name – DCRI-000001 (Image 4 and Image 6).

Image 4. DCRI-000001, No base station

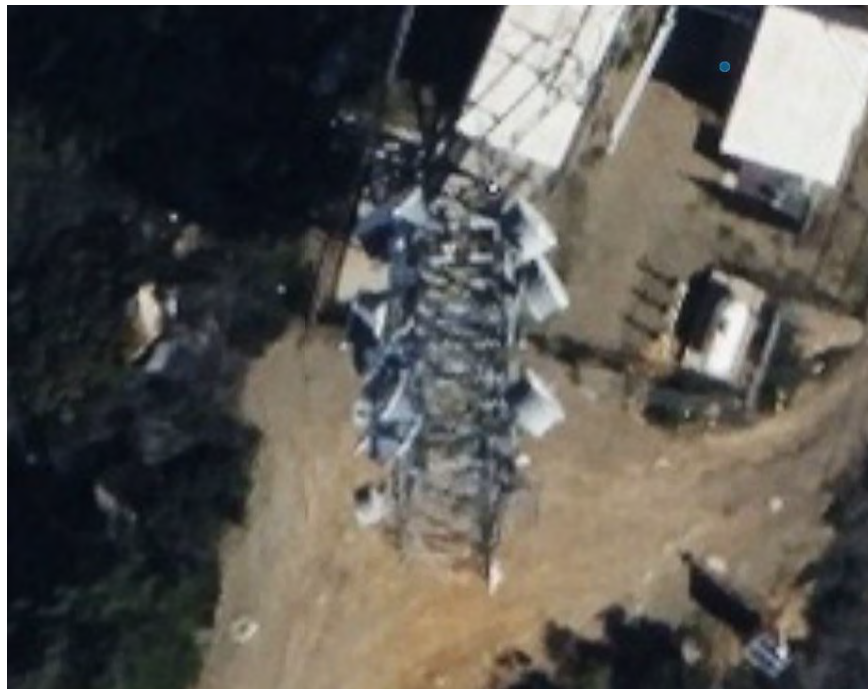
Image 7. DCRI 000002, Base station with multiple antenna

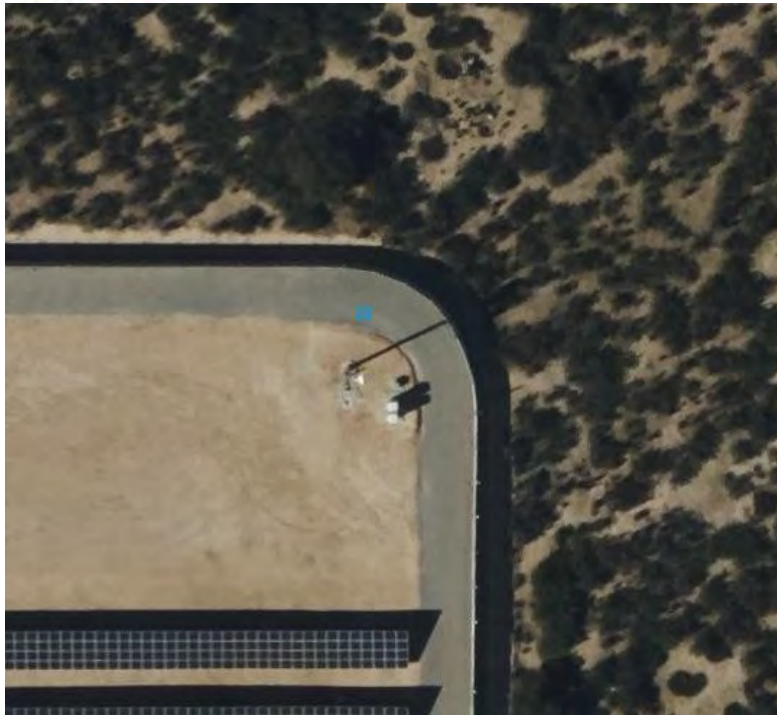
Image 8. DCRI 000007, Base station

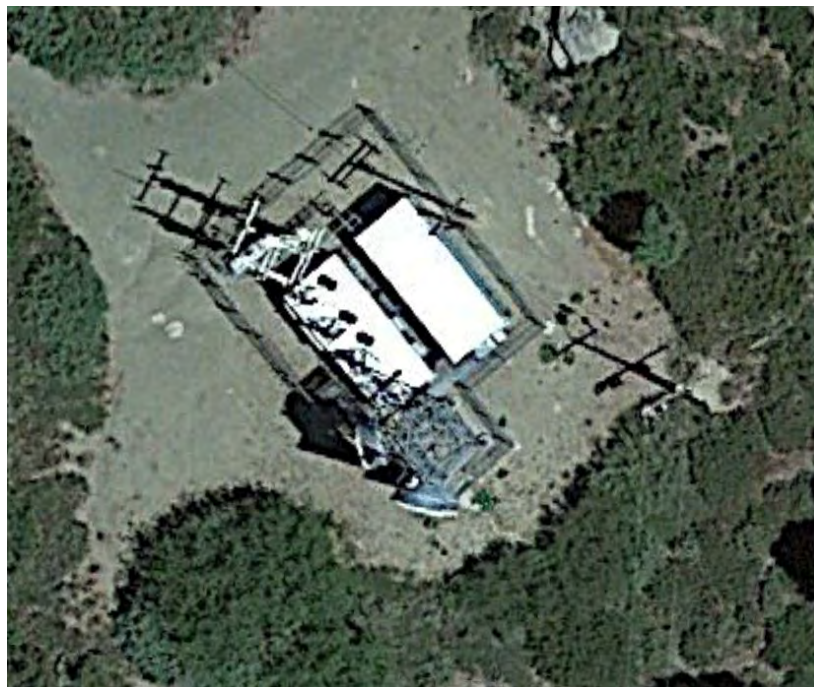
Image 9. Base station with multiple antenna

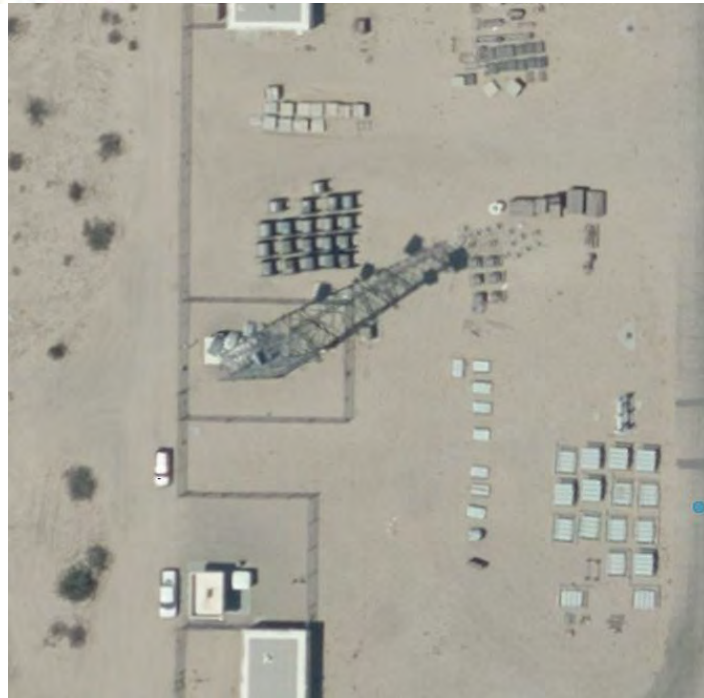
Image 10. DCRI-000004 Base station with multiple antenna

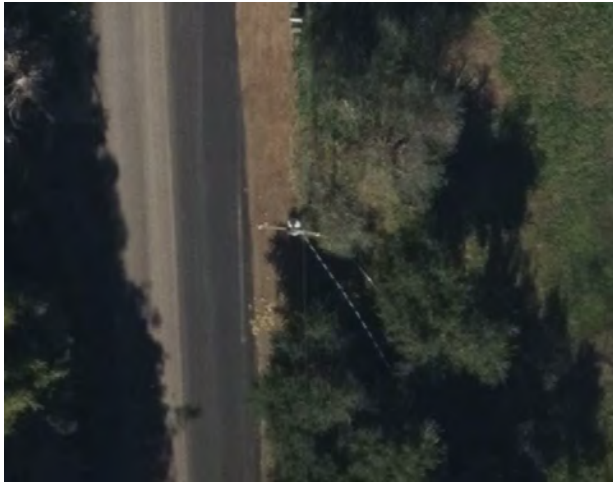
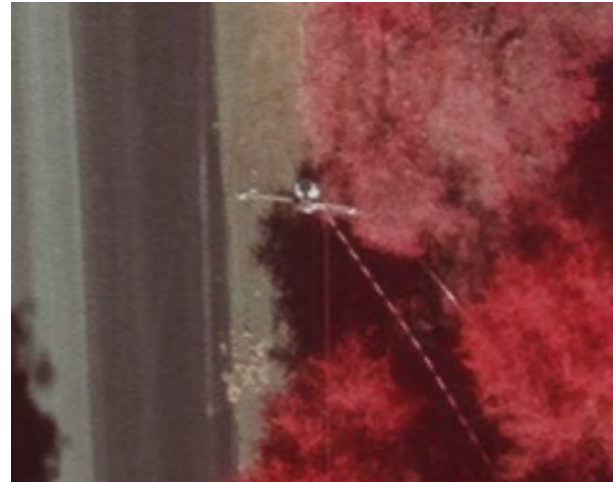
Image 1. Q4-7355-11673

- Image 1 showed canopy of tree very close to the pole.
- Image 12 showed potential low vegetation growth in the base of the pole.
- Image 21 showed dead trunks and branches of trees no further than 12-15 feet from the pole.
- Image 30 showed canopies surrounding the pole in close proximity.
- Additional issues were noticed on images 32 – 35. On these images high level of inaccuracy of GPS positioning of poles were noticed.

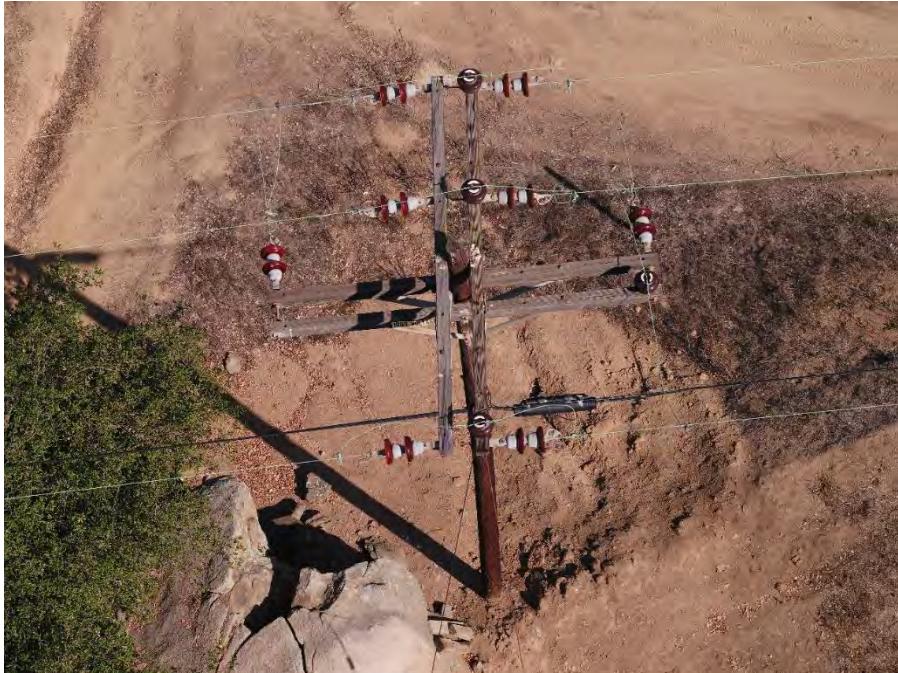
Image 36. Drone image of pole P711567

Images 36 – 38 show clean base of the pole, with little to no needs for trimming of vegetation.

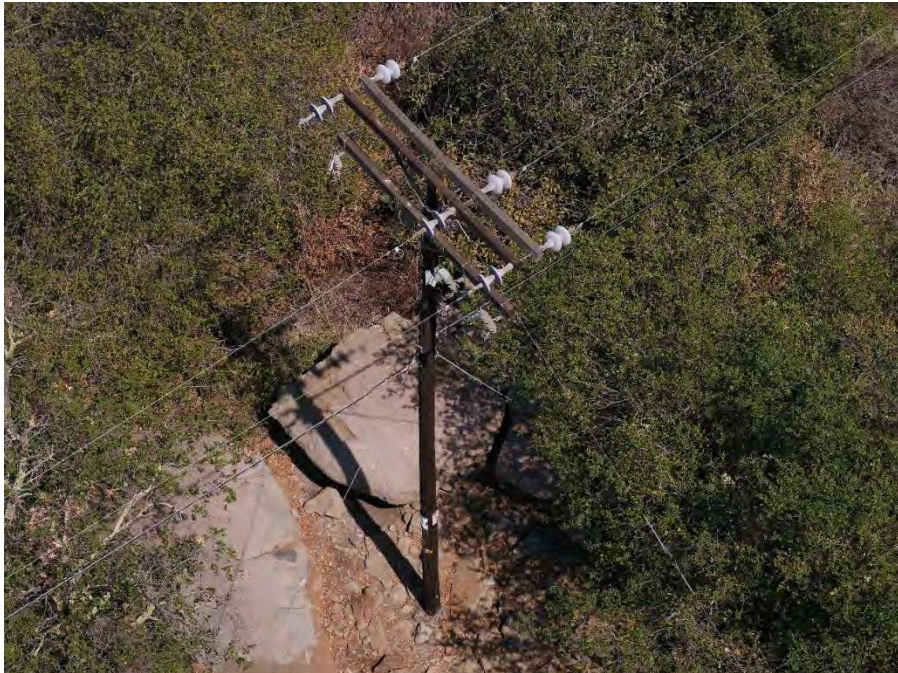
Image 37. Drone image of pole P115804

Poles P115804 and P115803 had trimming (7.3.5.20) and fuel management done (7.3.5.5). Although P115803 had been trimmed and base of pole kept clean, P115804, requires very little trimming (if any) and consequently very little fuel management activities. This was observed for fuel management activities. Poles were sampled blindly, and many of them that had fuel management activity had been surrounded only with low vegetation. Positive observation was that those poles had very well-defined clearance around the basis.

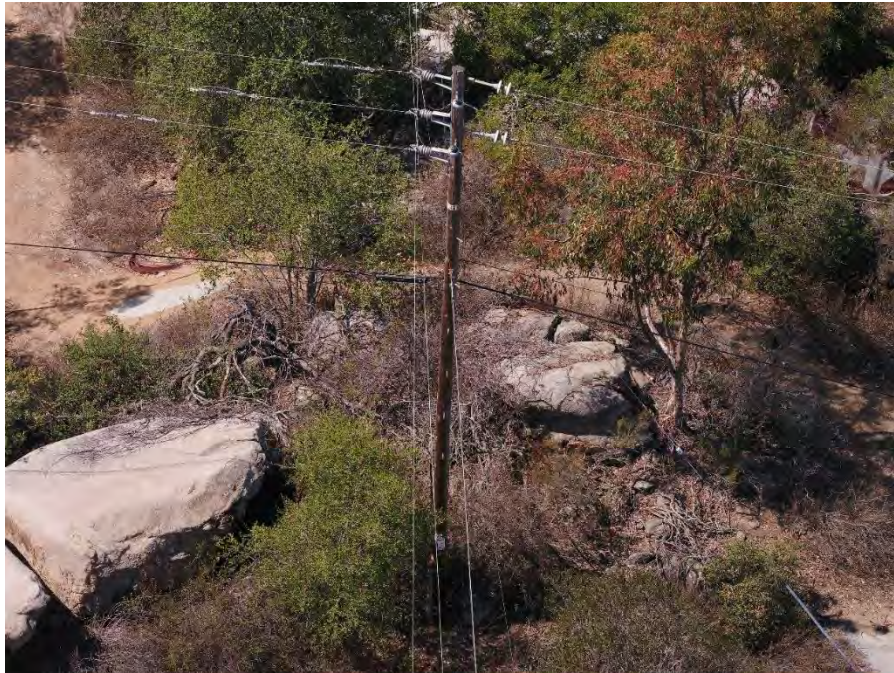
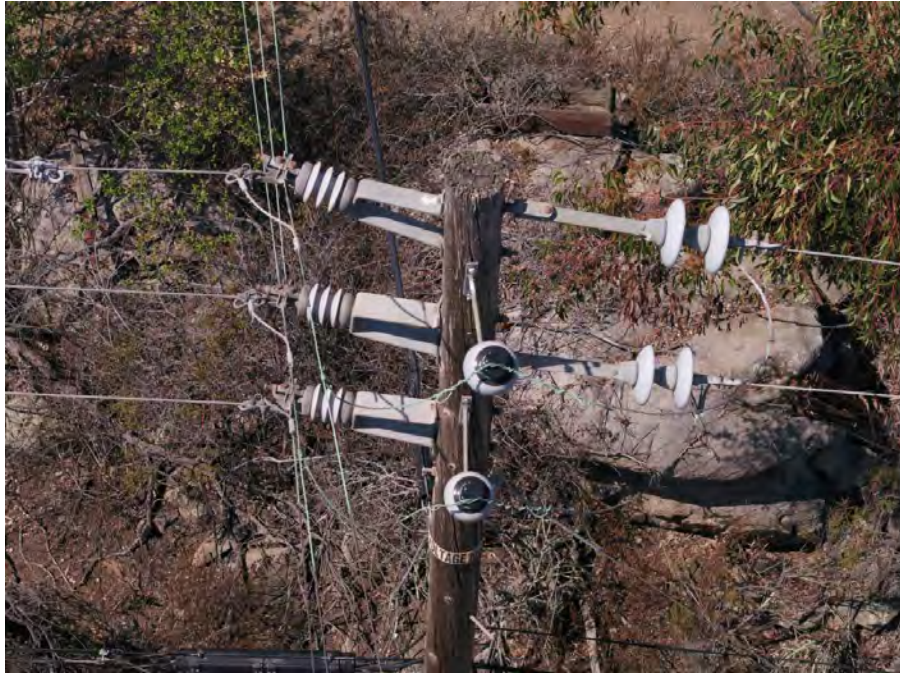
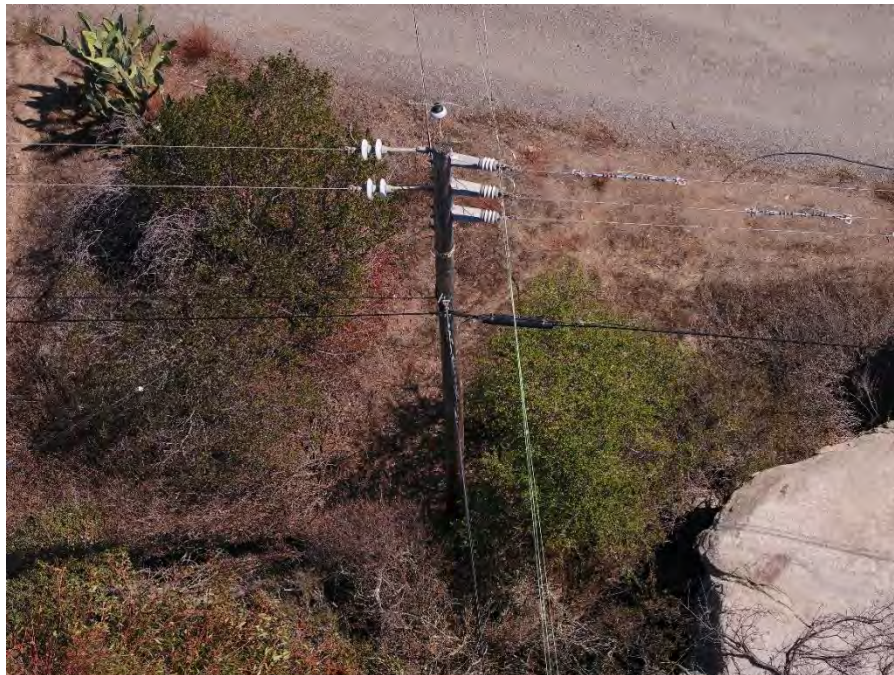
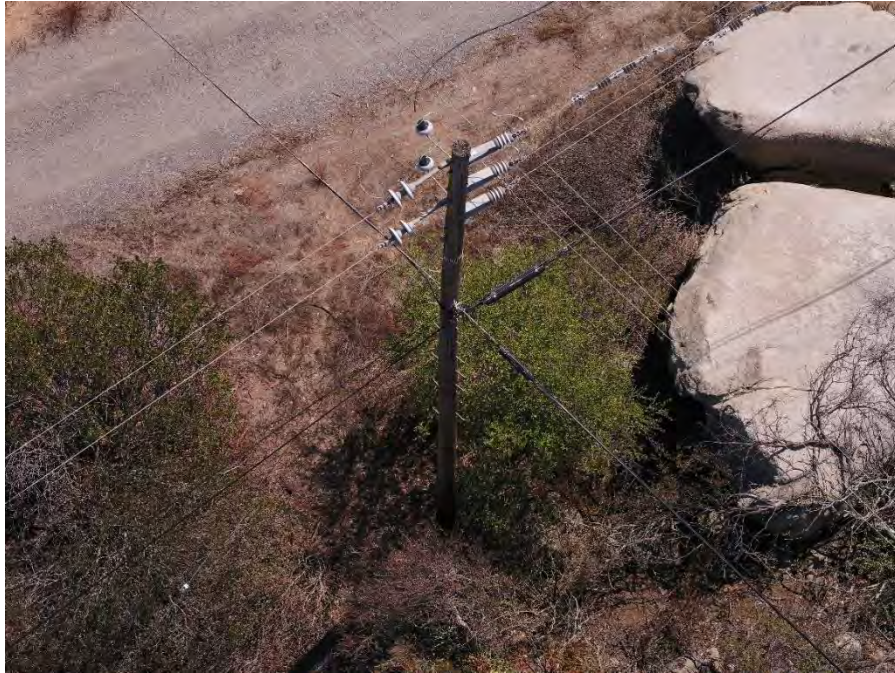
IE would consider this kind of vegetation presence around the pole to be a priority for trimming and cleaning, and it was obviously skipped while 2 closest poles had vegetation management work performed. This could raise a question on the vegetation inspection criteria and the criteria on selection of work to be done.

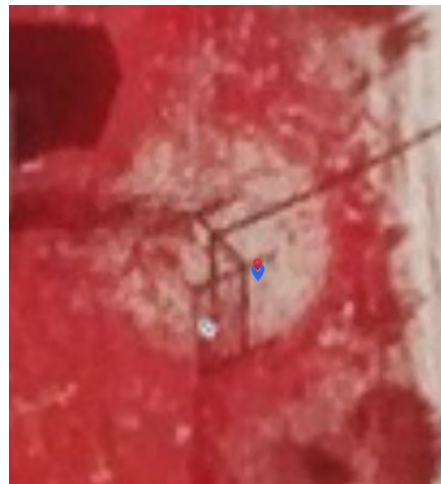
Image 12. Q4-7355-11742

- Image 1 showed canopy of tree very close to the pole.
- Image 12 showed potential low vegetation growth in the base of the pole.
- Image 21 showed dead trunks and branches of trees no further than 12-15 feet from the pole.
- Image 30 showed canopies surrounding the pole in close proximity.
- Additional issues were noticed on images 32 – 35. On these images high level of inaccuracy of GPS positioning of poles were noticed.

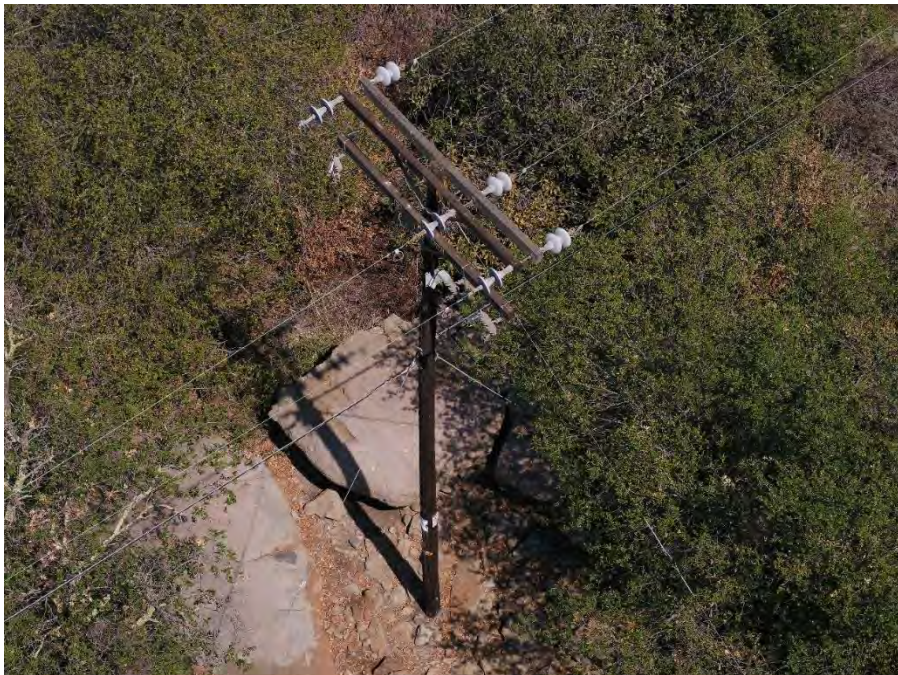
Image 38. Drone image of pole P115803

Poles P115804 and P115803 had trimming (7.3.5.20) and fuel management done (7.3.5.5). Although P115803 had been trimmed and base of pole kept clean, P115804, requires very little trimming (if any) and consequently very little fuel management activities. This was observed for fuel management activities. Poles were sampled blindly, and many of them that had fuel management activity had been surrounded only with low vegetation. Positive observation was that those poles had very well-defined clearance around the basis.
