NOV_SCE_MYU_20220406-01_Revised

NOTICE OF VIOLATION

Energy Safety Inspection Report

Report Name: MYU_SCE_20220406-01_Revised

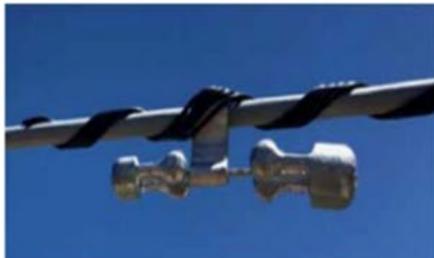
Figure 1: Stockbridge Damper

Installing vibration dampers on the covered conductor mitigates Aeolian vibration by protecting the covered conductor from abrasion and fatigue damage. The vibration damper standard was put into effect in October 2020 and is required for all covered conductors in light loading areas (elevation below 3,000 feet). Recently, SCE has been experiencing an acute shortage of Stockbridge Dampers (refer to Figure 1) for 336 ACSR Covered Conductor due to the high demand and supplier constraints. Additionally, the spiral vibration dampers (refer to Figure 2) for 1/0 ACSR, #2 Copper, and 2/0 Copper may be running low on stock.
