OFFICE OF ENERGY INFRASTRUCTURE SAFETY

~~DRAFT~~ ANNUAL REPORT

PACIFIC GAS & ELECTRIC COMPANY

2020 WILDFIRE MITIGATION PLAN

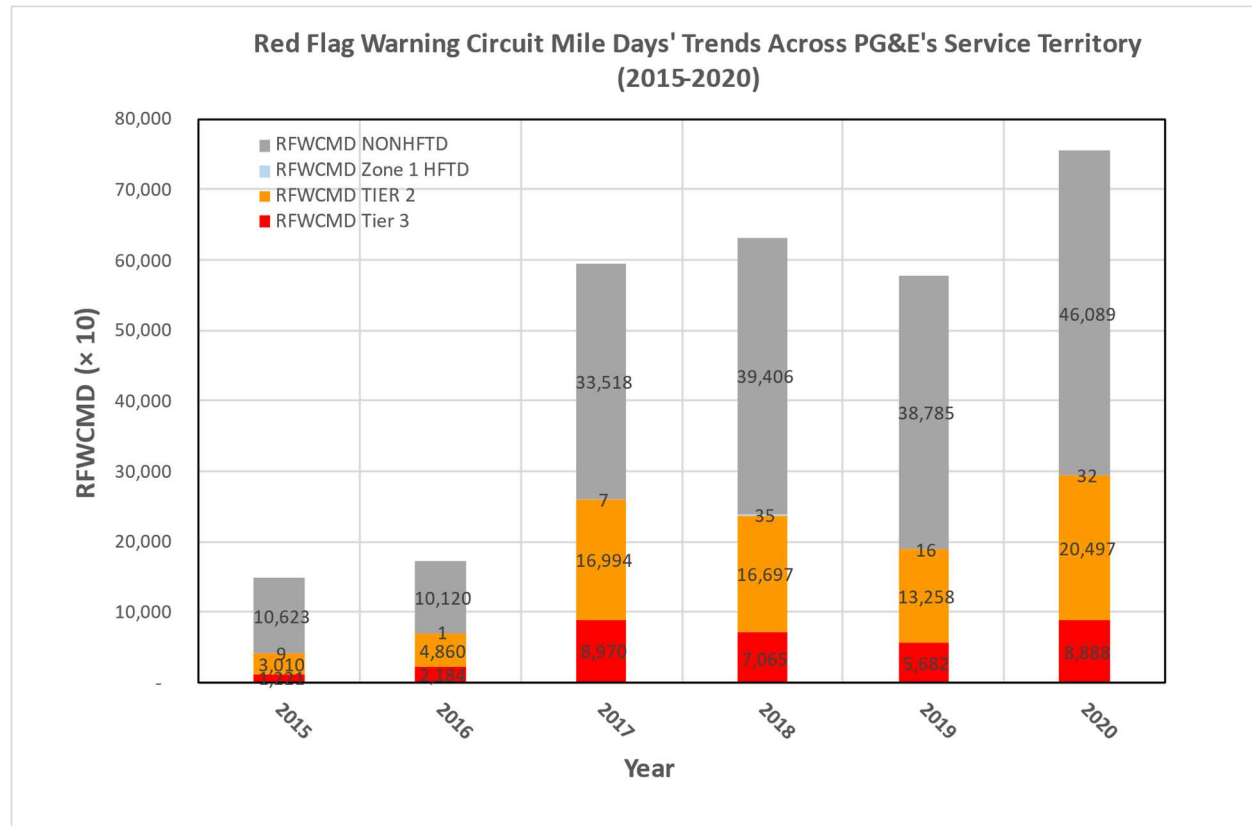
Figure 4: Variances in Extreme Fire Weather Across PG&E Territory from 2015-2020 by location.

PG&E has seen a steady increase in extreme fire weather events since 2015 with a significant spike in 2017. Energy Safety uses a metric, the red flag warnings circuit mile days (RWCMD) for overhead assets, to depict wildfire risk normalized for the size of an electrical corporation's service territory. Use of this metric allowed for comparisons across reporting years and enabled assessment of performance in 2020 relative to previous trends from 2015-2019. As noted in Figure 4 below, the RWCMD experienced in 2020 represented the largest value (i.e., worst fire weather and greatest exposure) over the six-year 2015-2020 reporting period.

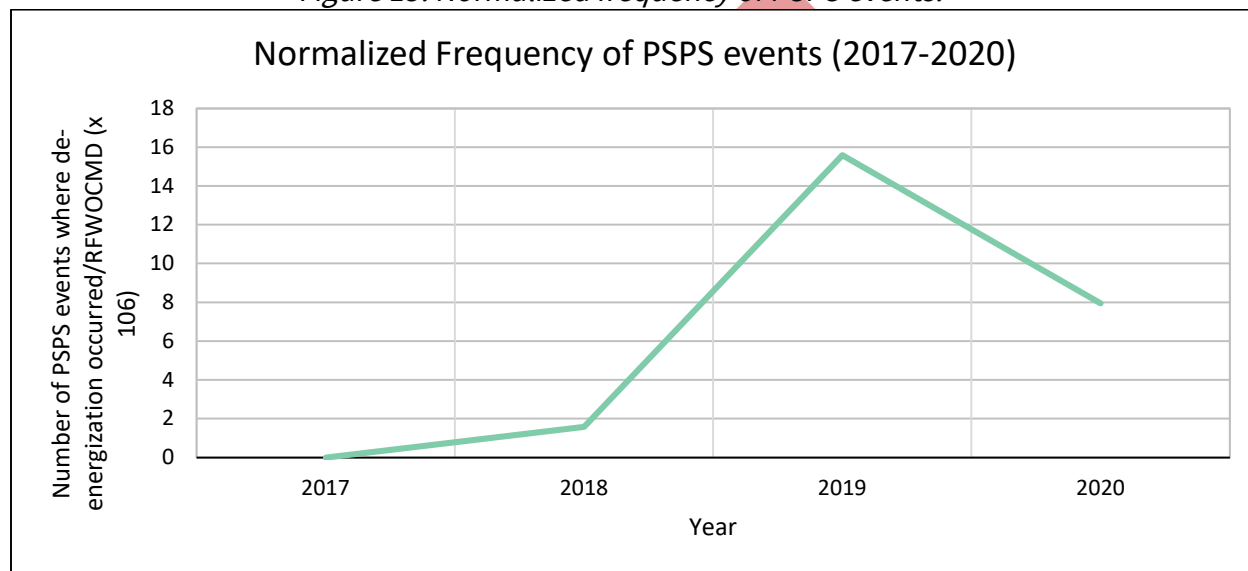
Figure 15: Normalized frequency of PSPS events.¹⁸²

PG&E reported data on its use of PSPS and other PSPS metrics in Table 11 of its QDR (QDR Table 11).¹⁸¹ Again, Energy Safety applied the RFWCMD metric as a normalizing parameter. All charts show a sharp uptick in usage and impact of PSPS in 2019 followed by a significant decline in 2020, although still well above zero.

The above figures show a marked decreased in PSPS duration, scope, and frequency from 2019 to 2020; however, PG&E's use of PSPS in 2019 was significant. Therefore, the downward trend between 2019 and 2020 belies PG&E's progress. Energy Safety will compare future years to 2020 in order to assess progress more accurately in this area.

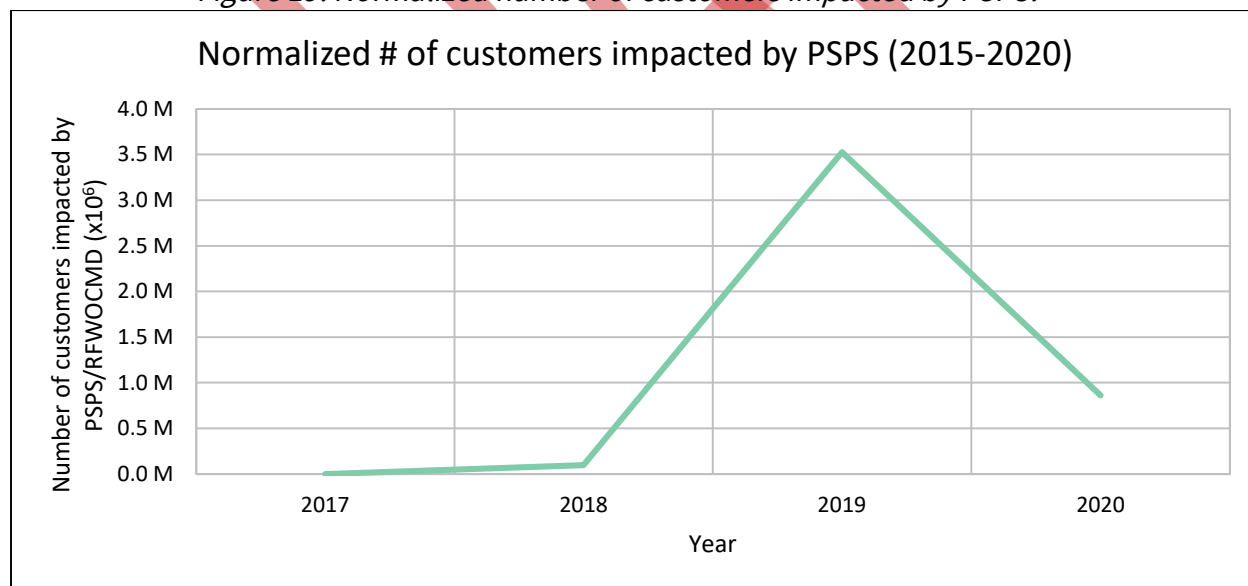
Figure 19: Normalized number of customers impacted by PSPS.¹⁸⁶

PG&E was largely successful in achieving its objective to reduce the scope and impact of PSPS from 2019 levels. As shown in Figure 19, PG&E significantly reduced the number of customers impacted by PSPS events, although given PG&E's widespread usage of PSPS in 2019, this
