April 25, 2022

Reference: Energy Safety Record ID: NOD_MJ4_PGE_20211207_01
Notice of Defect: Government Code § 15475.2 and the California Code of Regulations, Title
14, Section 29302(b)(1)

This letter is in response to the March 11, 2022, Office of Energy Infrastructure Safety (Energy Safety) Notice of Defect (NOD) from an inspection occurring on December 7, 2021, of grid topology improvements and system hardening work in Santa Cruz, Santa Cruz County. The NOD alleges two (2) types of defects which include vegetation contacting the guy wire above the insulator and excessive splicing in a single span.

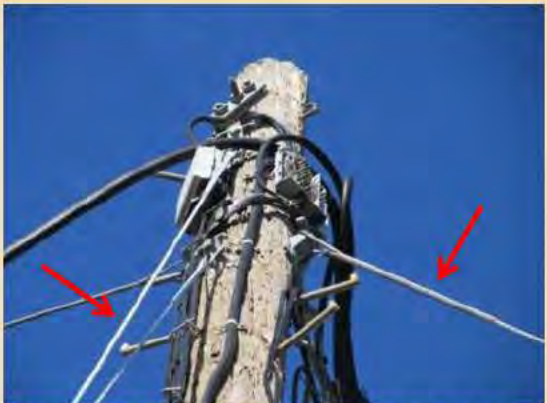
COMMUNICATION IN CLIMBING SPACE	CLIMBING SPACE OBSTRUCTED

<p>At this Location: Obstructed climbing space, access via bucket truck from street below. Also clearance issues between communications facilities and the PG&E down guys.</p> <hr/> <p>Perform Minor Work: No</p> <hr/> <p>Write Third Party Notification: No</p> <hr/> <p>Write EC Form: No</p>

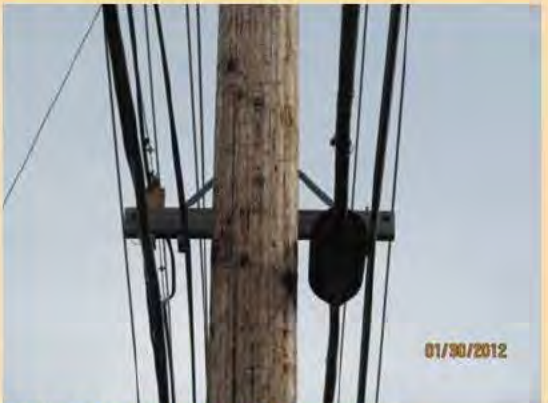
<p>At this Location: Climbing space obstruction by communication facilities on pole with equipment. Communication messengers are too close. No bucket truck access.</p> <hr/> <p>Perform Minor Work: No</p> <hr/> <p>Write Third Party Notification: Yes</p> <hr/> <p>Write EC Form: No</p>

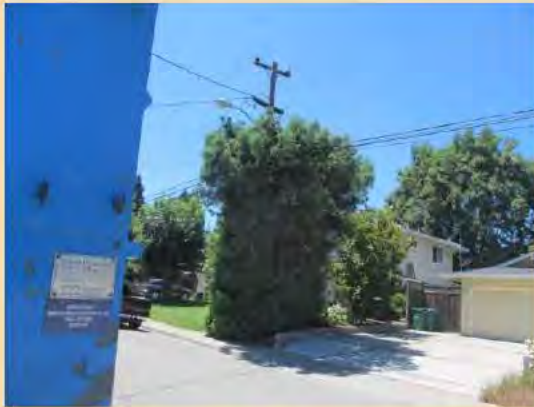
OBSTRUCTED CLIMBING SPACE

At this Location: Obstructed climbing space. Inspector cannot see enough of the pole to complete inspection (heavy vegetation, cannot see through) No equipment on pole. The only reason to address is to complete the inspection.

- FDA=OH Facility / Limited Access/Obstruct / Inspect (Primary)
- FDA=OH Facility / Limited Access/Obstruct / Remove
- Priority "B", 0-3 months depending upon exposure; must complete before CPUC due date for map

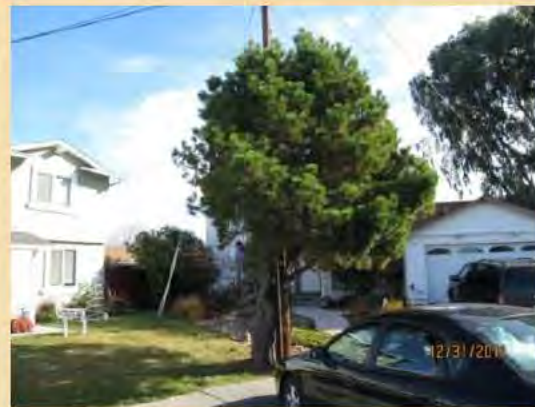
CLIMBING SPACE OBSTRUCTED

At this Location: Climbing space obstruction, able to perform inspection, no equipment on pole (able to see guys, able to see up the pole under tree)

Write EC: No, not compelling

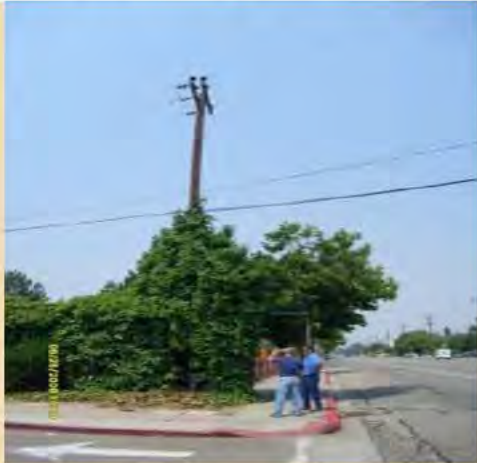
POLE WITH VEGETATION

At this Location: 360° pole inspection not possible

- FDA= OH Facility / Limited Access/Obstruct / Inspect (Primary)
- FDA=OH Facility / Limited Access/Obstruct / Remove
- Priority "B", 0-3 months depending upon exposure; must complete before CPUC due date for map

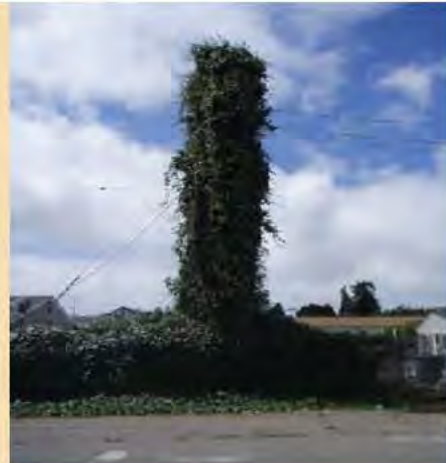
IVY COVERED POLE

At this Location: 360° pole inspection not possible

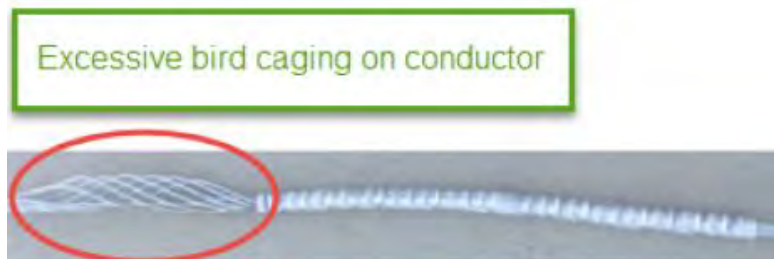
Visual examples of types of conductor damage referenced under conductor general guidance**Example: Bird-caged conductor**

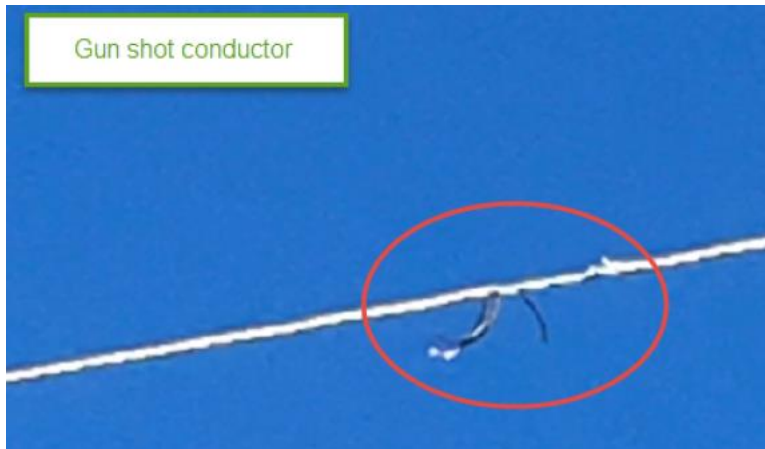
Example: Gun-shot conductor

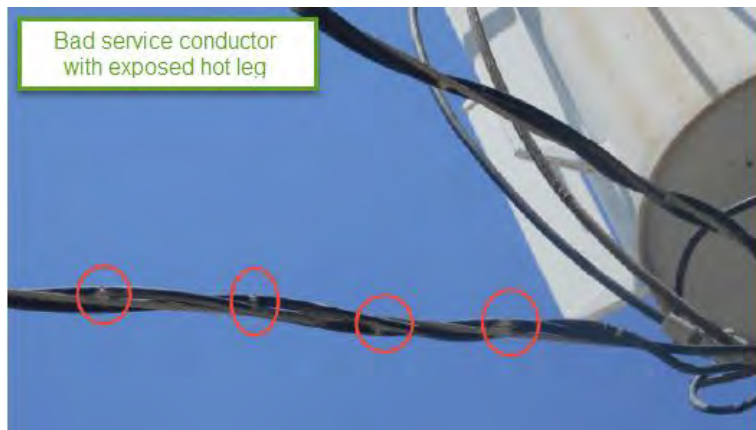
Example: Bad service conductor with exposed hot leg.

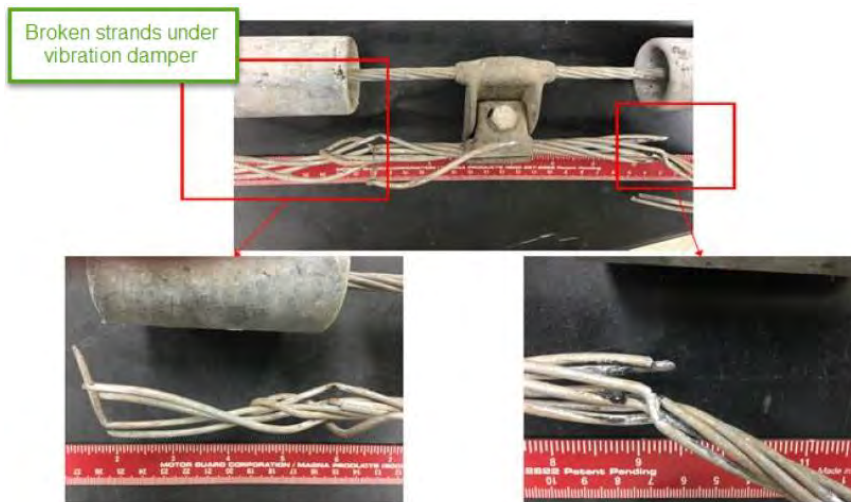
Example: Broken strands under vibration damper

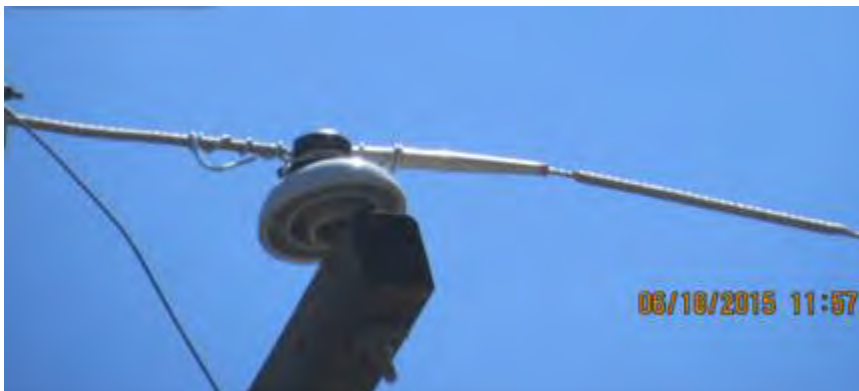
Example: Splice tied in to insulator

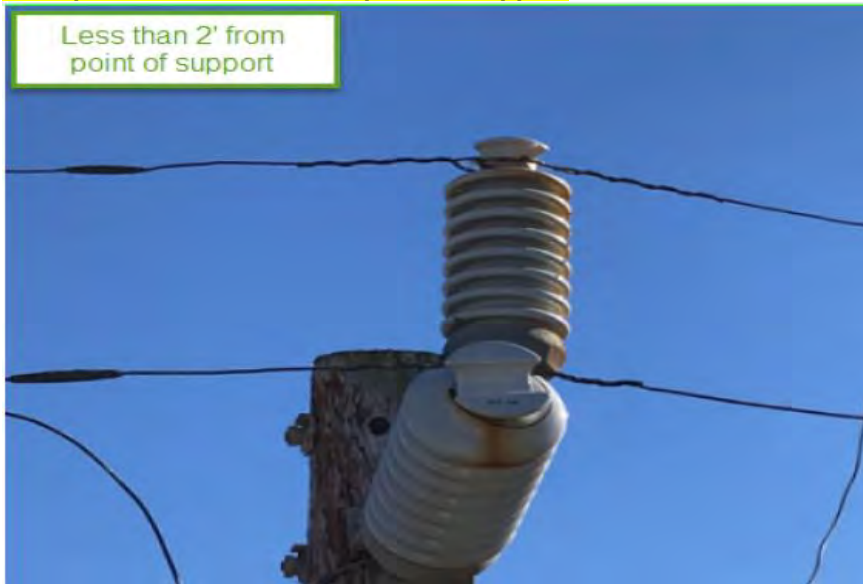
Example: Less than 2' from point of support

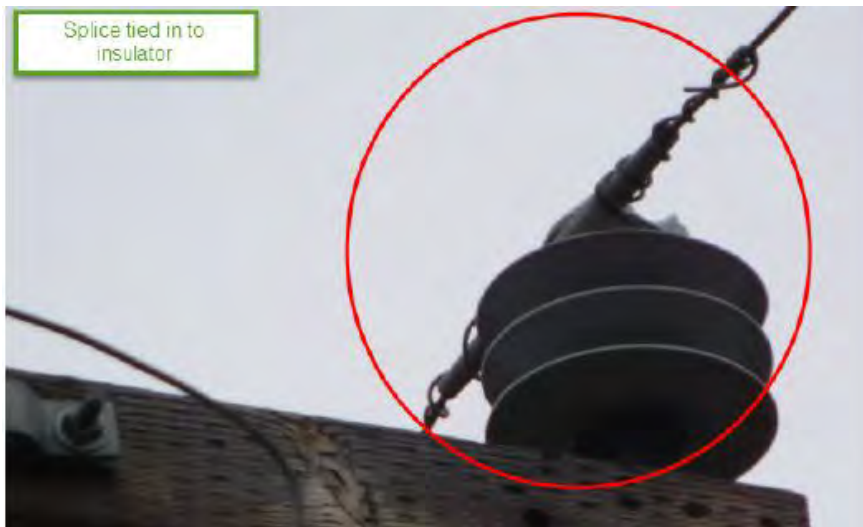
Example: Splice tied in to insulator

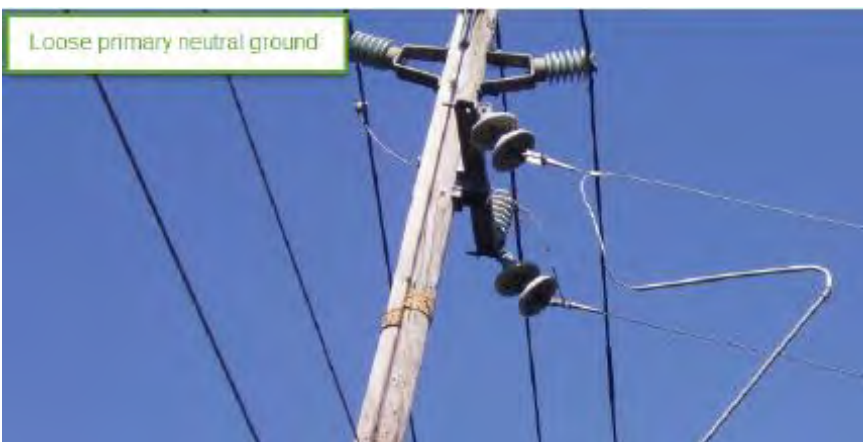
Example: Loose primary neutral ground:

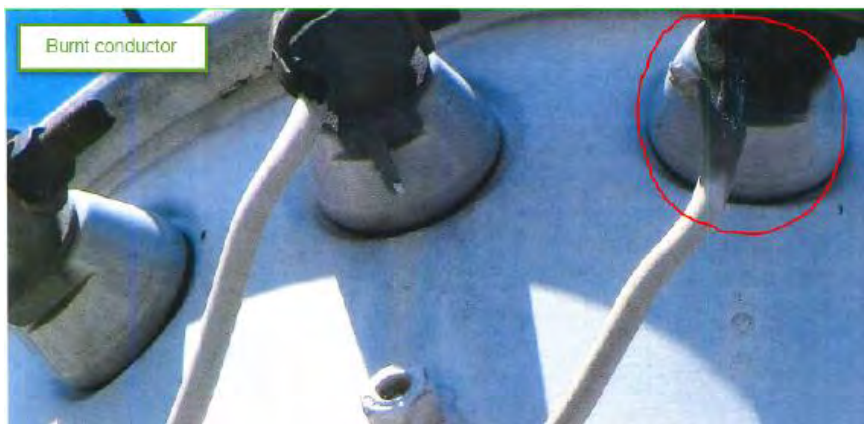
Example: Burnt conductor:

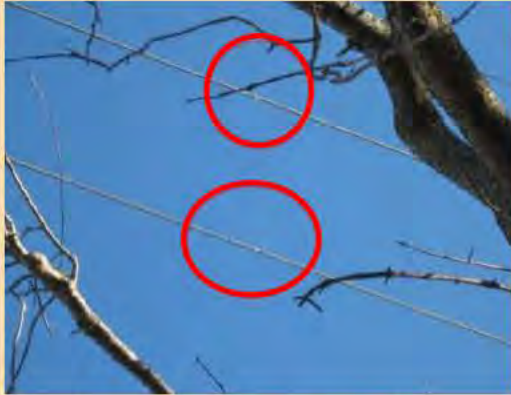
DAMAGED SECONDARY

At this Location: Damaged strands

- FDA= Conductor / Damage / Repair
- Priority "E", 3-12 months depending upon exposure

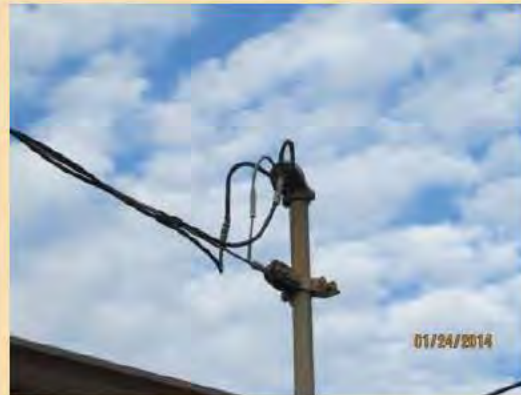
EXPOSED SERVICE CONNECTOR

At this Location: Exposed conductors

Perform Minor Work: Yes, if safe to do so.

- FDA= Conductor / Broken/Damage / Repair
- Priority "E", 3-12 months depending upon exposure

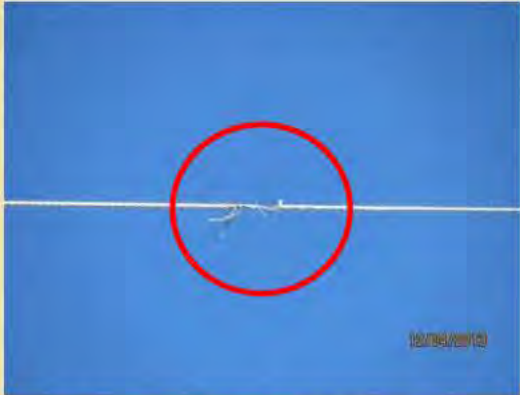
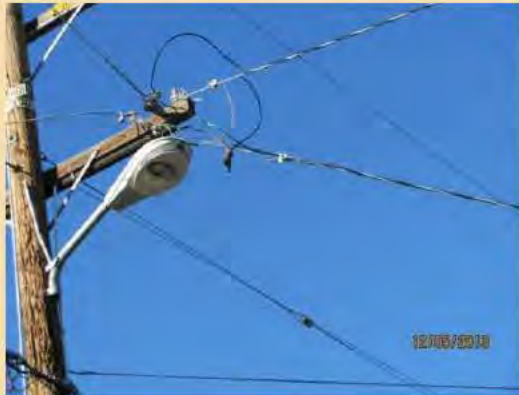
CONDUCTOR TEARING APART	HARDWARE BROKEN

<p>At this Location: Primary conductor damage (possibly shotgun)</p>	<p>At this Location: The #6 solid copper is broken causing strain on the conductor. Unsecured service.</p>
<p>Perform Minor Work: No</p>	<p>Perform Minor Work: Yes, if safe to do so</p>
<p>Third-Party Notification: No</p>	<p>Write Third-Party Notification: No</p>
<p>Write EC Form: Yes</p> <ul style="list-style-type: none"> • FDA= Conductor / Broken/Damage / Repair • Priority "B", 0-3 months depending upon exposure 	<p>Write EC Form: Yes, if minor work is not possible</p> <ul style="list-style-type: none"> • FDA= Hardware/Framing / Broken/Damaged / Repair • Priority "E", 3-12 months depending upon exposure

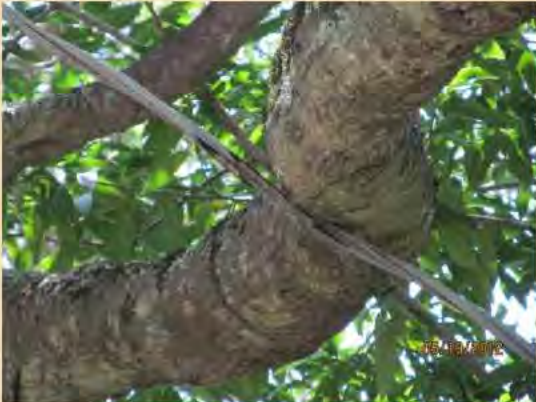
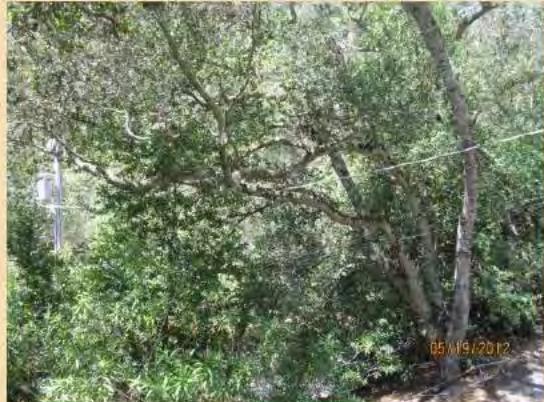
OVERHEAD SERVICE STRAIN ABRASION	OVERHEAD SERVICE STRAIN ABRASION

<p>At this Location: Service strain abrasion, with possible burning at some sections. Damaged insulation.</p>	<p>At this Location: Service strain abrasion, no slack remaining</p>
<p>Perform Minor Work: Yes, if safe to do so. If you replace the service conductor, this is capital Minor Work.</p>	<p>Perform Minor Work: Yes, if safe to do so. If you replace the service conductor this is capital Minor Work.</p>
<p>Fill out EC Form to account for this minor work; charge time to your Division standing order.</p>	<p>Fill out EC Form to account for this minor work; charge time to your Division standing order.</p>
<p>Write Third Party Notification: No</p>	<p>Write Third Party Notification: No</p>
<p>Write EC Form: Yes, if minor work is not possible, or to document completed capital minor work</p> <ul style="list-style-type: none"> • FDA=Conductor / Broken/Damaged/ Repair or Replace • Priority "E", 3-12 months depending upon exposure, in comments add note about strain abrasion burnt conductor • If abrasion has caused an exposed hotleg, assign Priority A, emergency, and stand-by. 	<p>Write EC Form: Yes, if minor work is not possible, or to document completed capital minor work</p> <ul style="list-style-type: none"> • FDA=Conductor / Broken/Damaged/ Repair or Replace • Priority "E", 3-12 months depending upon exposure, in comments add note about strain abrasion burnt conductor If abrasion has caused an exposed hotleg, assign Priority A, emergency, and stand-by.

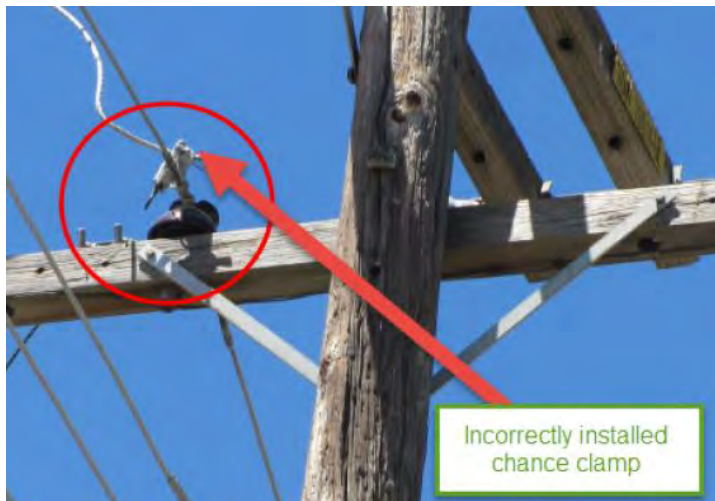
Example: Incorrectly installed chance clamp

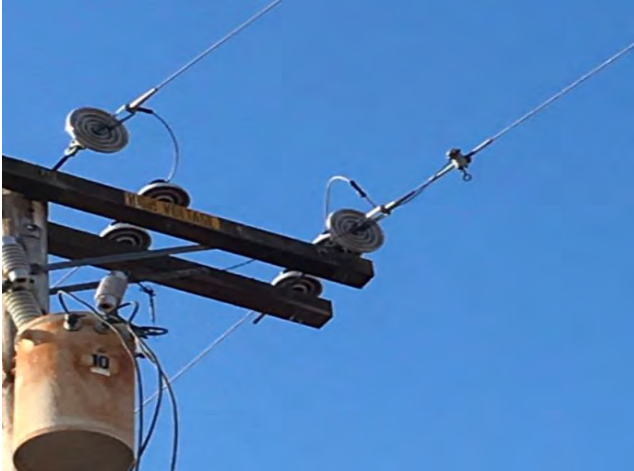
Example: Secondary connector installed in primary

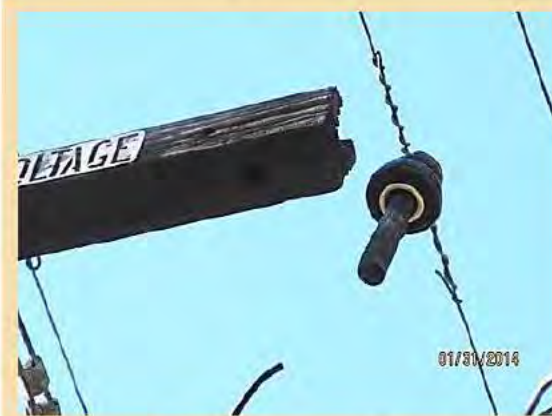
FLOATER

At this Location: Floater, conductor is not contacting the arm. Rotten crossarm.

- FDA=Crossarm / Decayed/Rotten/ Replace
- Priority "A", follow Emergency Process

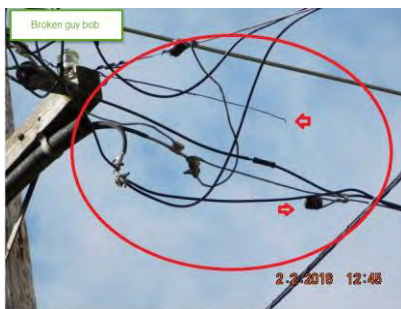
Example: Broken service bob

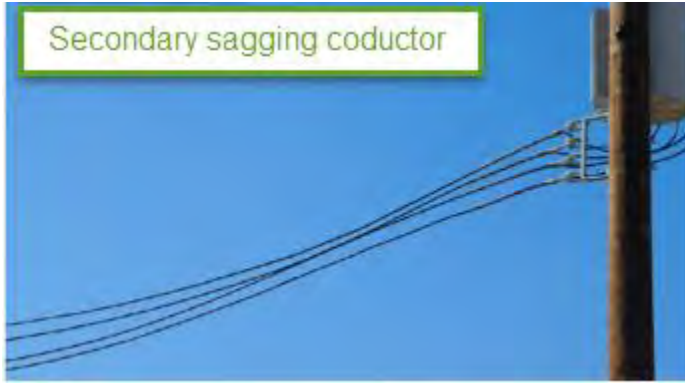
Example: Secondary sagging conductor

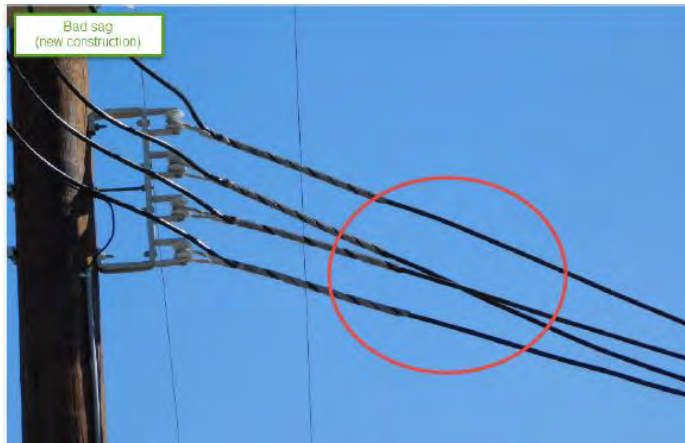
Example: Sagging conductor

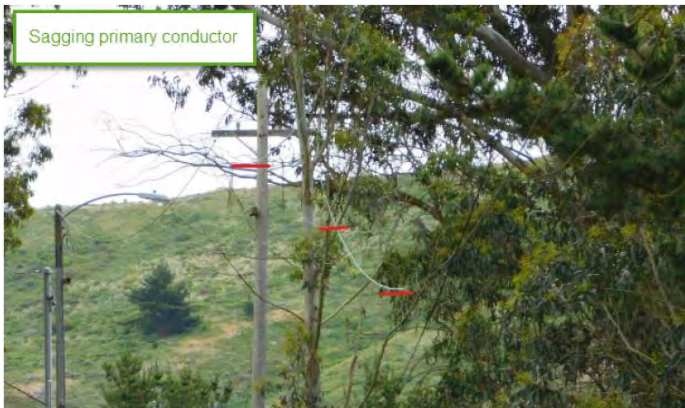
Example: Sagging primary conductor

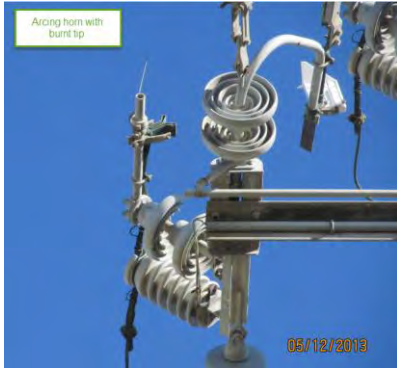
Example: Arcing horn with burnt tip

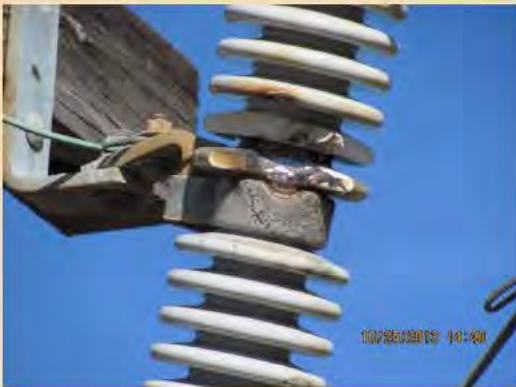
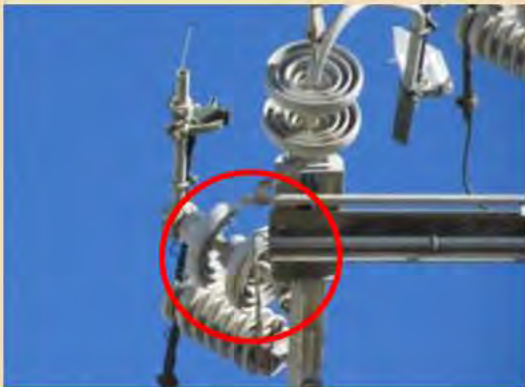
BROKEN DAMAGED CROSSARM MOUNTED CUTOUT	BROKEN INSULATOR ON AIR SWITCH

<p>At this Location: Broken/Flashed cutout</p>	<p>At this Location: Broken insulator on air switch</p>
<p>Perform Minor Work: No</p>	<p>Perform Minor Work: No</p>
<p>Write Third-Party Notification: No</p>	<p>Write Third-Party Notification: No</p>
<p>Write EC Form: Yes</p> <ul style="list-style-type: none"> • FDA=Cutout / Broken/Damaged / Replace • Priority "E", 3-12 months depending upon exposure • COE = No 	<p>Write EC Form: Yes</p> <ul style="list-style-type: none"> • FDA=Cutout / Broken/Damaged / Replace • FDA Switch / Broken/Damaged / Replace • Priority "E", 3-12 months depending upon exposure • COE = Depending on voltage & Insulation value remaining if not operable

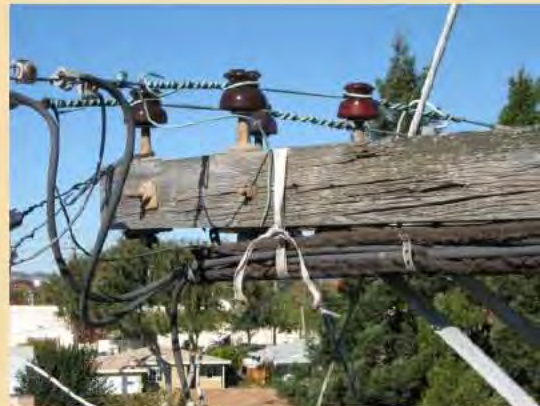
Front View

UNDER-ARM BUS LOOSE AND DETERIORATED

At this Location: UAB deteriorated, partial repair with rope, secured with one strap.

- FDA=Under-Arm Bus / Broken/Damaged / Repair
- At minimum – must write up as Priority "F-R", next inspection cycle; based on field condition and exposure, corrosion, etc.; prioritize as needed (A, B, E, or F)

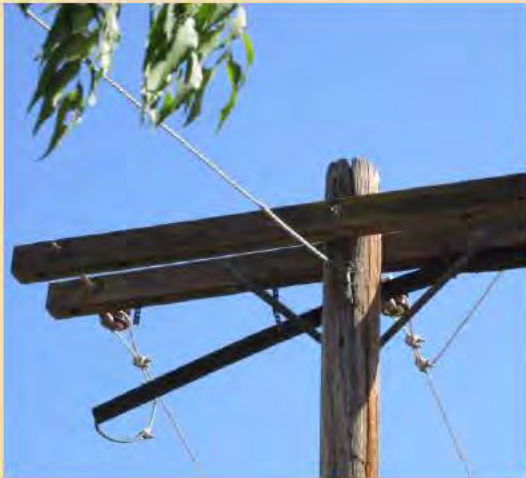
UNDER-ARM BUS LOOSE

At this Location: UAB Loose

- FDA=Under-Arm Bus / Broken/Damaged / Repair
Priority "E", 3-12 months depending upon exposure

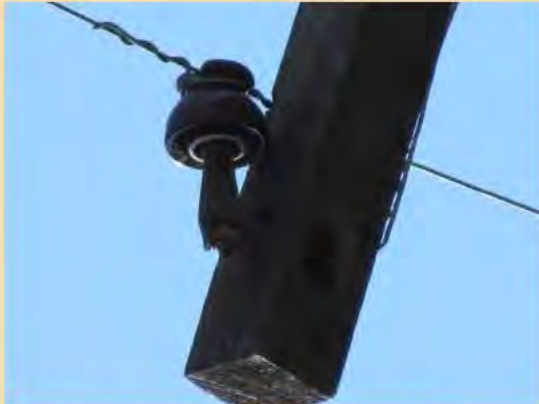
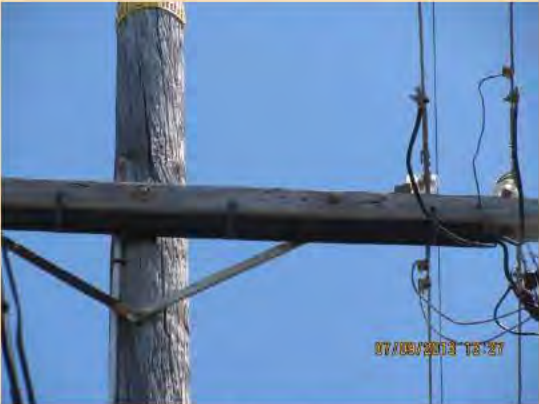
PIN BROKEN	PIN BROKEN (FLOATER)

<p>At this Location: Primary wood pin is broken, and the conductor is laying on the crossarm. Wood pin arm replace with Composite arm</p>	<p>At this Location: Secondary wood pin is broken, and the conductor is laying on the crossarm. Woodpin arm. Replace arm.</p>
<p>Perform Minor Work: No</p>	<p>Perform Minor Work: Yes, replace wooden pin with steel pin.</p>
<p>Write Third-Party Notification: No</p>	<p>Write Third-Party Notification: No</p>
<p>Write EC Form: Yes</p> <ul style="list-style-type: none"> • FDA=Hardware/Framing / Broken/Damage / Replace • FDA= Crossarm/Broken Damaged/Replace • Priority "A", follow Emergency Process 	<p>Write EC Form: Yes</p> <ul style="list-style-type: none"> • FDA= Conductor / Floating / Repair • FDA= Crossarm/Broken Damaged/Replace • Priority "A", follow Emergency Proces

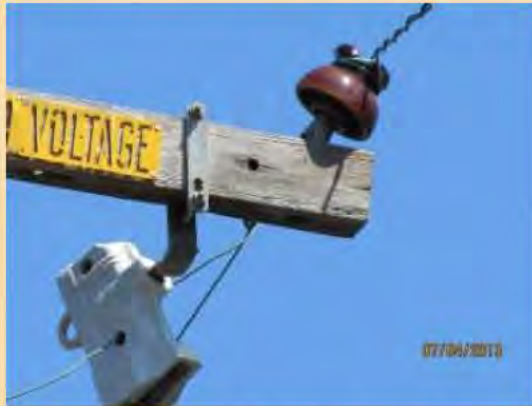
PRIMARY WOOD PIN AT ANGLE

At this Location: Deteriorated primary wood pin at angle. All insulators need to be replaced. Replace the crossarm with a composite arm.

- FDA= Crossarm/Broken Damaged/Replace
- FDA=Hardware/Framing / /Broken/Damaged / Replace
- Priority "B", 0-3 Months depending upon exposure.

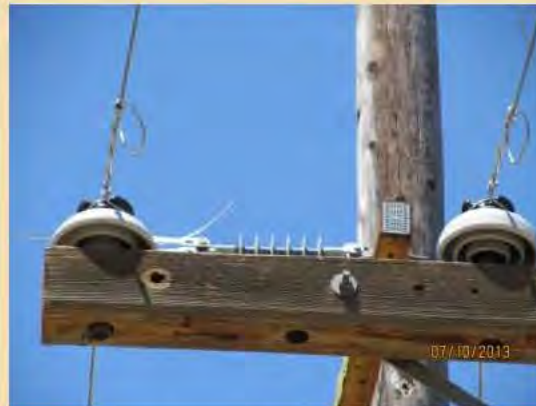
PRIMARY WOOD PIN SQUATTER

At this Location: Primary wood pin squatter. Replace Crossarm. No armor rod with hand-tie.

- FDA= Crossarm/Broken Damaged/Replace
- FDA=Insulator / Primary Squatter/ Replace
- Priority "E", 3-12 months depending upon exposure

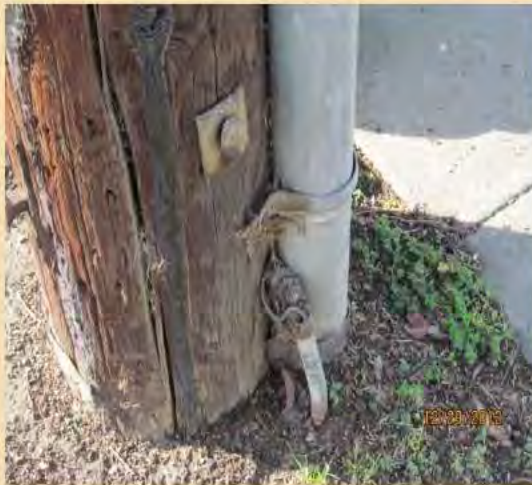
EXPOSED GROUND

At this Location: Exposed grounds near sidewalk

- FDA=Ground / Exposed / Repair
- Priority "A", emergency – due to public exposure at ground level.

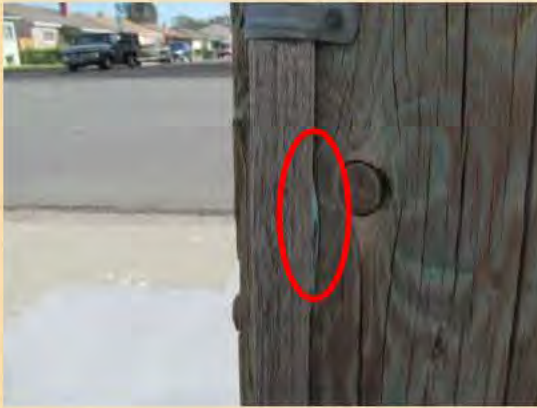
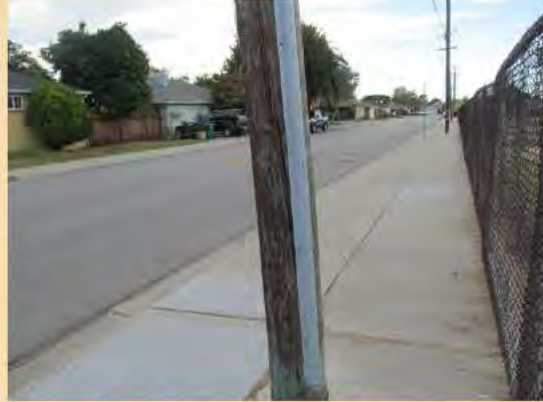
Before: Copper Wire sticking out from under the wood molding

After: 1.5 inch u-shaped molding installed over existing wood molding

At this Location: Wood molding with ground exposed

Write EC Form: Only if not able to perform minor work

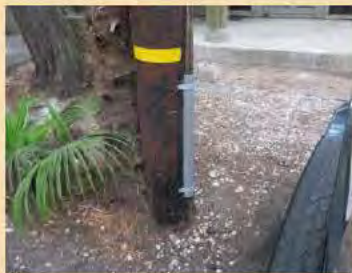
At this Location: Condition acceptable after repair of exposed ground

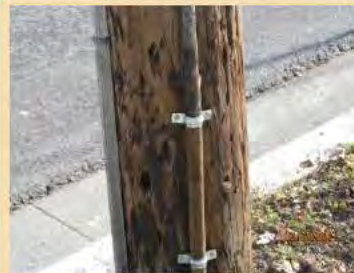
At this Location: Condition acceptable after repair with wood molding

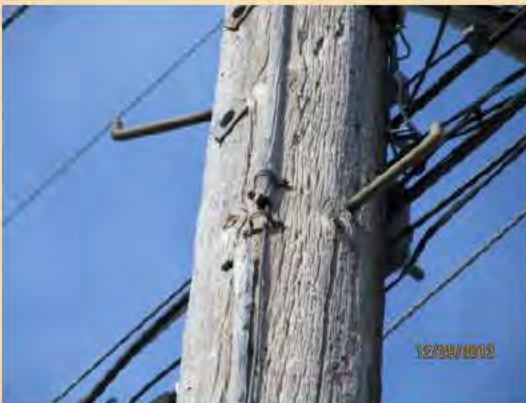
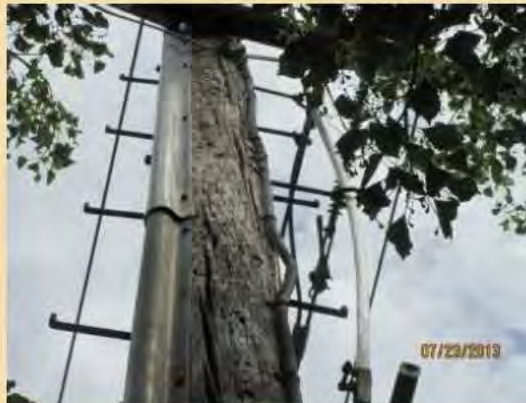
EXPOSED GROUND AT COMMUNICATION LEVEL	EXPOSED GROUND DUE TO TWISTED MOLDING

<p>At this Location: Exposed ground at communications level. Wood molding broken in climbing space.</p>	<p>At this Location: Exposed ground in wood molding.</p>
<p>Perform Minor Work: Yes, if safe to do so.</p>	<p>Perform Minor Work: Yes, when safe to do so.</p>
<p>Write Third-Party Notification: No</p>	<p>Write Third-Party Notification: No</p>
<p>Write EC Form: Only if unable to perform minor work.</p> <ul style="list-style-type: none"> • FDA=Ground / Exposed / Repair • At minimum – must write up as Priority "F-R", next inspection cycle; based on field condition and exposure, corrosion, etc.; prioritize as needed (A, B, E, or F) 	<p>Write EC Form: Only if unable to perform minor work.</p> <ul style="list-style-type: none"> • FDA=Ground / Exposed / Repair • FDA=Molding / Broken/Damaged / Repair • At minimum – must write up as Priority "F-R", next inspection cycle; based on field condition and exposure, corrosion, etc.; prioritize as needed (A, B, E, or F)

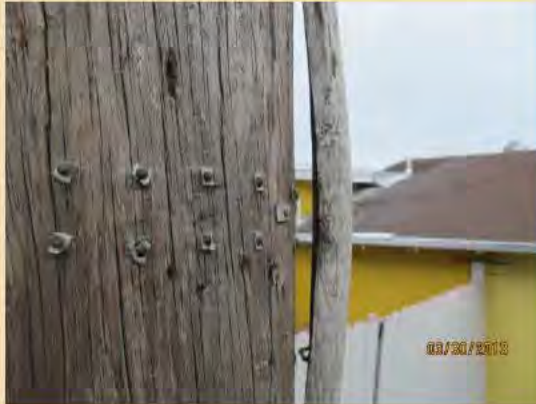
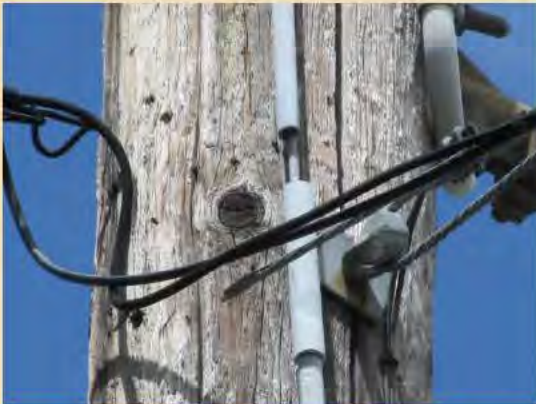
WOOD MOLDING NOT SECURE EXPOSING GROUND	PVC MOLDING NOT SECURE EXPOSING GROUND

<p>At this Location: Wood molding not secure, allowing human contact.</p>	<p>At this Location: PVC molding not secure, due to failure of previous repairs, allowing human contact.</p>
<p>Perform Minor Work: Yes</p>	<p>Perform Minor Work: Yes</p>
<p>Write Third-Party Notification: No</p>	<p>Write Third-Party Notification: No</p>
<p>Write EC Form: Only if unable to perform minor work.</p> <ul style="list-style-type: none"> • FDA=Ground / Exposed / Repair <p>At minimum – must write up as Priority "F-R", next inspection cycle; based on field condition and exposure, corrosion, etc.; prioritize as needed (A, B, E, or F)</p>	<p>Write EC Form: Only if unable to perform minor work.</p> <ul style="list-style-type: none"> • FDA=Ground / Exposed / Repair <p>At minimum – must write up as Priority "F-R", next inspection cycle; based on field condition and exposure, corrosion, etc.; prioritize as needed (A, B, E, or F)</p>

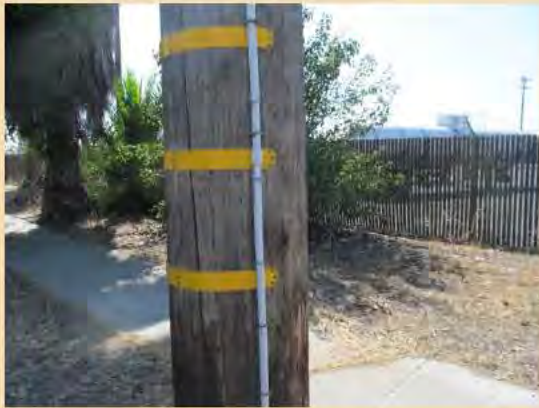
At this Location: PVC molding adequately secured with staples upon arrival. No action is required.

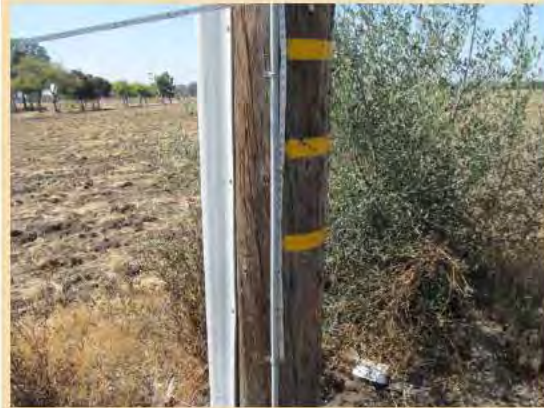
At this Location: Wood molding adequately secured with straps spacing 36 inches or less upon arrival. No action required.

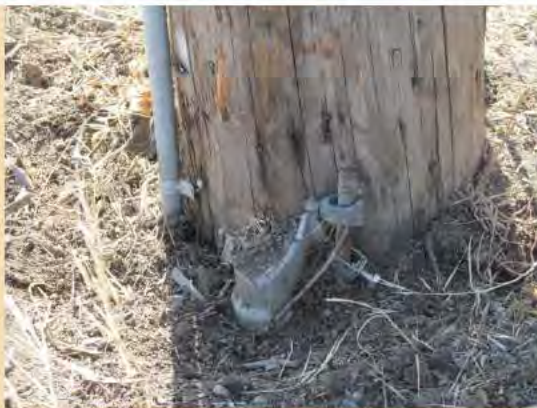
At this Location: Exposed ground rod

- FDA=Ground / Exposed / Repair
- At minimum – must write up as Priority "F-R", next inspection cycle; based on field condition and exposure, corrosion, etc.; prioritize as needed (A, B, E, or F)

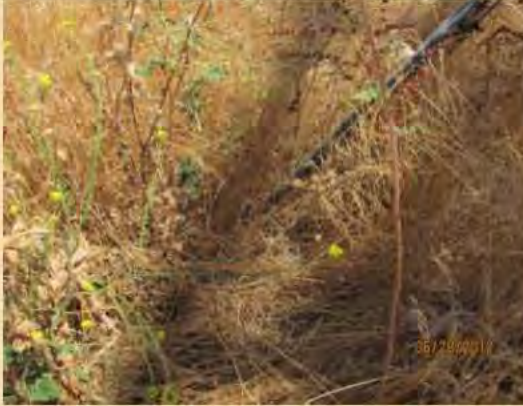
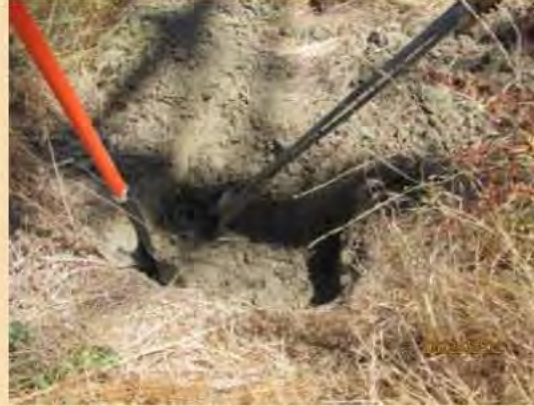
**Before:** Vegetation covers anchor

**After:** Vegetation cleared from anchor

At this Location: Anchor below grade overgrown with vegetation. After minor work inspector decides if the anchor can be adjusted or needs replaced.

- FDA=Anchor / Soil/Eroded/Graded / Replace (if the anchor cannot be adjusted)
- At minimum – must write up as Priority "F-R", next inspection cycle; based on field condition and exposure, corrosion, etc.; prioritize as needed (A, B, E, or F)

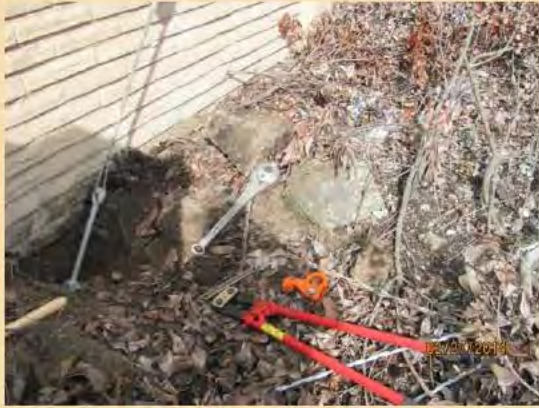
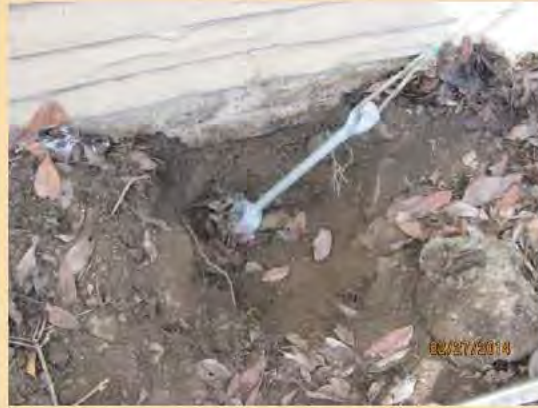
At this Location: Inspector performed minor work, exposed anchor, evaluated anchor to be in good condition so that extension could be installed, then installed extension. (Back fill not shown)

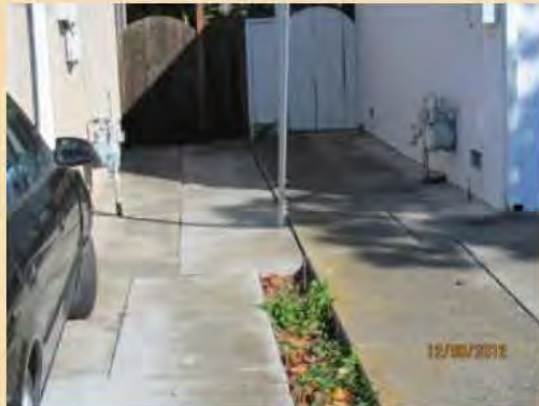
At this Location: Anchor covered by concrete

FDA=Anchor /Soil/Eroded/Graded / Replace
 At minimum – must write up as Priority "F-R", next inspection cycle; based on field condition and exposure, corrosion, etc.; prioritize as needed (A, B, E, or F)

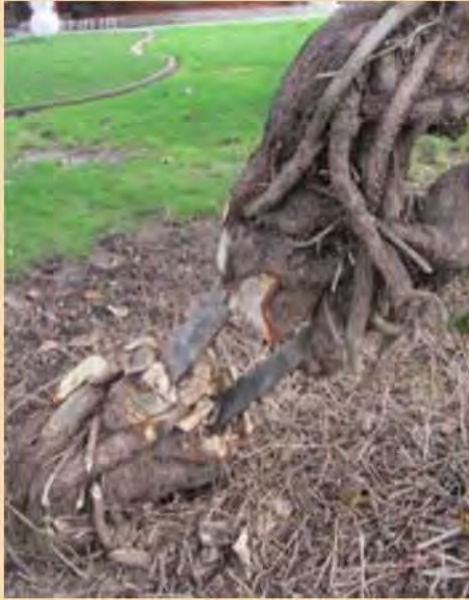
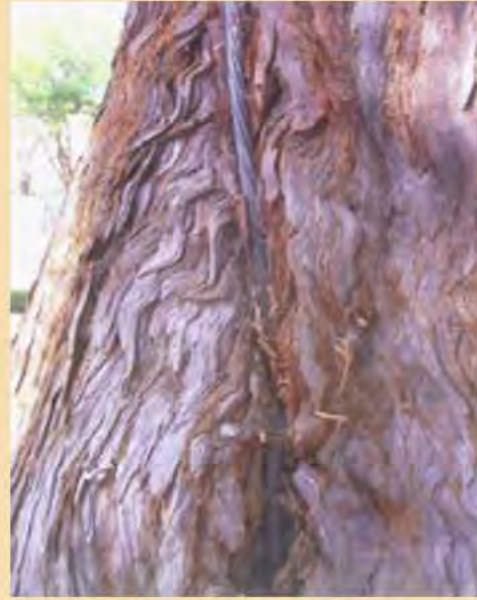
Anchor buried by roots

Anchor buried by tree

At this Location: Anchor buried by ivy roots / tree

- FDA=Anchor / Soil/Eroded/Graded / Replace
- At minimum – must write up as Priority "F-R", next inspection cycle; based on field condition and exposure, corrosion, etc.; prioritize as needed (A, B, E, or F)

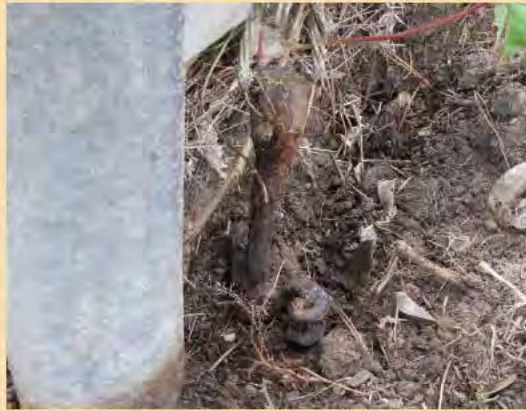
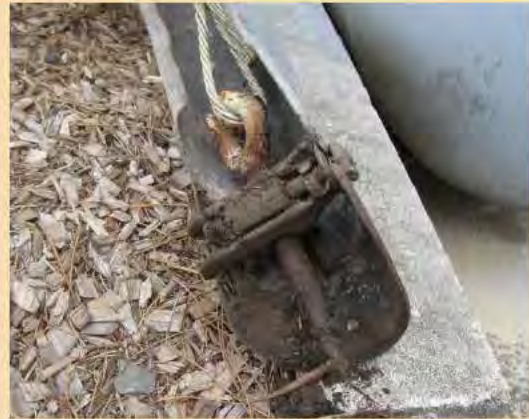
At this Location: Corroded Anchor

- FDA=Anchor / Corroded / Replace
- Priority "E", 3-12 months depending upon exposure

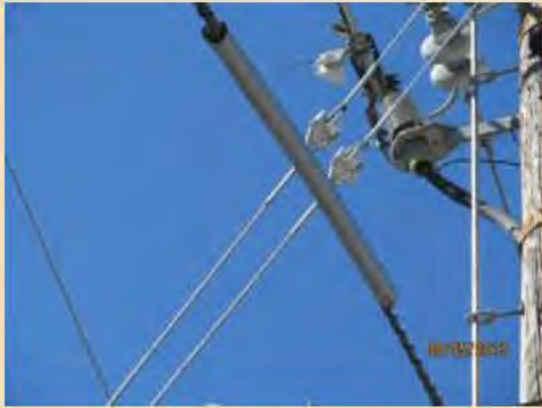
<p>At this Location: Acceptable solution through plastic barrier.</p> <p>GO 95 requires 3" of radial clearance. Plastic barriers can be installed if less than 3" of clearance.</p>

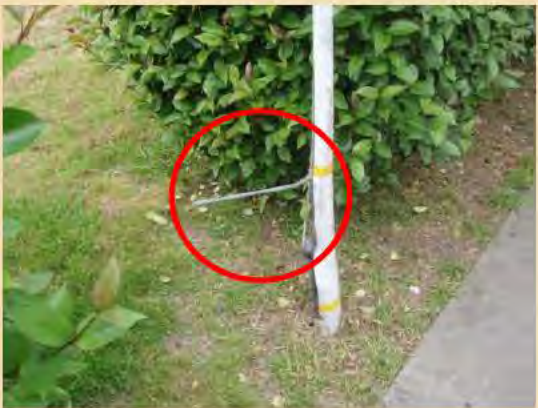
<p>At this Location: Guy tail extends beyond the preform <u>near sidewalk</u>, safety hazard.</p> <hr/> <p>Perform Minor Work: Yes</p> <hr/> <p>Write Third-Party Notification: No</p> <hr/> <p>Write EC Form: Only if minor work cannot be performed.</p> <ul style="list-style-type: none"> • FDA Guy / Broken/Damaged/ Repair • Priority "E", 3-12 months depending upon exposure

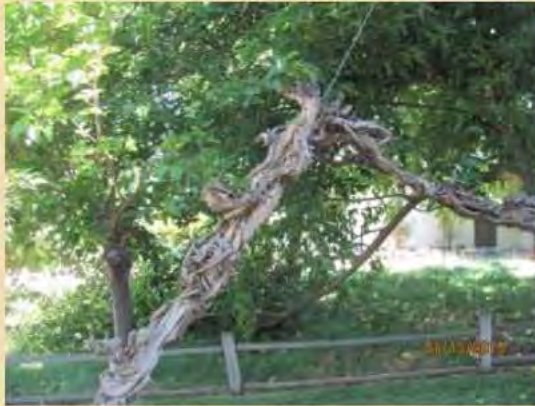
At this Location: Extensive dead ivy covering half of length of guy.

- FDA=Guy / Broken/Damaged / Replace
- Priority "E", 3-12 months depending upon exposure

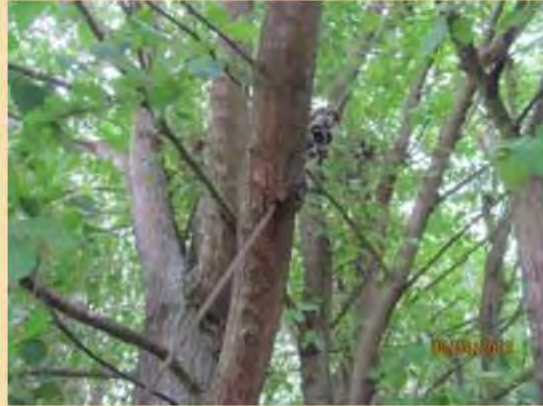
At this Location: Tree growing around guy

- FDA=Guy / Broken/Damaged / Replace
- Priority "E", 3-12 months depending upon exposure

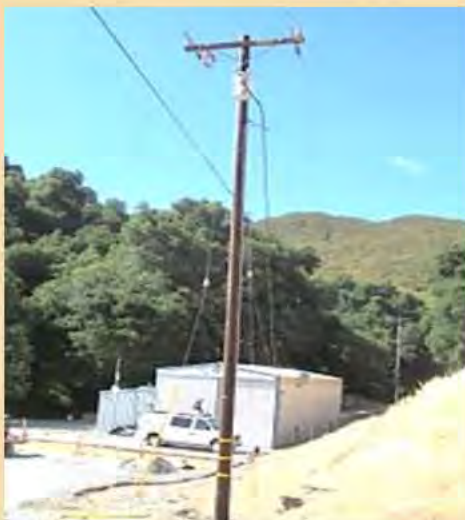
At this Location: Loose guy on left side

- FDA=Guy / Loose / Adjust
- At minimum – must write up as Priority "F-R", next inspection cycle; based on field condition and exposure, corrosion, etc.; prioritize as needed (A, B, E, or F)

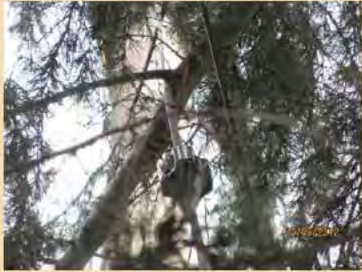
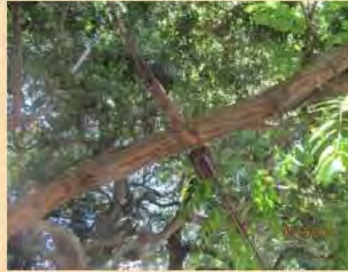
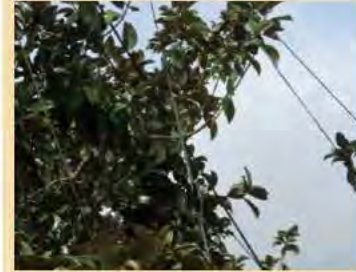
Guy grounded by vegetation

Guy overgrown by vegetation

At this Location: Guy grounded by vegetation, above the bob.

- FDA=Guy / Overgrown / Trim
- Priority "E", 3-12 months depending upon exposure

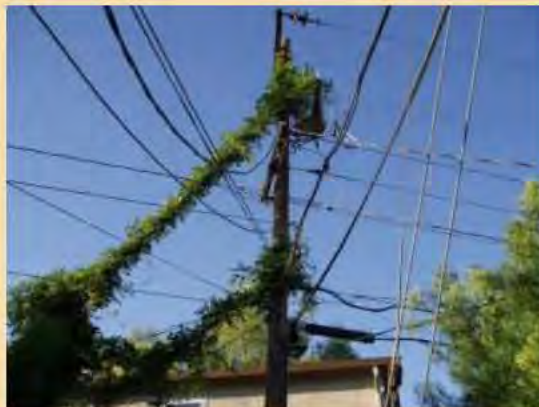
At this Location: Ivy on guy and on primary. Safety issues, possible energized guy and pole, transformer weeping – no oil on ground, evaluate per oil spill matrix.

- FDA=Transformer / Leaks/Seeps/Weeps / Replace (primary)
- FDA=Guy / Overgrown / Trim
- Priority "B", 3 months or less depending upon exposure

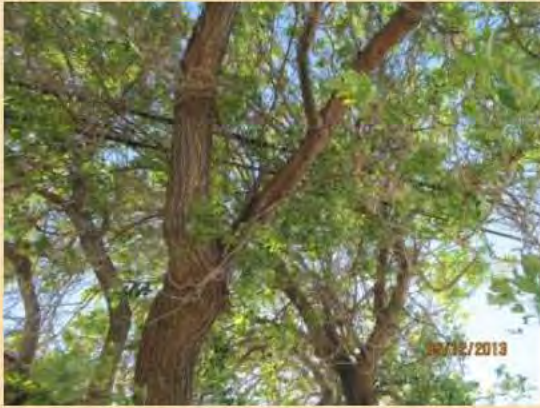
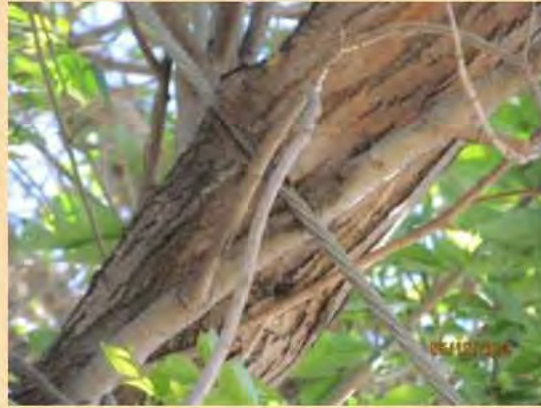
Guy through tree

At this Location: Tree limb growing around guy, below the bob.

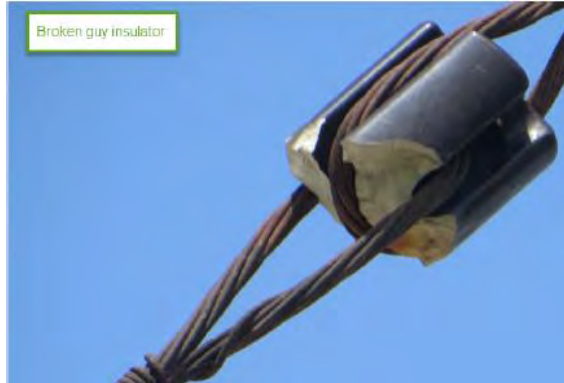
Example: Broken guy insulator

Must be sectionalized and ungrounded. Ensure there is an intact guy insulator.

- FDA: Guy / Broken/Damaged / Replace or Guy / Missing / Install
- Select the Priority and Due Date based upon compelling abnormal condition that may adversely impact public safety and/or service reliability in the next five (5) years

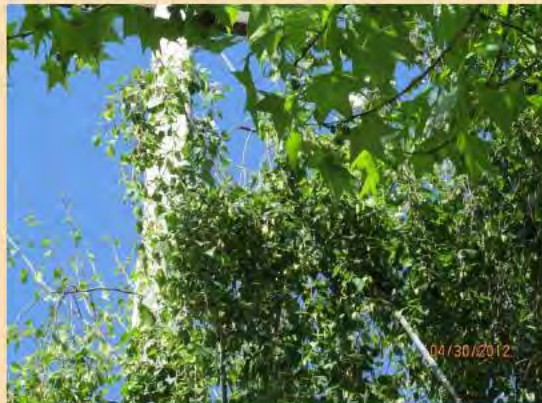
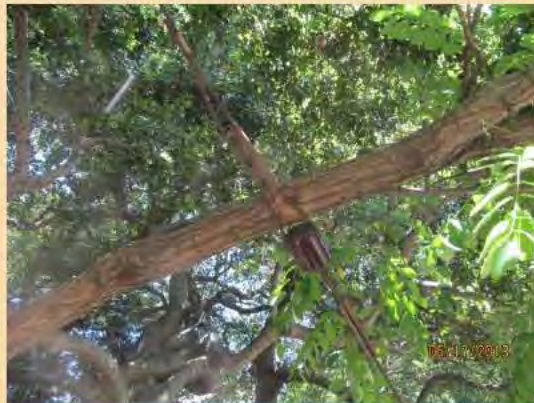
DOWN GUY GROUNDED ABOVE GUY INSULATOR	DOWN GUY GROUNDED ABOVE GUY INSULATOR CAUSING STRAIN AND ABRASION

<p>At this Location: Vine growing up and across the guy insulator grounding the guy.</p>	<p>At this Location: Tree grounding the guy above the guy insulator causing strain and abrasion.</p>
<p>Perform Minor Work: Yes</p>	<p>Perform Minor Work: Yes, if minor work not possible</p>
<p>Write Third-Party Notification: No</p>	<p>Write Third-Party Notification: No</p>
<p>Write EC Form: Yes, only if minor work cannot be performed</p> <ul style="list-style-type: none"> • FDA=Guy / Overgrown / Trim • Priority "E", 3-12 months depending upon exposure 	<p>Write EC Form: Yes, only if minor work cannot be performed</p> <ul style="list-style-type: none"> • FDA=Guy / Strain/Abrasion / Remove • FDA=Guy / Overgrown / Trim • Priority "E", 3-12 months depending upon exposure

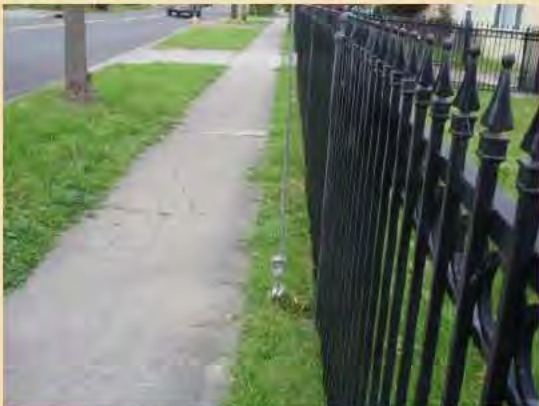
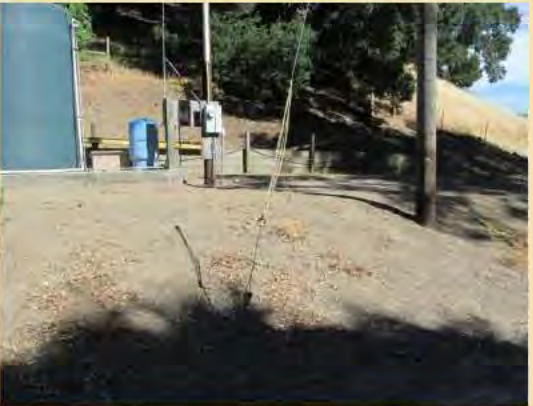
GUY MARKER MISSING	CATTLE GUARD LESS THAN 8 FT

<p>At this Location: Guy marker missing</p>	<p>At this Location: Cattle guard is less than 8 feet in length</p>
<p>Perform Minor Work: Yes, install new guy marker</p>	<p>Perform Minor Work: Yes, lower cattle guard and add guy marker to meet 8 feet requirement.</p>
<p>Write Third-Party Notification: No</p>	<p>Write Third-Party Notification: No</p>
<p>Write EC Form: No, perform minor work</p>	<p>Write EC Form: No, perform minor work</p>

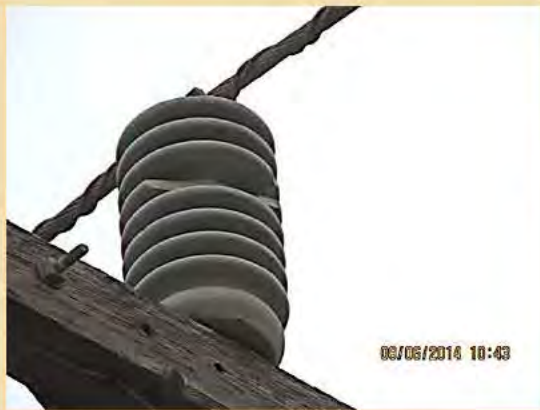
DAMAGED INSULATOR

At this Location: Damaged insulator with an insulator that I no longer approved. Replace all insulators and the arm

- FDA= Crossarm / Decayed/Rotten / Replace
- FDA=Insulator / Broken/ Damage / Replace
- Priority "E", 3-12 months depending upon exposure

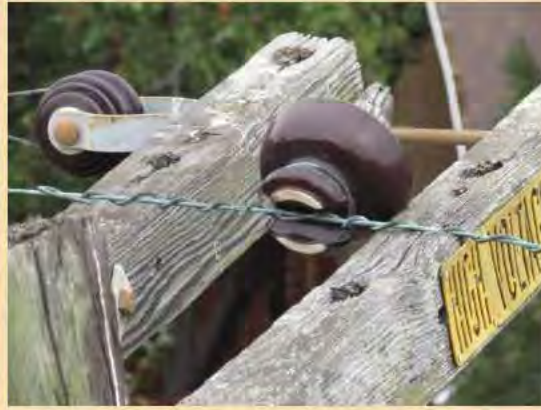
INSULATOR LAYING ON ITS SIDE / PRIMARY ON THE ARM

At this Location: Insulator lying on its side. Primary on the arm.

- FDA= Crossarm / Decayed/Rotten / Replace
- Priority "A", follow Emergency Process

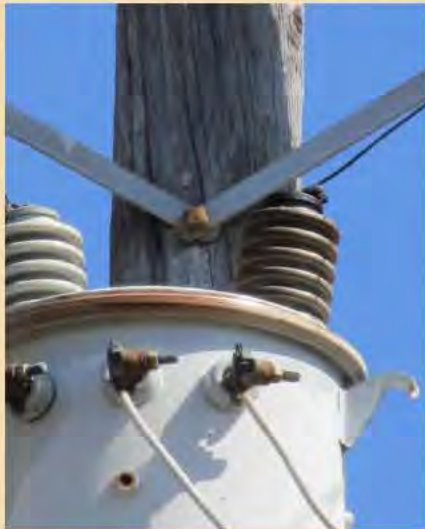
FLASHED INSULATOR ON TRANSFORMER

At this Location: Flashed insulator on transformer

- FDA= Transformer / Flashed / Replace
- Priority "E", 3-12 months depending upon exposure
