April 25, 2022

Reference: Energy Safety Record ID: NOD_MJ4_PGE_20211207_01
Notice of Defect: Government Code § 15475.2 and the California Code of Regulations, Title
14, Section 29302(b)(1)

This letter is in response to the March 11, 2022, Office of Energy Infrastructure Safety (Energy Safety) Notice of Defect (NOD) from an inspection occurring on December 7, 2021, of grid topology improvements and system hardening work in Santa Cruz, Santa Cruz County. The NOD alleges two (2) types of defects which include vegetation contacting the guy wire above the insulator and excessive splicing in a single span.

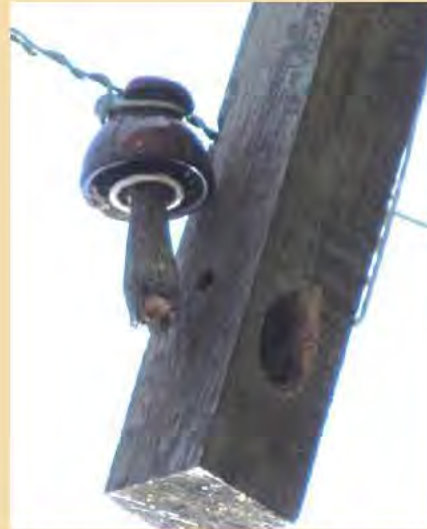
BROKEN WOOD PIN ON PRIMARY

At this Location: Broken wood pin. Primary (High Voltage Sign). Conductor on arm. Replace all insulators and the crossarm with a composite arm.

- FDA= Crossarm / Decayed/Rotten / Replace
- FDA=Insulator / Squatter-(Primary) / Replace
- Priority "A", follow Emergency Process, (Conductor contacting crossarm)

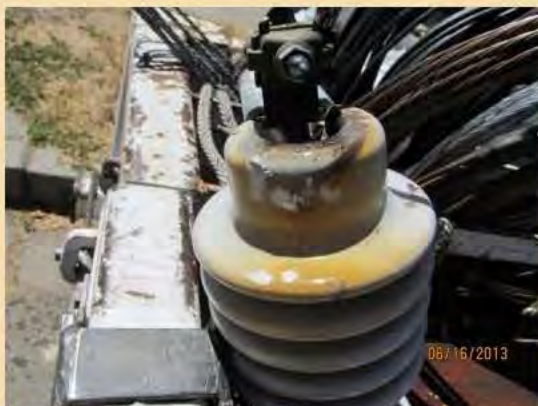
FLASHED INSULATOR POTHEAD

At this Location: Flashed pothead

- FDA=Riser/Pothead / Flashed / Replace
- At minimum – must write up as Priority "F-R", next inspection cycle; based on field condition and exposure, corrosion, etc.; prioritize as needed (A, B, E, or F)

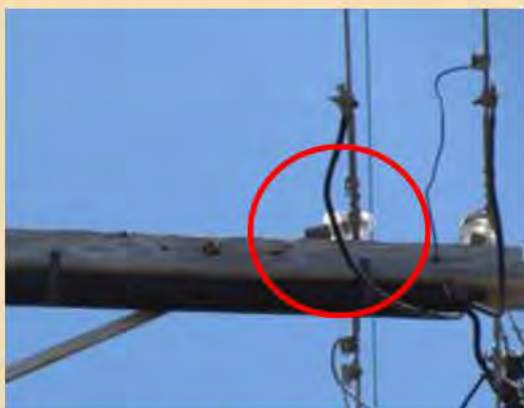
BROKEN WOOD PIN ON SECONDARY

At this Location: Broken secondary wood pin. Conductor lying on the arm, tangent pole. (excluding urban wildfire areas, use risk priority matrix). Wood pin arm at end of life replace arm with composite arm

- FDA= Crossarm / Decayed/Rotten / Replace
- FDA= Insulator / Squatter (Secondary) / Replace
- Priority "B", 0-3 months depending upon exposure

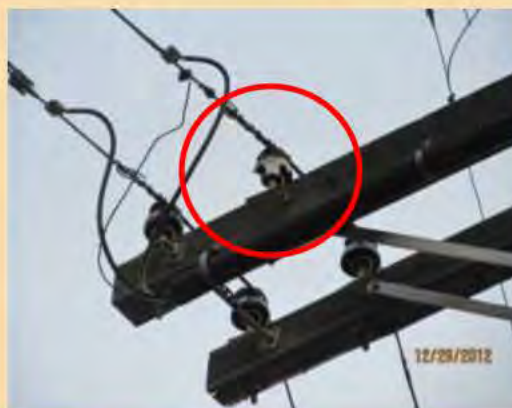
BROKEN SECONDARY INSULATOR

At this Location: Broken secondary insulator

- FDA= Crossarm / Decayed/Rotten / Replace
- FDA= Insulator / Broken/ Damage / Replace

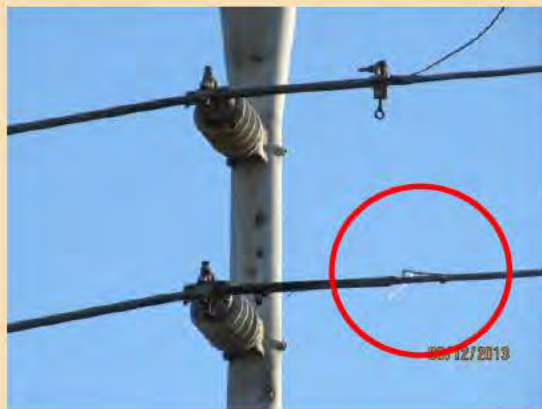
FLASHED INSULATOR MYLAR BALLOON

At this Location: Flashed insulator by Mylar balloon

- FDA= Insulator / Flashed / Replace
- Priority "E", 3-12 months depending upon exposure

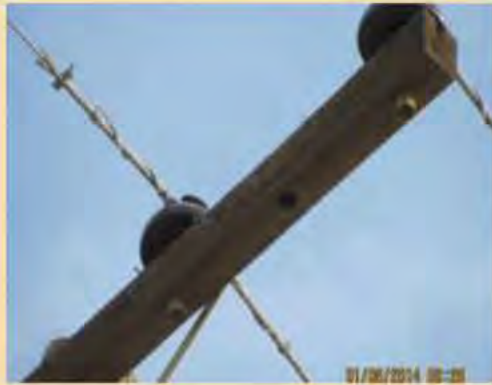
PRIMARY SQUATTER

At this Location: 2 Primary Wood Pin Squatters; replace wood crossarm with composite crossarm.

- FDA = Crossarm Decayed/Rotten / Replace
- FDA = Insulator / Primary Squatter / Replace
- At minimum – must write up as Priority "E", based on field condition and exposure, corrosion, etc.; prioritize as needed (A, B, or E)

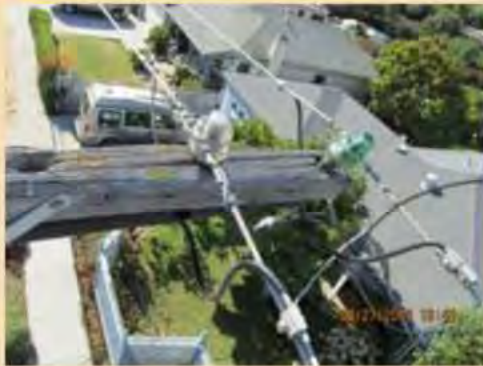
SECONDARY SQUATTER AND DECAYED CROSSARM

At this Location: Secondary Squatter and decayed crossarm.

- FDA= Crossarm / Decayed/Rotten / Replace
- Priority "E", 3-12 months depending upon exposure
- Note: When replacing insulators, do NOT mismatch insulators.

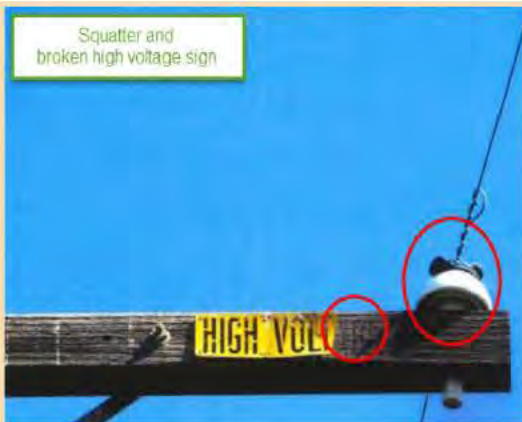
PRIMARY SQUATTER AND BROKEN HIGH VOLTAGE SIGN

At this Location: Primary squatter and broken high voltage sign

- FDA = Insulator / Primary Squatter / Replace
- FDA = High Sign / Broken / Replace
- Assign priority depending upon condition of asset/component, location, and public safety & exposure
- Note: Consider replacing wood crossarm with composite.

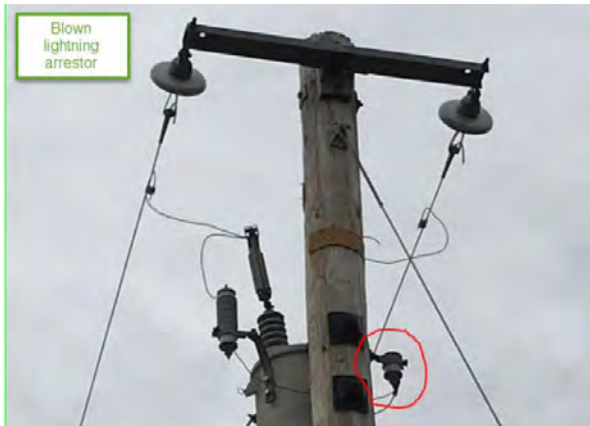
Example: Blown lightning arrestor

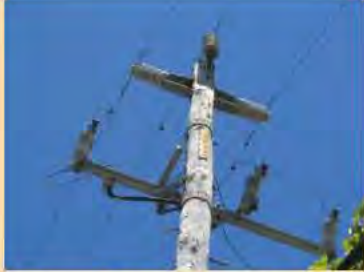
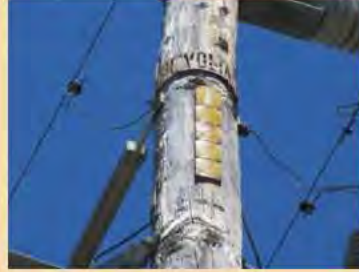
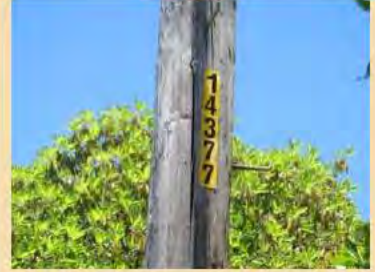
FADED OPERATING NUMBER

Before: Faded operating number

At this Location: Operating number is faded

After: Minor work completed, operating number applied below operating position.

- FDA=Marking / Broken/Damaged / Replace
- At minimum – must write up as Priority "F-R", next inspection cycle; based on field condition and exposure, corrosion, etc.; prioritize as needed (A, B, E, or F)

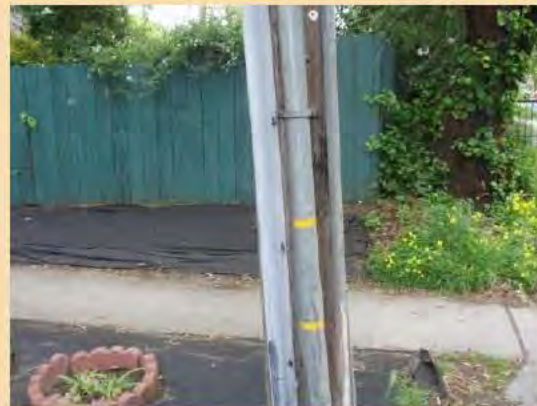
INADEQUATE VISIBILITY STRIPS

At this Location: Pole with vehicular exposure. Two small sections of yellow adhesive visibility strips.

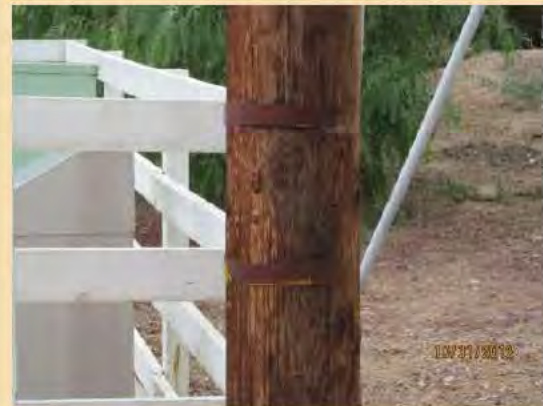
VISIBILITY STRIPS PAINTED OVER NO LONGER REFLECTIVE

At this Location: Visibility strips painted brown (3rd visibility strip located above not shown in picture)

Perform Minor Work: Yes, remove old visibility strips and install new.

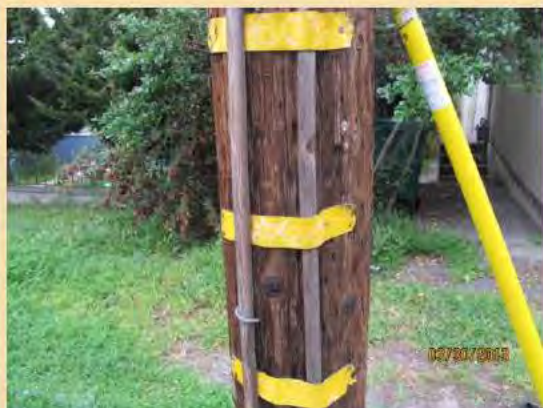
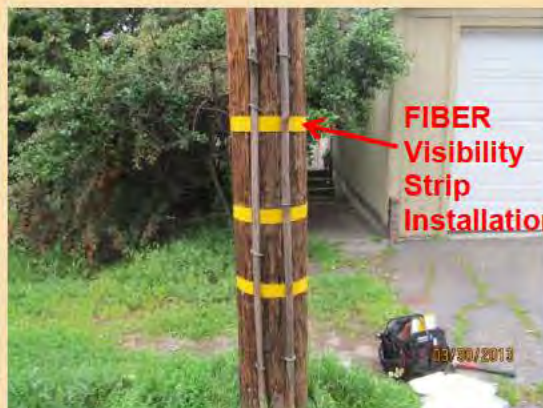
METAL OVER MOLDING

At this Location: Metal visibility strips under wood molding and over wood molding with protruding edge.

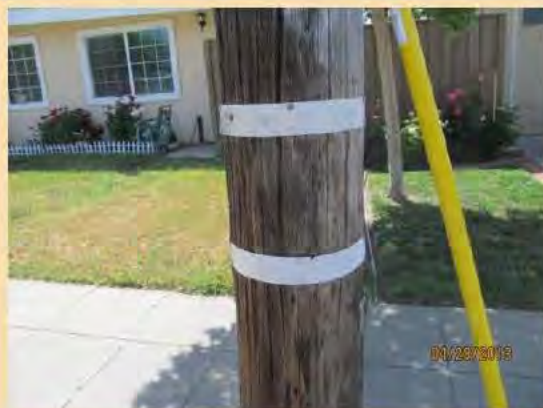
OLD METHOD VISIBILITY STRIPS

At this Location: Aged visibility strips have lost reflectivity.

Perform Minor Work: Yes, replace with 3 yellow visibility strips

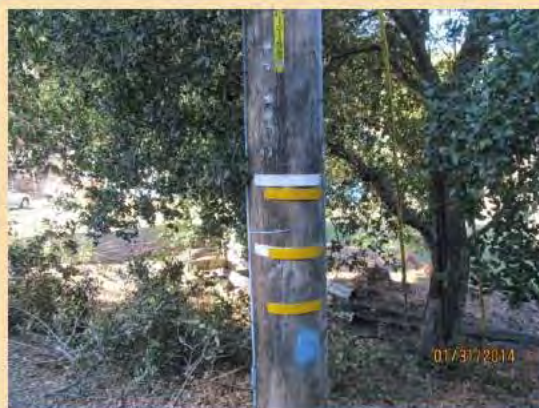
OLD AND NEW VISIBILITY STRIPS

At this Location: Yellow visibility strips mounted over old white visibility strips.

Perform Minor Work: Yes, remove old visibility strips

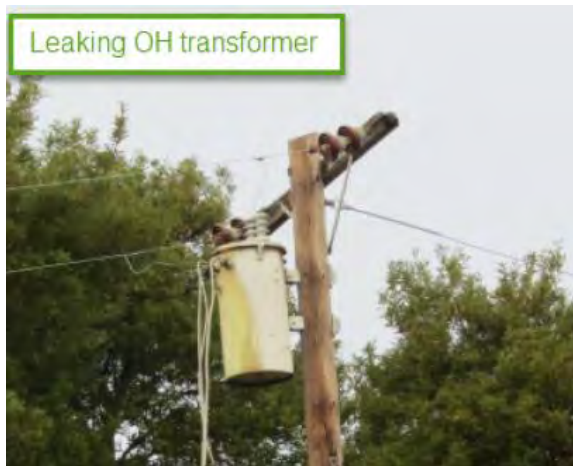
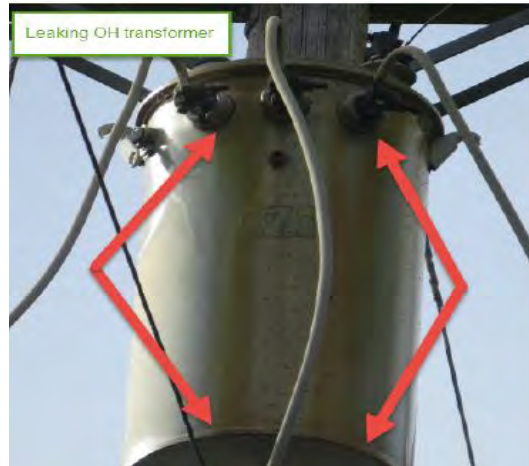
Examples: Leaking OH Transformer

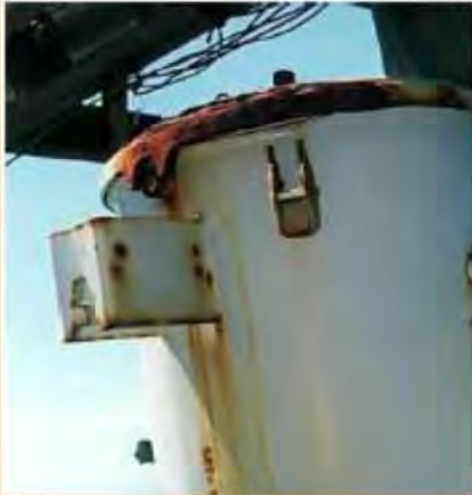
At this Location: Corrosion Weakening Integrity of Tank

Metal is separating into layers

Corrosion will breach tank

- FDA=Transformer Leaks/Seeps/Weeps Replace
- Priority "E", 3-12 months depending upon exposure

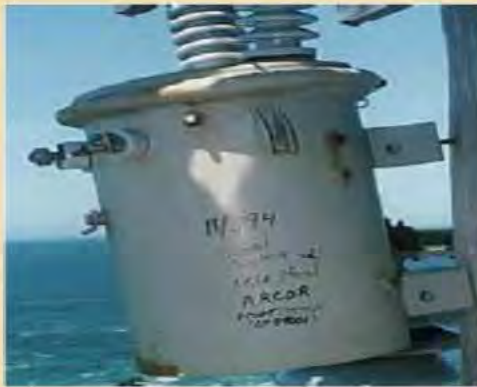
At this Location: Transformer with moderate/heavy corrosion

Metal structure still sound (rust staining from attachments)

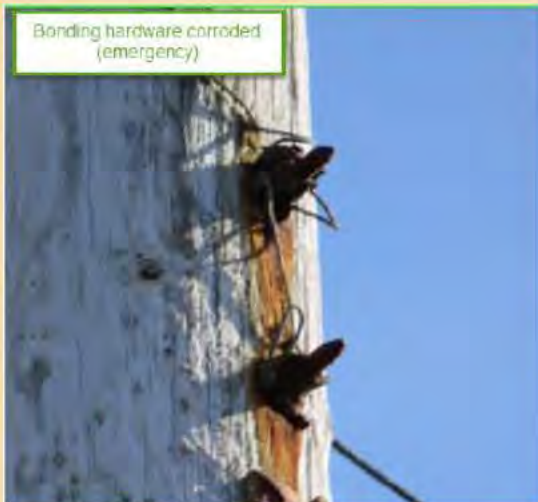
At this Location: Bonding hardware corroded

- FDA=Transformer Leaks/Seeps/Weeps Replace
- Priority "E", 3-12 months depending upon exposure

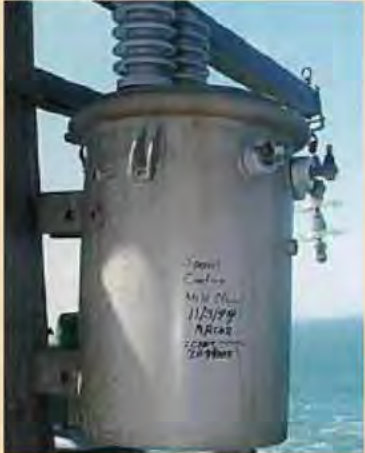
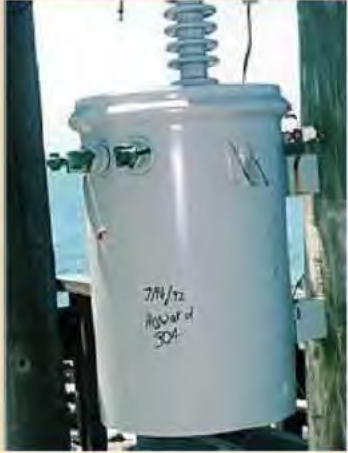
TRANSFORMER WITH STAINING, NO CORROSION	TRANSFORMER CASE WITH LITTLE OR NO CORROSION

<p>At this Location: Transformer with dirt and salt spray staining, no metal damage</p>	<p>At this Location: Transformer with little to no corrosion, no metal damage</p>
<p>Perform Minor Work: No</p>	<p>Perform Minor Work: No</p>
<p>Write Third-Party Notification: No</p>	<p>Write Third-Party Notification: No</p>
<p>Write EC Form: No</p>	<p>Write EC Form: No</p>

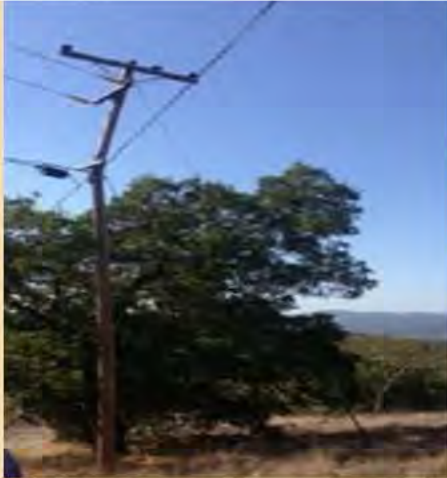
POLE BROKEN AT THE COMMUNICATION LEVEL

At this Location: Pole broken at the communication level in HFTD area.
Complete Pole Inspection Test Report

- FDA=Pole / Broken/Damaged / Replace
- Priority "A" address immediately

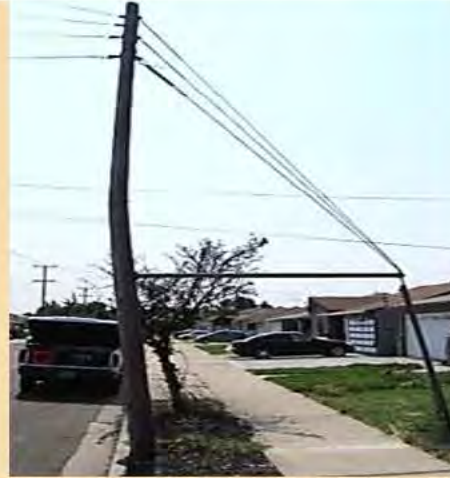
POLE BROKEN AT MIDDLE SECTION

At this Location: Broken pole. Complete Pole Inspection Test Report

- FDA=Pole / Broken/Damaged / Replace
- Priority "B", 0-3 months depending upon exposure

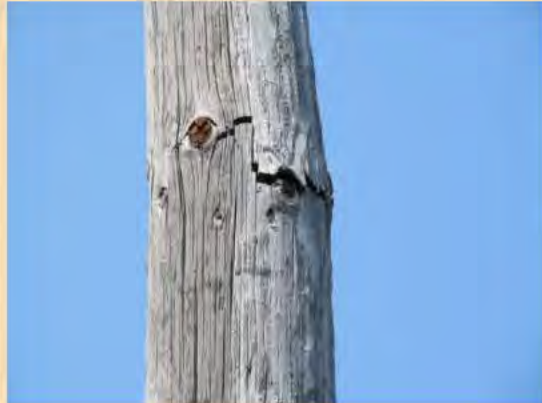
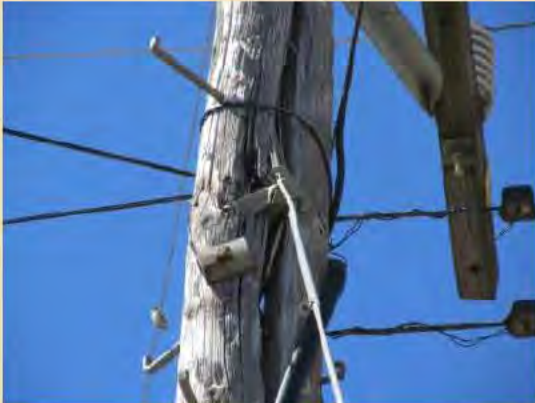
BROKEN POLE	POLE SPLIT AT COMMUNICATION LEVEL

<p>At this Location: Broken pole. Complete the Pole Inspection Test Report. Pole supported in four directions.</p>	<p>At this Location: Pole split at communication level. Complete the Pole Inspection Test Report.</p>
<p>Perform Minor Work: No</p>	<p>Perform Minor Work: No</p>
<p>Write Third-Party Notification: No</p>	<p>Write Third-Party Notification: No</p>
<p>Write EC Form: Yes</p> <ul style="list-style-type: none"> • FDA=Pole / Broken/Damaged / Replace • Priority "B", 0-3 months depending upon exposure 	<p>Write EC Form: Yes</p> <ul style="list-style-type: none"> • FDA=Pole / Broken/Damaged/ Replace • Priority "B", 0-3 months depending upon exposure

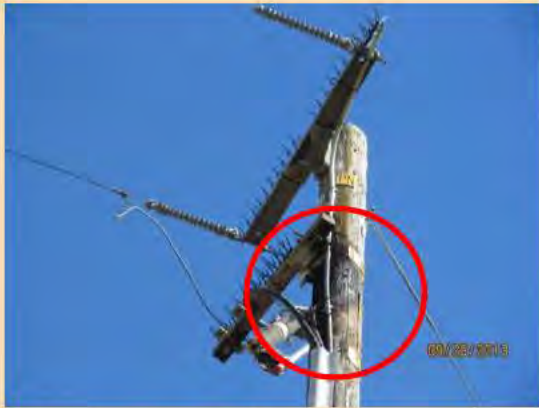
DAMAGE TO POLE FROM SPECIFIC EVENT

At this Location: Pole burnt
 If pole has reduced circumference. Write EC notification for estimating to confirm pole loading.

- FDA=Pole/Overloaded/Test
- Priority "E", 3-12 months depending on exposure.

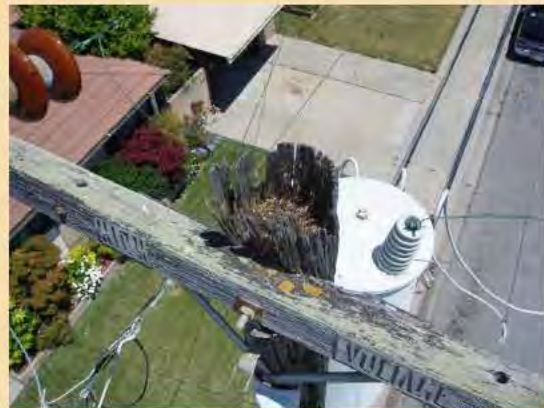
DECAY OF POLE OVER TIME

At this Location: Pole top decayed. Entire pole failed pole test. Complete the Pole Inspection Test Report.

- FDA=Pole Decayed/Rotten/Replace
- Priority "E", 3-12 months depending upon exposure

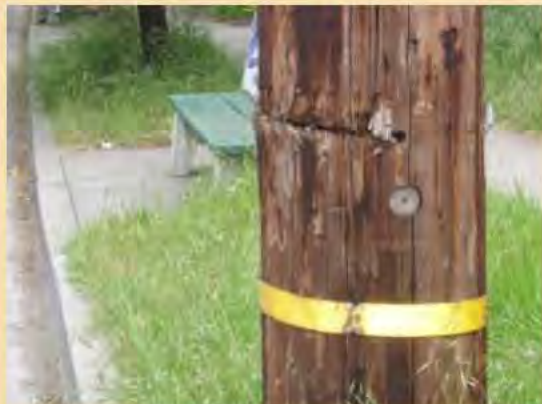
SAW CUT INTO POLE

At this Location: Vandalized pole. Chain saw cut into lower portion of pole. Half of pole circumference cut into.
 Notify supervisor of possible vandalism. Supervisor will have to communicate to damage claims. Complete Poles Inspection Test Report.

- FDA=Pole / Broken/Damaged/ Replace
- Priority "A" or "B", 0-3 months depending upon exposure

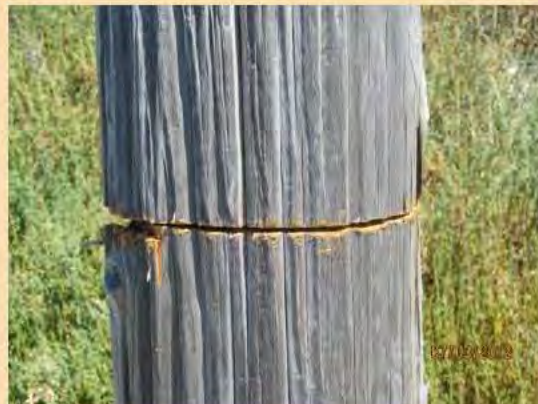
At this Location: Vandalized pole. Chain saw cut into lower portion of pole. More than half of pole circumference cut into.
 Notify supervisor of possible vandalism. Supervisor will have to communicate to damage claims. Complete Poles Inspection Test Report.

- FDA=Pole / Broken/Damaged / Replace
- Priority "A" or "B", 0-3 months depending upon exposure

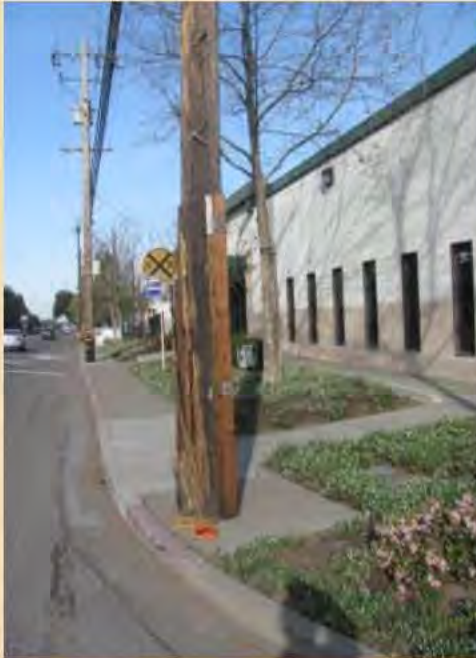
POLE DAMAGED ON THE BOTTOM BUT OK

At this Location: Pole damaged by vehicle. Splint installed as temporary repair. Inspection shows adequate circumference/strength. Sharp ragged splinters. Curb is adequate protection – visibility strips not required.

If pole has reduced circumference write EC notification for estimating to confirm pole loading. If damage requires replacement, create an EC notification to replace the pole.

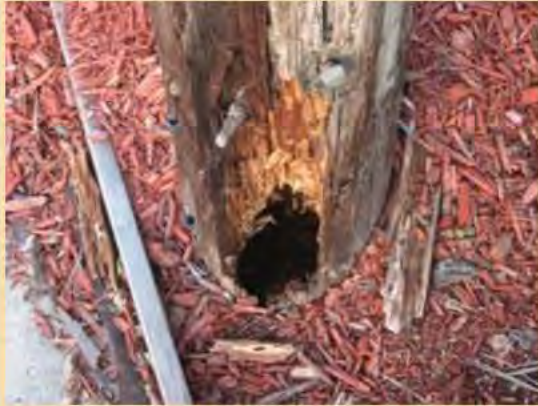
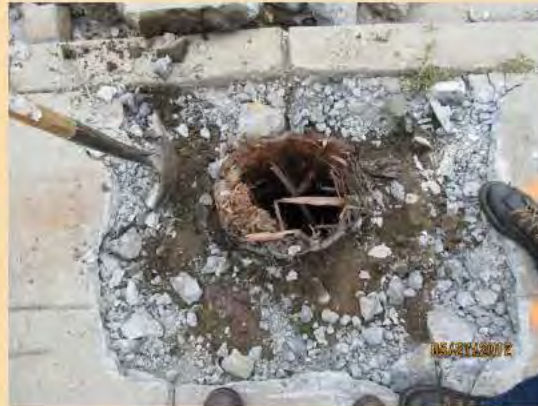
DETERIORATION AROUND GROUND LINE

At this Location: Deteriorated condition found during normal inspection. Complete Pole Inspection Test Report. If pole has reduced circumference. Write EC notification for estimating to confirm pole loading.

- FDA=Pole / Decayed/Rotten / Replace
- Priority "A", follow Emergency Process

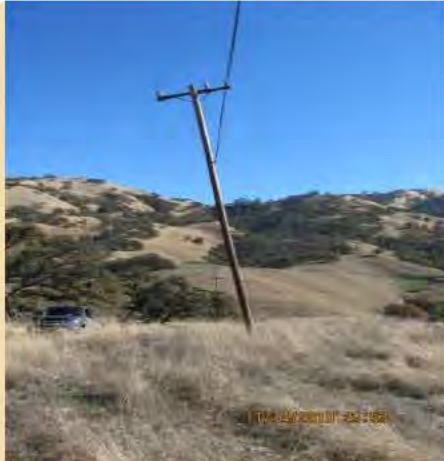
LEANING POLE

At this Location: Leaning pole greater than 10% out of plumb. Pole is stable. No equipment in rural area. Causing reduced clearance.

- FDA=Pole / Leaning / Replace
- Priority "E", 3-12 months depending upon exposure

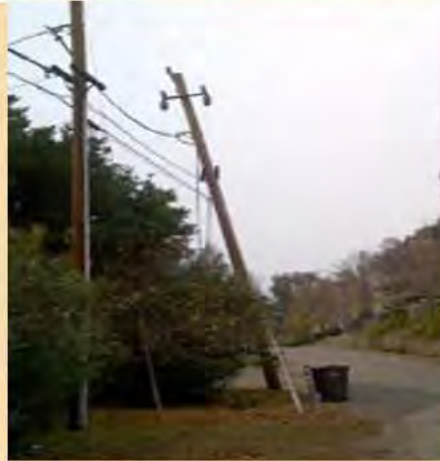
LEANING SLACK SPAN

At this Location: Leaning pole more than 10% out of plumb. Pole test indicates that pole is solid below ground and can be straightened. Probability of equipment failure is moderate.

- FDA=Pole / Leaning / Adjust
- Priority "E", 3-12 months depending upon exposure

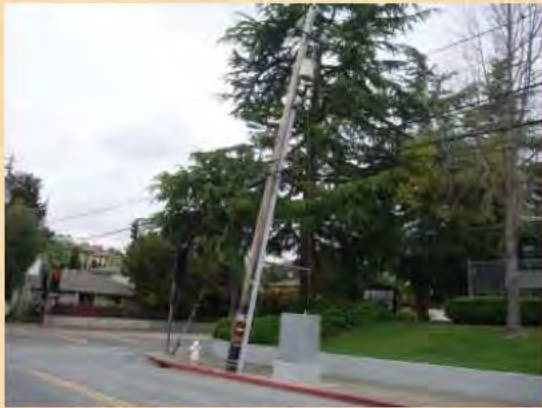
STUBBED POLE LEANING TOWARDS SCHOOL

At this Location: Stubbed pole leaning towards school, supported by down guy. Pole Bands are loose due to additional deterioration of the pole. Pole test data sheet indicates that pole no longer meets stubbing criteria causing reduced clearance issues

- FDA=Pole / Decay/Rotten / Replace
- Priority "E", 3-12 months depending upon exposure

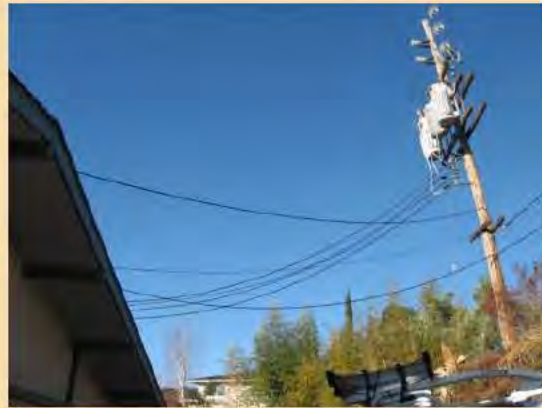
POLE LEANING 3 POT TRANSFORMER IN BUCK POSITION

At this Location: Pole is leaning less than 10% out of plumb, leaning in direction of offset equipment. Pole inspection found pole stable.

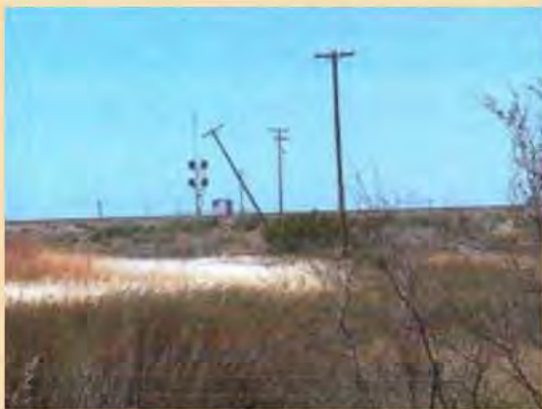
POLE LEANING NEAR RAILROAD TRACKS

At this Location: Severe lean being held up by the primary conductors. Low clearance over active railroad tracks. Pole located in a swamp area with standing water.

- FDA=Pole / Decayed/Rotten/ Replace
- Priority "A", follow Emergency Process

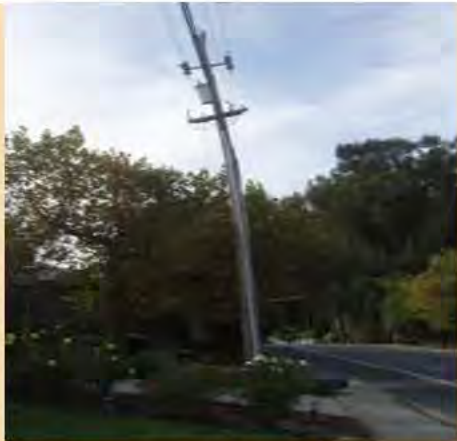
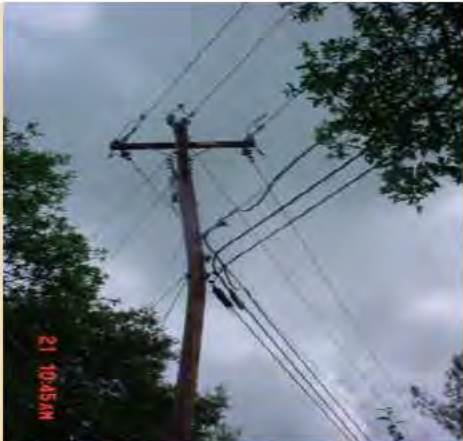
POLE BENT 4 FEET OUT OF LINE	INADEQUATE SUPPORT AT COMMUNICATIONS LEVEL

<p>At this Location: Pole bent 4 feet out of line, less than 10% lean</p>	<p>At this Location: Two guys stabilizing communication level.</p>
<p>Perform Minor Work: No</p>	<p>Perform Minor Work: No</p>
<p>Write Third-Party Notification: No</p>	<p>Write Third-Party Notification: No</p>
<p>Write EC Form: Yes, only when the inspector decides that further assessment is required.</p> <ul style="list-style-type: none"> • FDA=Pole / Overloaded / Test • Priority "E", 3-12 months depending upon exposure 	<p>Write EC Form: Yes, only when the inspector decides that further assessment is required.</p> <ul style="list-style-type: none"> • FDA=Pole / Overloaded / Test • Priority "E", 3-12 months depending upon exposure

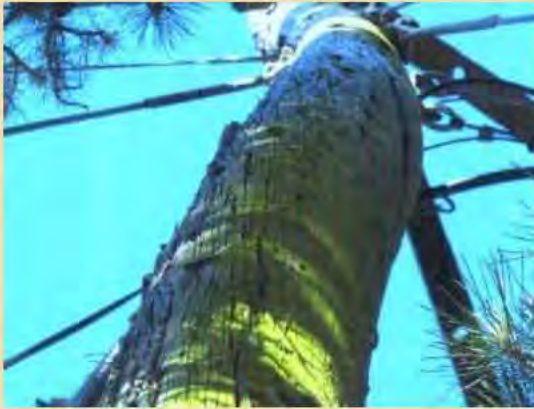
OVER STRESSED POLE

At this Location: Pole is twisted, cracked, due to communication.

- FDA=Pole / Overloaded / Replace Pole Test Data Sheet is Required
- Priority "E", 3-12 months depending upon exposure; add in field comments "overloaded by communications."

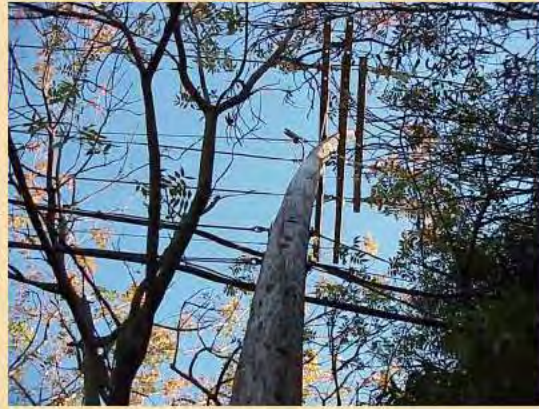
UNBALANCED LOAD AT TOP

At this Location: Deformed pole with bowed top in line with conductor.

- FDA = Pole / Overloaded / Test
- Select the Priority and Due Date based upon compelling abnormal condition that may adversely impact public safety and/or service reliability in the next five (5) years

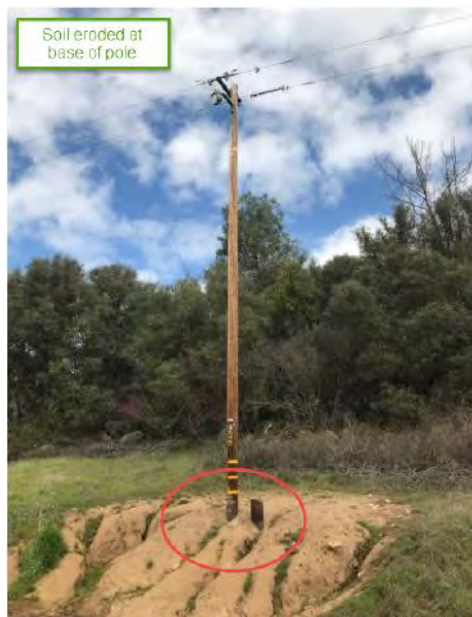
Example: Soil eroded at base of pole

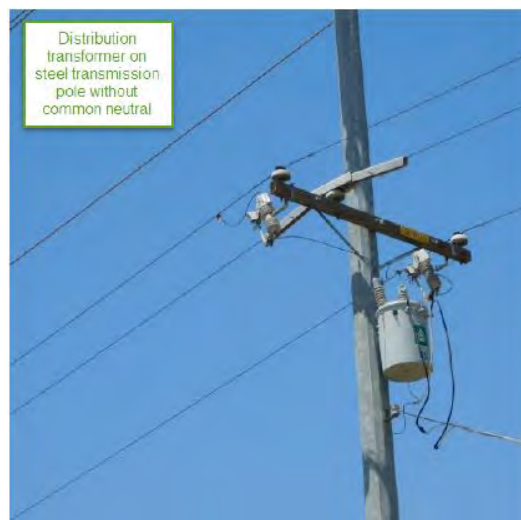
Example: Distribution transformer on steel transmission pole without common neutral.

Is there a distribution transformer serving an external customer installed on a steel pole without a common neutral present? If yes, create EC notification to relocate the transformer.

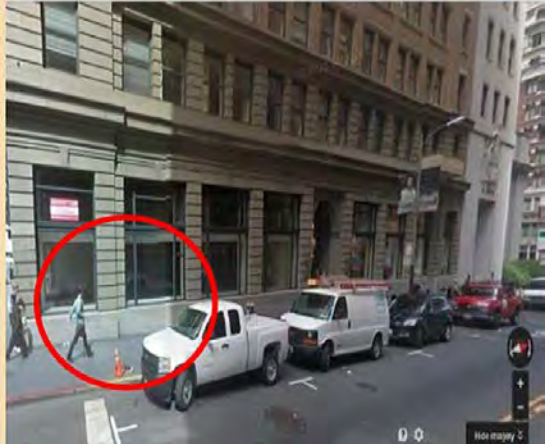
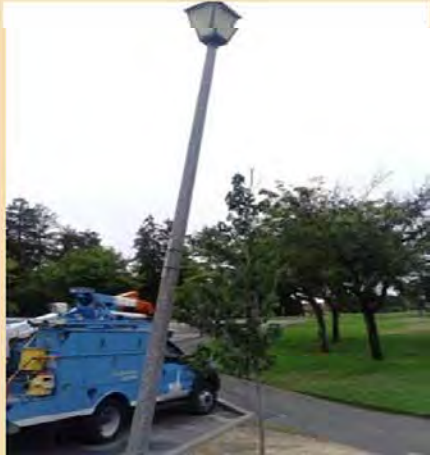
1. Broken or Damaged Streetlight Pole

MISSING STREET LIGHT	LEANING AGGREGATE POLE

<p>At this Location: Cone indicates location of missing decorative street light and pole. Exposed wire is de-energized. Include picture of similar street light for replacement.</p>	<p>At this Location: Leaning aggregate pole more than 10% out of plumb. Pole is broken at base and not stable. Light still working.</p>
<p>Perform Minor Work: Yes, make safe.</p>	<p>Perform Minor Work: No</p>
<p>Write Third-Party Notification: No</p>	<p>Write Third-Party Notification: No</p>
<p>Write EC Form: Yes</p> <ul style="list-style-type: none"> • FDA=Streetlight / Missing / Install • Priority "B", 30 days for regular streetlights, add in field comment section if pole is missing. • Priority "E", 6 months for decorative streetlights, add in field comment section – describe if pole is missing. 	<p>Write EC Form: Yes</p> <ul style="list-style-type: none"> • FDA=Pole / Broken/Damaged / Replace • Priority "B", 0-3 months depending upon exposure

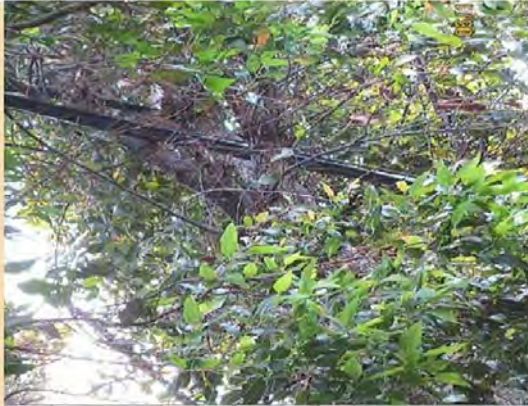
PHONE TREE CONDITION

At this Location: Tree putting strain on the pole, due to communication line

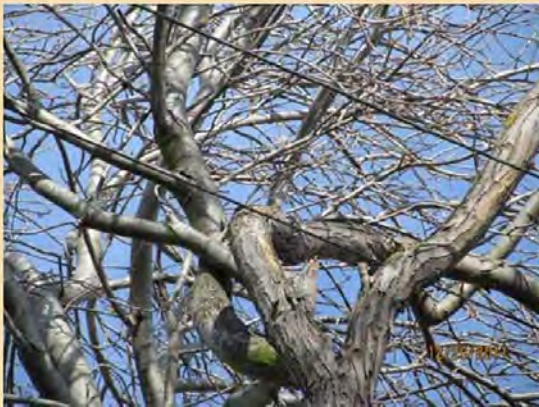
SECONDARY HARD AGAINST TREE

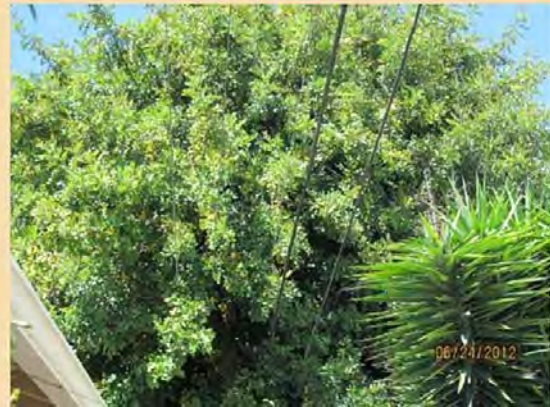
SECONDARY OVERGROWN REDUCING CONDUCTOR CLEARANCES

At this Location: Secondary conductor resting on tree/vegetation

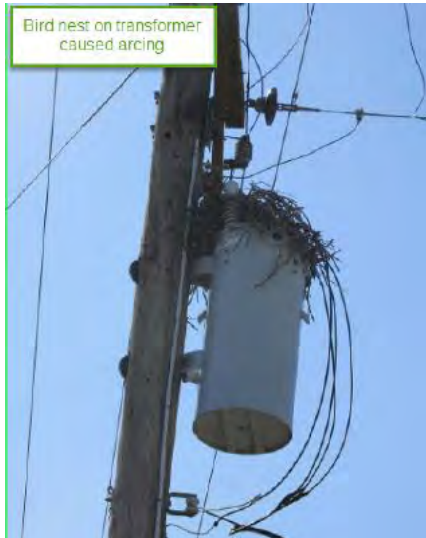
Example: Bird nest on transformer

Note: If there is a nest at the location, write EC Notification to install animal mitigation if nest is already abandoned.

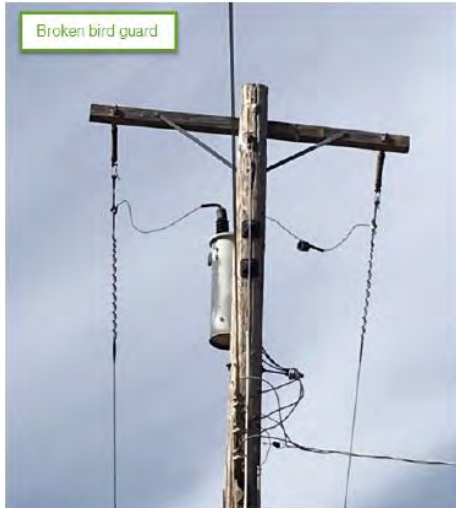
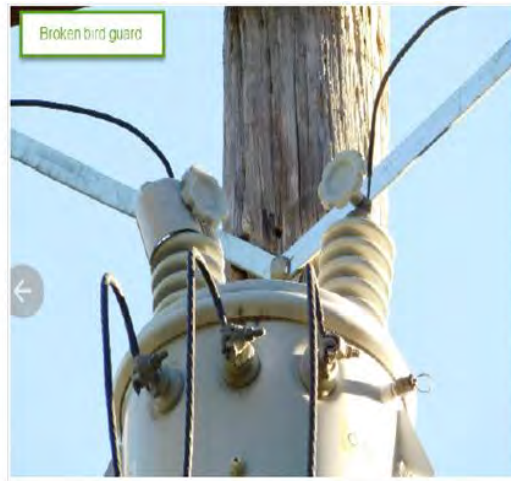
Examples: Broken bird guard

General Guidance: Inspector should create EC notification to repair/replace existing wildlife protection installed in the field (cow guards, etc.)

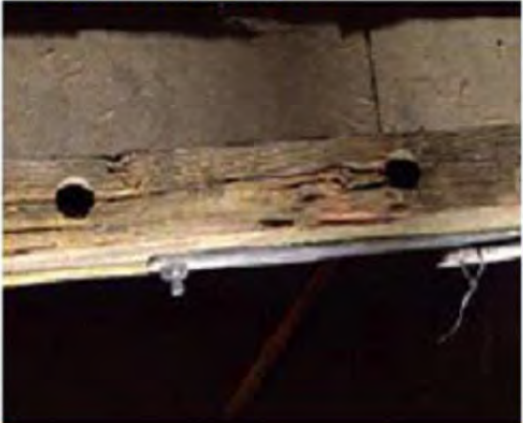
Table 2 – Crossarm Grading Aid	
BOTTOM VIEW	TOP VIEW
<p>Evidence of decay near hole</p>

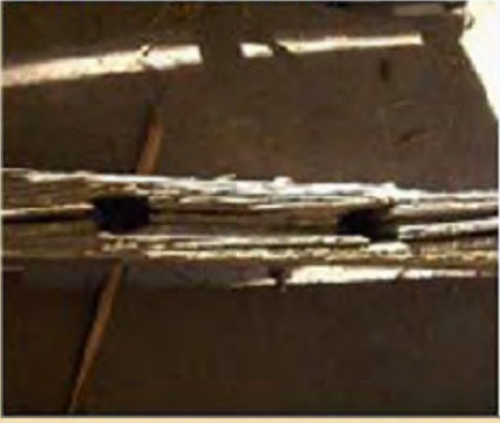
<p>Evidence of Significant Decay</p>

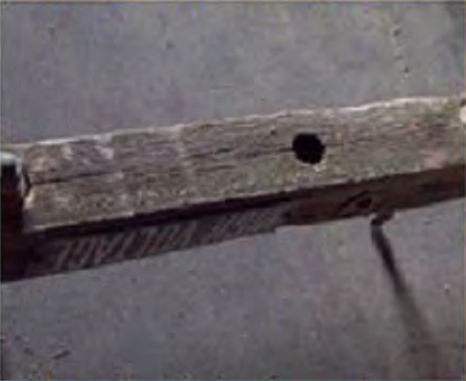
<p>Enlarged hole, minor moss/discoloration/splits near pin hole</p>

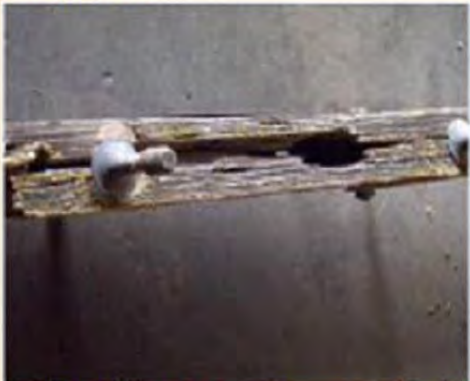
<p>Enlarged hole, minor moss/discoloration/splits near pin hole</p>

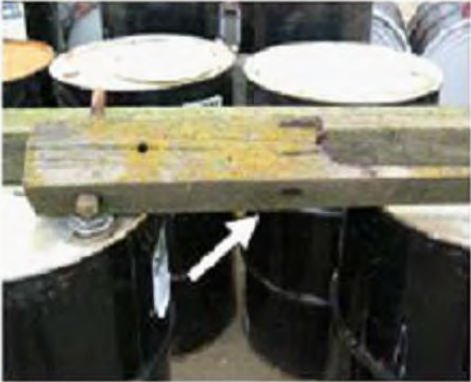
<p>Evidence of tracking/burning near brace and pin holes</p>

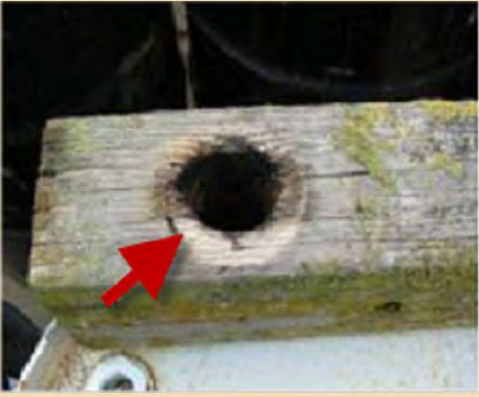
<p>Evidence of burning near brace and pin holes</p>

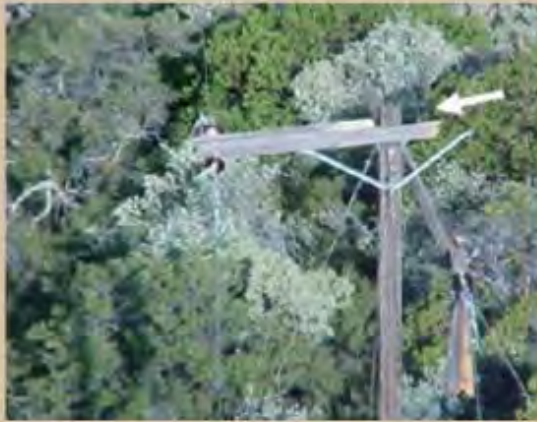
BROKEN CROSSARM

Crossarm is completely broken/fractured

Emergency - make safe immediately

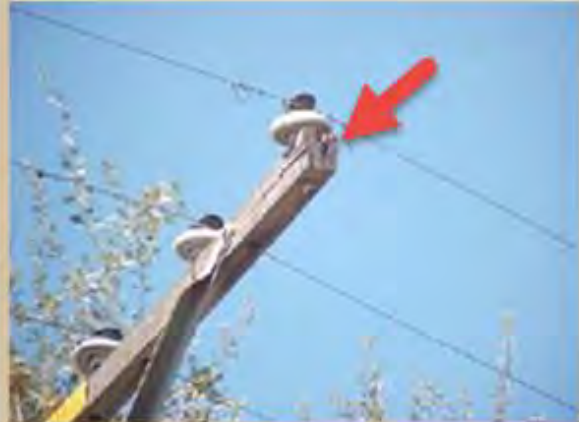
SPLIT CROSSARM

Primary Squatter (wood pin). Crossarm split within 2" of pinhole.

Replace in the next 3 months.

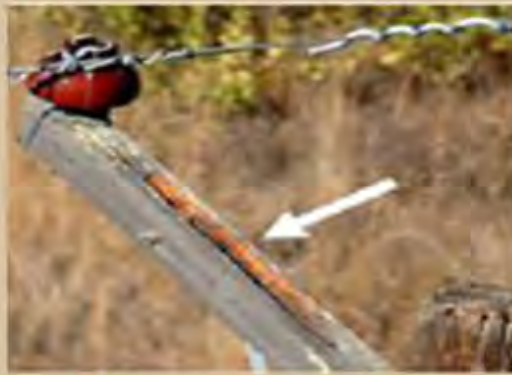
TOP OF CROSSARM DECAYED

Evidence of pole top decay and face of crossarm decay; may need additional assessment of crossarm.

Replace 3-12 months

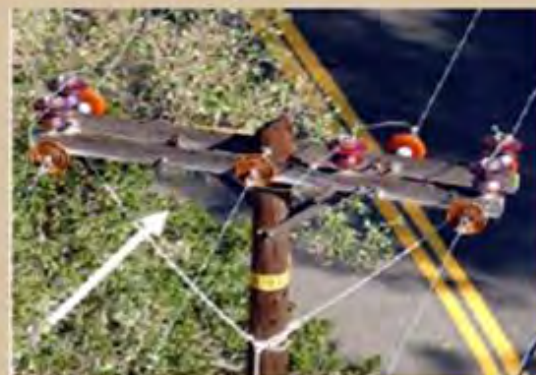
DETERIORATED CROSSARM

Significant deterioration, both arms are broken/split. Evidence of previous temporary repair.

Replace 3-12 months

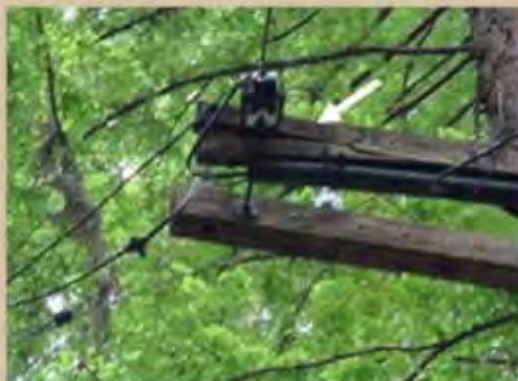
BROKEN SECONDARY CROSSARM

Secondary arm broken; split/fractured within 2" of bolt holes in heavy tree area.

Replace 3-12 months
