**Event
Analysis
Report**

Murphys – Property Damage

EIR No.: EI200909A

Date of Event: September 09, 2020

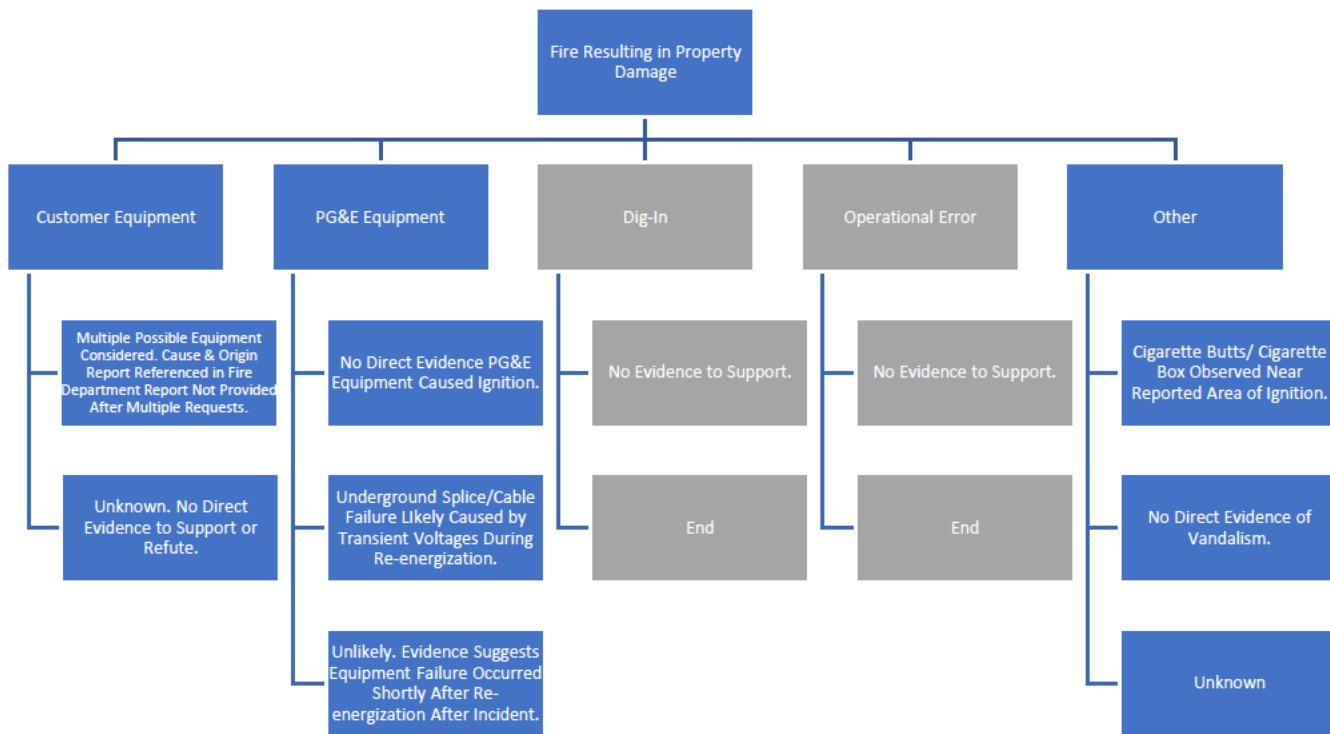
Table 6: Cause-Factor Tree

A cause factor tree analysis was performed as part of this investigation. Based upon the availability of limited evidence, the cause of the fire is currently undetermined. It is possible a customer related electrical issue could have caused the fire, although insufficient evidence was found to support this hypothesis⁶¹.
