Event Analysis Report

Woodland – Property Damage

EIR No.: EI220611A

Date of Event: June 11, 2022

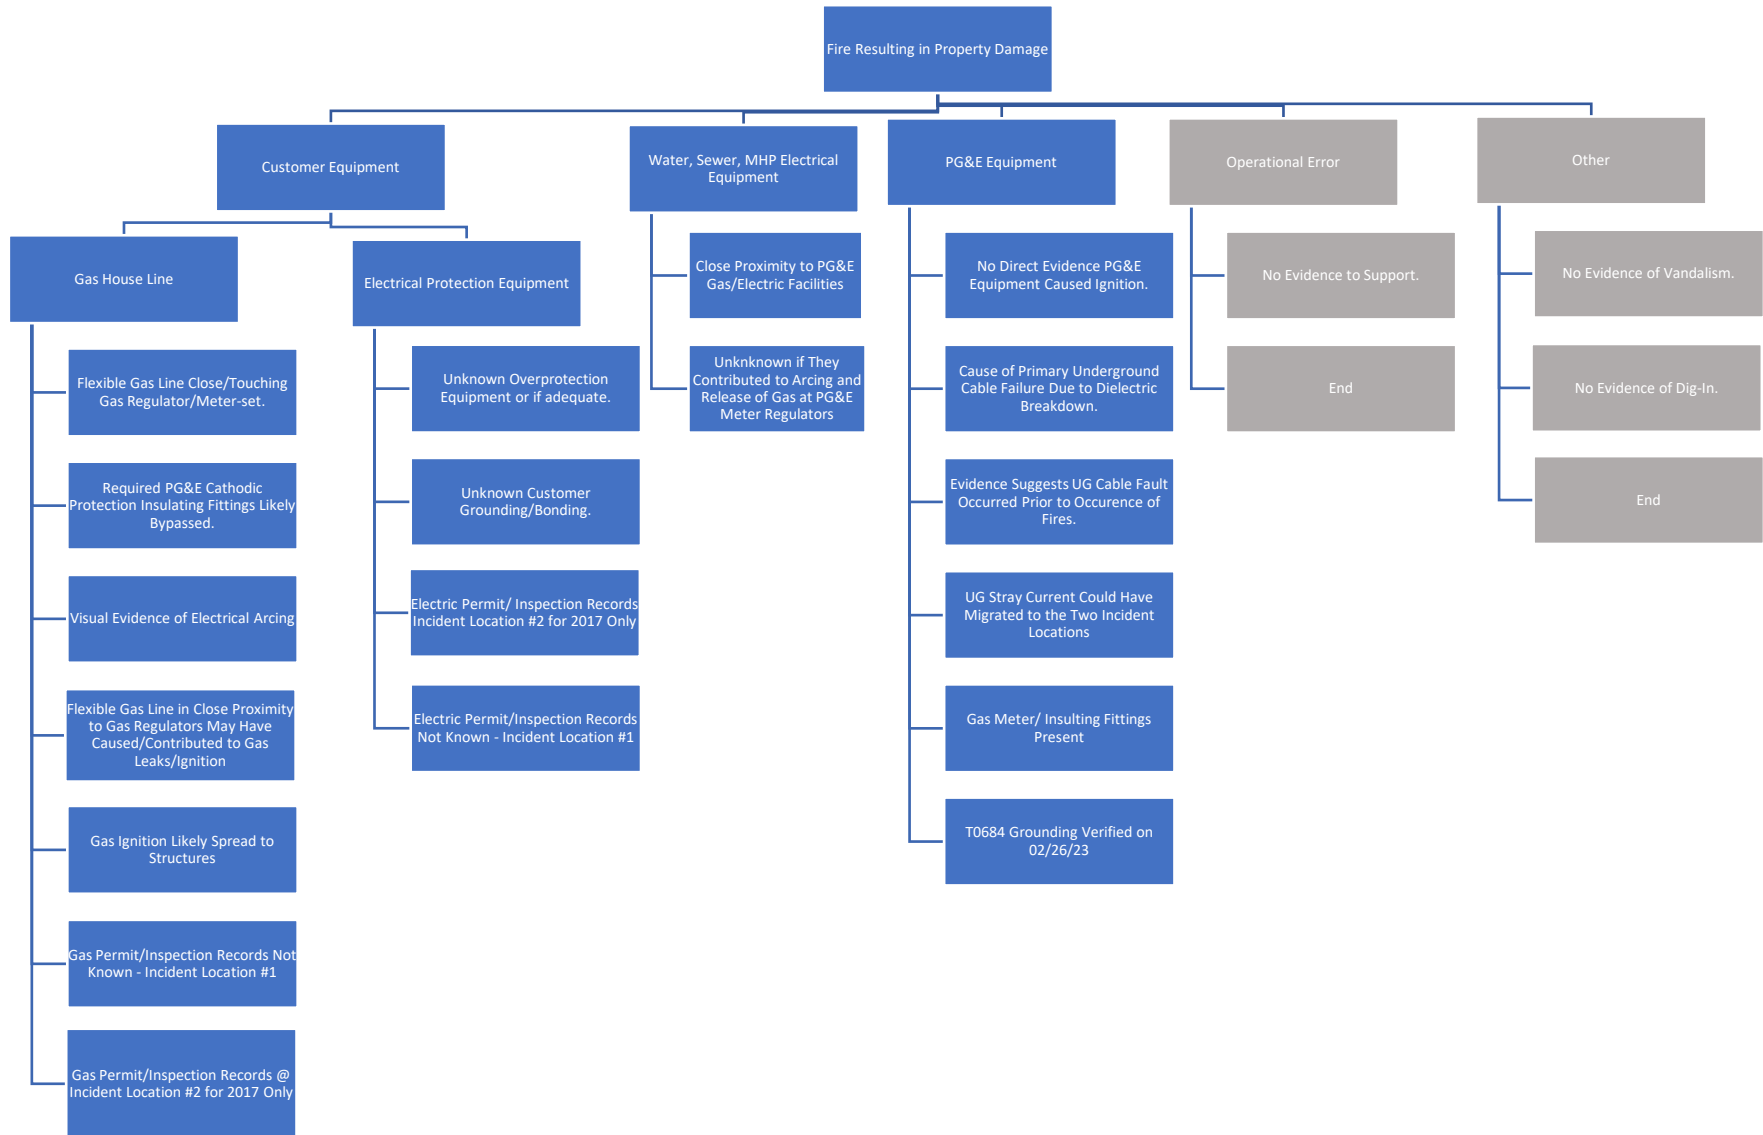
Figure 14: Fault Tree Analysis

The following additional finding (AF) was identified:

- **AF-1:** PG&E's Greenbook does not currently have specific guidance related to keeping all customer gas piping, including flexible and rigid pipe, away and not in contact with PG&E gas meter set equipment.
