March 22, 2024

## NOTICE OF VIOLATION

# INSPECTION REPORT

Electrical Corporation:	Liberty Utilities (LU)
Report Number:	LU_CAC18_20231102_1208
Inspector:	CAC18
WMP Year Inspected:	2023
Quarterly Data Report (QDR) Referenced:	Quarter 2 (Q2)
Inspection Selection:	Energy Safety viewed the contents of the Q2 QDR and performed an analysis that resulted in the selection of the WMP initiatives and locations referenced in this report.
Relevant WMP Initiative(s):	Clearance (2023 WMP initiative 8.2.3.3)
Date of inspection:	November 2, 2023
City and/or County of Inspection:	Coleville, Mono County
Inspection Purpose:	Assess the accuracy of Liberty Utilities’ QDR data, completeness of its work, compliance with WMP requirements, and compliance with its protocols.

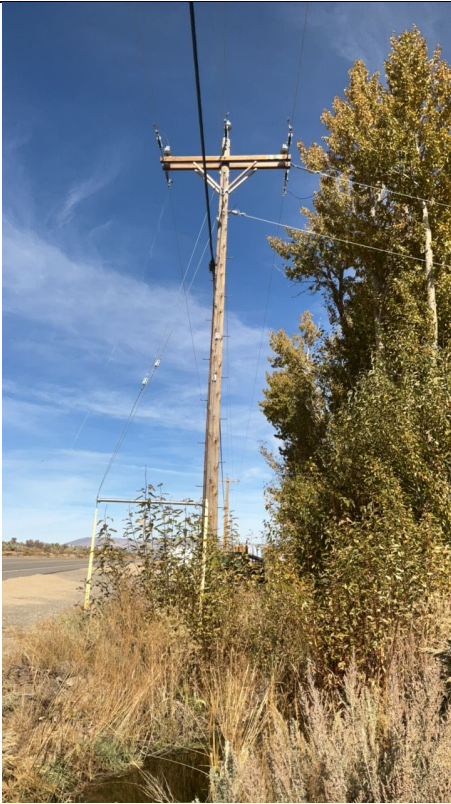
Item2G1mg2: Overall pole.

Near pole ID 128913 at 110520-111298 US Highway 395, Coleville, CA, 96107, USA, 38.5532305947518, -119.502482688142, the inspector observed cottonwood trees within Liberty Utilities' clearance distance of six feet. The inspector's observations are documented in Violation 1 photographs, which are attachments to this report. Photograph numbers Item2G1mg1, Item2G1mg2, Item2IA1mg1, and Item2IA1mg2 depict cottonwood trees approximately four to five feet from primary conductors. The radial clearance requirement from these primary conductors (12kV-25kV) is six feet, and Liberty Utilities failed to trim back to 12-15 feet, per Liberty Utilities' MAT shown in Table 8-23 above.

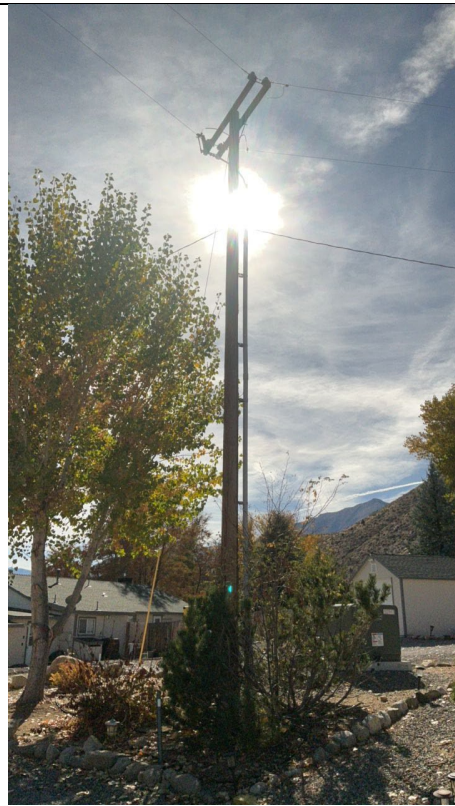
**Item4Gimg2: Overall pole.**

Near pole ID 260086 at 110065-110499 US Highway 395, Coleville, CA, 96107, USA, 38.5520217369178, -119.503151731416, the inspector observed a cottonwood tree within Liberty Utilities’ clearance distance of six feet. The inspector’s observations are documented in Violation 2 photographs, which are attachments to this report. Photograph numbers Item4G1mg1, Item4G1mg2, Item4IA11mg1, and Item4IA11mg2 depict a cottonwood tree within approximately six feet from primary conductors. The radial clearance requirement from these primary conductors (12kV-25kV) is six feet, and Liberty Utilities failed to trim back to 12-15 feet, per Liberty Utilities’ MAT shown in Table 8-23 above.

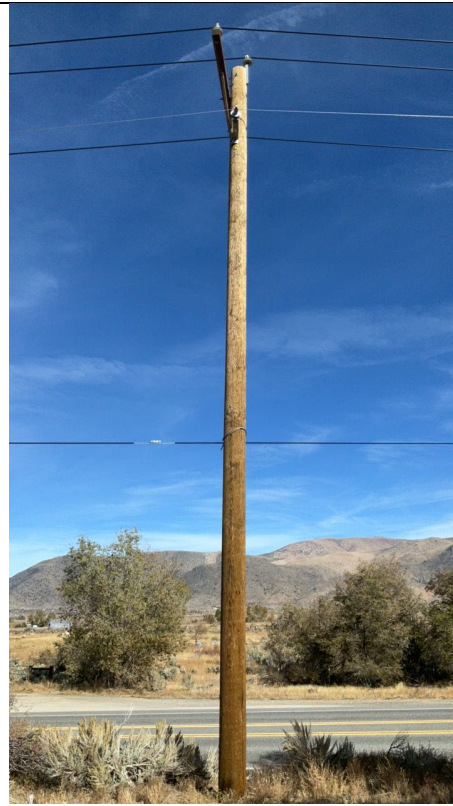
**Item5GImg2: Overall pole.**

Near pole ID 293672 at Mile 108 US Highway 395, Coleville, CA, 96107, USA, 38.5196868593662, - 119.484202482983, the inspector observed an elm tree within Liberty Utilities’ clearance distance of six feet. The inspector’s observations are documented in Violation 3 photographs, which are attachments to this report. Photograph numbers Item5GIimg1, Item5GIimg2, Item5IA1img1, and Item5IA1img2 depict the elm tree approximately five feet from primary conductors. The radial clearance requirement from these primary conductors (12kV-25kV) is six feet, and Liberty Utilities failed to trim back to 12-15 feet, per Liberty Utilities’ MAT shown in Table 8-23 above.
