# Review of 2023 SCE Wildfire Mitigation Targets:

Independent Evaluator Annual Report on  
Compliance (IE ARC)

Prepared for: Southern California Edison (SCE)

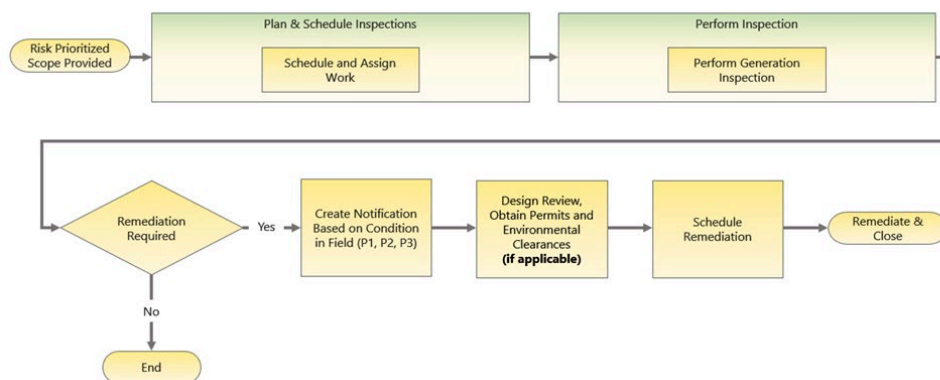
**Figure 8-1g - Generation Inspections Workflow**

An SME interview was held on 10 June 2024. At the interview SCE oriented the IE to the information provided and reviewed the file, “*IN-5 Inspection Survey Information 2023.xlsx*”. This document reflects the results of the 29 randomly sampled generation asset inspections. The document does not provide work order or other information regarding the next or follow up mitigation steps these inspections identified, as discussed in the Figure taken from the WMP (Figure 8-1g).

*IE Findings:* SCE states that 225 Generation Inspections were performed. The information sampled indicates that the Inspections are being performed as stated. IE was not able to confirm, through follow up work-orders or similar documentation, that the full lifecycle of the workflow described in the 2023 WMP was completed.

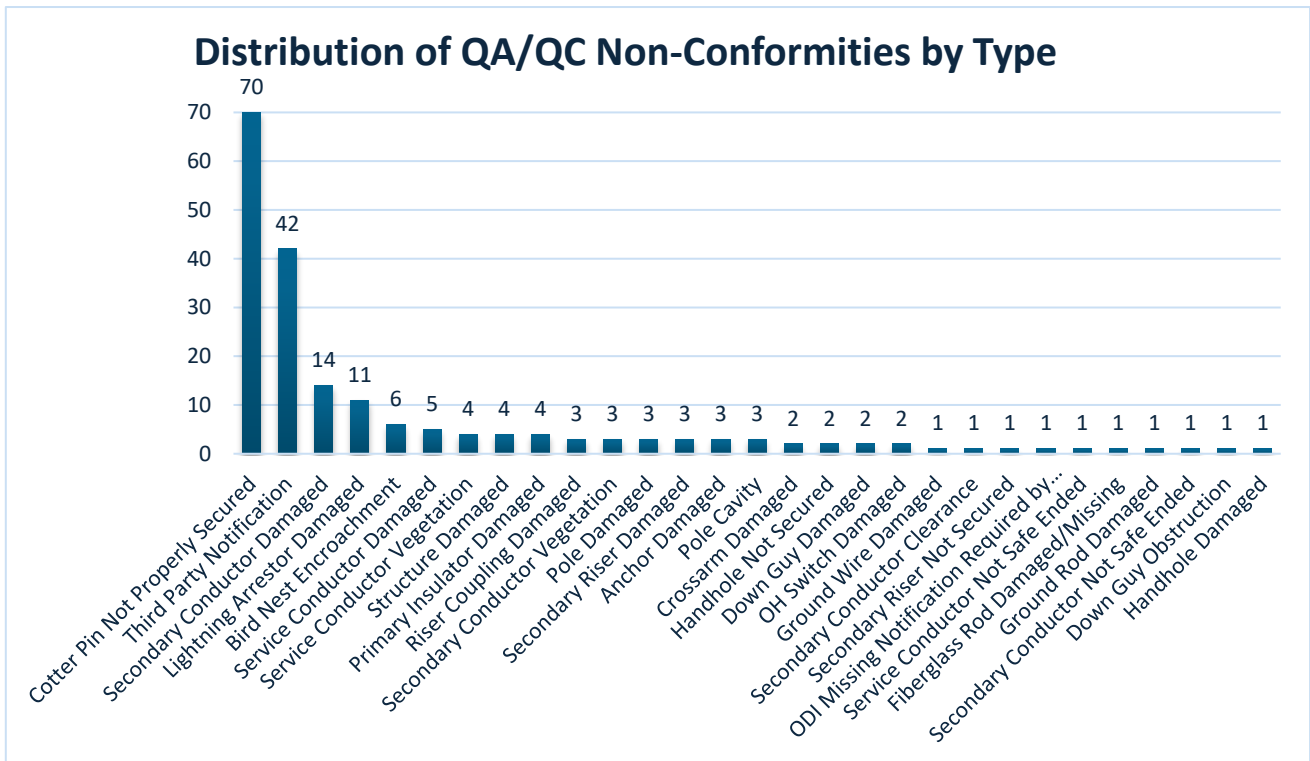
**Table 3: Tally of QA/QC Nonconformities**

During the review with the Quality Team, it was identified that addressing non-conformances, which accounted for the majority of issues, required remedial training. The Quality Team subsequently developed training materials specifically targeting the "Cotter Pin Not Properly Secured" issue, aligning with the WMP QA and QC goal of improving practices to prevent recurrence as an example of that process.

In reviewing the open and closed non-conformances, by the end of 2023, the IE noted that only 64 out of the 204 non-conformances had been completed and closed. Further clarification from the QA/QC team revealed that the high number of open items stemmed from incomplete paperwork rather than unfinished work. Following this discussion with SCE, 122 work orders were closed, with the following distribution of completion dates:
