NOTICE OF VIOLATION

On November 21, 2024, Energy Safety conducted an inspection of SDG&E's WMP initiatives in the vicinity of the city of Lakeside in High Fire Threat District (HFTD) Tier 2. The inspection report is enclosed herewith. Energy Safety found the following violation:

INSPECTION REPORT

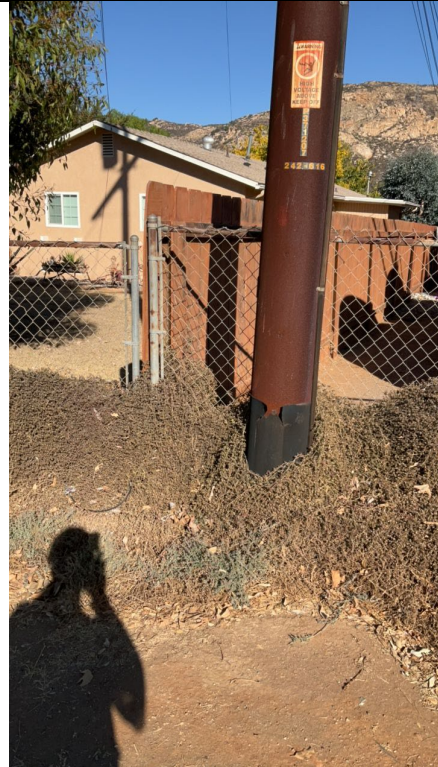
Energy Safety concludes that Violation 1 is "Moderate" because the remaining vegetation fuel bed consists of flammable material in the form of dying, dry vegetation.

At Vegetation Management Point (VMP) ID 452-YY16833 near GPS coordinates 32.881357, -116.927326 in Lakeside, SDG&E reported that it completed work under its Pole Clearing program (WMP initiative number 8.2.3.1). SDG&E's Q3 QDR data reports that pole ID P371207 located near 11235 Highway 67 was mechanically cleared on August 18, 2024. However, the inspector observed that SDG&E did not complete its pole clearing activity at the location, having left dying, dry vegetation (ice plant) within the 10-foot clearance radius of the subject pole. The inspector's observation is documented in Violation 1 photographs, which are exhibits to this report. Photo numbers Item1G1mg1 and Item1G1mg2 depict the pole ID P371207 and the overall pole. Photo number Item1G1mg3 shows the vegetation on both sides of the fence and photo numbers Item1G1mg4, Item1IA1img1, and Item1IA1img4 depicts a closer view of the dying vegetation within the 10-foot radius. Photo numbers Item1IA1img2 and Item1IA1img3 also show vegetation within the 10-foot radius of the pole.

Item1IA1Img1: Closeup of dying, flammable vegetation and trash within the vegetation.
