## NOTICE OF VIOLATION

# INSPECTION REPORT

Electrical Corporation:	Pacific Gas and Electric Company
Report Number:	CAD_PGE_ATJ_20240813_1556
Inspector:	Anthony Trujillo
WMP Year Inspected:	2023
Quarterly Data Report (QDR) Referenced:	Quarter 4 (Q4)
Inspection Selection:	Energy Safety viewed the contents of the Q4 QDR and performed an analysis that resulted in the selection of the WMP initiatives and locations referenced in this report.
Relevant WMP Initiative(s):	Covered conductor installation - distribution (2023 WMP initiative number 8.1.2.1)
Date of inspection:	August 13, 2024
City and/or County of Inspection:	Mariposa, Mariposa County
Inspection Purpose:	Assess the accuracy of Pacific Gas and Electric Companies QDR data, completeness of its work, compliance with WMP requirements, and compliance with its protocols.

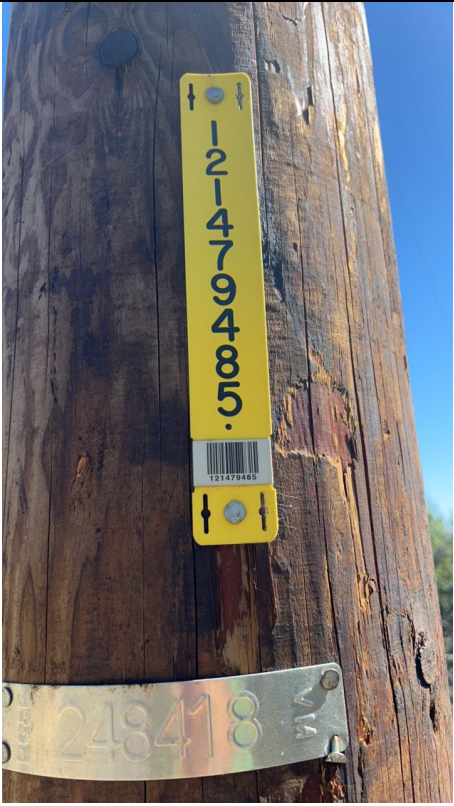
A close-up photograph of the wooden pole. A yellow identification tag is attached to the pole with two screws. The tag contains the number '121479485' and a barcode. Below the tag, a metal band is wrapped around the pole with the number '248418' embossed on it.
<p><b>Item1Gimg1:</b> Overall pole south view</p>	<p><b>Item1Gimg2:</b> Pole ID</p>

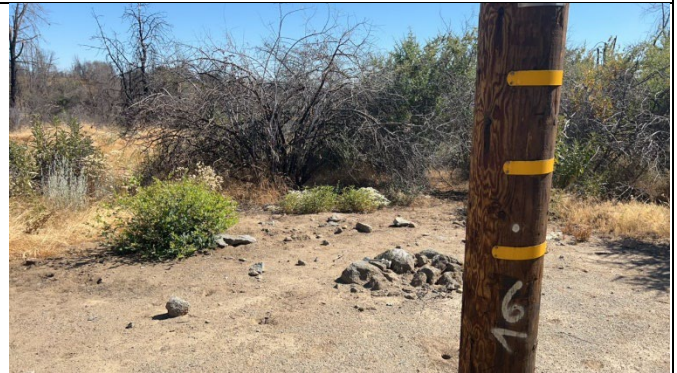
**Item1IA1Img2:** South view

Energy Safety observed bare conductor with upgraded associated framing where PG&E reported covered conductor installation – distribution as completed.

The inspector's observation is documented in Violation 1 photographs, which are attachments to this report. For pole ID 121479485, photo numbers Item1GIImg1 and Item1IA1Img1 depict bare conductor and a new crossarm where covered conductor installation was reported as completed.

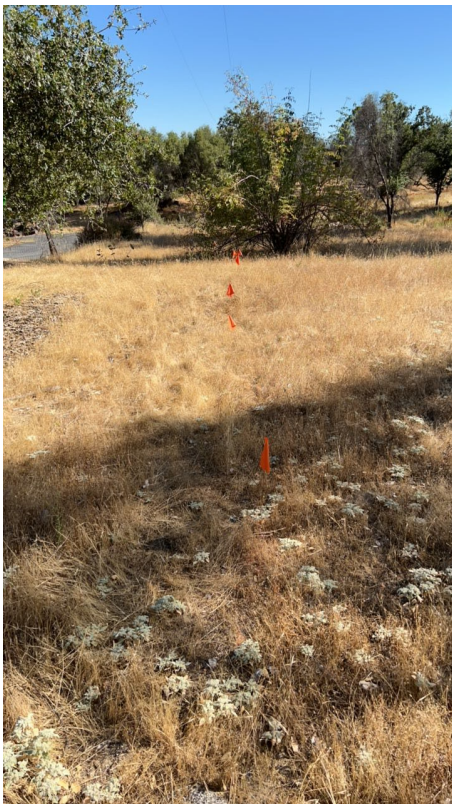
**Item3IA1Img3:** Planted flags south of pole
