Job Aid: Overhead Inspection

This job aid is designed to assist Electric Distribution Compliance Inspectors in assessing and prioritizing **compelling abnormal conditions** on overhead facilities during scheduled GO 165 Inspections.

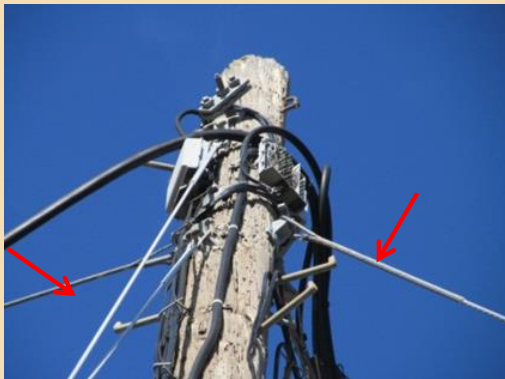
COMMUNICATION IN CLIMBING SPACE

At this Location: Obstructed climbing space, access via bucket truck from street below. Also, look for clearance issues between communications facilities and the PG&E down guys.

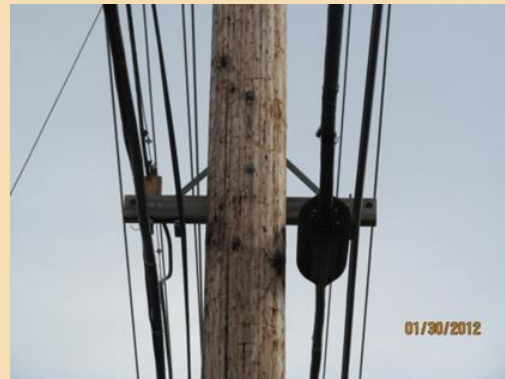
CLIMBING SPACE OBSTRUCTED

At this Location: Climbing space obstruction by communication facilities on pole with equipment. Communication messengers are too close. No bucket truck access.

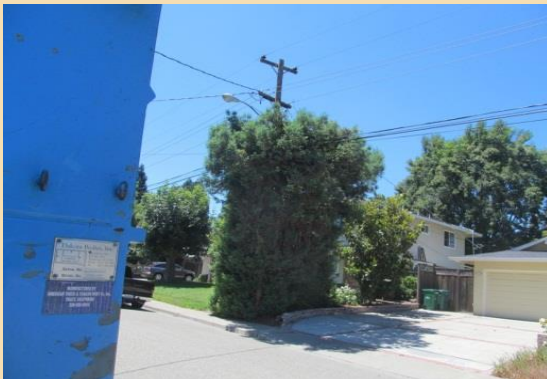
OBSTRUCTED CLIMBING SPACE

At this Location: Obstructed climbing space. Inspector cannot see enough of the pole to complete Inspection (heavy vegetation, cannot see through) No equipment on pole. The only reason to address is to complete the inspection.

- FDA=OH Facility / Limited Access/Obstruct / Inspect (Primary)
- FDA=OH Facility / Limited Access/Obstruct / Remove
- Priority "B", 0-3 months depending upon exposure; must complete before CPUC due date for map

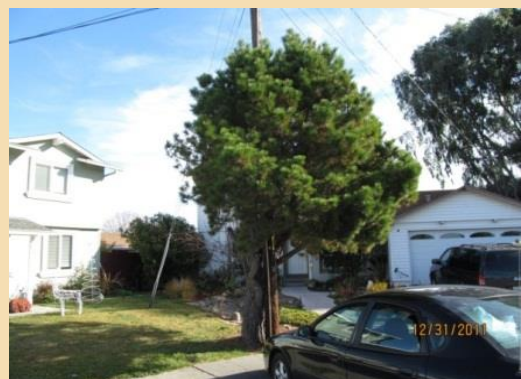
CLIMBING SPACE OBSTRUCTED

At this Location: Climbing space obstruction, able to perform inspection, no equipment on pole (able to see guys, able to see up the pole under tree)

Write EC: No, not compelling

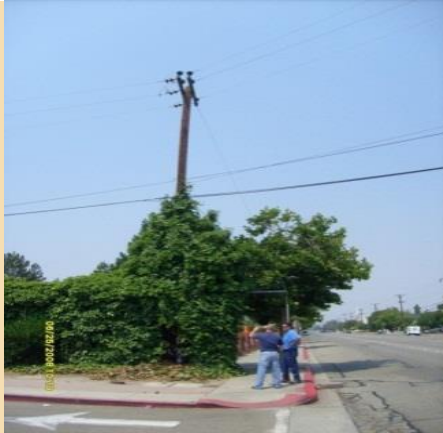
At this Location: 360° pole inspection not possible

- FDA= OH Facility / Limited Access/Obstruct / Inspect (Primary)
- FDA=OH Facility / Limited Access/Obstruct / Remove
- Priority "B", 0-3 months depending upon exposure; must complete before CPUC due date for map

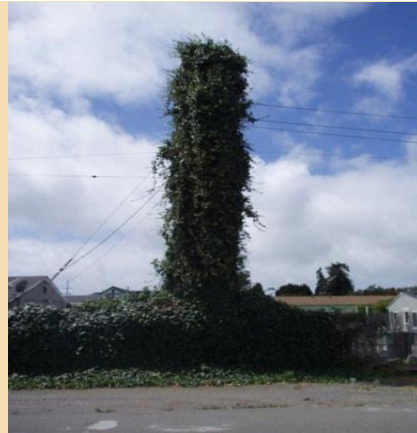
IVY COVERED POLE

At this Location: 360° pole inspection not possible

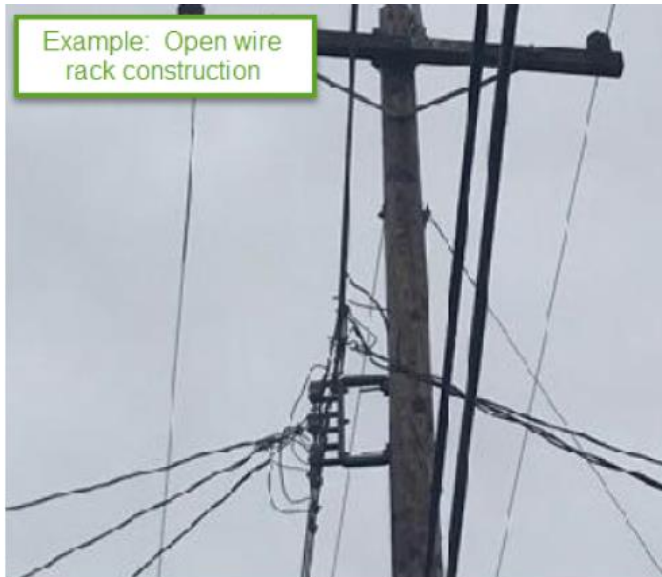
Example: Open wire rack construction

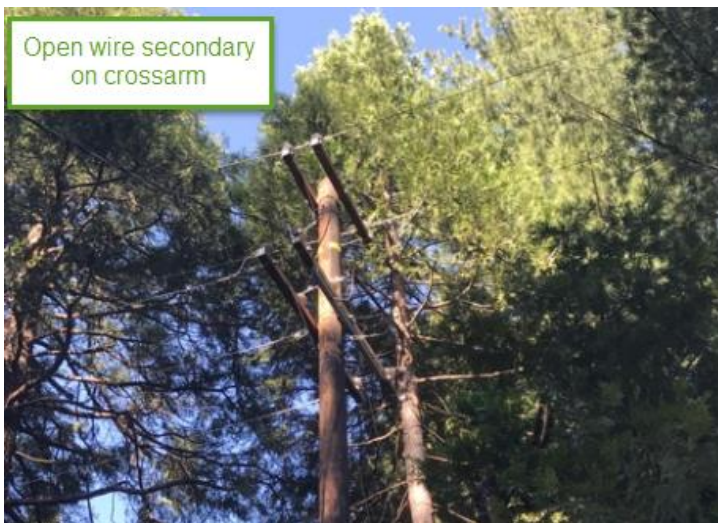
Example: Open wire on crossarm

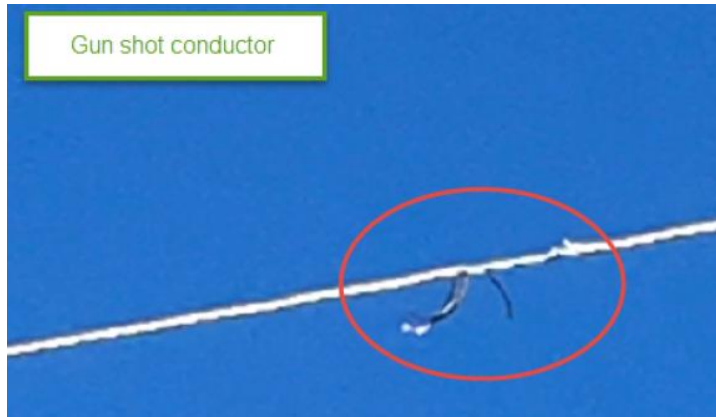
Example: Gun-shot conductor

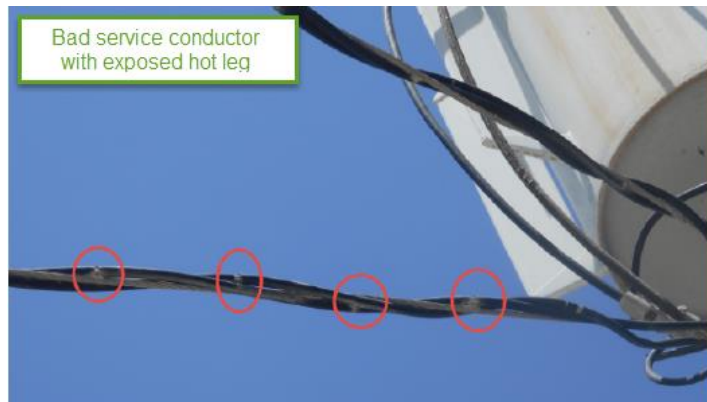
**Example: Bad service conductor with exposed hotleg**

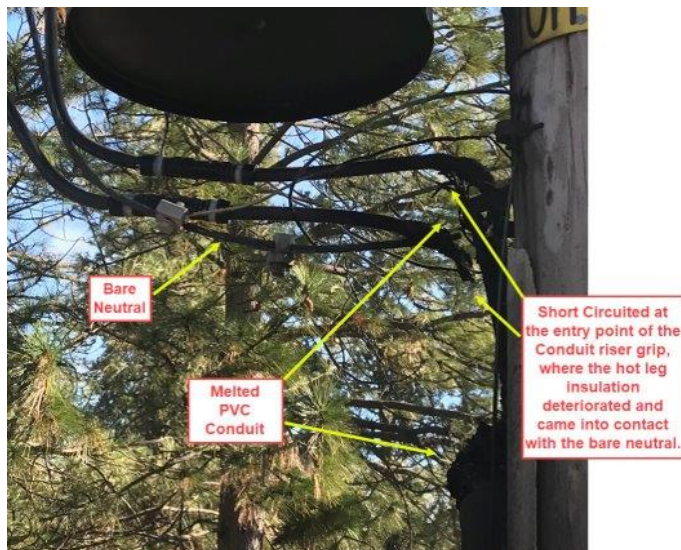
**Example: Bare neutral coming into contact with hotleg**

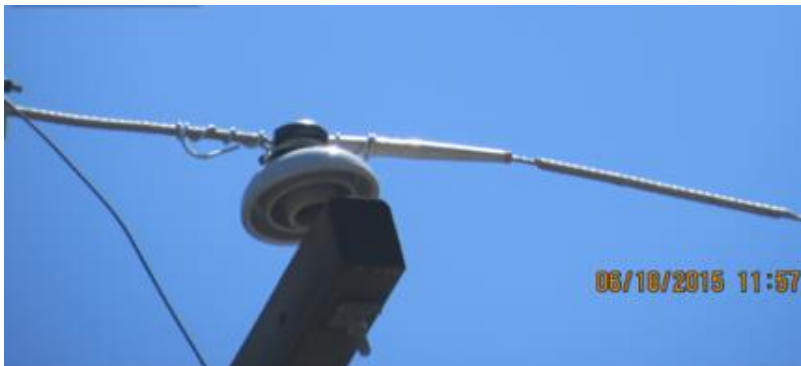
**Example:** Splice tied into insulator

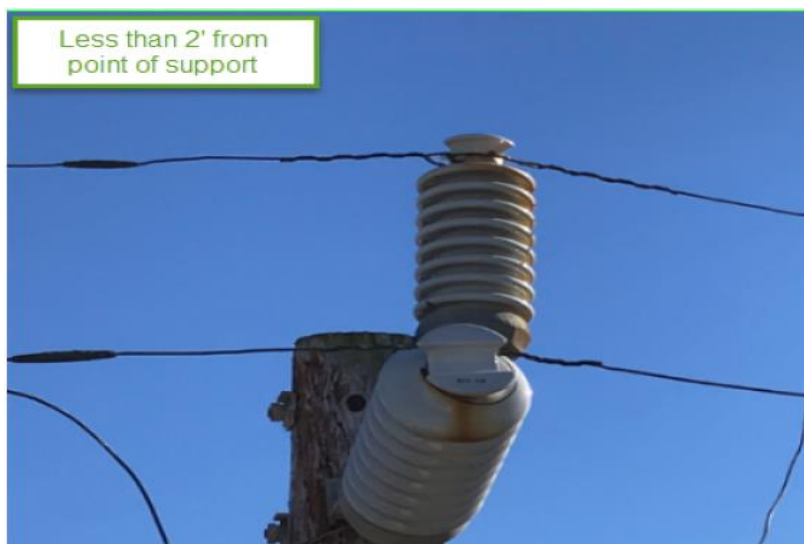
**Example:** Less than 2' from point of support

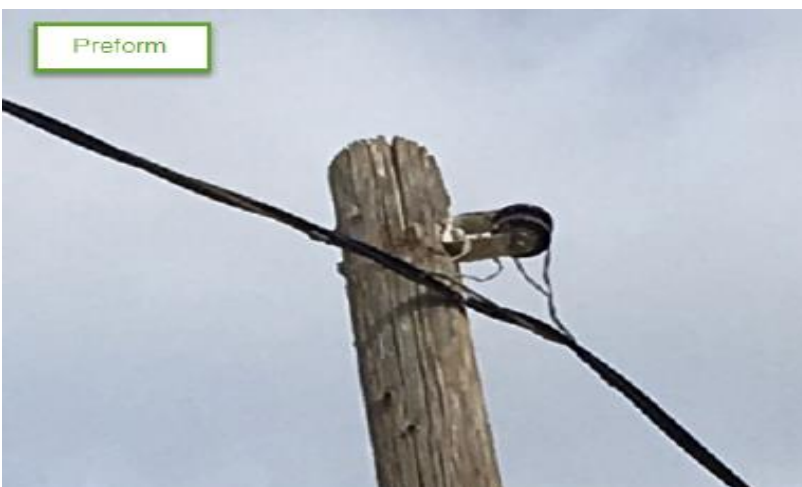
Example: Preform:

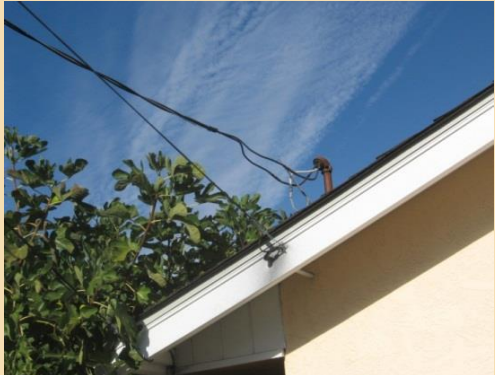
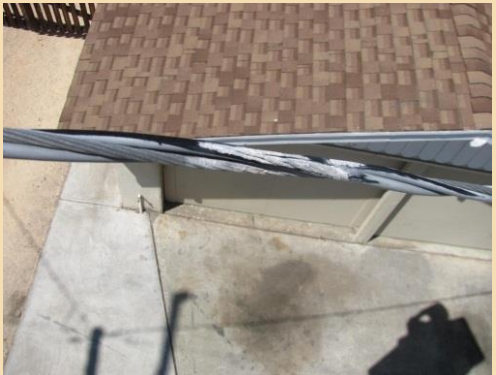
BROKEN SERVICE NEUTRAL	DAMAGED/CRACKED GREY SERVICE

<p>At this Location: Broken service neutral</p>	<p>At this Location: Cracked grey service. Older grey services tend to crack and will appear to have rings around the insulation.</p>
<p>Perform Minor Work: Yes, if safe to do so. If you replace the service conductor, this is capital Minor Work.</p> <p>Fill out EC Form to account for this minor work; charge time to your Division standing order</p>	<p>Perform Minor Work: Yes, if safe to do so. If you replace the service conductor, this is capital Minor Work.</p> <p>Fill out EC Form to account for this minor work; charge time to your Division standing order</p>
<p>Write Third Party Notification: No</p>	<p>Write Third Party Notification: No</p>
<p>Write EC Form: Yes, if minor work is not possible, or to document completed capital minor work</p> <ul style="list-style-type: none"> • FDA=Conductor / Broken/Damage / Repair or Replace • Priority "A", follow Emergency Process 	<p>Write EC Form: Yes, if minor work is not possible, or to document completed capital minor work</p> <ul style="list-style-type: none"> • FDA=Conductor / Broken / Replace - OR • FDA=Conductor / Damaged / Replace - OR • FDA=Conductor / Burnt / Replace • Priority "A", emergency, due to exposed hotleg.

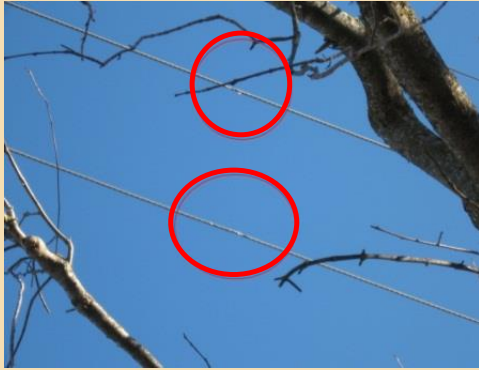
**At this Location:** Damaged strands**Perform Minor Work:** No**Write Third Party Notification:** No**Write EC Form:** Yes

- FDA= Conductor / Damage / Repair
- Priority "E", 3-12 months depending upon exposure

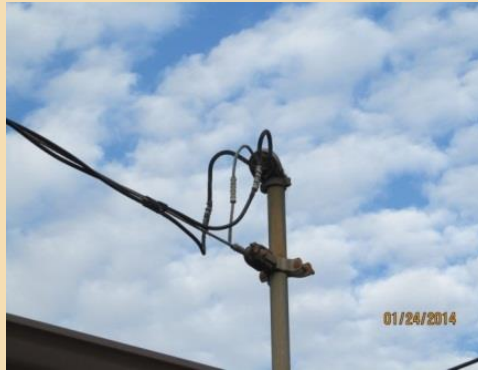
EXPOSED SERVICE CONNECTOR

**At this Location:** Exposed conductors**Perform Minor Work:** Yes, if safe to do so.**Third-Party Notification:** No**Write EC Form:** Yes, if minor work is not possible

- FDA= Conductor / Broken/Damage / Repair
- Priority "E", 3-12 months depending upon exposure

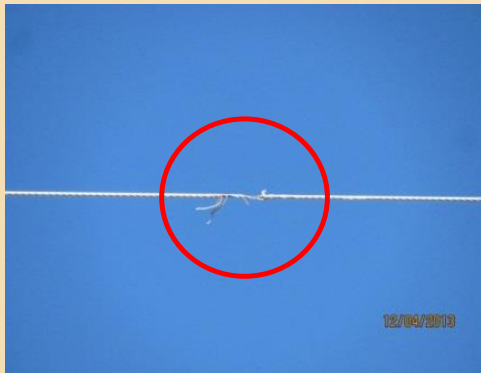
CONDUCTOR TEARING APART

At this Location: Primary conductor damage (possibly shotgun)

- FDA= Conductor / Broken/Damage / Repair
- Priority "B", 0-3 months depending upon exposure

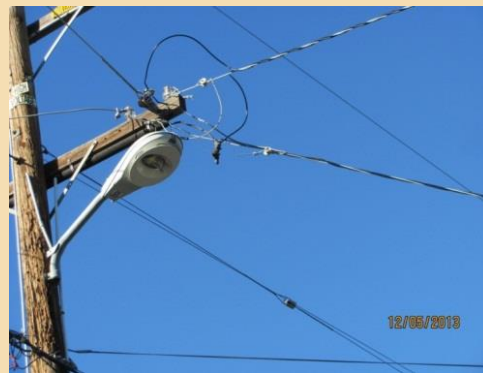
HARDWARE BROKEN

At this Location: The #6 solid copper is broken causing strain on the conductor. Unsecured service.

Perform Minor Work: Yes, if safe to do so

- FDA= Hardware/Framing / Broken/Damaged / Repair
- Priority "E", 3-12 months depending upon exposure

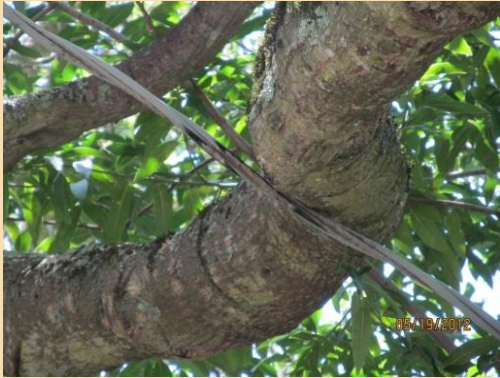
**OVERHEAD SERVICE STRAIN
ABRASION**

At this Location: Service strain abrasion, with possible burning at some sections. Damaged insulation.

Perform Minor Work: Yes, if safe to do so. If you replace the service conductor, this is capital Minor Work.

- FDA=Conductor / Broken/Damaged/ Repair or Replace
- Priority "E", 3-12 months depending upon exposure, in comments add note about strain abrasion burnt conductor
- If abrasion has caused an exposed hotleg, assign Priority A, emergency, and stand-by.

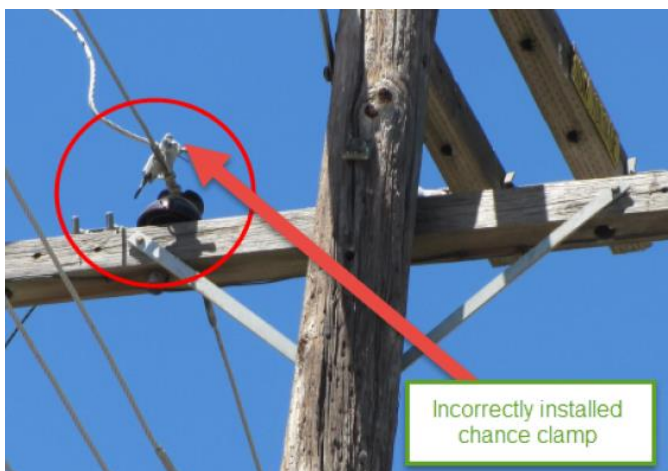
Example: Incorrectly installed chance clamp

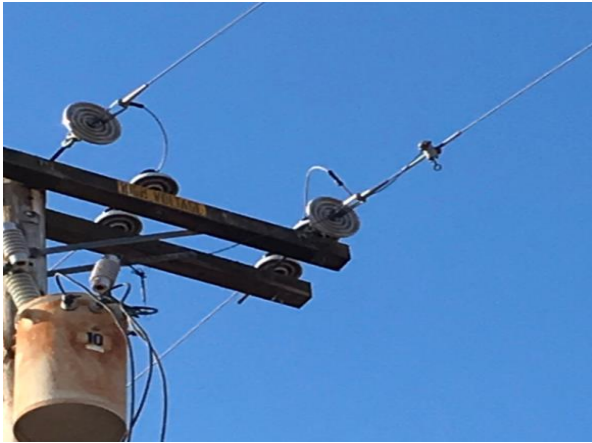
Example: Secondary connector installed in primary

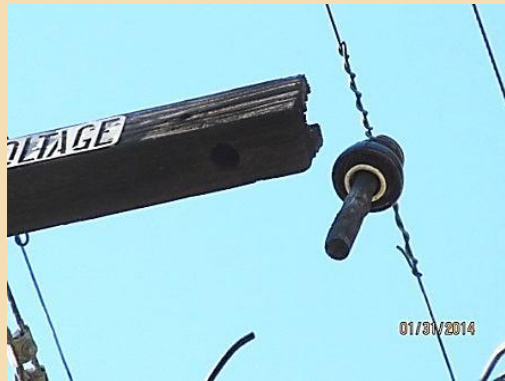
FLOATER

At this Location: Floater, conductor is not contacting the arm. Rotten crossarm.

- FDA=Crossarm / Decayed/Rotten/ Replace
- Priority "A", follow Emergency Process

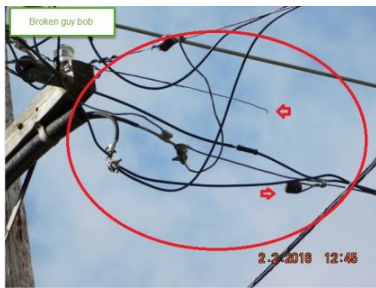
Example: Broken service bob

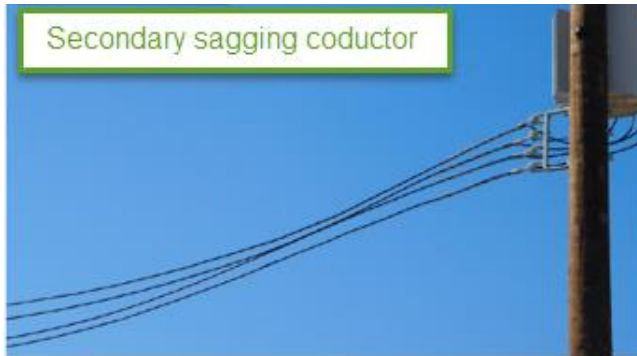
Example: Secondary sagging conductor

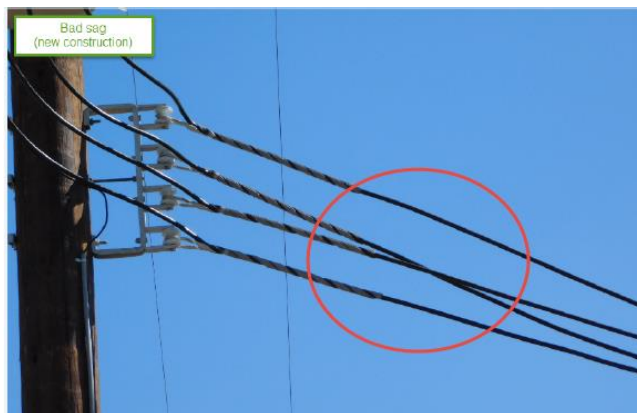
Example: Sagging conductor

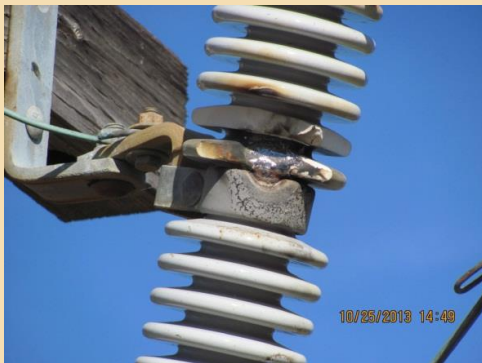
**BROKEN DAMAGED CROSSARM
MOUNTED CUTOUT**

At this Location: Broken/Flashed cutout

- FDA=Cutout / Broken/Damaged / Replace
- Priority "E", 3-12 months depending upon exposure
- COE = No

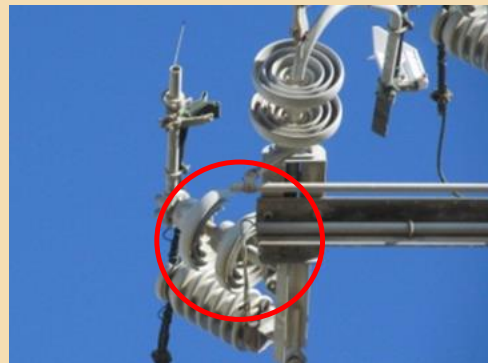
BROKEN INSULATOR ON AIR SWITCH

At this Location: Broken insulator on air switch

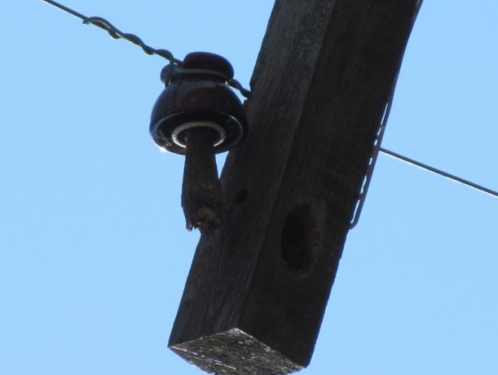
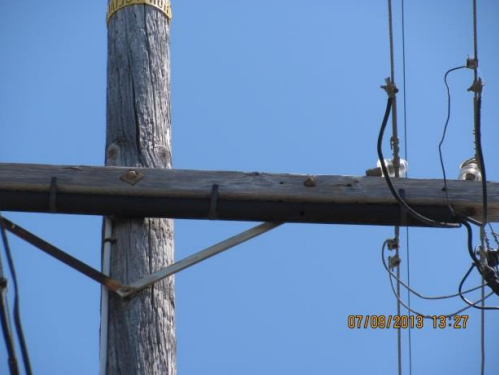
PIN BROKEN	PIN BROKEN (FLOATER)

<p>At this Location: Primary wood pin is broken, and the conductor is laying on the crossarm. Wood pin arm replace with Composite arm</p>	<p>At this Location: Secondary wood pin is broken, and the conductor is laying on the crossarm. Woodpin arm. Replace arm.</p>
<p>Perform Minor Work: No</p>	<p>Perform Minor Work: Yes, replace wooden pin with steel pin.</p>
<p>Write Third-Party Notification: No</p>	<p>Write Third-Party Notification: No</p>
<p>Write EC Form: Yes</p> <ul style="list-style-type: none"> • FDA=Hardware/Framing / Broken/Damage / Replace • FDA= Crossarm/Broken Damaged/Replace • Priority "A", follow Emergency Process 	<p>Write EC Form: Yes</p> <ul style="list-style-type: none"> • FDA= Conductor / Floating / Repair • FDA= Crossarm/Broken Damaged/Replace • Priority "A", follow Emergency Process

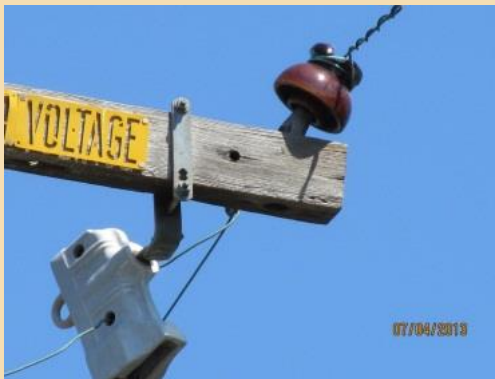
PRIMARY WOOD PIN AT ANGLE

At this Location: Deteriorated primary wood pin at angle. All insulators need to be replaced. Replace the crossarm with a composite arm.

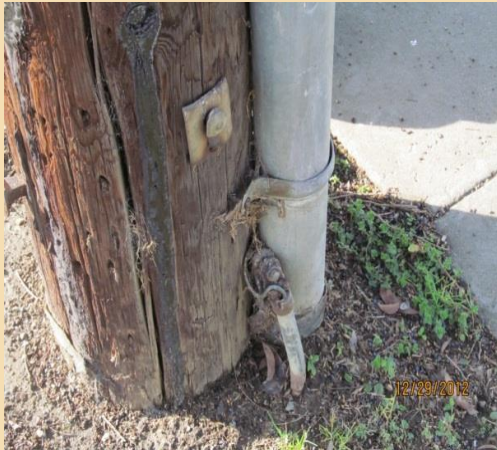
EXPOSED GROUND

At this Location: Exposed grounds near sidewalk

Perform Minor Work: Yes, at a minimum make safe

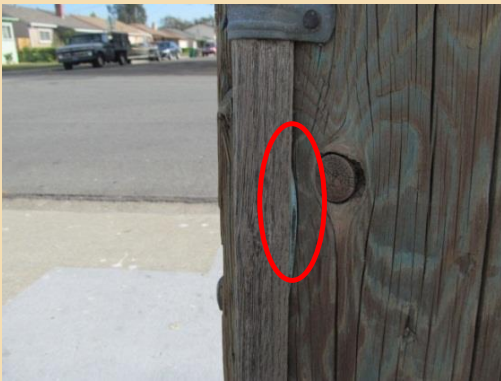
REPAIR WITH 1.5" MOLDING

Before: Copper Wire sticking out from under the wood molding

At this Location: Wood molding with ground exposed

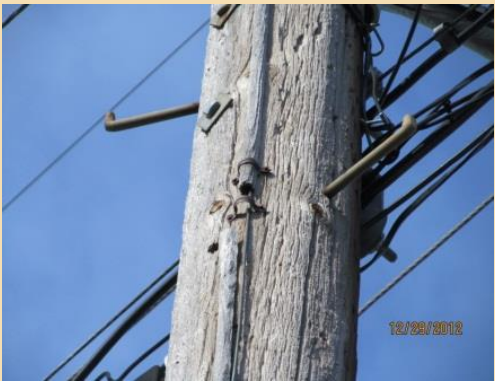
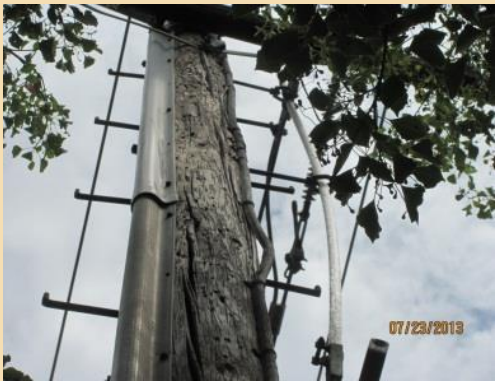
EXPOSED GROUND AT COMMUNICATION LEVEL	EXPOSED GROUND DUE TO TWISTED MOLDING

<p>At this Location: Exposed ground at communications level. Wood molding broken in climbing space.</p>	<p>At this Location: Exposed ground in wood molding.</p>
<p>Perform Minor Work: Yes, if safe to do so.</p>	<p>Perform Minor Work: Yes, when safe to do so.</p>
<p>Write Third-Party Notification: No</p>	<p>Write Third-Party Notification: No</p>
<p>Write EC Form: Only if unable to perform minor work.</p> <ul style="list-style-type: none"> • FDA=Ground / Exposed / Repair • At minimum – must write up as Priority "F-R", next inspection cycle; based on field condition and exposure, corrosion, etc.; prioritize as needed (A, B, E, or F) 	<p>Write EC Form: Only if unable to perform minor work.</p> <ul style="list-style-type: none"> • FDA=Ground / Exposed / Repair • FDA=Molding / Broken/Damaged / Repair • At minimum – must write up as Priority "F-R", next inspection cycle; based on field condition and exposure, corrosion, etc.; prioritize as needed (A, B, E, or F)

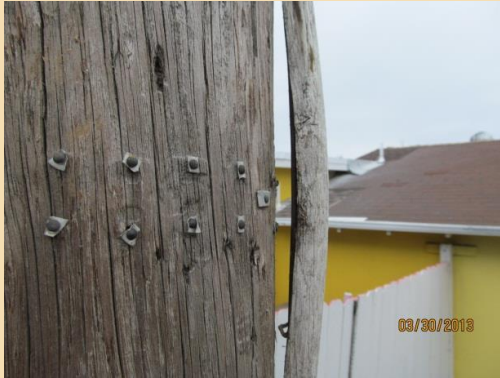
**WOOD MOLDING NOT SECURE
EXPOSING GROUND**

At this Location: Wood molding not secure, allowing human contact.

Perform Minor Work: Yes

At minimum – must write up as Priority "F-R", next inspection cycle; based on field condition and exposure, corrosion, etc.; prioritize as needed (A, B, E, or F)

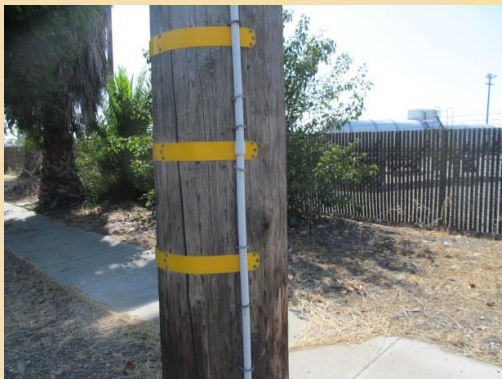
PVC MOLDING SECURED

At this Location: PVC molding adequately secured with staples upon arrival. No action is required.

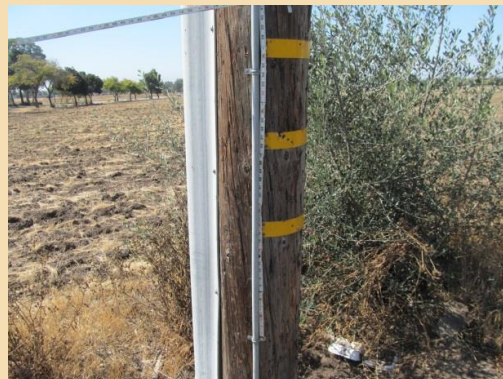
WOOD MOLDING SECURED

At this Location: Wood molding adequately secured with straps spacing 36 inches or less upon arrival. No action required.

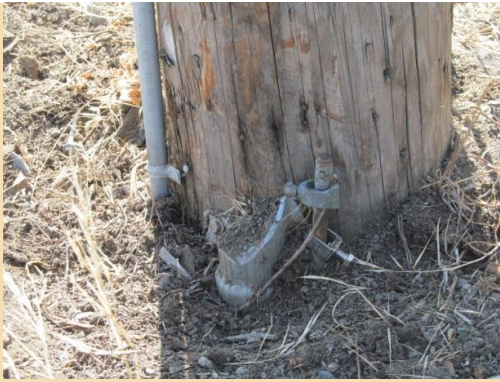
EXPOSED GROUND ROD

At this Location: Exposed ground rod

Perform Minor Work: Yes

- FDA=Ground / Exposed / Repair
- At minimum – must write up as Priority "F-R", next inspection cycle; based on field condition and exposure, corrosion, etc.; prioritize as needed (A, B, E, or F)

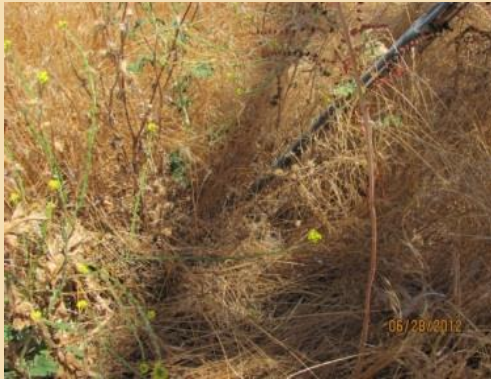
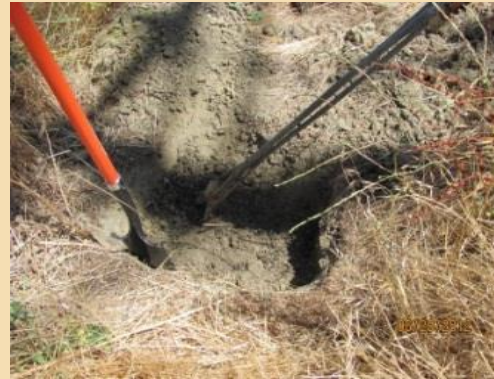
BURIED ANCHOR

**Before:** Vegetation covers anchor

At this Location: Anchor below grade overgrown with vegetation. After minor work inspector decides if the anchor can be adjusted or needs replaced.

**After:** Vegetation cleared from anchor

Yes, expose anchor and evaluate condition/corrosion

- FDA=Anchor / Soil/Eroded/Graded / Replace (if the anchor cannot be adjusted)
- At minimum – must write up as Priority "F-R", next inspection cycle; based on field condition and exposure, corrosion, etc.; prioritize as needed (A, B, E, or F)

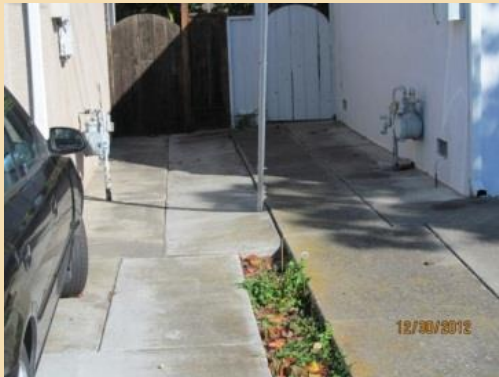
ANCHOR COVERED BY CONCRETE

At this Location: Anchor covered by concrete

FDA=Anchor /Soil/Eroded/Graded / Replace
At minimum – must write up as Priority "F-R",
next inspection cycle; based on field
condition and exposure, corrosion, etc.;
prioritize as needed (A, B, E, or F)

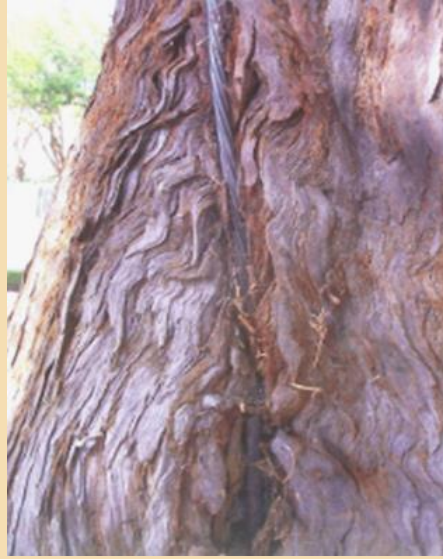
**Anchor buried by tree**

At this Location: Anchor buried by ivy roots / tree

- FDA=Anchor / Soil/Eroded/Graded / Replace
- At minimum – must write up as Priority "F-R", next inspection cycle; based on field condition and exposure, corrosion, etc.; prioritize as needed (A, B, E, or F)

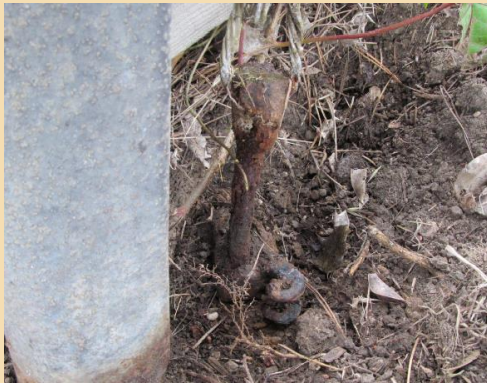
ANCHOR ROD WITH SIGNIFICANT CORROSION

Anchor above ground

At this Location: Corroded Anchor

- FDA=Anchor / Corroded / Replace
- Priority "E", 3-12 months depending upon exposure

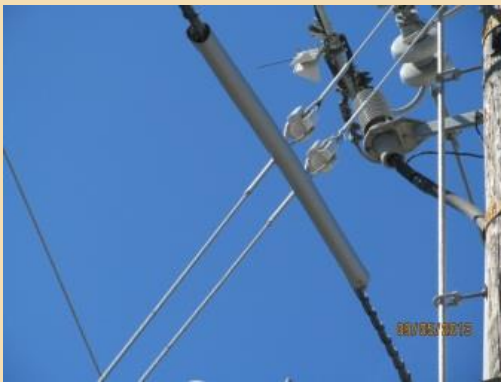
GUY CLEARANCE

At this Location: Acceptable solution through plastic barrier.

GO 95 requires 3" of radial clearance. Plastic barriers can be installed if less than 3" of clearance.

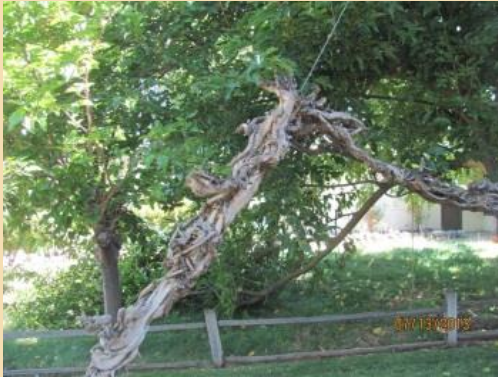
At this Location: Extensive dead ivy covering half of length of guy.

- FDA=Guy / Broken/Damaged / Replace
- Priority "E", 3-12 months depending upon exposure

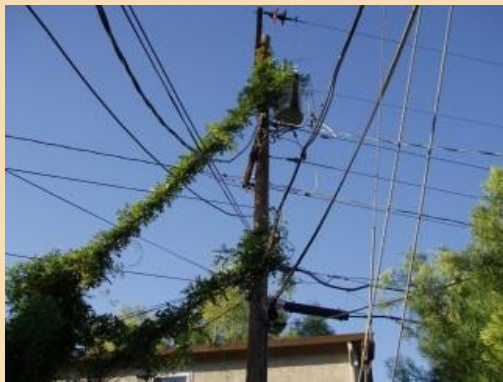
IVY ON GUY AND PRIMARY

At this Location: Ivy on guy and on primary. Safety issues, possible energized guy and pole, transformer weeping – no oil on ground, evaluate per oil spill matrix.

- FDA=Transformer / Leaks/Seeps/Weeps / Replace (primary)
- FDA=Guy / Overgrown / Trim
- Priority "B", 3 months or less depending upon exposure

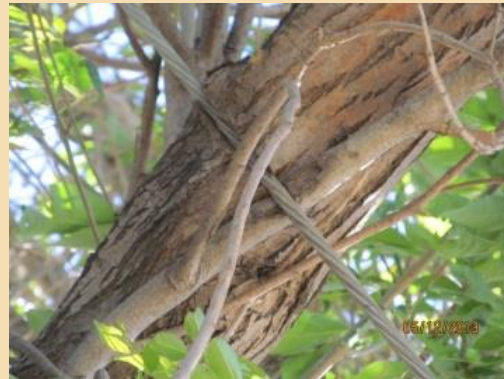
Close-up

At this Location: Tree limb growing around guy, below the bob.

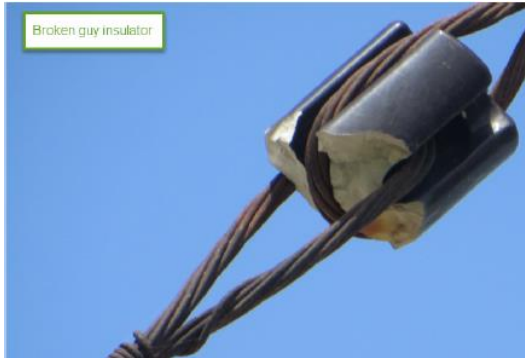
Example: Broken guy insulator

Must be sectionalized and ungrounded. Ensure there is an intact guy insulator.

- FDA: Guy / Broken/Damaged / Replace or Guy / Missing / Install
- Select the Priority and Due Date based upon compelling abnormal condition that may adversely impact public safety and/or service reliability in the next five (5) years

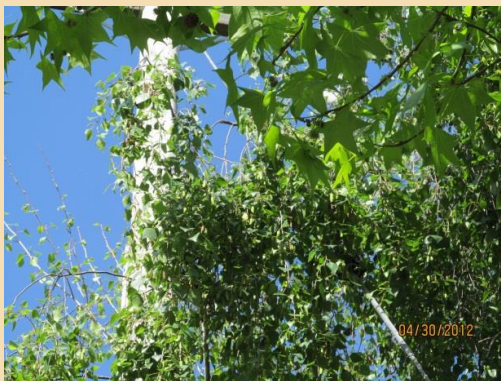
DOWN GUY GROUNDED ABOVE GUY INSULATOR

At this Location: Vine growing up and across the guy insulator grounding the guy.

Perform Minor Work: Yes

- FDA=Guy / Overgrown / Trim
- Priority "E", 3-12 months depending upon exposure

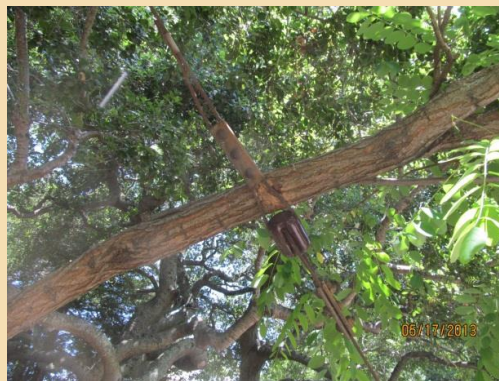
DOWN GUY GROUNDED ABOVE GUY INSULATOR CAUSING STRAIN AND ABRASION

At this Location: Tree grounding the guy above the guy insulator causing strain and abrasion.

Perform Minor Work: Yes, if minor work not possible

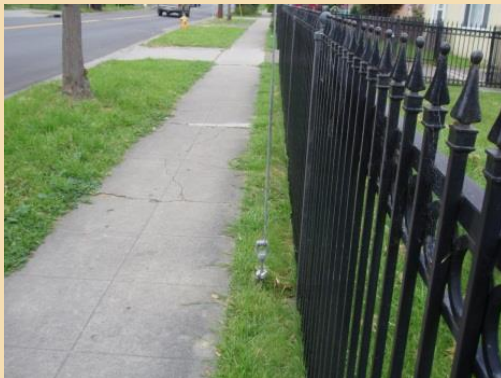
GUY MARKER MISSING

At this Location: Guy marker missing

Perform Minor Work: Yes, install new guy marker

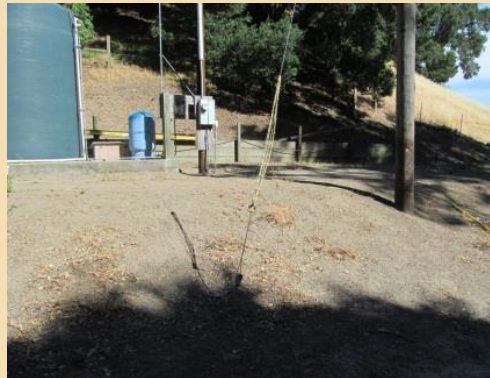
CATTLE GUARD LESS THAN 8 FT

At this Location: Cattle guard is less than 8 feet in length

Perform Minor Work: Yes, lower cattle guard and add guy marker to meet 8 feet requirement.

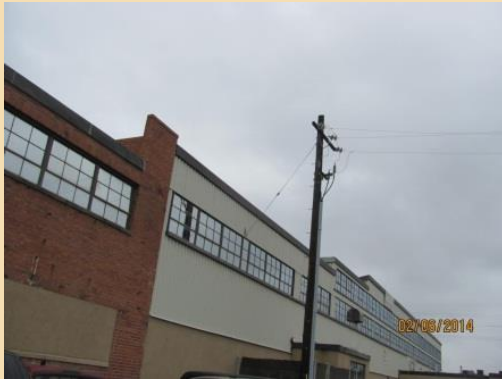
DOWN GUY: MARKER NOT REQUIRED

At this Location: Acceptable down guy attached to building, no marker required.

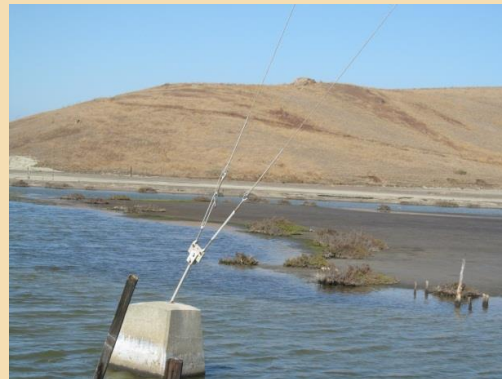
At this Location: Acceptable down guy in marsh, no marker required.

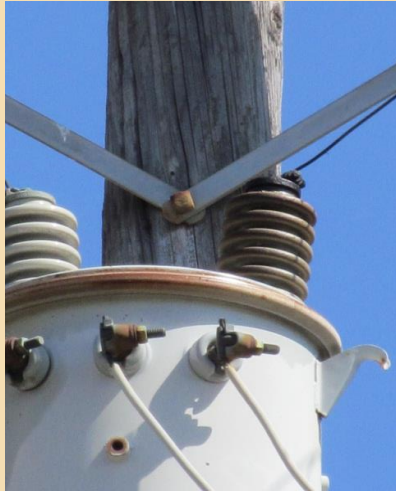
FLASHED INSULATOR ON TRANSFORMER

At this Location: Flashed insulator on transformer

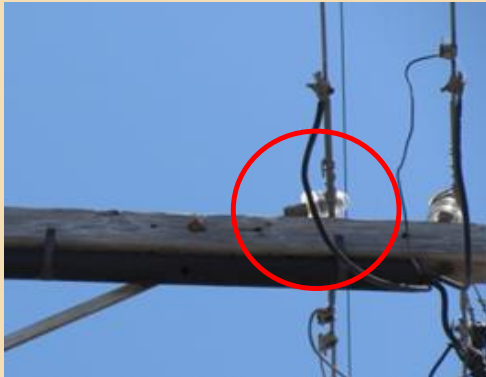
BROKEN WOOD PIN ON SECONDARY

At this Location: Broken secondary wood pin. Conductor lying on the arm, tangent pole. (excluding urban wildfire areas, use risk priority matrix). Wood pin arm at end of life replace arm with composite arm

Perform Minor Work: Yes

- FDA= Crossarm / Decayed/Rotten / Replace
- FDA= Insulator / Squatter (Secondary) / Replace
- Priority "B", 0-3 months depending upon exposure

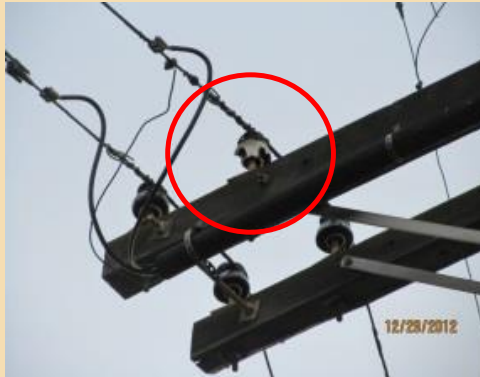
BROKEN SECONDARY INSULATOR

At this Location: Broken secondary insulator

- FDA= Crossarm / Decayed/Rotten / Replace
- FDA=Insulator / Broken/ Damage / Replace

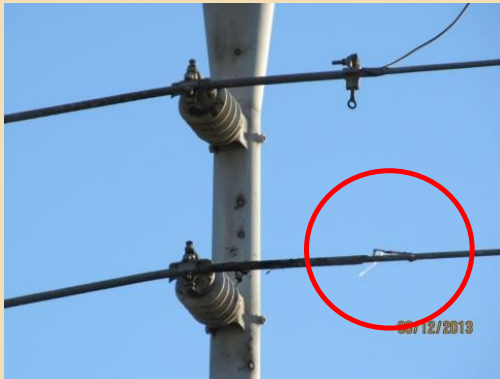
FLASHED INSULATOR MYLAR BALLOON

At this Location: Flashed insulator by Mylar balloon

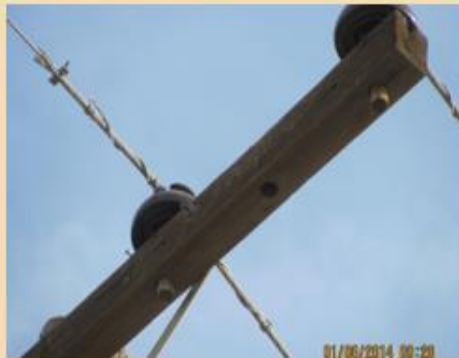
PRIMARY SQUATTER

At this Location: 2 Primary Wood Pin Squatters; replace wood crossarm with composite crossarm.

- FDA = Crossarm Decayed/Rotten / Replace
- FDA = Insulator / Primary Squatter / Replace
- At minimum – must write up as Priority "E", based on field condition and exposure, corrosion, etc.; prioritize as needed (A, B, or E)

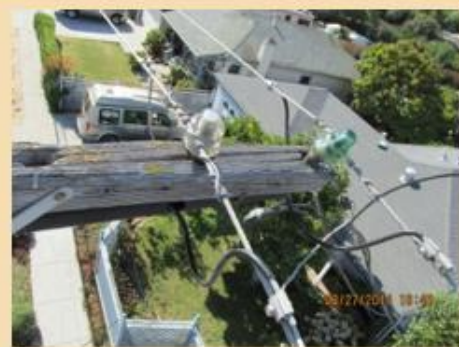
SECONDARY SQUATTER AND DECAYED CROSSARM

At this Location: Secondary Squatter and decayed crossarm.

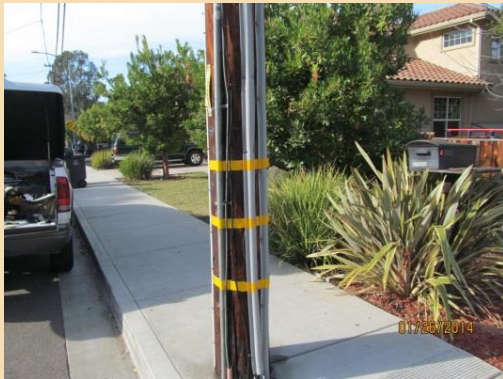
ADHESIVE VISIBILITY STRIPS

At this Location: Acceptable application of plastic and adhesive visibility strips

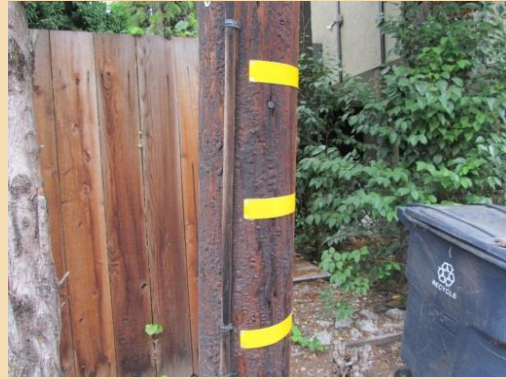
CLEARANCE FROM GROUND

At this Location: Acceptable metal visibility strips attached 1 ½" from ground.

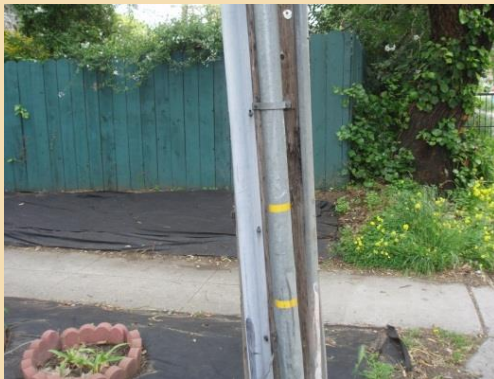
INADEQUATE VISIBILITY STRIPS

At this Location: Pole with vehicular exposure. Two small sections of yellow adhesive visibility strips.

Perform Minor Work:

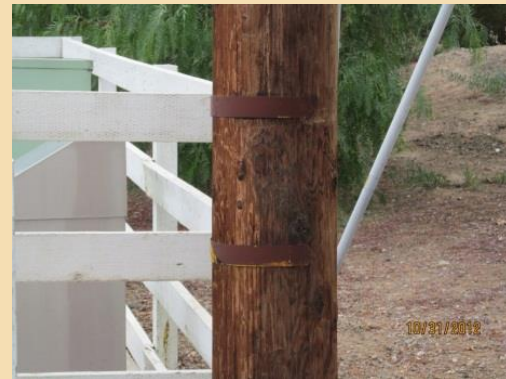
VISIBILITY STRIPS PAINTED OVER NO LONGER REFLECTIVE

At this Location: Visibility strips painted brown (3rd visibility strip located above not shown in picture)

Perform Minor Work: Yes, remove old visibility strips and install new.

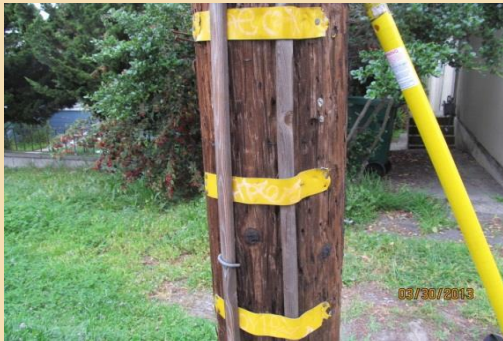
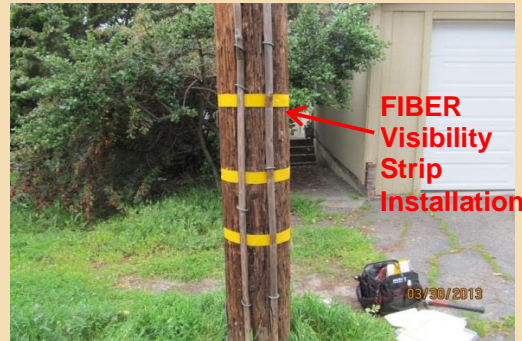
METAL OVER MOLDING

At this Location: Metal visibility strips under wood molding and over wood molding with protruding edge.

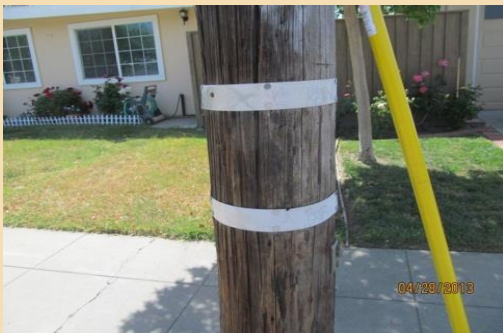
OLD METHOD VISIBILITY STRIPS

At this Location: Aged visibility strips have lost reflectivity.

Perform Minor Work: Yes, replace with 3 yellow visibility strips

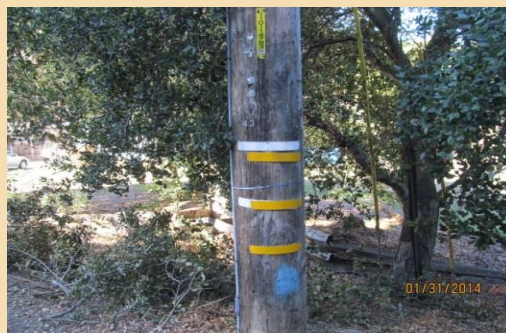
OLD AND NEW VISIBILITY STRIPS

At this Location: Yellow visibility strips mounted over old white visibility strips.

Perform Minor Work: Yes, remove old visibility strips

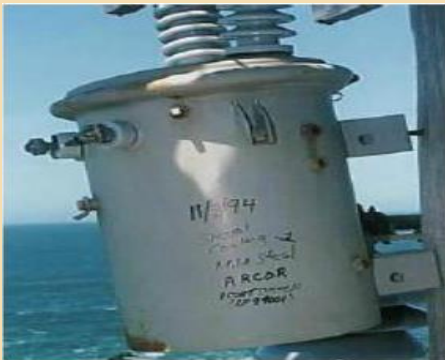
At this Location: Transformer with moderate/heavy corrosion

Metal structure still sound (rust staining from attachments)

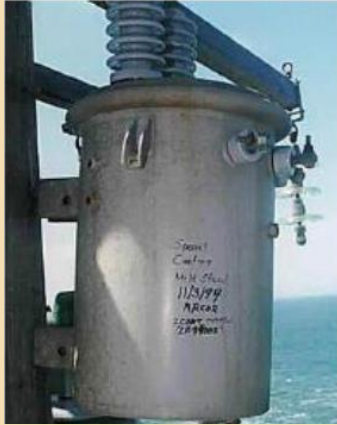
TRANSFORMER WITH STAINING, NO CORROSION

At this Location: Transformer with dirt and salt spray staining, no metal damage

Perform Minor Work: No

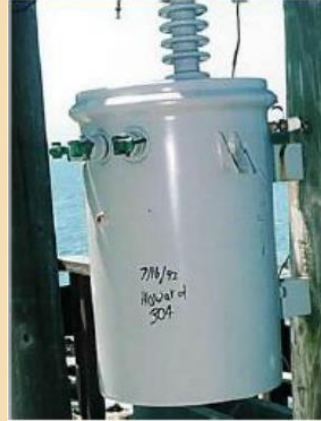
TRANSFORMER CASE WITH LITTLE OR NO CORROSION

At this Location: Transformer with little to no corrosion, no metal damage

Perform Minor Work: No

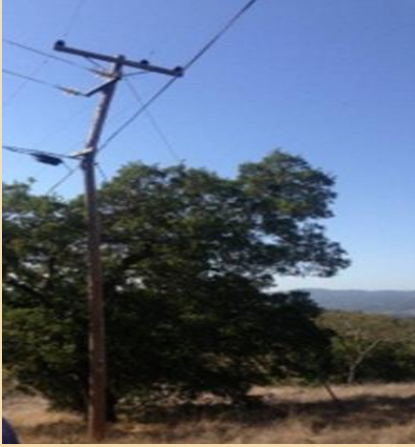
At this Location: Pole broken at the communication level in HFTD area.
Complete Pole Inspection Test Report

- FDA=Pole / Broken/Damaged / Replace
- Priority "A" address immediately

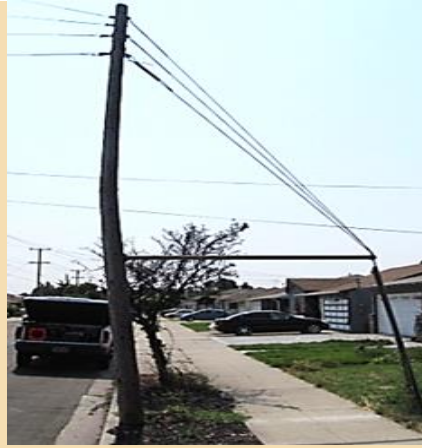
POLE BROKEN AT MIDDLE SECTION

At this Location: Broken pole. Complete Pole Inspection Test Report

- FDA=Pole / Broken/Damaged / Replace
- Priority "B", 0-3 months depending upon exposure

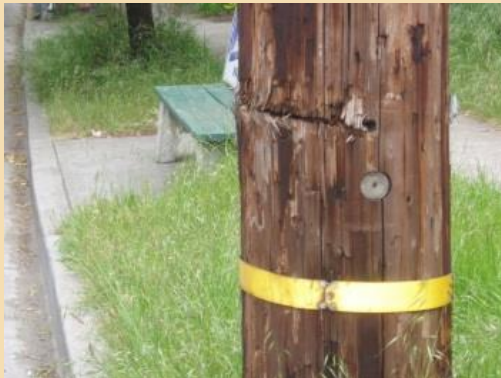
SAW CUT INTO POLE

At this Location: Vandalized pole. Chain saw cut into lower portion of pole. Half of pole circumference cut into.

Notify supervisor of possible vandalism. Supervisor will have to communicate to damage claims. Complete Poles Inspection Test Report.

- FDA=Pole / Broken/Damaged/ Replace
- Priority "A" or "B", 0-3 months depending upon exposure

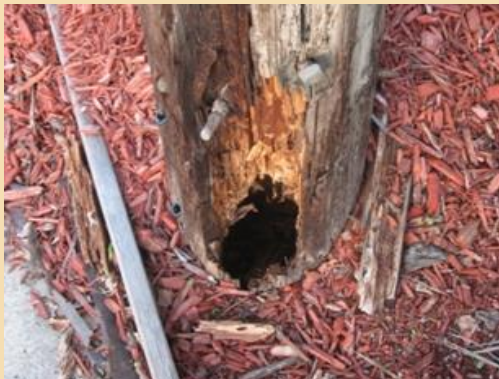
DETERIORATION AROUND GROUND LINE

At this Location: Deteriorated condition found during normal inspection. Complete Pole Inspection Test Report. If pole has reduced circumference. Write EC notification for estimating to confirm pole loading.

- FDA=Pole / Decayed/Rotten / Replace
- Priority "A", follow Emergency Process

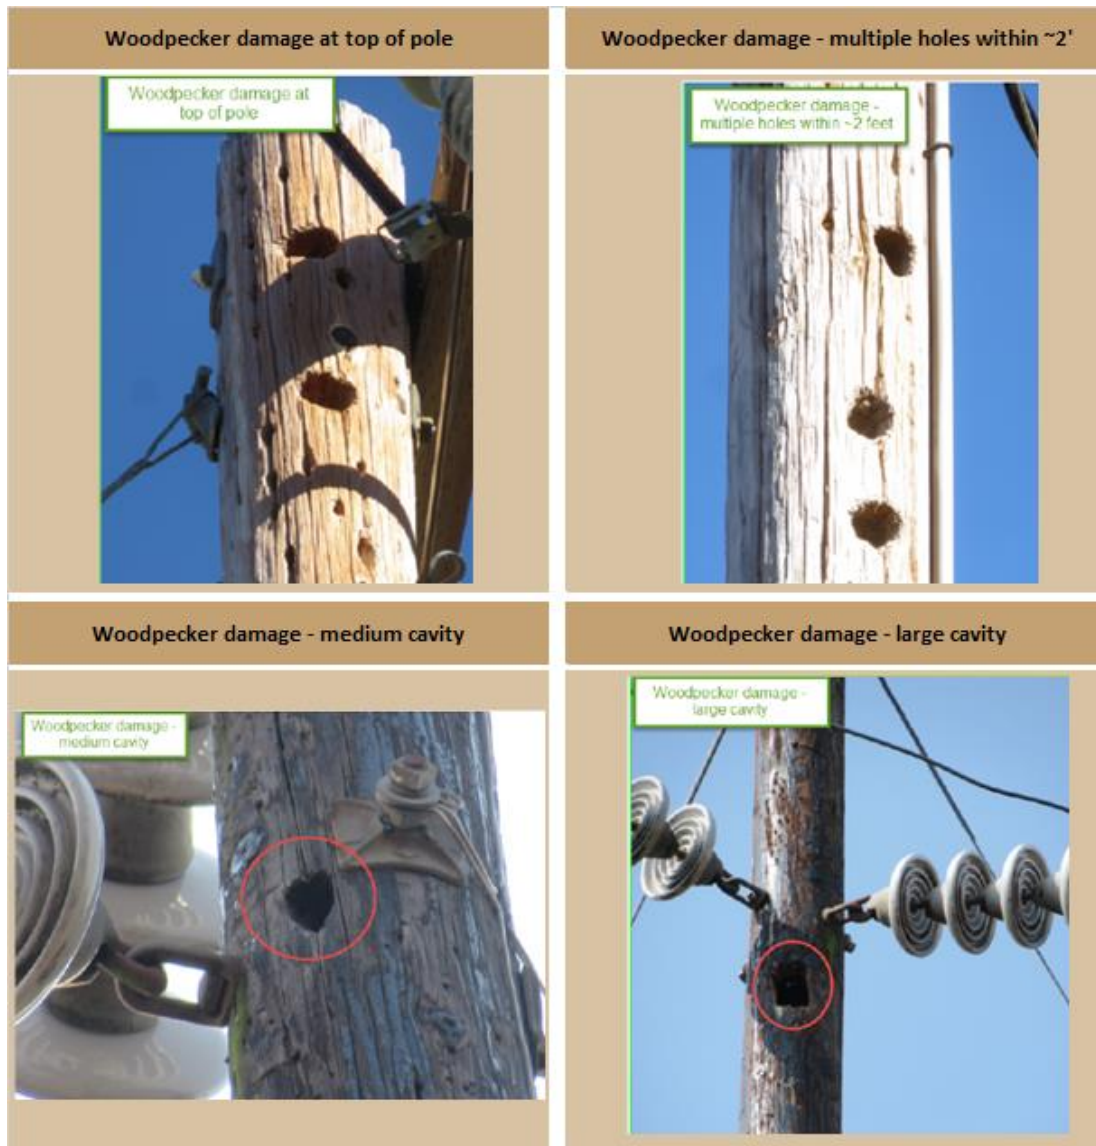
Examples: Poles with woodpecker damage – assess using woodpecker assessment guidelines.

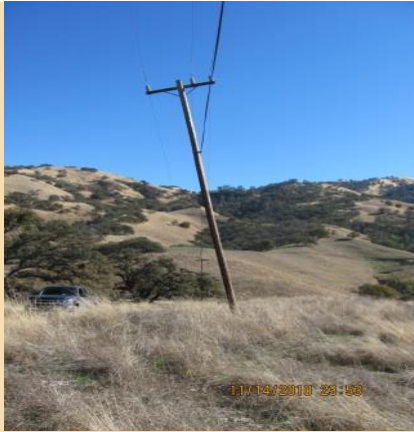
At this Location: Leaning pole greater than 10% out of plumb. Pole is stable. No equipment in rural area. Causing reduced clearance.

- FDA=Pole / Leaning / Replace
- Priority "E", 3-12 months depending upon exposure

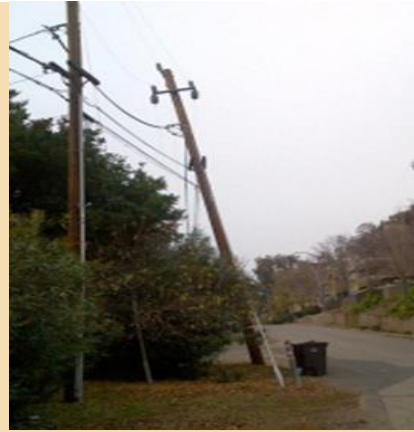
LEANING SLACK SPAN

At this Location: Leaning pole more than 10% out of plumb. Pole test indicates that pole is solid below ground and can be straightened. Probability of equipment failure is moderate.

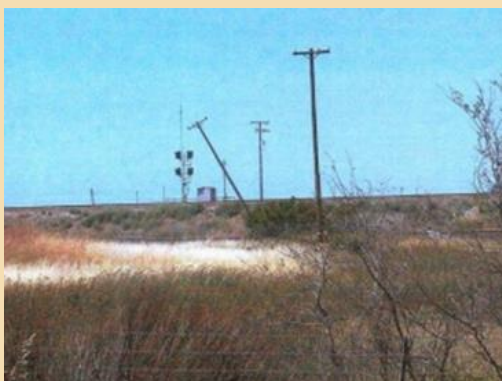
POLE LEANING NEAR RAILROAD TRACKS

At this Location: Severe lean being held up by the primary conductors. Low clearance over active railroad tracks. Pole located in a swamp area with standing water.

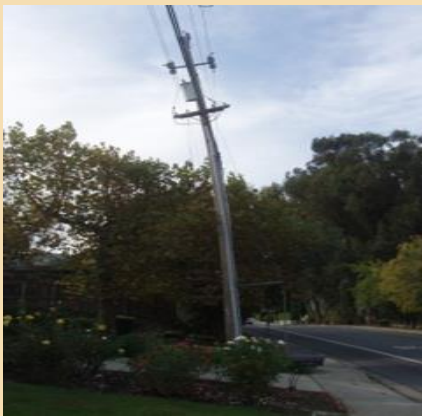
POLE BENT 4 FEET OUT OF LINE

At this Location: Pole bent 4 feet out of line, less than 10% lean

- FDA=Pole / Overloaded / Test
- Priority "E", 3-12 months depending upon exposure

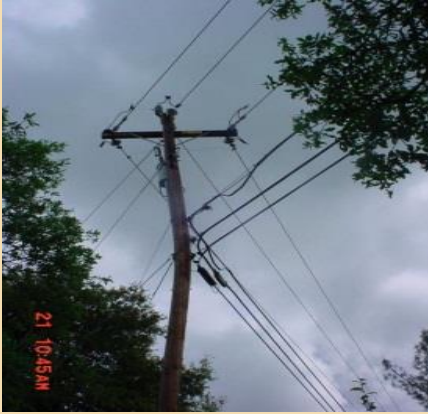
INADEQUATE SUPPORT AT COMMUNICATIONS LEVEL

At this Location: Two guys stabilizing communication level.

- FDA=Pole / Overloaded / Test
- Priority "E", 3-12 months depending upon exposure

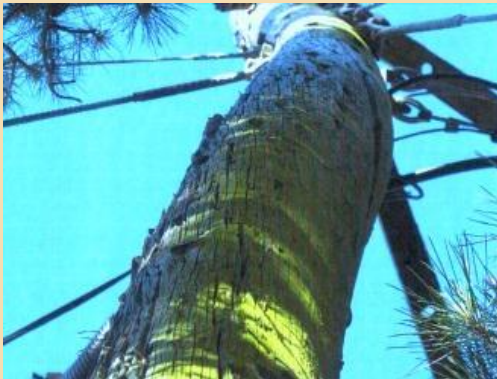
OVER STRESSED POLE

At this Location: Pole is twisted, cracked, due to communication.
