Job Aid: Overhead Inspection

This job aid is designed to assist Electric Distribution Compliance Inspectors in assessing and prioritizing **compelling abnormal conditions** on overhead facilities during scheduled GO 165 Inspections.

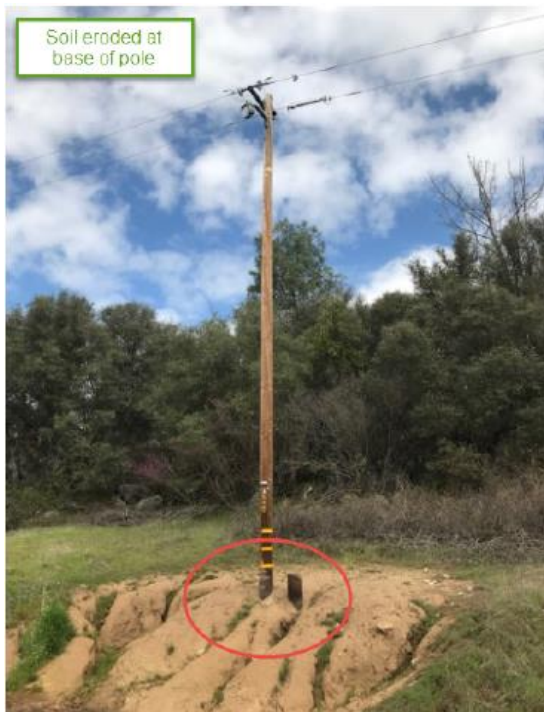
Example: Soil eroded at base of pole

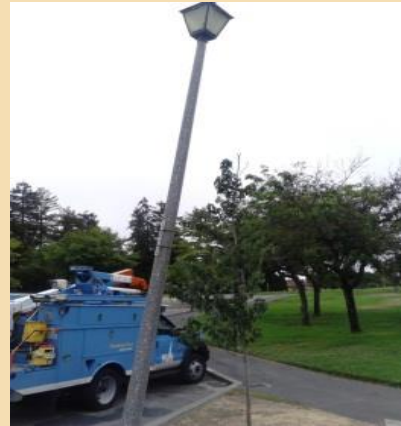
LEANING AGGREGATE POLE

At this Location: Leaning aggregate pole more than 10% out of plumb. Pole is broken at base and not stable. Light still working.

- FDA=Pole / Broken/Damaged / Replace
- Priority "B", 0-3 months depending upon exposure

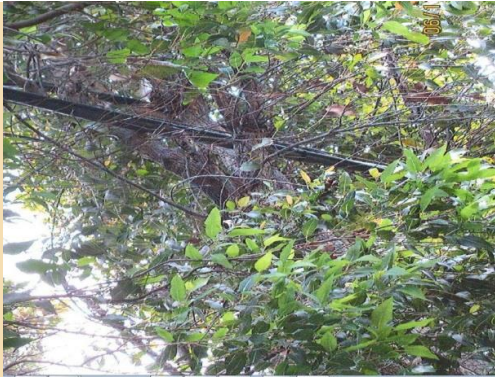
PHONE TREE CONDITION

At this Location: Tree putting strain on the pole, due to communication line

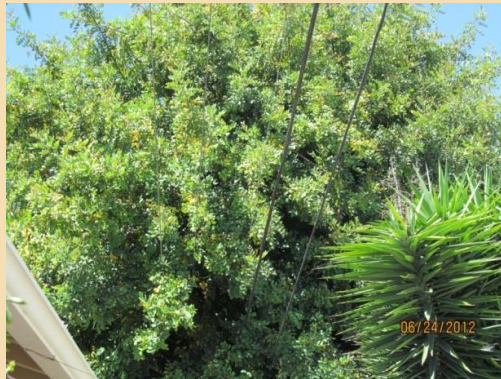
SECONDARY OVERGROWN REDUCING CONDUCTOR CLEARANCES

At this Location: Secondary conductor resting on tree/vegetation

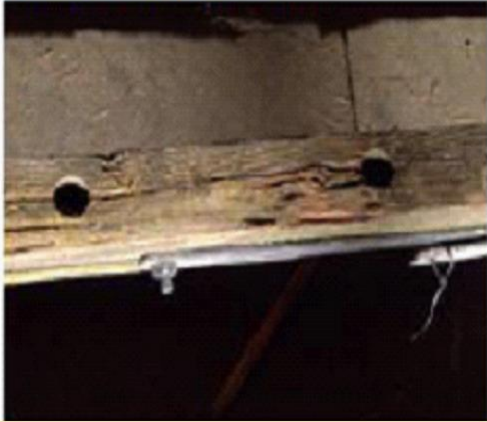
BOTTOM VIEW	TOP VIEW
<p>Evidence of decay near hole</p>

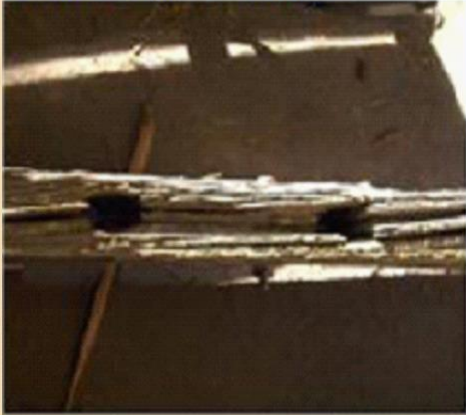
<p>Evidence of Significant Decay</p>

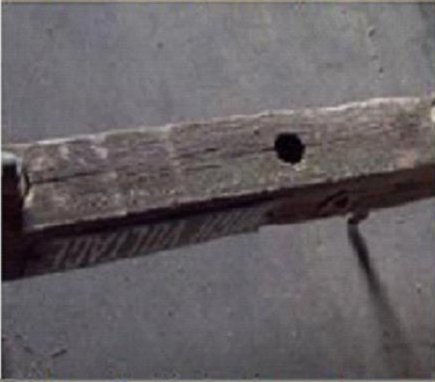
<p>Enlarged hole, minor moss/discoloration/splits near pin hole</p>

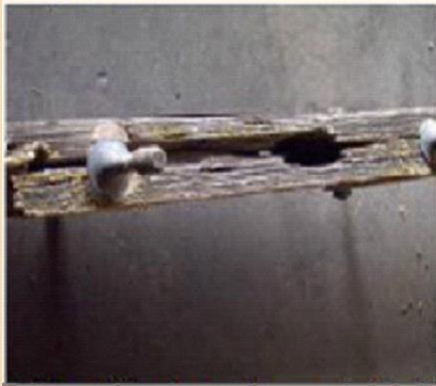
<p>Enlarged hole, minor moss/discoloration/splits near pin hole</p>

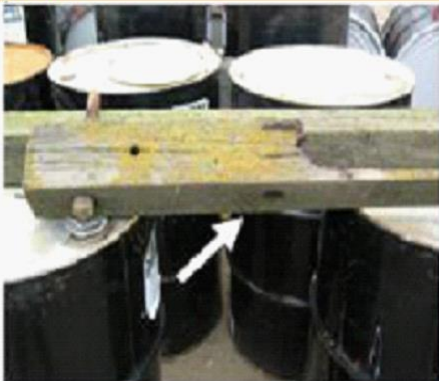
<p>Evidence of tracking/burning near brace and pin holes</p>

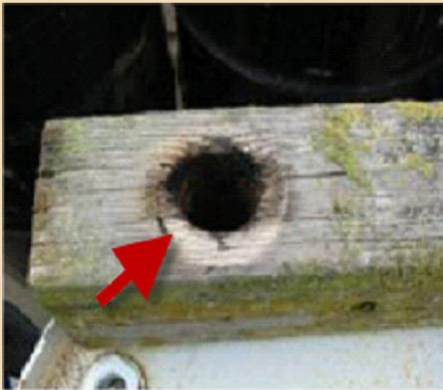
<p>Evidence of burning near brace and pin holes</p>

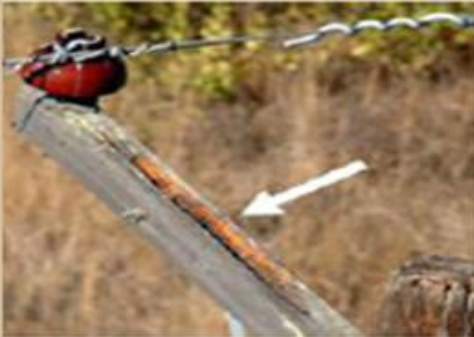
TOP OF CROSSARM DECAYED

Evidence of pole top decay and face of crossarm decay; may need additional assessment of crossarm.

Replace 3-12 months

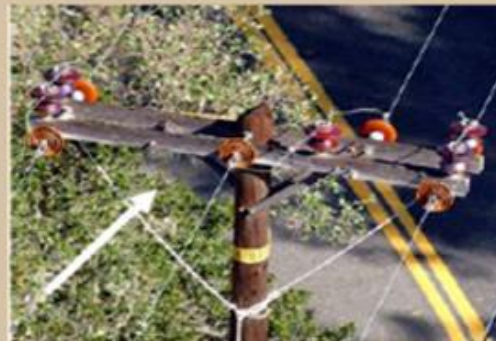
DETERIORATED CROSSARM

Significant deterioration, both arms are broken/split. Evidence of previous temporary repair.

Replace 3-12 months

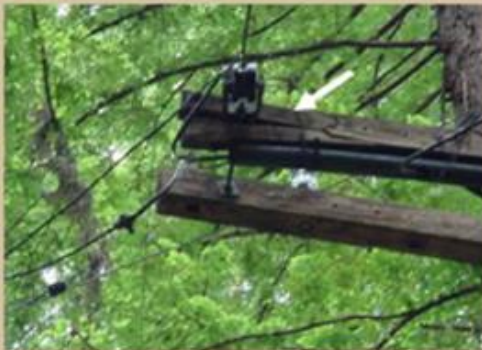
BROKEN SECONDARY CROSSARM

Secondary arm broken; split/fractured within 2" of bolt holes in heavy tree area.

Replace 3-12 months
