# Job Aid: Overhead Assessment

This job aid is designed to assist Electric Distribution Compliance Inspectors, PG&E Employees, and Contractors in assessing and prioritizing compelling **abnormal conditions** on overhead facilities, including but not limited to GO 165 Inspections. Compelling Abnormal Condition is defined as any electric distribution pole, equipment, component, conductors, vegetation, or third-party condition that causes a safety or fire ignition risk that, in the judgment of the field employee, may adversely impact public safety and/or service reliability **within 5 years**.

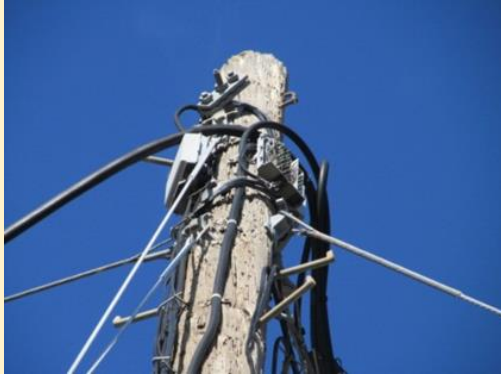
### COMMUNICATION IN CLIMBING SPACE

Obstructed climbing space, access via bucket truck from street below. Also, look for clearance issues between communications facilities and the PG&E down guys.

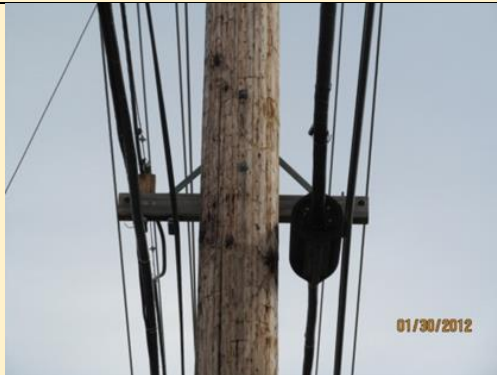
### CLIMBING SPACE OBSTRUCTED

Climbing space obstruction by communication facilities on pole with equipment. Communication messengers are too close. No bucket truck access.

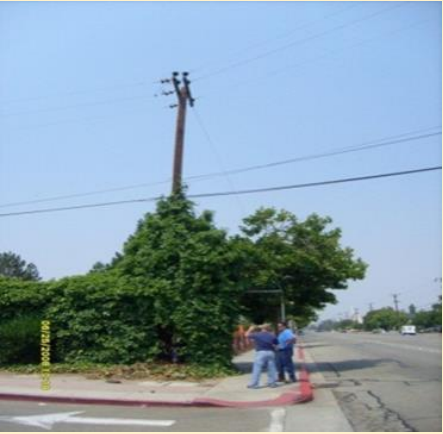
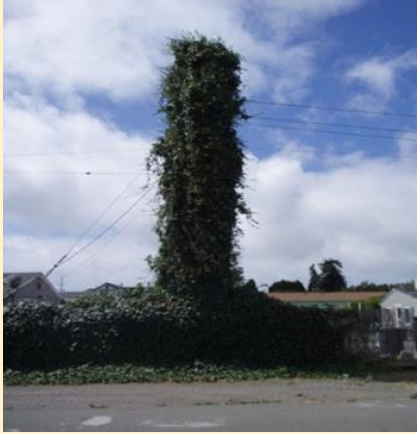
Pole with Vegetation	IVY COVERED POLE

<b>At this Location:</b> 360° pole inspection not possible	<b>At this Location:</b> 360° pole inspection not possible
<b>Perform Minor Work:</b> No	<b>Perform Minor Work:</b> No
<b>Write 3<sup>rd</sup> Party Notification:</b> No	<b>Write 3<sup>rd</sup> Party Notification:</b> No
<b>Write EC Notification:</b> Yes  <b>FDA =</b> OH Facility / Limited Access/Obstruct / Inspect (Primary)  <b>FDA=</b> OH Facility / Limited Access/Obstruct / Remove  <b>Priority =</b> B Tag, 0-3 months depending upon exposure; must complete before CPUC due date for map	<b>Write EC Notification:</b> Yes  <b>FDA =</b> OH Facility / Limited Access/Obstruct / Inspect (Primary)  <b>FDA=</b> OH Facility / Limited Access/Obstruct / Remove  <b>Priority =</b> B Tag, 0-3 months depending upon exposure; must complete before CPUC due date for map

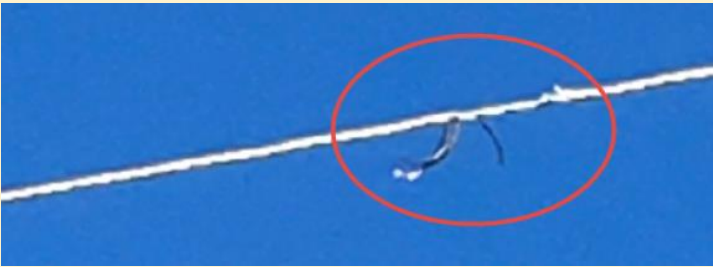
Gun Shot Damage

<b>At this Location:</b> Less than 40% broken strands in a Non-HFTD rural area with low public exposure.
	<b>Perform Minor Work:</b> No
	<b>Write 3<sup>rd</sup> Party Notification:</b> No
	<b>Write EC Notification:</b> Yes  <b>FDA:</b> FDA = Conductor / Broken / Damaged / Repair or Replace  <b>Priority:</b> E Tag 3-12 months depending on exposure

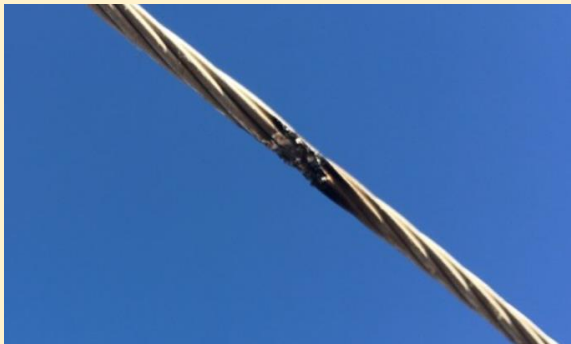
### Burnt Conductor Primary or Secondary

**At this Location:** Burnt Conductor, midspan, primary or secondary

**FDA:** FDA = Conductor / Burnt / Repair or Replace

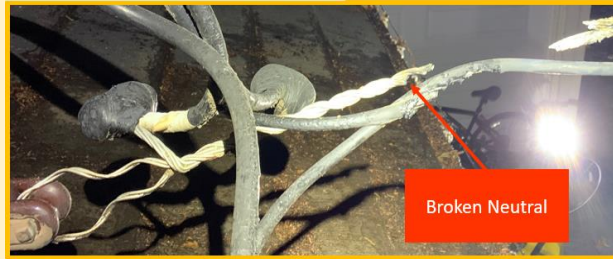
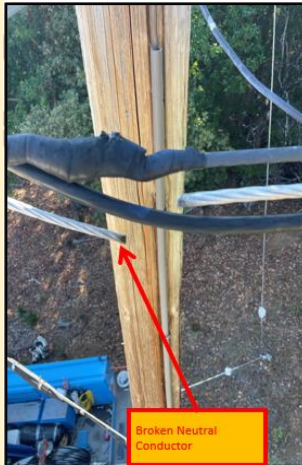
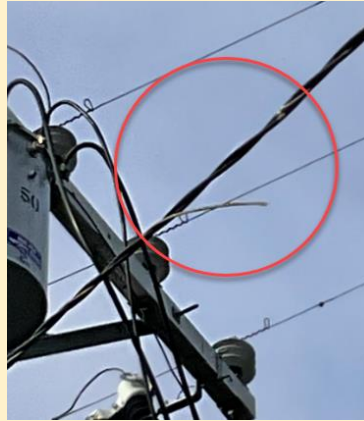
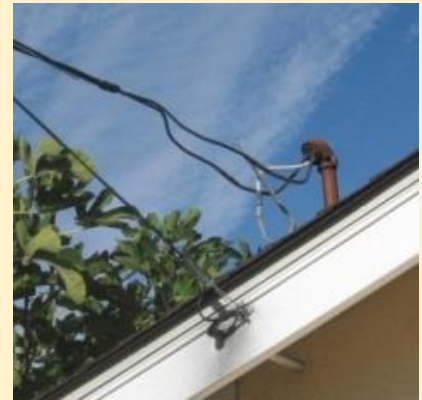
### Broken or Open Service Neutral

**At this Location:** Broken / Open Service neutral

**Perform Minor Work:** Yes, if safe to do so. If you replace the service conductor, this is capital Minor Work. Fill out EC Notification to account for this minor work; charge time to your division standing order

**FDA =** Conductor / Broken / Damaged / Repair or Replace

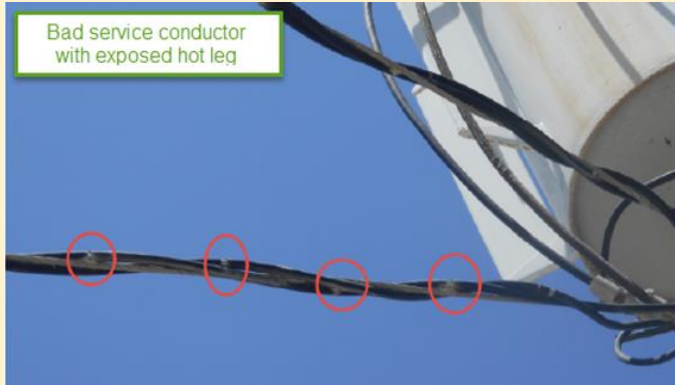
### Bad service conductor with exposed hot leg

**At this Location:** Bad service conductor with exposed hot leg, bundled with a potential to cross phase

**FDA:** FDA = Conductor / Broken / Damaged / Replace

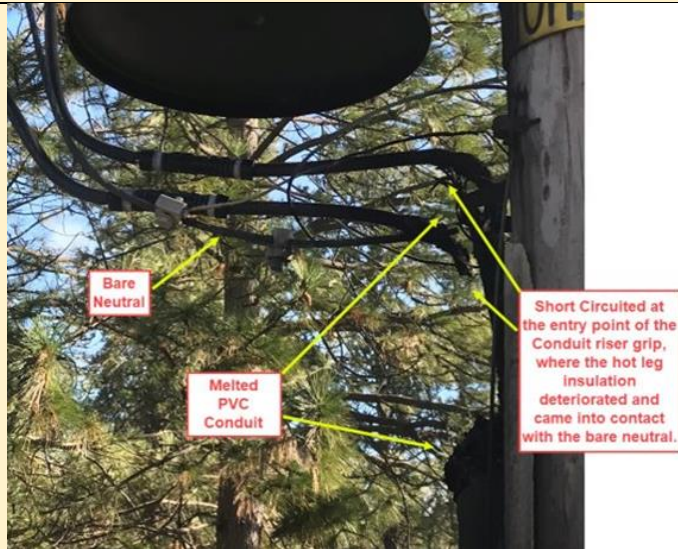
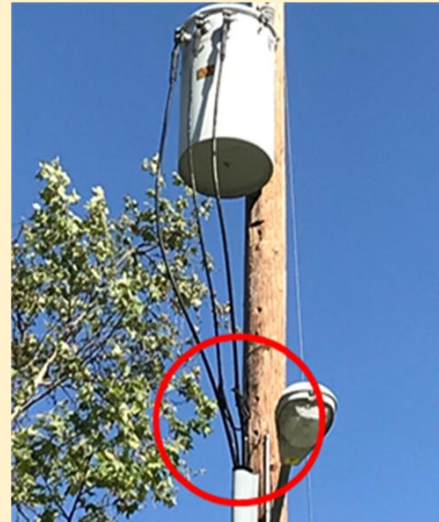
### Secondary Service Riser Drops

**At this Location:** hot leg insulation frayed at the point of entry point of the molding exposing the conductor into contact with the neutral

**FDA=**Conductor / Broken / Damaged / Replace

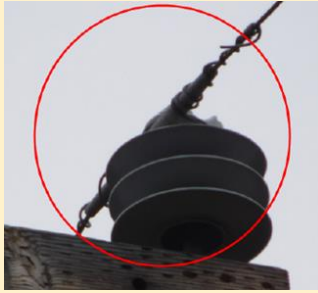
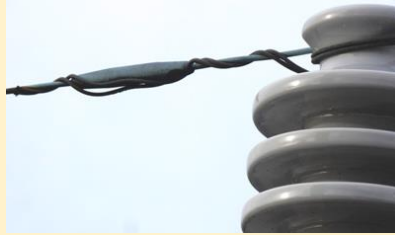
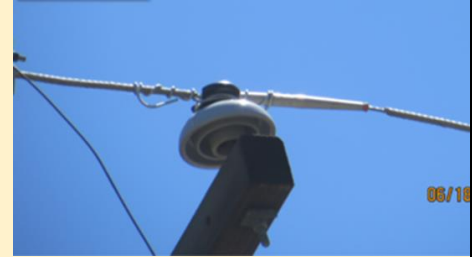
### Splices tied into the insulator or under the tie wire

**At this Location:** Splice under the tie wire or tied into the insulator

**Priority =** E Tag, 3-12 months depending on exposure

**FDA =** Conductor / Splice Tied In / Replace

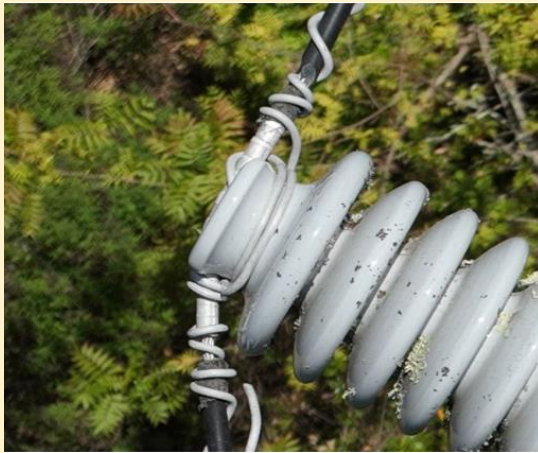
### Splices tied into the insulator or under the tie wire – Aerial View

**At this Location:** Splice under the tie wire or tied into the insulator. Splice bent / damaged.

**FDA =** Conductor / Splice Tied In / Replace

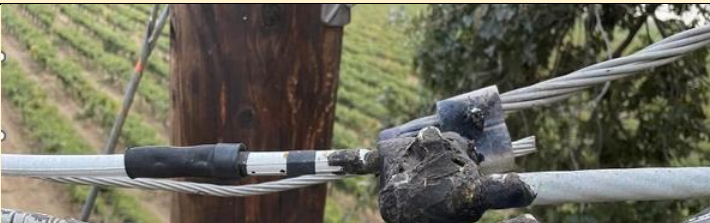
Cracked Grey Service and Deteriorated Insulation Tape

<b>At this Location:</b> Deteriorated cracked Grey service and deteriorated tape insulation for potential cross-phasing
	<b>Perform Minor Work:</b> No
	<b>Write 3<sup>rd</sup> Party Notification:</b> No

**FDA=** Conductor / Damaged / Replace

**FDA=** Connector/ Insulation Deteriorated / Repair

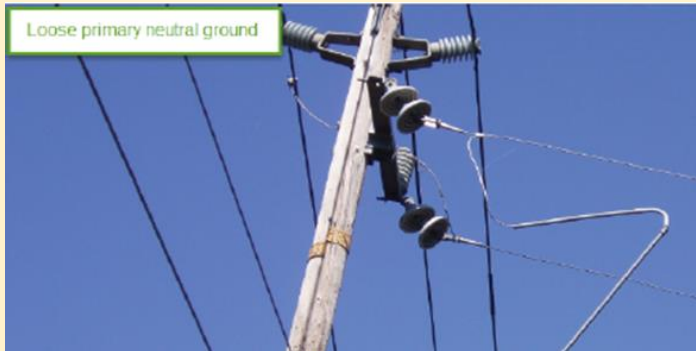
### Loose Primary Neutral Ground

**At this Location:** Loose primary neutral ground, unsupported conductor, hanging

**FDA =** Molding, Loose, Adjust

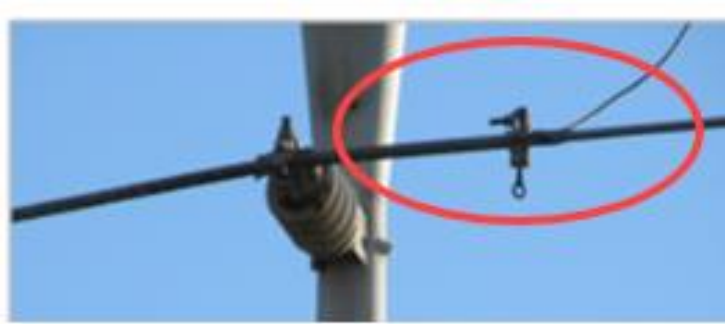
Incorrectly Installed Chance Clamp

<p>Tap clamp on armor rod installed incorrectly.</p>	<b>At this Location:</b> Incorrectly installed per note C above - chance clamp on armor rod
	<b>Perform Minor Work:</b> No
	<b>Write 3<sup>rd</sup> Party Notification:</b> No
	<b>Write EC Notification:</b> Yes <b>FDA:</b> Connector / Incorrectly Installed / Replace <b>Priority:</b> E Tag 3-12 months depending on exposure

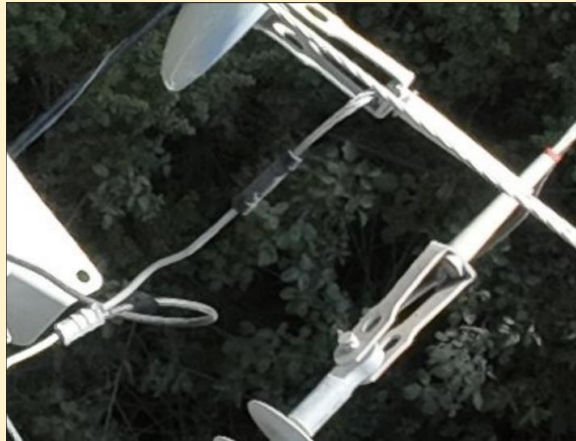
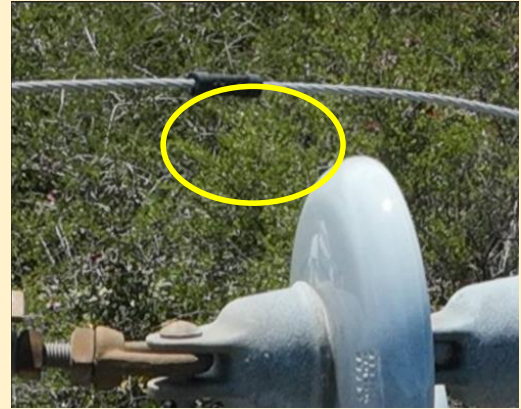
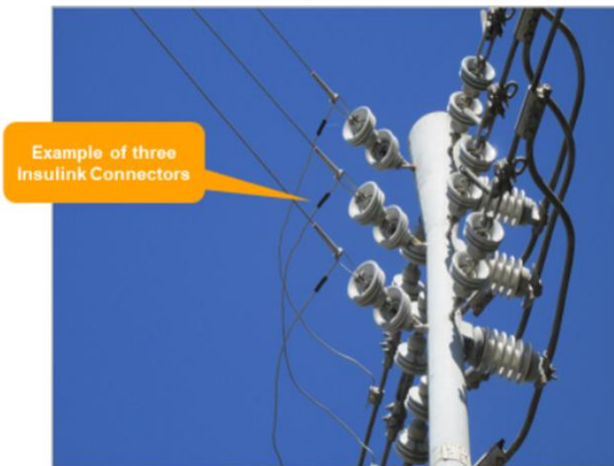
**At this Location:** Secondary connector installed on primary

**FDA:** Connector / Incorrectly Installed / Replace

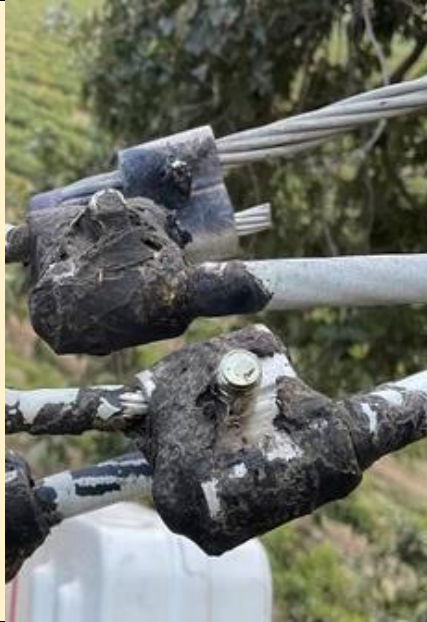
### Connector with Deteriorated Tape

**At this Location:** Deteriorated tape insulation, **potential** cross-phasing

**FDA=** Connector/ Insulation Deteriorated / Repair

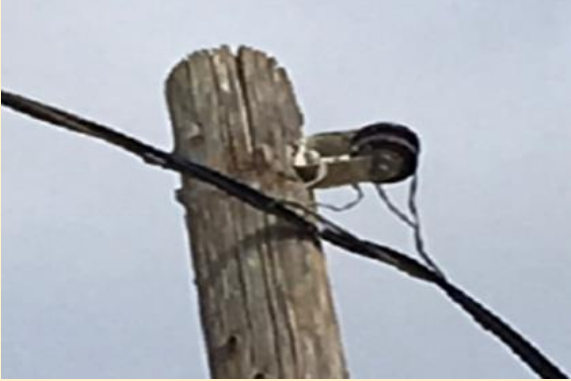
Preform not attached to Insulator

<b>At this Location:</b> Preform not attached to the insulator, rural area, low exposure with no vehicular access
	<b>Perform Minor Work:</b> Yes, if safe to do so.
	<b>Write 3<sup>rd</sup> Party Notification:</b> No
	<b>Write EC Notification:</b> Yes <b>FDA=</b> Tie Wire / Loose / Replace <b>Priority =</b> E Tag, 3-12 months depending on exposure

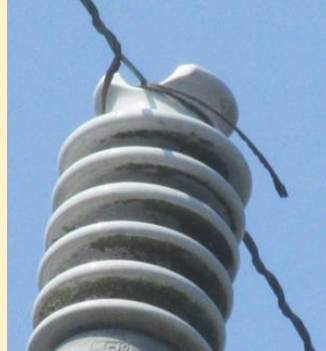
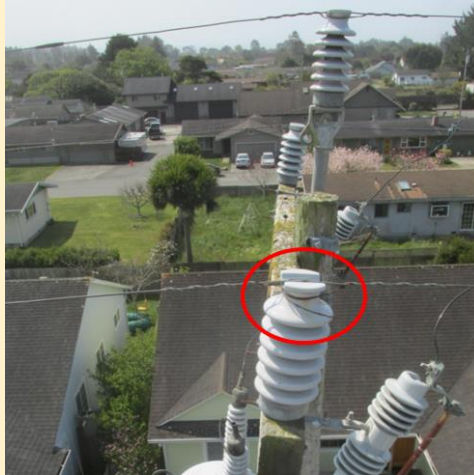
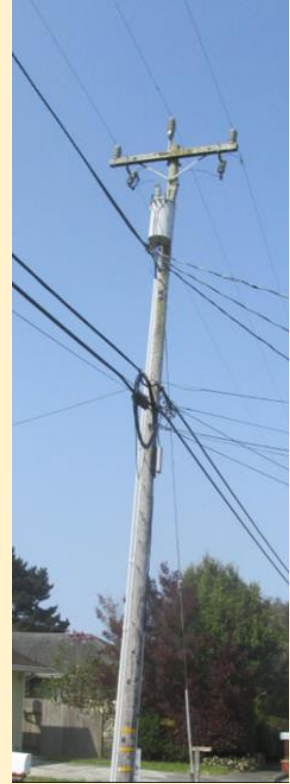
### Broken / Corroded Tie Wire

**At this Location:** Corroded and broken tie wire, top tie, with one strand remaining

**FDA =** Tie wire / Broken / Damaged / Repair / Replace

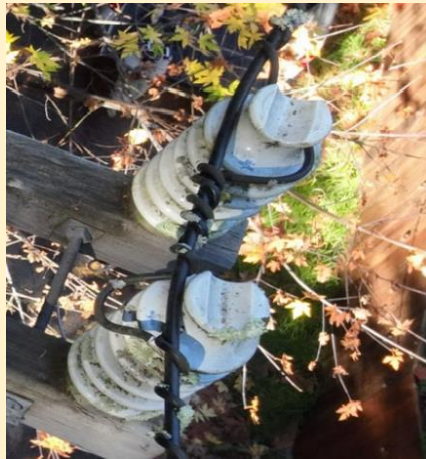
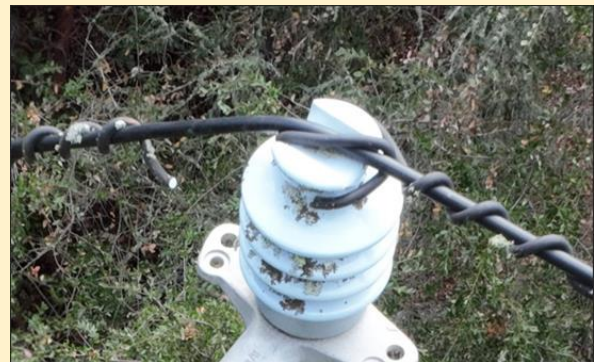
### Broken / Corroded Tie Wire

**At this Location:** Broken tie wire

**FDA =** Tie wire / Broken / Damaged / Repair / Replace

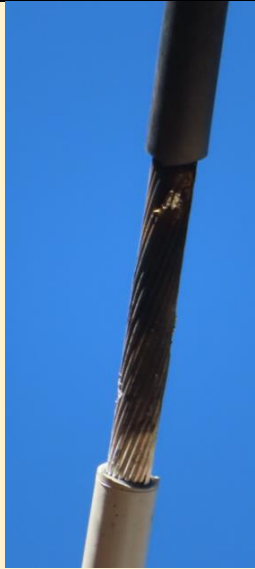
### Exposed Primary Covered Conductor Tree Wire, Burnt Conductor

**At this Location:** Tree Wire conductor exposed and burnt

**Priority:** E Tag, 3-12 months depending on exposure

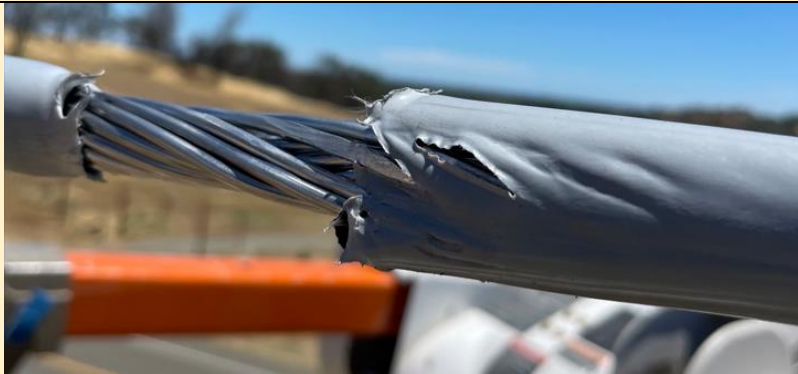
### Exposed Primary Covered Conductor Tree Wire

**At this Location:** Tree Wire jacket cut into and bare conductor exposed

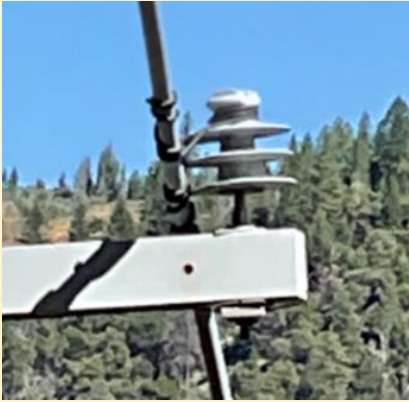
Broken Tie Wire

<b>At this Location:</b> Broken tie wire, which caused a floating conductor condition (sitting on the cross-arm) Insufficient clearance
	<b>Perform Minor Work:</b> No
	<b>Write 3<sup>rd</sup> Party Notification:</b> No
	<b>Write EC Notification:</b> Yes <b>FDA=</b> Conductor / Floater / Repair <b>Priority=</b> A Tag, Follow emergency procedure

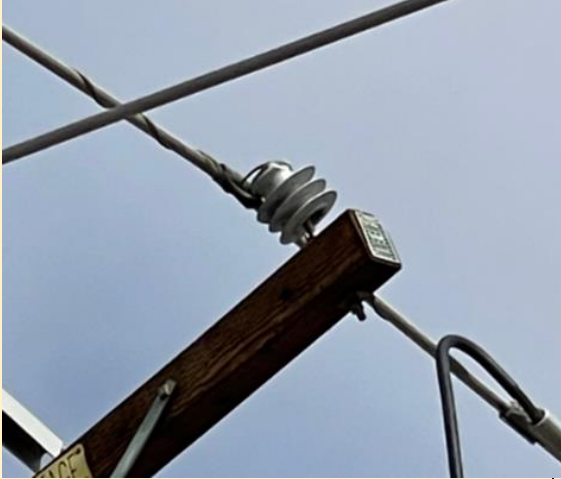
Conductor Tied to Side of Skirt, not in Groove	Tie Wire Broken / Loose / Not in Groove

<b>At this Location:</b> Insulator spun, and conductor tied on the skirt, non-angle pole.	<b>At this Location:</b> Tie Wire Broken / Loose / Not in Groove
<b>Perform Minor Work:</b> No	<b>Perform Minor Work:</b> No
<b>Write 3<sup>rd</sup> Party Notification:</b> No	<b>Write 3<sup>rd</sup> Party Notification:</b> No
<b>Write EC Notification:</b> Yes  <b>FDA =</b> Tie Wire / Broken / Damaged / Replace  <b>Priority =</b> B Tag, 0-3 months depending on exposure	<b>Write EC Notification:</b> Yes  <b>FDA =</b> Tie Wire / Improperly Installed / Repair  <b>Priority =</b> B Tag, 0-3 months depending on exposure

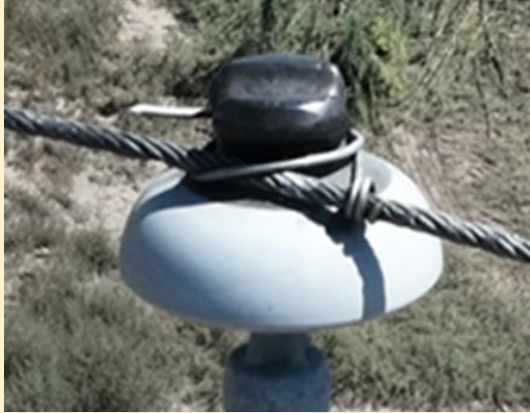
### Conductor Not in Groove

**At this Location:** (From an arial shot)  
Conductor not sitting in the groove, may  
not be possible to identify from the ground.

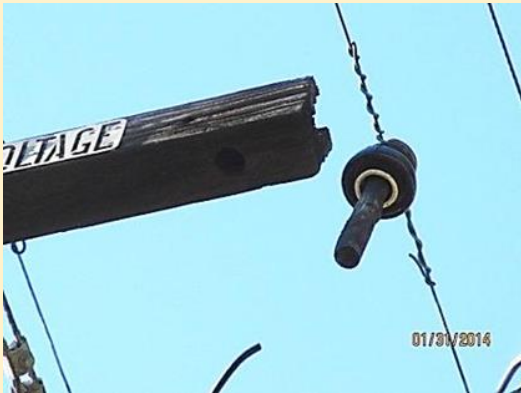
<b>At this Location:</b> Floater, conductor is not contacting the arm. Rotten crossarm.
	<b>Perform Minor Work:</b> No
	<b>Write 3<sup>rd</sup> Party Notification:</b> No
	<b>Write EC Notification:</b> Yes <b>FDA=</b> Crossarm / Decayed/Rotten/ Replace <b>FDA=</b> Conductor / Floater / Repair  <b>Priority=</b> A Tag, follow Emergency Process

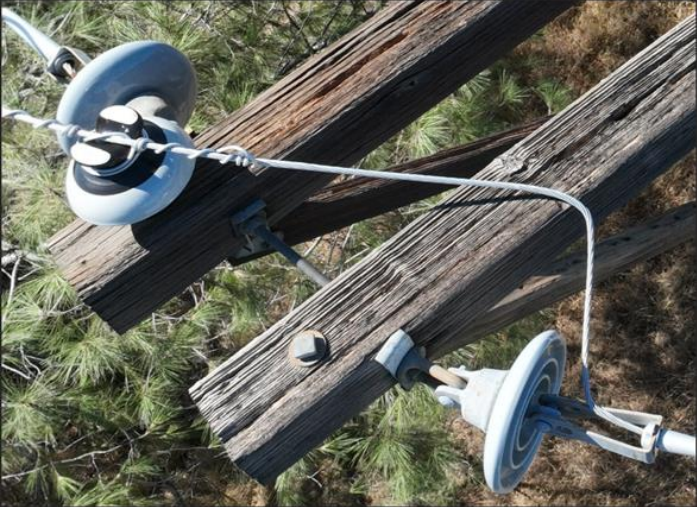
Insufficient Clearance – Aerial View

<b>At this Location:</b> Over the top jumper laying on cross-arm
	<b>Perform Minor Work:</b> No
	<b>Write 3<sup>rd</sup> Party Notification:</b> No
	<b>Write EC Notification:</b> Yes
	<b>FDA:</b> Jumper / Clearance / Impaired / Adjust  <b>Priority:</b> A Tag, Follow the emergency process

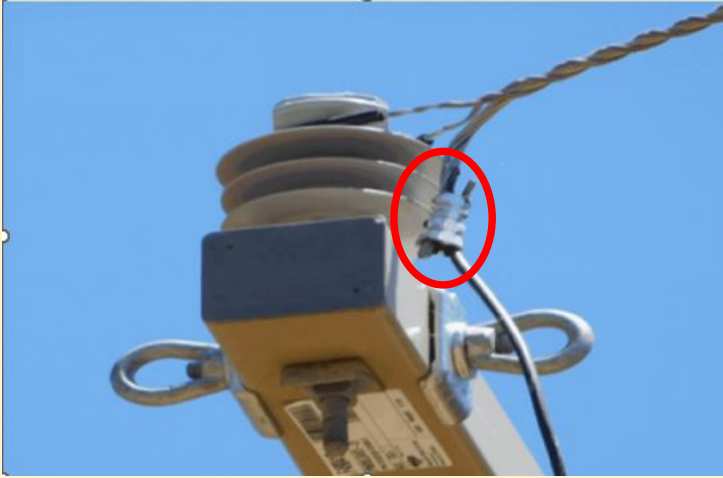
### Insufficient Clearance

**At this Location:** Insufficient clearance between connector and cross-arm

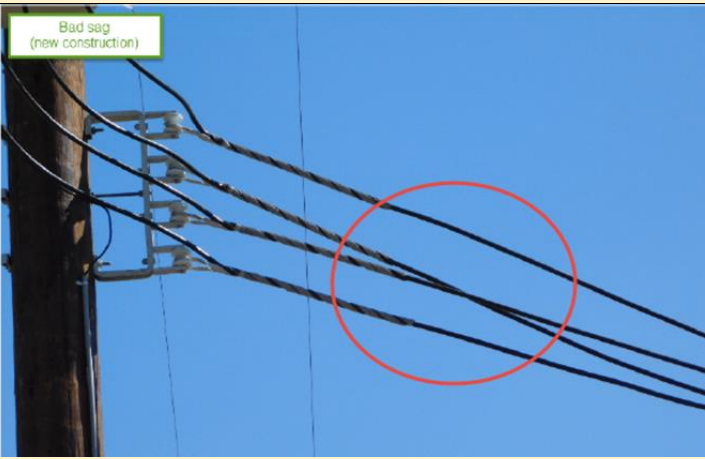
Secondary Sagging Conductor

<b>At this Location:</b> Extended Rack Construction sagging covered and insulated secondary conductor, resulting in conductors touching
	<b>Perform Minor Work:</b> Yes, if safe to do so
	<b>Write 3<sup>rd</sup> Party Notification:</b> No
	<b>Write EC Notification:</b> Yes  <b>FDA=</b> Conductor / Sag / Clearance / Adjust <b>PRIORITY=</b> E TAG, 3-12 months depending upon exposure

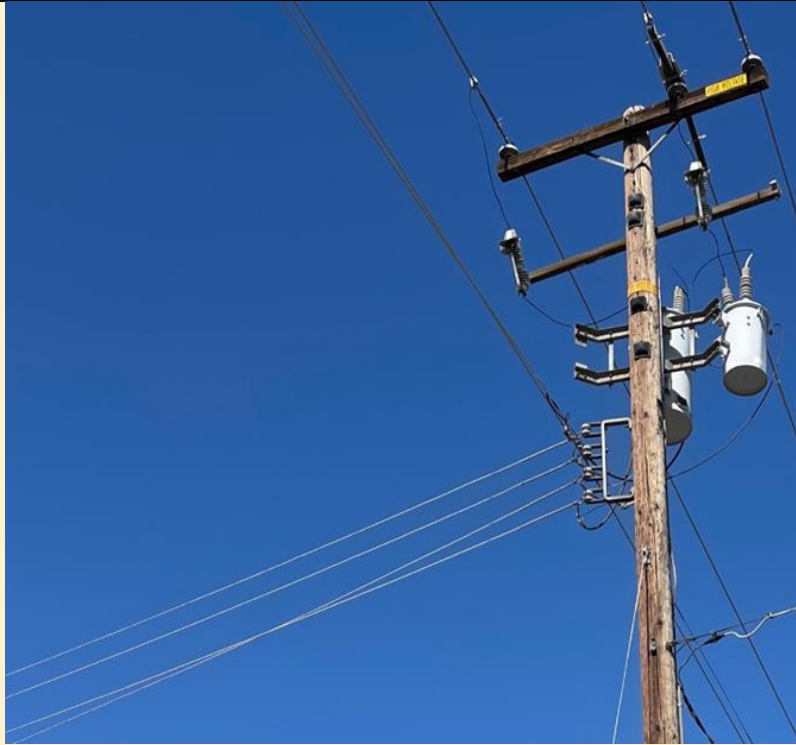
### Open Wire Secondary Sag

**At this Location:** Open wire secondary sag into neutral, energizing the neutral

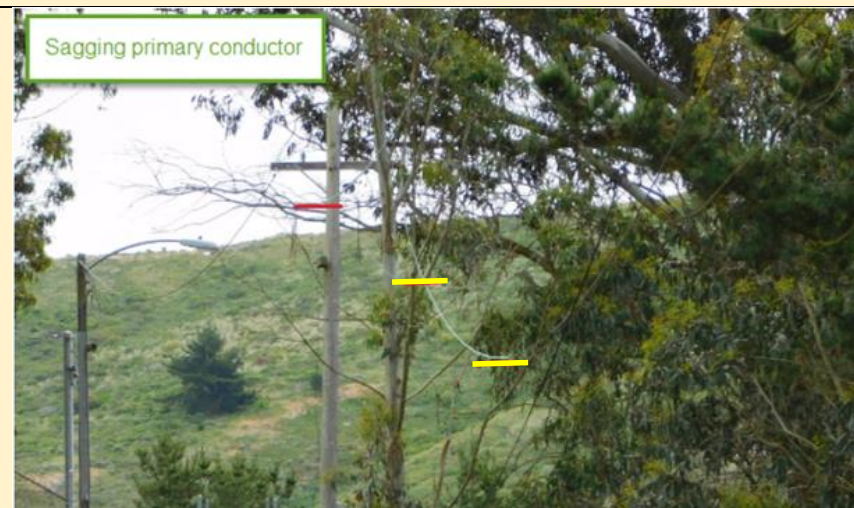
### Primary Sagging Conductor

**At this Location:** Sagging Primary Conductor

**General Guidance:** Are jumpers burnt or are there clearance issues? If yes, create EC notification.

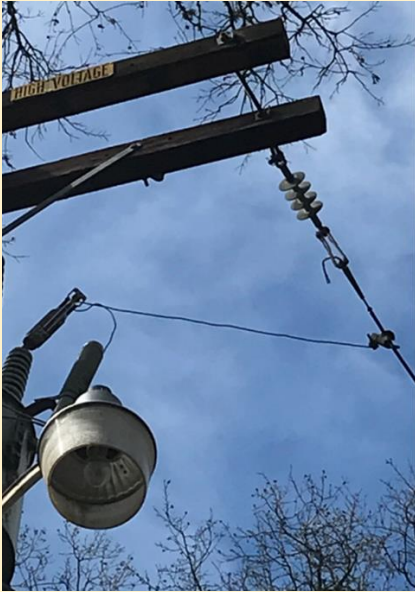
**At this Location:** Jumper Tension, pulling over cutout

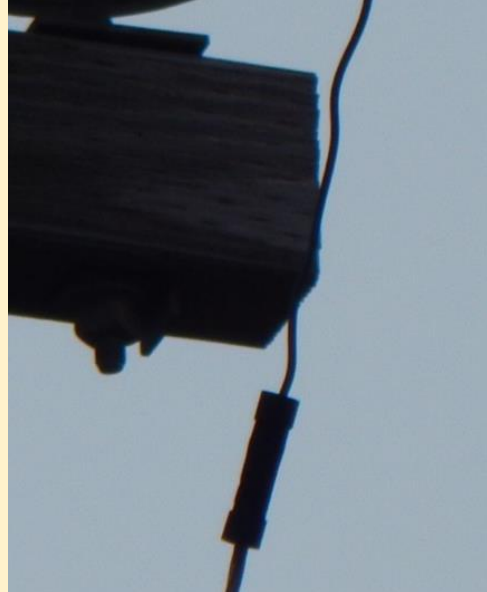
**At this Location:** Jumper Clearance

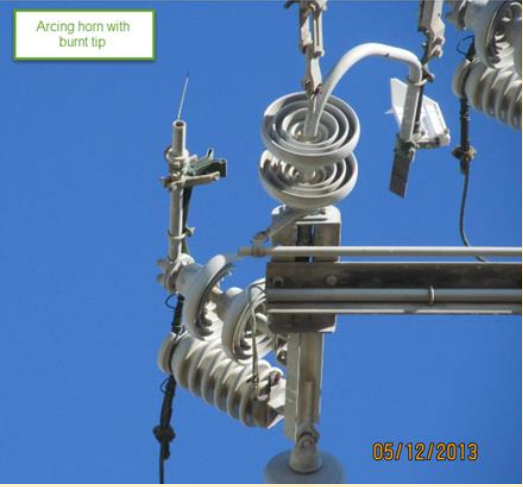
<b>At this Location:</b> Arcing horn with burnt tip
	<b>Perform Minor Work:</b> No
	<b>Write 3<sup>rd</sup> Party Notification:</b> No
	<b>Write EC Notification:</b> No <b>FOLLOW COE PROCESS</b>

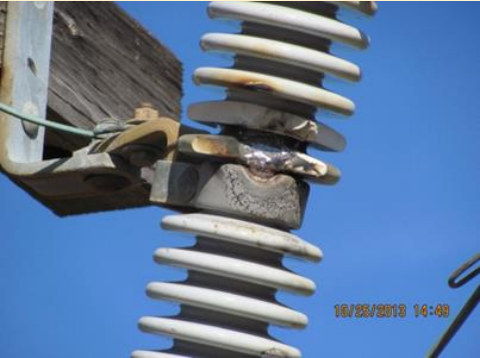
BROKEN DAMAGED CROSSARM MOUNTED CUTOUT	Broken Cutout

<b>At this Location:</b> Broken/Flashed cutout	<b>At this Location:</b> Broken Cutout
<b>Perform Minor Work:</b> No	<b>Perform Minor Work:</b> No
<b>Write 3<sup>rd</sup> Party Notification:</b> No	<b>Write 3<sup>rd</sup> Party Notification:</b> No
<b>Write EC Notification:</b> Yes <b>FDA =</b> Cutout / Broken/Damaged / Replace <b>Priority =</b> E Tag, 3-12 months depending upon exposure, no COE	<b>Write EC Notification:</b> Yes <b>FDA =</b> Cutout / Broken/Damaged / Replace <b>Priority =</b> A Tag, Follow the emergency procedure

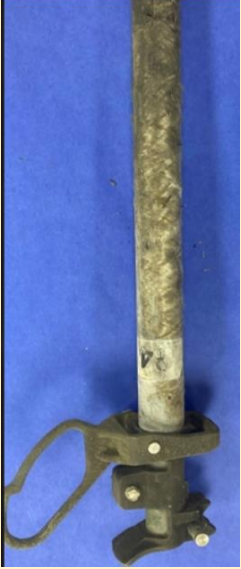
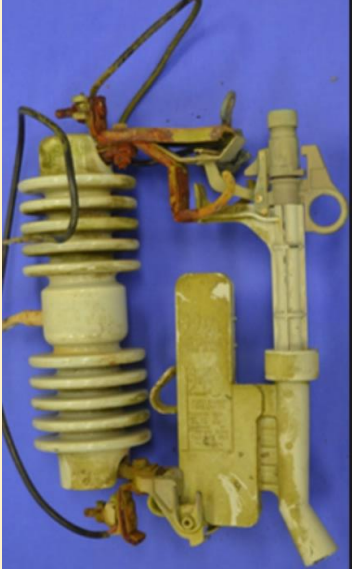
PART 63 POWER FUSE	Part 75 Fault Tamer

<b>At this Location:</b> Fuse End fitting corroded; fiberglass layer exposed	<b>At this Location:</b> excessive cutout corrosion leading to corrosion on the metal components of the FT Fuse, deteriorated housing on the FT Fuse will not contain an arc within the snuffing tube. Any reasonable suspicion of damage that will not be able to operate correctly
<b>Perform Minor Work:</b> No	<b>Perform Minor Work:</b> No
<b>Write 3<sup>rd</sup> Party Notification:</b> No	<b>Write 3<sup>rd</sup> Party Notification:</b> No
<b>Write EC Notification:</b> Yes  <b>FDA =</b> Fuse / Broken / Damaged / Replace  <b>Priority =</b> E Tag – 3-12 months depending on exposure.	<b>Write EC Notification:</b> Yes  <b>FDA =</b> Cutout / Broken/Damaged / Replace  <b>And</b>  <b>FDA=</b> Fuse / Broken / Damaged / Replace  <b>Priority =</b> E Tag – 3-12 months depending on exposure.

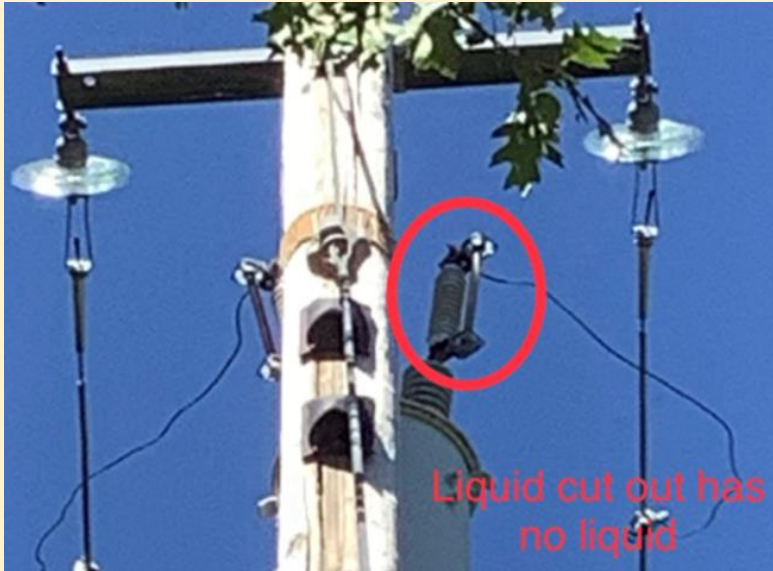
### Liquid Fuse with no Liquid

**At this Location:** Liquid Fuse with no liquid, not in HFTD

**FDA** = Fuse / Broken/Damaged / Replace

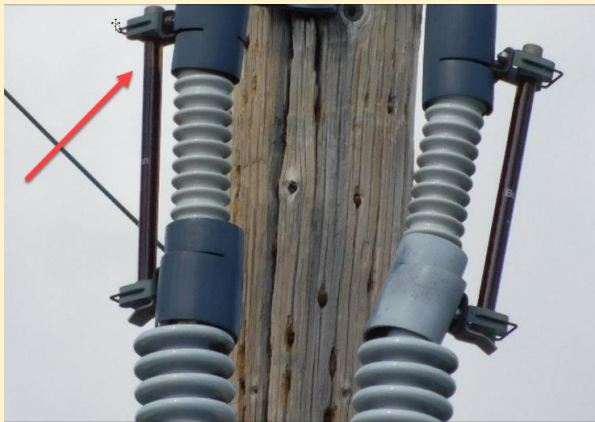
### Liquid Fuse Oil Level is Low

**At this Location:** Liquid Fuse with low oil level in HFTD area.

**FDA** = Fuse / Broken/Damaged / Replace

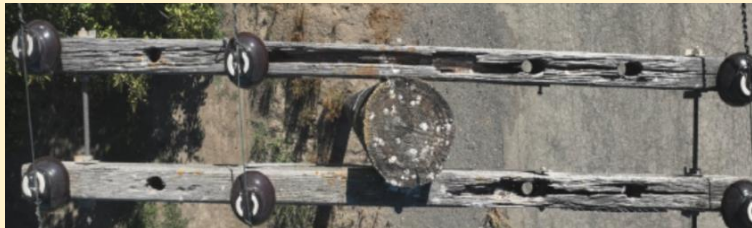
### Deteriorated Cross-Arm – Aerial View

**At this Location:** Top view of a Deteriorated/Rotten cross-arm. May not be seen from the ground. Quarter brace hardware coming loose.

**Priority =** Minimum B tag 0-3 months, consider A Tag for conditions such as conductor size, double / single arm, exposure, etc.

**FDA =** Cross-arm / Broken / Damaged / Replace

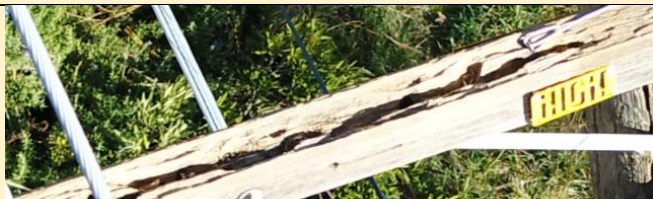
### Deteriorated Cross-Arm – Aerial View

**At this Location:** Deteriorated Cross-Arm – Aerial View

**Priority =** Minimum B tag 0-3months, consider A Tag for conditions such as conductor size, double / single arm, exposure, etc.

**FDA =** Cross-arm / Broken / Damaged / Replace

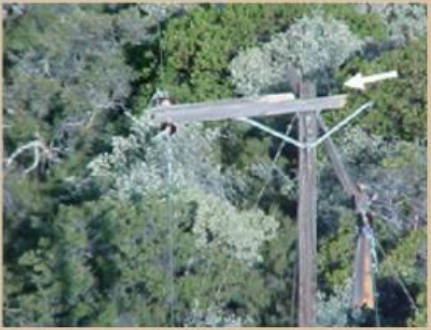
<p><b>BROKEN CROSSARM</b></p> <p>Crossarm is completely broken/fractured</p>

<p>Emergency - make safe immediately</p>	<p><b>SPLIT CROSSARM</b></p> <p>Primary Squatter (wood pin). Crossarm split within 2" of pinhole.</p>

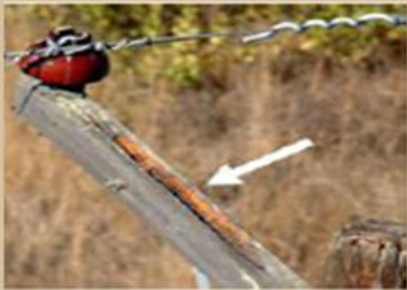
<p>Replace in the next 3 months.</p>
<p><b>TOP OF CROSSARM DECAYED</b></p> <p>Evidence of pole top decay and face of crossarm decay; may need additional assessment of crossarm.</p>

<p>Replace 3-12 months</p>	<p><b>DETERIORATED CROSSARM</b></p> <p>Significant deterioration, both arms are broken/split. Evidence of previous temporary repair.</p>

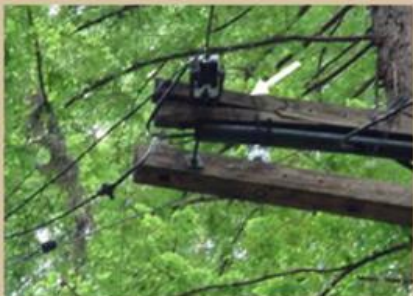
<p>Replace 3-12 months</p>
<p><b>BROKEN SECONDARY CROSSARM</b></p> <p>Secondary arm broken; split/fractured within 2" of bolt holes in heavy tree area.</p>

<p>Replace 3-12 months</p>

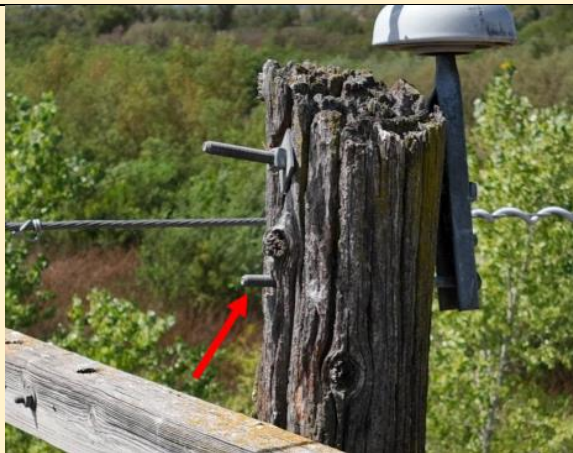
### Missing Hardware – Aerial View

**At this Location:** The nut on the through bolt has come off of the king pin.

**FDA =** Hardware / Loose / Adjust

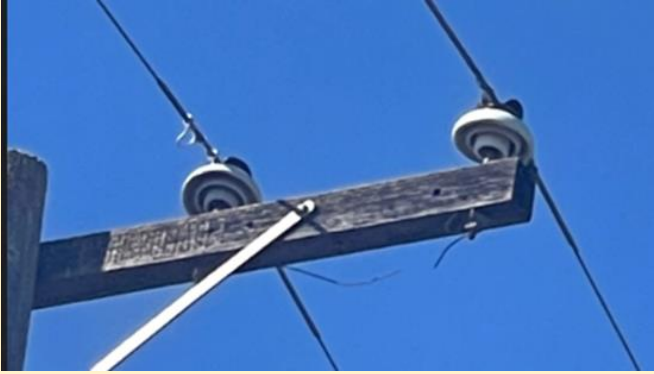
**General Guidance:** Visual observation of broken / unattached bonding wire on a cross-arm. Create EC notification.

<b>At this Location:</b> Broken or unattached bonding
	<b>Perform Minor Work:</b> No
	<b>Write 3<sup>rd</sup> Party Notification:</b> No
	<b>Write EC Notification:</b> Yes
	<b>FDA =</b> Bonding / Broken / Damaged / Replace <b>Priority =</b> E Tag, 3-12 months depending on exposure

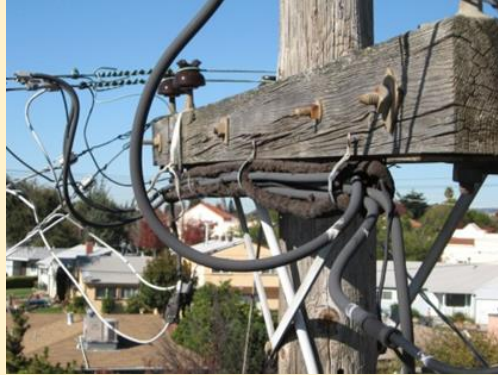
### Under-Arm Bus Loose and Deteriorated

**At this Location:** UAB deteriorated, partial repair with rope, secured with one strap

**Priority** = At minimum – must write up as F Tag, next inspection cycle; based on field condition and exposure, corrosion, etc.; prioritize as needed (A, B, E, or F)

**FDA=**Under-Arm Bus / Broken/Damaged / Repair

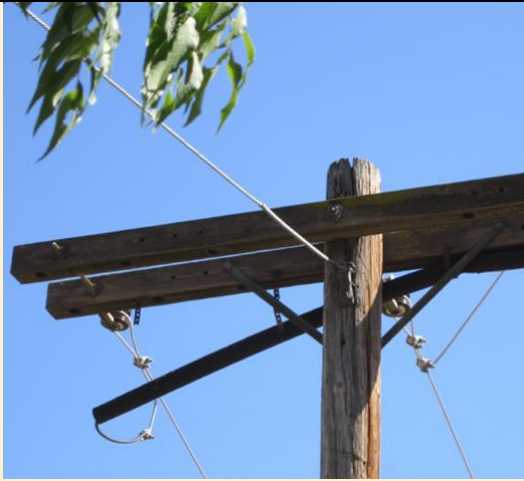
### Under-arm Bus Loose

**At this Location:** UAB Loose, unattached and hanging

**FDA=** Under-Arm Bus / Broken/Damaged / Repair

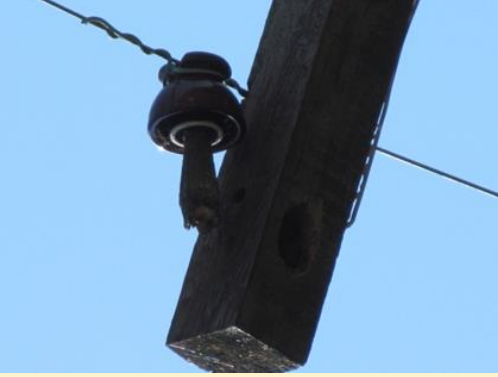
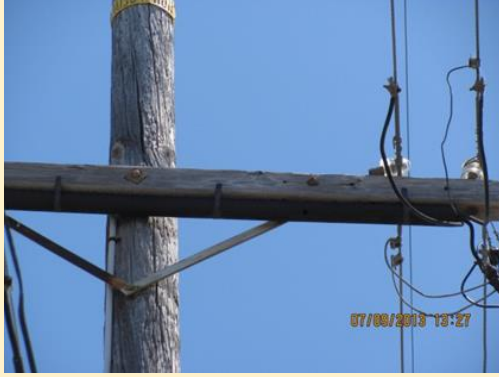
PIN BROKEN	PIN BROKEN (FLOATER)

<b>At this Location:</b> Primary wood pin is broken, and the conductor is laying on the crossarm. Wood pin arm replace with Composite arm	<b>At this Location:</b> Secondary wood pin is broken, and the conductor is laying on the crossarm. Wood pin arm. Replace arm with composite arm
<b>Perform Minor Work:</b> No	<b>Perform Minor Work:</b> No
<b>Write 3<sup>rd</sup> Party Notification:</b> No	<b>Write 3<sup>rd</sup> Party Notification:</b> No
<b>Write EC Notification:</b> Yes	<b>Write EC Notification:</b> Yes
<b>FDA =</b> Conductor / Floater / Repair	<b>FDA=</b> Conductor / Floating / Repair
<b>FDA=</b> Crossarm/Broken Damaged/Replace	<b>FDA=</b> Crossarm/Broken Damaged/Replace
<b>Priority =</b> A Tag, follow emergency process	<b>Priority=</b> A Tag, follow Emergency Process

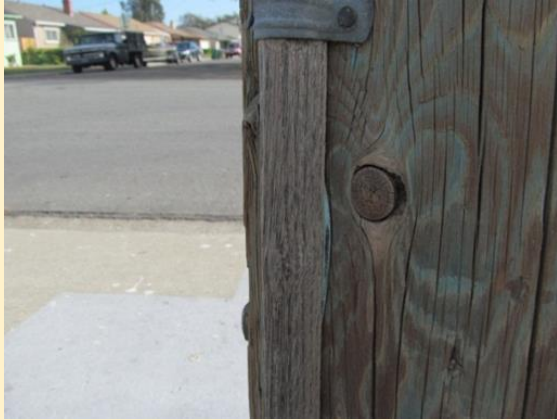
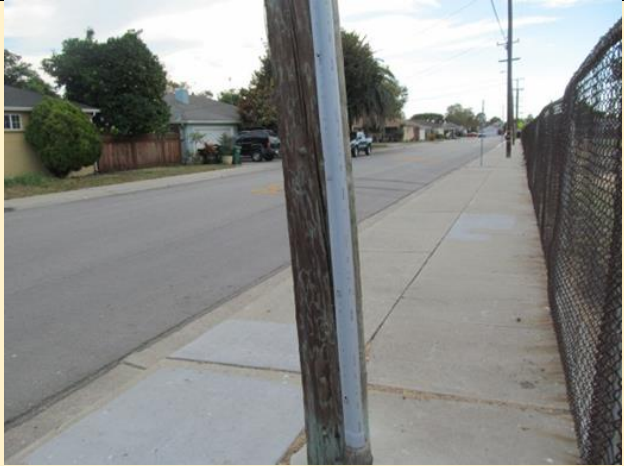
### REPAIR WITH 1.5" MOLDING

**Before:** Copper Wire sticking out from under the wood molding

**At this Location:** Wood molding with ground exposed

**After:** 1.5-inch u-shaped molding installed over existing wood molding

**FDA=** Ground / Exposed / Repair

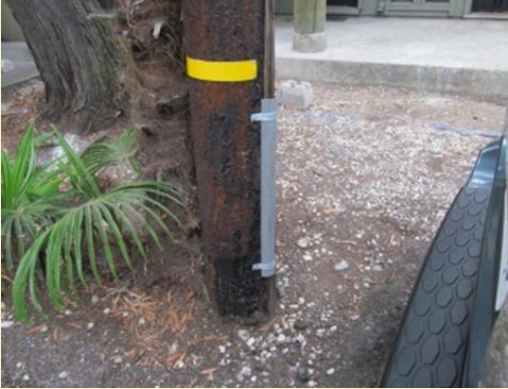
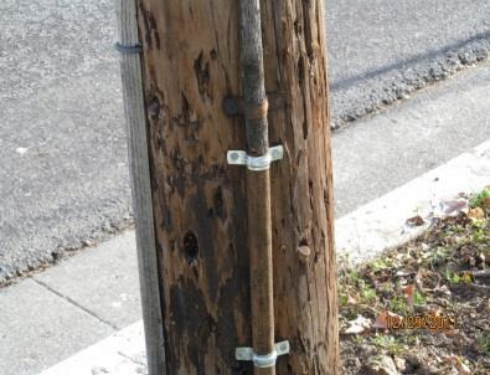
REPAIR WITH 2" PLASTIC	REPAIR WITH WOOD MOLDING

<p><b>At this Location:</b> Condition acceptable after repair of exposed ground</p>	<p><b>At this Location:</b> Condition acceptable after repair with wood molding</p>

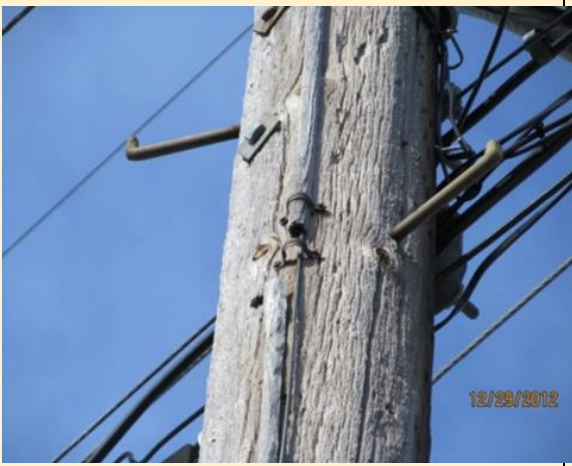
<b>At this Location:</b> Exposed ground at communications level. Wood molding broken in climbing space	<b>At this Location:</b> Exposed ground in wood molding.
<b>Perform Minor Work:</b> Yes, if safe to do so	<b>Perform Minor Work:</b> Yes, if safe to do so
<b>Write 3<sup>rd</sup> Party Notification:</b> No	<b>Write 3<sup>rd</sup> Party Notification:</b> No
<b>Write EC Notification:</b> Yes, only if unable to perform minor work.	<b>Write EC Notification:</b> Yes, only if unable to perform minor work.
<b>FDA=</b> Ground / Exposed / Repair	<b>FDA=</b> Ground / Exposed / Repair
<b>Priority=</b> F Tag At minimum – next inspection cycle; based on field condition and exposure, corrosion, etc.; prioritize as needed (A, B, E, or F)	<b>Priority=</b> F Tag At minimum – next inspection cycle; based on field condition and exposure, corrosion, etc.; prioritize as needed (A, B, E, or F)

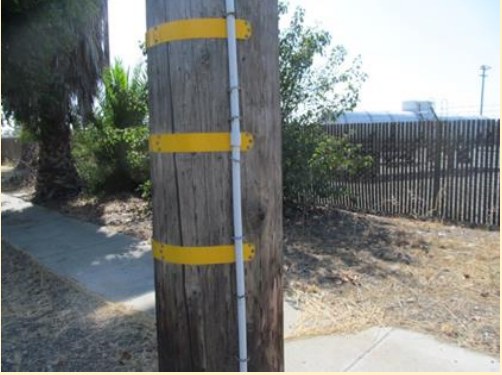
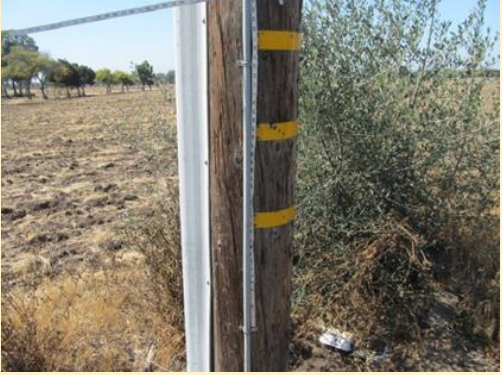
MOLDING SECURED	MOLDING SECURED

<p><b>At this Location:</b> Molding adequately secured with staples upon arrival. No action is required.</p>	<p><b>At this Location:</b> Molding adequately secured with straps spacing 36 inches or less upon arrival. No action required.</p>

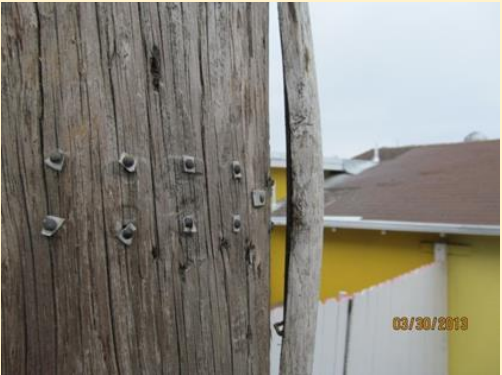
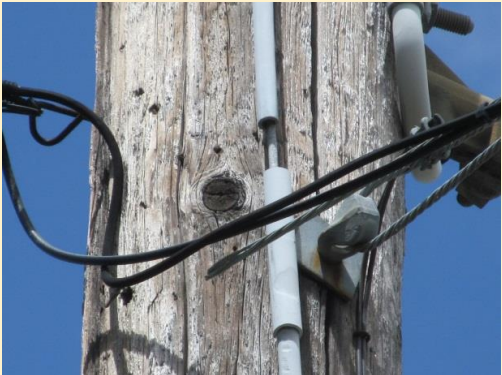
WOOD MOLDING ABOVE 8', NOT SECURE EXPOSING GROUND	PVC MOLDING ABOVE 8', NOT SECURE EXPOSING GROUND

<b>At this Location:</b> PG&E solely owned pole, Wood molding is not secure allowing human contact.	<b>At this Location:</b> At communication level, PVC molding not secure, due to failure of previous repairs, allowing human contact.
<b>Perform Minor Work:</b> Yes, if safe to do so	<b>Perform Minor Work:</b> Yes, if safe to do so
<b>Write 3<sup>rd</sup> Party Notification:</b> No	<b>Write 3<sup>rd</sup> Party Notification:</b> No
<b>Write EC Notification:</b> No	<b>Write EC Notification:</b> Yes, only if unable to perform minor work.  <b>FDA=</b> Ground / Exposed / Repair  <b>Priority=</b> F Tag At minimum – next inspection cycle; based on field condition and exposure, corrosion, etc.; prioritize as needed (A, B, E, or F)

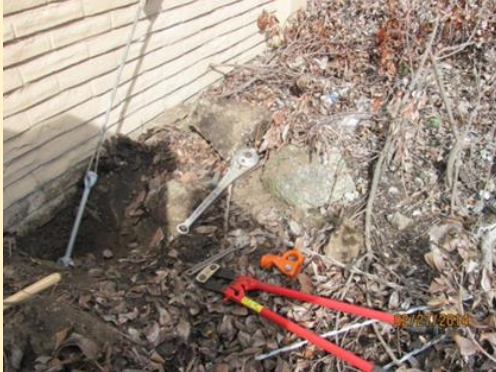
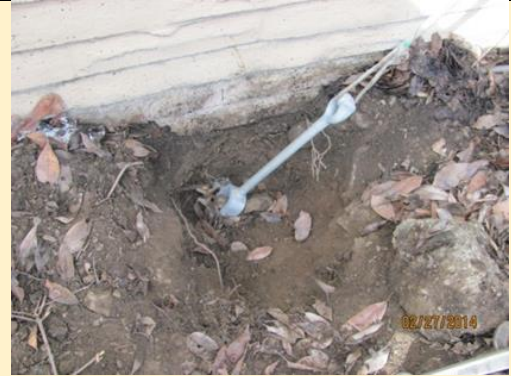
### ANCHOR EXTENSION

**At this Location:** : Inspector performed minor work, exposed anchor, evaluated anchor to be in good condition so that extension could be installed, then installed extension. (Back fill not shown)

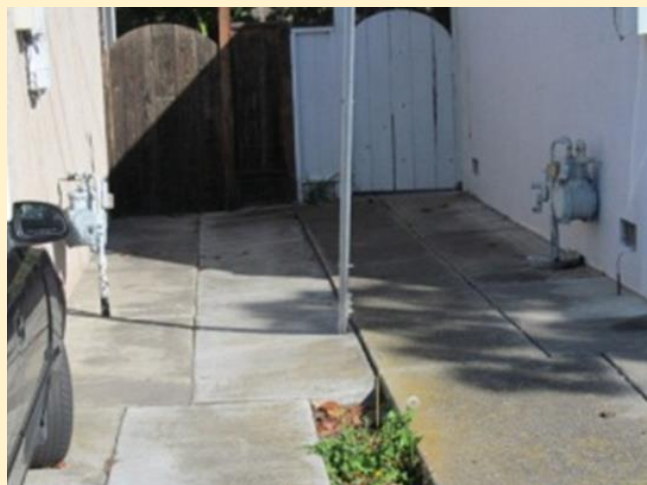
### ANCHOR COVERED BY CONCRETE

**At this Location:** Anchor covered by concrete

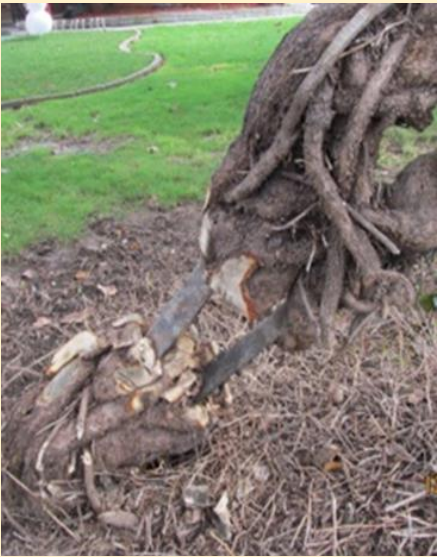
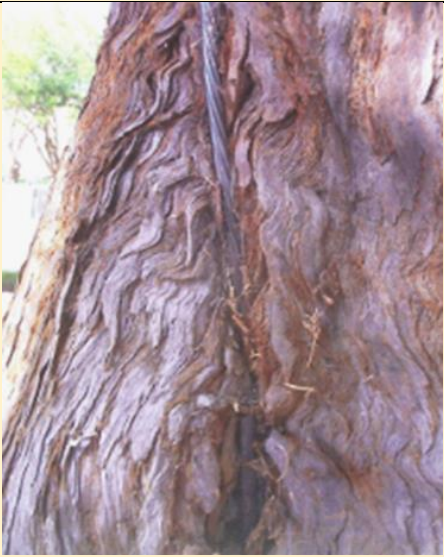
Anchor buried by roots	Anchor buried by tree

<b>At this Location:</b> Anchor buried by ivy roots / tree	
<b>Perform Minor Work:</b> No	
<b>Write 3<sup>rd</sup> Party Notification:</b> No	
<b>Write EC Notification:</b> Yes <b>FDA=</b> Anchor / Soil / Eroded / Graded / Replace <b>Priority=</b> F Tag at minimum, next inspection cycle; based on field condition and exposure, corrosion, etc.; prioritize as needed (A, B, E, or F)

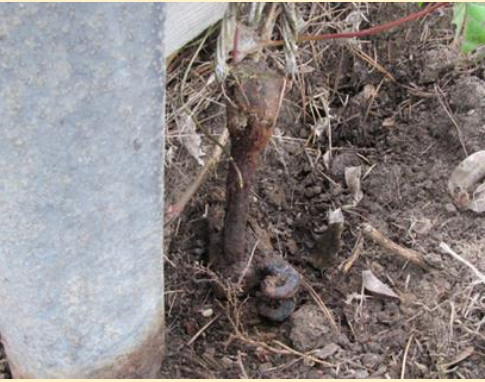
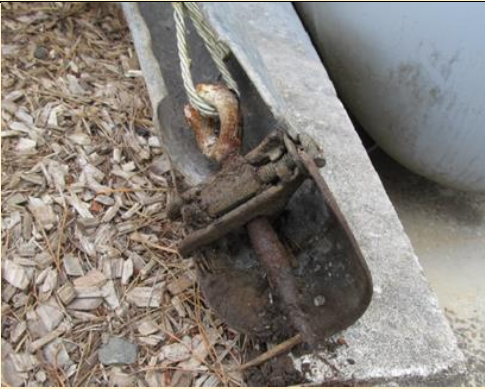
ANCHOR ROD WITH SIGNIFICANT CORROSION	
Anchor above ground	Below

<b>At this Location:</b> Corroded Anchor	
<b>Perform Minor Work:</b> No	
<b>Write 3<sup>rd</sup> Party Notification:</b> No	
<b>Write EC Notification:</b> Yes	
<b>FDA=</b> Anchor / Corroded / Replace	
<b>Priority=</b> E Tag, 3-12 months depending upon exposure

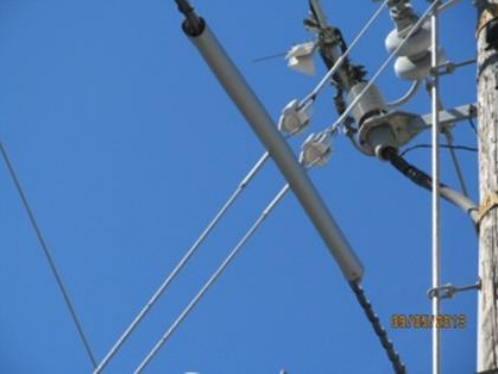
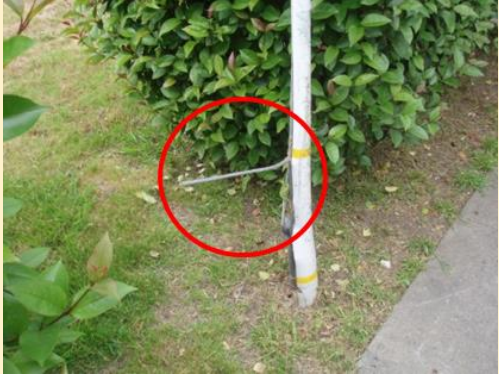
GUY CLEARANCE	GUY DAMAGED REPAIR

<b>At this Location:</b> Acceptable solution through plastic barrier	<b>At this Location:</b> Guy tail extends beyond the preform, <u>near sidewalk</u> , safety hazard
<b>Perform Minor Work:</b> No	<b>Perform Minor Work:</b> Yes, if safe to do so
<b>Write 3<sup>rd</sup> Party Notification:</b> No	<b>Write 3<sup>rd</sup> Party Notification:</b> No
<b>Write EC Notification:</b> No	<b>Write EC Notification:</b> Yes, only if unable to perform minor work.  <b>FDA=</b> Guy / Broken / Damaged / Repair  <b>Priority=</b> E Tag, 3-12 months depending upon exposure

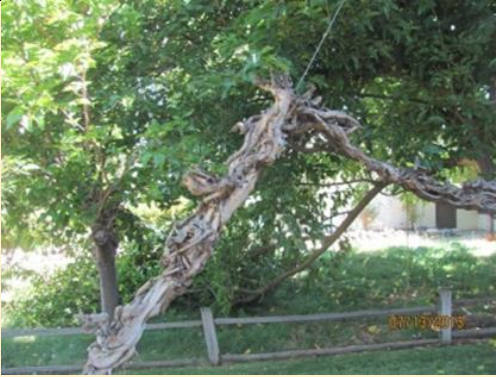
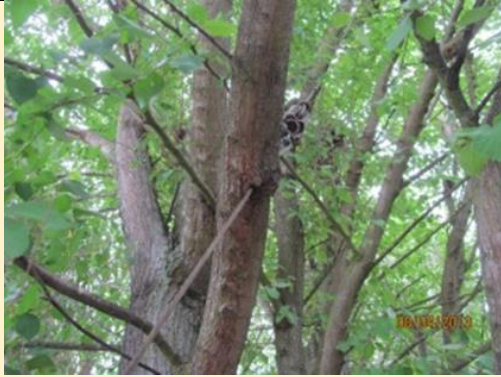
OVERGROWN GUY	TREE GROWING AROUND GUY

<b>At this Location:</b> Extensive dead ivy covering half of length of guy, below the bob.	<b>At this Location:</b> Tree growing around guy, below the bob.
<b>Perform Minor Work:</b> No	<b>Perform Minor Work:</b> No
<b>Write 3<sup>rd</sup> Party Notification:</b> No	<b>Write 3<sup>rd</sup> Party Notification:</b> No
<b>Write EC Notification:</b> Yes <b>FDA=</b> Guy / Broken/Damaged / Replace <b>Priority=</b> E Tag, 3-12 months depending upon exposure	<b>Write EC Notification:</b> Yes <b>FDA=</b> Guy / Broken/Damaged / Replace <b>Priority=</b> E Tag, 3-12 months depending upon exposure
