# Job Aid: Overhead Assessment

This job aid is designed to assist Electric Distribution Compliance Inspectors, PG&E Employees, and Contractors in assessing and prioritizing compelling **abnormal conditions** on overhead facilities, including but not limited to GO 165 Inspections. Compelling Abnormal Condition is defined as any electric distribution pole, equipment, component, conductors, vegetation, or third-party condition that causes a safety or fire ignition risk that, in the judgment of the field employee, may adversely impact public safety and/or service reliability **within 5 years**.

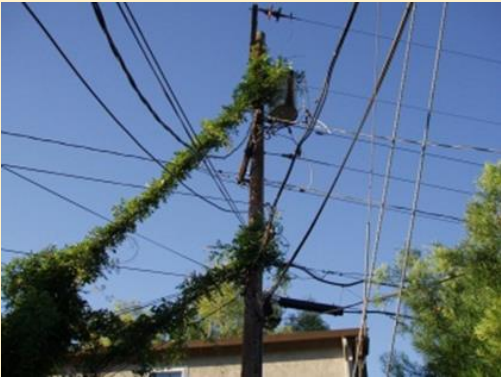
IVY ON GUY AND PRIMARY

<b>At this Location:</b> Ivy on guy and on primary. Safety issues, possible energized guy and pole
	<b>Perform Minor Work:</b> No
	<b>Write 3<sup>rd</sup> Party Notification:</b> No
	<b>Write EC Notification:</b> Yes <b>FDA=</b> Guy / Overgrown / Trim <b>Priority=</b> B Tag, 3 months or less depending upon exposure

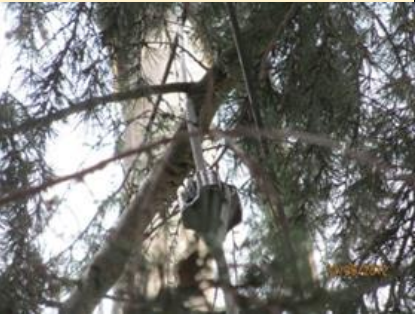
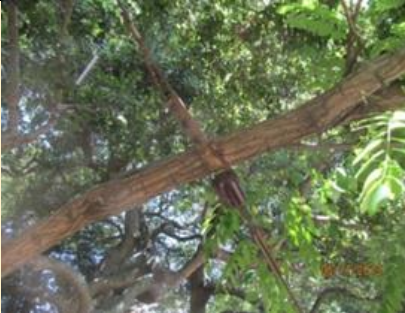
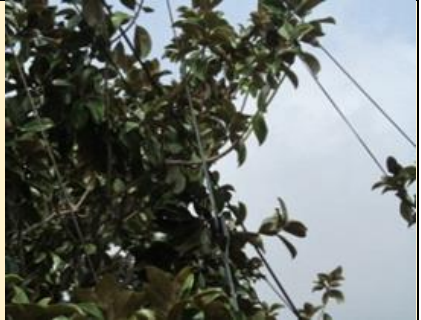
GUY GROUNDED BY VEGETATION		
Guy grounded by vegetation	Guy grounded by vegetation	Guy overgrown by vegetation

<b>At this Location:</b> Guy grounded by vegetation, above the bob		
<b>Perform Minor Work:</b> Yes		
<b>Write 3<sup>rd</sup> Party Notification:</b> No		
<b>Write EC Notification:</b> Yes, only if minor work cannot be performed <b>FDA=</b> Guy / Overgrown / Trim		
<b>Priority=</b> E Tag, 3-12 months depending upon exposure

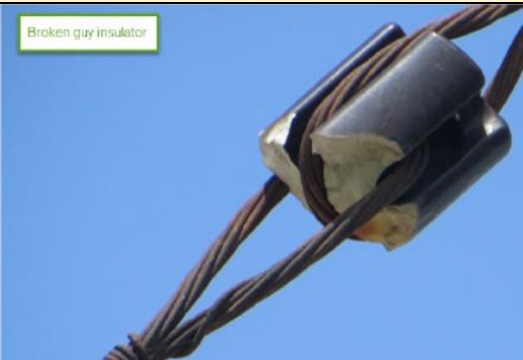
Broken guy insulator

<b>At this Location:</b> Broken guy insulator
	<b>Perform Minor Work:</b> No
	<b>Write 3<sup>rd</sup> Party Notification:</b> No
	<b>Write EC Notification:</b> Yes <b>FDA=</b> Guy / Broken/Damaged / Replace <b>Priority=</b> E Tag, 3-12 months depending upon exposure

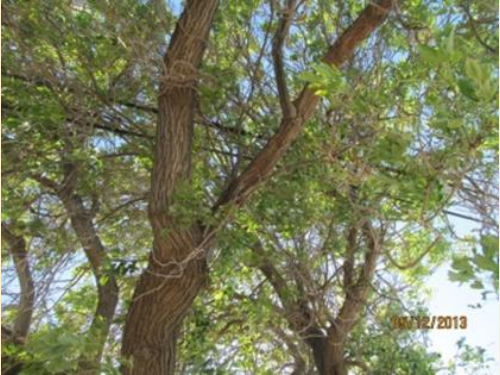
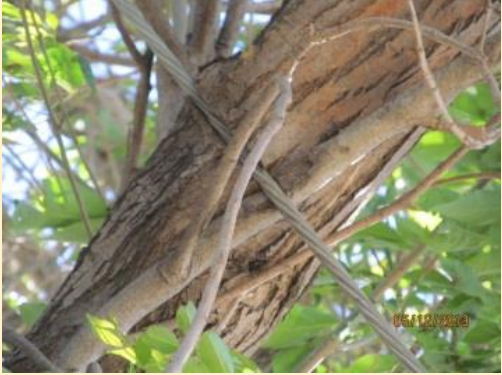
Guy through tree	Close Up

<b>At this Location:</b> Tree limb growing around guy, below the bob	
<b>Perform Minor Work:</b> No	
<b>Write 3<sup>rd</sup> Party Notification:</b> No	
<b>Write EC Notification:</b> Yes <b>FDA=</b> Guy / Strain/Abrasion / Remove <b>Priority=</b> E Tag, 3-12 months depending upon exposure

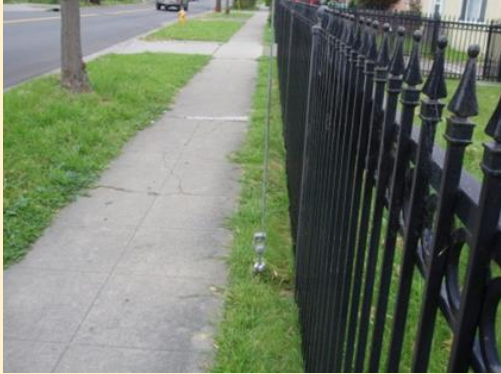
GUY MARKER MISSING	CATTLE GUARD LESS THAN 8 FT

<b>At this Location:</b> Guy marker missing	<b>At this Location:</b> Cattle guard is less than 8 feet in length
<b>Perform Minor Work:</b> Yes, install new guy marker	<b>Perform Minor Work:</b> Yes, lower cattle guard and add guy marker to meet 8 feet requirement.
<b>Write 3<sup>rd</sup> Party Notification:</b> No	<b>Write 3<sup>rd</sup> Party Notification:</b> No
<b>Write EC Notification:</b> No, perform minor work. <b>If minor work cannot be performed</b> <b>FDA=:</b> Guy Marker / missing / Install or replace <b>Priority=:</b> F Tag	<b>Write EC Notification:</b> No, perform minor work <b>If minor work cannot be performed</b> <b>FDA=</b> Guy Marker / missing / Install or replace <b>Priority=</b> F Tag

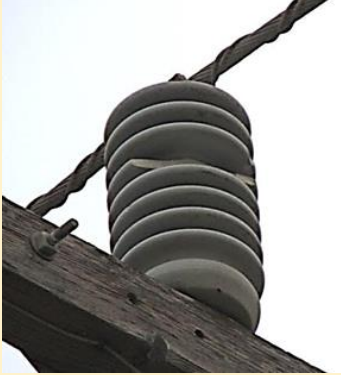
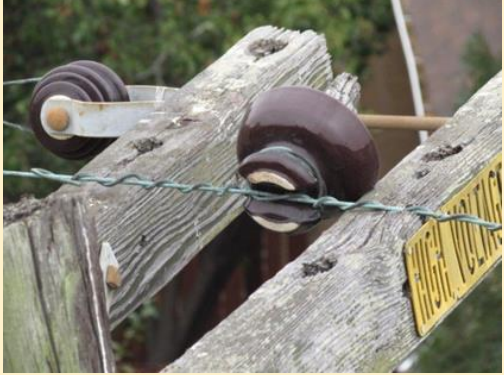
DAMAGED INSULATOR	INSULATOR LAYING ON ITS SIDE / PRIMARY ON THE ARM

<b>At this Location:</b> Damaged insulator, Replace all insulators and the arm	<b>At this Location:</b> Insulator lying on its side. Primary on the arm.
<b>Perform Minor Work:</b> No	<b>Perform Minor Work:</b> No
<b>Write 3<sup>rd</sup> Party Notification:</b> No	<b>Write 3<sup>rd</sup> Party Notification:</b> No
<b>Write EC Notification:</b> Yes <b>FDA=</b> Crossarm / Decayed/Rotten / Replace <b>FDA=</b> Insulator / Broken/ Damage / Replace <b>Priority=</b> E Tag, 3-12 months depending upon exposure	<b>Write EC Notification:</b> Yes <b>FDA=</b> Crossarm / Decayed/Rotten / Replace <b>FDA=</b> Conductor / Floater / Repair <b>Priority=</b> A Tag, follow Emergency Process

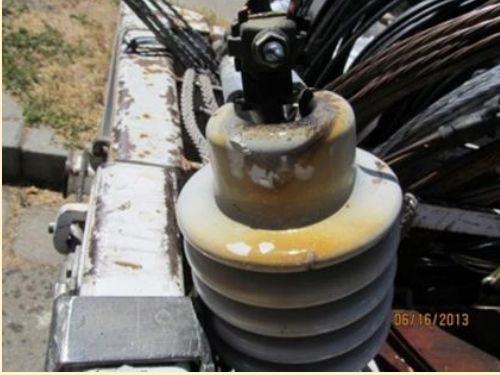
FLASHED INSULATOR POTHEAD

<b>At this Location:</b> Flashed pothead
	<b>Perform Minor Work:</b> No
	<b>Write 3<sup>rd</sup> Party Notification:</b> No
	<b>Write EC Notification:</b> Yes, or COE (see a set of combo cutouts at location follow COE process) <b>FDA=</b> Riser/Pothead / Flashed / Replace <b>Priority=</b> F Tag At minimum, next inspection cycle; based on field condition and exposure, corrosion, etc.; prioritize as needed (A, B, E, or F)

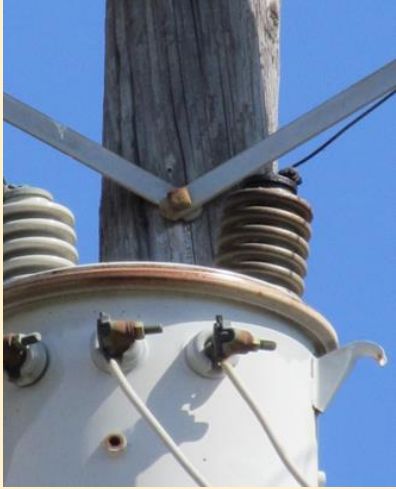
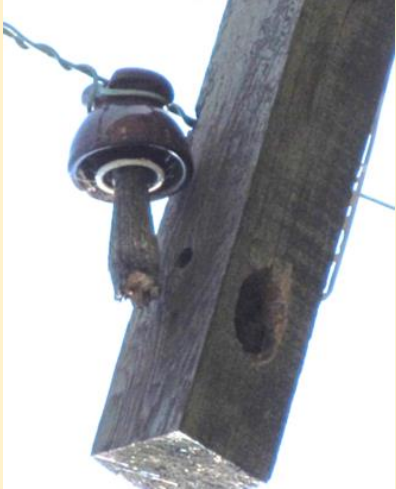
FLASHED INSULATOR ON TRANSFORMER	BROKEN WOOD PIN ON PRIMARY

<b>At this Location:</b> Flashed insulator on transformer	<b>At this Location:</b> Broken wood pin. Conductor on arm. Replace all insulators and the crossarm with a composite arm.
<b>Perform Minor Work:</b> No	<b>Perform Minor Work:</b> No
<b>Write 3<sup>rd</sup> Party Notification:</b> No	<b>Write 3<sup>rd</sup> Party Notification:</b> No
<b>Write EC Notification:</b> Yes <b>FDA=</b> Transformer / Flashed / Replace  <b>Priority=</b> E Tag, 3-12 months depending upon exposure	<b>Write EC Notification:</b> Yes <b>FDA=</b> Crossarm / Decayed/Rotten / Replace <b>FDA=</b> Conductor / Floater / Repair  <b>Priority=</b> A Tag, follow Emergency Process, (Conductor contacting crossarm)

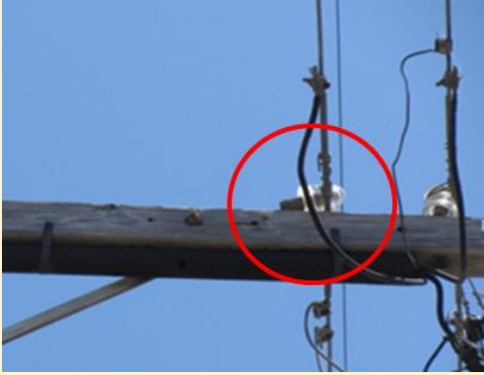
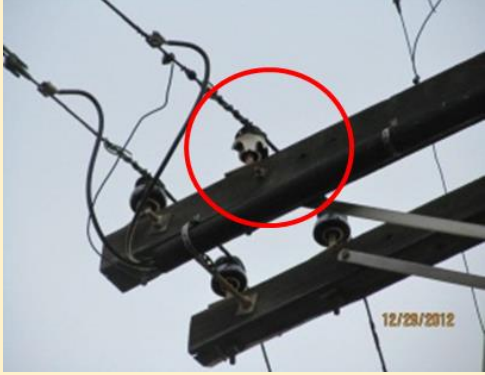
BROKEN WOOD PIN ON SECONDARY	BROKEN SECONDARY INSULATOR

<p><b>At this Location:</b> Broken secondary wood pin. Conductor lying on the arm, tangent pole. (Excluding urban wildfire areas, use risk priority matrix). Wood pin arm at end of life replace arm with composite arm</p>	<p><b>At this Location:</b> Broken secondary insulator. Strain is controlled by the second insulator on the Double arm construction.</p>
<p><b>Perform Minor Work:</b> Yes, if safe to do so</p>	<p><b>Perform Minor Work:</b> No</p>
<p><b>Write 3<sup>rd</sup> Party Notification:</b> No</p>	<p><b>Write 3<sup>rd</sup> Party Notification:</b> No</p>
<p><b>Write EC Notification:</b> Yes, if minor work not possible</p> <p><b>FDA=</b> Crossarm / Decayed/Rotten / Replace</p> <p><b>FDA=</b> Conductor / Floater / Replace</p> <p><b>Priority=</b> A Tag, Follow emergency process</p>	<p><b>Write EC Notification:</b> Yes</p> <p><b>FDA=</b> Crossarm / Decayed/Rotten / Replace</p> <p><b>FDA=</b> Insulator / Broken/ Damage / Replace</p> <p><b>Priority=</b> E Tag, 3-12 months depending on exposure</p>

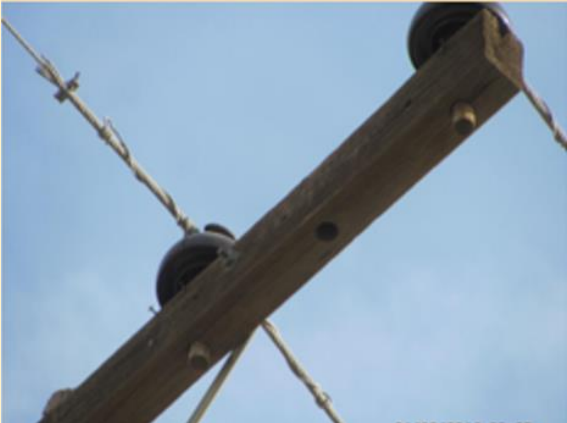
<b>At this Location:</b> 2 Primary wood pin squatters, replace wood crossarm with composite arm
	<b>Perform Minor Work:</b> No
	<b>Write 3<sup>rd</sup> Party Notification:</b> No
	<b>Write EC Notification:</b> Yes <b>FDA=</b> Crossarm Decayed / Rotten / Replace <b>FDA=</b> Insulator / Primary Squatter / Replace <b>Priority=</b> E Tag, 3-12 months, At minimum, next inspection cycle; based on field condition and exposure, corrosion, etc.; prioritize as needed (A, B, E, or F)

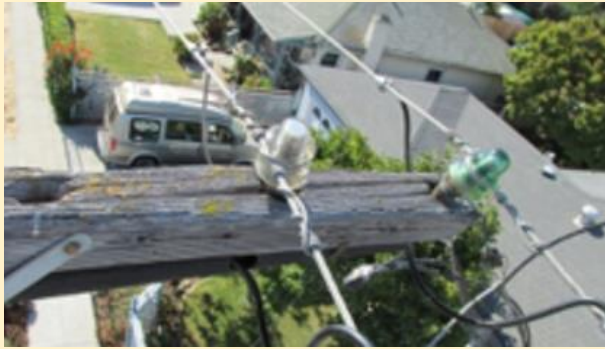
### Secondary Squatter and Decayed Crossarm

**At this Location:** Secondary Squatter and decayed crossarm, replace wood crossarm with composite arm.

**FDA=** Crossarm Decayed / Rotten / Replace

**FDA=** Secondary Squatter / Broken / Damaged / Replace

**Priority=** E Tag, 3-12 months at minimum, next inspection cycle; based on field condition and exposure, corrosion, etc.; prioritize as needed (A, B, E, or F)

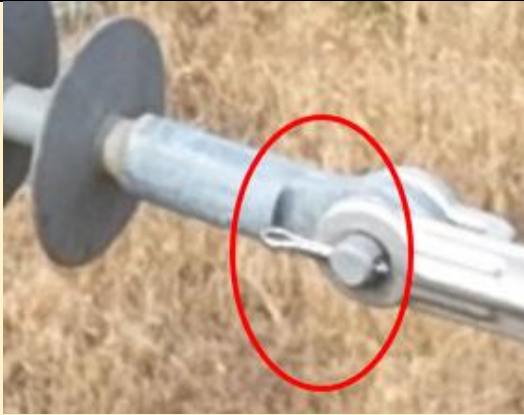
### Cotter Key Backed Out

**At this Location:** Cotter Key partially backed out

**FDA=** Hardware / Loose / Adjust

**Priority=** E Tag, 3-12 months, depending on exposure

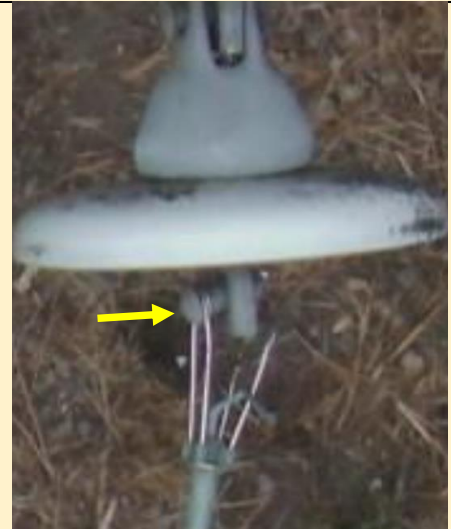
### Retainer Pin Coming loose, almost pulled out

**At this Location:** Retainer Pin coming loose, almost pulled out

**FDA =** Hardware / Loose / Adjust

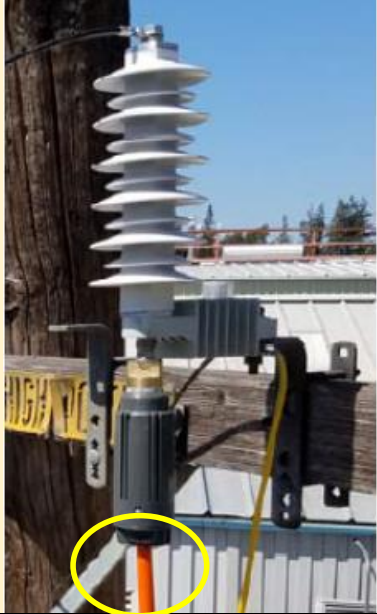
Non-Exempt Surge Arrestor Blown	Exempt ABB-type Arrestor Blown

<b>At this Location:</b> Non-Exempt Surge Arrestor Blown	<b>At this Location:</b> Exempt ABB arrestor operated / blown indicated by the orange marker sticking out the bottom
<b>Perform Minor Work:</b> No	<b>Perform Minor Work:</b> No
<b>Write 3<sup>rd</sup> Party Notification:</b> No	<b>Write 3<sup>rd</sup> Party Notification:</b> No
<b>Write EC Notification:</b> Yes <b>FDA=</b> Lightning Arrestor / Broken / Damaged / Replace  <b>Priority=</b> E Tag, 3-12 months, depending on exposure	<b>Write EC Notification:</b> Yes <b>FDA=</b> Lightning Arrestor / Broken / Damaged / Replace  <b>Priority=</b> E Tag, 3-12 months, depending on exposure

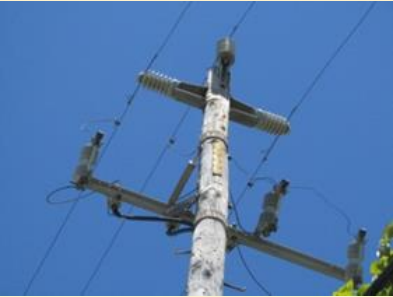
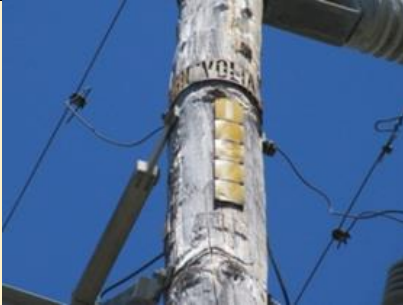
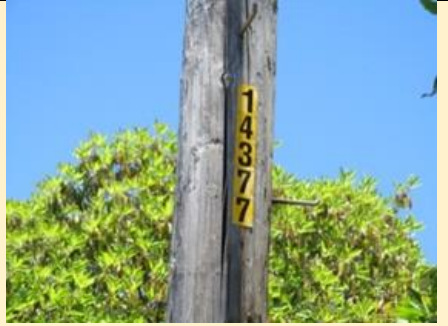
FADED OPERATING NUMBER		
<b>Before:</b> Faded operating number	<b>Close Up</b>	<b>After:</b> Minor work completed, operating number applied below operating position.

<b>At this Location:</b> Operating number is faded		
<b>Perform Minor Work:</b> Yes		
<b>Write 3<sup>rd</sup> Party Notification:</b> No		
<b>Write EC Notification:</b> Yes, only if minor work cannot be performed <b>FDA=</b> Marking / Broken / Damaged / Replace <b>Priority=</b> E Tag, 12 months

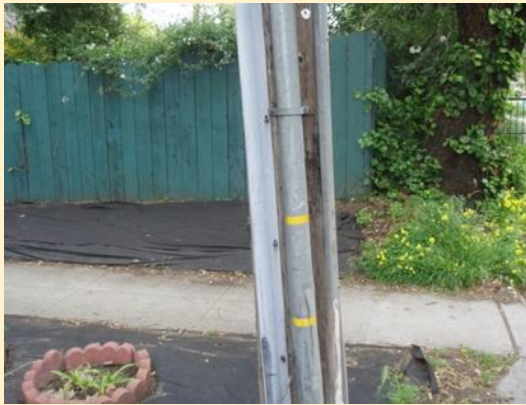
### INADEQUATE VISIBILITY STRIPS

**At this Location:** Pole with vehicular exposure. Two small sections of yellow adhesive visibility strips.

**FDA=** Vis-Strips / Broken / Damaged / Replace

**Priority=** At minimum –must write up as Priority F Tag next inspection cycle; based on field condition and exposure, corrosion, etc.; prioritize as needed (A, B, E, or F)

**Perform Minor Work:** Yes

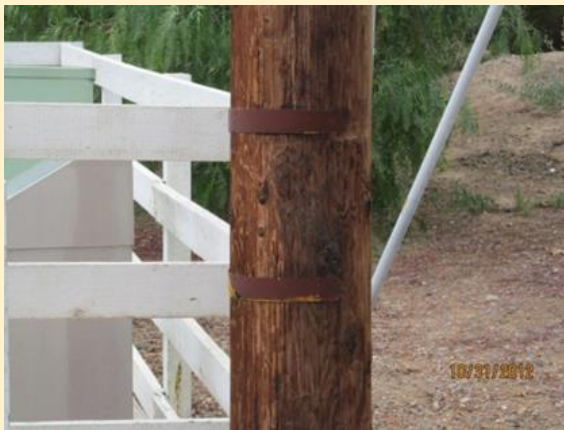
### VISIBILITY STRIPS PAINTED OVER NO LONGER REFLECTIVE

**At this Location:** Visibility strips painted brown (3PrdP visibility strip located above not shown in picture).

**FDA=** Vis-Strips / Broken / Damaged / Replace

**Priority=** At minimum – must write up as Priority F Tag next inspection cycle; based on field condition and exposure, corrosion, etc.; prioritize as needed (A, B, E, or F)

**Perform Minor Work:** Yes

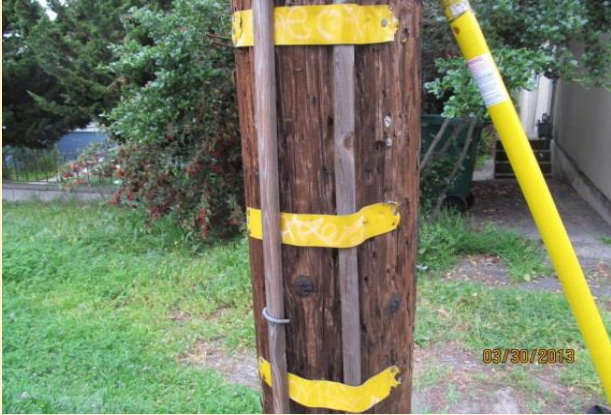
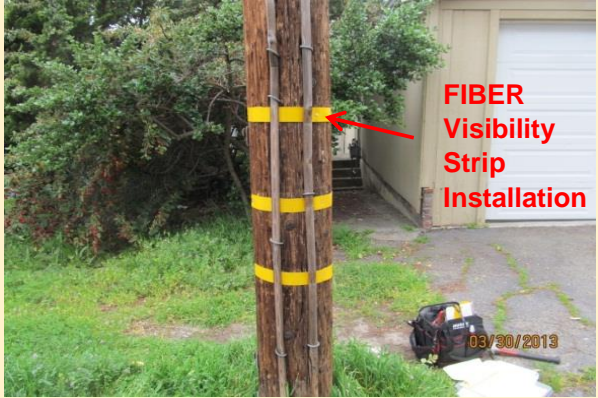
METAL OVER MOLDING	
Before	After

<p><b>At this Location:</b> Metal visibility strips under wood molding and over wood molding with protruding edge.</p>	
<p><b>Perform Minor Work:</b> Yes, remove old metal visibility strips and apply new visibility strips; <b>visibility strips installed in “after” photo are fiber, not metal</b> (coded item)</p>	
<p><b>Write 3<sup>rd</sup> Party Notification:</b> No</p>	
<p><b>Write EC Notification:</b> Yes, only if minor work cannot be performed</p> <p><b>FDA=</b> Vis-Strips / Broken / Damaged / Replace</p>	
<p><b>Priority=</b> At minimum – must write up as Priority F Tag next inspection cycle; based on field condition and exposure, corrosion, etc.; prioritize as needed (A, B, E, or F)</p>

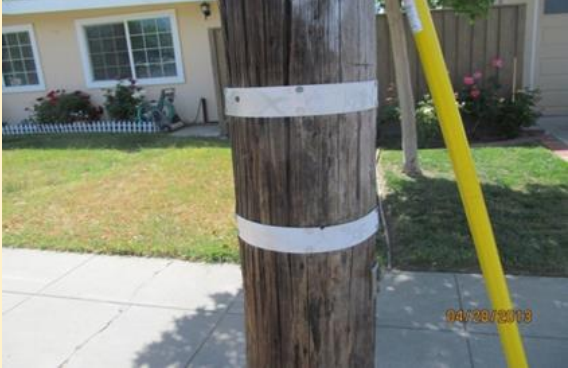
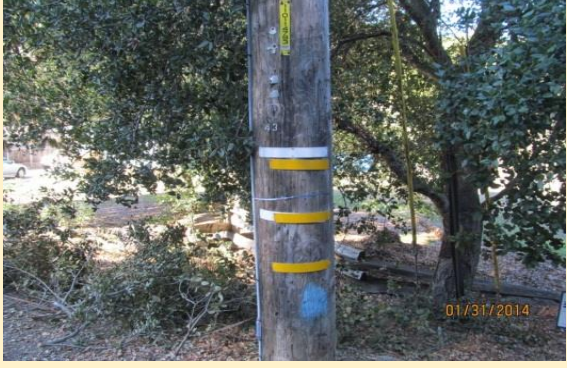
<b>OLD METHOD VISIBILITY STRIPS NOT YELLOW</b>	<b>OLD AND NEW VISIBILITY STRIPS NOT YELLOW</b>

<b>At this Location:</b> Aged visibility strips have lost reflectivity.	<b>At this Location:</b> Yellow visibility strips mounted over old white visibility strips.
<b>Perform Minor Work:</b> Yes, Replace with 3 yellow visibility strips	<b>Perform Minor Work:</b> Yes, remove old visibility strips
<b>Write 3<sup>rd</sup> Party Notification:</b> No	<b>Write 3<sup>rd</sup> Party Notification:</b> No
<b>Write EC Notification:</b> Yes, if minor work cannot be performed.	<b>Write EC Notification:</b> Yes, if minor work cannot be performed.
<b>FDA=</b> Vis-Strips / Broken / Damaged / Replace	<b>FDA=</b> Vis-Strips / Broken / Damaged / Replace
<b>Priority=</b> At minimum – must write up as Priority F Tag next inspection cycle; based on field condition and exposure, corrosion, etc.; prioritize as needed (A, B, E, or F)	<b>Priority=</b> At minimum – must write up as Priority F Tag next inspection cycle; based on field condition and exposure, corrosion, etc.; prioritize as needed (A, B, E, or F)

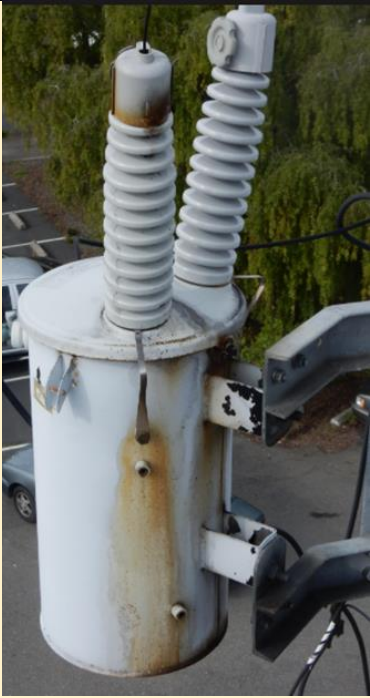
<b>At this Location:</b> Leaking OH Transformer, Residual Stain mark that appears dried, no sign of oil on ground. Oil has leaked out of the high side bushing, appears dried.
	<b>Perform Minor Work:</b> No
	<b>Write 3<sup>rd</sup> Party Notification:</b> No
	<b>Write EC Notification:</b> No No further action
LEAKING OH TRANSFORMER

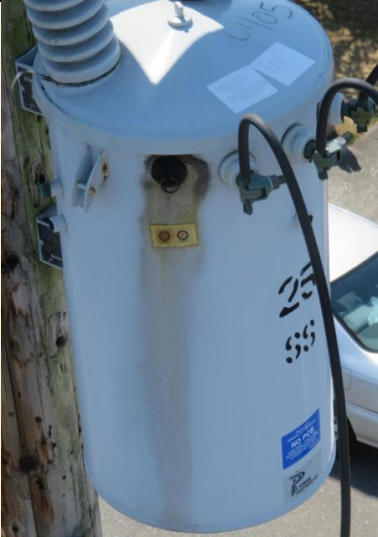
<b>At this Location:</b> Leaking OH Transformer, Residual Stain mark that appears dried on IFD (Internal Fault Detection)
	<b>Perform Minor Work:</b> No
	<b>Write 3<sup>rd</sup> Party Notification:</b> No
	<b>Write EC Notification:</b> No No further action

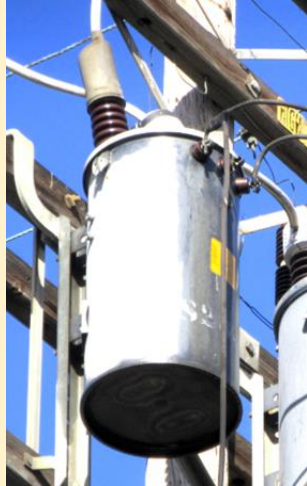
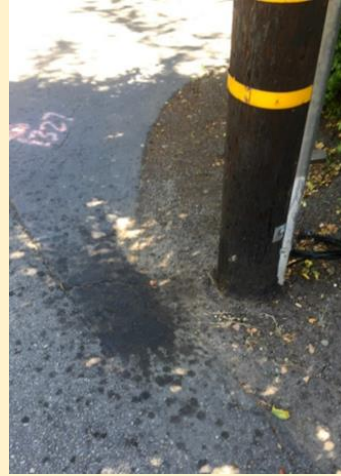
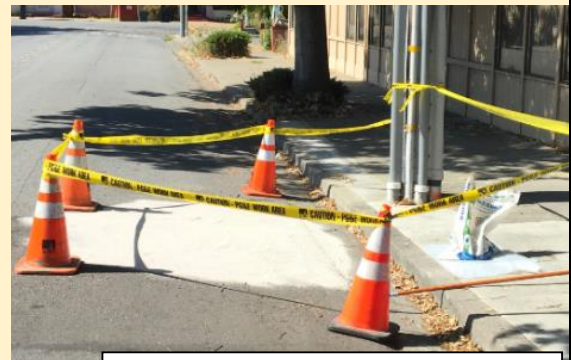
### LEAKING OH TRANSFORMER, OIL ON THE GROUND

**At this Location:** Leaking OH transformer, oil on the ground

**FDA=** Transformer / Leaking / Seeping / Replace

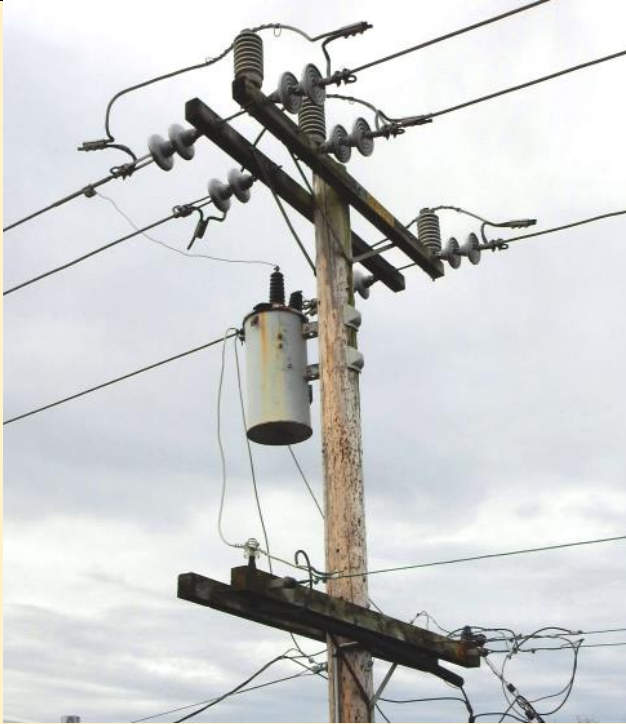
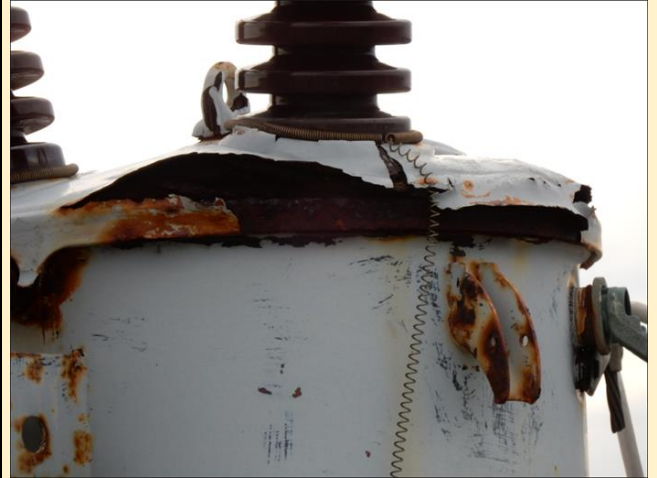
### TRANSFORMER CORROSION

**At this Location:** Transformer with heavy corrosion.

**FDA =** Transformer / Corroded / Replace

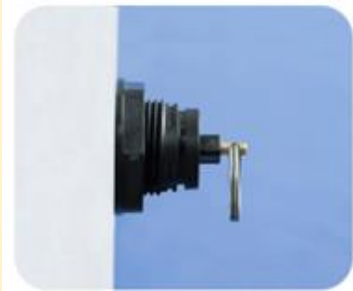
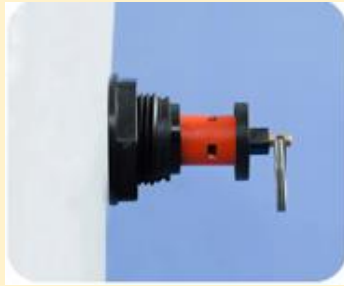
Transformer Internal Fault Device Activated

<b>Not Activated</b>	<b>Activated</b>
<b>At this Location:</b> Transformer internal fault device activated, indicating overheating, and the orange band is visible.	
<b>Perform Minor Work:</b> No	
<b>Write 3<sup>rd</sup> Party Notification:</b> No	
<b>Write EC Notification:</b> Yes	
<b>FDA=</b> Transformer / Broken / Damaged / Replace	
<b>Priority=</b> E Tag, 3-12 months depending on exposure

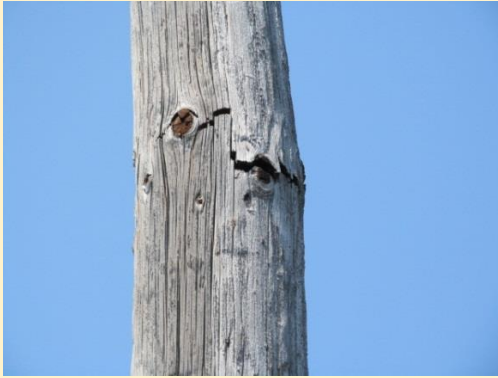
### BROKEN POLE

**At this Location:** Broken pole, Rural area, low public exposure, Pole supported in four directions equal tension in all directions.

**FDA=** Pole / Broken/Damaged / Replace

Complete the Pole Inspection Test Report.

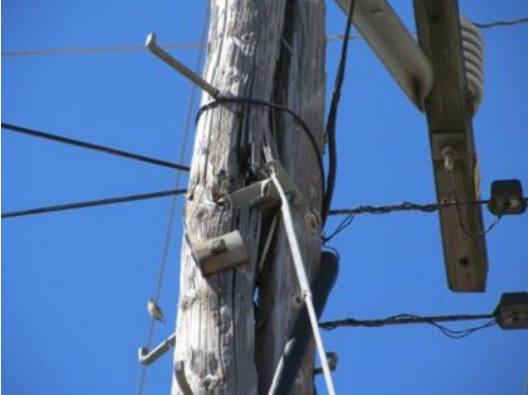
POLE SPLIT AT COMMUNICATION LEVEL	Pole Check

<b>At this Location:</b> Pole split at communication level. Joint pole. Complete the Pole Inspection Test Report.	<b>At this Location:</b> Pole Check
<b>Perform Minor Work:</b> No	<b>Perform Minor Work:</b> No
<b>Write 3<sup>rd</sup> Party Notification:</b> No	<b>Write 3<sup>rd</sup> Party Notification:</b> No
<b>Write EC Notification:</b> Yes <b>FDA=</b> Pole / Broken/Damaged / Replace  <b>Priority=</b> B Tag, 0-3 months, depending on exposure	<b>Write EC Notification:</b> No

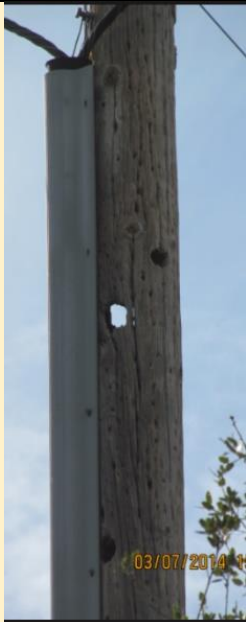
WOODPECKER DAMAGE NESTNG CAVITY

<b>At this Location:</b> Obvious sign of a cavity in the pole by seeing daylight through the pole. Unable to determine the depth of the cavity.
	<b>Perform Minor Work:</b> No
	<b>Write 3<sup>rd</sup> Party Notification:</b> No
	<b>If unable to determine damage:</b> <ul style="list-style-type: none"> <li>• <b>Write EC Notification:</b> Yes</li> <li>• <b>FDA=</b> Pole / Woodpecker Damage / Assessment</li> <li>• <b>Priority=</b> E Tag, 3-12 months</li> </ul> <b>If damage is determined sufficient:</b> <ul style="list-style-type: none"> <li>• <b>Write EC Notification:</b> Yes</li> <li>• <b>FDA=</b> Pole / Woodpecker Damage / Replace</li> <li>• <b>Priority=</b> E Tag, 3-12 months</li> </ul>

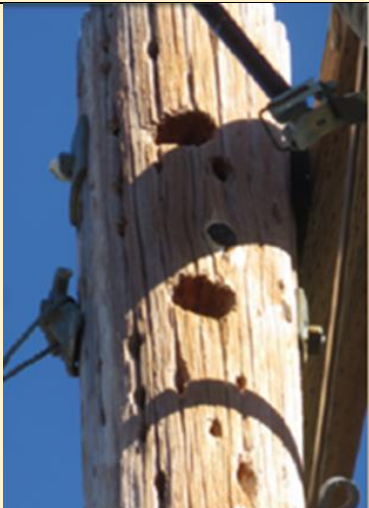
WOODPECKER DAMAGE AT THE TOP OF THE POLE

<b>At this Location:</b> Woodpecker holes near framing hardware.
	<b>Perform Minor Work:</b> No
	<b>Write 3<sup>rd</sup> Party Notification:</b> No
	<b>Write EC Notification:</b> Yes <b>FDA=</b> Pole / Woodpecker Damage / Replace  <b>Priority=</b> E Tag, 3-12 months

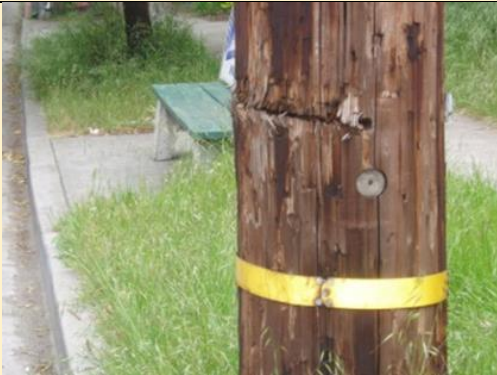
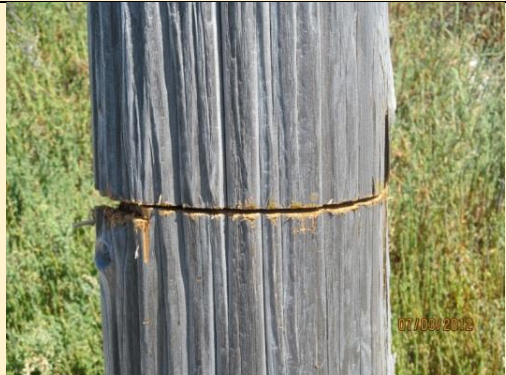
CUT INTO POLE

<b>At this Location:</b> Vandalized pole. Chain saw cut into lower portion of pole. <u>Half of pole circumference cut into.</u> Complete Pole Inspection Test Report	
<b>Perform Minor Work:</b> No	
<b>Write 3<sup>rd</sup> Party Notification:</b> No	
<b>Write EC Notification:</b> Yes <b>FDA=</b> Pole / Broken / Damaged / Replace <b>Priority=</b> A Tag, Follow the emergency process

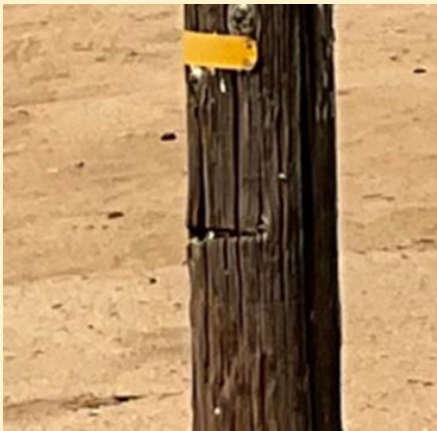
CUT INTO POLE

<b>At this Location:</b> Cut into pole. Not a deep cut, no strain on pole, no public exposure. Complete the Pole Inspection Test Report.
	<b>Perform Minor Work:</b> No
	<b>Write 3<sup>rd</sup> Party Notification:</b> No
	<b>Write EC Notification:</b> Yes <b>FDA=</b> Pole / Broken/Damaged / Replace <b>Priority=</b> E Tag, 3-12 months, depending on exposure send to estimating for pole loading calc. (pole overload test)

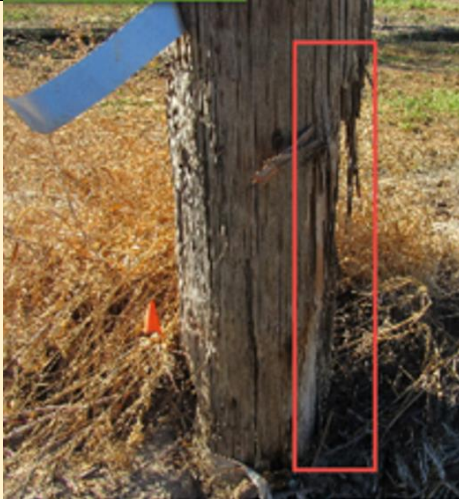
### Significant Reduced Circumference (Tractor Damage)

**At this Location:** Significant Reduced Circumference (Tractor Damage)

**Priority=** E Tag, 12 months, depending on exposure

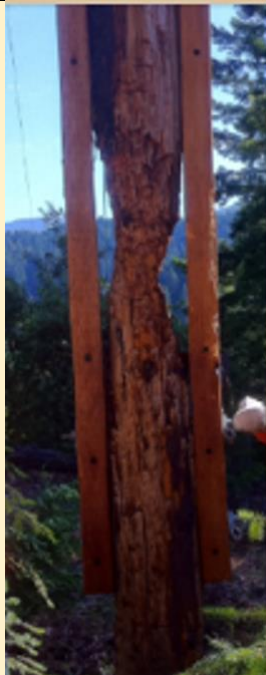
### Significant Reduced Circumference (Bear Damage)

**At this Location:** Significant Reduced Circumference (Bear Damage). Temporary Repairs made.

**FDA=** Pole / Broken / Damaged / Replace

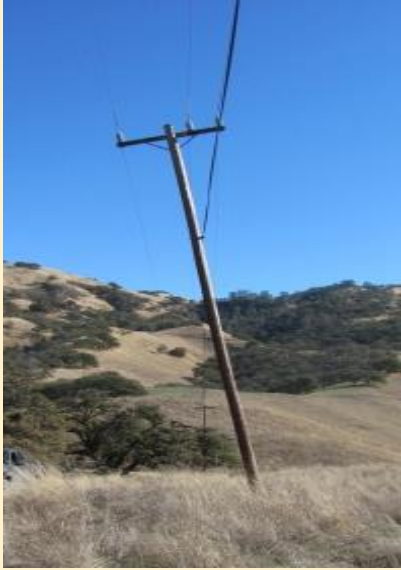
LEANING POLE	LEANING SLACK SPAN

<b>At this Location:</b> Leaning pole greater than 10% out of plumb. Pole is stable. No equipment, in rural area. Causing reduced clearance.	<b>At this Location:</b> Leaning towards a tree more than 10% out of plumb. Inspector pulled plug and confirmed pole is solid below ground. Probability of equipment failure is moderate.
<b>Perform Minor Work:</b> No	<b>Perform Minor Work:</b> No
<b>Write 3<sup>rd</sup> Party Notification:</b> No	<b>Write 3<sup>rd</sup> Party Notification:</b> No
<b>Write EC Notification:</b> Yes <b>FDA=</b> Pole / Leaning / Replace	<b>Write EC Notification:</b> Yes <b>FDA=</b> Pole / Leaning / Replace
<b>Priority=</b> E Tag, 3-12 months, depending on exposure	<b>Priority=</b> B Tag, 0-3 months, depending on exposure

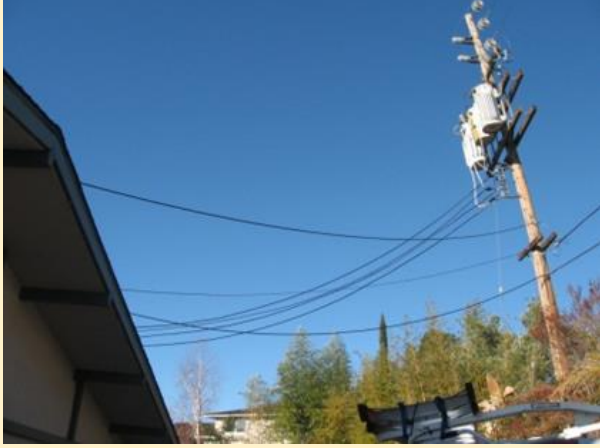
STUBBED POLE LEANING TOWARDS SCHOOL	POLE LEANING 3 POT TRANSFORMER IN BUCK POSITION

<b>At this Location:</b> Stubbed pole leaning towards school, supported by down guy. Pole Bands are loose due to additional deterioration of the pole.	<b>At this Location</b> Pole is leaning less than 10% out of plumb, leaning in direction of offset equipment.
<b>Perform Minor Work:</b> No	<b>Perform Minor Work:</b> No
<b>Write 3<sup>rd</sup> Party Notification:</b> No	<b>Write 3<sup>rd</sup> Party Notification:</b> No
<b>Write EC Notification:</b> Yes <b>FDA=</b> Pole / Decayed / Rotten / Replace  <b>Priority=</b> B Tag, 0-3 months, depending on exposure	<b>Write EC Notification:</b> No

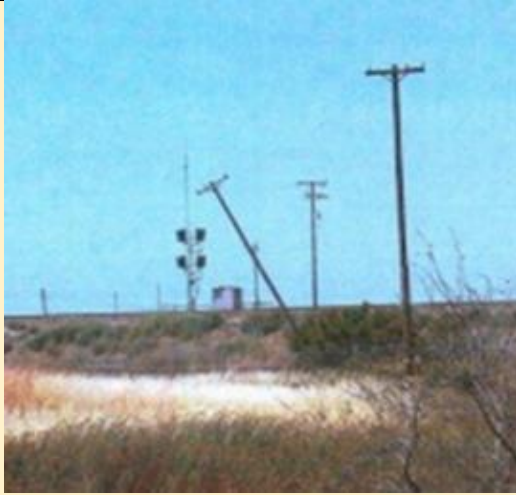
### POLE LEANING NEAR RAILROAD TRACKS

**At this Location:** Severe lean being held up by the primary conductors. Low clearance over an active railroad track. Pole located in a swamp area with standing water.

**FDA=** Pole / Decayed / Rotten / Replace

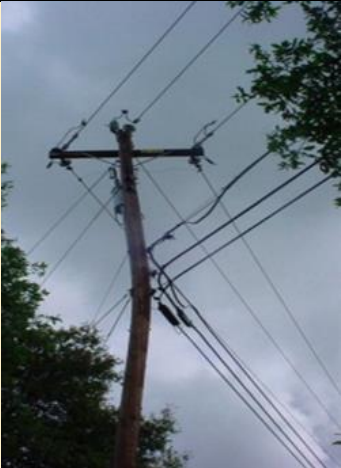
INADEQUATE SUPPORT AT COMMUNICATIONS LEVEL

<b>At this Location:</b> Two guys stabilizing communication level.
	<b>Perform Minor Work:</b> No
	<b>Write 3<sup>rd</sup> Party Notification:</b> No
	<b>Write EC Notification:</b> Yes <b>FDA=</b> Pole / Overload / Replace  <b>Priority=</b> E Tag, 3-12 months depending on exposure

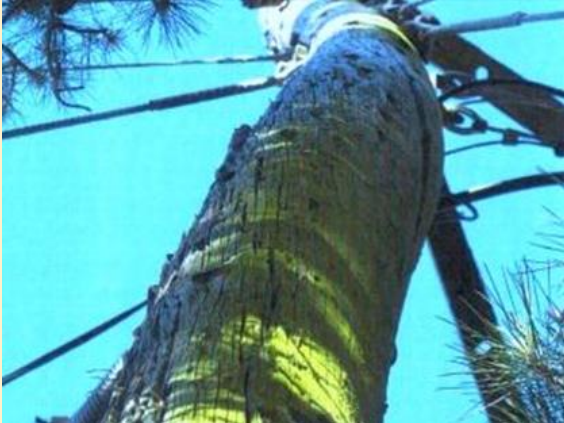
OVER STRESSED POLE	UNBALANCED LOAD AT TOP

<b>At this Location:</b> Pole is twisted, cracked, due to communication. Field comments "overloaded by communications"	<b>At this Location:</b> Deformed pole with bowed top in line with conductor.
<b>Perform Minor Work:</b> No	<b>Perform Minor Work:</b> No
<b>Write 3<sup>rd</sup> Party Notification:</b> No	<b>Write 3<sup>rd</sup> Party Notification:</b> No
<b>Write EC Notification:</b> Yes <b>FDA=</b> Pole / Overloaded / Replace Pole Test Data Sheet is Required	<b>Write EC Notification:</b> Yes <b>FDA=</b> Pole / Overloaded / Replace Pole Test Data Sheet is Required
<b>Priority=</b> E Tag, 3-12 months, depending on exposure	<b>Priority=</b> E Tag, 3-12 months, depending on exposure

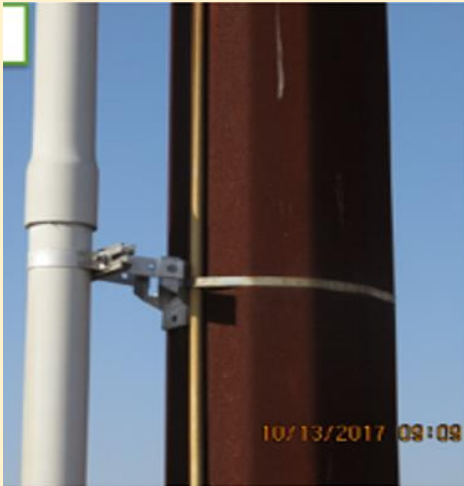
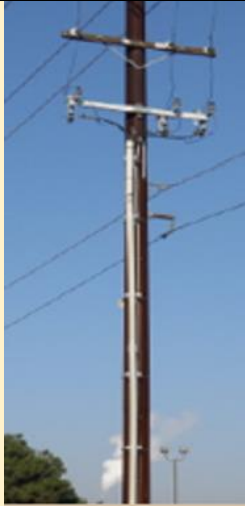
Riser on Steel Transmission Pole

<p><b>At this Location:</b> Steel Transmission Structure with Distribution underbuild with external riser on steel pole.</p>	
<p><b>Perform Minor Work:</b> No</p>	
<p><b>Write 3<sup>rd</sup> Party Notification:</b> No</p>	
<p><b>Write EC Notification:</b> Yes</p> <p><b>FDA=</b> Riser / Pothead / Installed in Error / Relocate</p> <p><b>Priority=</b> E Tag, 3-12 months, depending on exposure</p> <p><b>EC Notification:</b> Yes</p>

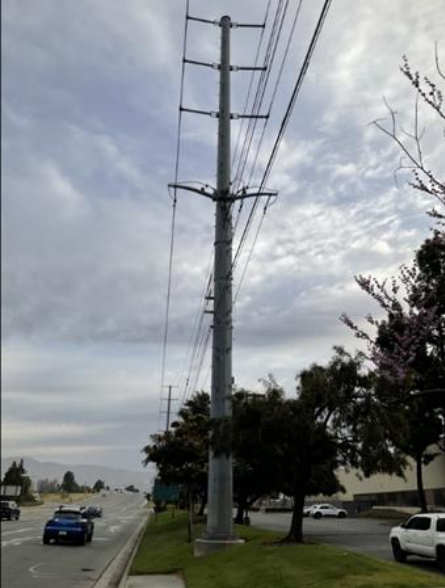
Steel Transmission Structure with Distribution Underbuild with internal riser within steel pole

<b>At this Location:</b> steel Transmission Structure with Distribution underbuild with internal riser within steel pole
	<b>Perform Minor Work:</b> No
	<b>Write 3<sup>rd</sup> Party Notification:</b> No
	<b>Write EC Notification:</b> Yes <b>FDA=</b> Riser / Pothead / Installed in Error / Relocate  <b>Priority=</b> E Tag, 3-12 months depending upon exposure

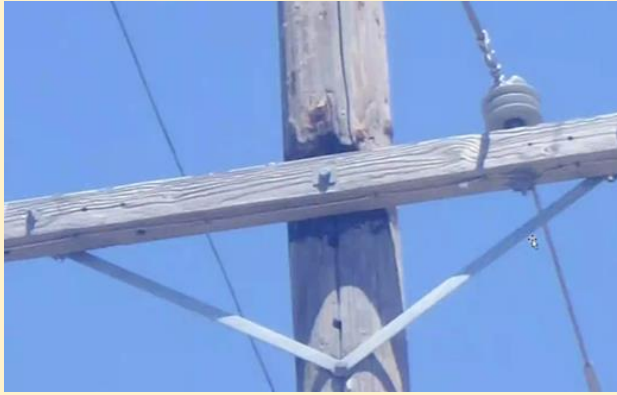
### BURNT POLE DUE TO MISSING BRIDGING

**At this Location:** Transmission pole with missing bridging on the distribution cross-arm, burnt pole, assess pole

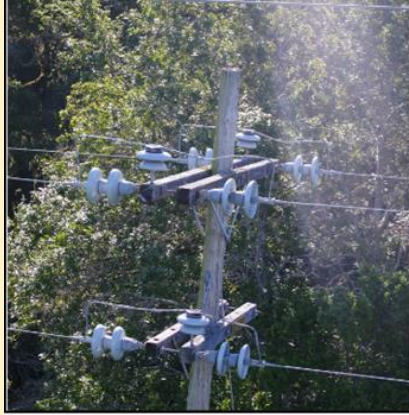
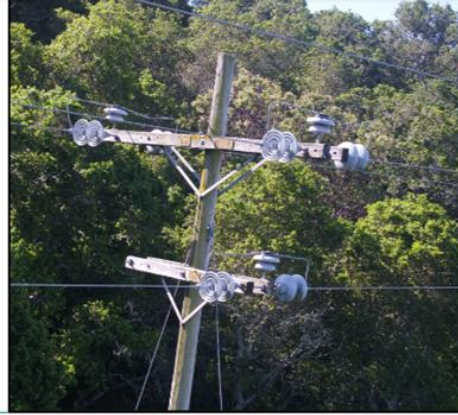
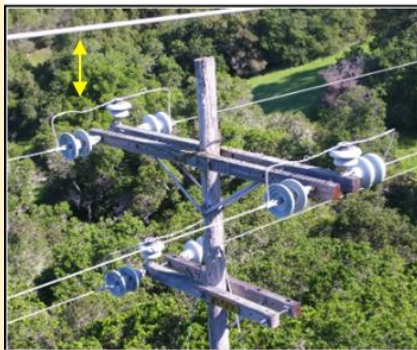
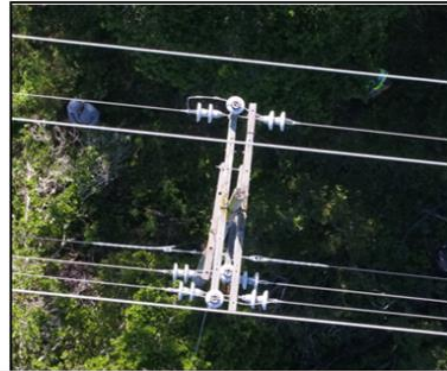
### UNSUPPORTED TRANSMISSION LINE WITH DIMINISHED CLEARANCE

**At this Location:** Unsupported transmission line with diminished clearance to the distribution level seen from the ground or aerial.

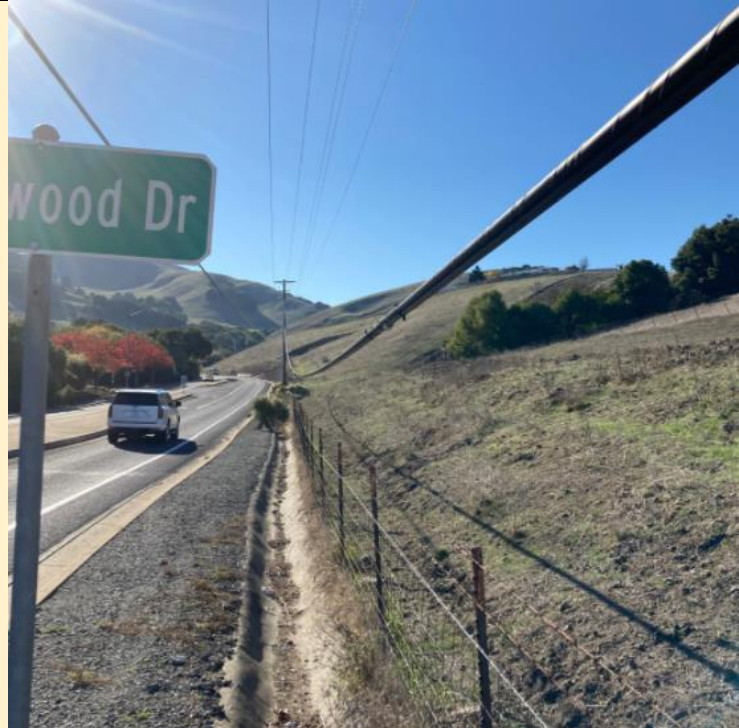
Communication Line Extremely Sagged

<b>At this Location:</b> Comm sag 6' above the road, off the road, no potential for vehicle contact.
	<b>Perform Minor Work:</b> No
	<b>Write 3<sup>rd</sup> Party Utility Notification:</b> Yes
	<b>Priority:</b> Level 2
	<b>Write EC Notification:</b> No

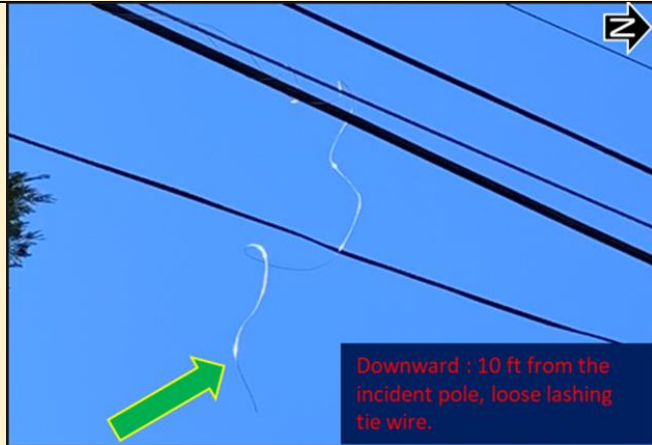
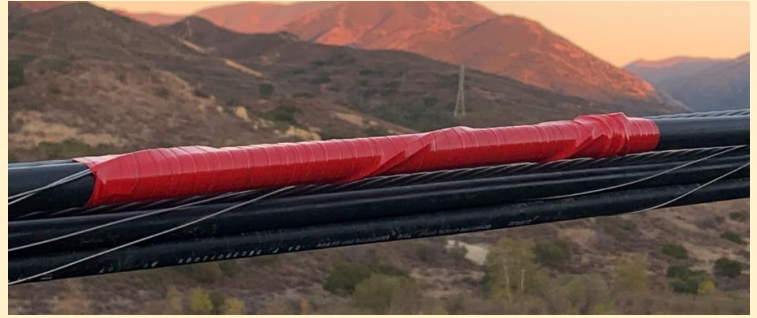
**At this Location:** 3<sup>rd</sup> party communication line has a loose lashing long enough to whip into power lines. Stand-by situation.

**FDA=** Conductor / Loose Lashing / Repair

After - Snip Lashing and Tape

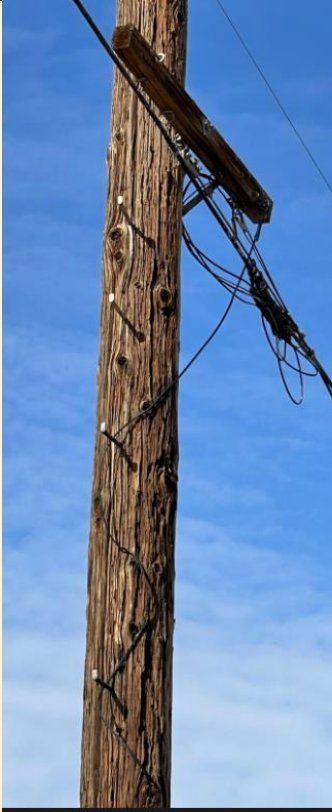
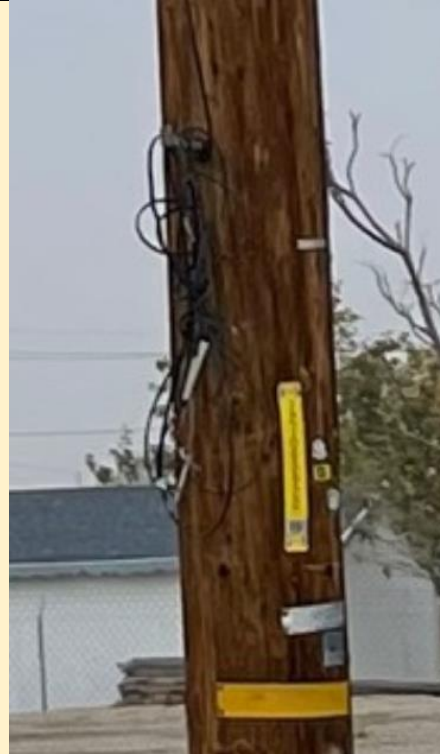
**At this Location:** Abandoned Phone Drop

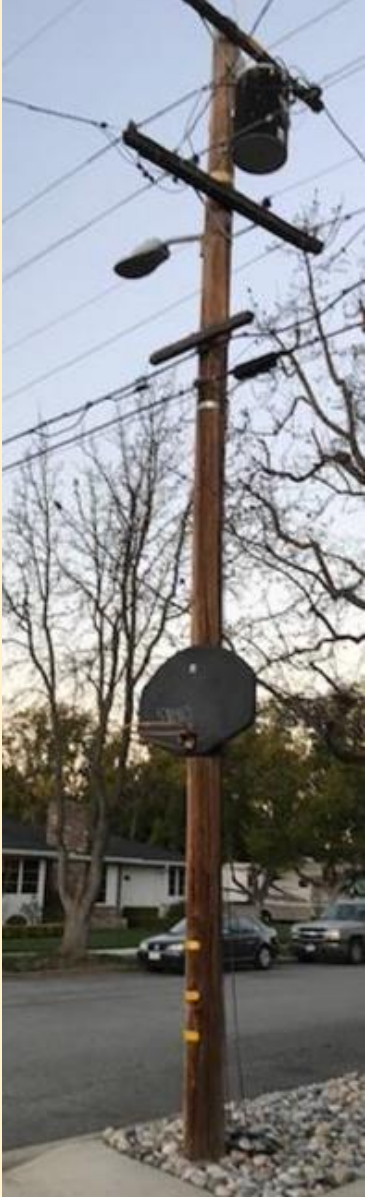
Unauthorized Attachment

<b>At this Location:</b> Basketball Hoop Installed on a PG&E pole.
	<b>Perform Minor Work:</b> No
	<b>Write 3<sup>rd</sup> Party Notification:</b> Yes
	<b>Write EC Notification:</b> No

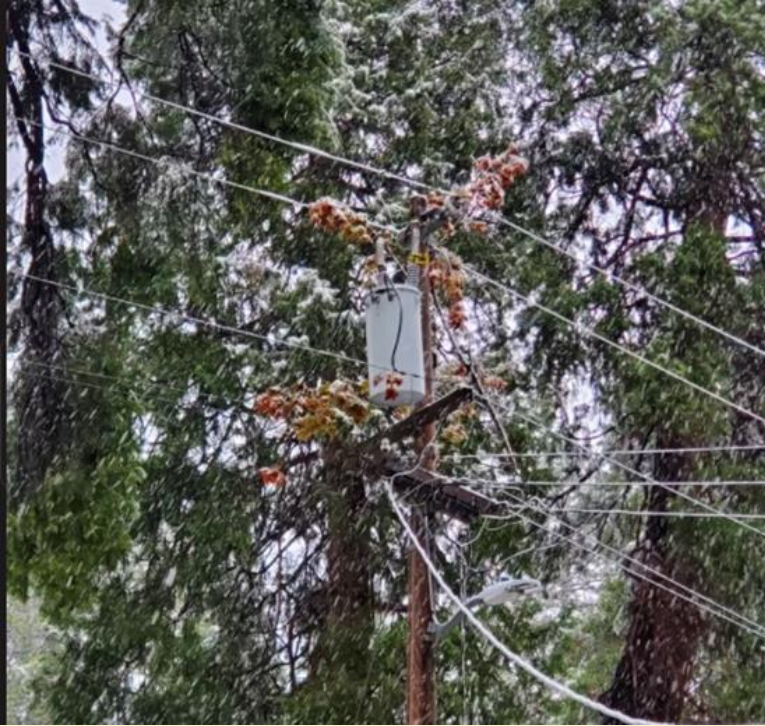
### Dead Tree Branch fell into Primary

**At this Location:** Dead tree branch fell into primary

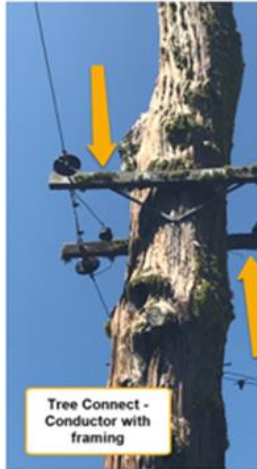
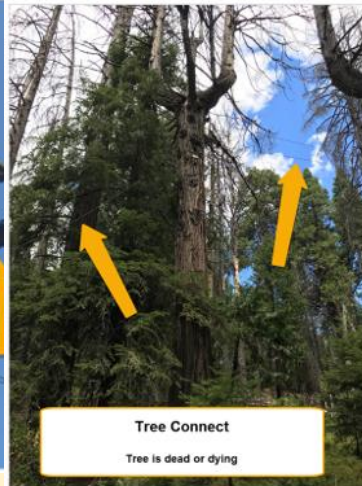
**At this Location:** Tier 3 area, tree connect on dead/dying tree; attachments are solid.

**FDA=** Tree/Vine / Decayed/Rotten / Install Clearance Pole

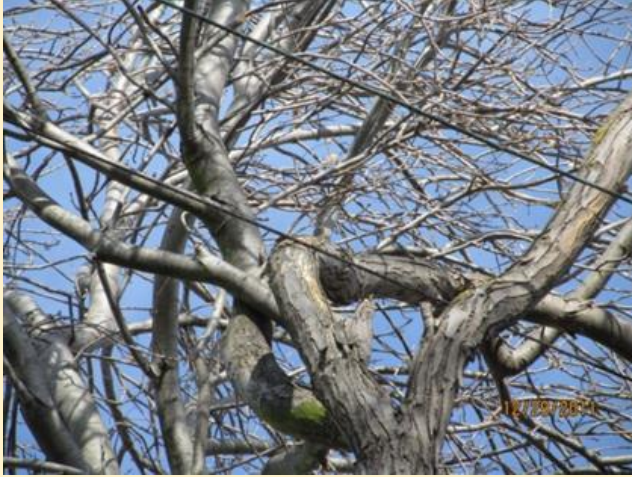
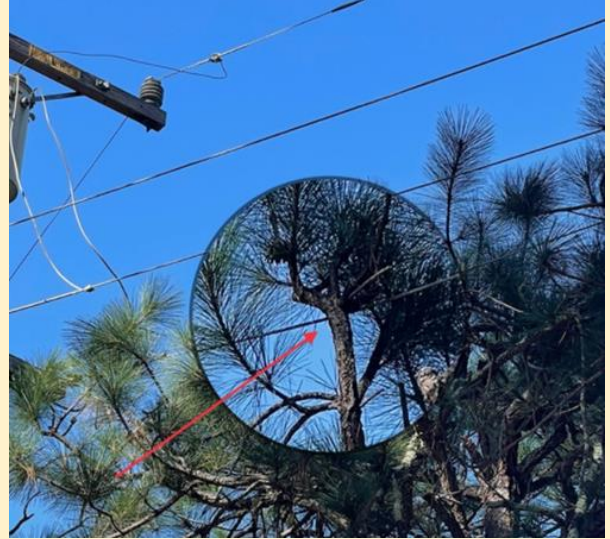
**At this Location:** Secondary conductor resting on tree/vegetation. Tree causing strain on open wire secondary, **feeding more than one customer.**

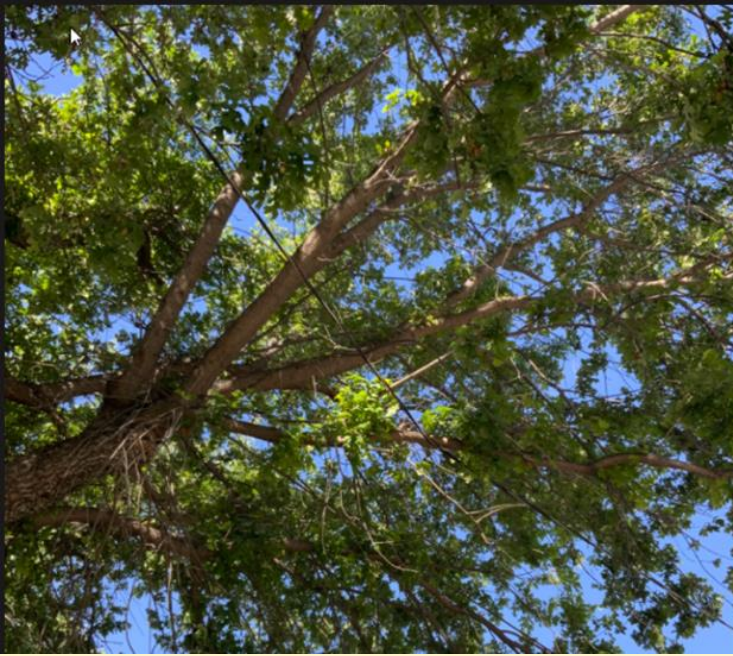
### Tree Strain on Service Drop

**At this Location:** Tree strain on service drop

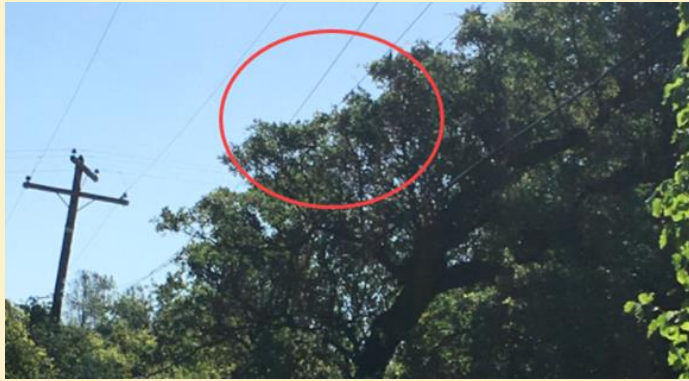
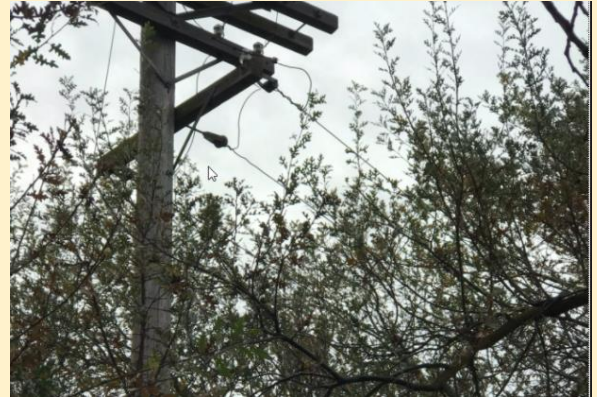
### TREE GROWING INTO BARE OPEN WIRE SECONDARY OR BARE OPEN WIRE SERVICE, NO STRAIN OR ABRASION

**At this Location:** Tree grown around bare open wire secondary, no strain or abrasion. Spreader bracket already installed.

**FDA=** Conductor/ Sag / Clearance / Replace

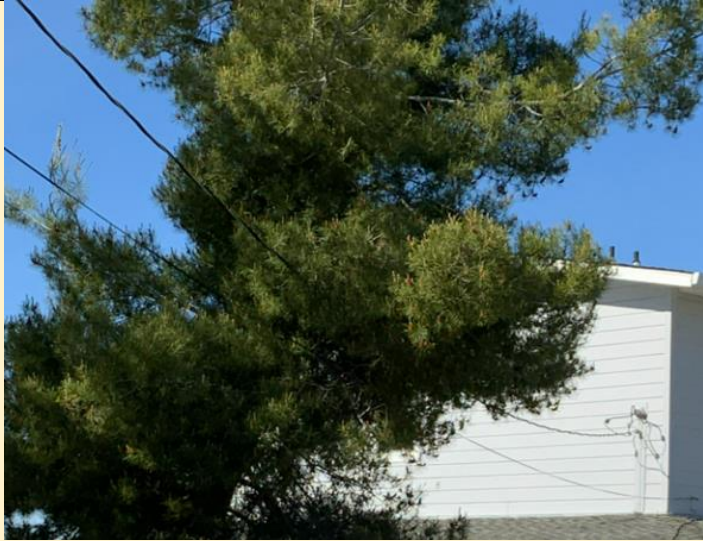
### TREE GROWING AROUND SERVICE, NO STRAIN OR ABRASION

**At this Location:** Tree grown around service, no strain or abrasion.
