# Job Aid: Overhead Assessment

This job aid is designed to assist Electric Distribution Compliance Inspectors, PG&E Employees, and Contractors in assessing and prioritizing compelling **abnormal conditions** on overhead facilities, including but not limited to GO 165 Inspections. Compelling Abnormal Condition is defined as any electric distribution pole, equipment, component, conductors, vegetation, or third-party condition that causes a safety or fire ignition risk that, in the judgment of the field employee, may adversely impact public safety and/or service reliability **within 5 years**.

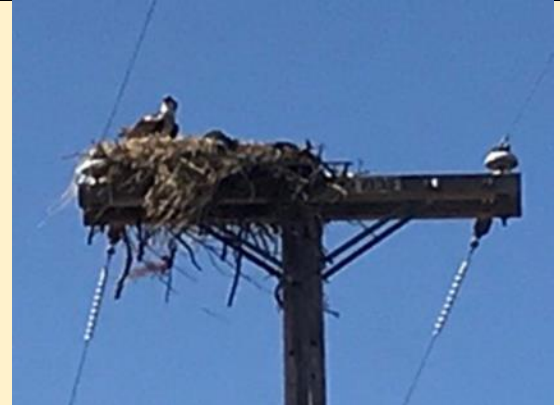
**At this Location:** Active Nest, missing cutout covers. **Notify lead or supervisor to contact bird program manager**

**FDA=** Bird protection / Bird Protection Deteriorated / Install

**Priority=** E Tag, 3-12 months depending on exposure

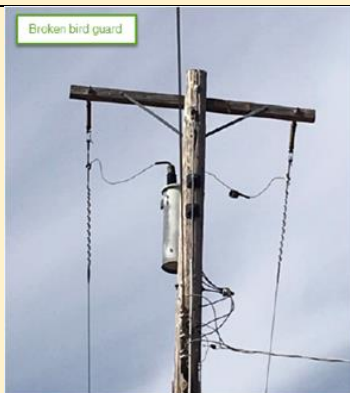
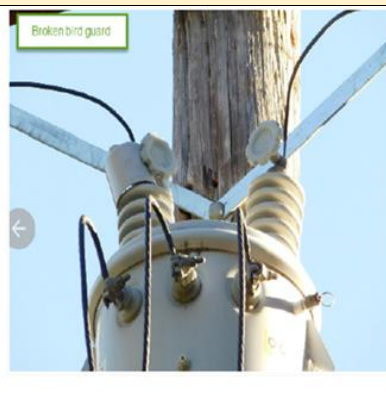
### BROKEN INSULATOR COVERS

**At this Location:** Broken insulator covers
