Job Aid: Overhead Assessment

This job aid is designed to assist Electric Distribution Compliance Inspectors, PG&E Employees, and Contractors in assessing and prioritizing compelling **abnormal conditions** on overhead facilities, including but not limited to GO 165 Inspections. Compelling Abnormal Condition is defined as any electric distribution pole, equipment, component, conductors, vegetation, or third-party condition that causes a safety or fire ignition risk that, in the judgment of the field employee, may adversely impact public safety and/or service reliability **within 5 years**.

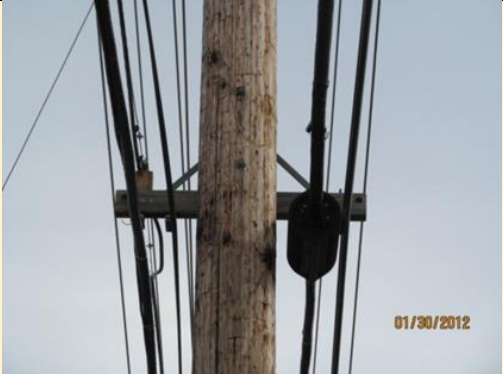
CLIMBING SPACE OBSTRUCTED

At this Location: Climbing space obstruction by communication facilities on pole with equipment. Communication messengers are too close. No bucket truck access.
	Perform Minor Work: No
	Write 3rd Party Notification: Yes
	Write EC Notification: No

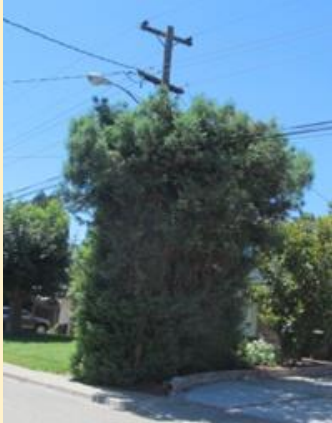
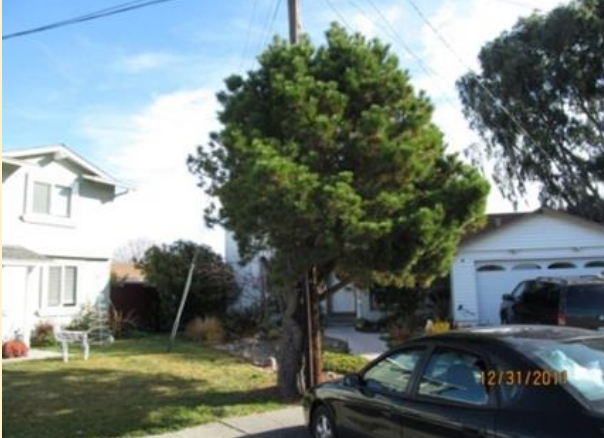
OBSTRUCTED CLIMBING SPACE	CLIMBING SPACE OBSTRUCTED

At this Location: Obstructed climbing space. Inspector cannot see enough of the pole to complete Inspection (heavy vegetation, cannot see through). No equipment on pole. The only reason to address is to complete the inspection.	At this Location: Climbing space obstruction, able to perform inspection, no equipment on pole (able to see guys, able to see up the pole under tree)
Perform Minor Work: No	Perform Minor Work: No
Write 3rd Party Notification: No, only need clearing to perform inspection	Write 3rd Party Notification: No
Write EC Notification: Yes FDA = OH Facility / Limited Access/Obstruct / Inspect (Primary) FDA= OH Facility / Limited Access/Obstruct / Remove Priority = B tag, 0-3 months depending upon exposure; must complete before CPUC due date for map	Write EC Notification: No

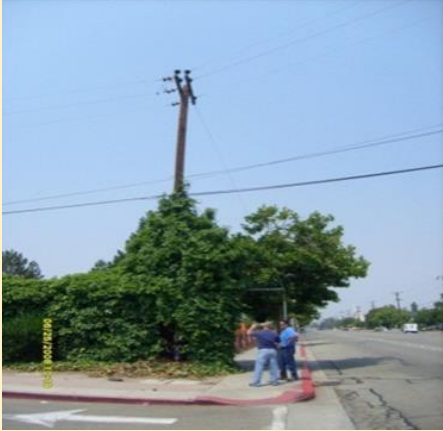
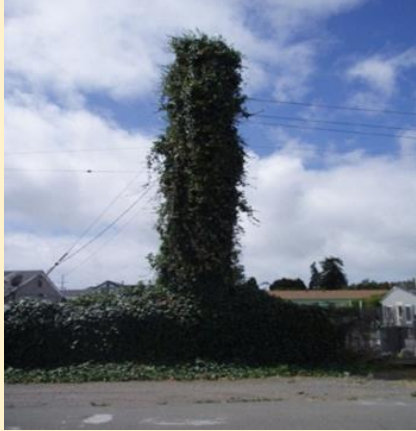
Pole with Vegetation	IVY COVERED POLE

At this Location: 360° pole inspection not possible	At this Location: 360° pole inspection not possible
Perform Minor Work: No	Perform Minor Work: No
Write 3rd Party Notification: No	Write 3rd Party Notification: No
Write EC Notification: Yes FDA = OH Facility / Limited Access/Obstruct / Inspect (Primary) FDA= OH Facility / Limited Access/Obstruct / Remove Priority = B Tag, 0-3 months depending upon exposure; must complete before CPUC due date for map	Write EC Notification: Yes FDA = OH Facility / Limited Access/Obstruct / Inspect (Primary) FDA= OH Facility / Limited Access/Obstruct / Remove Priority = B Tag, 0-3 months depending upon exposure; must complete before CPUC due date for map

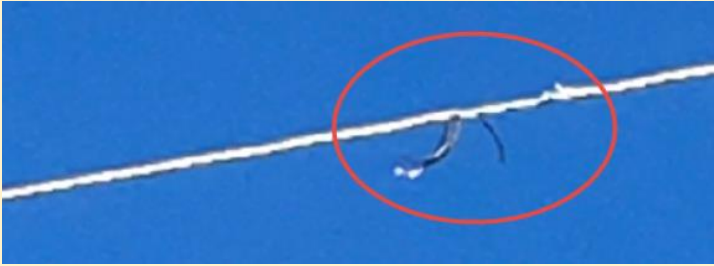
Gun Shot Damage

At this Location: Less than 40% broken strands in a Non-HFTD rural area with low public exposure.
	Perform Minor Work: No
	Write 3rd Party Notification: No
	Write EC Notification: Yes FDA: FDA = Conductor / Broken / Damaged / Repair or Replace Priority: E Tag 3-12 months depending on exposure

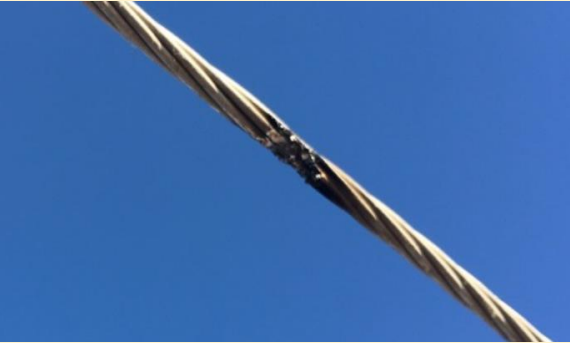
Burnt Conductor Primary or Secondary

At this Location: Burnt Conductor, midspan, primary or secondary
	Perform Minor Work: No
	Write 3rd Party Notification: No
	Write EC Notification: Yes
	FDA: FDA = Conductor / Burnt / Repair or Replace
	Priority: E Tag 3-12 months depending on exposure

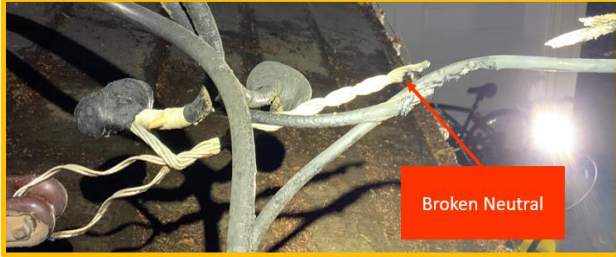
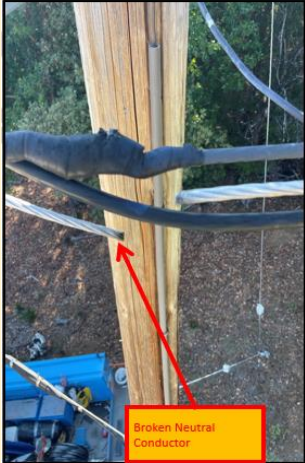
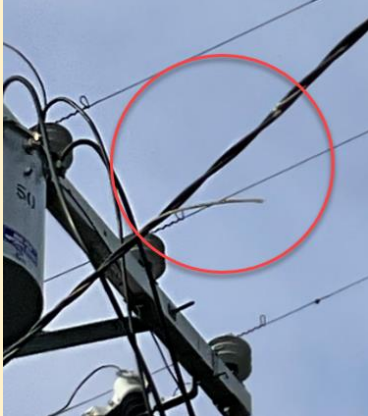
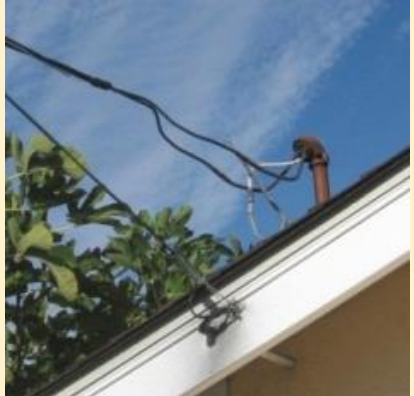
Broken or Open Service Neutral

At this Location: Broken / Open Service neutral	
Perform Minor Work: Yes, if safe to do so. If you replace the service conductor, this is capital Minor Work. Fill out EC Notification to account for this minor work; charge time to your division standing order	
Write 3rd Party Notification: No	
Write EC Notification: Yes, if minor work is not possible, or to document completed capital minor work	
FDA = Conductor / Broken / Damaged / Repair or Replace	
Priority = A Tag, Emergency due to exposed hot leg, follow emergency process

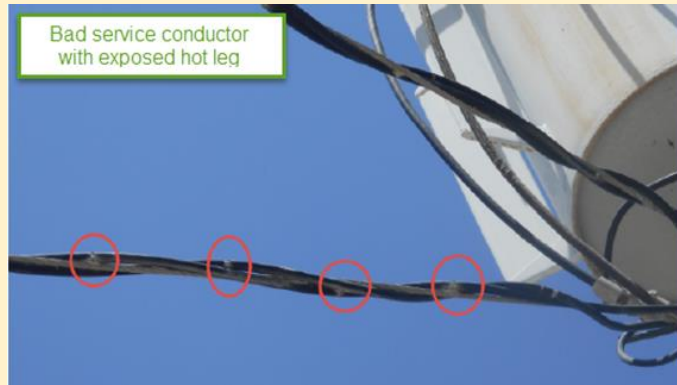
Bad service conductor with exposed hot leg

At this Location: Bad service conductor with exposed hot leg, bundled with a potential to cross phase

FDA: FDA = Conductor / Broken / Damaged / Replace

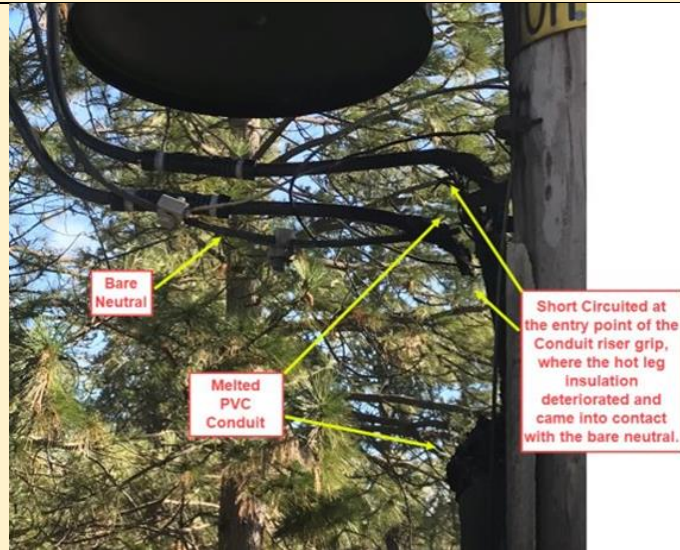
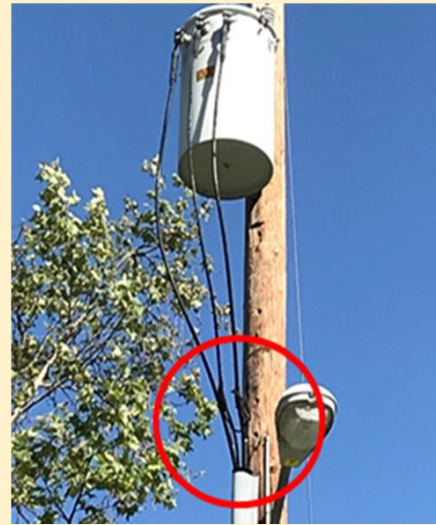
Secondary Service Riser Drops

At this Location: hot leg insulation frayed at the point of entry point of the molding exposing the conductor into contact with the neutral

FDA=Conductor / Broken / Damaged / Replace

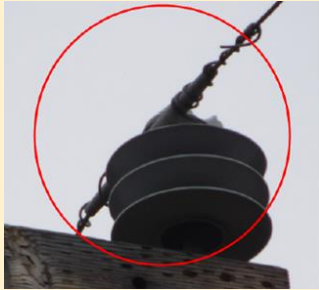
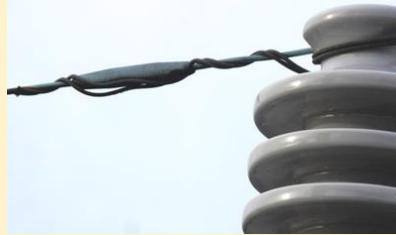
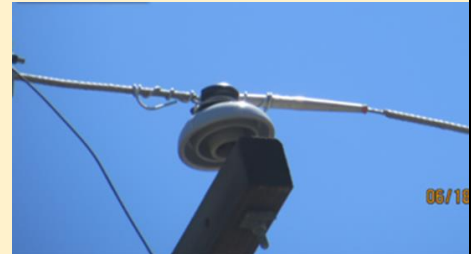
Splices tied into the insulator or under the tie wire

At this Location: Splice under the tie wire or tied into the insulator

FDA = Conductor / Splice Tied In / Replace

Priority = E Tag, 3-12 months depending on exposure

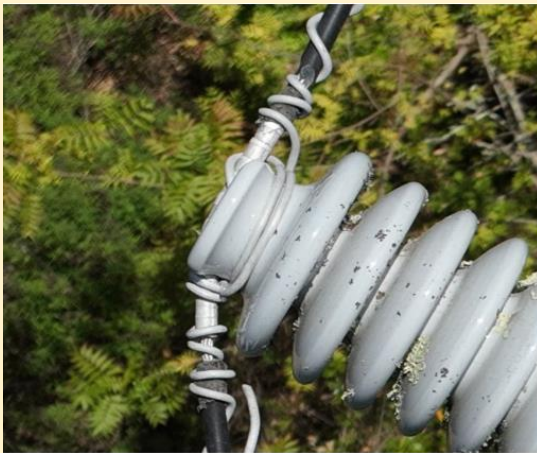
Splices tied into the insulator or under the tie wire – Aerial View

At this Location: Splice under the tie wire or tied into the insulator. Splice bent / damaged.

FDA = Conductor / Splice Tied In / Replace

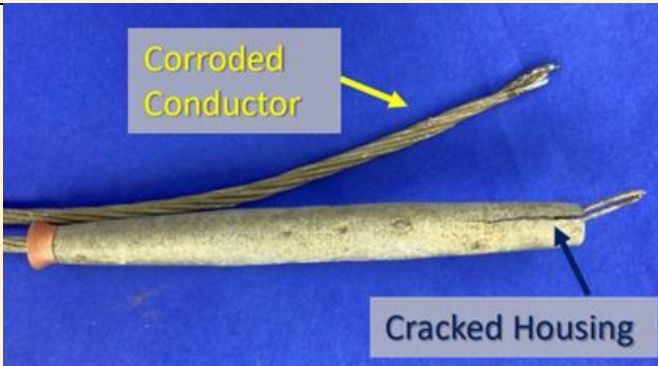
Damaged, Corroded, or Cracked Splices

At this Location: Cracked Splice
	Perform Minor Work: No
	Write 3rd Party Notification: No
	Write EC Notification: Yes FDA= Conductor / Broken Splice / Damaged / Replace Priority = B tag, 0-3 months, depending on exposure

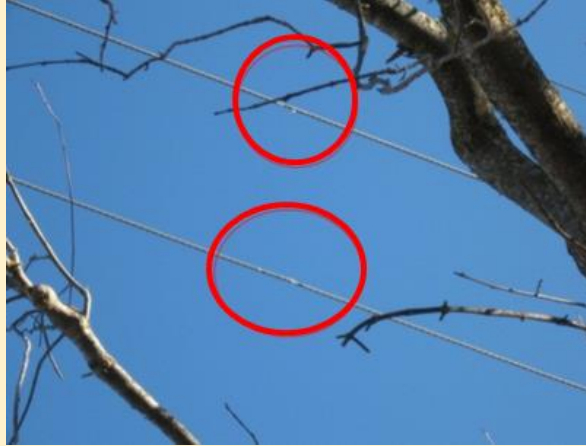
Damaged Secondary

At this Location: Damaged strands, less than 40%

FDA= Conductor / Damaged / Repair

Priority = E Tag, 3-12 months depending on exposure

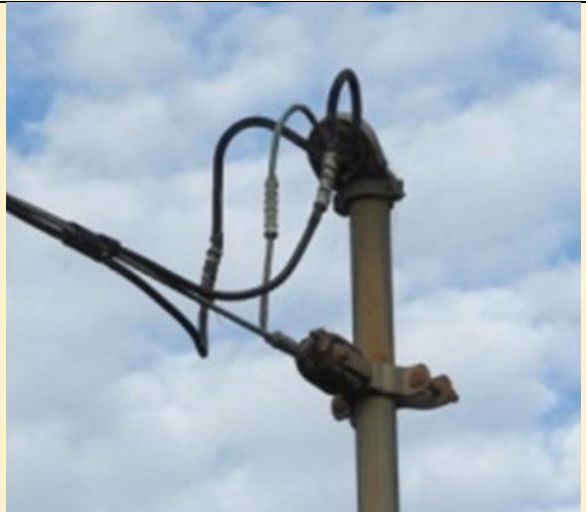
Exposed Service Connector

At this Location: Exposed Conductors, with an acceptable air gap between conductors

FDA= Conductor / Broken / Damaged / Repair

Perform Minor Work: Yes, if safe to do so

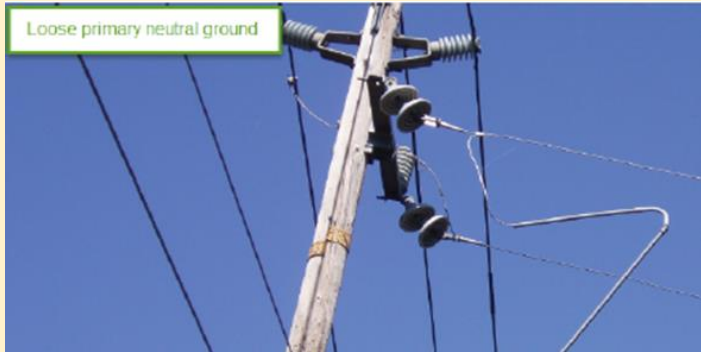
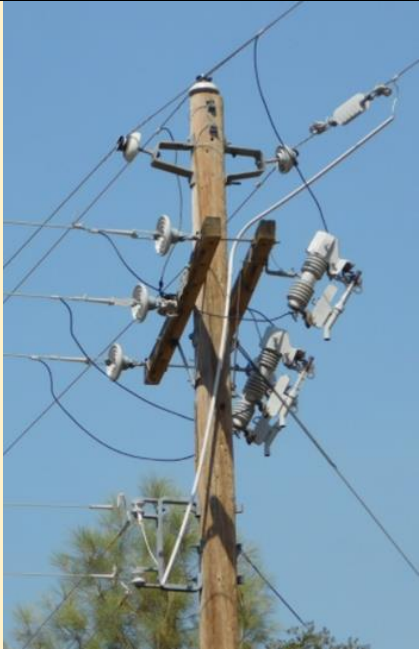
Loose Primary Neutral Ground

At this Location: Loose primary neutral ground, unsupported conductor, hanging	At this Location: Loose primary neutral ground, unsupported conductor, hanging
Perform Minor Work: No	Perform Minor Work: No
Write 3rd Party Notification: No	Write 3rd Party Notification: No
Write EC Notification: Yes	Write EC Notification: Yes
FDA = Molding, Loose, Adjust	FDA = Molding, Loose, Adjust
Priority = E Tag, 3-12 month, depending on exposure	Priority = E Tag, 3-12 month, depending on exposure

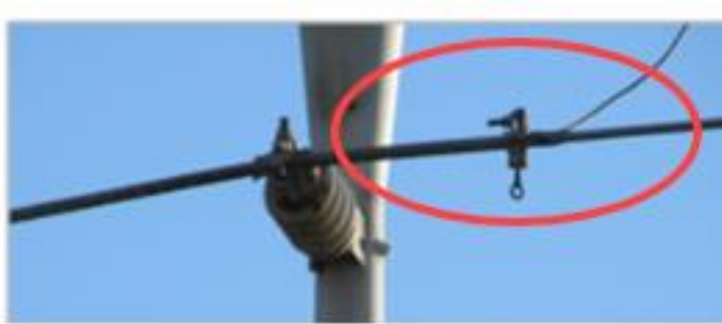
Incorrectly Installed Chance Clamp

<p>Tap clamp on armor rod installed incorrectly.</p>	At this Location: Incorrectly installed per note C above - chance clamp on armor rod
	Perform Minor Work: No
	Write 3rd Party Notification: No
	Write EC Notification: Yes FDA: Connector / Incorrectly Installed / Replace Priority: E Tag 3-12 months depending on exposure

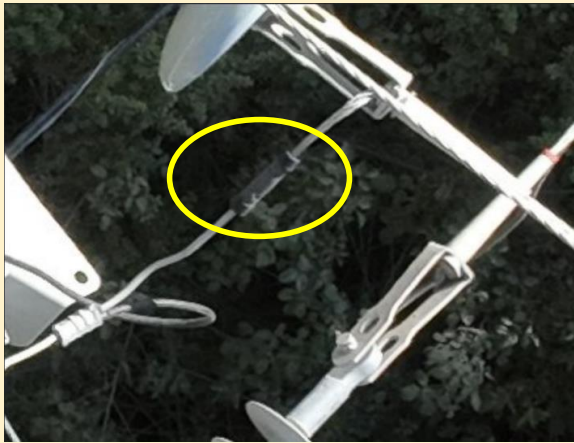
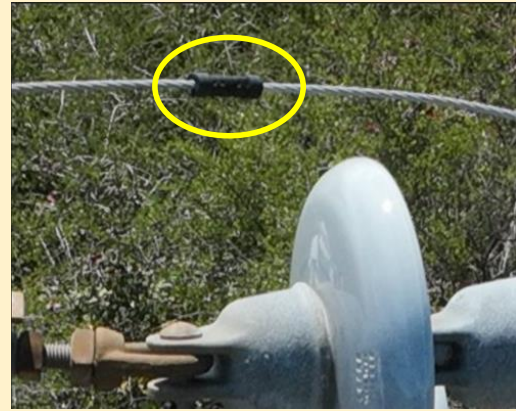
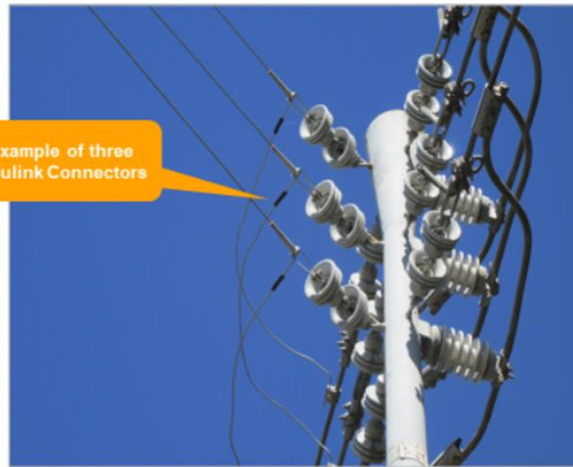
Secondary Connector Installed on Primary

At this Location: Secondary connector installed on primary

FDA: Connector / Incorrectly Installed / Replace

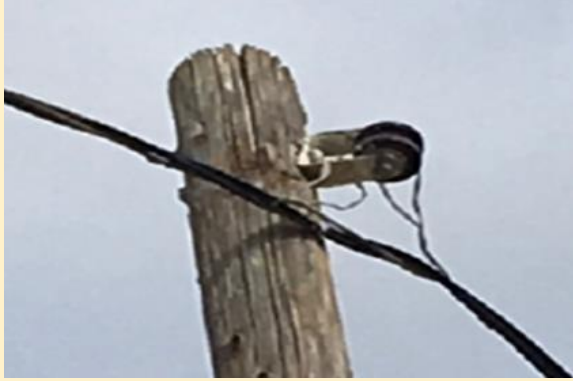
Preform not attached to Insulator

At this Location: Preform not attached to the insulator, rural area, low exposure with no vehicular access
	Perform Minor Work: Yes, if safe to do so.
	Write 3rd Party Notification: No
	Write EC Notification: Yes FDA= Tie Wire / Loose / Replace
	Priority = E Tag, 3-12 months depending on exposure

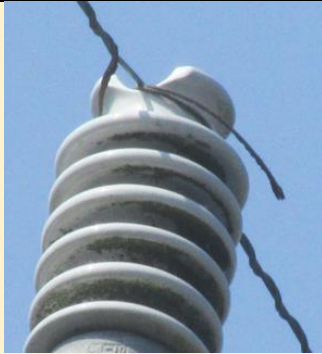
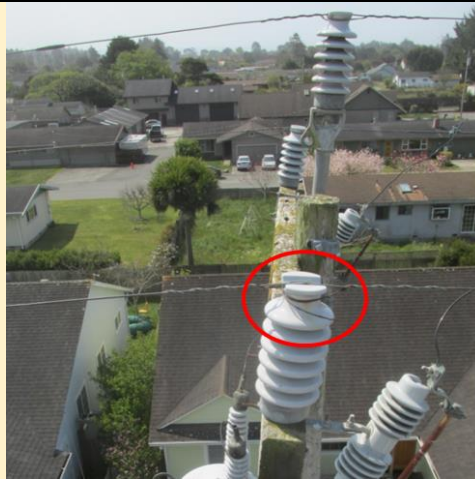
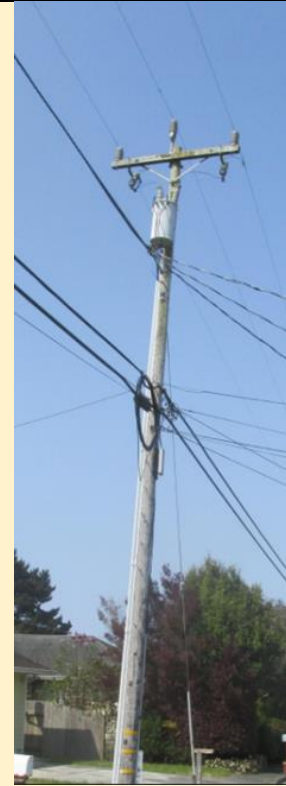
Broken / Corroded Tie Wire

At this Location: Corroded and broken tie wire, top tie, with one strand remaining

FDA = Tie wire / Broken / Damaged / Repair / Replace

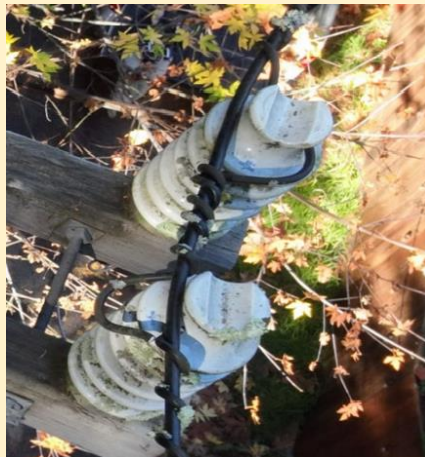
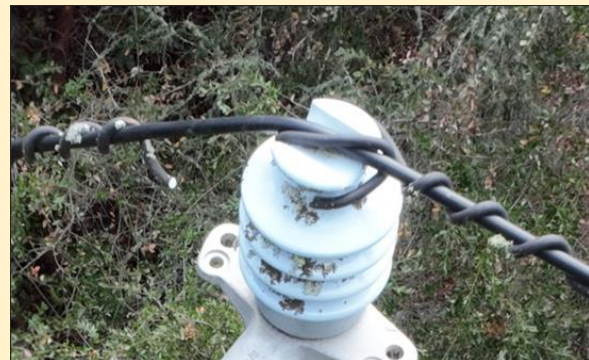
Broken / Corroded Tie Wire

At this Location: Broken tie wire

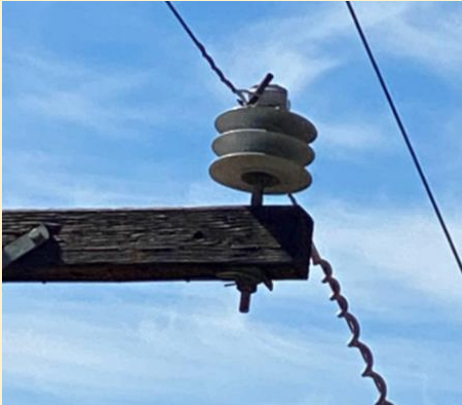
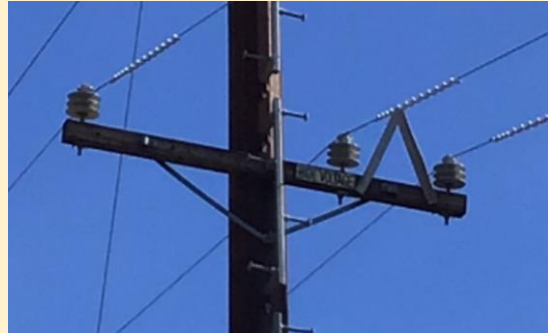
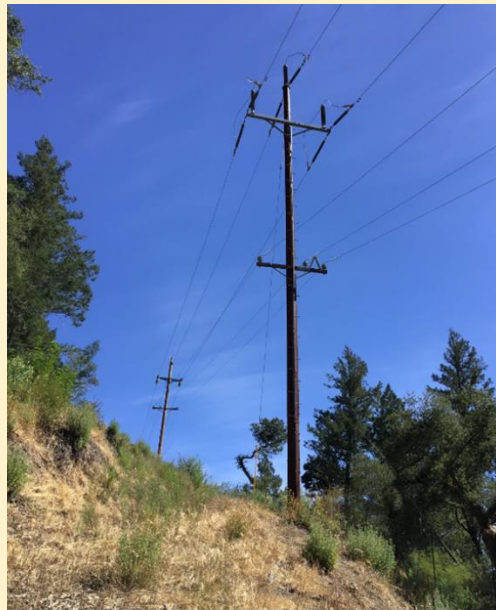
Questionable Tie Wire

At this Location: Not obvious if it's still attached, Transmission with distribution under-build, in HFTD. Insulator has spun.

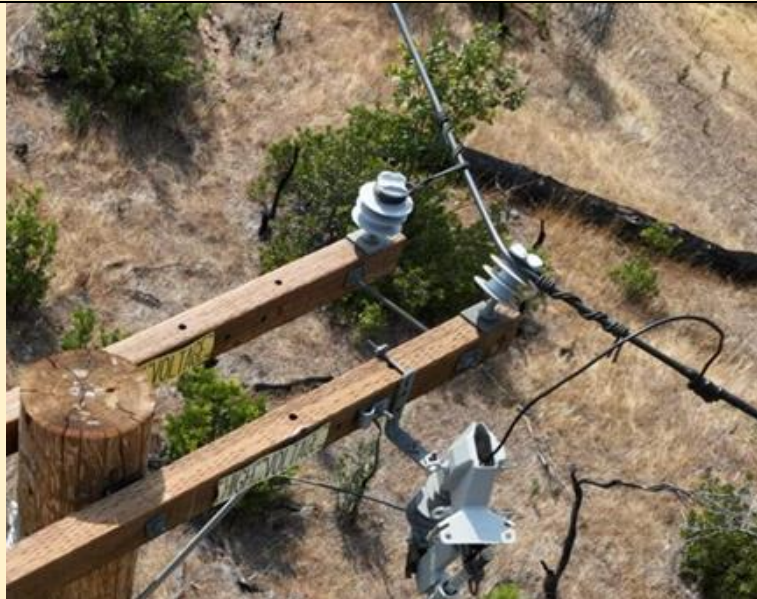
Angle Pole with Tie wire, Bent Steel Pin

At this Location: Angle pole with post top insulator, where the inside angle insulator conductor is only being supported by tie wire (non-clamped). Post top insulator steel pin is bent

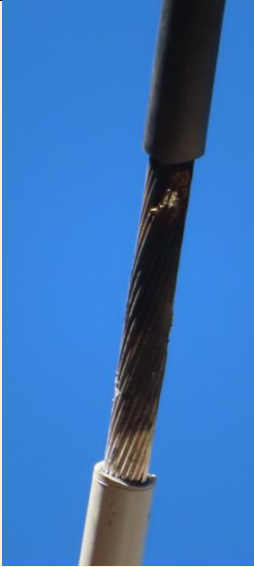
Exposed Primary Covered Conductor Tree Wire, Burnt Conductor

At this Location: Tree Wire conductor exposed and burnt
	Perform Minor Work: No
	Write 3rd Party Notification: No
	Write EC Notification: Yes FDA= Tree Wire / Exposed / Repair FDA= Conductor / Burnt / Repair Priority: E Tag, 3-12 months depending on exposure

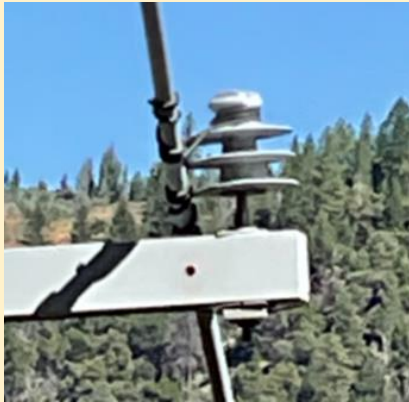
Broken Tie Wire

At this Location: Broken tie wire, which caused a floating conductor condition (sitting on the cross-arm) Insufficient clearance
	Perform Minor Work: No
	Write 3rd Party Notification: No
	Write EC Notification: Yes FDA= Conductor / Floater / Repair Priority= A Tag, Follow emergency procedure

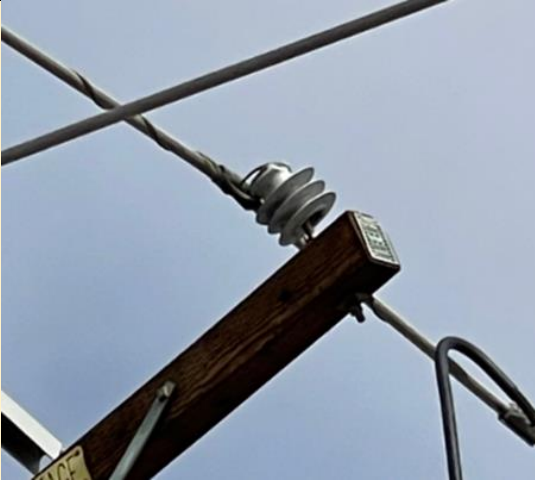
Conductor Tied to Side of Skirt, not in Groove	Tie Wire Broken / Loose / Not in Groove

At this Location: Insulator spun, and conductor tied on the skirt, non-angle pole.	At this Location: Tie Wire Broken / Loose / Not in Groove
Perform Minor Work: No	Perform Minor Work: No
Write 3rd Party Notification: No	Write 3rd Party Notification: No
Write EC Notification: Yes FDA = Tie Wire / Broken / Damaged / Replace Priority = B Tag, 0-3 months depending on exposure	Write EC Notification: Yes FDA = Tie Wire / Improperly Installed / Repair Priority = B Tag, 0-3 months depending on exposure

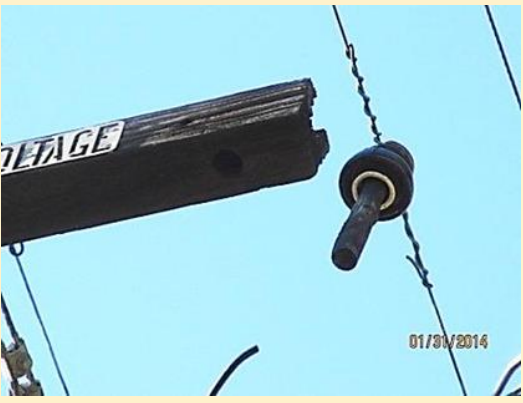
At this Location: Floater, conductor is not contacting the arm. Rotten crossarm.
	Perform Minor Work: No
	Write 3rd Party Notification: No
	Write EC Notification: Yes
	FDA= Crossarm / Decayed/Rotten/ Replace FDA= Conductor / Floater / Repair Priority= A Tag, follow Emergency Process

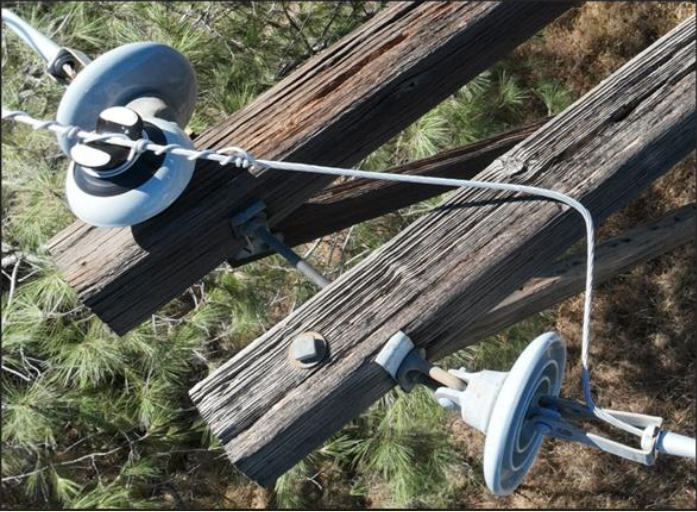
Insufficient Clearance – Aerial View

At this Location: Over the top jumper laying on cross-arm
	Perform Minor Work: No
	Write 3rd Party Notification: No
	Write EC Notification: Yes FDA: Jumper / Clearance / Impaired / Adjust Priority: A Tag, Follow the emergency process

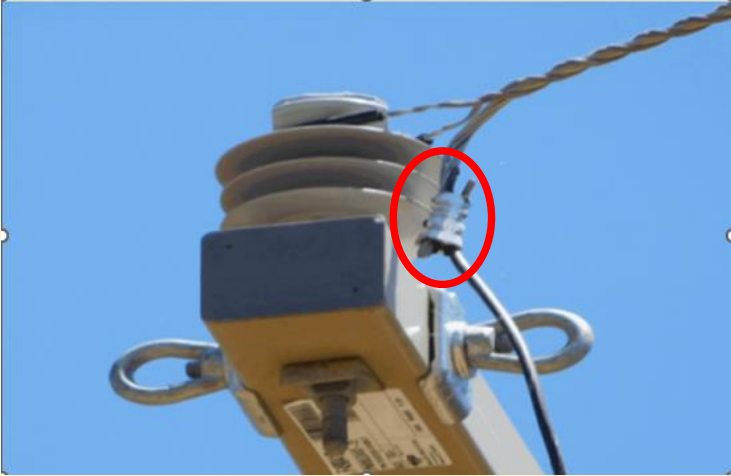
Insufficient Clearance

At this Location: Insufficient clearance between connector and cross-arm
	Perform Minor Work: No
	Write 3rd Party Notification: No
	Write EC Notification: Yes
	FDA: Conductor / Clearance / Impaired / Adjust Priority: E Tag 3-12 months max depending on exposure

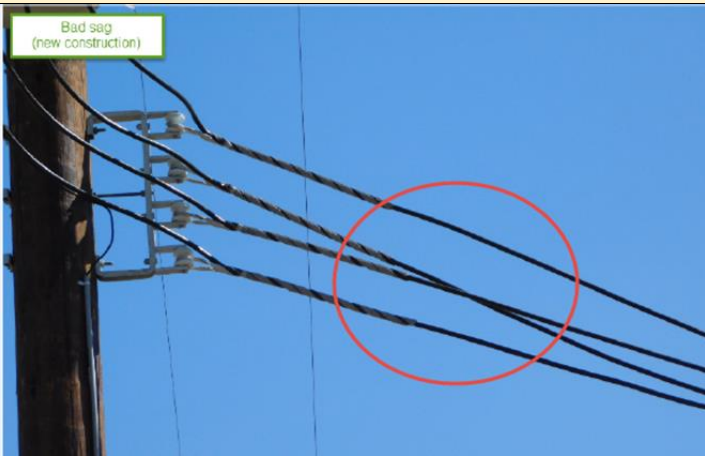
Secondary Sagging Conductor

At this Location: Extended Rack Construction sagging covered and insulated secondary conductor, resulting in conductors touching
	Perform Minor Work: Yes, if safe to do so
	Write 3rd Party Notification: No
	Write EC Notification: Yes FDA= Conductor / Sag / Clearance / Adjust PRIORITY= E TAG, 3-12 months depending upon exposure

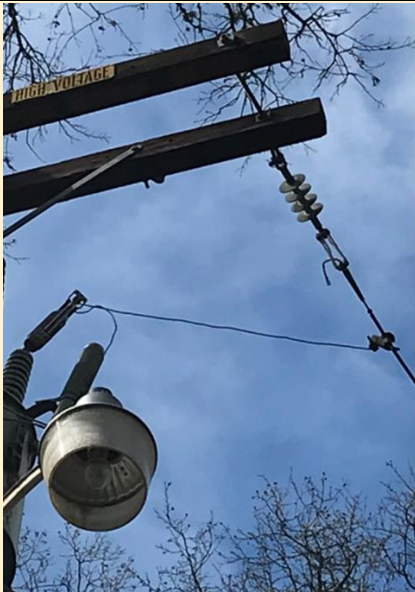
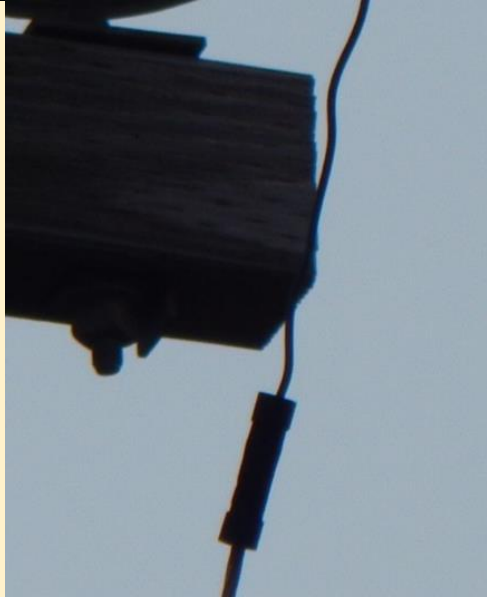
JUMPER TENSION	Jumper Clearance

At this Location: Jumper Tension, pulling over cutout	At this Location: Jumper Clearance
Perform Minor Work: No	Perform Minor Work: No
Write 3rd Party Notification: No	Write 3rd Party Notification: No
Write EC Notification: Yes	Write EC Notification: Yes
FDA= Jumper / Clearance impaired / Adjust	FDA= Jumper / Clearance impaired / Adjust
Priority= E Tag, 3-12 months depending upon exposure	Priority= E Tag, 3-12 months depending upon exposure

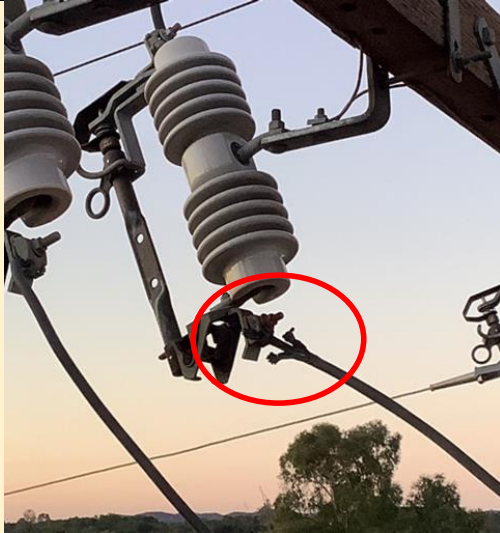
Burnt Jumper

At this Location: Primary jumpers and / or transformer secondary connection jumpers frayed and burnt.

FDA = Jumper / Burnt / Replaced

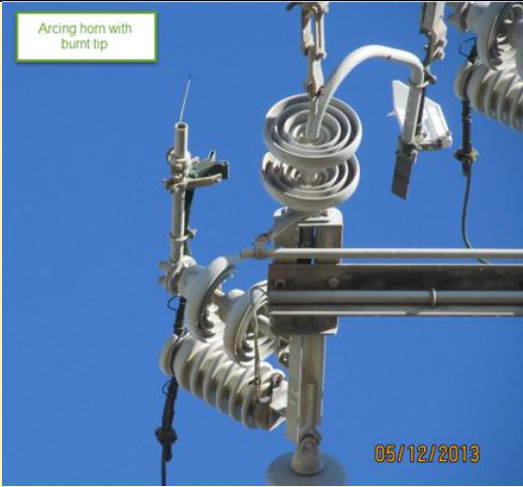
At this Location: Arcing horn with burnt tip
	Perform Minor Work: No
	Write 3rd Party Notification: No
	Write EC Notification: No FOLLOW COE PROCESS

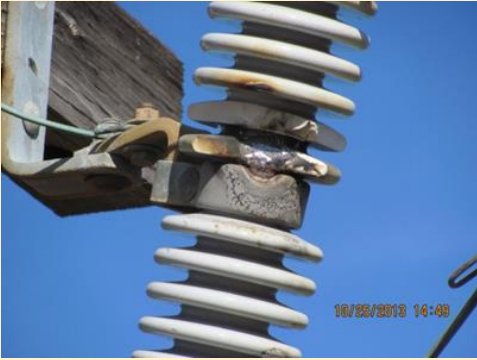
BROKEN DAMAGED CROSSARM MOUNTED CUTOUT	Broken Cutout

At this Location: Broken/Flashed cutout	At this Location: Broken Cutout
Perform Minor Work: No	Perform Minor Work: No
Write 3rd Party Notification: No	Write 3rd Party Notification: No
Write EC Notification: Yes FDA = Cutout / Broken/Damaged / Replace Priority = E Tag, 3-12 months depending upon exposure, no COE	Write EC Notification: Yes FDA = Cutout / Broken/Damaged / Replace Priority = A Tag, Follow the emergency procedure

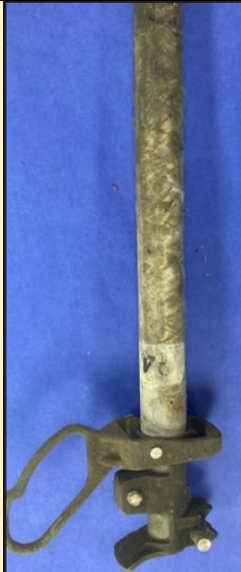
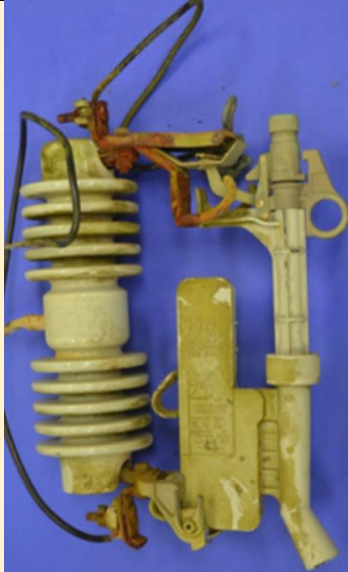
PART 63 POWER FUSE	Part 75 Fault Tamer

At this Location: Fuse End fitting corroded; fiberglass layer exposed	At this Location: excessive cutout corrosion leading to corrosion on the metal components of the FT Fuse, deteriorated housing on the FT Fuse will not contain an arc within the snuffing tube. Any reasonable suspicion of damage that will not be able to operate correctly
Perform Minor Work: No	Perform Minor Work: No
Write 3rd Party Notification: No	Write 3rd Party Notification: No
Write EC Notification: Yes FDA = Fuse / Broken / Damaged / Replace Priority = E Tag – 3-12 months depending on exposure.	Write EC Notification: Yes FDA = Cutout / Broken/Damaged / Replace And FDA= Fuse / Broken / Damaged / Replace Priority = E Tag – 3-12 months depending on exposure.

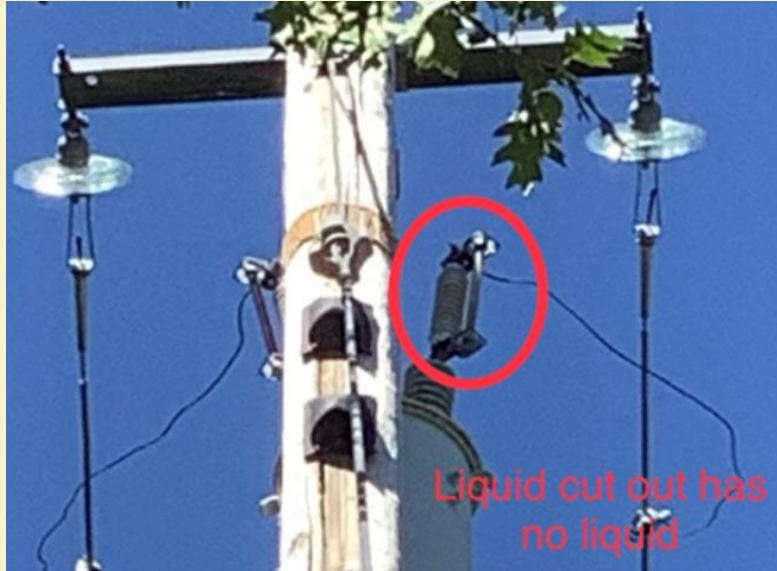
Liquid Fuse with no Liquid

At this Location: Liquid Fuse with no liquid, not in HFTD

FDA = Fuse / Broken/Damaged / Replace

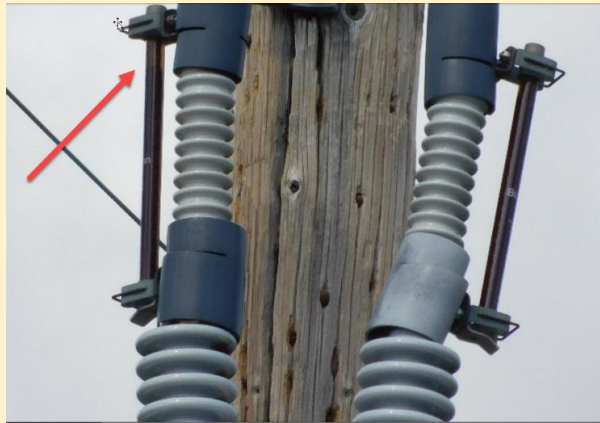
Liquid Fuse Oil Level is Low

At this Location: Liquid Fuse with low oil level in HFTD area.

FDA = Fuse / Broken/Damaged / Replace

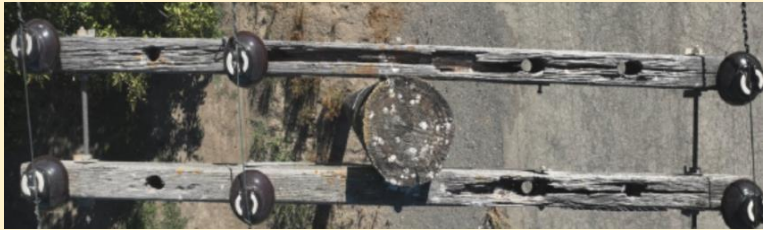
Deteriorated Cross-Arm – Aerial View

At this Location: Top view of a Deteriorated/Rotten cross-arm. May not be seen from the ground. Quarter brace hardware coming loose.
	Perform Minor Work: No
	Write 3rd Party Notification: No
	Write EC Notification: Yes FDA = Cross-arm / Broken / Damaged / Replace Priority = Minimum B tag 0-3 months, consider A Tag for conditions such as conductor size, double / single arm, exposure, etc.

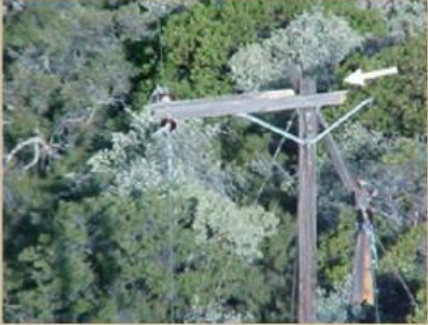
<p>BROKEN CROSSARM</p> <p>Crossarm is completely broken/fractured</p>

<p>Emergency - make safe immediately</p>	<p>SPLIT CROSSARM</p> <p>Primary Squatter (wood pin). Crossarm split within 2" of pinhole.</p>

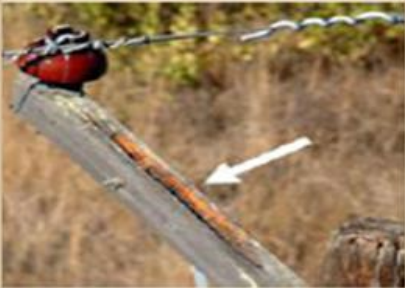
<p>Replace in the next 3 months.</p>
<p>TOP OF CROSSARM DECAYED</p> <p>Evidence of pole top decay and face of crossarm decay; may need additional assessment of crossarm.</p>

<p>Replace 3-12 months</p>	<p>DETERIORATED CROSSARM</p> <p>Significant deterioration, both arms are broken/split. Evidence of previous temporary repair.</p>

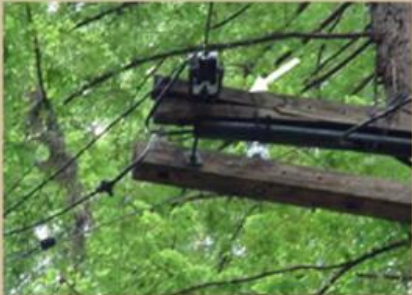
<p>Replace 3-12 months</p>
<p>BROKEN SECONDARY CROSSARM</p> <p>Secondary arm broken; split/fractured within 2" of bolt holes in heavy tree area.</p>

<p>Replace 3-12 months</p>

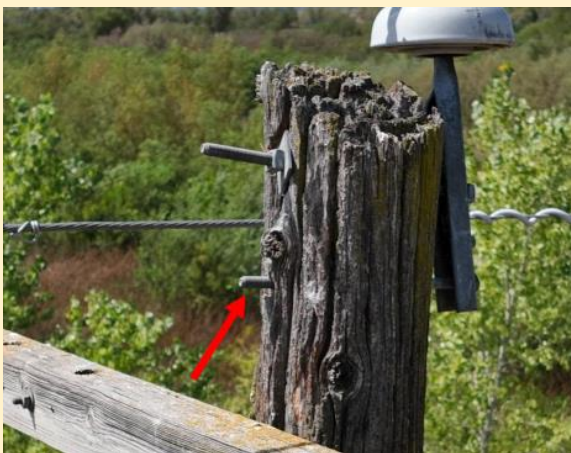
Missing Hardware – Aerial View

At this Location: The nut on the through bolt has come off of the king pin.

FDA = Hardware / Loose / Adjust

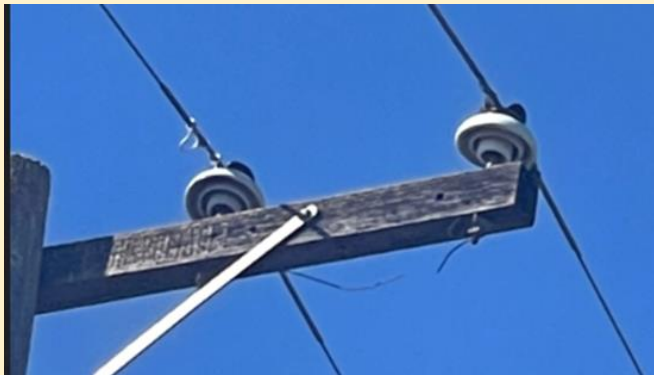
At this Location: Broken or unattached bonding
	Perform Minor Work: No
	Write 3rd Party Notification: No
	Write EC Notification: Yes
	FDA = Bonding / Broken / Damaged / Replace Priority = E Tag, 3-12 months depending on exposure

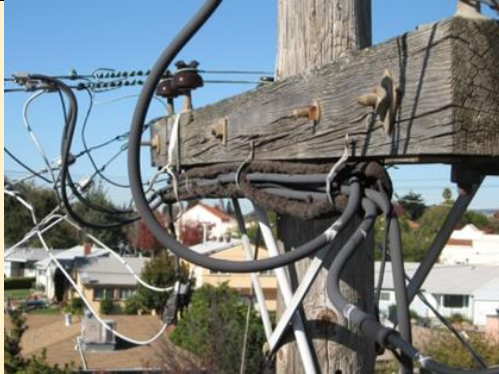
Under-Arm Bus Loose and Deteriorated

At this Location: UAB deteriorated, partial repair with rope, secured with one strap	
Perform Minor Work: No	
Write 3rd Party Notification: No	
Write EC Notification: Yes	
FDA= Under-Arm Bus / Broken/Damaged / Repair	
Priority = At minimum – must write up as F Tag, next inspection cycle; based on field condition and exposure, corrosion, etc.; prioritize as needed (A, B, E, or F)

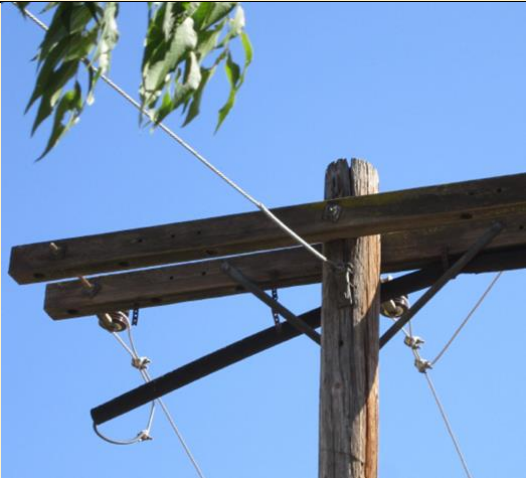
Under-arm Bus Loose

At this Location: UAB Loose, unattached and hanging Perform Minor Work: No Write 3rd Party Notification: No Write EC Notification: Yes FDA= Under-Arm Bus / Broken/Damaged / Repair Priority= E Tag, 3-12 months depending upon exposure

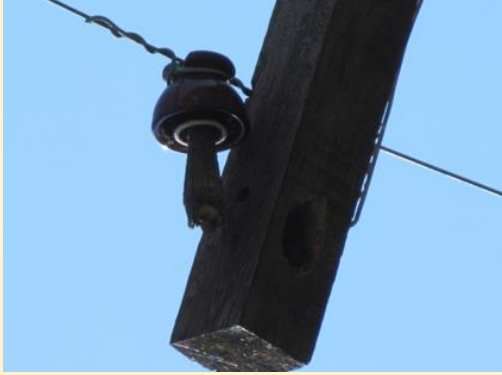
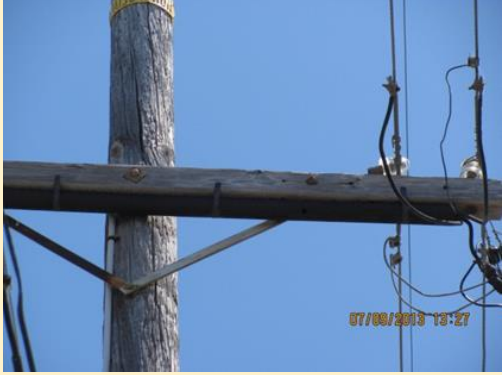
PIN BROKEN	PIN BROKEN (FLOATER)

At this Location: Primary wood pin is broken, and the conductor is laying on the crossarm. Wood pin arm replace with Composite arm	At this Location: Secondary wood pin is broken, and the conductor is laying on the crossarm. Wood pin arm. Replace arm with composite arm
Perform Minor Work: No	Perform Minor Work: No
Write 3rd Party Notification: No	Write 3rd Party Notification: No
Write EC Notification: Yes FDA = Conductor / Floater / Repair FDA= Crossarm/Broken Damaged/Replace Priority = A Tag, follow emergency process	Write EC Notification: Yes FDA= Conductor / Floating / Repair FDA= Crossarm/Broken Damaged/Replace Priority= A Tag, follow Emergency Process

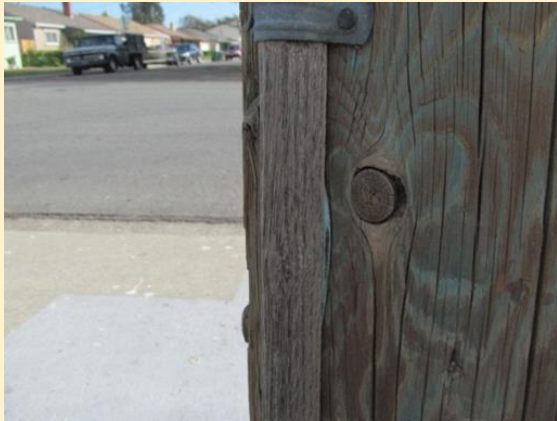
REPAIR WITH 1.5" MOLDING

Before: Copper Wire sticking out from under the wood molding

At this Location: Wood molding with ground exposed

After: 1.5-inch u-shaped molding installed over existing wood molding

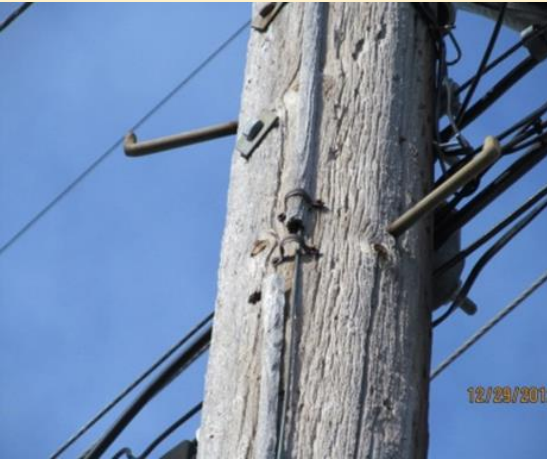
At this Location: Exposed ground at communications level. Wood molding broken in climbing space	At this Location: Exposed ground in wood molding.
Perform Minor Work: Yes, if safe to do so	Perform Minor Work: Yes, if safe to do so
Write 3rd Party Notification: No	Write 3rd Party Notification: No
Write EC Notification: Yes, only if unable to perform minor work.	Write EC Notification: Yes, only if unable to perform minor work.
FDA= Ground / Exposed / Repair	FDA= Ground / Exposed / Repair
Priority= F Tag At minimum – next inspection cycle; based on field condition and exposure, corrosion, etc.; prioritize as needed (A, B, E, or F)	Priority= F Tag At minimum – next inspection cycle; based on field condition and exposure, corrosion, etc.; prioritize as needed (A, B, E, or F)

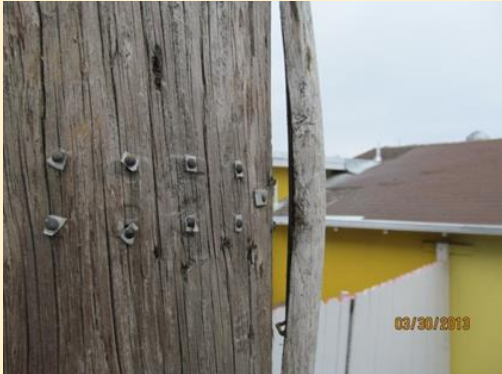
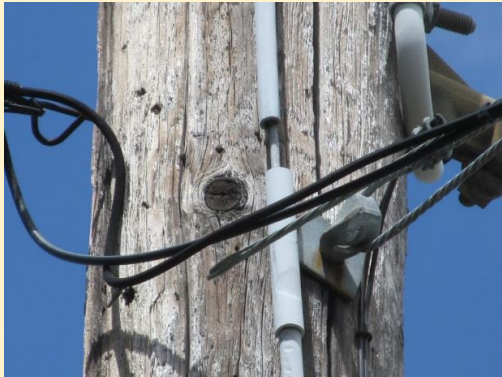
WOOD MOLDING ABOVE 8', NOT SECURE EXPOSING GROUND	PVC MOLDING ABOVE 8', NOT SECURE EXPOSING GROUND

At this Location: PG&E solely owned pole, Wood molding is not secure allowing human contact.	At this Location: At communication level, PVC molding not secure, due to failure of previous repairs, allowing human contact.
Perform Minor Work: Yes, if safe to do so	Perform Minor Work: Yes, if safe to do so
Write 3rd Party Notification: No	Write 3rd Party Notification: No
Write EC Notification: No	Write EC Notification: Yes, only if unable to perform minor work. FDA= Ground / Exposed / Repair Priority= F Tag At minimum – next inspection cycle; based on field condition and exposure, corrosion, etc.; prioritize as needed (A, B, E, or F)

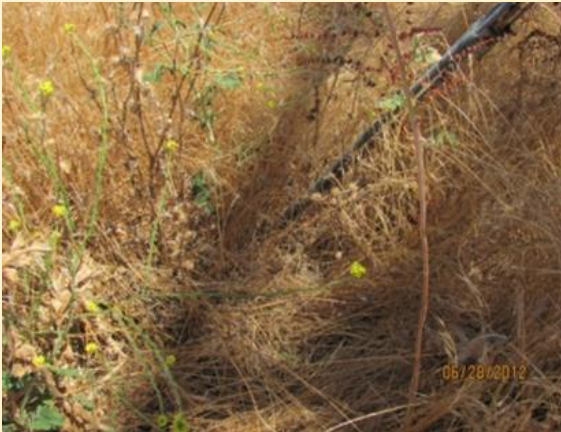
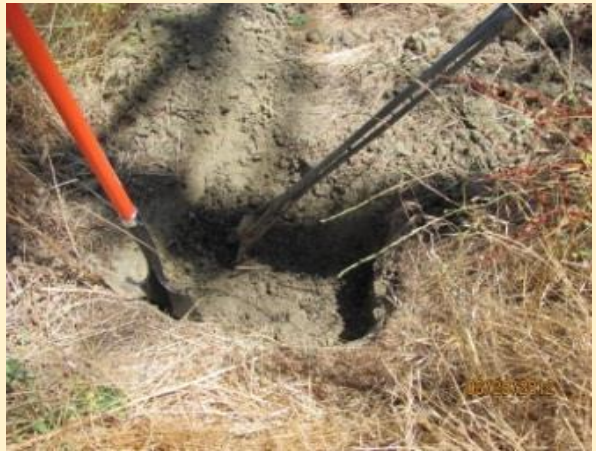
BURIED ANCHOR

Before: Vegetation covers anchor	
After: Vegetation cleared from anchor	
At this Location: Anchor below grade overgrown with vegetation. After minor work inspector decides if the anchor can be adjusted or needs replaced.	
Perform Minor Work: Yes, remove the vegetation Yes, expose anchor and evaluate condition/corrosion Yes, preferred method is to adjust anchor by adding extension	
Write 3rd Party Notification: No	
Write EC Notification: Yes, if cannot be addressed as minor work FDA= Anchor / Soil/Eroded/Graded / Replace (if the anchor cannot be adjusted)	
Priority= F Tag at minimum – must write up as, next inspection cycle; based on field condition and exposure, corrosion, etc.; prioritize as needed (A, B, E, or F)

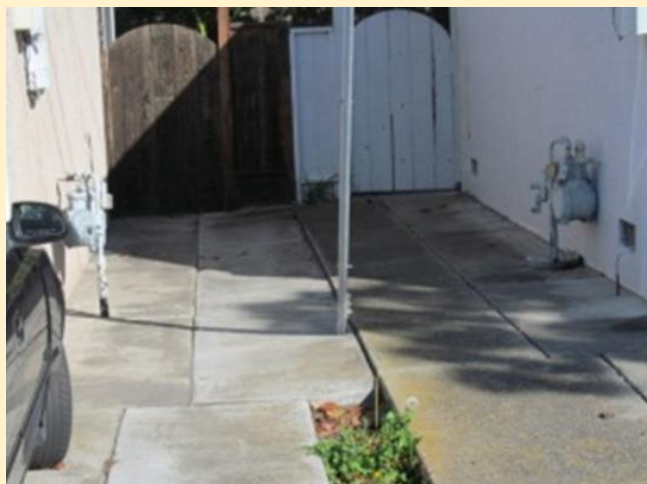
ANCHOR COVERED BY CONCRETE

At this Location: Anchor covered by concrete

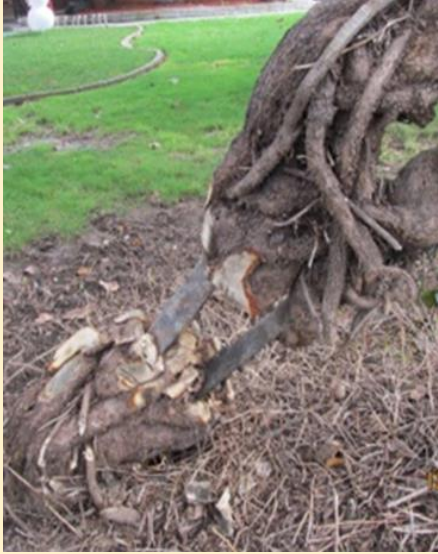
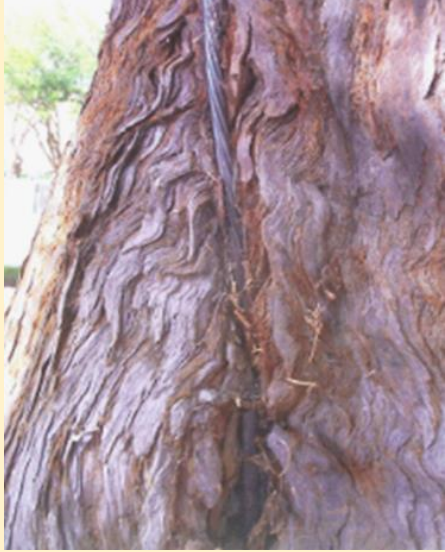
ANCHOR BURIED BY VEGETATION	
Anchor buried by roots	Anchor buried by tree

At this Location: Anchor buried by ivy roots / tree	
Perform Minor Work: No	
Write 3rd Party Notification: No	
Write EC Notification: Yes FDA= Anchor / Soil / Eroded / Graded / Replace Priority= F Tag at minimum, next inspection cycle; based on field condition and exposure, corrosion, etc.; prioritize as needed (A, B, E, or F)

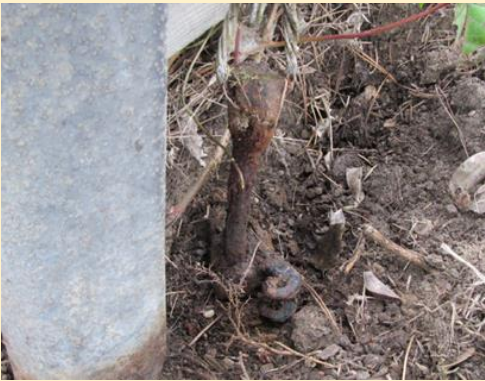
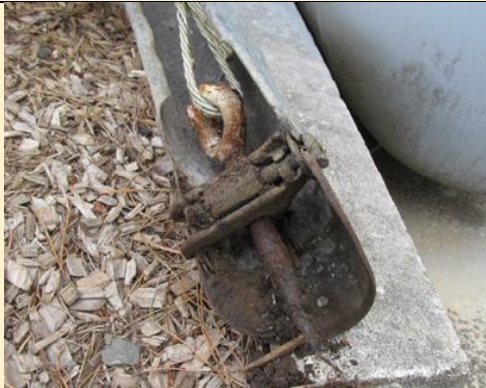
ANCHOR ROD WITH SIGNIFICANT CORROSION	
Anchor above ground	Below

At this Location: Corroded Anchor	
Perform Minor Work: No	
Write 3rd Party Notification: No	
Write EC Notification: Yes	
FDA= Anchor / Corroded / Replace	
Priority= E Tag, 3-12 months depending upon exposure

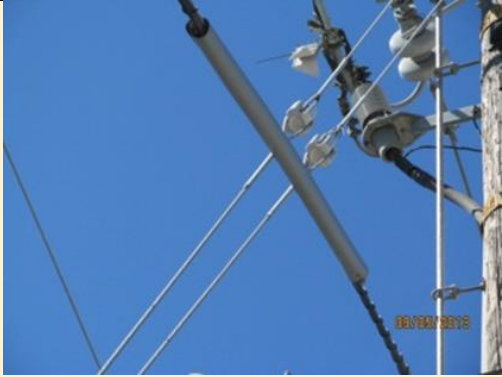
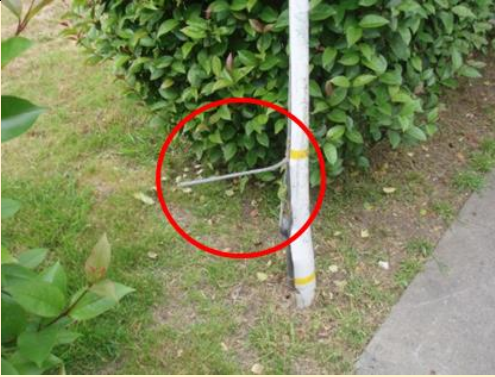
GUY CLEARANCE	GUY DAMAGED REPAIR

At this Location: Acceptable solution through plastic barrier	At this Location: Guy tail extends beyond the preform, <u>Nar sidewalk</u> , safety hazard
Perform Minor Work: No	Perform Minor Work: Yes, if safe to do so
Write 3rd Party Notification: No	Write 3rd Party Notification: No
Write EC Notification: No	Write EC Notification: Yes, only if unable to perform minor work. FDA= Guy / Broken / Damaged / Repair Priority= E Tag, 3-12 months depending upon exposure

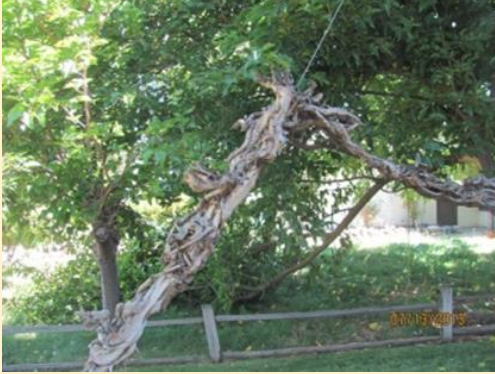
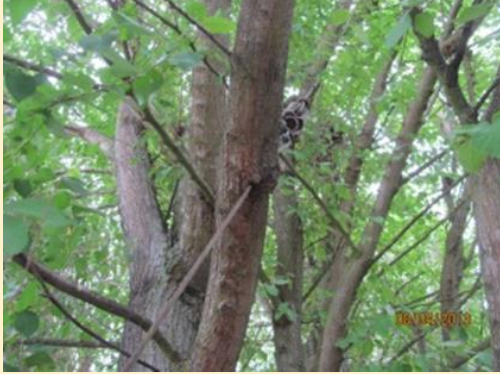
OVERGROWN GUY	TREE GROWING AROUND GUY

At this Location: Extensive dead ivy covering half of length of guy, below the bob.	At this Location: Tree growing around guy, below the bob.
Perform Minor Work: No	Perform Minor Work: No
Write 3rd Party Notification: No	Write 3rd Party Notification: No
Write EC Notification: Yes FDA=Guy / Broken/Damaged / Replace Priority= E Tag, 3-12 months depending upon exposure	Write EC Notification: Yes FDA=Guy / Broken/Damaged / Replace Priority= E Tag, 3-12 months depending upon exposure
