Job Aid: Overhead Assessment

This job aid is designed to assist Electric Distribution Compliance Inspectors, PG&E Employees, and Contractors in assessing and prioritizing compelling **abnormal conditions** on overhead facilities, including but not limited to GO 165 Inspections. Compelling Abnormal Condition is defined as any electric distribution pole, equipment, component, conductors, vegetation, or third-party condition that causes a safety or fire ignition risk that, in the judgment of the field employee, may adversely impact public safety and/or service reliability **within 5 years**.

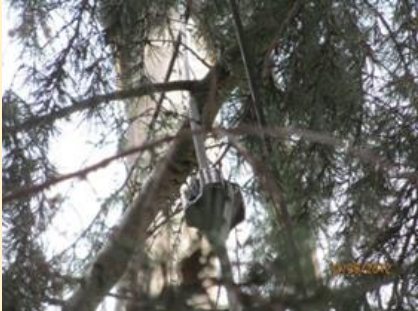
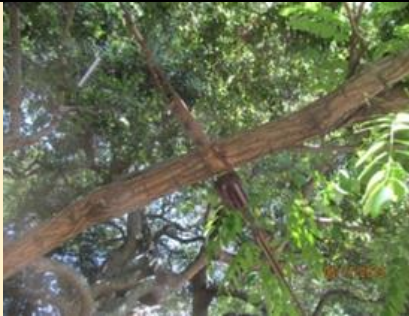
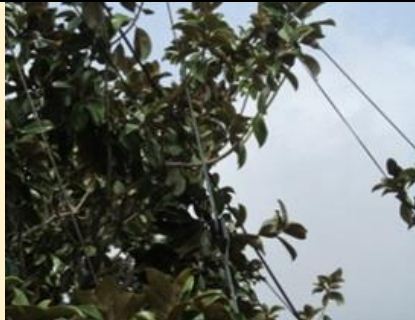
GUY GROUNDED BY VEGETATION		
Guy grounded by vegetation	Guy grounded by vegetation	Guy overgrown by vegetation

At this Location: Guy grounded by vegetation, above the bob		
Perform Minor Work: Yes		
Write 3rd Party Notification: No		
Write EC Notification: Yes, only if minor work cannot be performed FDA= Guy / Overgrown / Trim		
Priority= E Tag, 3-12 months depending upon exposure

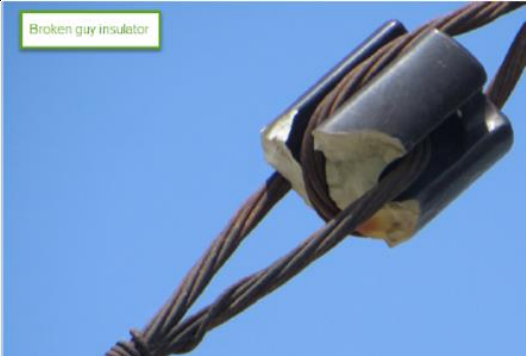
At this Location: Broken guy insulator
	Perform Minor Work: No
	Write 3rd Party Notification: No
	Write EC Notification: Yes FDA= Guy / Broken/Damaged / Replace Priority= E Tag, 3-12 months depending upon exposure

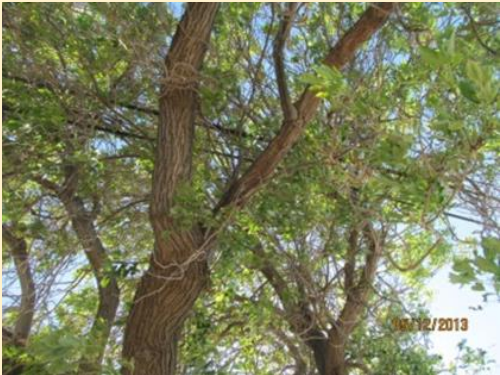
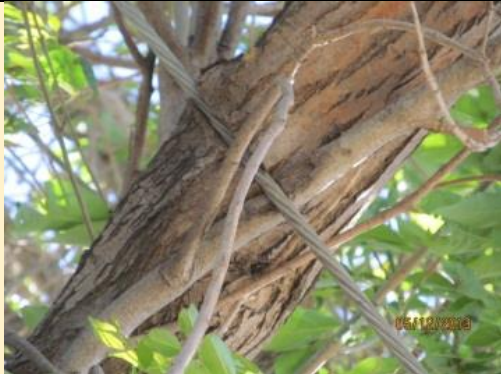
TREE LIMB GROWING AROUND GUY	
Guy through tree	Close Up

At this Location: Tree limb growing around guy, below the bob	
Perform Minor Work: No	
Write 3rd Party Notification: No	
Write EC Notification: Yes FDA= Guy / Strain/Abrasion / Remove Priority= E Tag, 3-12 months depending upon exposure

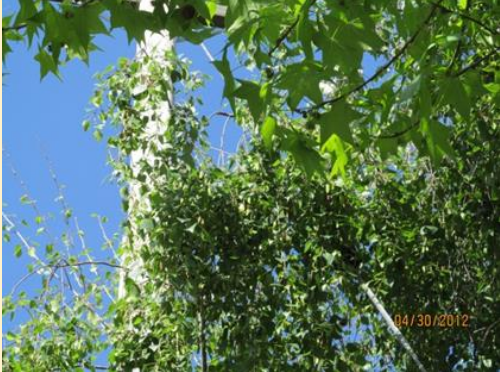
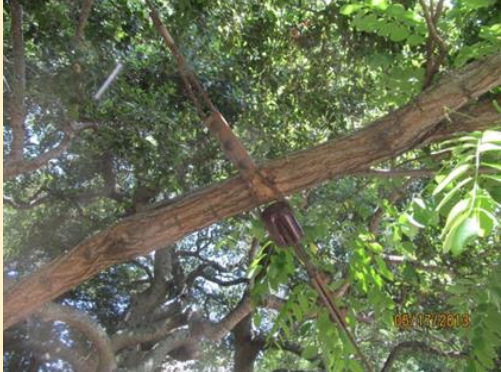
DOWN GUY GROUNDED ABOVE GUY INSULATOR	DOWN GUY GROUNDED ABOVE GUY INSULATOR CAUSING STRAIN AND ABRASION

At this Location: Vine growing up and across the guy insulator grounding the guy	At this Location: Tree grounding the guy above the guy insulator causing strain and abrasion.
Perform Minor Work: Yes	Perform Minor Work: Yes
Write 3rd Party Notification: No	Write 3rd Party Notification: No
Write EC Notification: Yes, only if minor work cannot be performed FDA=Guy / Overgrown / Trim Priority= E Tag, 3-12 months depending upon exposure	Write EC Notification: Yes, only if minor work cannot be performed FDA=Guy / Strain/Abrasion / Remove FDA=Guy / Overgrown / Trim Priority= E Tag, 3-12 months depending upon exposure

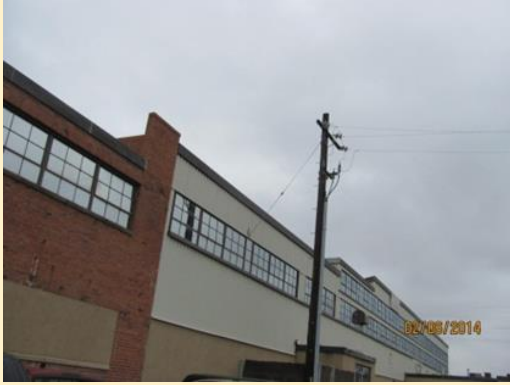
DOWN GUY: MARKER NOT REQUIRED

At this Location: Acceptable down guy attached to building; no marker required

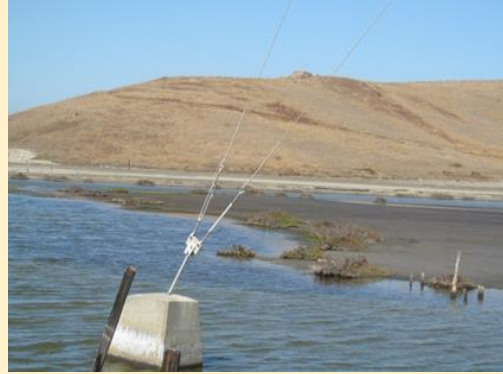
At this Location: Acceptable down guy in marsh, no marker required

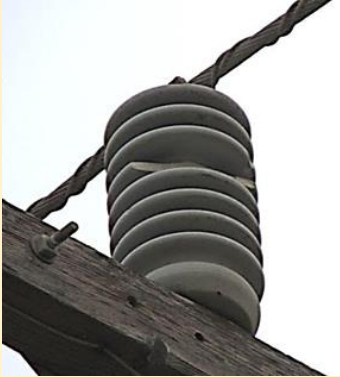
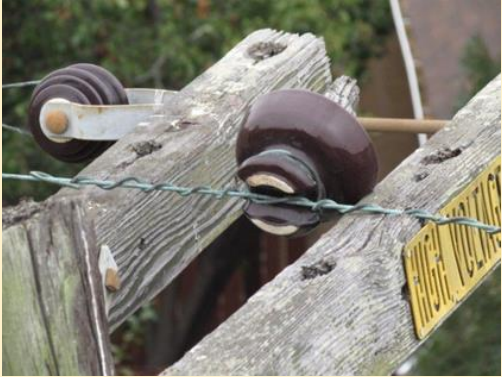
DAMAGED INSULATOR	INSULATOR LAYING ON ITS SIDE / PRIMARY ON THE ARM

At this Location: Damaged insulator, Replace all insulators and the arm	At this Location: Insulator lying on its side. Primary on the arm.
Perform Minor Work: No	Perform Minor Work: No
Write 3rd Party Notification: No	Write 3rd Party Notification: No
Write EC Notification: Yes FDA= Crossarm / Decayed/Rotten / Replace FDA= Insulator / Broken/ Damage / Replace Priority= E Tag, 3-12 months depending upon exposure	Write EC Notification: Yes FDA= Crossarm / Decayed/Rotten / Replace FDA= Conductor / Floater / Repair Priority= A Tag, follow Emergency Process

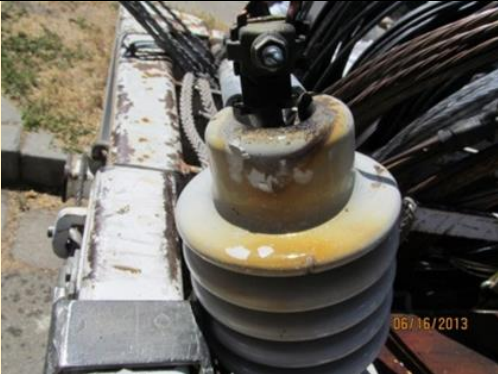
FLASHED INSULATOR POTHEAD

At this Location: Flashed pothead
	Perform Minor Work: No
	Write 3rd Party Notification: No
	Write EC Notification: Yes, or COE (see a set of combo cutouts at location follow COE process) FDA= Riser/Pothead / Flashed / Replace Priority= F Tag At minimum, next inspection cycle; based on field condition and exposure, corrosion, etc.; prioritize as needed (A, B, E, or F)

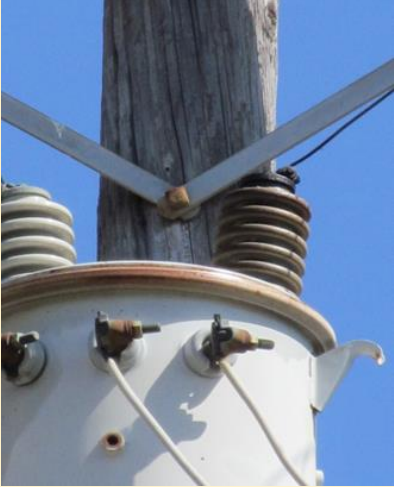
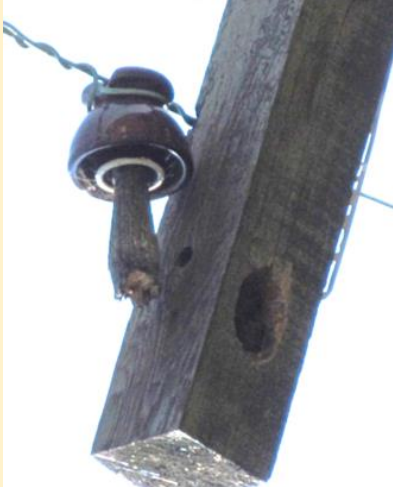
FLASHED INSULATOR ON TRANSFORMER	BROKEN WOOD PIN ON PRIMARY

At this Location: Flashed insulator on transformer	At this Location: Broken wood pin. Conductor on arm. Replace all insulators and the crossarm with a composite arm.
Perform Minor Work: No	Perform Minor Work: No
Write 3rd Party Notification: No	Write 3rd Party Notification: No
Write EC Notification: Yes FDA= Transformer / Flashed / Replace Priority= E Tag, 3-12 months depending upon exposure	Write EC Notification: Yes FDA= Crossarm / Decayed/Rotten / Replace FDA= Conductor / Floater / Repair Priority= A Tag, follow Emergency Process, (Conductor contacting crossarm)

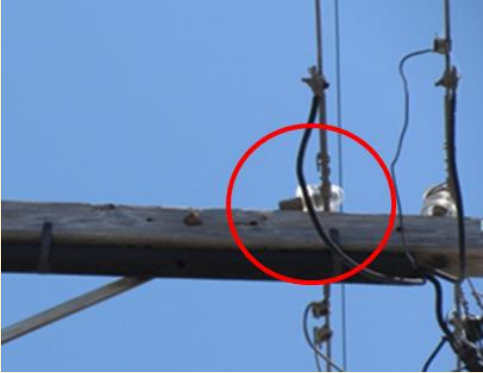
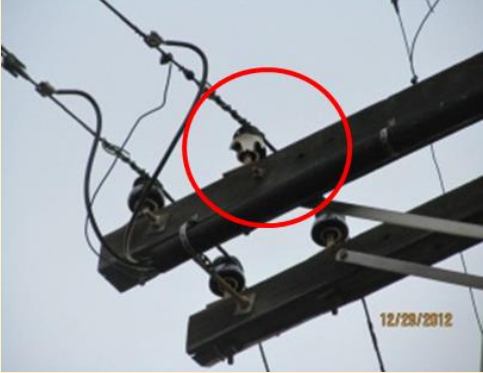
BROKEN WOOD PIN ON SECONDARY	BROKEN SECONDARY INSULATOR

<p>At this Location: Broken secondary wood pin. Conductor lying on the arm, tangent pole. (Excluding urban wildfire areas, use risk priority matrix). Wood pin arm at end of life replace arm with composite arm</p>	<p>At this Location: Broken secondary insulator. Strain is controlled by the second insulator on the Double arm construction.</p>
<p>Perform Minor Work: Yes, if safe to do so</p>	<p>Perform Minor Work: No</p>
<p>Write 3rd Party Notification: No</p>	<p>Write 3rd Party Notification: No</p>
<p>Write EC Notification: Yes, if minor work not possible</p> <p>FDA= Crossarm / Decayed/Rotten / Replace</p> <p>FDA= Conductor / Floater / Replace</p> <p>Priority= A Tag, Follow emergency process</p>	<p>Write EC Notification: Yes</p> <p>FDA= Crossarm / Decayed/Rotten / Replace</p> <p>FDA= Insulator / Broken/ Damage / Replace</p> <p>Priority= E Tag, 3-12 months depending on exposure</p>

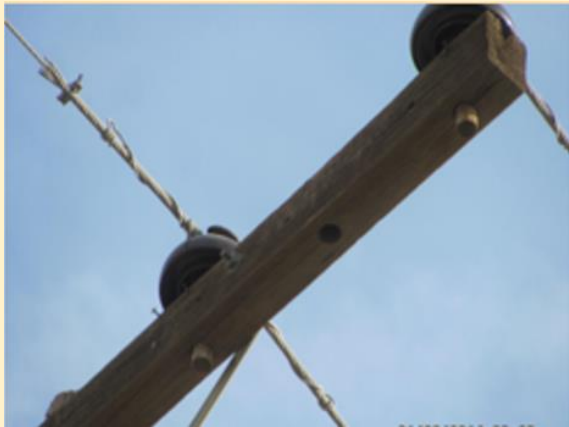
At this Location: 2 Primary wood pin squatters, replace wood crossarm with composite arm
	Perform Minor Work: No
	Write 3rd Party Notification: No
	Write EC Notification: Yes FDA= Crossarm Decayed / Rotten / Replace FDA= Insulator / Primary Squatter / Replace Priority= E Tag, 3-12 months, at minimum, next inspection cycle; based on field condition and exposure, corrosion, etc.; prioritize as needed (A, B, E, or F)

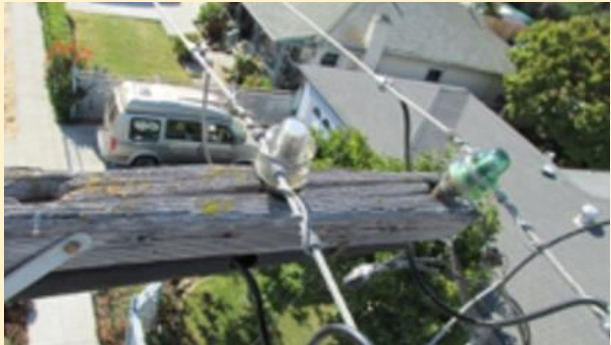
Secondary Squatter and Decayed Crossarm

At this Location: Secondary Squatter and decayed crossarm, replace wood crossarm with composite arm.
	Perform Minor Work: No
	Write 3rd Party Notification: No
	Write EC Notification: Yes
	FDA= Crossarm Decayed / Rotten / Replace FDA= Secondary Squatter / Broken / Damaged / Replace Priority= E Tag, 3-12 months at minimum, next inspection cycle; based on field condition and exposure, corrosion, etc.; prioritize as needed (A, B, E, or F)

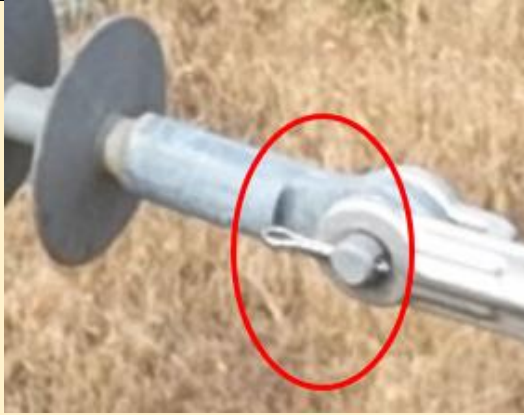
Cotter Key Backed Out

At this Location: Cotter Key partially backed out

FDA= Hardware / Loose / Adjust

Priority= E Tag, 3-12 months, depending on exposure

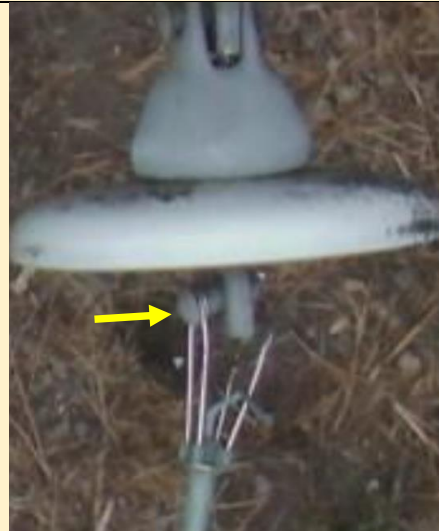
Retainer Pin Coming loose, almost pulled out

At this Location: Retainer Pin coming loose, almost pulled out

FDA = Hardware / Loose / Adjust

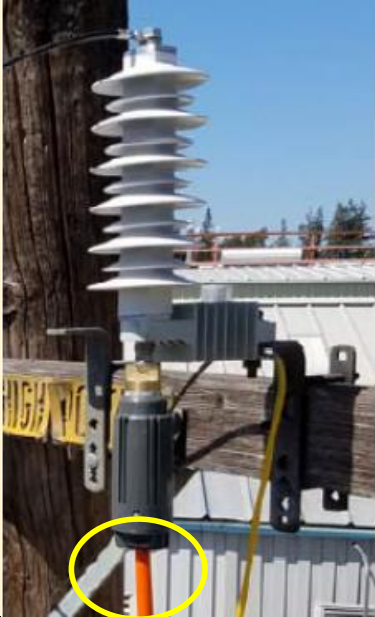
Non-Exempt Surge Arrestor Blown	Exempt ABB-type Arrestor Blown

At this Location: Non-Exempt Surge Arrestor Blown	At this Location: Exempt ABB arrester operated / blown indicated by the orange marker sticking out the bottom
Perform Minor Work: No	Perform Minor Work: No
Write 3rd Party Notification: No	Write 3rd Party Notification: No
Write EC Notification: Yes FDA= Lightning Arrestor / Broken / Damaged / Replace Priority= E Tag, 3-12 months, depending on exposure	Write EC Notification: Yes FDA= Lightning Arrestor / Broken / Damaged / Replace Priority= E Tag, 3-12 months, depending on exposure

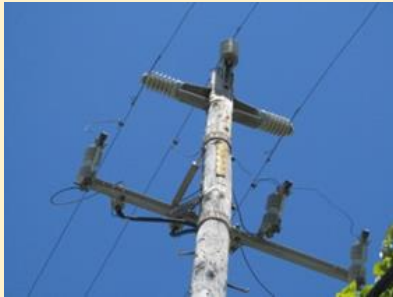
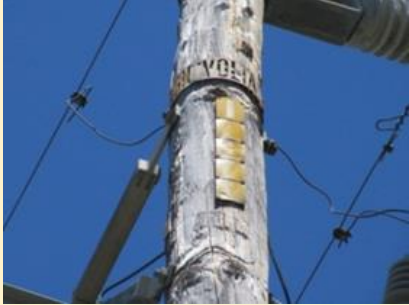
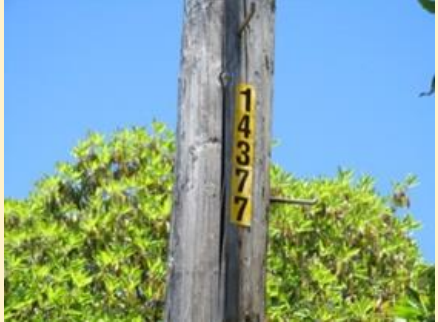
FADED OPERATING NUMBER		
Before: Faded operating number	Close Up	After: Minor work completed, operating number applied below operating position.

At this Location: Operating number is faded		
Perform Minor Work: Yes		
Write 3rd Party Notification: No		
Write EC Notification: Yes, only if minor work cannot be performed FDA= Marking / Broken / Damaged / Replace Priority= E Tag, 12 months

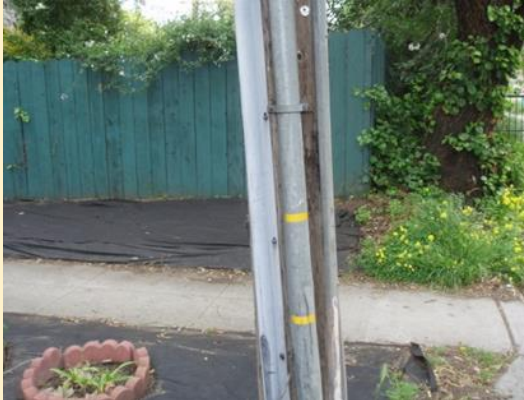
INADEQUATE VISIBILITY STRIPS

At this Location: Pole with vehicular exposure. Two small sections of yellow adhesive visibility strips.

Priority= At minimum –must write up as Priority F Tag next inspection cycle; based on field condition and exposure, corrosion, etc.; prioritize as needed (A, B, E, or F)

Perform Minor Work: Yes

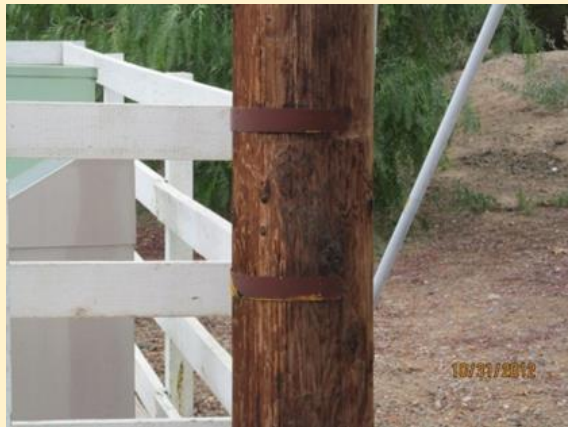
VISIBILITY STRIPS PAINTED OVER NO LONGER REFLECTIVE

At this Location: Visibility strips painted brown (3PrdP visibility strip located above not shown in picture).

Perform Minor Work: Yes

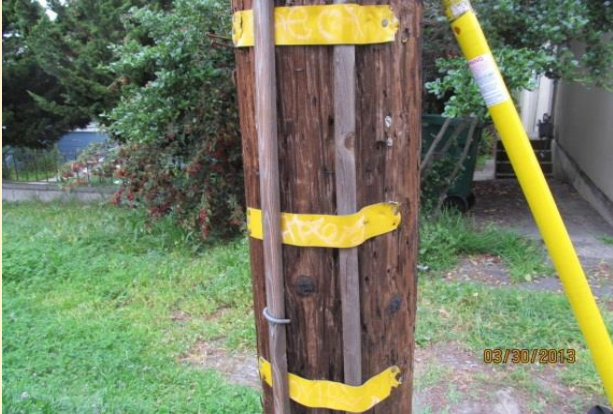
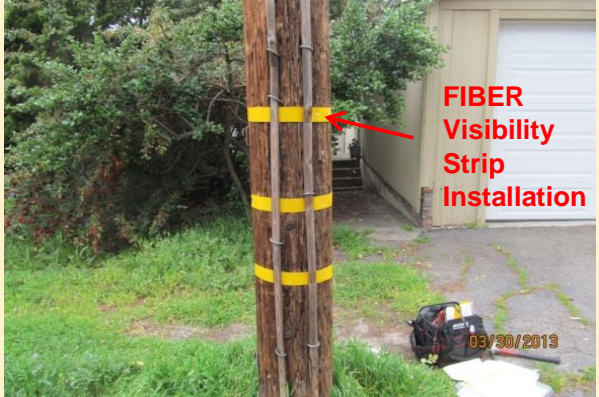
METAL OVER MOLDING	
Before	After

At this Location: Metal visibility strips under wood molding and over wood molding with protruding edge.	
Perform Minor Work: Yes, remove old metal visibility strips and apply new visibility strips; visibility strips installed in “after” photo are fiber, not metal (coded item)	
Write 3rd Party Notification: No	
Write EC Notification: Yes, only if minor work cannot be performed FDA= Vis-Strips / Broken / Damaged / Replace	
Priority= At minimum – must write up as Priority F Tag next inspection cycle; based on field condition and exposure, corrosion, etc.; prioritize as needed (A, B, E, or F)

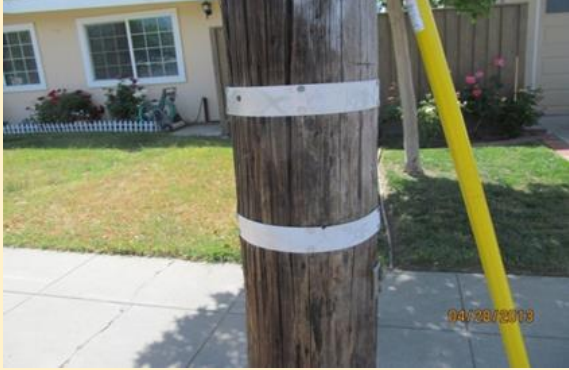
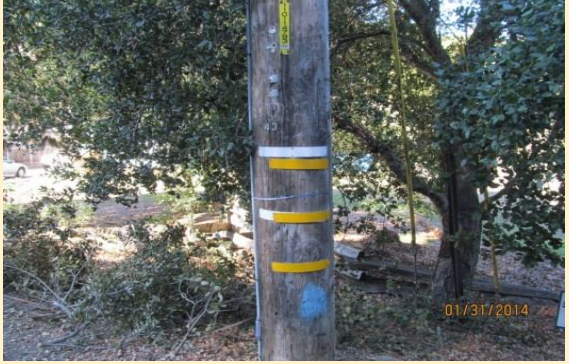
OLD METHOD VISIBILITY STRIPS NOT YELLOW	OLD AND NEW VISIBILITY STRIPS NOT YELLOW

At this Location: Aged visibility strips have lost reflectivity.	At this Location: Yellow visibility strips mounted over old white visibility strips.
Perform Minor Work: Yes, Replace with 3 yellow visibility strips	Perform Minor Work: Yes, remove old visibility strips
Write 3rd Party Notification: No	Write 3rd Party Notification: No
Write EC Notification: Yes, if minor work cannot be performed.	Write EC Notification: Yes, if minor work cannot be performed.
FDA= Vis-Strips / Broken / Damaged / Replace	FDA= Vis-Strips / Broken / Damaged / Replace
Priority= At minimum – must write up as Priority F Tag next inspection cycle; based on field condition and exposure, corrosion, etc.; prioritize as needed (A, B, E, or F)	Priority= At minimum – must write up as Priority F Tag next inspection cycle; based on field condition and exposure, corrosion, etc.; prioritize as needed (A, B, E, or F)

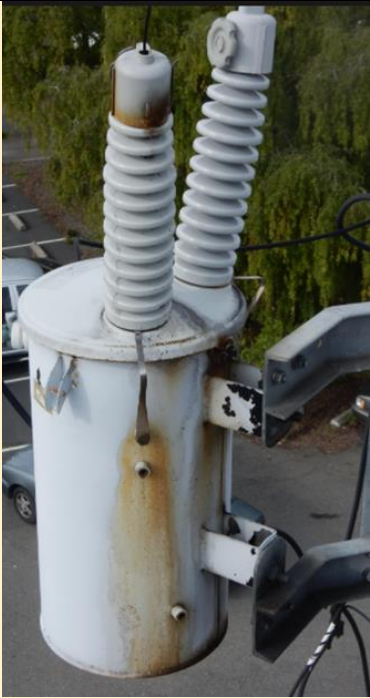
At this Location: Leaking OH Transformer, Residual Stain mark that appears dried, no sign of oil on ground. Oil has leaked out of the high side bushing, appears dried.
	Perform Minor Work: No
	Write 3rd Party Notification: No
	Write EC Notification: No No further action
LEAKING OH TRANSFORMER

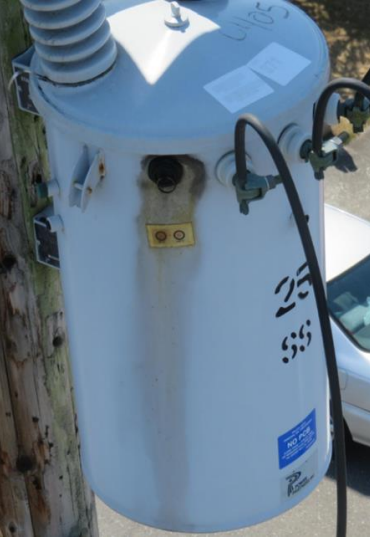
At this Location: Leaking OH Transformer, Residual Stain mark that appears dried on IFD (Internal Fault Detection)
	Perform Minor Work: No
	Write 3rd Party Notification: No
	Write EC Notification: No No further action

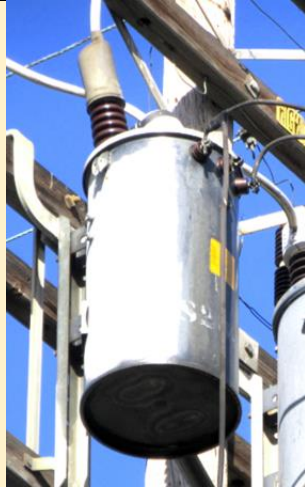
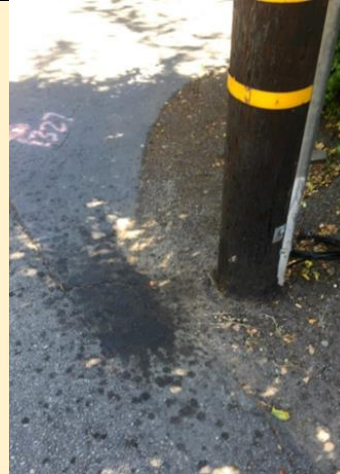
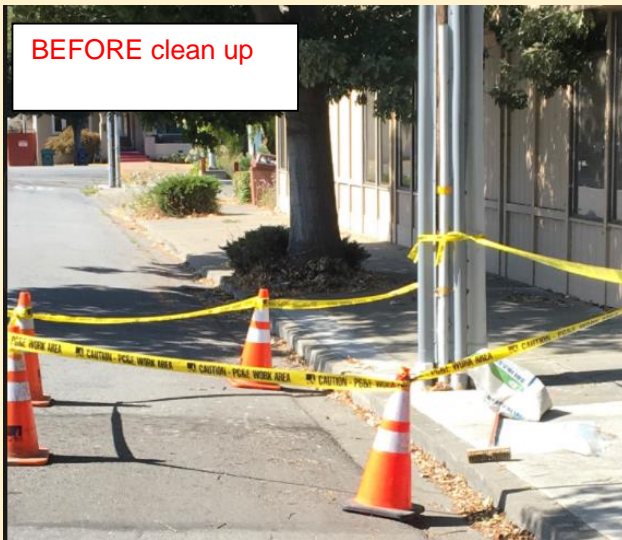
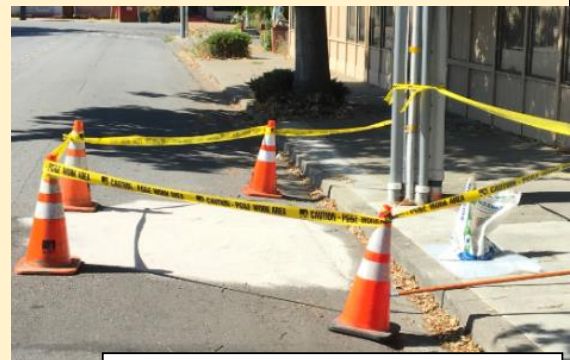
LEAKING OH TRANSFORMER, OIL ON THE GROND

BEFORE clean up

AFTER - Taped off, cleaning measures applied, stand by still

At this Location: Leaking OH transformer, oil on the ground

FDA= Transformer / Leaking / Seeping / Replace

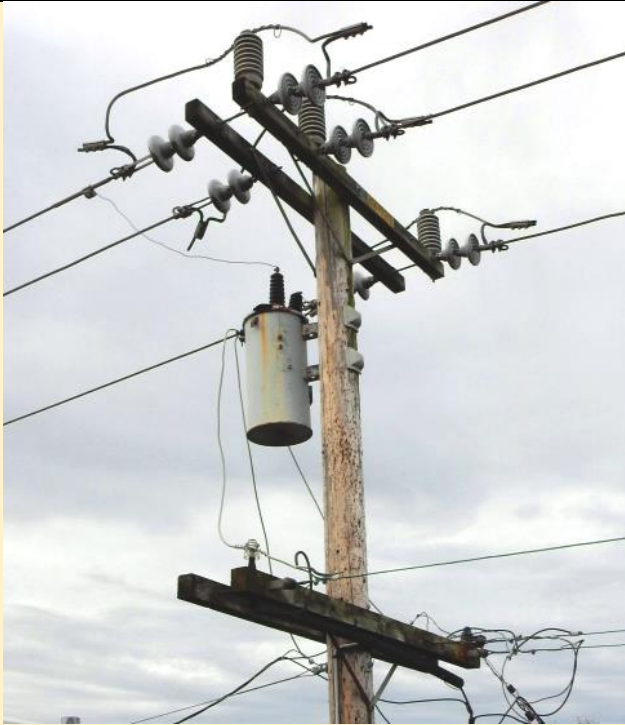
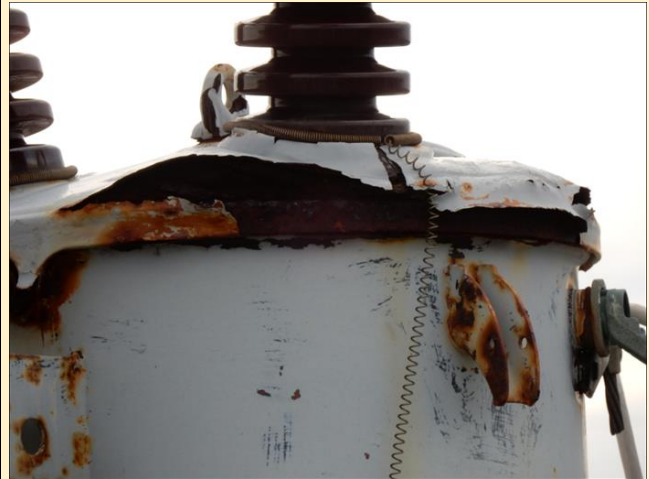
TRANSFORMER CORROSION

At this Location: Transformer with heavy corrosion.

FDA = Transformer / Corroded / Replace

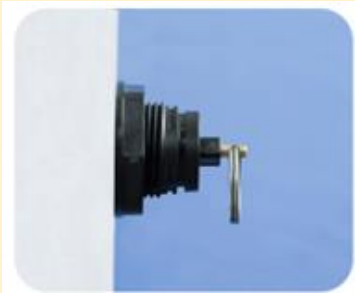
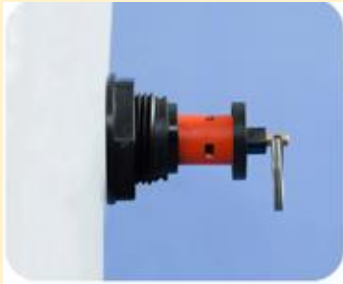
Transformer Internal Fault Device Activated

Not Activated	Activated
At this Location: Transformer internal fault device activated, indicating overheating, and the orange band is visible.	
Perform Minor Work: No	
Write 3rd Party Notification: No	
Write EC Notification: Yes	
FDA= Transformer / Broken / Damaged / Replace	
Priority= E Tag, 3-12 months depending on exposure

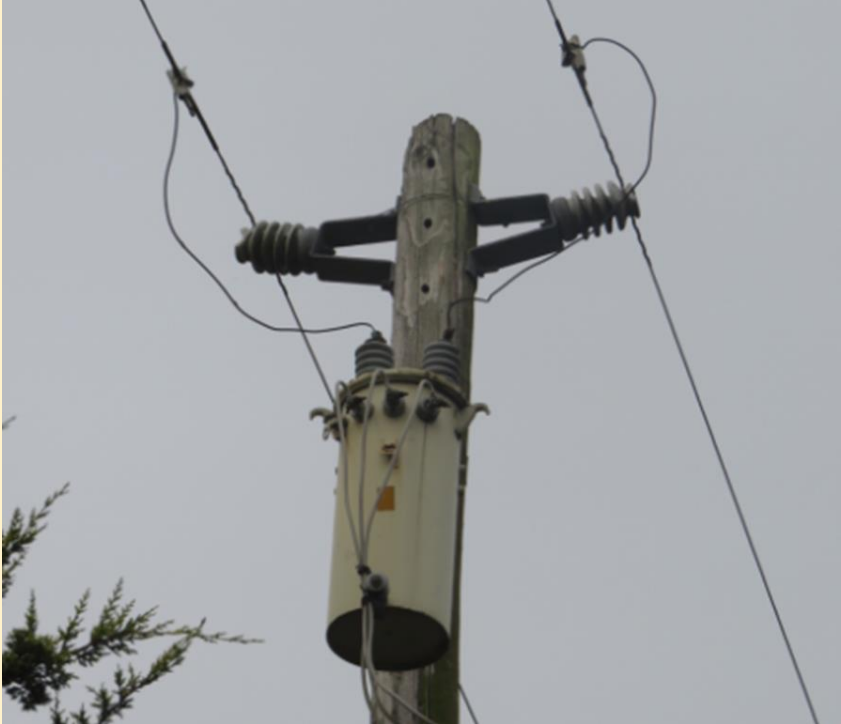
BLUE STICKER TRANSFORMER

At this Location: Blue Sticker not present on transformer, suspect for PCB. Answer questionnaire.	
Perform Minor Work: No	
Write 3rd Party Notification: No	
Write EC Notification: No

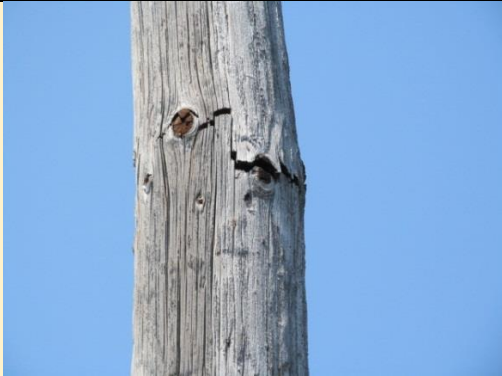
BROKEN POLE

At this Location: Broken pole, Rural area, low public exposure. More Than 30% of the diameter. Complete the Pole Inspection Test Report.
	Perform Minor Work: No
	Write 3rd Party Notification: No
	Write EC Notification: Yes FDA= Pole / Broken/Damaged / Replace Priority= A Tag, Follow the Emergency Procedure

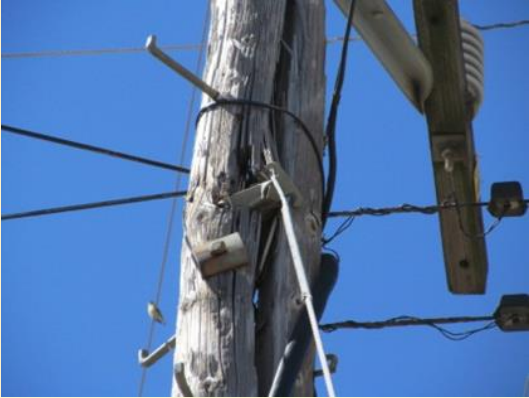
POLE SPLIT AT COMMUNICATION LEVEL	Pole Check

At this Location: Pole split at communication level. Joint pole. Complete the Pole Inspection Test Report.	At this Location: Pole Check, structural integrity not compromised. Natural cracking on the pole. Not due to strain or loading.
Perform Minor Work: No	Perform Minor Work: No
Write 3rd Party Notification: No	Write 3rd Party Notification: No
Write EC Notification: Yes FDA= Pole / Broken/Damaged / Replace Priority= B Tag, 3 months, depending on exposure	Write EC Notification: No

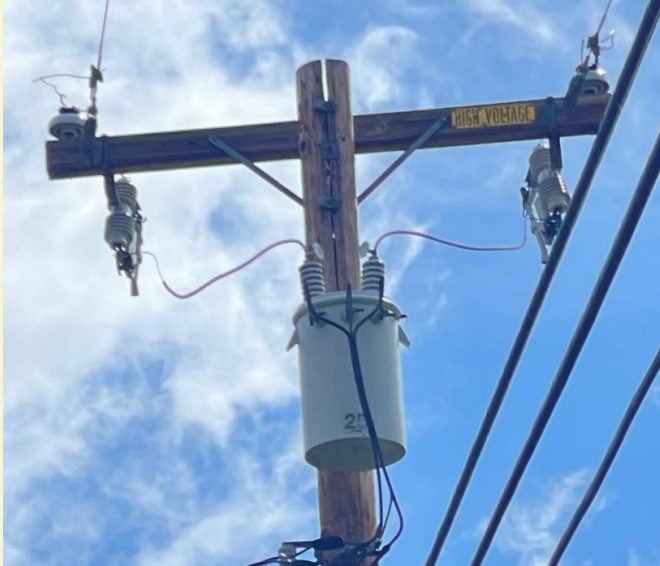
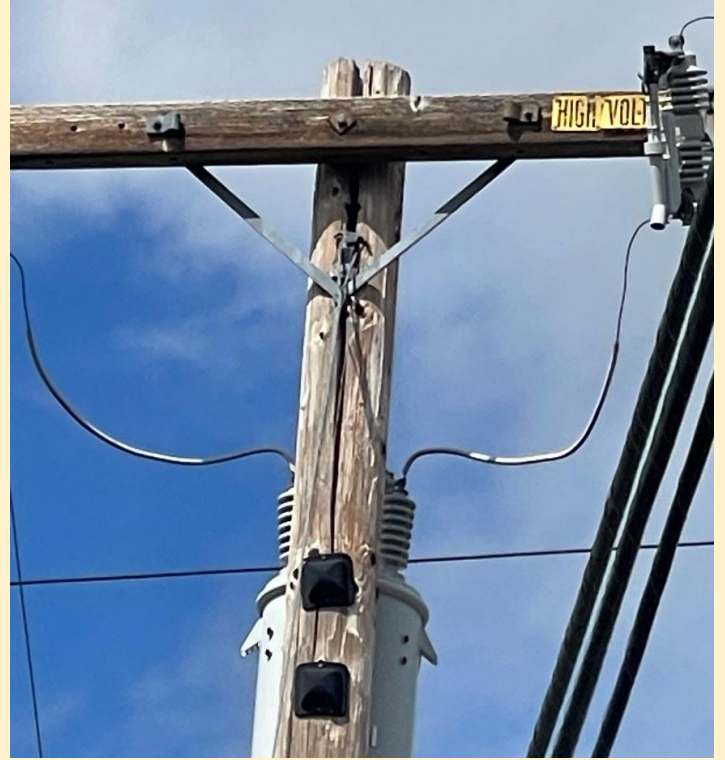
POLE SPLIT

At this Location: Pole top split and can see daylight. Dead end single guy, down guy fixture has moved and slid down from original location onto the brace. Cross-arm brace hardware also compromised. No split bolt.

FDA= Pole / Broken/Damaged / Replace

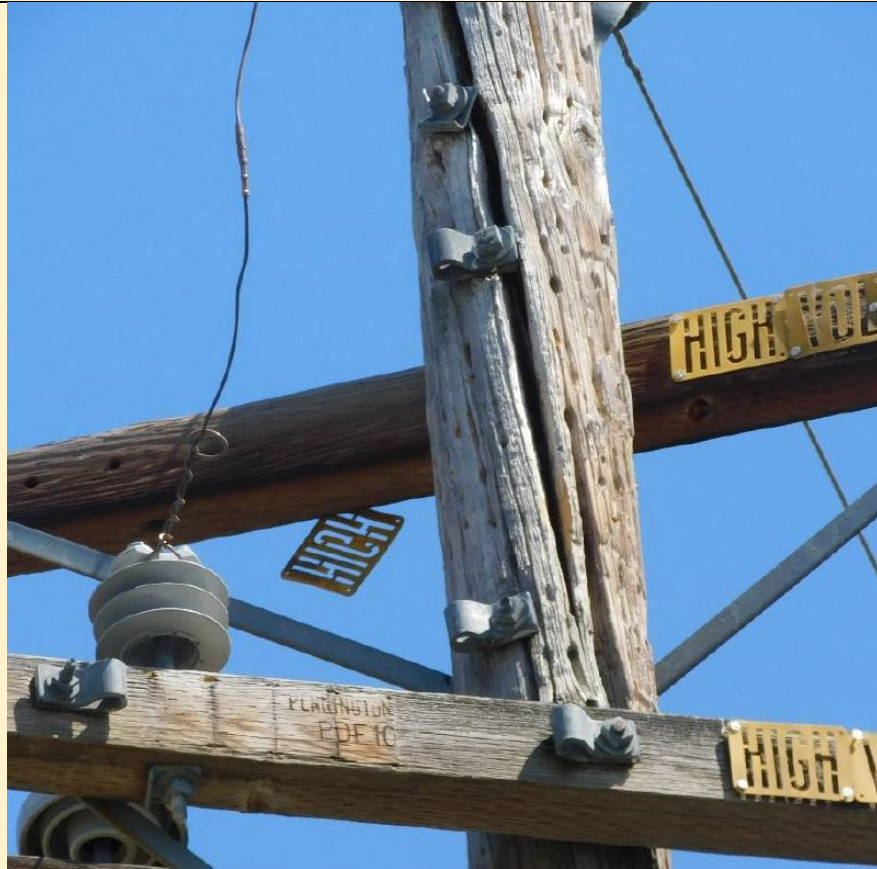
POLE SPLIT

At this Location: Checks are opening on the pole at the equipment level. Multiple checks, possible movement on the cross-arm hardware, at the brace bolt on the top cross-arm. Hardware sinking in, pole twist spiral.

FDA = Pole / Broken/Damaged / Replace

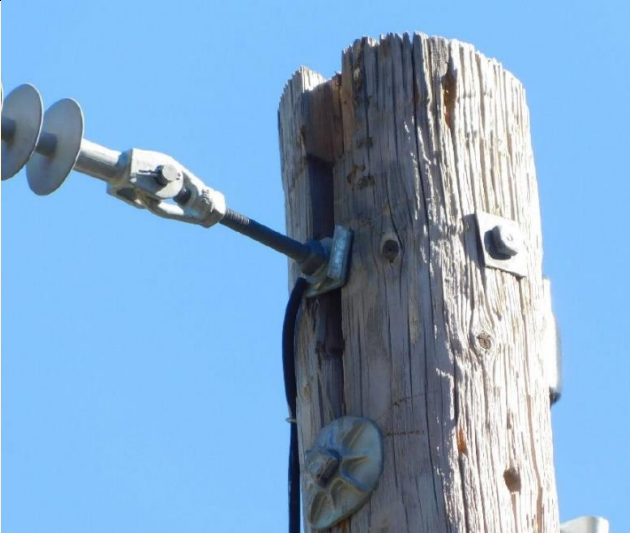
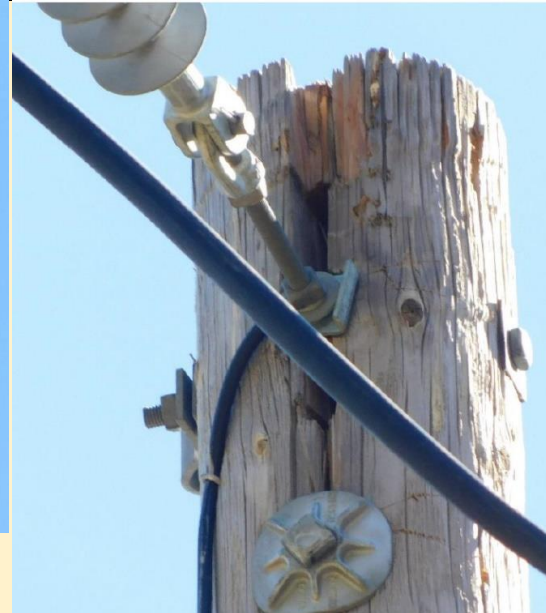
POLE SPLIT

At this Location: Split in the pole top has been corrected with a split bolt, but the dead end has moved and is laying on top of the split bolt.

FDA = Pole / Broken/Damaged / Replace

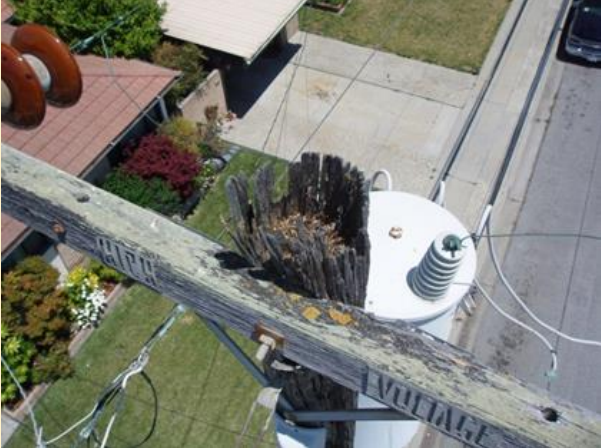
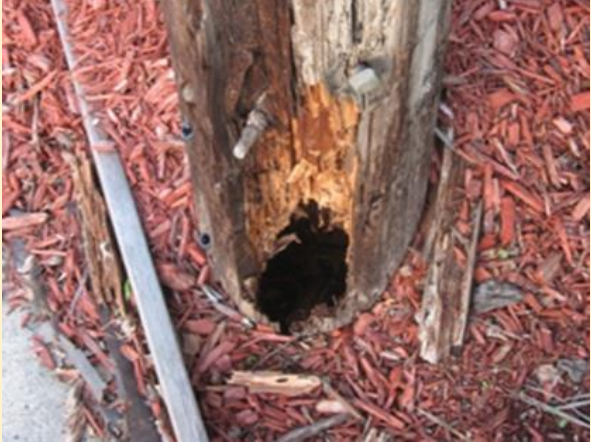
DECAY OF POLE OVER TIME	SEVERE DETERIORATION AT GROUND LEVEL

At this Location: Pole top decayed Complete the Pole Inspection Test Report	At this Location: Deteriorated condition found during inspection. Complete Pole Inspection Test Report.
Perform Minor Work: No	Perform Minor Work: No
Write 3rd Party Notification: No	Write 3rd Party Notification: No
Write EC Notification: Yes FDA= Pole Decayed/Rotten/Replace	Write EC Notification: Yes FDA= Pole Decayed/Rotten/Replace
Priority= B Tag, 0-3 months, depending on exposure	Priority= A Tag, Follow the emergency process.

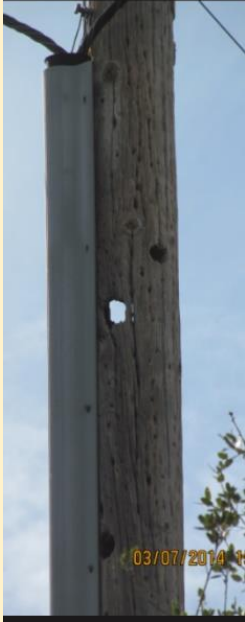
WOODPECKER DAMAGE NESTING CAVITY

At this Location: Obvious sign of a cavity in the pole by seeing daylight through the pole. Unable to determine the depth of the cavity.
	Perform Minor Work: No
	Write 3rd Party Notification: No
	If unable to determine damage: <ul style="list-style-type: none"> • Write EC Notification: Yes • FDA= Pole / Woodpecker Damage / Assessment • Priority= E Tag, 3-12 months If damage is determined sufficient: <ul style="list-style-type: none"> • Write EC Notification: Yes • FDA= Pole / Woodpecker Damage / Replace • Priority= E Tag, 3-12 months

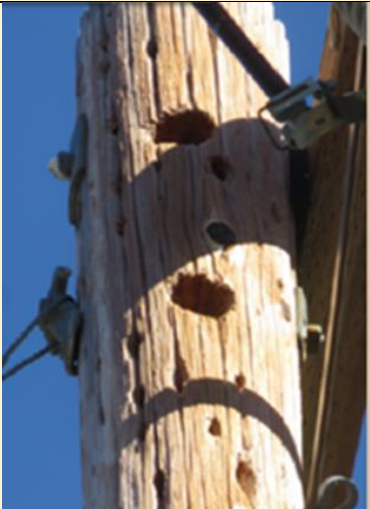
WOODPECKER DAMAGE AT THE TOP OF THE POLE

At this Location: Woodpecker holes near framing hardware.
	Perform Minor Work: No
	Write 3rd Party Notification: No
	Write EC Notification: Yes FDA= Pole / Woodpecker Damage / Replace Priority= E Tag, 3-12 months

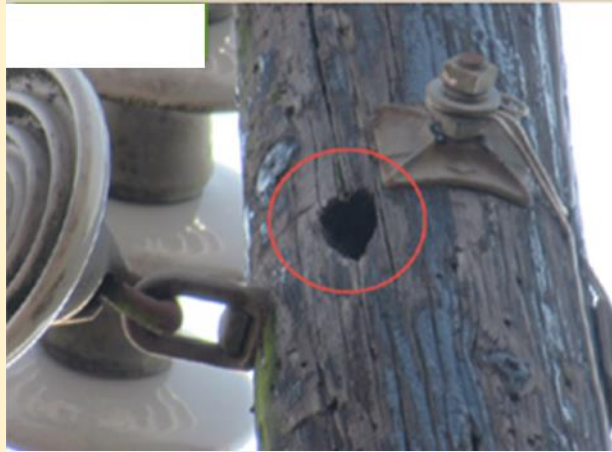
WOODPECKER DAMAGE MEDIUM CAVITY

At this Location: Woodpecker holes near framing hardware, per Guidance "There is 1 vertical inch of solid wood directly below any through bolt to support existing or proposed attachments".

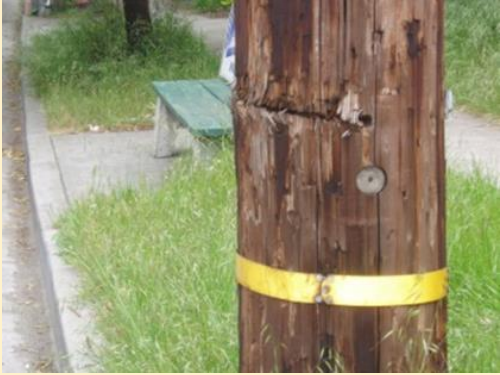
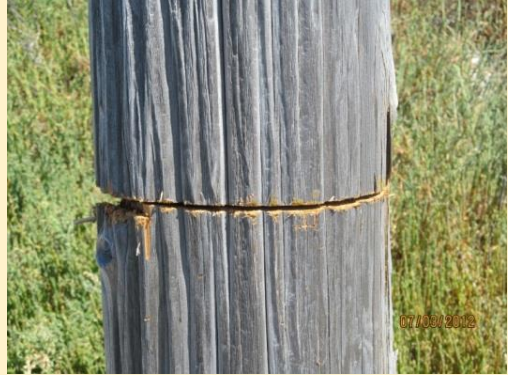
CUT INTO POLE

At this Location: Vandalized pole. Chain saw cut into lower portion of pole. <u>Half of pole circumference cut into.</u> Complete Pole Inspection Test Report	
Perform Minor Work: No	
Write 3rd Party Notification: No	
Write EC Notification: Yes FDA= Pole / Broken / Damaged / Replace Priority= A Tag, Follow the emergency process

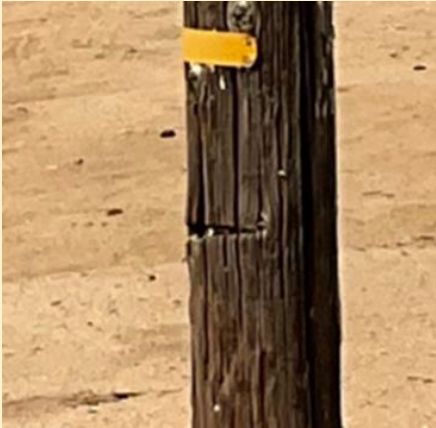
CUT INTO POLE

At this Location: Cut into pole. Not a deep cut, no strain on pole, no public exposure. Complete the Pole Inspection Test Report.
	Perform Minor Work: No
	Write 3rd Party Notification: No
	Write EC Notification: Yes FDA= Pole / Broken/Damaged / Replace Priority= E Tag, 3-12 months, depending on exposure send to estimating for pole loading calc. (pole overload test)

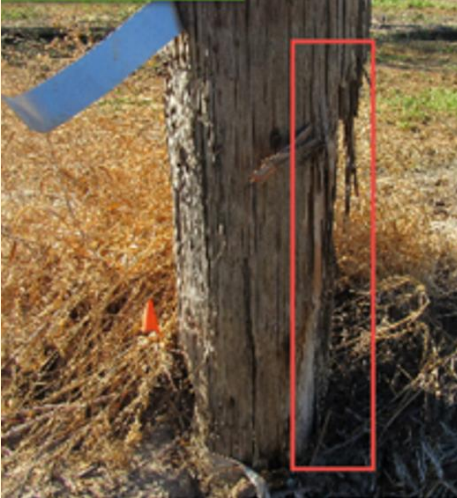
At this Location: Significant Reduced Circumference (Tractor Damage)

Priority= E Tag, 12 months, depending on exposure

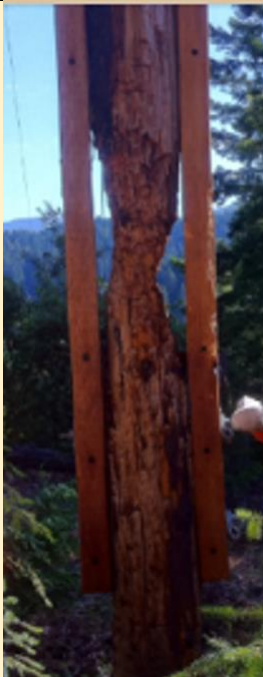
Significant Reduced Circumference (Bear Damage)

At this Location: Significant Reduced Circumference (Bear Damage). Temporary Repairs made.

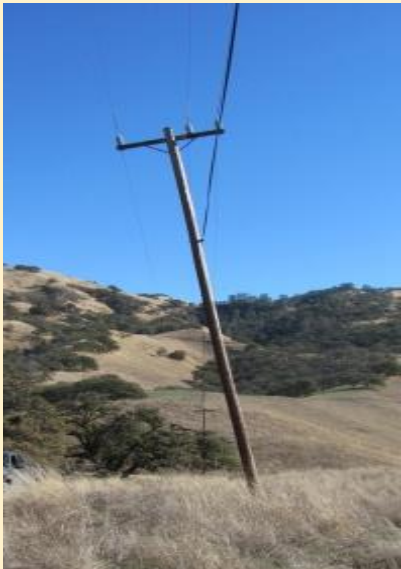
At this Location: Leaning pole greater than 10% out of plumb. Pole is stable. No equipment, in rural area. Causing reduced clearance.	At this Location: Leaning towards a tree more than 10% out of plumb. Inspector pulled plug and confirmed pole is solid below ground. Probability of equipment failure is moderate.
Perform Minor Work: No	Perform Minor Work: No
Write 3rd Party Notification: No	Write 3rd Party Notification: No
Write EC Notification: Yes FDA= Pole / Leaning / Adjust	Write EC Notification: Yes FDA= Pole / Leaning / Replace
Priority= E Tag, 3-12 months, depending on exposure	Priority= B Tag, 0-3 months, depending on exposure

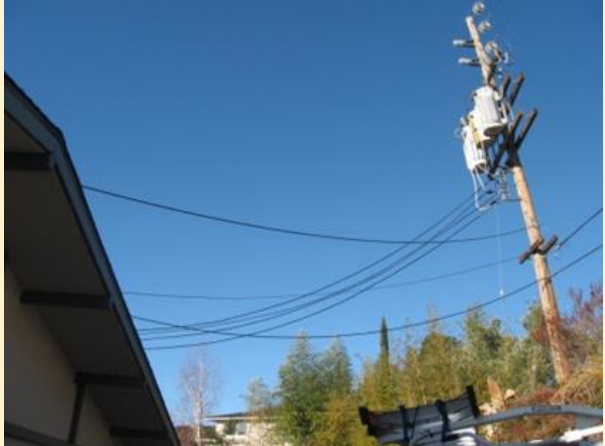
At this Location: Stubbed pole leaning towards school, supported by down guy. Pole Bands are loose due to additional deterioration of the pole.	At this Location Pole is leaning less than 10% out of plumb, leaning in direction of offset equipment.
Perform Minor Work: No	Perform Minor Work: No
Write 3rd Party Notification: No	Write 3rd Party Notification: No
Write EC Notification: Yes FDA= Pole / Decayed / Rotten / Replace Priority= B Tag, 0-3 months, depending on exposure	Write EC Notification: No

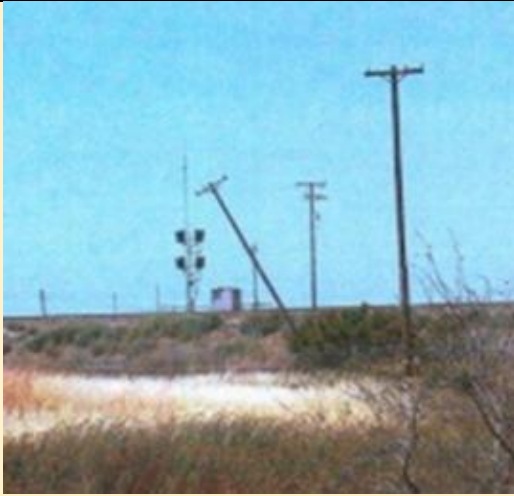
POLE LEANING NEAR RAILROAD TRACKS

At this Location: Severe lean being held up by the primary conductors. Low clearance over an active railroad track. Pole located in a swamp area with standing water.

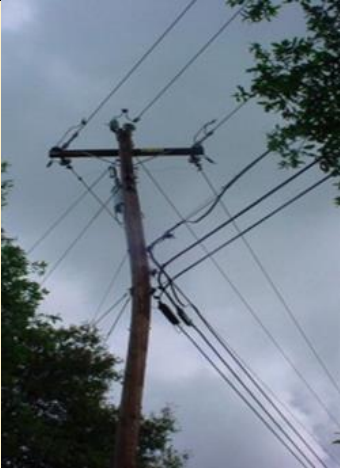
INADEQUATE SUPPORT AT COMMUNICATIONS LEVEL

At this Location: Two guys stabilizing communication level.
	Perform Minor Work: No
	Write 3rd Party Notification: No
	Write EC Notification: Yes FDA= Pole / Overload / Replace Priority= E Tag, 3-12 months depending on exposure
