#### **NOTICE OF VIOLATION**

On May 6 and 7, 2025, Energy Safety conducted an inspection of SCE's WMP initiatives in the vicinity of the city of Moreno Valley, California. The inspection report is enclosed herewith. Energy Safety found the following violation(s):

### **INSPECTION REPORT**

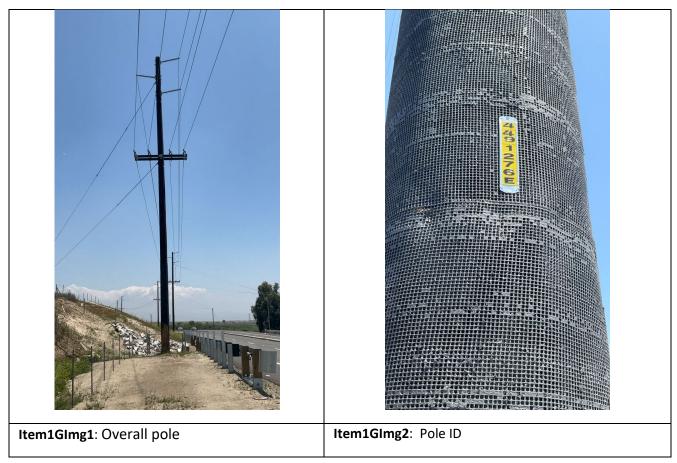
Exhibit A: Photo Log Structure ID: 4491276E

On pole ID 4491276E, Grid Hardening ID 410890030-4491276E at 34574-34810 Gilman Springs Rd, Moreno Valley, CA, 92555, USA, 33.8801406636701, -117.057241119606, the inspector observed that no wildlife covers were installed. The inspector's observation is documented in Violation 1 photographs, which are attachments to this report. Photo numbers Item1IA1Img1 andItem1IA1Img2 depict that there are no wildlife covers on the pole. Per information provided by SCE to the Compliance Inbox on June 4, 2025, at 4:13 pm, the remediation was completed.

**Item1IA1Img1:** View showing no wildlife covers installed
