NOTICE OF VIOLATION

On July 10, 2025, Energy Safety conducted an inspection of Southern California Edison Company's WMP initiatives in the vicinity of the city of Fallbrook, California. The inspection report is enclosed herewith. Energy Safety found the following violation(s):

INSPECTION REPORT

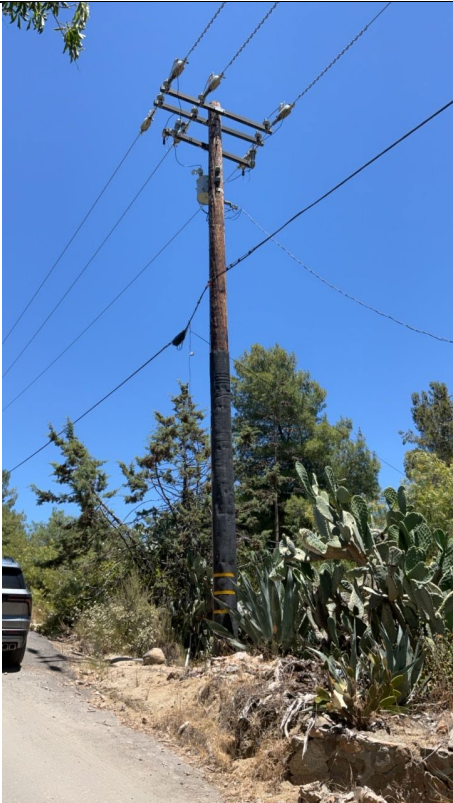
On pole ID 4527226E, Grid Hardening ID 414053882-4527226E at 47749 Rock Mountain Dr, Fallbrook, CA, 92028, USA, 33.436004, -117.236473, the inspector observed that the transformer bushing cover was opened. The inspector's observation is documented in Violation 1 photographs, which are attachments to this report. Photo numbers IA1Img1, IA1Img2, IA1Img3 depict that the transformer bushing cover was open. Per information provided by SCE to the Compliance Inbox on April 3, 2025, at 12:15 pm, the condition of opened transformer bushing was remediated.
