Subject: Acton Town Council Comments on the Draft Decision Issued by the Office of Electrical Infrastructure Safety to Approve Southern California Edison Company's 2026-2028 Base Wildfire Mitigation Plan.

Reference: Docket #2026-2028-Base-WMPs.

**COMMENTS SUBMITTED BY THE ACTON TOWN COUNCIL
TO THE CALIFORNIA PUBLIC UTILITIES COMMISSION ON
SCE PSPS POST EVENT REPORTS.**

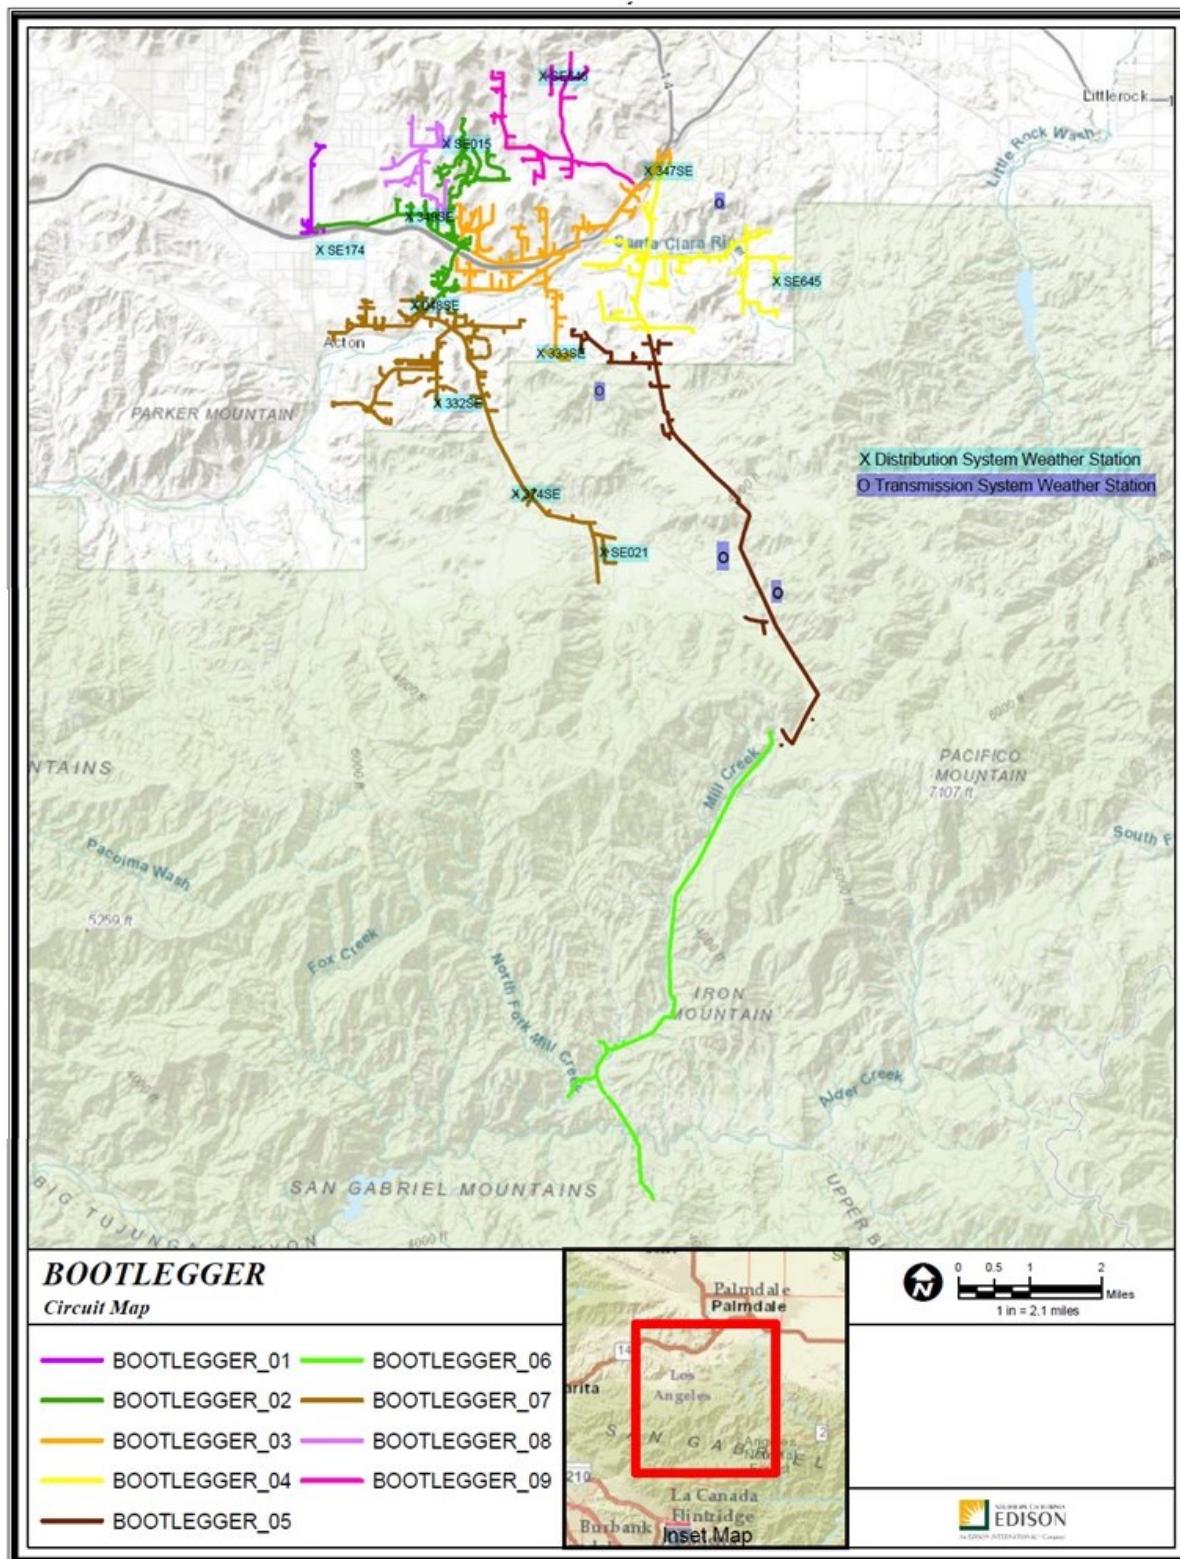
Figure 1. Bootlegger Circuit Map Showing Locations of Distribution Weather Stations.

Prior PSPS Post Event Reports indicate that SCE has frequently and unreasonably shut off power to residents on the Bootlegger circuit based on inapplicable weather data. For example, according to the Post Event Report that SCE prepared for the December 9, 2024 PSPS event, SCE cut power to residents on the north end of Bootlegger Segment 5 based on a claimed wind gust reading of 59.04 mph; however, none of the distribution circuit weather stations ever registered such a wind gust. In fact, the only weather station that registered a 59.04 mph wind gust was on a transmission tower on a ridgeline (specifically, Weather Station No. 555SE) which is located on the top of a 500 kV transmission tower on a high ridgeline and several miles from where Acton residents

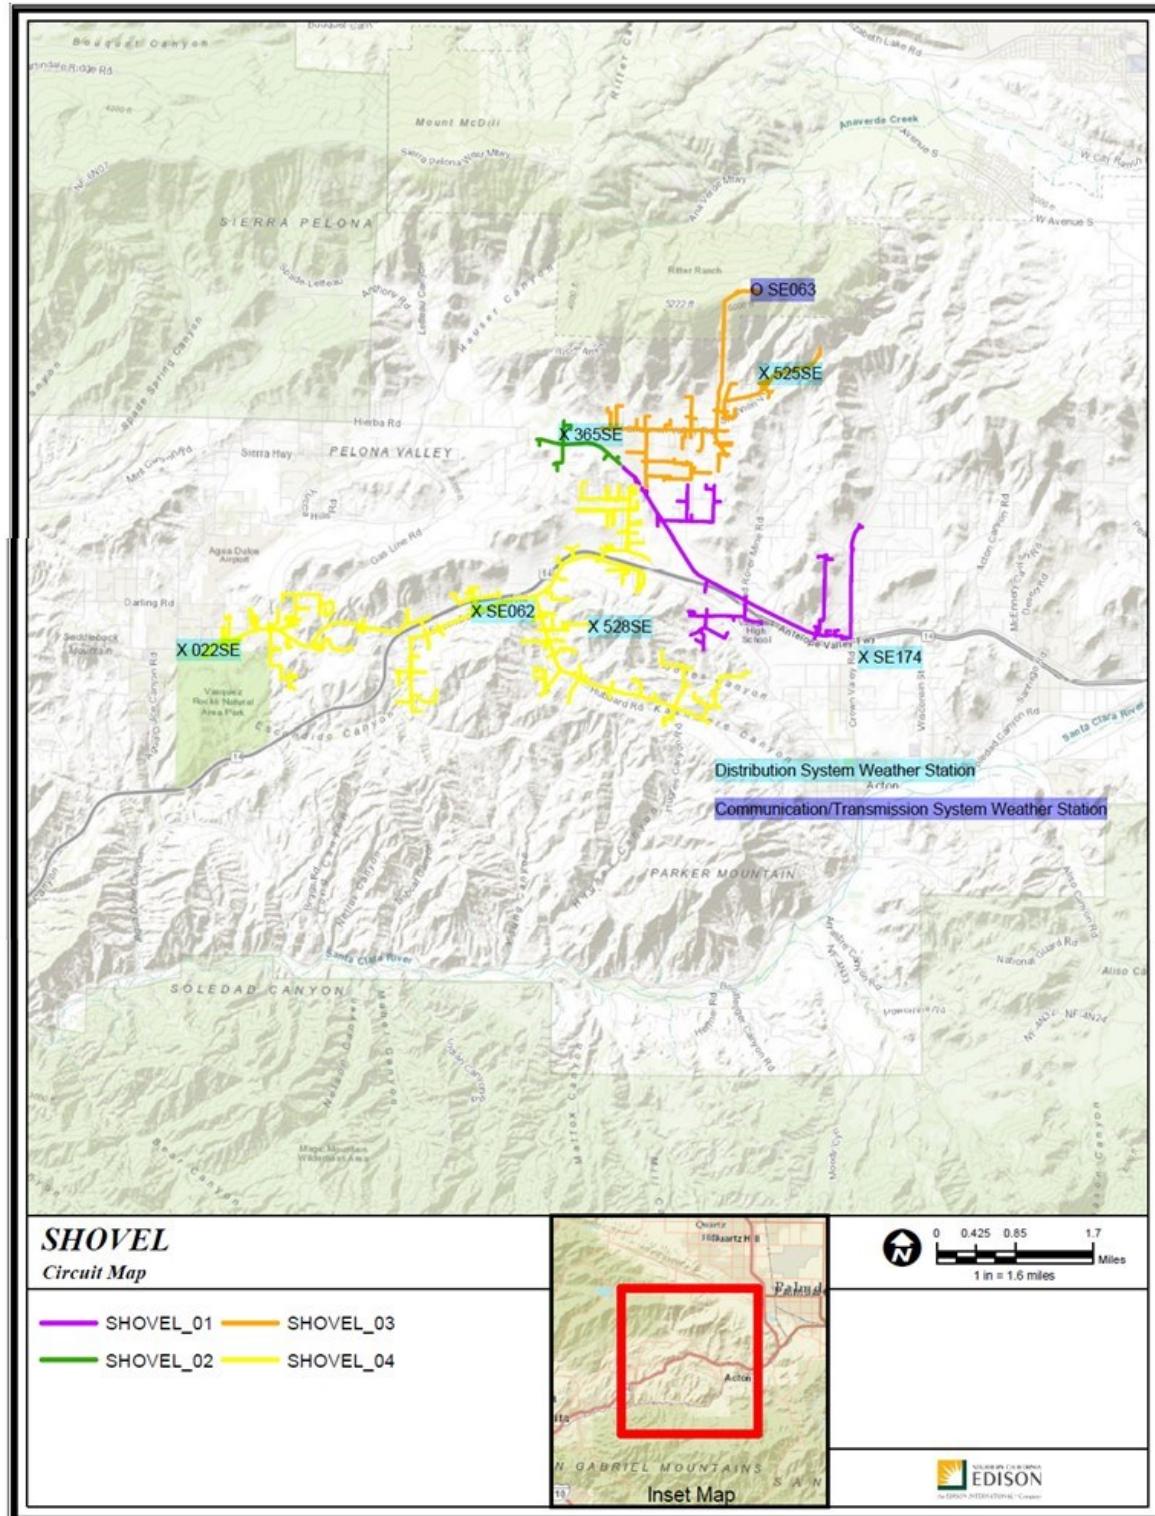
Figure 2. Shovel Circuit Map Showing Locations of Distribution Weather Stations.

The Shovel Circuit: The Council carefully mapped the location of SCE weather stations in the portion of Acton served by the Bootlegger distribution circuit. This map (provided in Figure 2) enabled the Council to identify all SCE weather stations that monitor conditions on the Shovel circuit and download weather data from these stations for the duration of the January 2 PSPS event. This weather data was then reconciled with SCE's power shutoff notices to precisely ascertain the weather conditions on each section of the Shovel circuit before and after it was shutoff. The results of this analysis are summarized in Table 2 which shows that the Shovel circuit never experienced any wind conditions which met or exceeded SCE de-energization thresholds either during the 12 hour period *before* power was shutoff or during the 12 hour period *after* the power shutoff. Accordingly, *none* of the power shutoffs that SCE initiated on any segments of the Shovel circuit during the January 2 PSPS event were warranted and *none* of them complied with SCE's own PSPS protocols which expressly limit power shutoffs to only circumstances in which the FPI threshold is exceeded AND a specific wind threshold is exceeded.

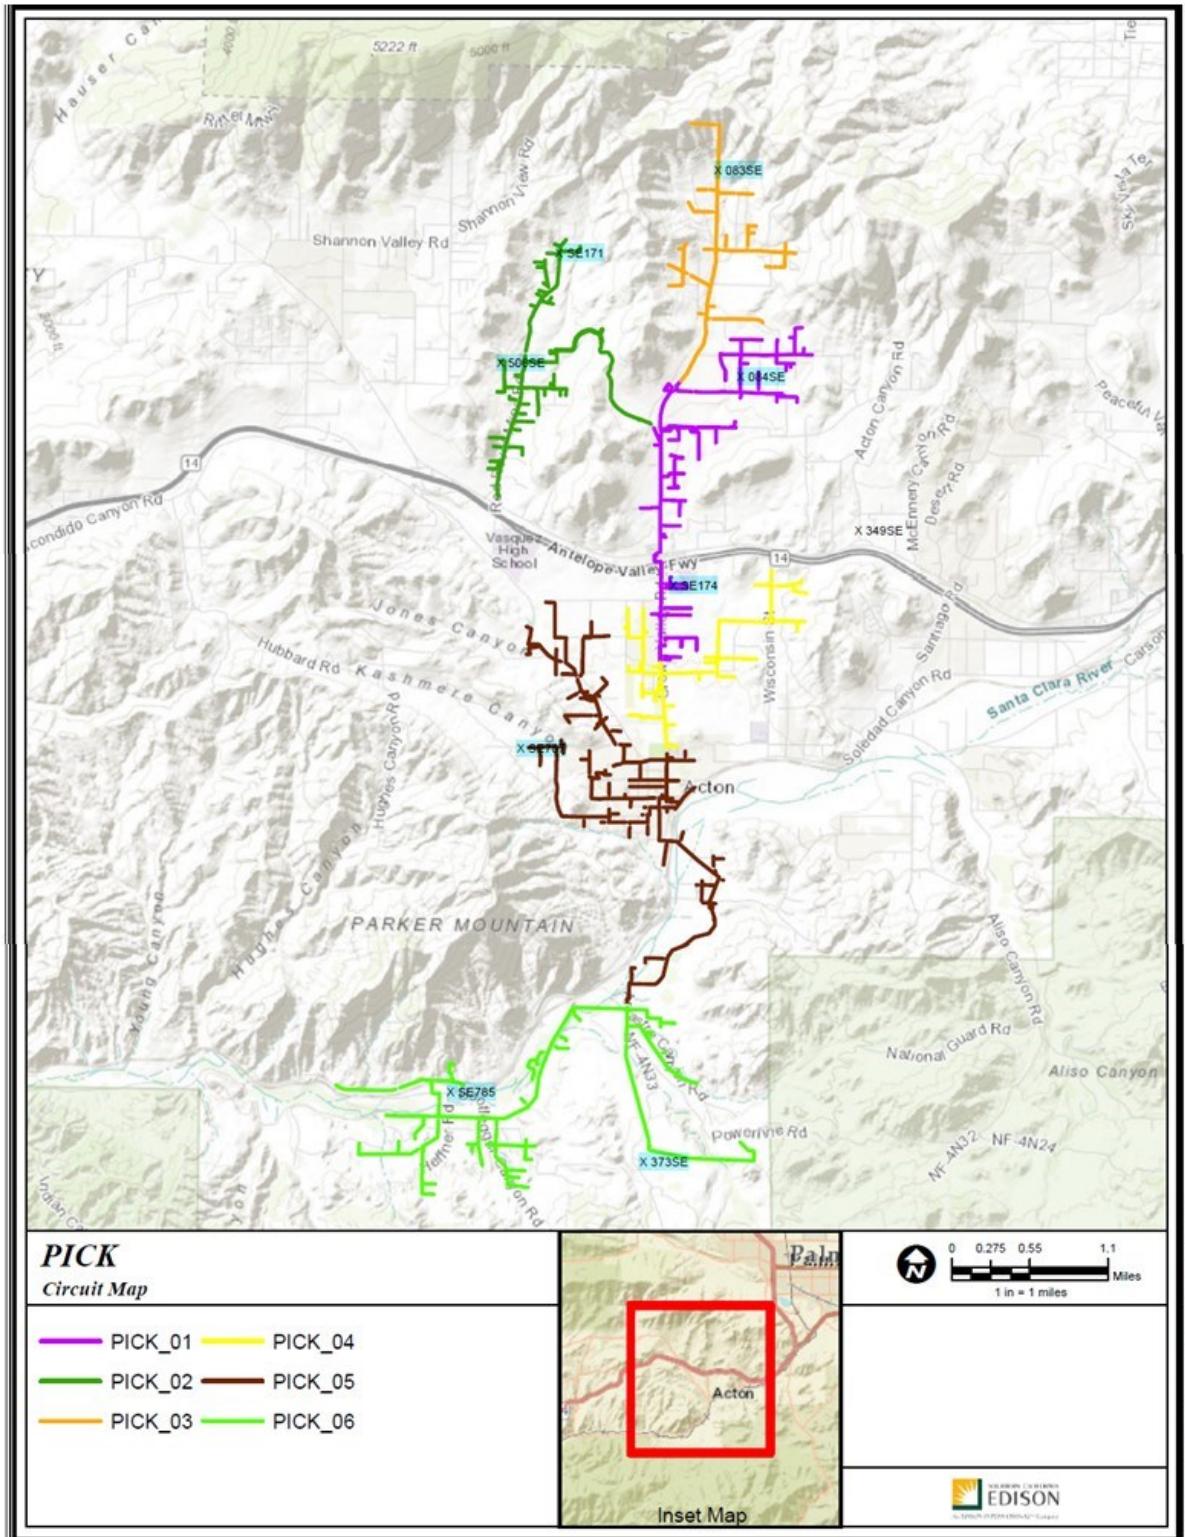
Figure 3. Pick Circuit Map Showing Locations of Distribution Weather Stations.

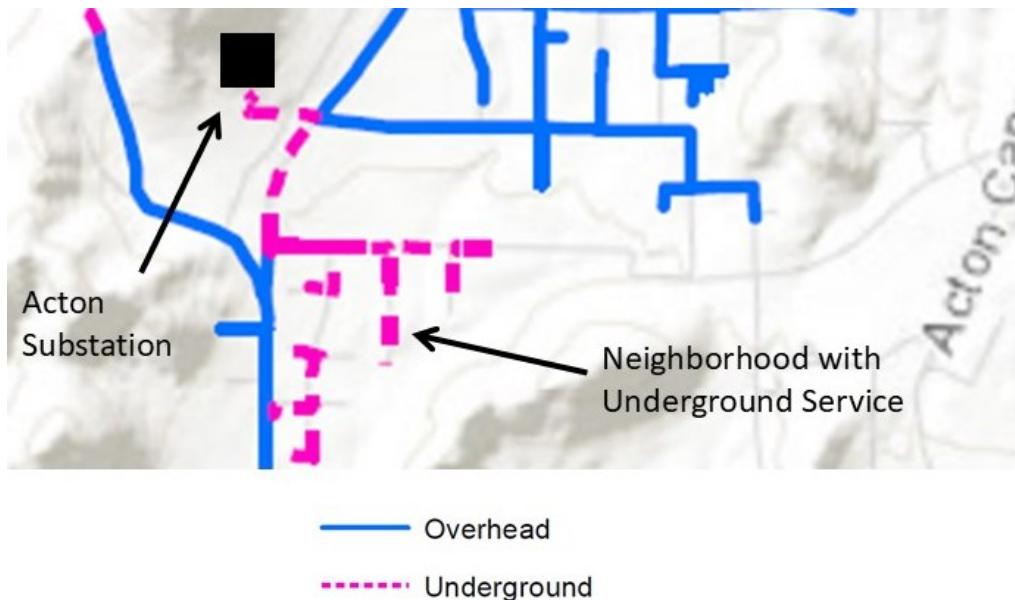
Figure 4. Pick Circuit Section with Full Underground Service from Acton Substation.

SCE has failed to sectionalize an entire neighborhood in Acton that has electrical service which is never affected by weather events because it is 100% underground from the Acton substation. The Council has pointed this out to SCE many times since SCE’s first PSPS events in 2019, but SCE has chosen not to sectionalize the area. We have also pointed out this significant deficiency to the Commission many times in our comments that we have filed in response to SCE Post PSPS Event reports and in our submissions in Proceeding I.19-11-013; unfortunately, the Commission ignored these concerns as well. SCE is aware that this neighborhood has full underground service; in fact, SCE recently provided the map depicted in Figure 4 which shows that the neighborhood has only underground service from the Acton Substation.

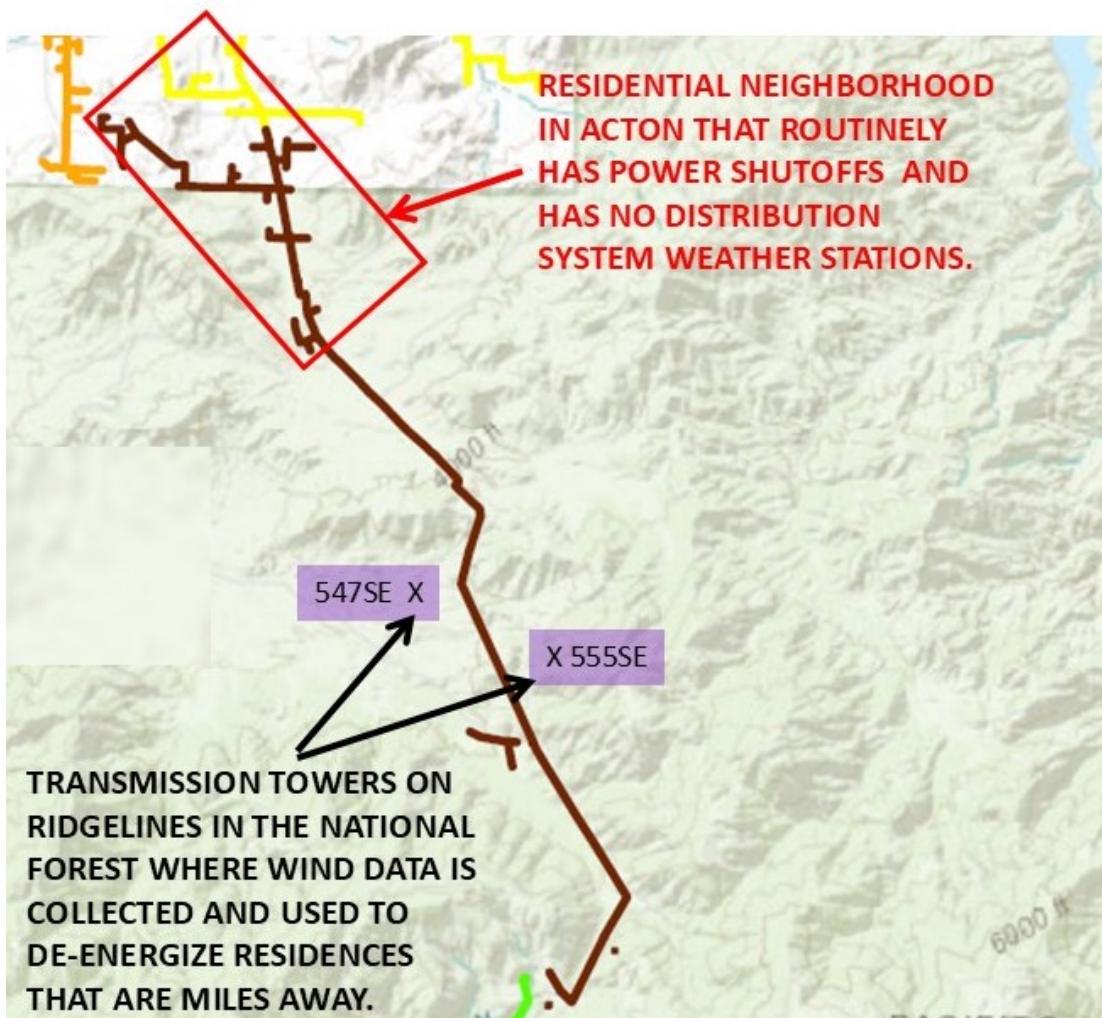
Figure 5. Residential Area on the Bootlegger Circuit that has not been Sectionalized and is Routinely De-Energized based on Erroneous Wind Data Collected from Atop Transmission Towers on Ridgelines Located Miles Away.

SCE has also failed to sectionalize a large residential area in Acton on Segment 5 of the Bootlegger circuit which experiences frequent and lengthy de-energizations based on *transmission system* wind measurements taken on top of 500 kV transmission towers located on high ridgelines miles from the homes where power is shutoff (as explained above). As shown in the map provided in Figure 5, SCE has not segmented a large residential area on the north end of Segment 5; this area has no dedicated distribution system weather stations, so SCE shuts off power to this neighborhood based on wind measurements collected on transmission facilities located on a ridgeline several miles south and deep into the Angeles National Forest. As a result, SCE routinely de-energizes Acton residents based on inapplicable wind data that does not represent *actual* wind conditions on the distribution circuit in the areas that are de-energized. All of this is improper and it violates the Commission's directive to continually reduce the scope and extent of PSPS events by sectionalizing circuits.

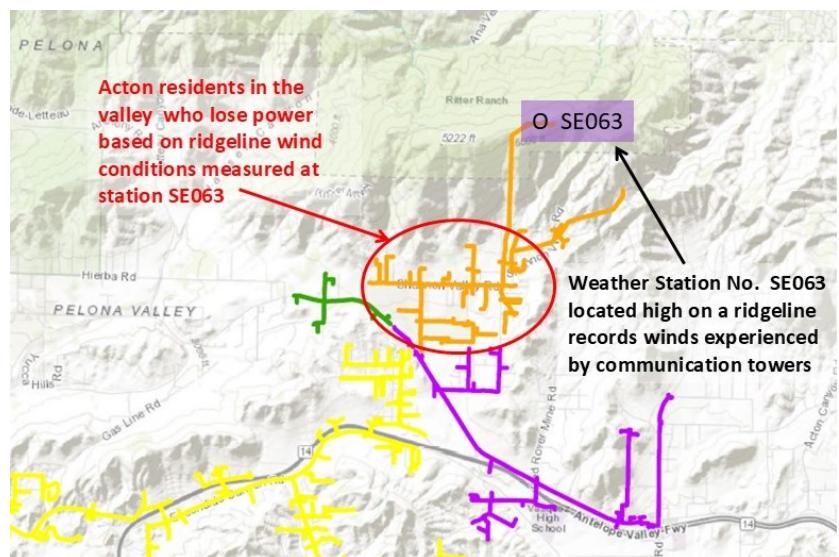
Figure 6. Residential Area on the Shovel Circuit that has not been Sectionalized and is Routinely De-Energized based on Erroneous Wind Data Collected from Atop Communication Towers located on Ridgelines High Above.

this ridgeline to de-energize homes located in the valley far below (as shown in Figure 6). SCE should have sectionalized that portion of the Shovel circuit years ago and installed a weather station in the valley to properly measure the actual, local wind conditions that residents experience. Acton residents pointed this out in workshops that SCE hosted in 2020 and 2021; nothing was done. UPDATE: On March 17, 2025, SCE provided the Council with a new map of the Shovel circuit showing that the portion of the Shovel Circuit that serves the ridgeline communication facilities has been sectionalized. That is appreciated. However, the fact remains that this sectionalization was not completed before SCE initiated the January 2, 2025 PSPS event and therefore these concerns regarding SCE's sectionalization failures remain valid.

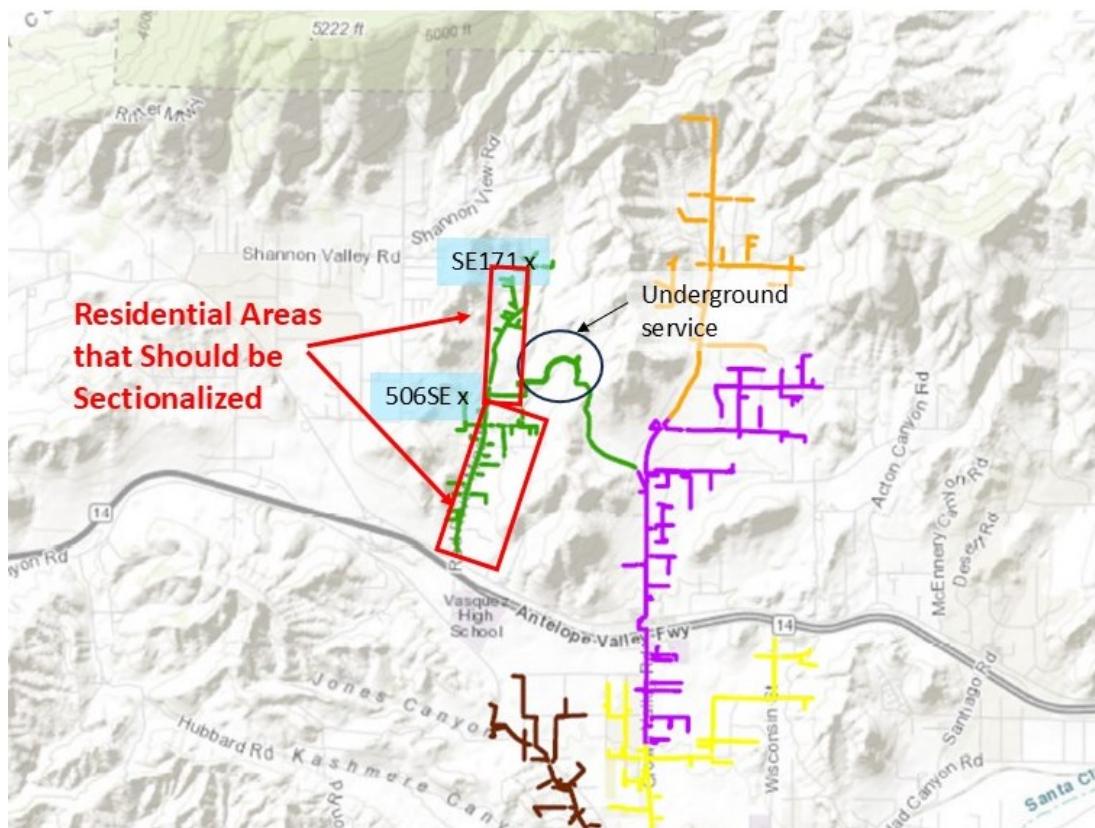
Figure 7. Map of Red Rover Mine Road Neighborhood Depicting Locations of Weather Stations and Showing Residential Areas that Should be Sectionalized.

Additionally, SCE should have sectionalized the west side of Pick Circuit Segment 2 that serves Red Rover Mine Road from the east. SCE maintains two weather stations along Red Rover Mine Road (which is a long, shallow, broad, north-south running canyon with many homes): Station No. SE171 is on the north end and Station No. 506SE is located high on the west side of the Canyon near a narrow gap in the hills where (of course) windspeeds are higher (not only because Station No. 506SE is higher up but also because windspeeds increase as they approach and pass through the narrow gap¹⁴). In other words, the wind speeds measured by weather station No 506SE only represent very localized conditions experienced by just a few residences on the west side of the canyon near the gap and do not reflect wind conditions anywhere else on Pick Segment 2 (see Figure 7). SCE's own weather data prove this to be true: during the wind events in January, 2025, Station No. SE171 on the north end recorded windspeeds that were consistently at least 30% lower than wind speeds recorded by Station No. 506SE. Nonetheless, SCE cuts power *everywhere* along Red Rover Mine Road based on windspeeds measured by Station No. 506SE. This is completely inappropriate.

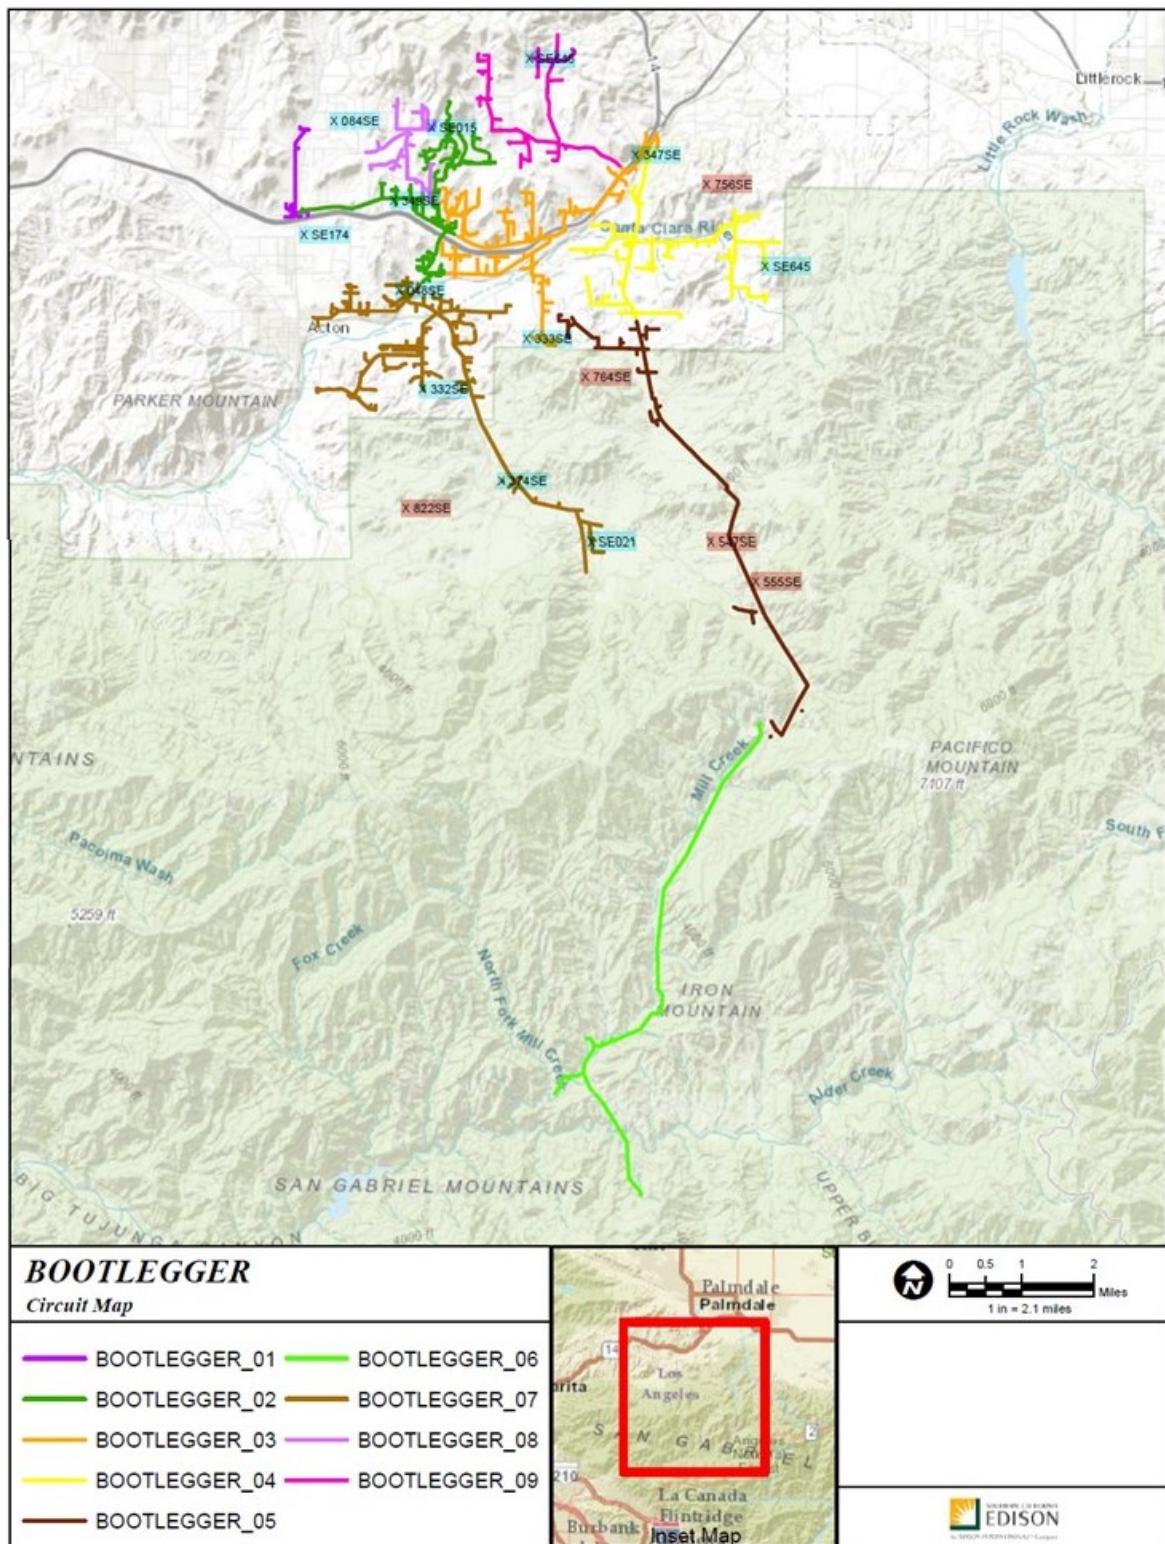
Figure 1. Bootlegger Circuit Map Showing Locations of Distribution Weather Stations.

NOTE: Shortly before these comments were submitted, SCE provided an updated Bootlegger map to the Council; however, this new map came too late to be incorporated herein. Therefore, this map depicts the Bootlegger configuration as of January 8, 2025.

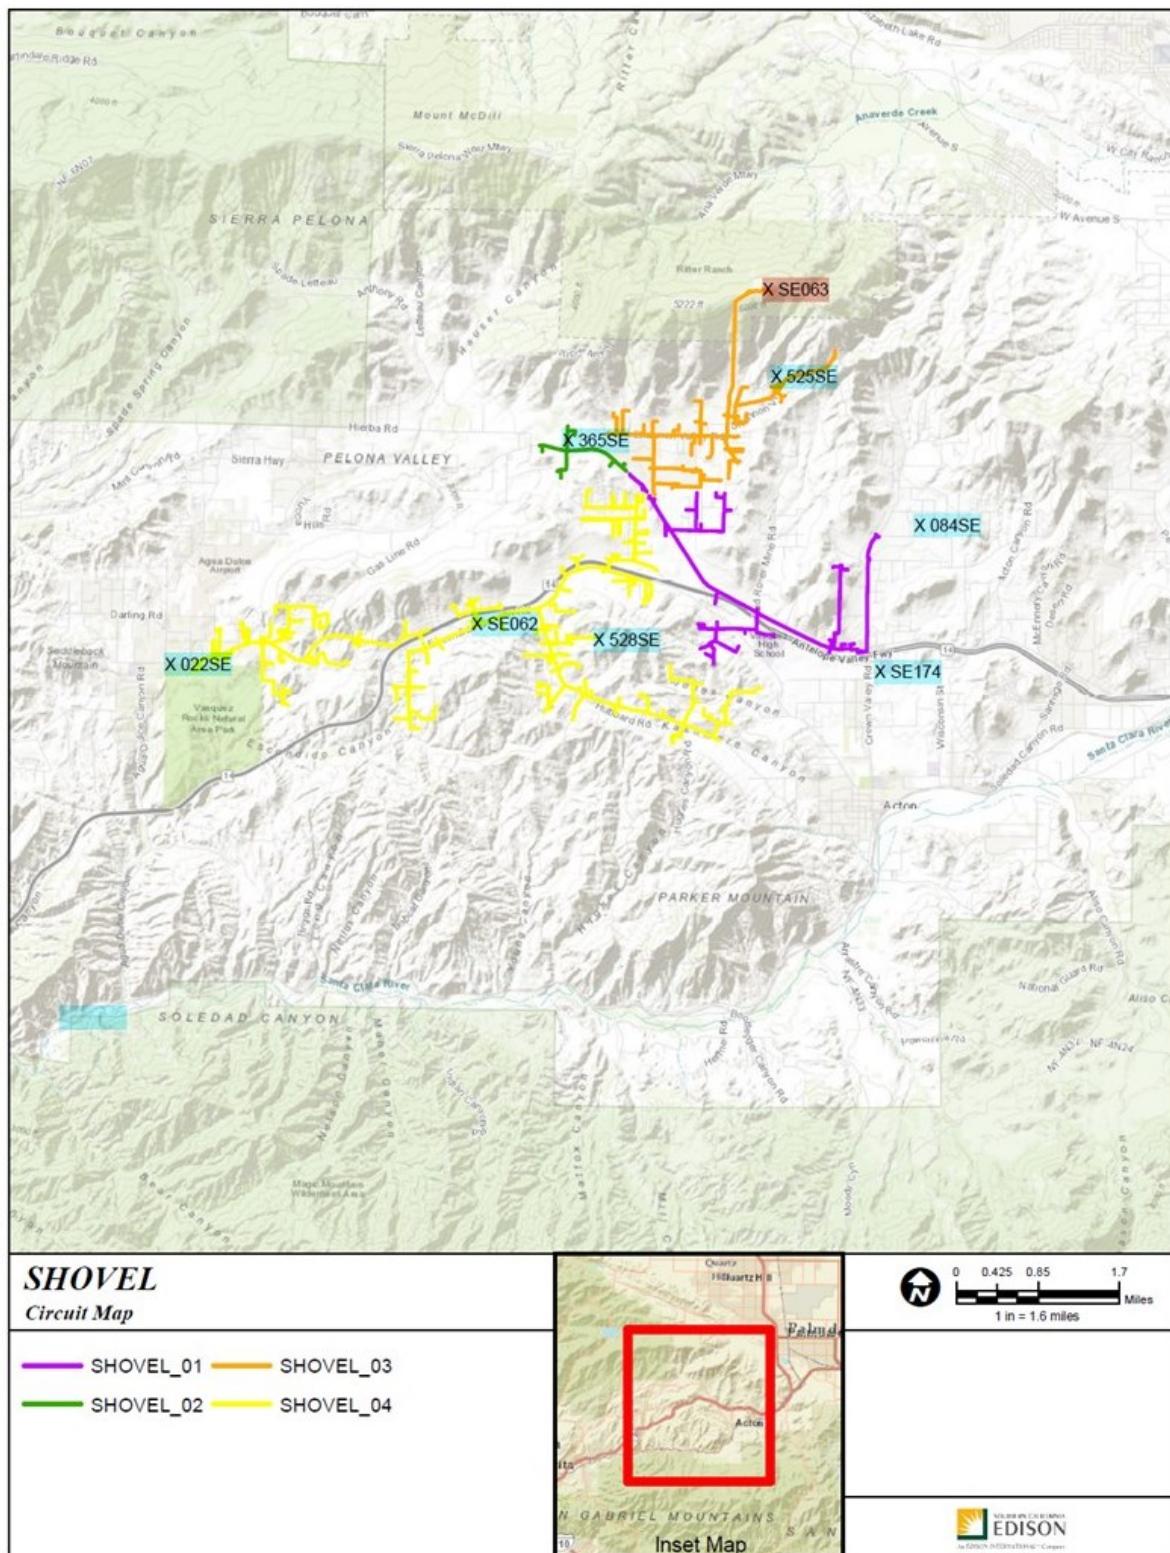
Figure 2. Shovel Circuit Map Showing Locations of Distribution Weather Stations.

NOTE: Shortly before these comments were submitted, SCE provided an updated Shovel Circuit map to the Council; however, this new map came too late to be incorporated herein. Therefore, this map depicts the Shovel Circuit configuration as of January 8, 2025.

The Shovel Circuit: During the January 17 PSPS event, SCE de-energized all four segments on the Shovel circuit multiple times; a map of the Shovel circuit is provided in Figure 2 and it is marked to indicate the locations of weather stations on the various segments (indicated in blue highlights) as well as other weather stations (such as transmission and radio tower/communication facilities which are indicated in purple highlights). Based on this map, the Council downloaded weather data pertaining to the Shovel circuit for the duration of the January 17 PSPS event and reconciled it with SCE's power shutoff notices issued for each circuit segment. The results of this analysis are summarized in Table 2 which shows that the Shovel distribution circuit did not experience wind conditions that met or exceeded SCE de-energization thresholds either during the 12 hour period *before* power was shutoff or during the 12 hour period *after* power shutoff. Accordingly, *none* of the power shutoffs on the Shovel circuit were warranted during the January 17 PSPS event and *none* complied with SCE's PSPS protocols.

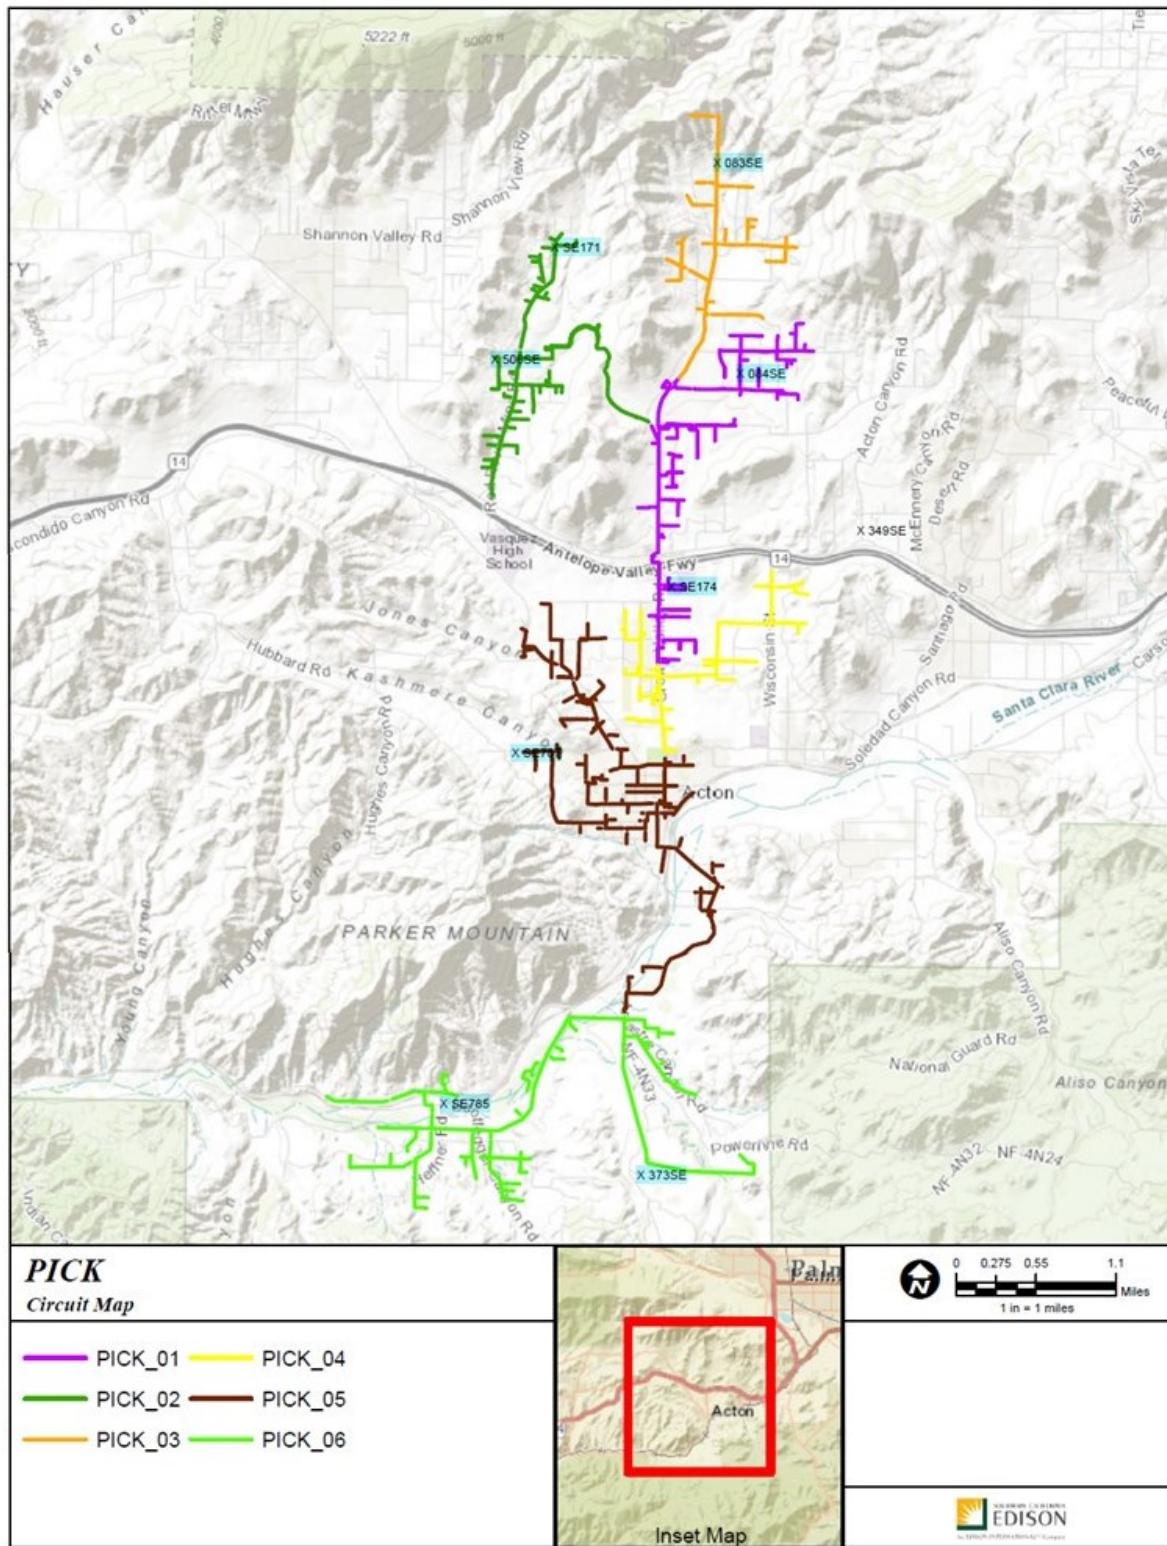
Figure 3. Pick Circuit Map Showing Locations of Distribution Weather Stations.

NOTE: Shortly before these comments were submitted, SCE provided an updated Pick Circuit map to the Council; however, this new map came too late to be incorporated herein. Therefore, this map depicts the Pick Circuit configuration as of January 8, 2025.

The Pick Circuit During the January 17 PSPS event, SCE de-energized all segments of the Pick Circuit (specifically, Segments 1, 2, 3, 4, 5, and 6). The Council has mapped the locations of SCE weather stations on these Pick segments; this map is provided in Figure 3. Based on this map, the Council downloaded weather data for each de-energized Pick circuit segment for the duration of the January 17 PSPS event and reconciled it with SCE’s power shutoff notices issued for each segment. The results of this analysis are summarized in Table 3 which shows that no segments of the Pick circuit experienced wind conditions that exceeded SCE’s de-energization thresholds of 40 mph sustained winds and 58 mph wind gusts⁷. It is noted that the wind gusts recorded for Pick Segment 2 are higher than the wind gusts recorded elsewhere on the Pick circuit; this is because Segment 2 is an offshoot that extends into a broad shallow valley known as Red Rover Mine Valley. Data recorded by SCE Weather Stations over the last 6+ years clearly demonstrate that wind conditions in the Red Rover Mine Valley are unique and do not reflect wind conditions elsewhere in Acton. Just before SCE de-energized the Pick circuit at 9:20 on January 20, a wind gust of 56.9 mph was recorded on a weather station on Segment 2; because this wind gust was close to the 58 mph de-energization threshold that SCE has established for the Pick circuit, it would perhaps provide SCE with sufficient basis to de-energize Pick Segment 2. However, *it did not under any circumstance provide any basis* for SCE to de-energize the entire Pick circuit; yet, by 11:15 that day, power was shutoff to every customer on the Pick circuit. As Table 3 demonstrates, *none* of the power shutoffs on Segments 1, 3, 4, 5, and 6 were warranted and *none* complied with SCE’s PSPS protocols.

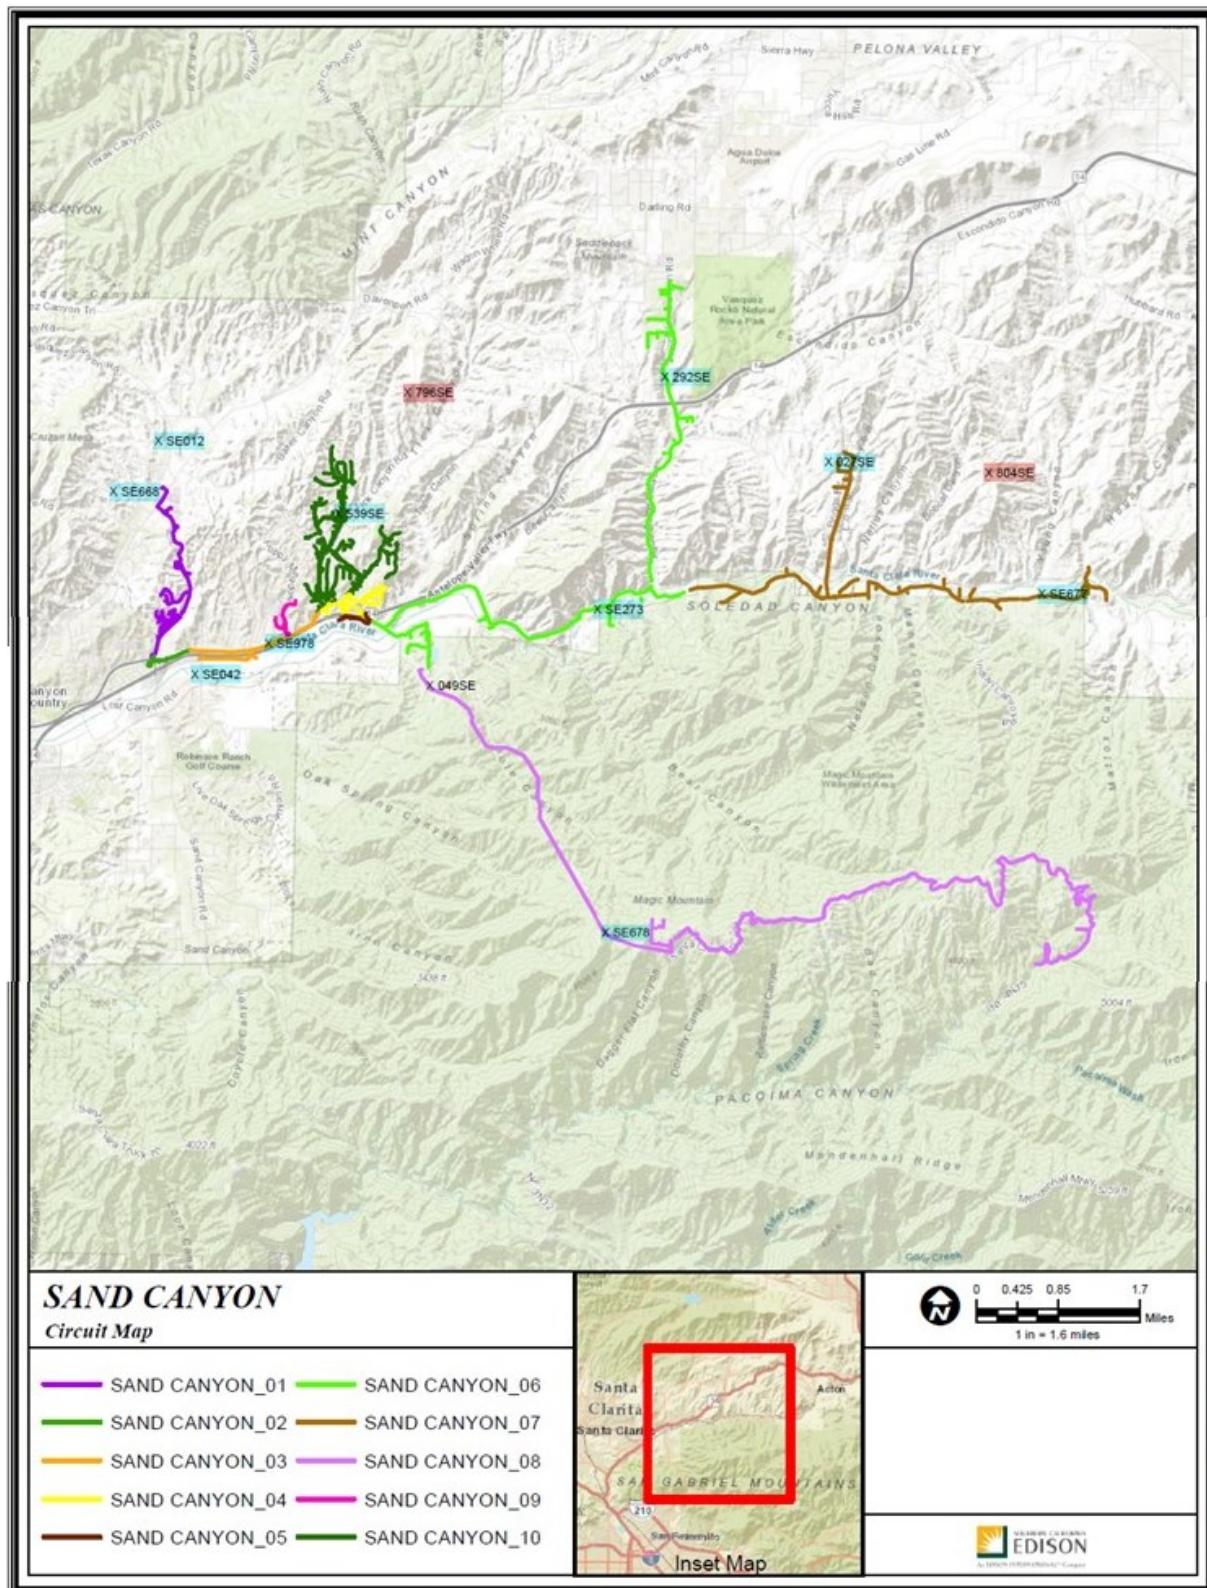
Figure 4. Sand Canyon Circuit Map Showing Locations of Weather Stations.

According to Tables 2 and 5 of SCE’s “Workbook”, the Sand Canyon Circuit was de-energized at 6:56 AM on January 20 because sustained winds of 44.6 mph and a wind gust of 68 mph were recorded. The Council has reviewed the wind data reported by all the weather stations on the Sand Canyon distribution Circuit (shown in Figure 4) and found only one weather station that recorded windspeeds exceeding SCE’s de-energization thresholds. This weather station (“SE678”) is located on a power line off shoot that extends to a remote radio and cellular communication facility at a 4500 foot

elevation (approximately) on a ridgeline surrounded by the Magic Mountain wilderness area. It appears that the only customer served by this power line off shoot is the communication facility itself and, as indicated in Figure 4, SCE has segmented it from the rest of the Sand Canyon circuit; SCE refers to it as “Segment 8”. Weather Station “SE678” recorded a sustained wind speed of 44.55 mph and a wind gust of 67.95 mph at 6:50 AM on January 20, so the Council assumes that this is the wind measurement that is noted in Table 2 of SCE’s Workbook. At 9:50 that same morning, this particular weather station recorded a sustained wind speed of 44.55 mph and a wind gust of 67.95 mph. These data indicate that it was certainly appropriate that SCE de-energize Segment 8 of the Sand Canyon circuit; however, there does not appear to be any justification for de-energizing other segments on the Sand Canyon Circuit. In fact, and insofar as the Council is able to discern, the only weather station that recorded wind data approaching (but not reaching) SCE’s de-energization thresholds is “027SE” which, as indicated in Figure 4, is located on an offshoot power line that extends north into Long Canyon from the east side of the Sand Canyon circuit. This offshoot power line up Long Canyon serves the Briggs Road neighborhood of Agua Dulce and unfortunately, SCE has never bothered to sectionalize it from the rest of the Sand Canyon circuit. As a result, SCE routinely and improperly de-energizes the entire east half of the Sand Canyon circuit (including Acton residents in the Santa Clara River Valley) based on windspeeds measured by Weather Station No. SE678 located several miles away and far up a canyon. In other words, there is no apparent justification for SCE’s de-energization of Acton residents on the Sand Canyon circuit during the January 17 PSPS event and had SCE properly implemented sectionalization, these shutoffs in Acton would have been avoided.

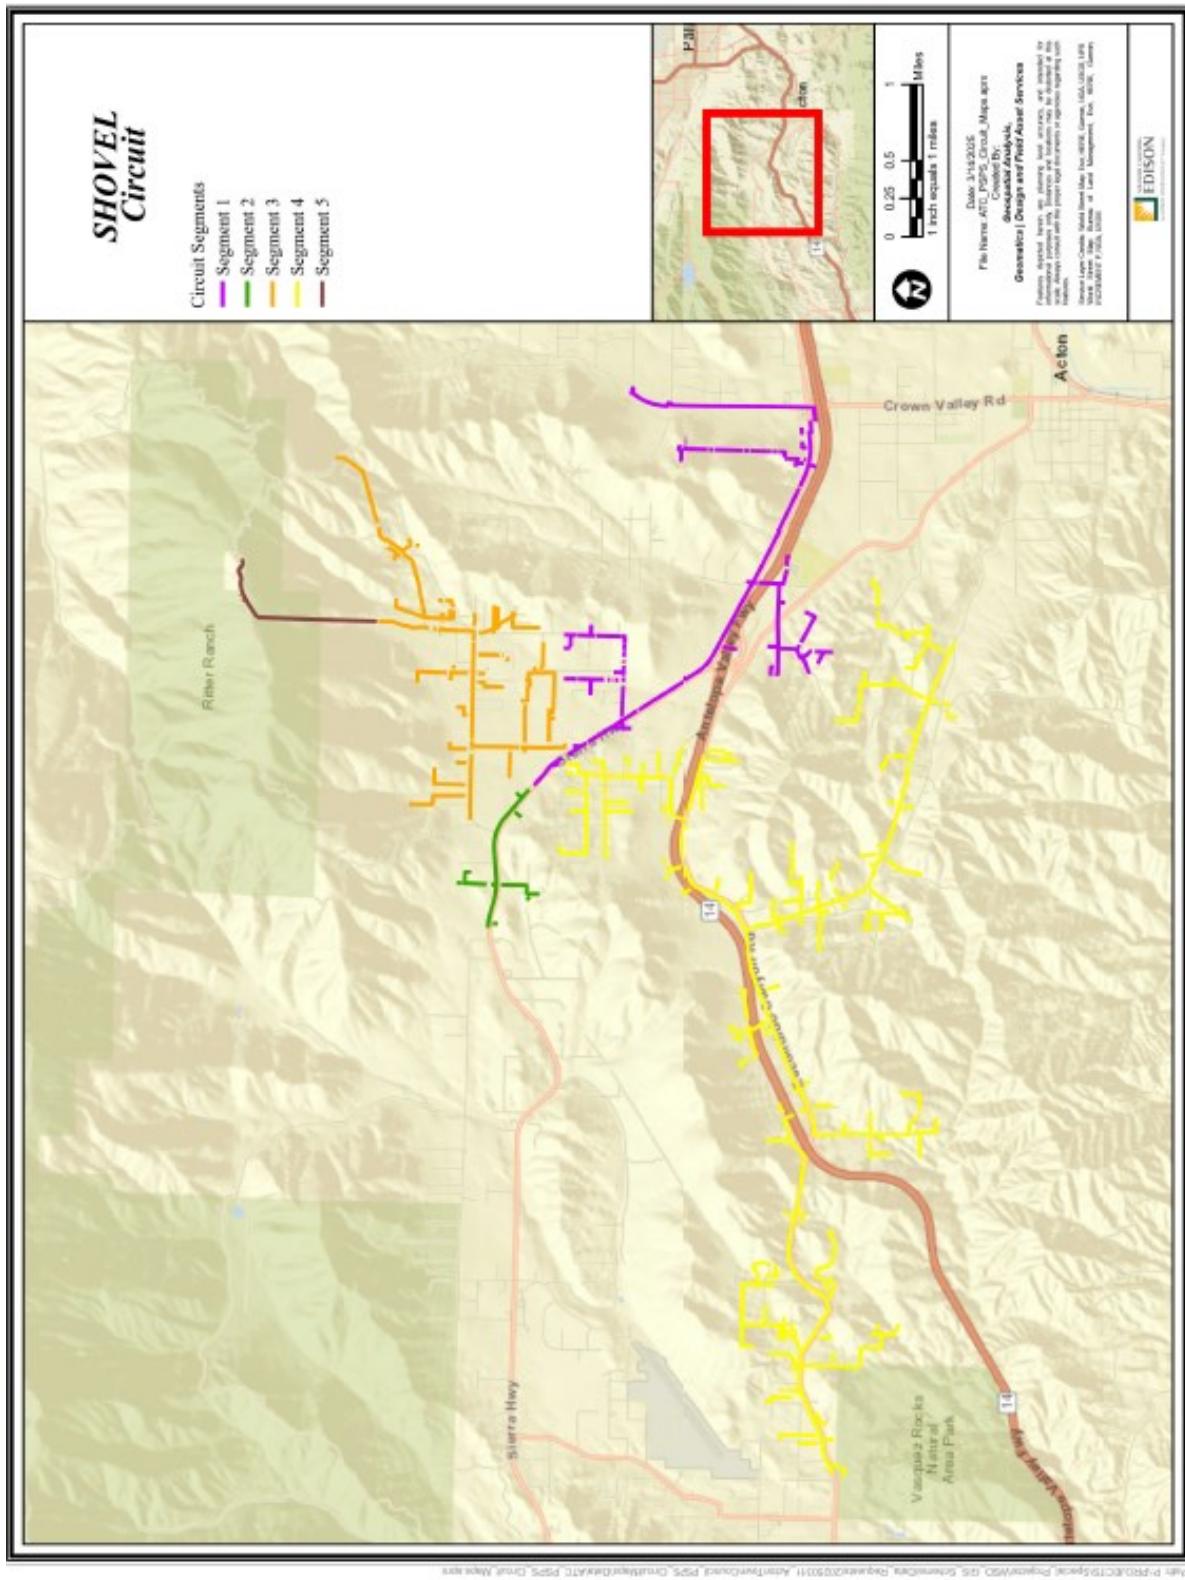
Figure 6. The Shovel Circuit

Another problem with SCE's misrepresentations regarding "phantom" circuits is that this practice conceals just how long and tenuous SCE's distribution networks really are. Specifically, the length of the Shovel circuit depicted in Figure 6 is only about 5.5 miles; however, when the Loucks facilities are factored in, the *actual* length of the Shovel circuit is nearly 10 miles. SCE should be directed to eliminate these phantom circuit labels and correct its distribution circuit maps to show the actual configurations of all sections of each circuit. Furthermore, and as we explained in detail in our comments on SCE's January 2 PSPS Post Event Report, SCE should be directed to individually report factors relevant to each energization decision made for each circuit segment throughout the entire PSPS event (even if the segment was de-energized multiple times) as well as identify the weather station that was relied upon for each de-energization decision made for each circuit segment. That is the only way that the Commission will have the information it requires to properly assess whether each de-energization decision made by each utility is "reasonable" and therefore authorized under §399.2 and §451 of the Code.
