Subject: Acton Town Council Comments on the Draft Decision Issued by the Office of Electrical Infrastructure Safety to Approve Southern California Edison Company's 2026-2028 Base Wildfire Mitigation Plan.

Reference: Docket #2026-2028-Base-WMPs.

**COMMENTS SUBMITTED BY THE ACTON TOWN COUNCIL
TO THE CALIFORNIA PUBLIC UTILITIES COMMISSION ON
SCE PSPS POST EVENT REPORTS.**

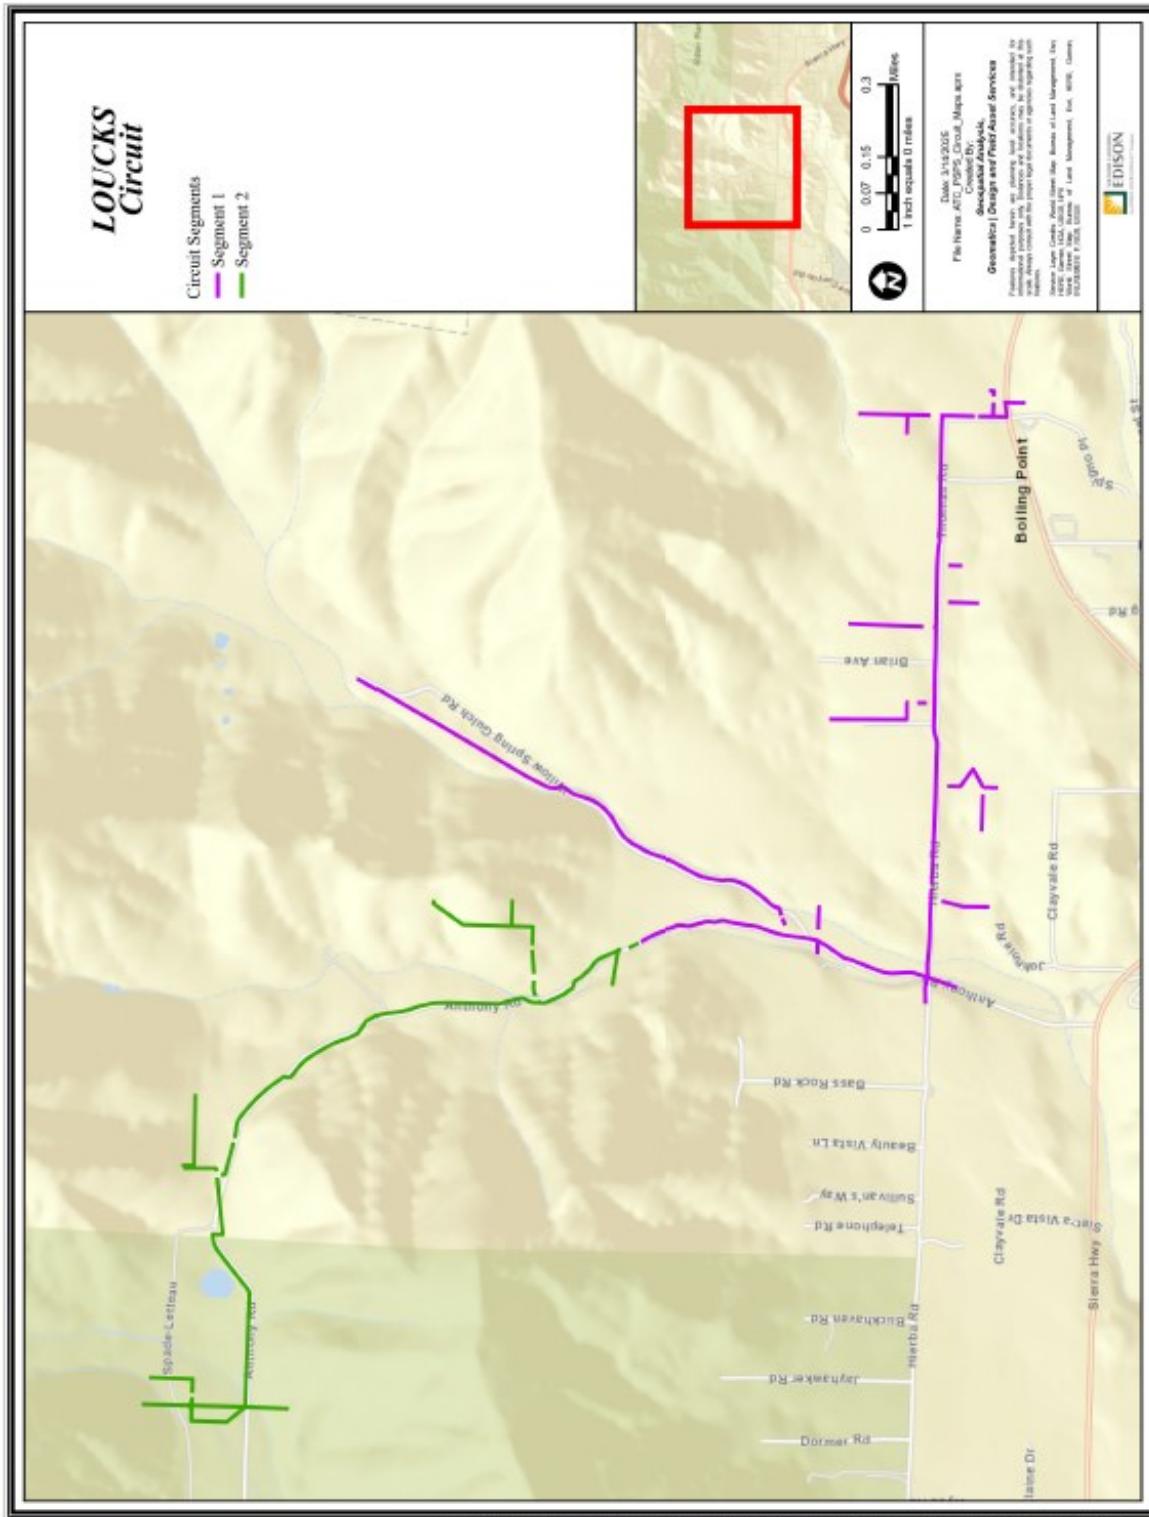
Figure 7. The “Loucks” Circuit

SCE's habit of misrepresenting a single circuit as two distinct circuits makes it impossible for residents who are served by the phantom circuits to understand why their power was shutoff. The phantom "Loucks" circuit again illustrates this point: for years, Agua Dulce residents on the "Loucks" could never understand why their power was constantly being shutoff during SCE PSPS events and SCE's Post Event Reports never shed any light on the matter because they consistently reported "N/A" in place of actual data for the "Loucks" circuit²¹. Additionally, SCE further muddied the waters in the case of the "Loucks" circuit because SCE consistently affiliates the "Loucks" circuit with the Davenport circuit²² (which is energized by the Solemint distribution substation) rather than the Shovel circuit (which is energized by the Acton distribution substation); that is why many residents in Agua Dulce could never understand why the southern portion of the community always had power but the northern portion never had power during PSPS events in which there was no wind in Agua Dulce.

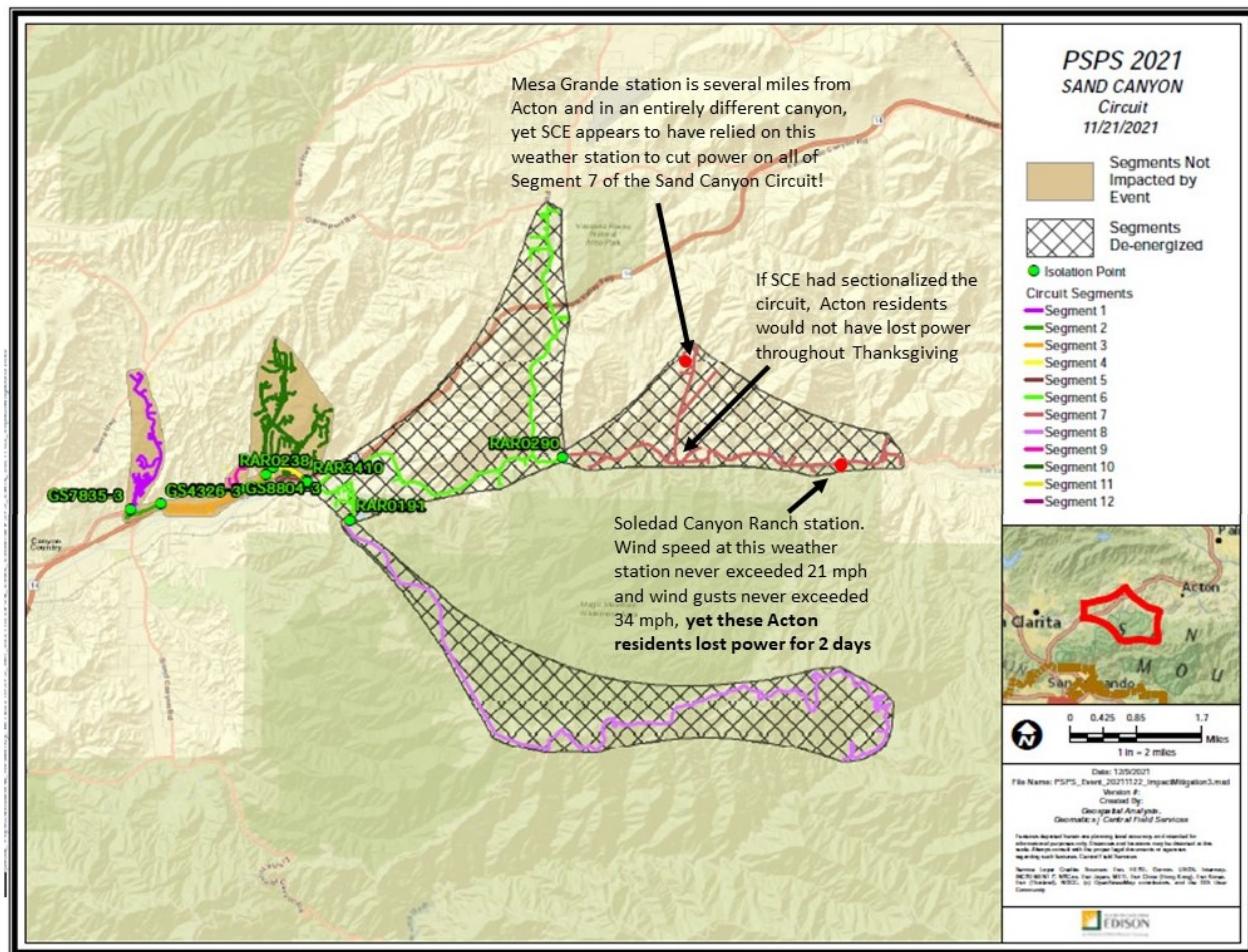
Figure 1. SCE's Sand Canyon Circuit with Annotations Indicating Where Sectionalization Should Have Been Deployed.

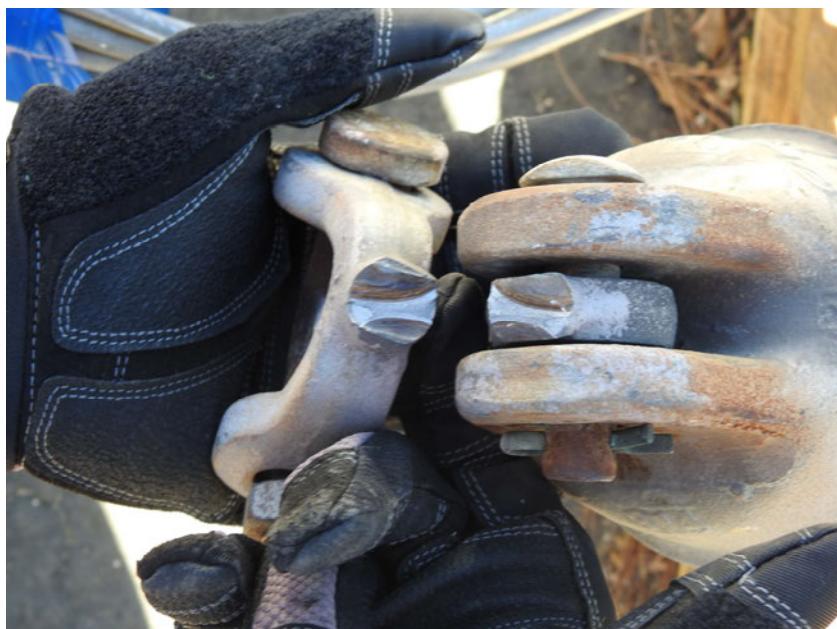
Figure 5: a photograph taken on October 25, 2019, at the evidence inspection at the SCE service yard, shows corrosion on the failed section of Y-clevis that supported the B-phase 220 kV conductor on tower M5-T2.

On October 25, 2019, ESRB inspected evidence at an SCE service yard. One of the items collected was the Y-clevis end fitting that was used to hold the ceramic string insulator onto the B-phase arm of tower M5-T2. The broken ends of the Y-clevis end fitting showed signs of fatigue, e.g., beach marks, and corrosion on the fracture surface (see Figure 5). SCE indicated that it believes that the Y-clevis end fitting, likely a Lindsey brand fitting forged from galvanized steel, was installed in 1970 and had an expected service life of 100+ years.

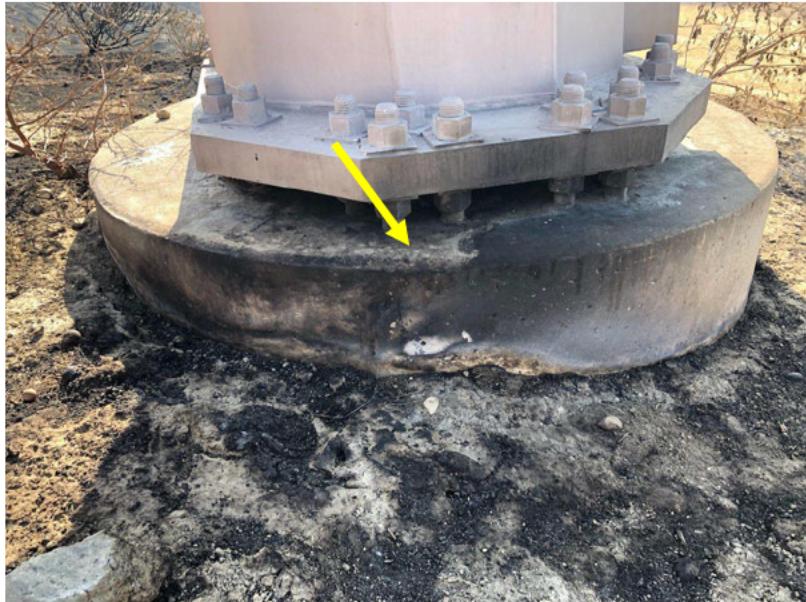
Figure 6: LAFD photograph showing evidence of unusual burning on one of the footings on Tower M2-T4.

Another piece of evidence that ESRB considered from a photograph from the Los Angeles Fire Department (see Figure 6). The photograph shows unusual burning on the footing on Tower M2-T4, which is one tower away from Tower M2-T5¹.

¹ LAFD Fire Investigation Report No. 2019-10-0664 states, “additional towers were surveyed for damage. At Tower 2/4, I observed high heat burn patterns at its base including spalling of the concrete. These patterns did not appear to be consistent with the fuel load and fuel arrangement in this area. It is possible the damage may be related to the catastrophic failure at Tower 5/2.”
