Burbank Water and Power

# WILDFIRE MITIGATION PLAN

2021

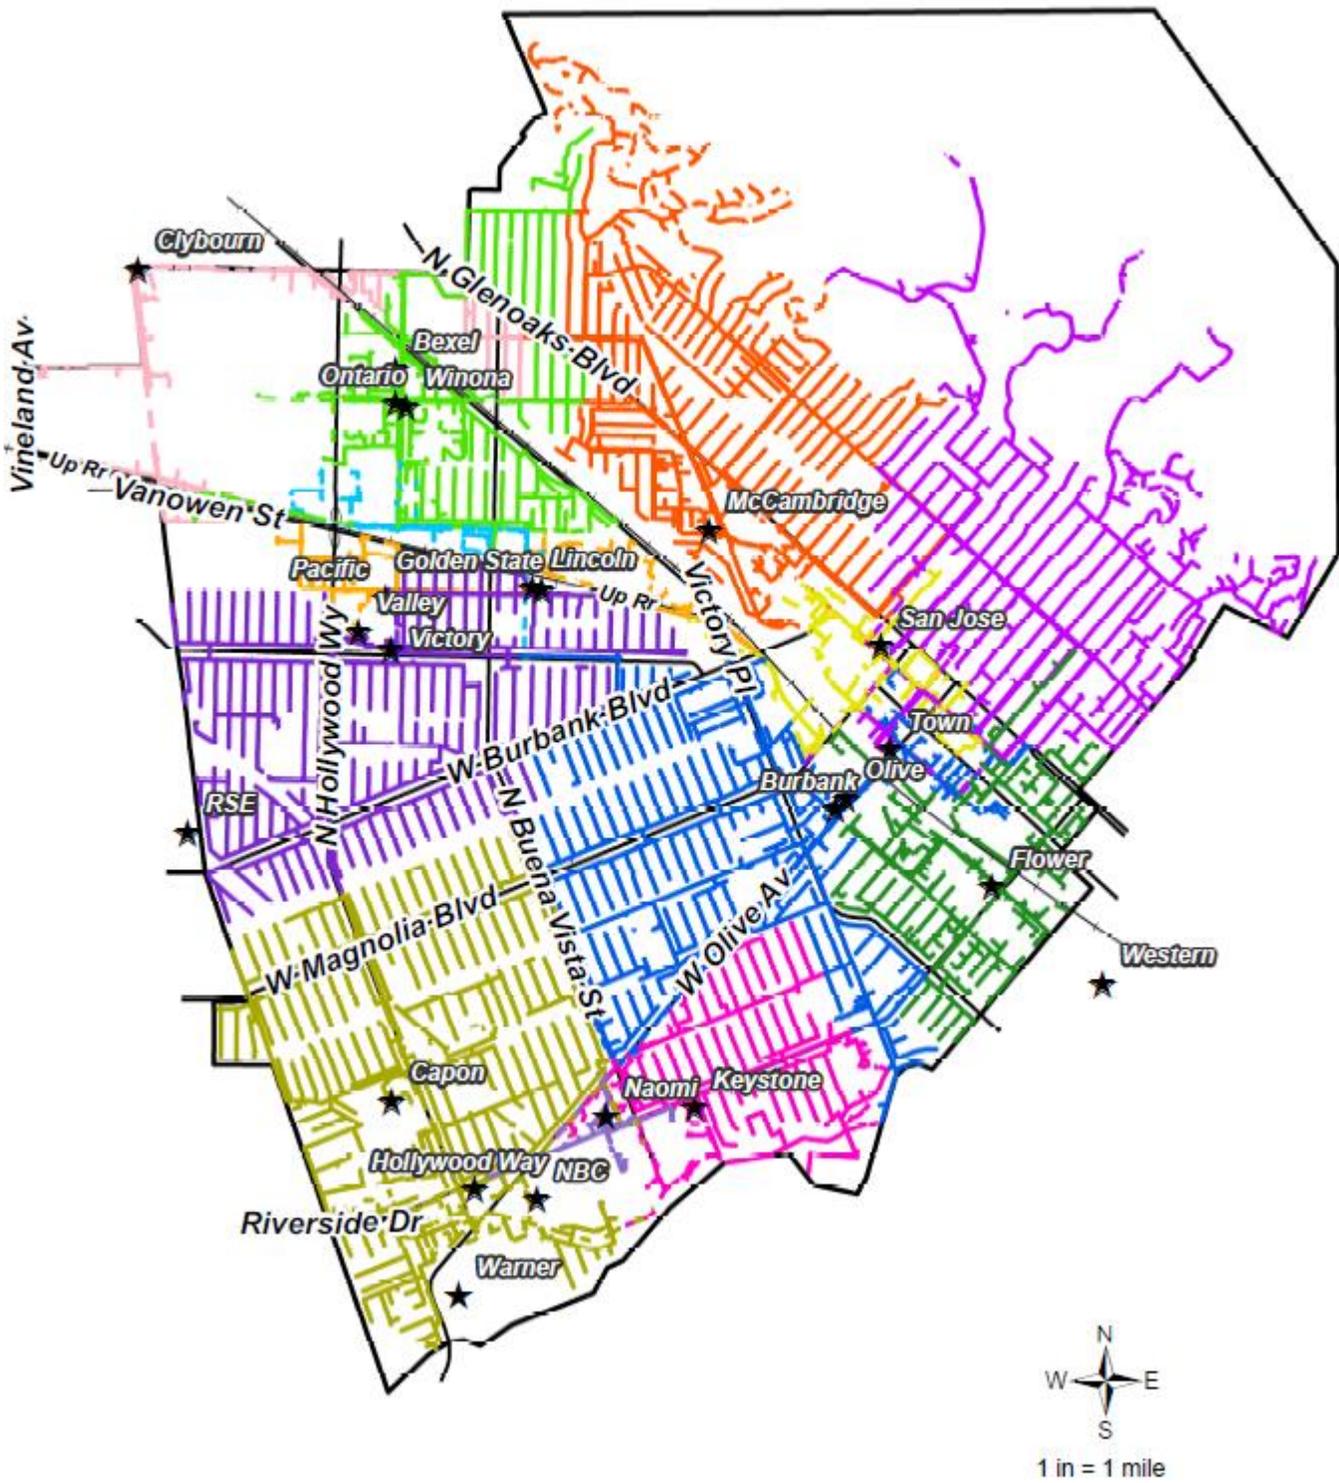
Figure 2 - BWP Electric Distribution System

BWP supplies electrical service to its customers through a distribution network, which includes 13 distribution substations, 2 customer substations, 5 switching stations, 45 miles of 34.5 kilovolt (kV) sub-transmission lines, 33 miles of 69 kV transmission lines, 204 miles of overhead distribution lines, 129 miles of underground distribution lines, 589 miles of overhead secondary lines, 115 miles of underground secondary lines, 10,714 poles, and 5,827 transformers. BWP's all-time peak demand was 322 MW in 2017, but is forecast to remain flat at about 314 to 322 MW for the next several years.

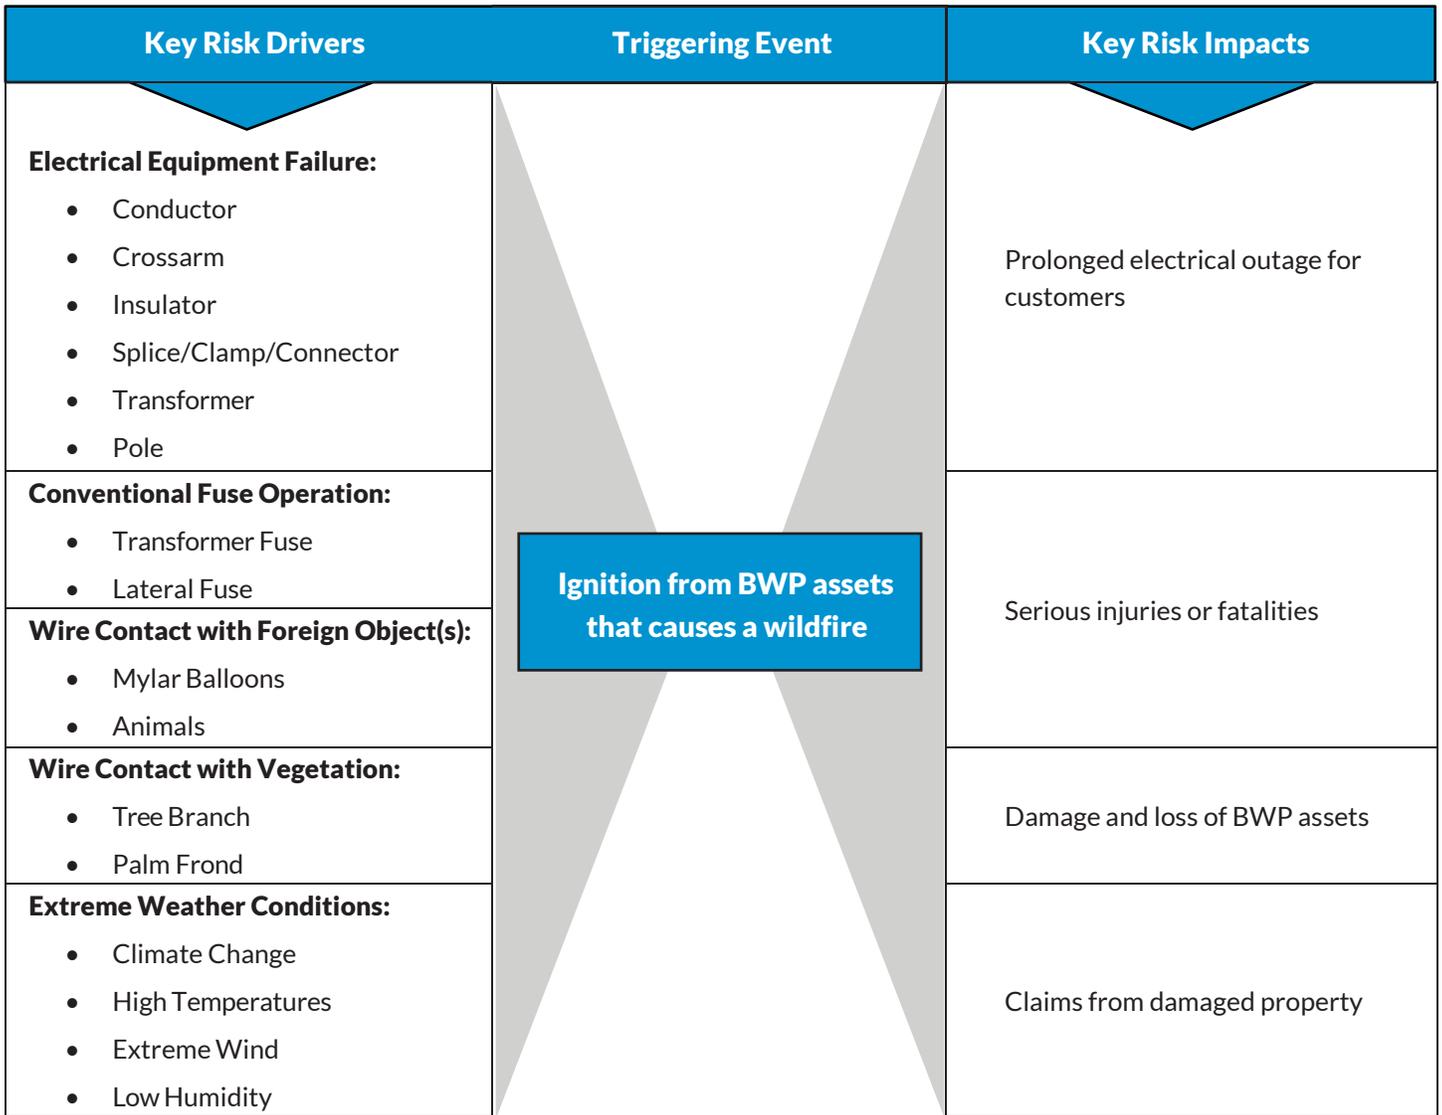
**Figure 3 – BWP’s Wildfire Risk Bowtie**

The risk of a vegetation ignition and potential for an uncontrollable wildfire caused by BWP electrical facilities is related to the type of vegetation (fuel bed) within its vicinity, the local/regional weather patterns, and the potential for a failure of BWP's equipment. For example, areas that include uninterrupted, natural (unmaintained) vegetation present a risk of ignition from ongoing operational activities or equipment failures. When the area also includes weather conditions that result in periodic high wind and low humidity, the wildfire risk is significantly enhanced. Both of these weather conditions can occur in BWP's Tier 2 HFTD area. A bow tie analysis was conducted to identify these risk drivers as well as their potential resulting impacts. Figure 3 provides the risk bow tie diagram, which summarizes the assessment process.

Risk drivers are important to identify because they are the primary ways in which BWP electrical facilities could result in a catastrophic wildfire. The center of the bow tie chart is the triggering event, which is an ignition caused by a BWP asset resulting in a catastrophic wildfire. During the wildfire threat assessment, five categories were identified as potential drivers for causing fire ignitions:

1. Electrical equipment failure;
2. Conventional fuse operation;
3. Wire contact with foreign object(s);
4. Wire contact with vegetation; and
5. Extreme weather conditions.

If one of the risk drivers listed above were to occur, resulting in a wildfire ignition caused by BWP electrical facilities, there could be potential consequences for BWP as presented on Figure 3.

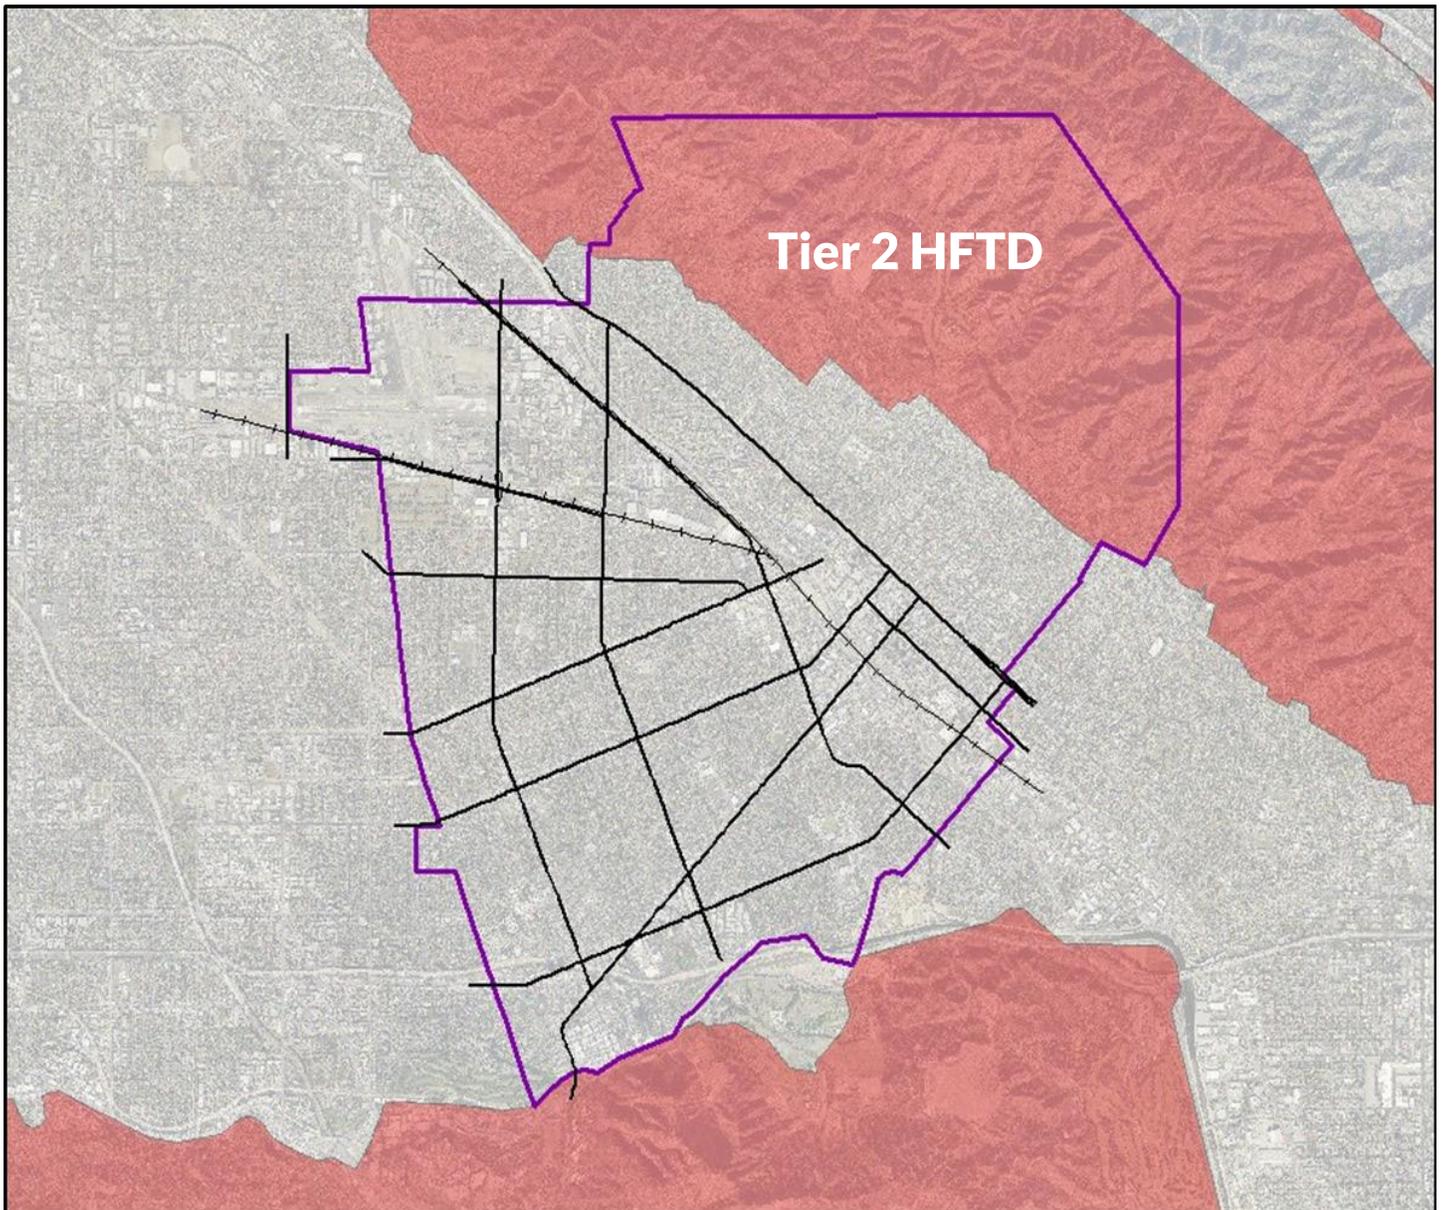
**Figure 4 - BWP's Tier 2 High Fire Threat District**

BWP directly participated in the development of the California Public Utilities Commission’s (CPUC) Fire-Threat Map which designates High-Fire Threat Districts (HFTDs) throughout the State of California. The CPUC Fire-Threat boundary map ranks HFTDs based on the need to increase infrastructure resiliency to mitigate the wildfire threat posed by electric infrastructure. The CPUC Fire-Threat Map is comprised of Tier 2 HFTDs (elevated risk of potential impacts to people and property) and Tier 3 HFTDs (extreme risk of potential impacts to people and property).

In the map development process, BWP served as a territory lead, and worked with local fire & government officials to identify the areas of BWP's service territory that are Tier 2 or Tier 3 HFTDs. It was determined through the development process and affirmed by both a peer review and a team of independent nationwide experts led by the California Department of Forestry and Fire Protection (CAL FIRE), that a portion of BWP's service territory is situated within a Tier 2 HFTD. Additionally, no portion of BWP's service territory falls within a Tier 3 HFTD.

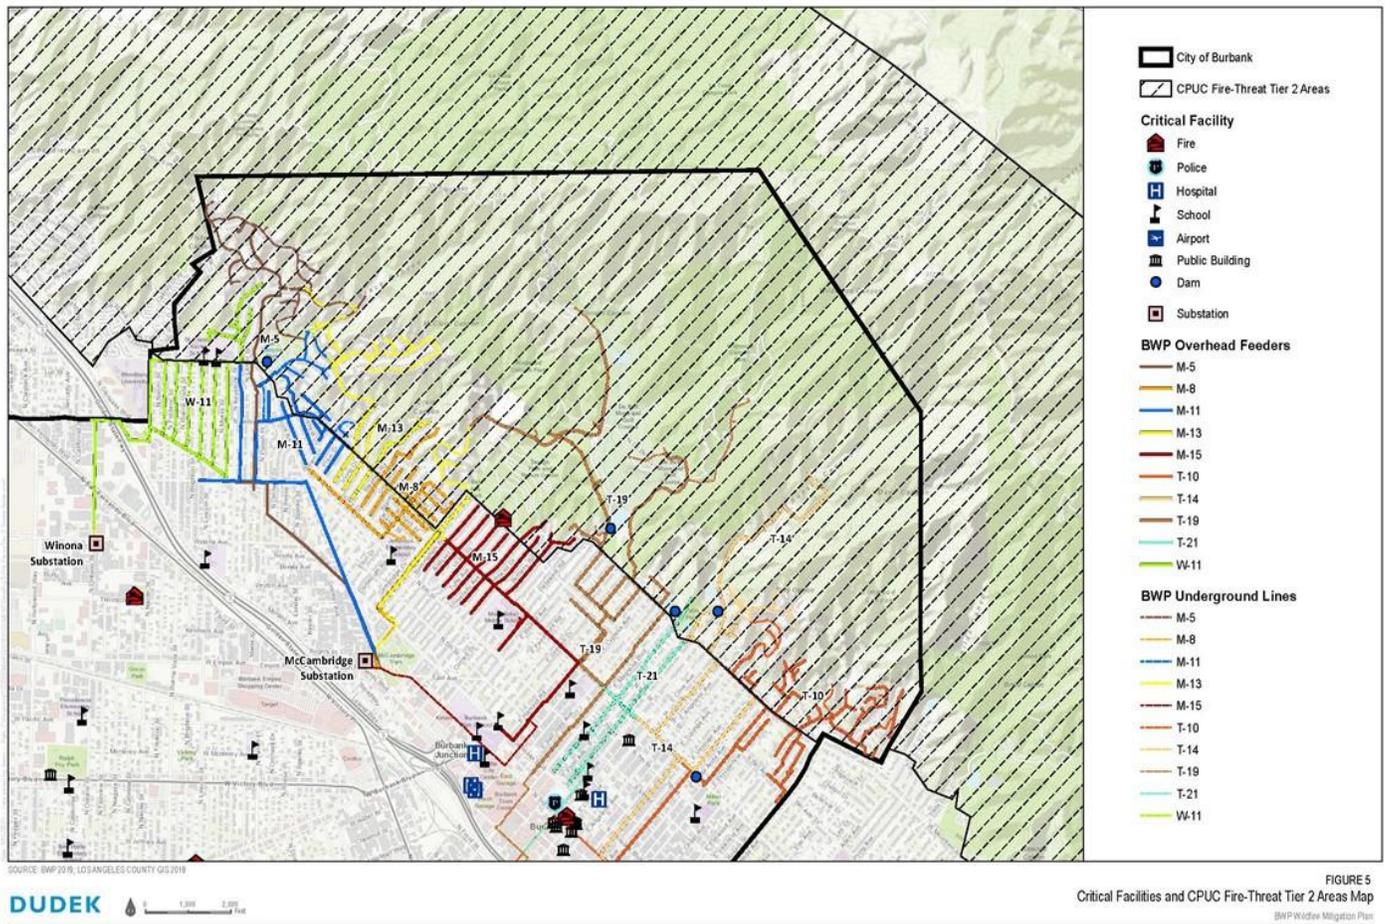
**Figure 6 - Electrical Facilities within Tier 2 HFTD**

Figure 6 presents the portion of BWP's service territory (e.g., feeder lines and equipment) within CPUC fire-threat areas. As illustrated in Figure 6, BWP's electrical system is located within both Tier 2 HFTDs and areas not considered within the HFTD (referred to as outside HFTD in this WMP). Table 3 includes the breakdown of BWP's electric system that falls within the Tier 2 HFTD.

**FIGURE 5**  
Critical Facilities and CPUC Fire-Threat Tier 2 Areas Map  
BWP Wildfire Mitigation Plan

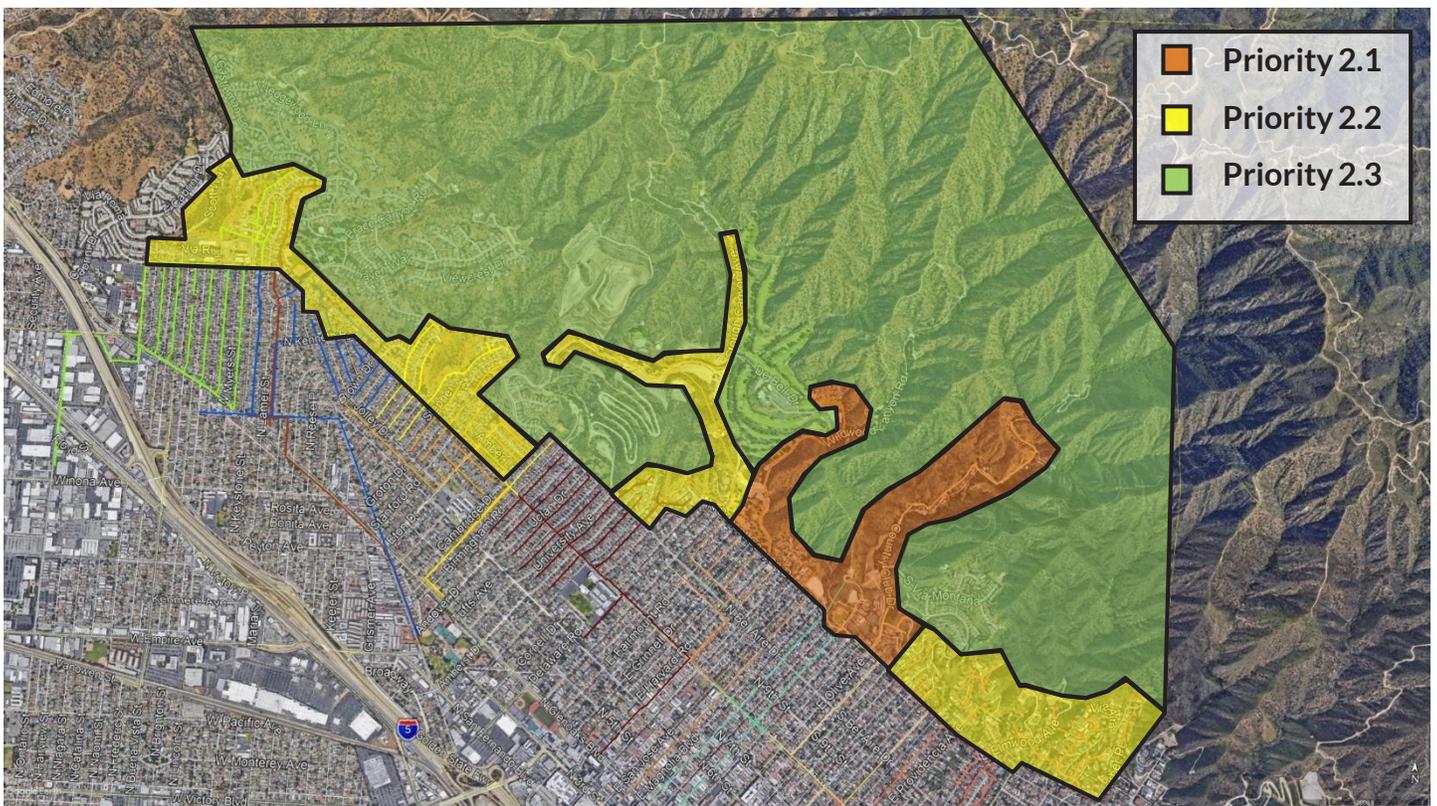
**Figure 7 - Wildfire Risk Prioritization within the Tier 2 HFTD**

**Priority Level 2.3** – Tier 2 HFTD with no overhead electrical facilities

In 2020, pole loading analysis was performed on 44 poles within the Tier 2 HFTD. This included an analysis of the 12 deteriorated poles that were replaced. Additionally, BWP completed the analysis of all poles in the Priority 2.1 Zone (see Figure 7). The analysis of the 32 remaining poles in the Priority 2.1 Zone did not result in any additional replacements as all poles currently meet our wind loading criteria.

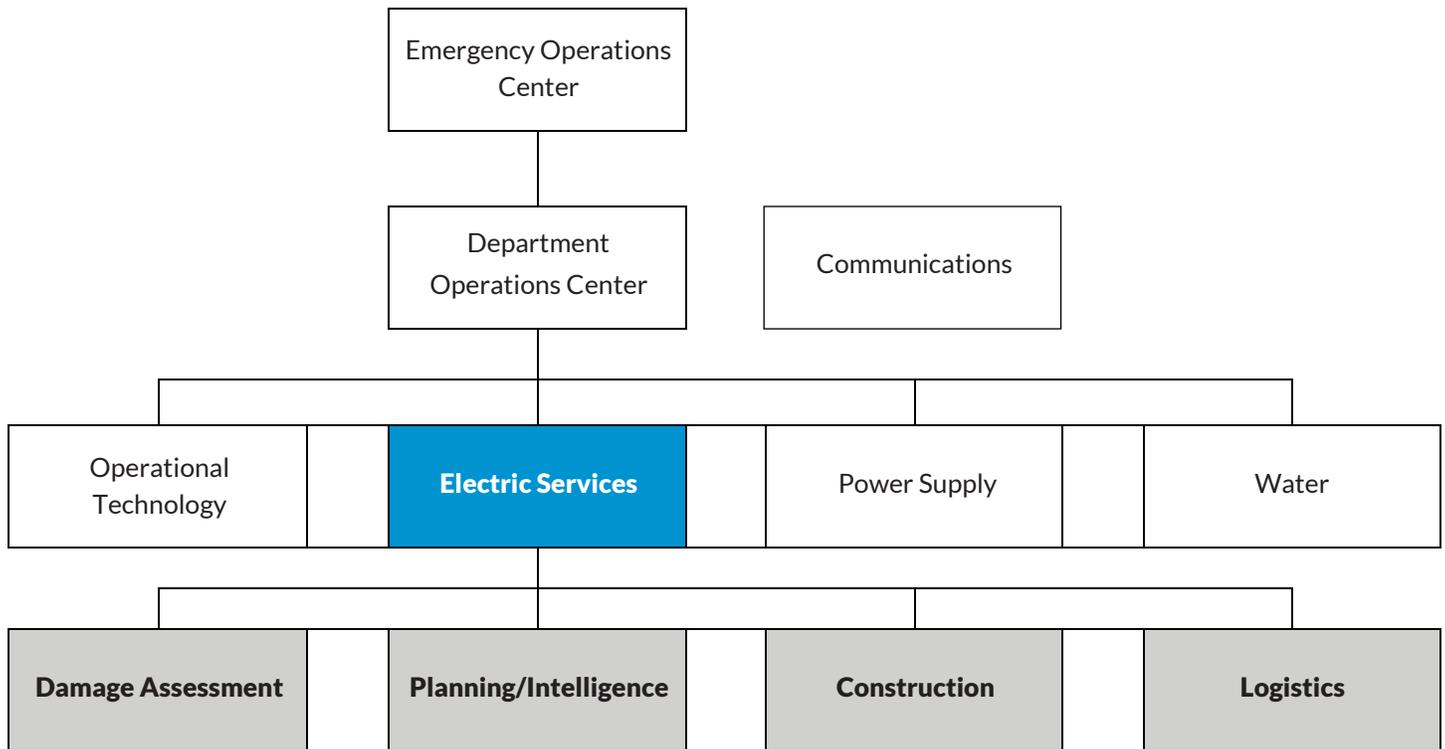
**Figure 8 - BWP Emergency Response Teams' Organization**

The Electric Services Response Team is comprised of four response teams: Damage Assessment, Planning/Intelligence, Construction, and Logistics as presented in Figure 7. The responsibilities of each response team are described in Table 10 below.
