SUBJECT: Southern California Edison Company's 2021 Wildfire Mitigation Plan Annual Report on Compliance (EC ARC) Pursuant to PUC Section 8386.3(c)(1)

Southern California Edison Company's 2021 WMP Annual Report on Compliance

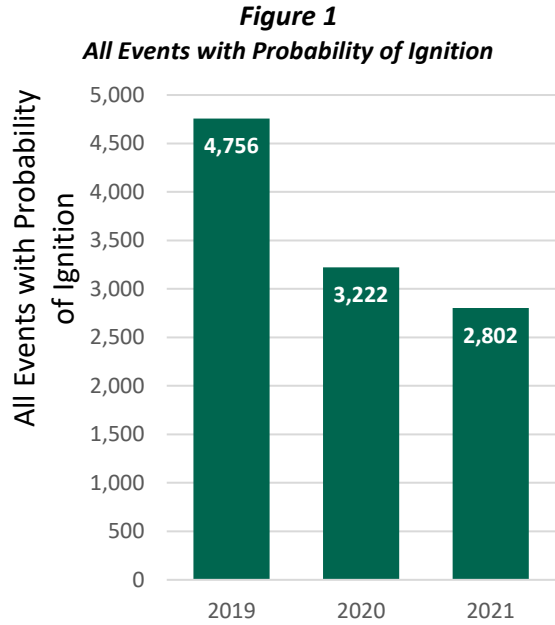
Probability of Ignition (POI) events include wire downs, contacts with objects, line slap, events with evidence of heat generation, and other events that cause sparking or have the potential to cause ignition.

Beyond meeting or exceeding the vast majority of its 2021 WMP activity targets and further implementing its risk-informed decision-making and prioritization practices, SCE continues to evaluate metrics that can offer insights into the effectiveness of its mitigation portfolio. The following figures (**Figure 1 to Figure 5**) provide a 3-year review (2019-2021) of examples of potential outcome-based metrics that SCE currently tracks. While these effectiveness metrics can provide encouraging indications of risk reduction from SCE's activities and initiatives, large variations in weather events (e.g., temperature, rainfall, fuel moisture, and wind) can impact the metrics' outputs and therefore may not represent direct correlations between wildfire risk reduction and SCE's wildfire mitigations.⁸

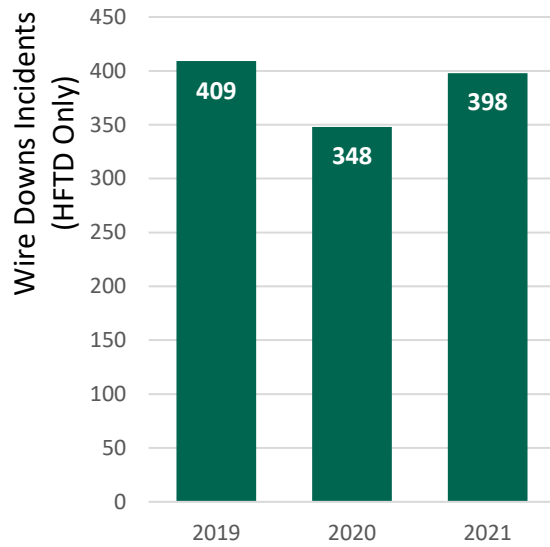
Figure 3
Wire Down Incidents in HFTD

Wire down events occur at a greater frequency than ignitions. Wire down events precede only a fraction of ignition events.

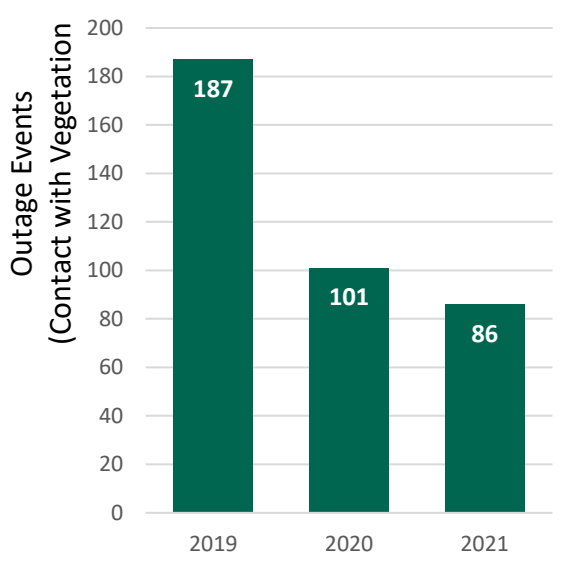
Figure 5
Outage Events due to Contact with Vegetation

Figure 5 represents outage events only caused by vegetation contact that have occurred in SCE's HFTD from 2019 to 2021.

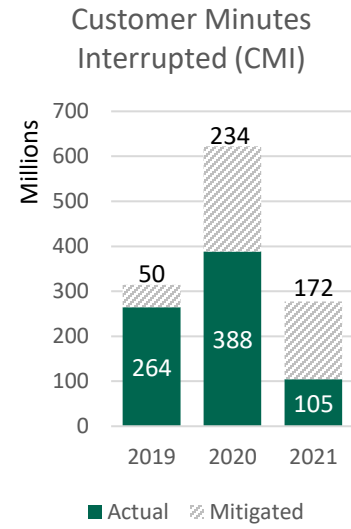
Figure 8

Customer Minutes Interrupted (CMI) generally correlates with the total number of customer outages

When incorporating impacts from mitigations implemented prior to 2021, the 2021 reductions in scope/scale and duration are estimated to grow even further. The total benefit toward annual circuit de-energizations (**Figure 6**), customer outages (**Figure 7**), and customer minutes interrupted (**Figure 8**) are illustrated below for the 2019-2021 period. “Mitigated” refers to the difference between the backcasting theoretical scenario and what actually occurred.
