Pacific Gas and Electric Company
2022 Wildfire Mitigation Plan
Response to Revision Notice

RN-PG&E-22-01
RN-PG&E-22-06
RN-PG&E-22-07
RN-PG&E-22-08
RN-PG&E-22-10
RN-PG&E-22-11
RN-PG&E-22-13

June 27, 2022

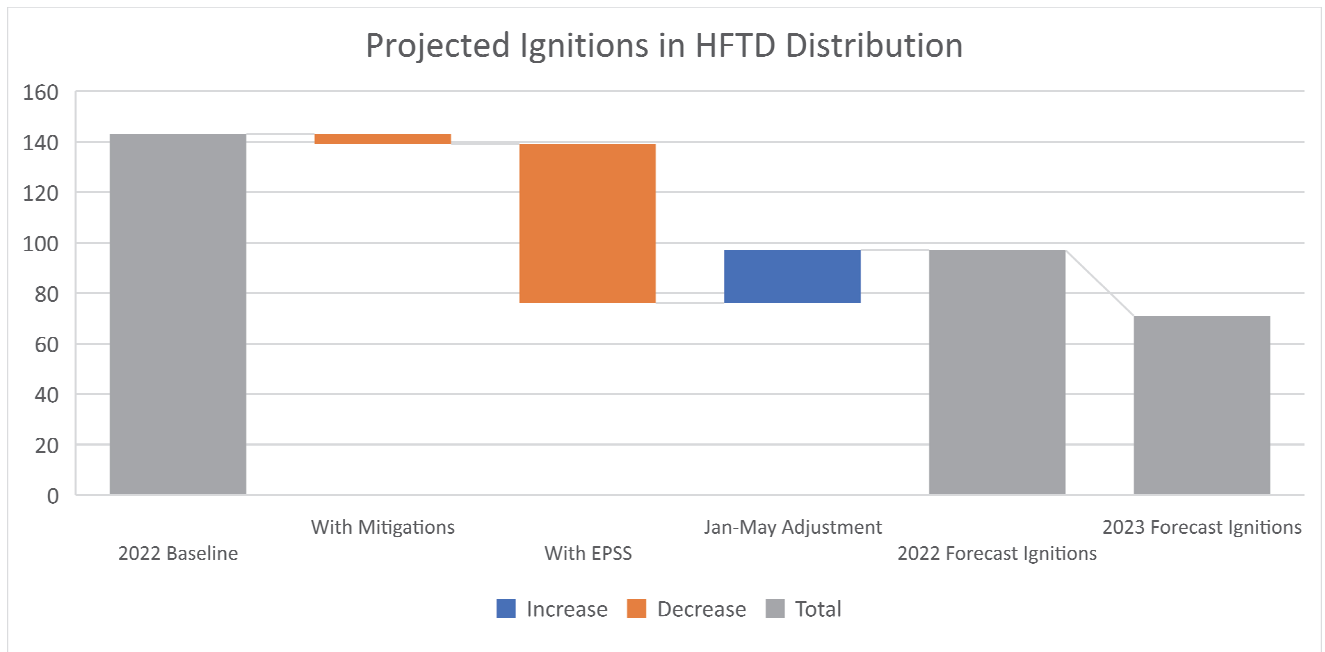
Figure RN-PG&E-22-07-01: HFTD Distribution Ignitions Forecast Waterfall

Figure RN-PG&E-22-07-01 below summarizes the changes to the HFTD ignition projections described above.

When these values are combined (observed 2022 year to date, and expected forecast), we computed a new projected 2022 year-end value of 97 HFTD distribution ignitions, but highlight that the range for this number, with a 95% confidence interval, is from 79 to 114 ignitions.
