DRAFT ANNUAL REPORT ON COMPLIANCE

PACIFIC GAS & ELECTRIC COMPANY
2020 WILDFIRE MITIGATION PLAN

DECEMBER 2022

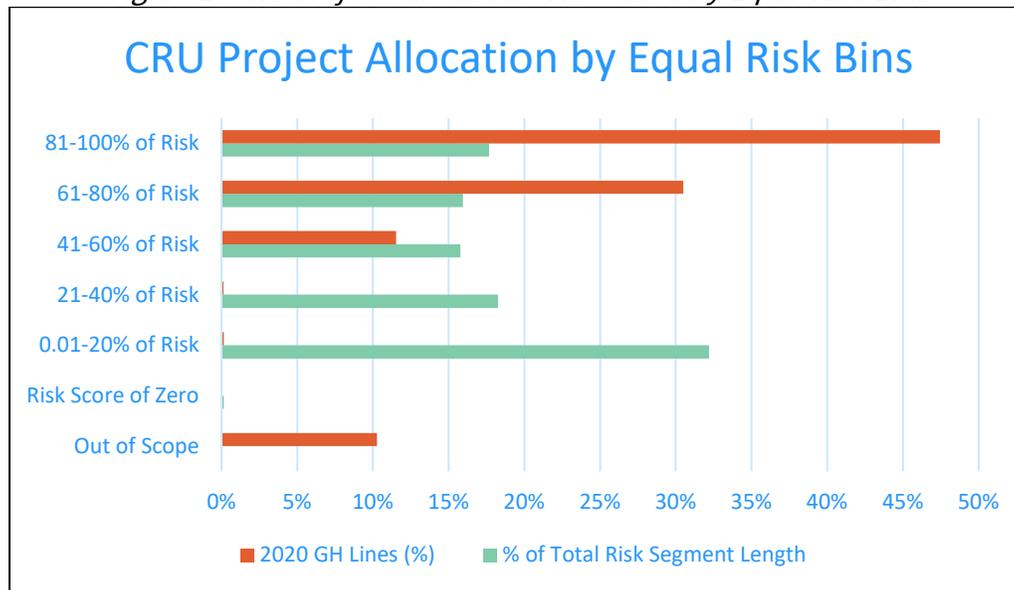
Figure 1: CRU Project Circuit Mile Allocation by Equal Risk Bins

Figure 1 below illustrates the results of Energy Safety’s analysis of PG&E’s completed CRU projects. CRU projects completed on risk segments with a risk score of zero and CRU projects completed more than 100 meters from a risk segment were sorted into separate bins, respectively.

As shown in Figure 1, 10% of the CRU projects completed by PG&E in 2020 were out of the scope of this analysis. While PG&E completed nearly half of its CRU projects in its highest risk bin, as discussed above, the 61-80% and 41-60% risk bins contained more risk per circuit mile. Given the amount of CRU projects completed in 2020, more risk may have been reduced for the same number of miles completed had there been more work allocated in the 61-80% and 41-60% risk bins.

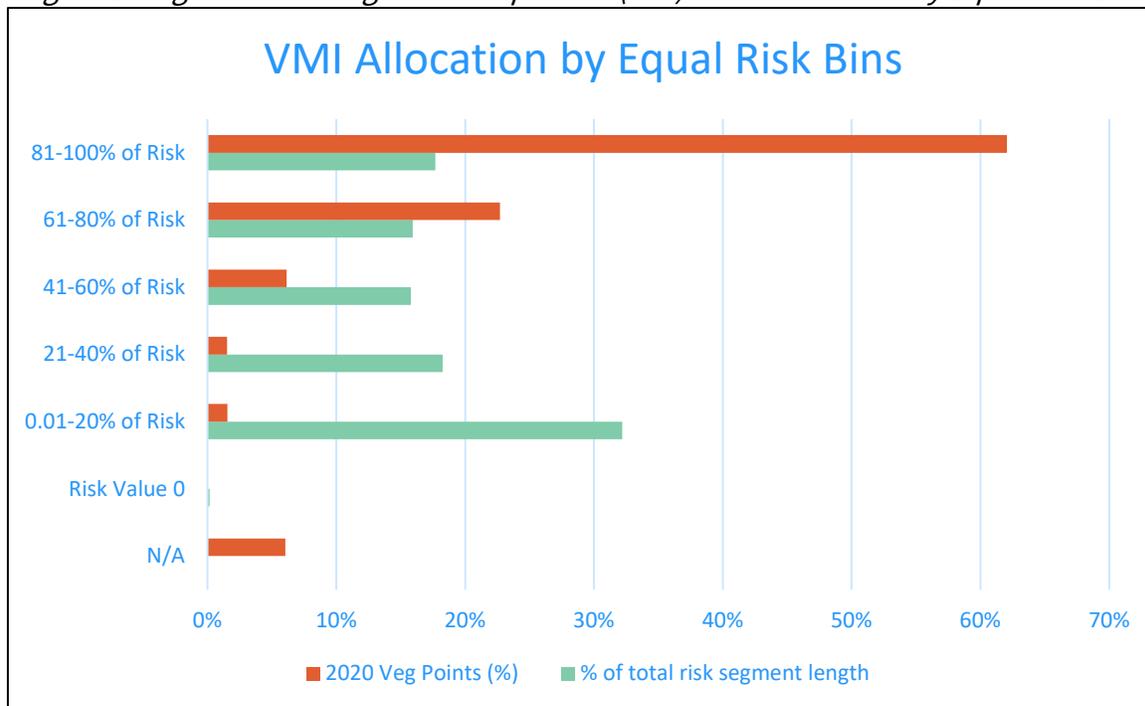
Figure 2: Vegetation Management Inspection (VMI) Point Allocation by Equal Risk Bins

Figure 2 below presents the results of Energy Safety’s analysis of PG&E’s completed non-routine VMI. Non-routine VMI work completed on risk segments with a score of zero and non-

PG&E completed approximately 90% of its non-routine VMI near risk segments that make up 60% of its distribution risk.¹⁵² While PG&E completed over 60% of its VMI work in its highest risk bin, as discussed above, the 61-80% and 41-60% risk bins contained more risk per circuit mile. Given the amount of VMI completed in 2020, more risk may have been reduced for the same volume of VMI work completed had there been more work allocated in the 61-80% and 41-60% risk bins.

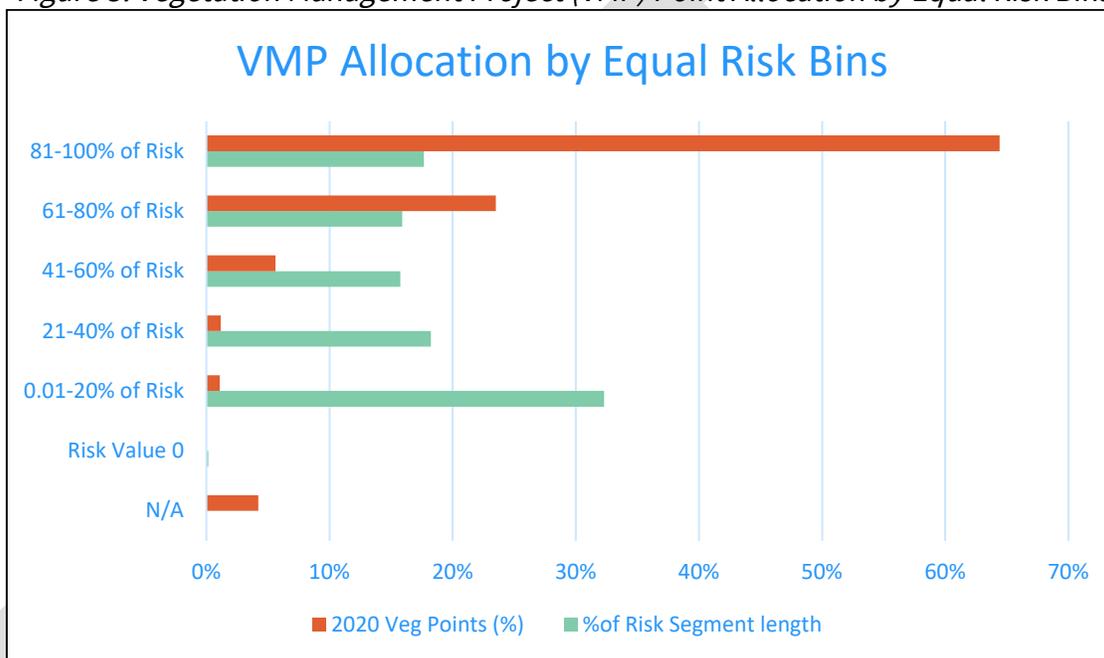
Figure 3: Vegetation Management Project (VMP) Point Allocation by Equal Risk Bins

Figure 3 below presents the results of Energy Safety’s analysis of PG&E’s completed non-routine VMP. Non-routine VMP work completed on risk segments with a score of zero and non-routine VMP work more than 200 meters from a risk segment were sorted into separate bins, respectively.

PG&E completed 88% of its non-routine VMP near risk segments making up the top 40% of riskiest segments.¹⁵³ While PG&E completed over 60% of its VMP work in its highest risk bin, as discussed above, the 61-80% and 41-60% risk bins contained more risk per circuit mile. Given the amount of VMP work completed in 2020, more risk may have been reduced for the same volume of work completed had there been more work allocated in the 61-80% and 41-60% risk bins.

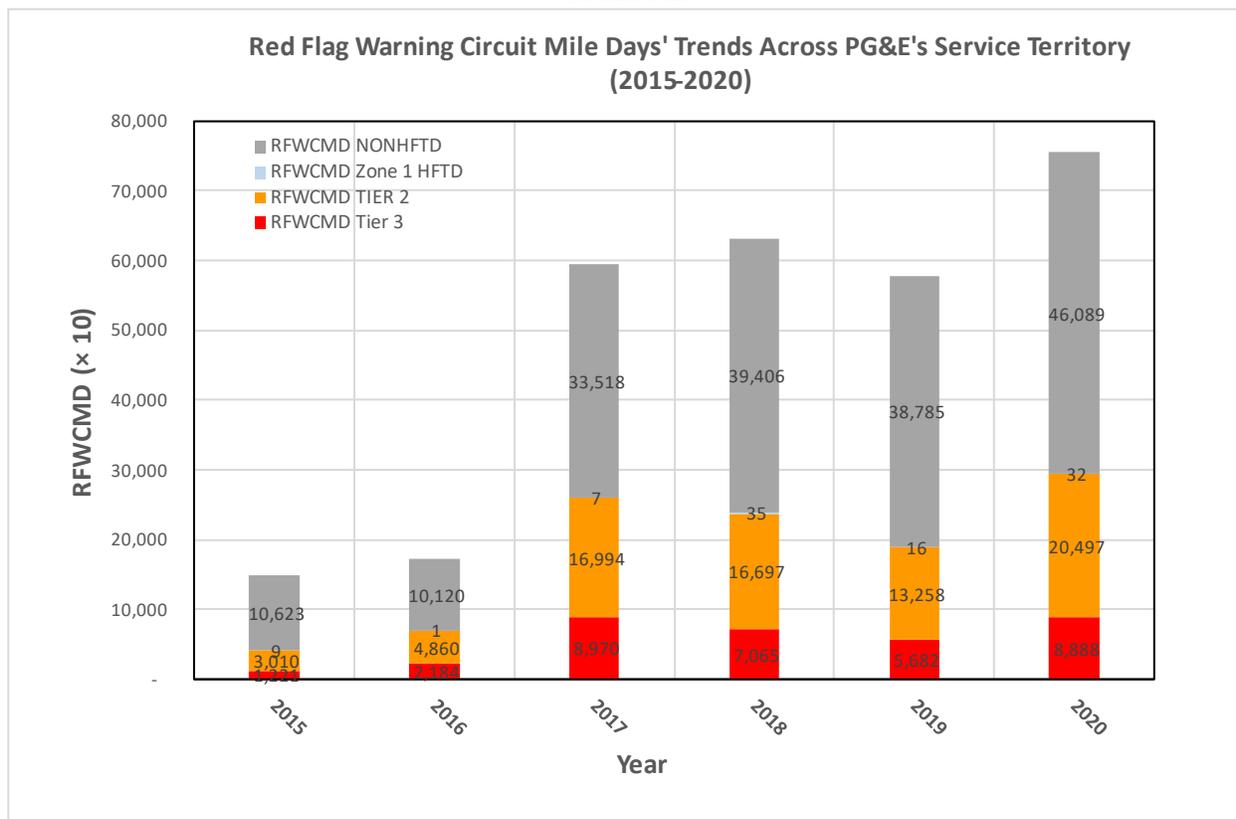
Figure 4: Variances in Extreme Fire Weather Across PG&E Territory from 2015-2020 by location.

PG&E has seen a steady increase in extreme fire weather events since 2015 with a significant spike in 2017. Energy Safety uses a metric, the red flag warnings circuit mile days (RWCMD) for overhead assets, to depict wildfire risk normalized for the size of an electrical corporation's service territory. Use of this metric allowed for comparisons across reporting years and enabled assessment of performance in 2020 relative to previous trends from 2015-2019. As noted in Figure 4 below, the RWCMD experienced in 2020 represented the largest value (i.e., worst fire weather and greatest exposure) over the six-year 2015-2020 reporting period.

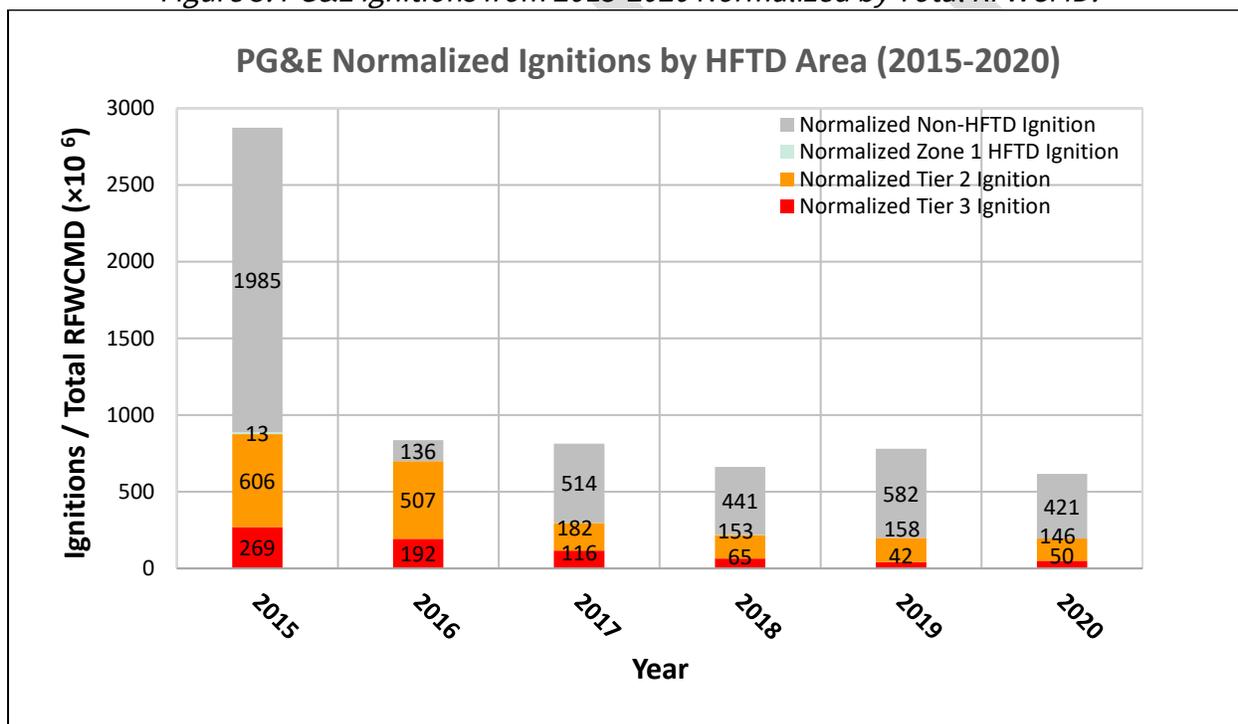
Figure 5: PG&E Ignitions from 2015-2020 Normalized by Total RFWCMD.

QDR Table 7.2 includes data on PG&E’s ignitions from 2015 through 2020, plotted below. Figure 5 shows the ignitions across PG&E’s service territory normalized by the total RFWCMD for each year and broken out by location (i.e., Tier 3 HFTD areas, Tier 2 HFTD areas, Zone 1 HFTD areas, and non-HFTD areas). Figure 6 shows the ignitions in Tier 3 HFTD areas of PG&E’s service territory normalized by the RFWCMD in Tier 3 only for each year. Figure 7 shows the ignitions in Tier 2 HFTD areas of PG&E’s service territory normalized by the RFWCMD in Tier 2 only for each year.

As can be seen in the three figures above, PG&E’s normalized ignitions decreased during the 2015-2020 period. There is a general downward trend in ignitions across PG&E’s service territory, as well as in Tier 2 and Tier 3 HFTD areas specifically.

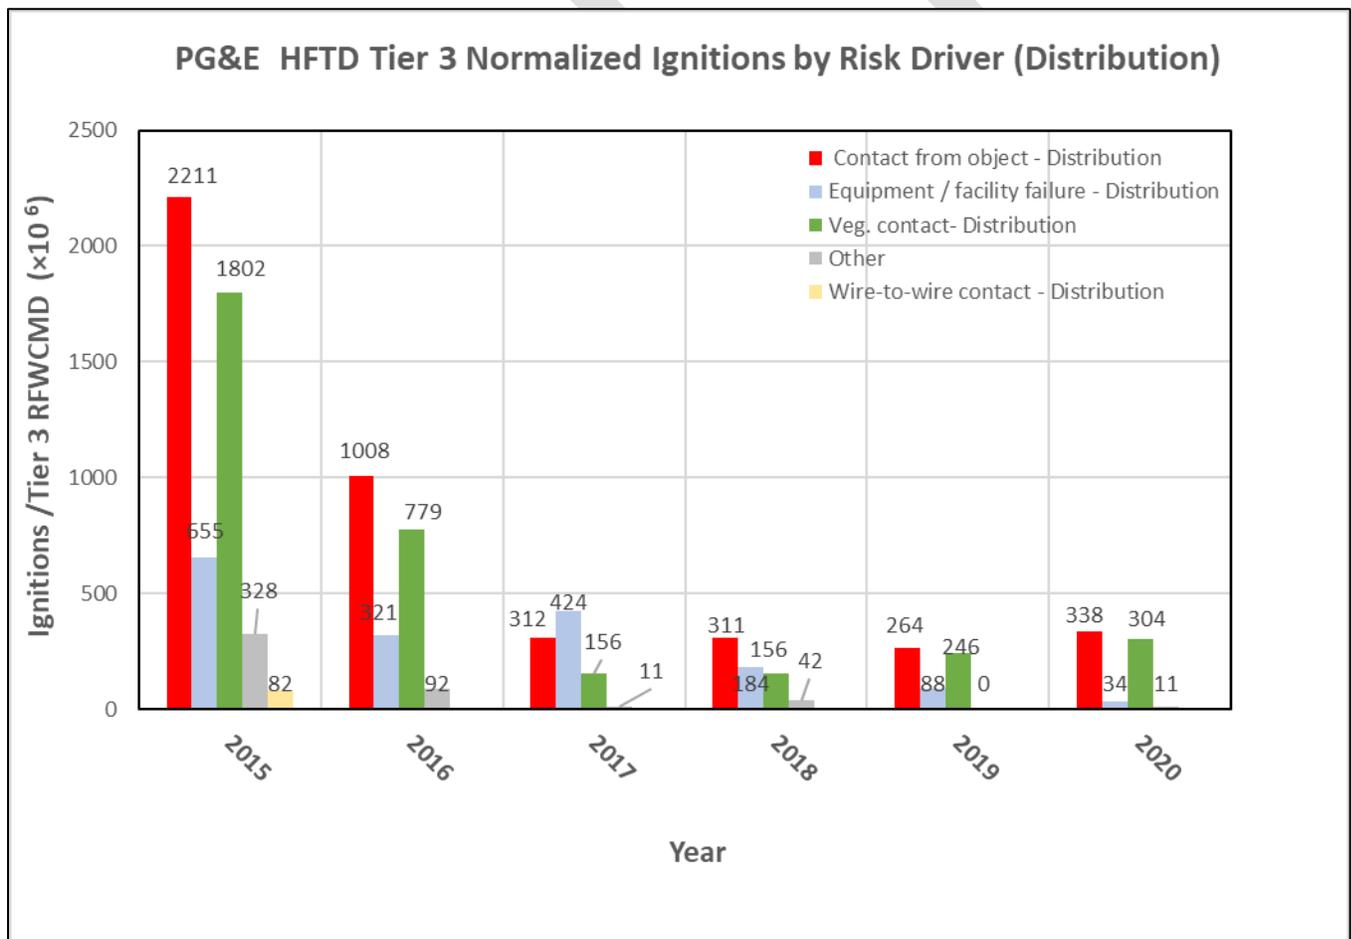
Figure 8: PG&E Distribution Ignitions in Tier 3 HFTD Areas from 2015-2020 Normalized by RFWCMD in Tier 3 Only Broken out by Risk Driver.¹⁷¹

As can be seen from the figures above for the distribution system, the primary drivers of ignition are object contact and vegetation contact followed by equipment or facility failure.

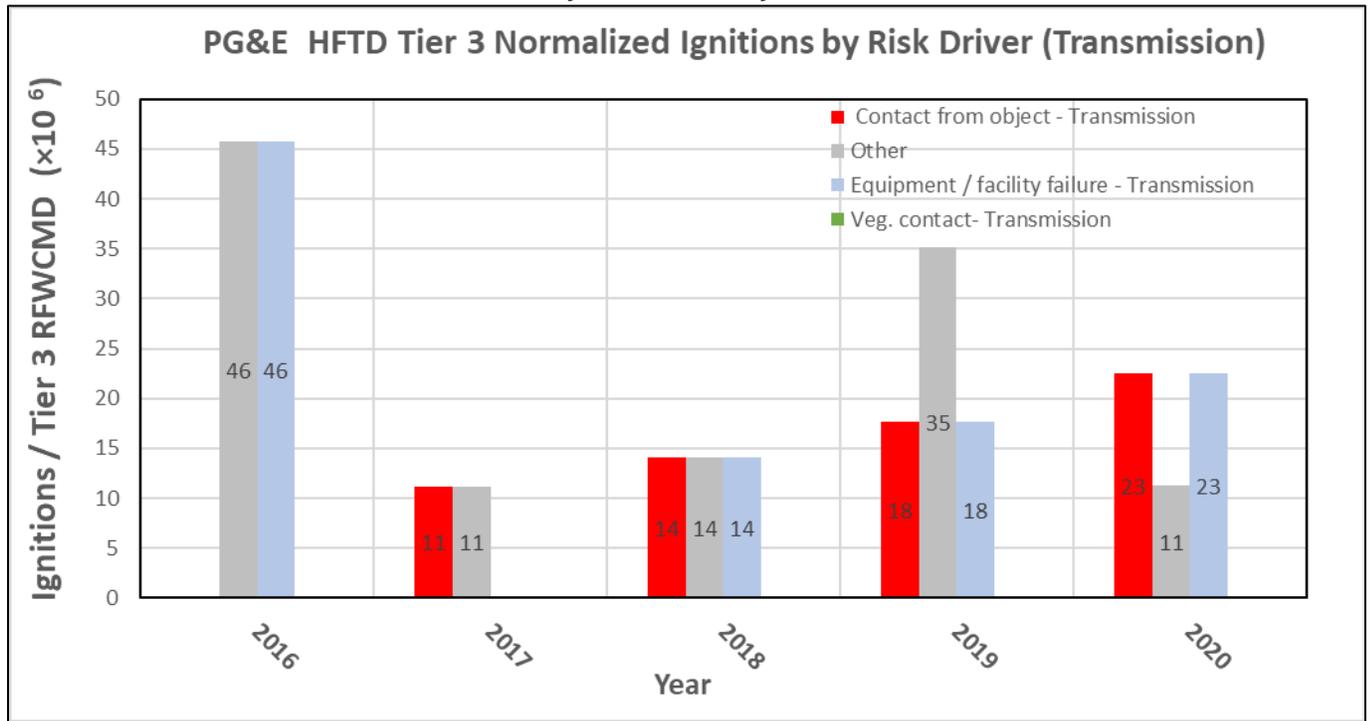
Figure 10: PG&E Transmission Ignitions in Tier 3 HFTD Areas from 2015-2020 Normalized by RFWCMD in Tier 3 Only Broken out by Risk Driver.¹⁷³

On the transmission system, the primary ignition drivers are object contact and equipment or facility failure, although HFTD Tier 3 ignitions are notably driven by drivers in the “other” category.¹⁷⁵

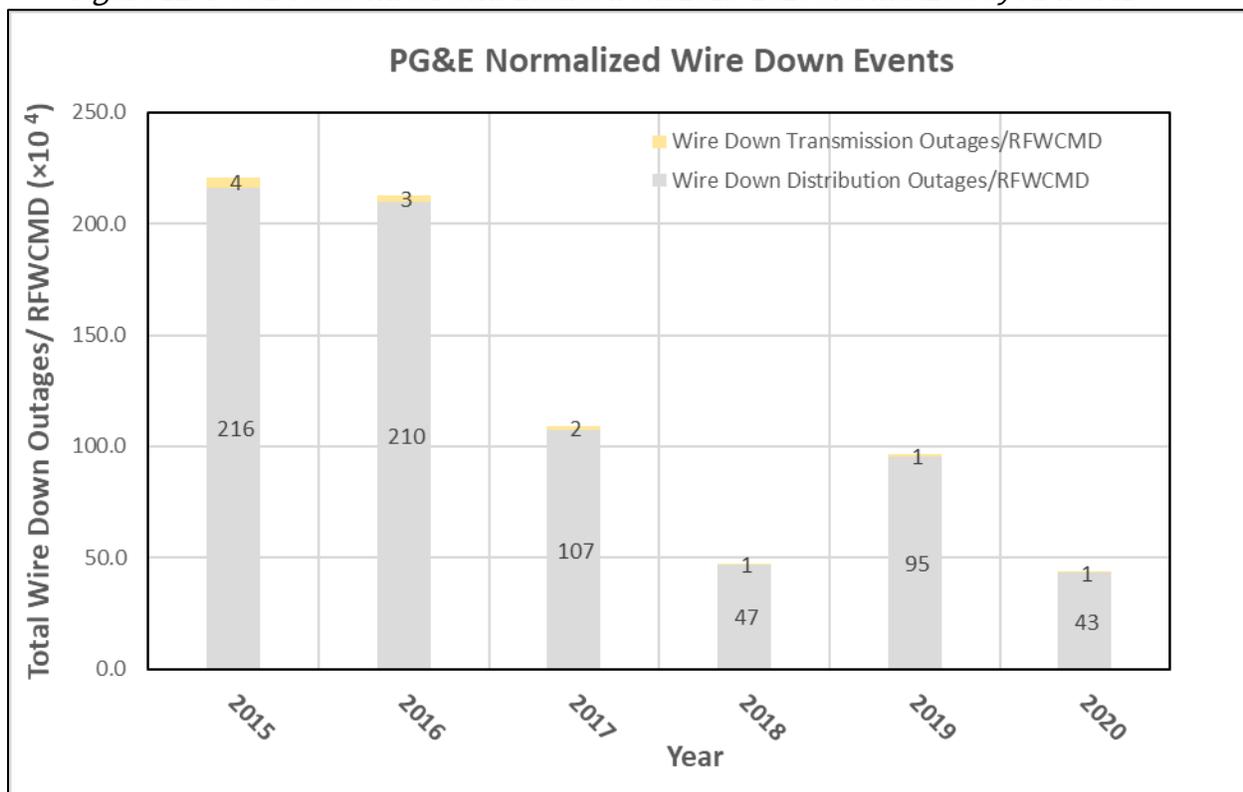
Figure 12: PG&E Total Wire Down Events from 2015-2020 Normalized by RFWCMD.¹⁷⁶

QDR Table 7.1, metrics 1 through 16 include data on PG&E’s distribution and transmission wire down events from 2015 through 2020, which were normalized for RFWCMD and plotted below in Figure 12. Wire down events can be a precursor to ignitions; therefore, Energy Safety will look for a downward trend over time.

Although there was an uptick in 2019, normalized wire down events trended lower over the 2015-2020 timeframe.

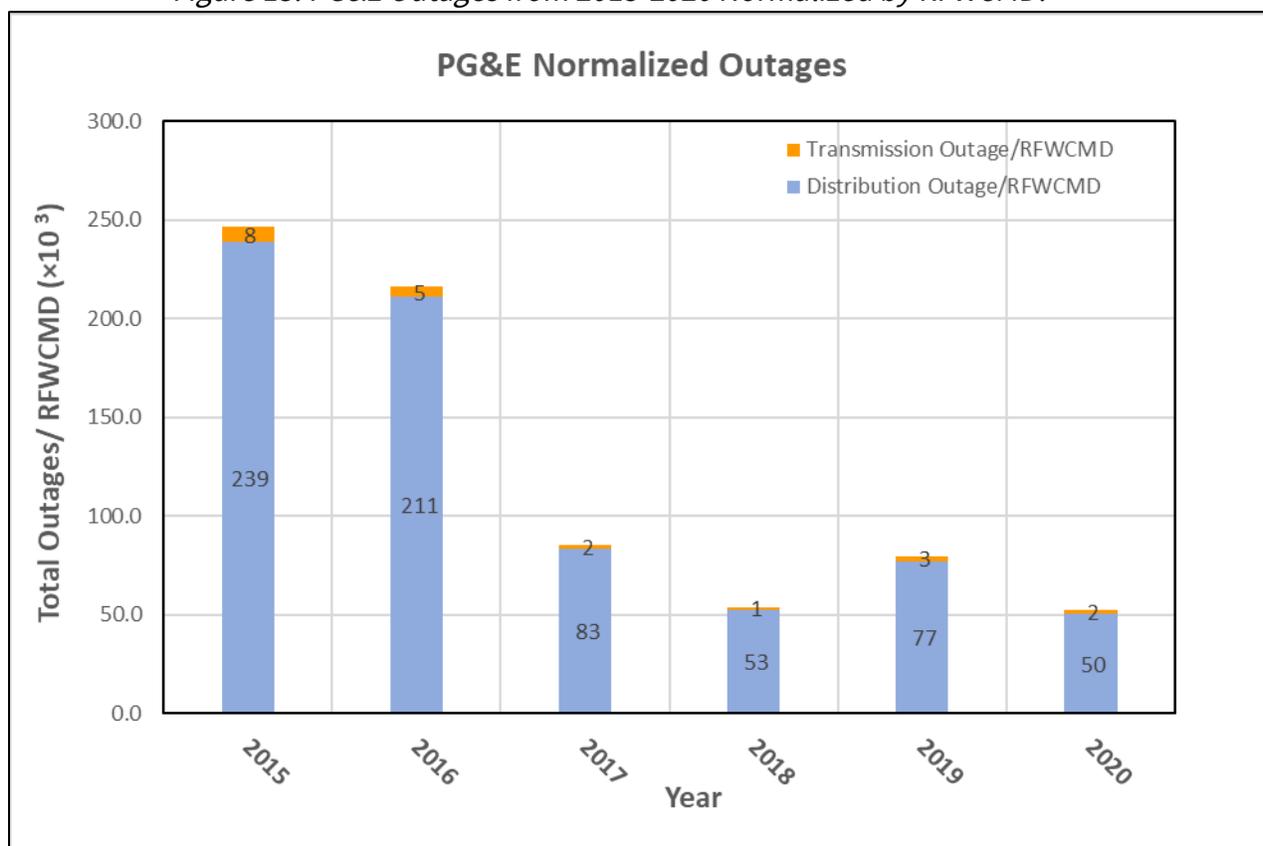
Figure 13: PG&E Outages from 2015-2020 Normalized by RFWCMD.¹⁷⁷

QDR Table 7.1, metrics 17 through 32 include data on distribution and transmission outages of all cause types from 2015 through 2020. Unplanned or unscheduled outages correlate to a potential for ignitions on the system, although they are not as strong a predictor as wire down events. Figure 13 below plots PG&E's transmission and distribution outages normalized for RFWCMD.

Although there was an uptick in 2019, normalized total unplanned outages trended lower over the 2015-2020 timeframe.

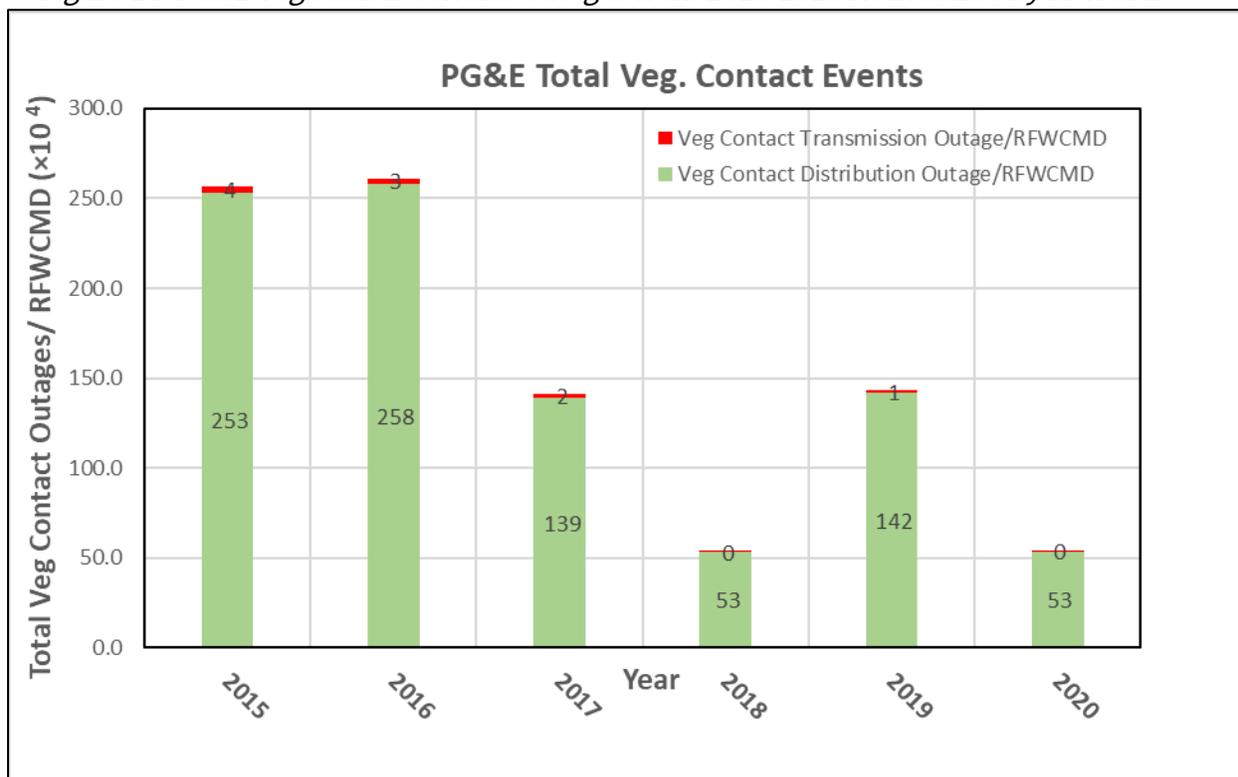
Figure 14: PG&E Vegetation Contact Outages from 2015-2020 Normalized by RFWCMD.¹⁷⁸

QDR Table 7.1, metrics 17a and 25a include data on transmission and distribution outages that are caused by vegetation contact from 2015 through 2020. Figure 14 below plots PG&E's transmission and distribution vegetation contact-caused outages normalized for RFWCMD.

Although there was an uptick in 2019, normalized outages due to vegetation contact trended lower over the 2015-2020 timeframe.

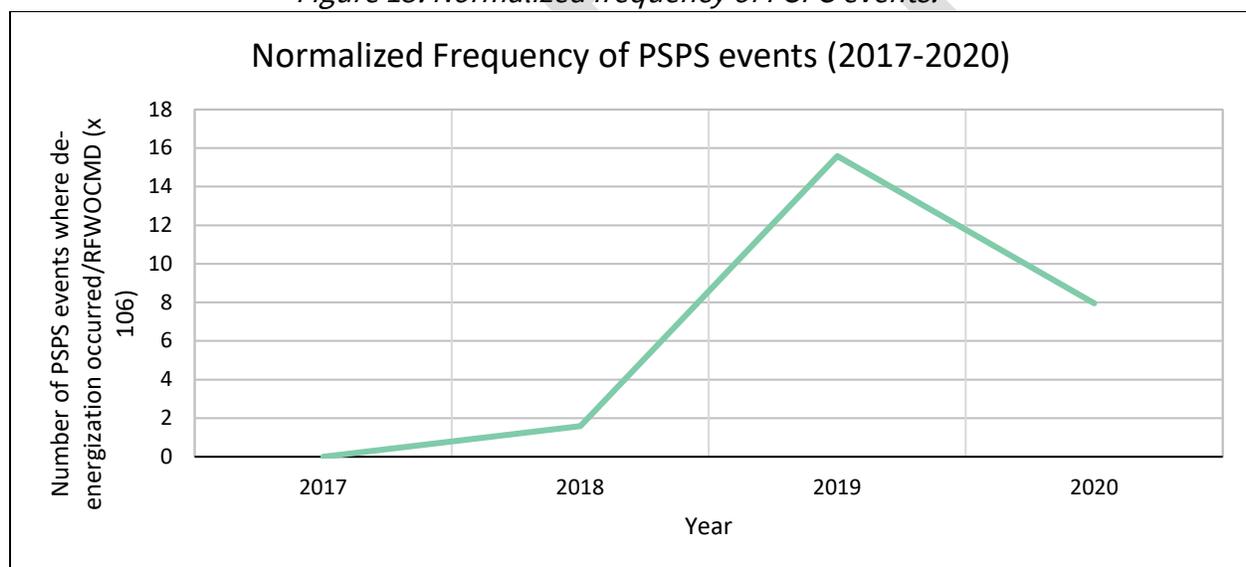
Figure 15: Normalized frequency of PSPS events.¹⁸²

PG&E reported data on its use of PSPS and other PSPS metrics in Table 11 of its QDR (QDR Table 11).¹⁸¹ Again, Energy Safety applied the RFWCMD metric as a normalizing parameter. All charts show a sharp uptick in usage and impact of PSPS in 2019 followed by a significant decline in 2020, although still well above zero.

PG&E was largely successful in achieving its objective to reduce the scope and impact of PSPS from 2019 levels. As shown in Figure 19, PG&E significantly reduced the number of customers impacted by PSPS events, although given PG&E's widespread usage of PSPS in 2019, this objective set a fairly low bar. As noted in Section 6.1, Energy Safety finds that PG&E had substantially completed its objective to shorten restoration time to 12-daylight hours, achieving an outcome of 96% out of a stated 98% target. PG&E's normalized frequency of PSPS events declined 50% from 2019 to 2020.

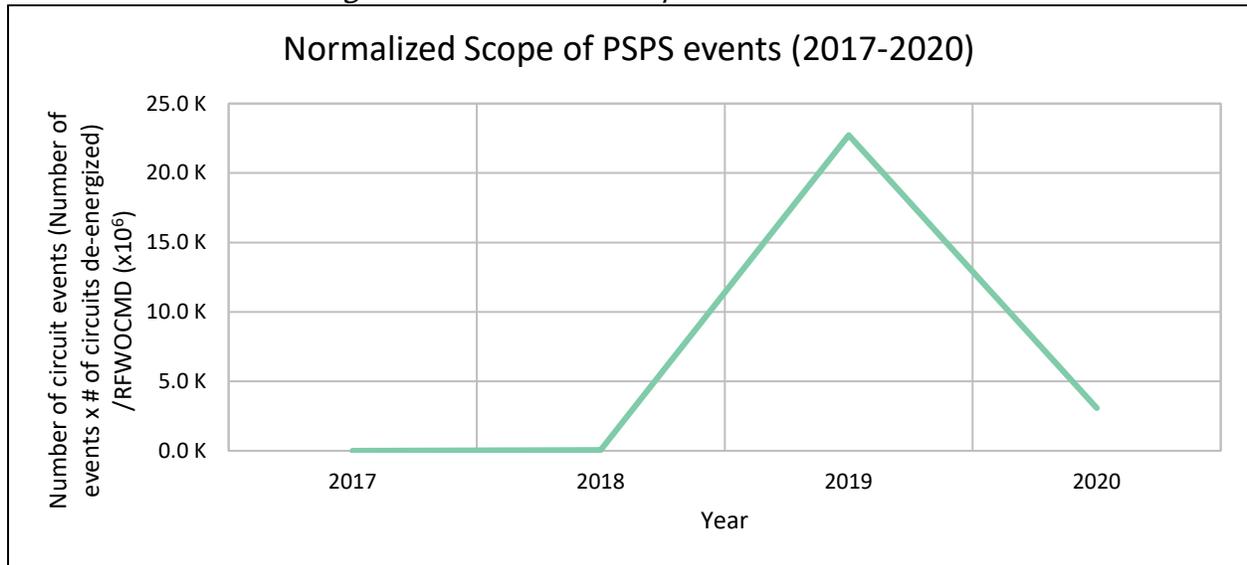
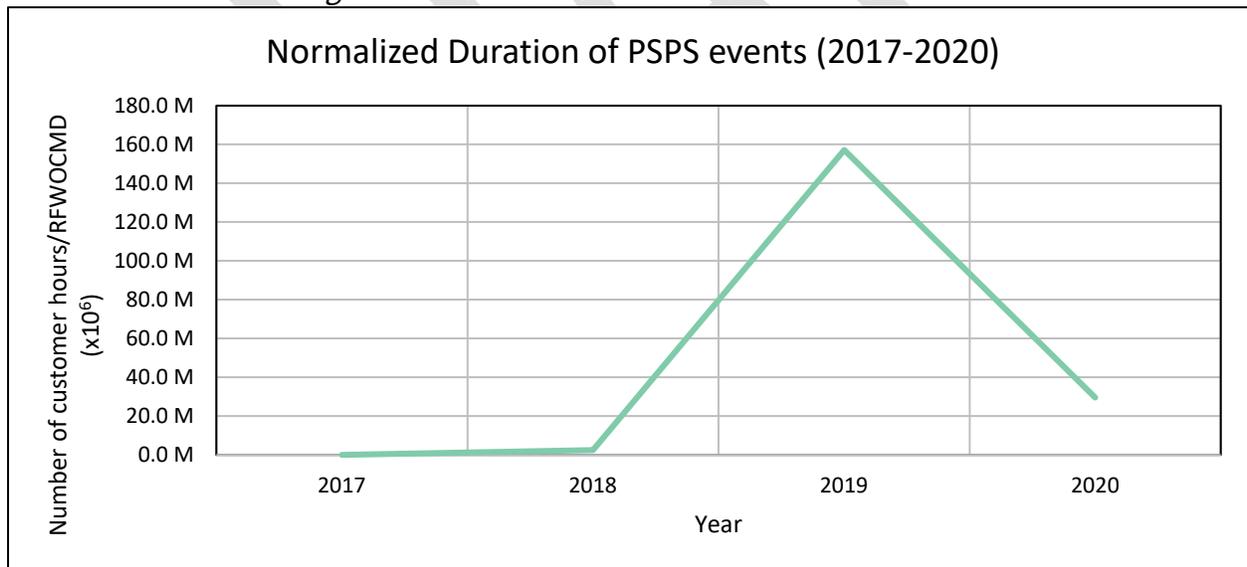
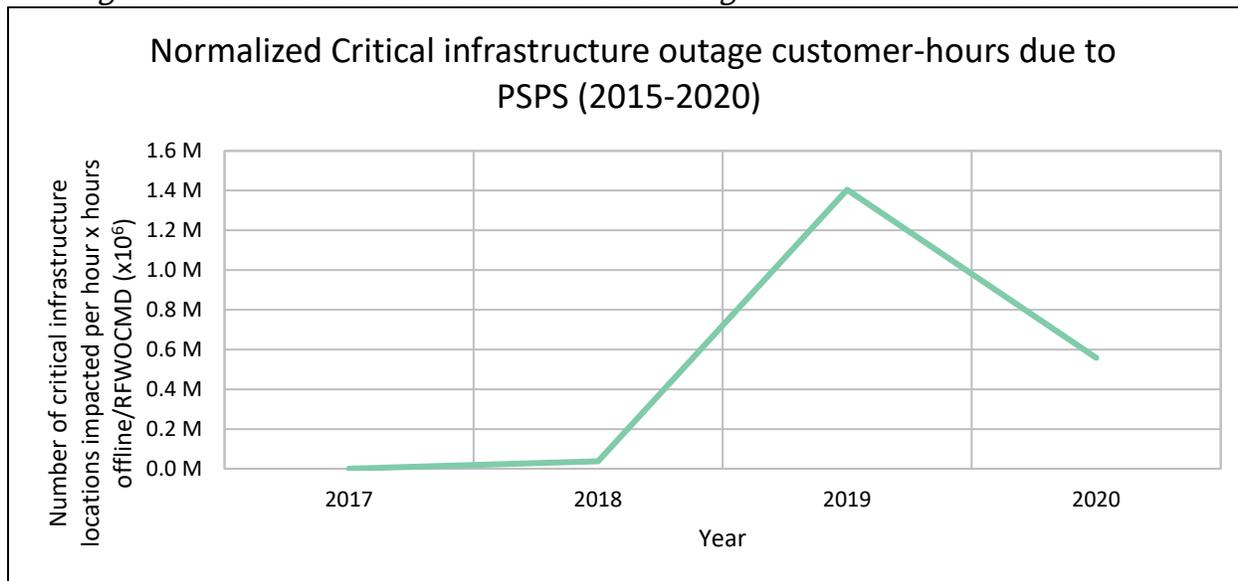
The above figures show a marked decreased in PSPS duration, scope, and frequency from 2019 to 2020; however, PG&E’s use of PSPS in 2019 was significant. Therefore, the downward

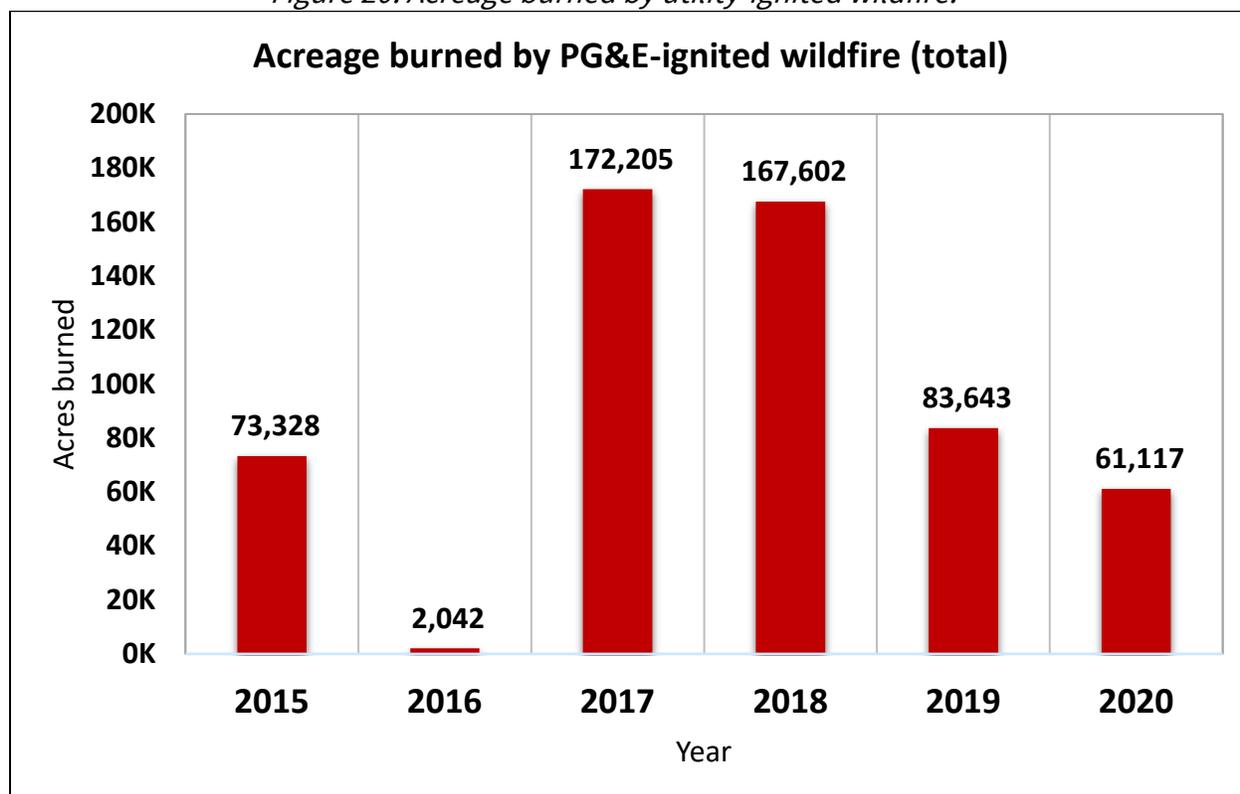
Figure 20: Acreage burned by utility-ignited wildfire.¹⁹³

As shown above, the acres burned from wildfires ignited by PG&E's infrastructure over the six-year reporting period generally follows a normal distribution and indicates a decline since 172,205 acres burned in 2017.

Taken alone, these data suggest that PG&E was on a positive trajectory. However, evaluating these metrics in a vacuum fails to capture the consequence of any single ignition. While PG&E had 38% fewer acres burned and 95% fewer structures damaged compared to the five-year average from 2015 through 2019 (Figures 20 and 21), that five-year average is highly skewed

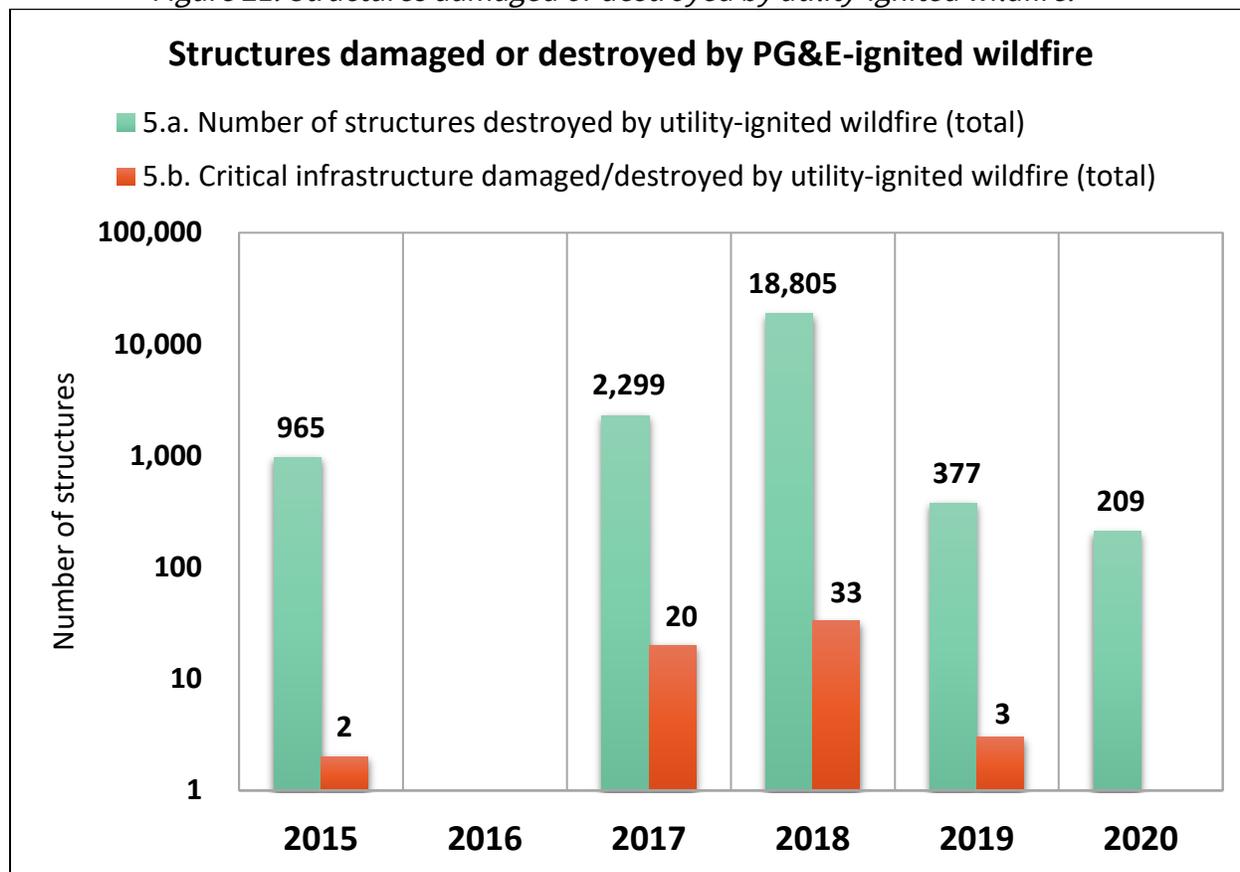
Figure 21: Structures damaged or destroyed by utility-ignited wildfire.¹⁹⁴

The number of structures and critical infrastructure damaged or destroyed from wildfires related to PG&E’s electrical lines and equipment decreased in 2020 compared to the 5-year average from 2015-2019 (4,489 structures and 12 critical infrastructure).

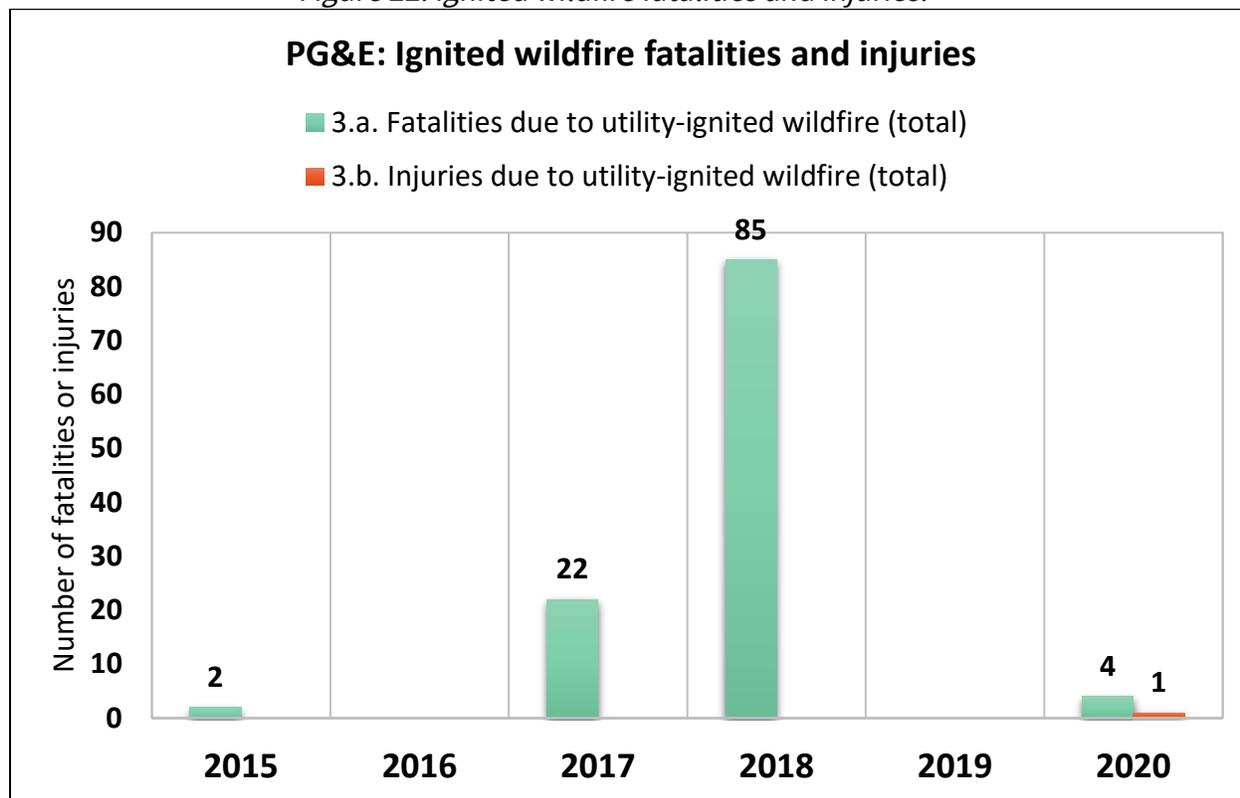
Figure 22: Ignited wildfire fatalities and injuries.¹⁹⁵

Following the significant loss of life from PG&E-ignited wildfires in 2017 and 2018 that claimed the lives of 107 individuals, a reprieve from such loss of life in 2019 was temporary as there were four fatalities and one injury attributable to PG&E-ignited wildfires in 2020.

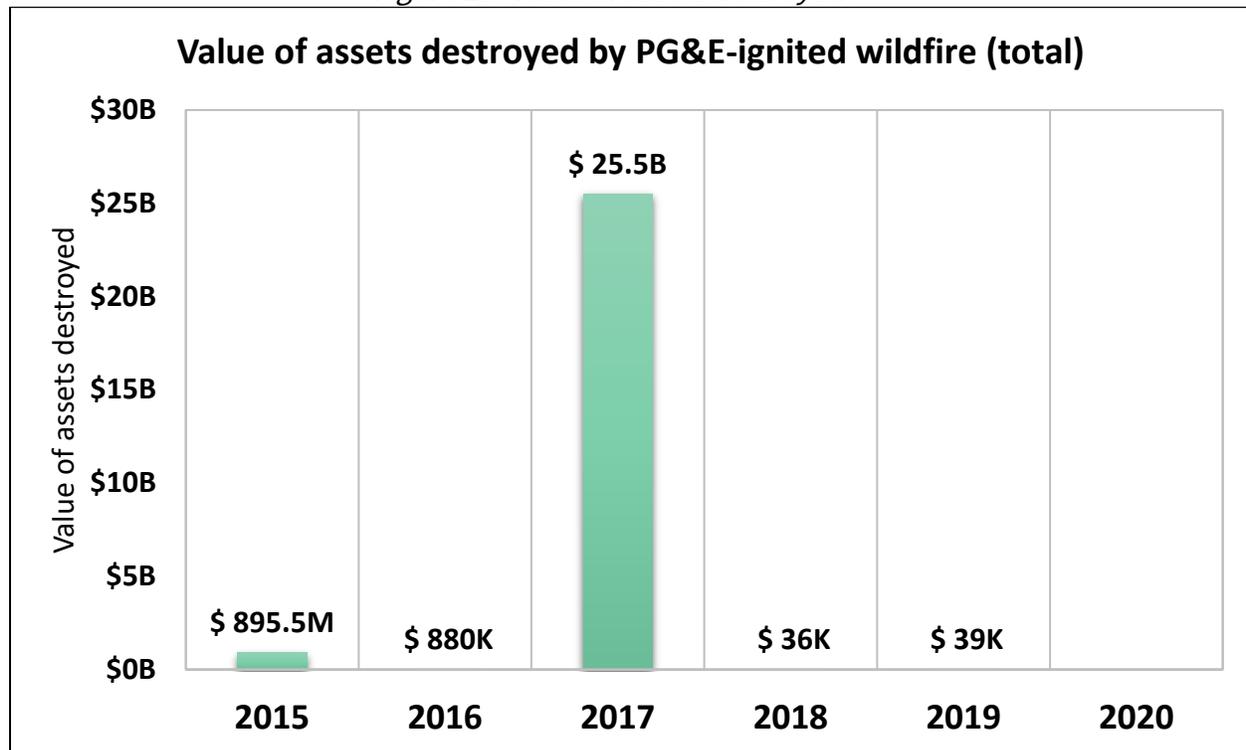
Figure 23: Value of assets destroyed.¹⁹⁶

The value of assets destroyed in 2020 was reported as \$0. Although it is unlikely that there was \$0 in damage given the volume of structures damaged or destroyed, Energy Safety relied upon the data as reported by PG&E in its 2021 Q1 QDR.
