ANNUAL REPORT ON COMPLIANCE

**PACIFIC GAS & ELECTRIC COMPANY
2020 WILDFIRE MITIGATION PLAN**

FEBRUARY 2023

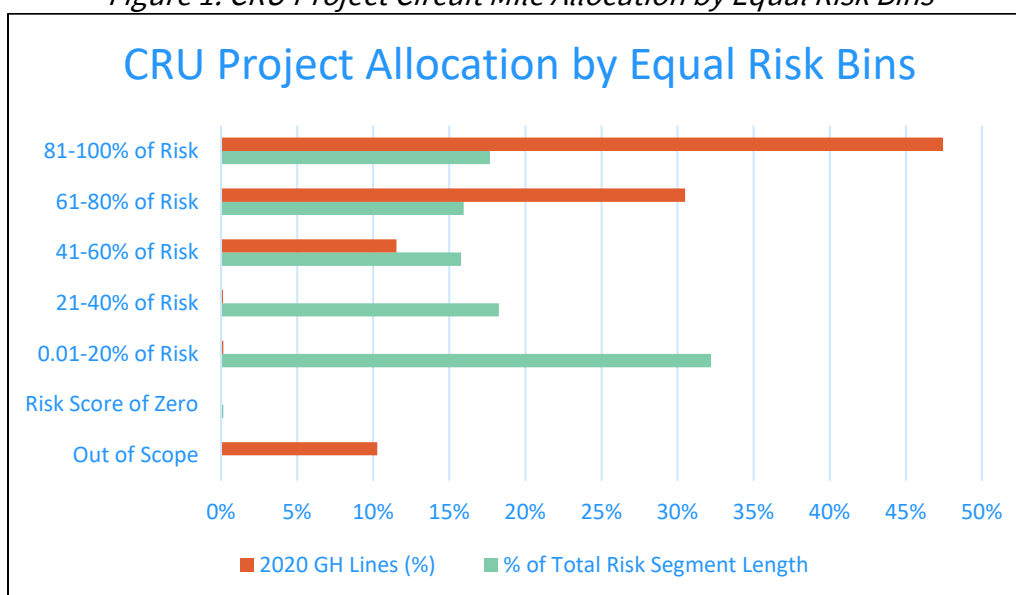
Figure 1: CRU Project Circuit Mile Allocation by Equal Risk Bins

Figure 1 below illustrates the results of Energy Safety's analysis of PG&E's completed CRU projects. CRU projects completed on risk segments with a risk score of zero and CRU projects completed more than 100 meters from a risk segment were sorted into separate bins, respectively.

As shown in Figure 1, 10% of the CRU projects completed by PG&E in 2020 were out of the scope of this analysis. While PG&E completed nearly half of its CRU projects in its highest risk bin, as discussed above, the 61-80% and 41-60% risk bins contained more risk per circuit mile. Given the amount of CRU projects completed in 2020, more risk may have been reduced for the same number of miles completed had there been more work allocated in the 61-80% and 41-60% risk bins.

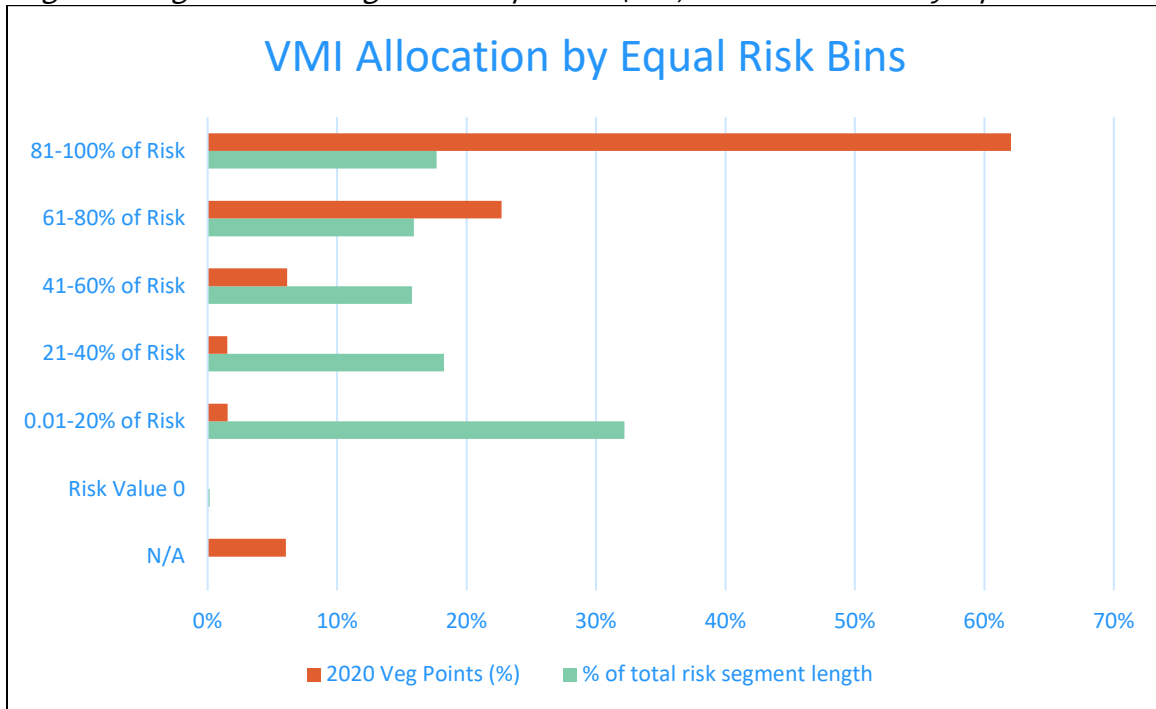
Figure 2: Vegetation Management Inspection (VMI) Point Allocation by Equal Risk Bins

Figure 2 below presents the results of Energy Safety's analysis of PG&E's completed non-routine VMI. Non-routine VMI work completed on risk segments with a score of zero and non-routine VMI work more than 200 meters from a risk segment were sorted into separate bins, respectively.

PG&E completed approximately 90% of its non-routine VMI near risk segments that make up 60% of its distribution risk.¹⁵² While PG&E completed over 60% of its VMI work in its highest risk bin, as discussed above, the 61-80% and 41-60% risk bins contained more risk per circuit mile. Given the amount of VMI completed in 2020, more risk may have been reduced for the same volume of VMI work completed had there been more work allocated in the 61-80% and 41-60% risk bins.

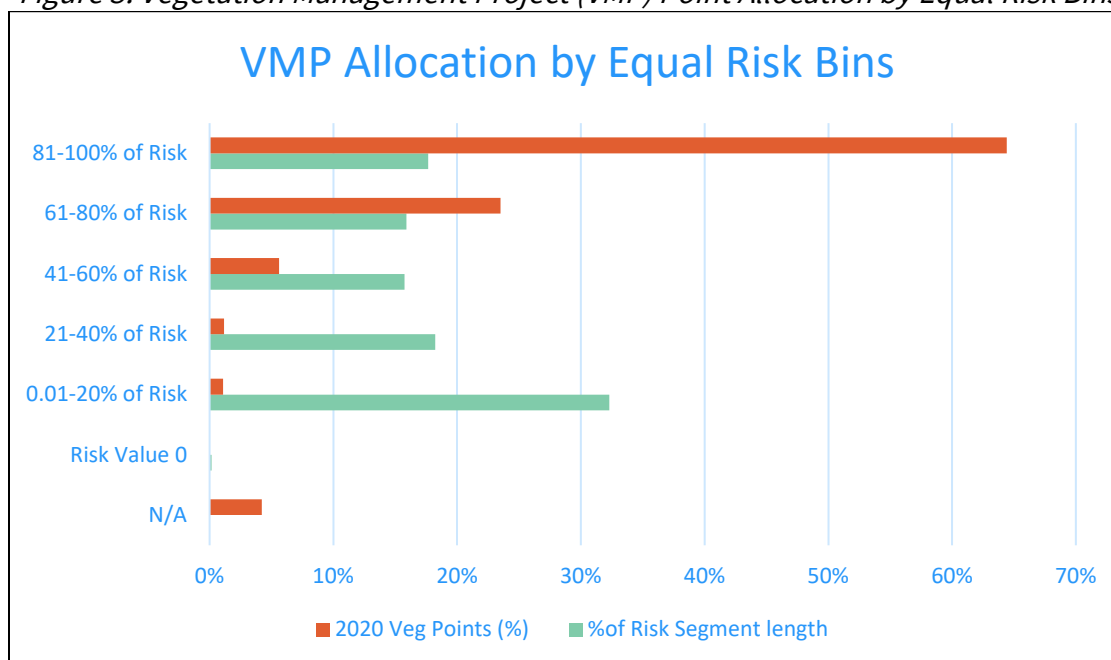
Figure 3: Vegetation Management Project (VMP) Point Allocation by Equal Risk Bins

Figure 3 below presents the results of Energy Safety's analysis of PG&E's completed non-routine VMP. Non-routine VMP work completed on risk segments with a score of zero and non-routine VMP work more than 200 meters from a risk segment were sorted into separate bins, respectively.

PG&E completed 88% of its non-routine VMP near risk segments making up the top 40% of riskiest segments.¹⁵³ While PG&E completed over 60% of its VMP work in its highest risk bin, as discussed above, the 61-80% and 41-60% risk bins contained more risk per circuit mile. Given the amount of VMP work completed in 2020, more risk may have been reduced for the same volume of work completed had there been more work allocated in the 61-80% and 41-60% risk bins.

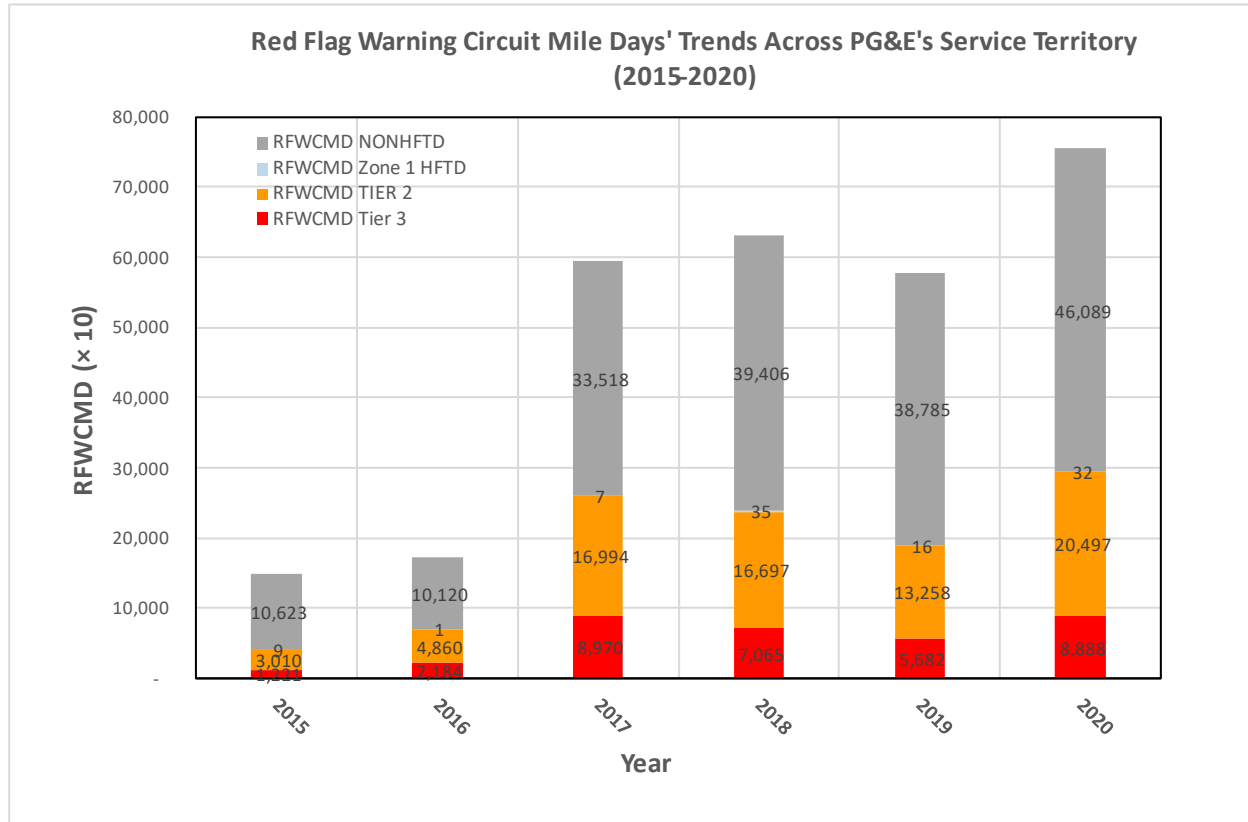
Figure 4: Variances in Extreme Fire Weather Across PG&E Territory from 2015-2020 by location.

PG&E has seen a steady increase in extreme fire weather events since 2015 with a significant spike in 2017. Energy Safety uses a metric, the red flag warnings circuit mile days (RWCMD) for overhead assets, to depict wildfire risk normalized for the size of an electrical corporation's service territory. Use of this metric allowed for comparisons across reporting years and enabled assessment of performance in 2020 relative to previous trends from 2015-2019. As noted in Figure 4 below, the RWCMD experienced in 2020 represented the largest value (i.e., worst fire weather and greatest exposure) over the six-year 2015-2020 reporting period.

Measuring ignitions provided the most direct measure of electrical corporation wildfire risk. Other metrics, such as wire down events and unplanned outages correlated with wildfire risk because some portion of these events will result in ignitions. As presented in Section 5.6.1, a review of normalized ignitions as well as wire down events and unplanned outages from 2015 to 2020 showed a general year over year downward trend. In fact, normalized ignitions in Tier 3 HFTD areas declined 67% over the five-year average as shown in Figure 6. Similarly, normalized ignitions from equipment/facility failure on the distribution system decreased 90% over the five-year average (Figure 8). However, transmission system ignitions in Tier 3 have shown a steady increase in the three-year period since 2017 with 2020 at a 52% increase over 2017 (Figure 10).

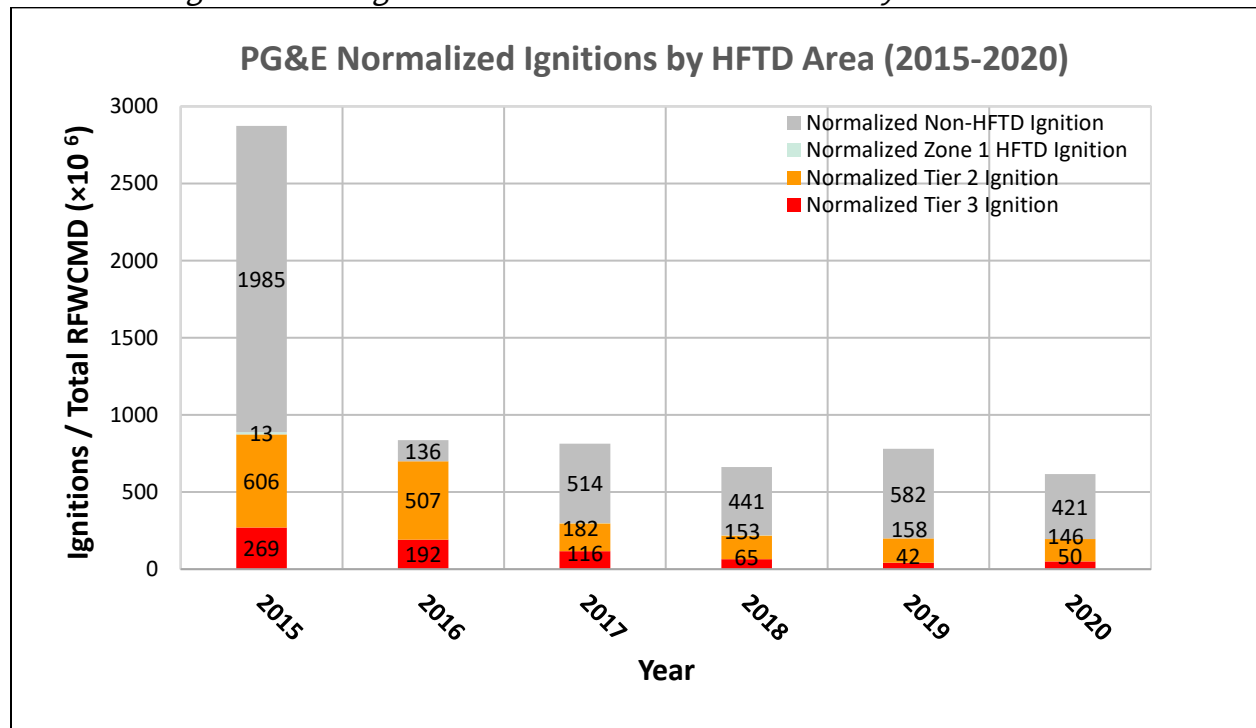
Figure 5: PG&E Ignitions from 2015-2020 Normalized by Total RFWCMD.

QDR Table 7.2 includes data on PG&E's ignitions from 2015 through 2020, plotted below. Figure 5 shows the ignitions across PG&E's service territory normalized by the total RFWCMD for each year and broken out by location (i.e., Tier 3 HFTD areas, Tier 2 HFTD areas, Zone 1 HFTD areas, and non-HFTD areas). Figure 6 shows the ignitions in Tier 3 HFTD areas of PG&E's service territory normalized by the RFWCMD in Tier 3 only for each year. Figure 7 shows the ignitions in Tier 2 HFTD areas of PG&E's service territory normalized by the RFWCMD in Tier 2 only for each year.

As can be seen in the three figures above, PG&E's normalized ignitions decreased during the 2015-2020 period. There is a general downward trend in ignitions across PG&E's service territory, as well as in Tier 2 and Tier 3 HFTD areas specifically.

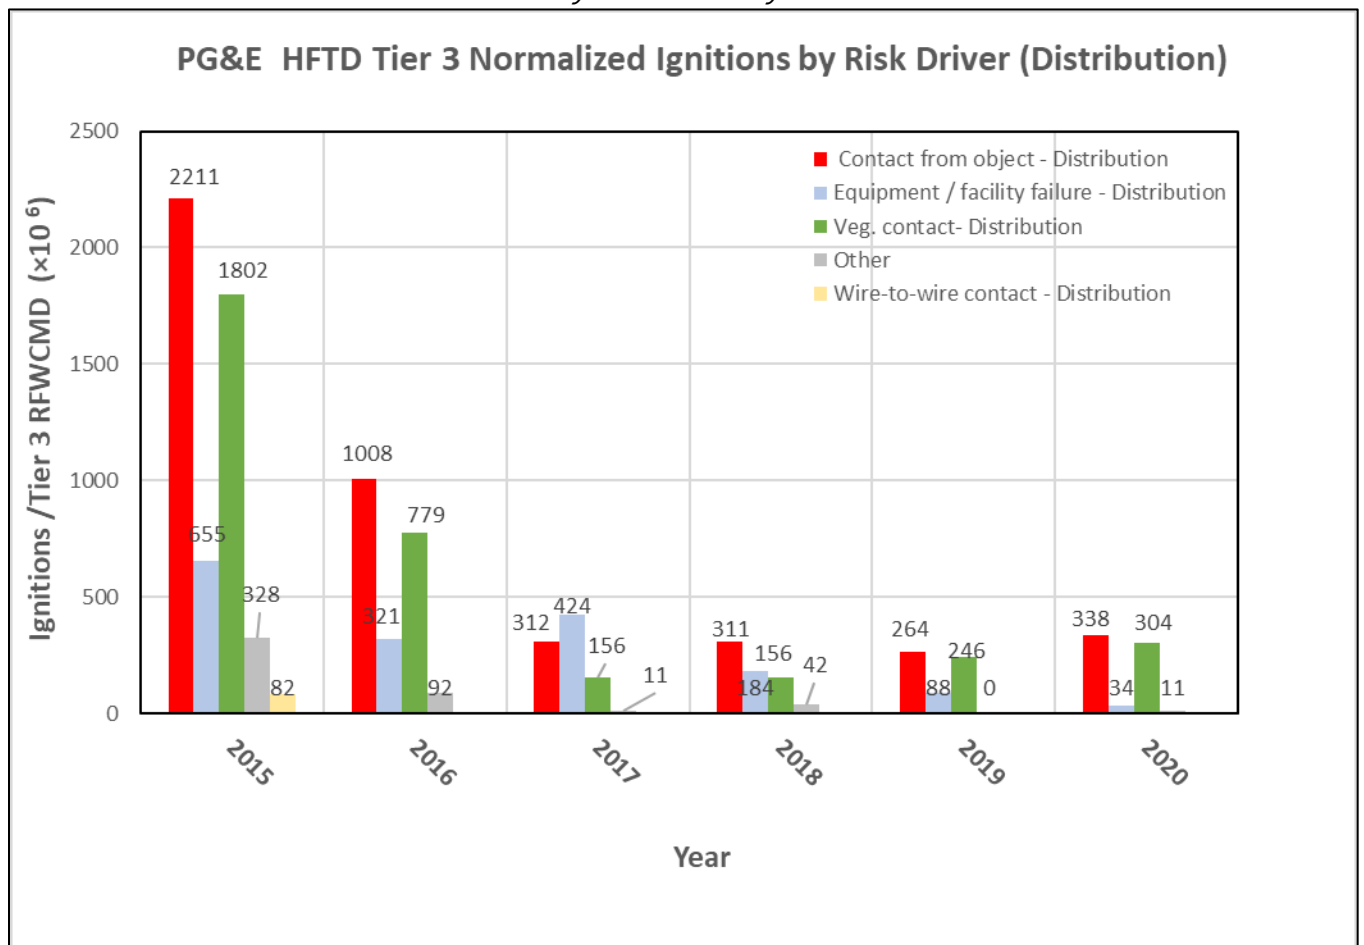
Figure 8: PG&E Distribution Ignitions in Tier 3 HFTD Areas from 2015-2020 Normalized by RFWCMD in Tier 3 Only Broken out by Risk Driver.¹⁷¹

The following four figures show drivers of PG&E ignitions during the 2015-2020 period broken out by asset classification i.e., distribution (first two figures) and transmission (second two figures) and HFTD location (i.e., Tier 3 and Tier 2).

As can be seen from the figures above for the distribution system, the primary drivers of ignition are object contact and vegetation contact followed by equipment or facility failure.

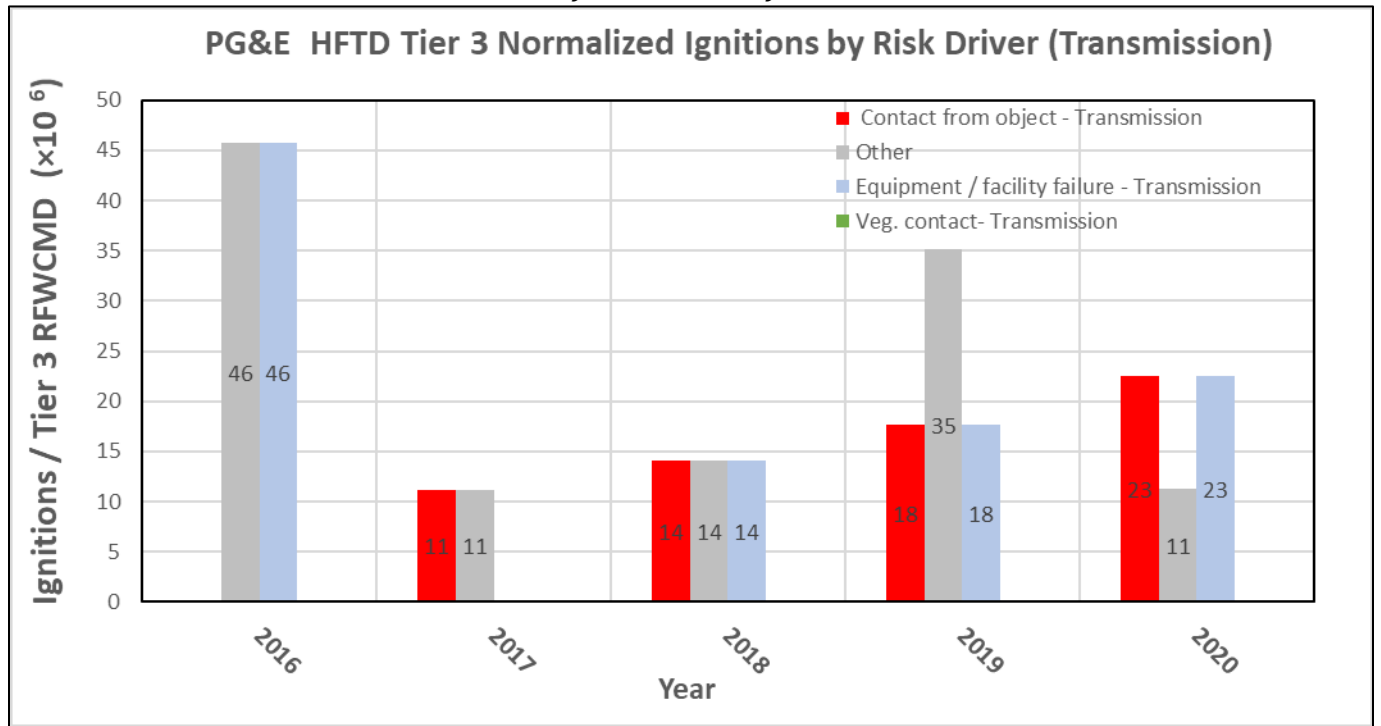
Figure 10: PG&E Transmission Ignitions in Tier 3 HFTD Areas from 2015-2020 Normalized by RFWCMD in Tier 3 Only Broken out by Risk Driver.¹⁷³

On the transmission system, the primary ignition drivers are object contact and equipment or facility failure, although HFTD Tier 3 ignitions are notably driven by drivers in the “other” category.¹⁷⁵

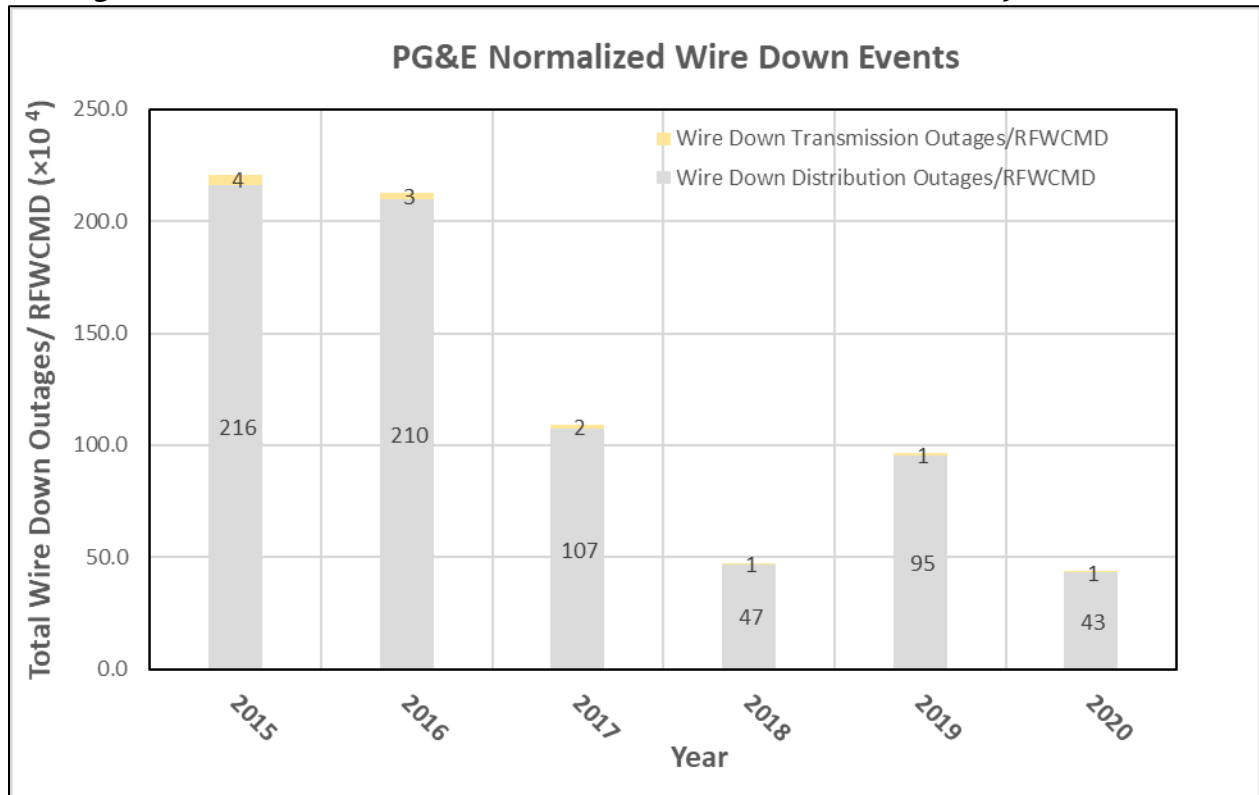
Figure 12: PG&E Total Wire Down Events from 2015-2020 Normalized by RFWCMD.¹⁷⁶

QDR Table 7.1, metrics 1 through 16 include data on PG&E’s distribution and transmission wire down events from 2015 through 2020, which were normalized for RFWCMD and plotted below in Figure 12. Wire down events can be a precursor to ignitions; therefore, Energy Safety will look for a downward trend over time.

Although there was an uptick in 2019, normalized wire down events trended lower over the 2015-2020 timeframe.

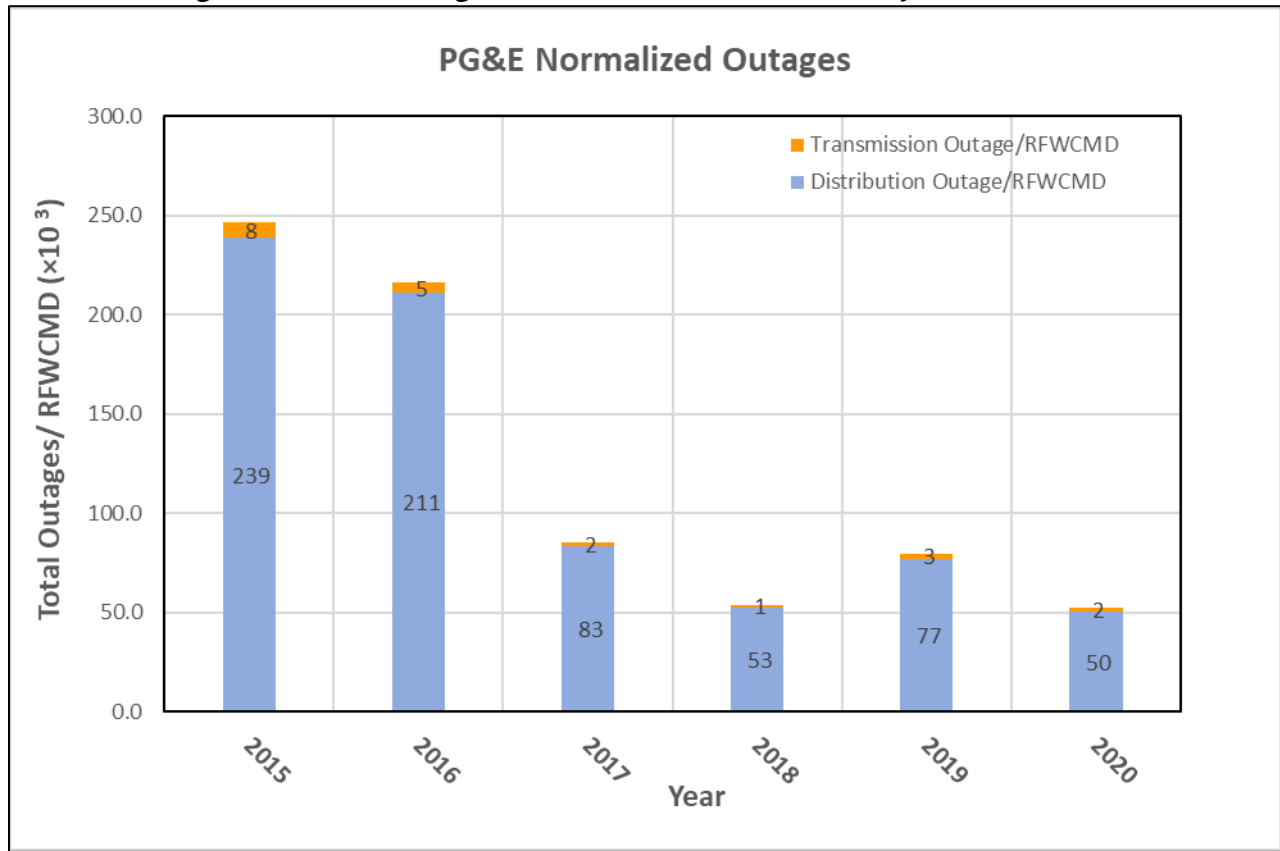
Figure 13: PG&E Outages from 2015-2020 Normalized by RFWCMD. ¹⁷⁷

QDR Table 7.1, metrics 17 through 32 include data on distribution and transmission outages of all cause types from 2015 through 2020. Unplanned or unscheduled outages correlate to a potential for ignitions on the system, although they are not as strong a predictor as wire down events. Figure 13 below plots PG&E's transmission and distribution outages normalized for RFWCMD.

Although there was an uptick in 2019, normalized total unplanned outages trended lower over the 2015-2020 timeframe.

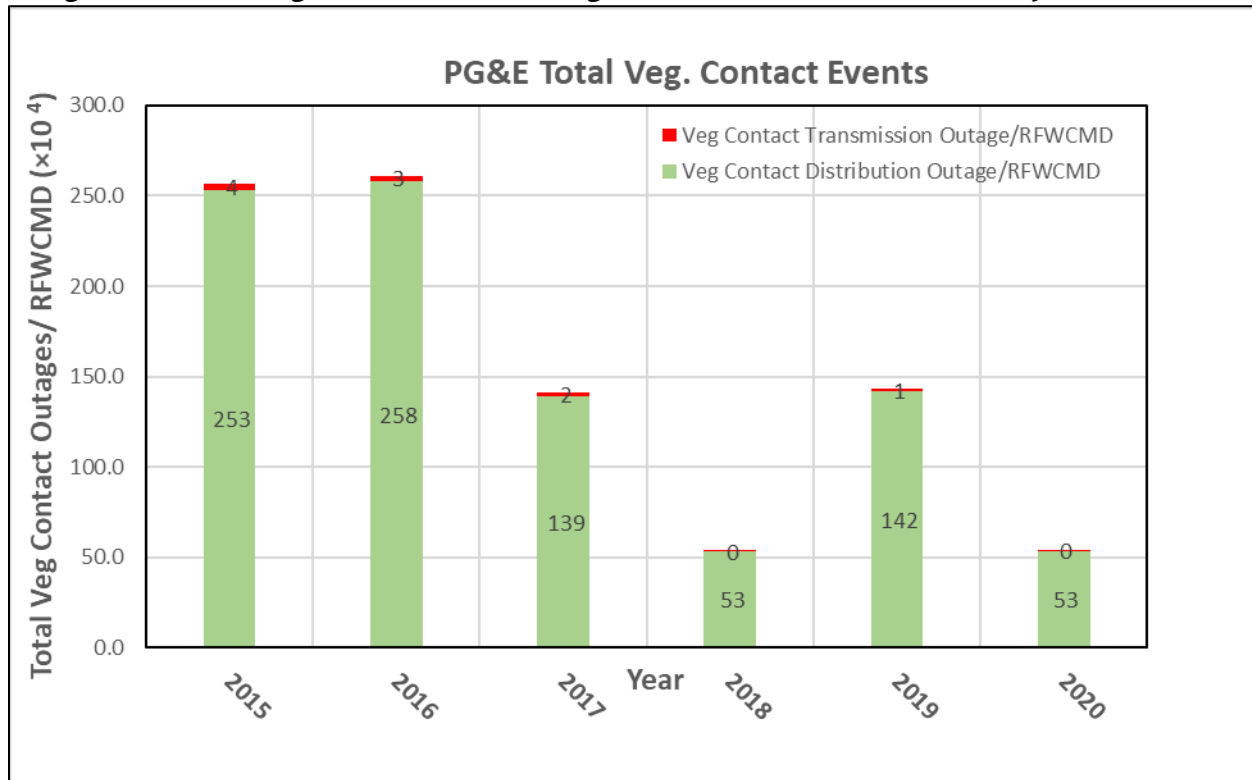
Figure 14: PG&E Vegetation Contact Outages from 2015-2020 Normalized by RFWCMD.¹⁷⁸

QDR Table 7.1, metrics 17a and 25a include data on transmission and distribution outages that are caused by vegetation contact from 2015 through 2020. Figure 14 below plots PG&E's transmission and distribution vegetation contact-caused outages normalized for RFWCMD.

Although there was an uptick in 2019, normalized outages due to vegetation contact trended lower over the 2015-2020 timeframe.

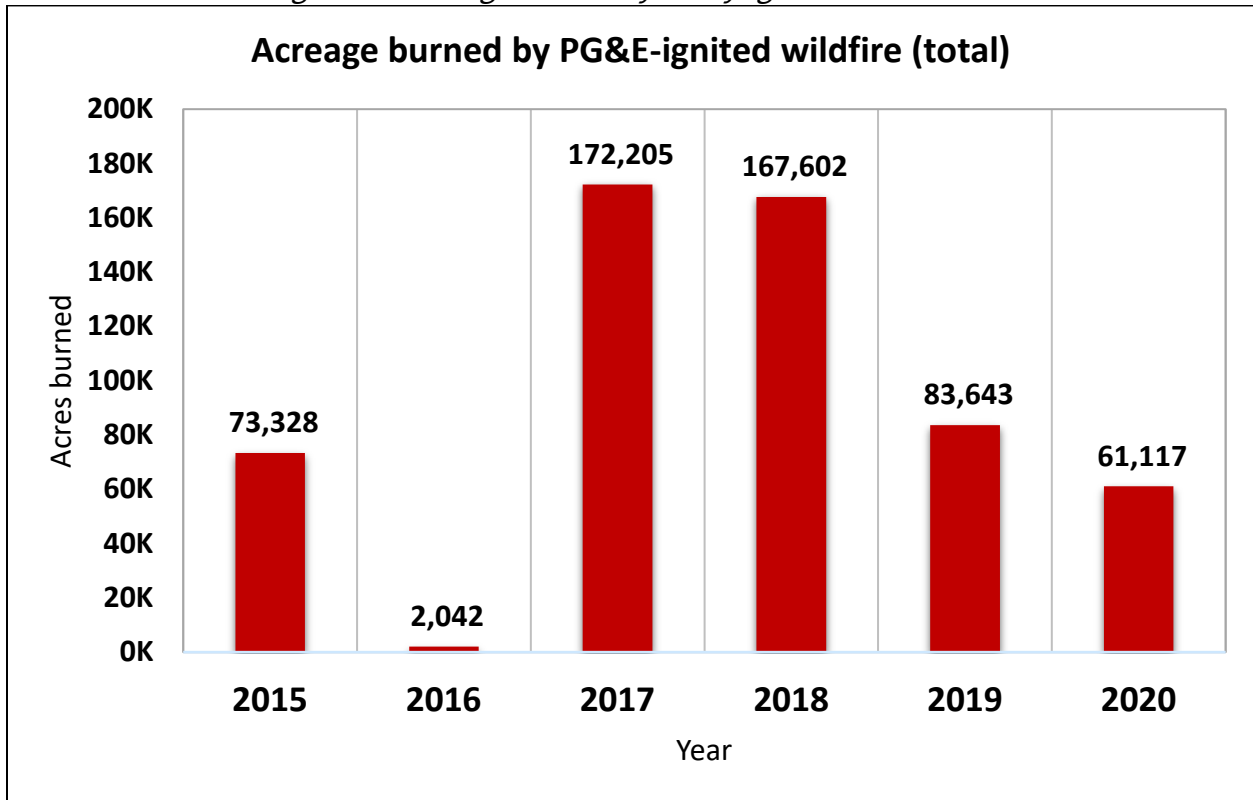
Figure 20: Acreage burned by utility-ignited wildfire.¹⁹³

As shown above, the acres burned from wildfires ignited by PG&E's infrastructure over the six-year reporting period generally follows a normal distribution and indicates a decline since 172,205 acres burned in 2017.

Taken alone, these data suggest that PG&E was on a positive trajectory. However, evaluating these metrics in a vacuum fails to capture the consequence of any single ignition. While PG&E had 38% fewer acres burned and 95% fewer structures damaged compared to the five-year average from 2015 through 2019 (Figures 20 and 21), that five-year average is highly skewed due to the 2017 and 2018 wildfire seasons. Regardless of trend, in 2020, PG&E reported 209 structures destroyed, 27 structures damaged, one injury, and four fatalities. Energy Safety finds these outcomes unacceptable.

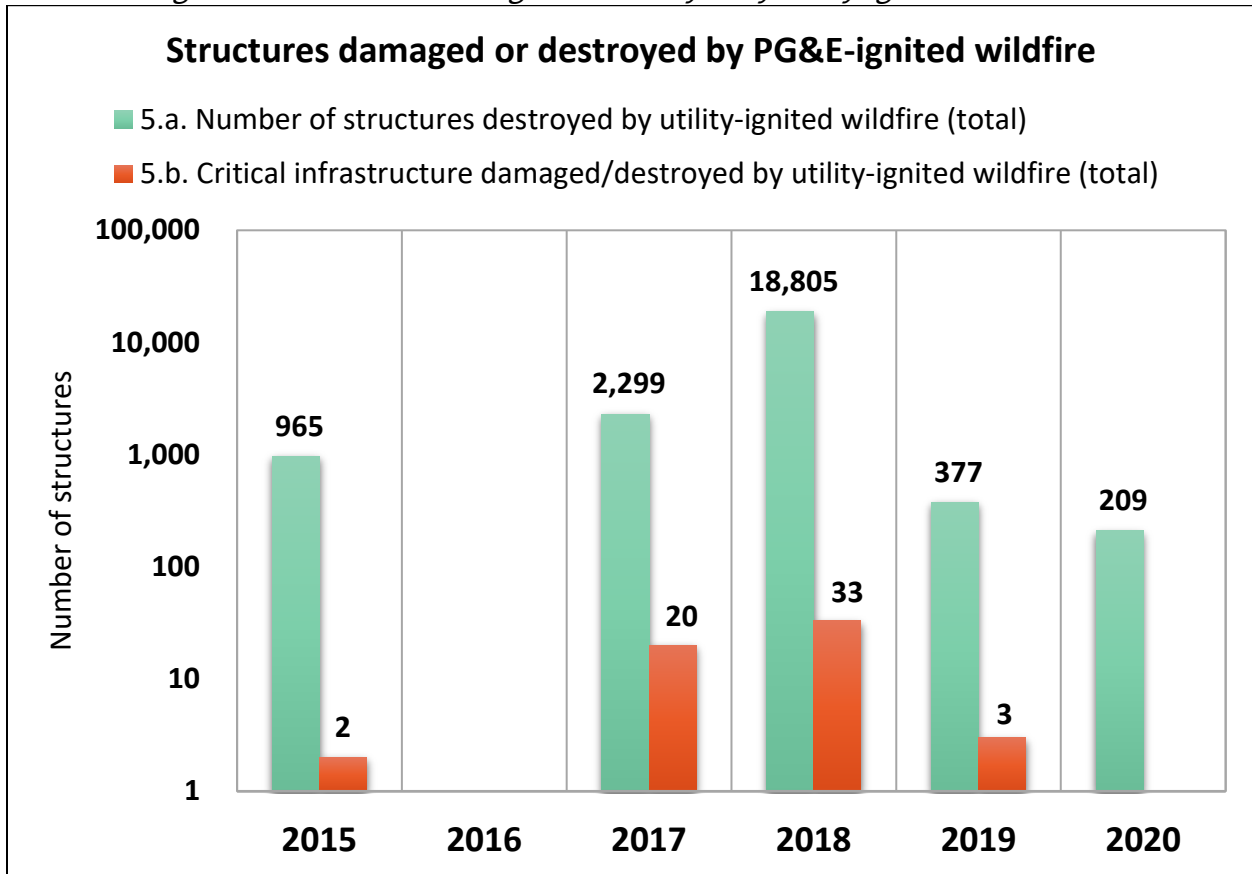
Figure 21: Structures damaged or destroyed by utility-ignited wildfire.¹⁹⁴

The number of structures and critical infrastructure damaged or destroyed from wildfires related to PG&E's electrical lines and equipment decreased in 2020 compared to the 5-year average from 2015-2019 (4,489 structures and 12 critical infrastructure).

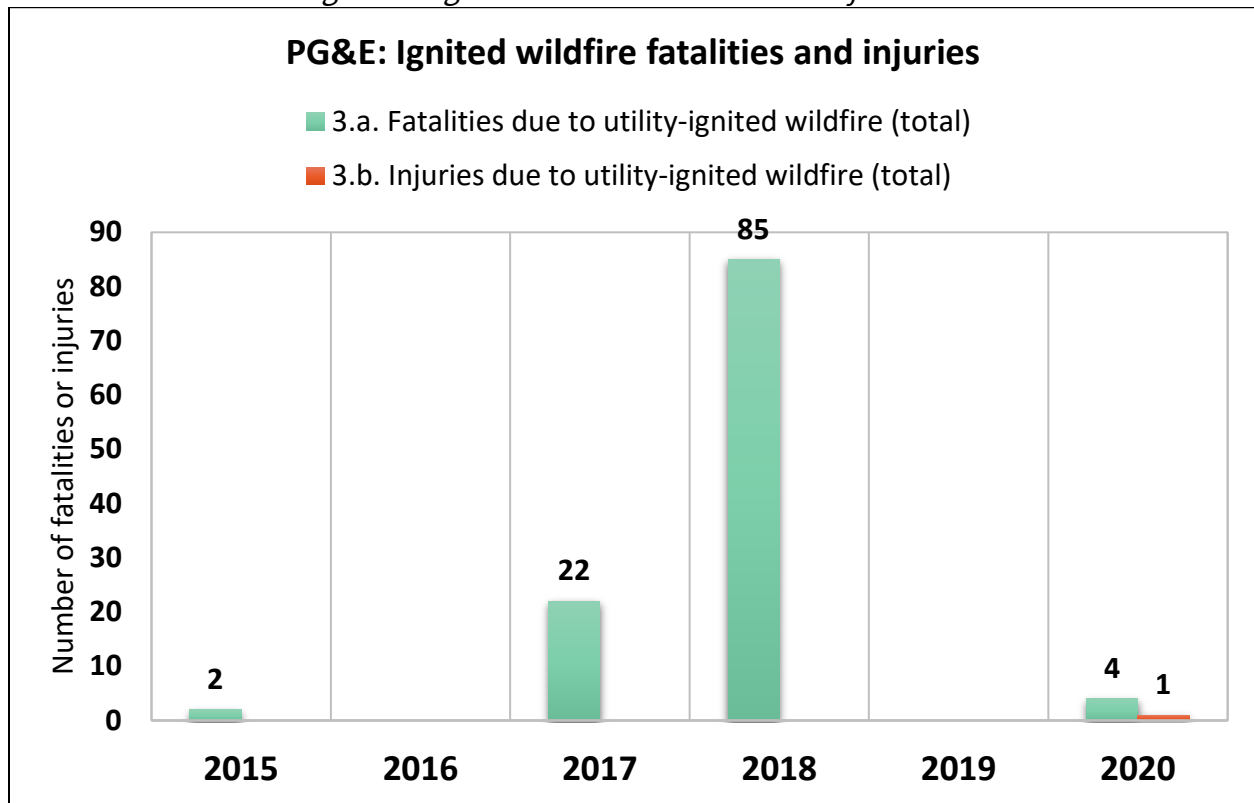
Figure 22: Ignited wildfire fatalities and injuries.¹⁹⁵

Following the significant loss of life from PG&E-ignited wildfires in 2017 and 2018 that claimed the lives of 107 individuals, a reprieve from such loss of life in 2019 was temporary as there were four fatalities and one injury attributable to PG&E-ignited wildfires in 2020.

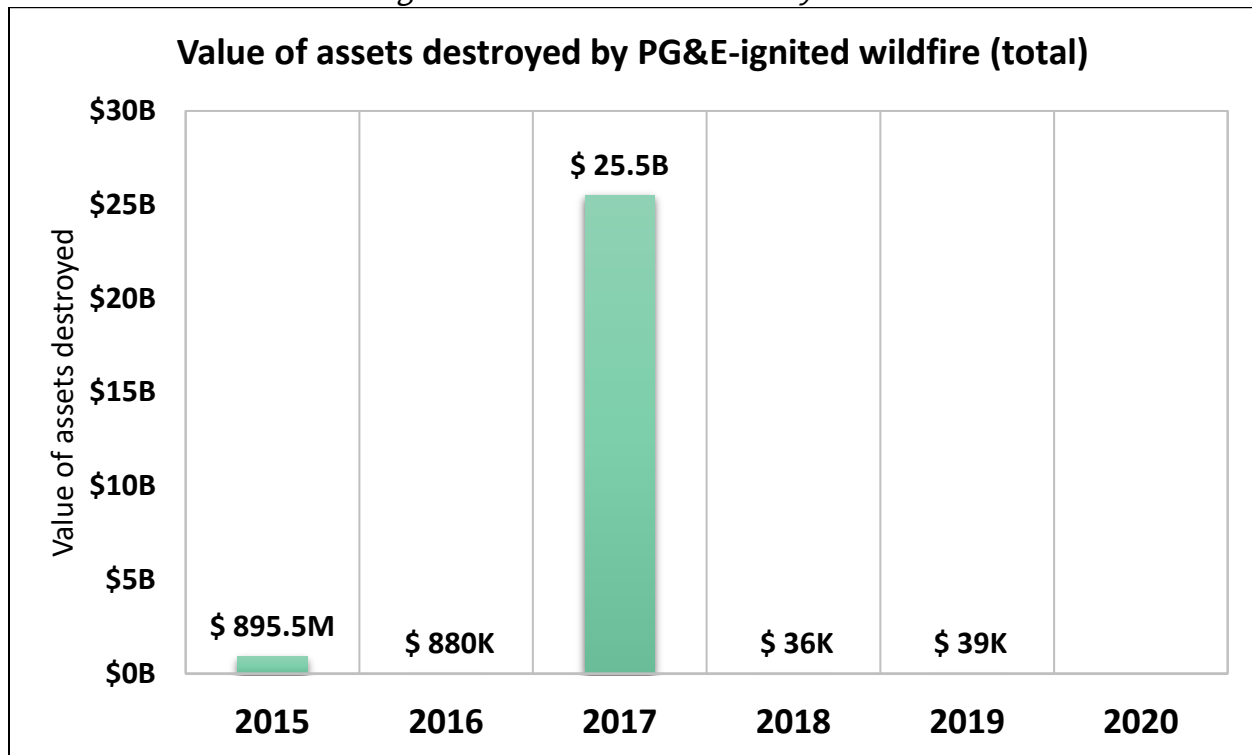
Figure 23: Value of assets destroyed.¹⁹⁶

The value of assets destroyed in 2020 was reported as \$0. Although it is unlikely that there was \$0 in damage given the volume of structures damaged or destroyed, Energy Safety relied upon the data as reported by PG&E in its 2021 Q1 QDR.
