AERIAL INSPECTION REVIEW+ TEAM

AIR+ TEAM HANDBOOK

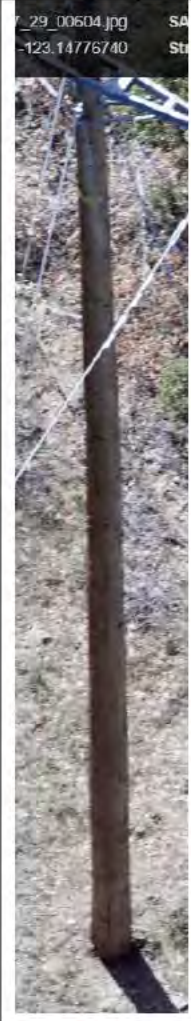
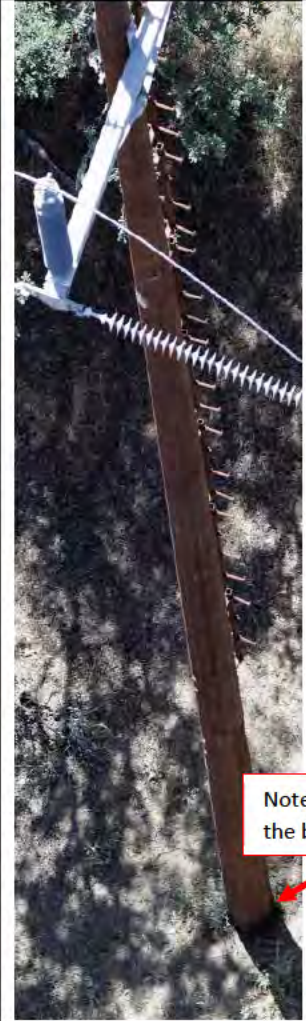
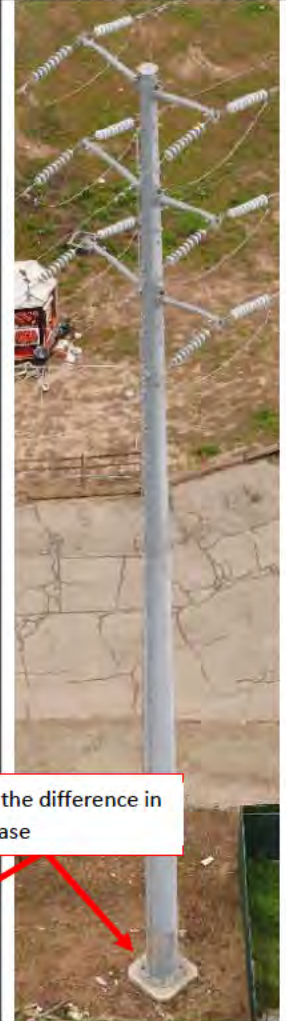
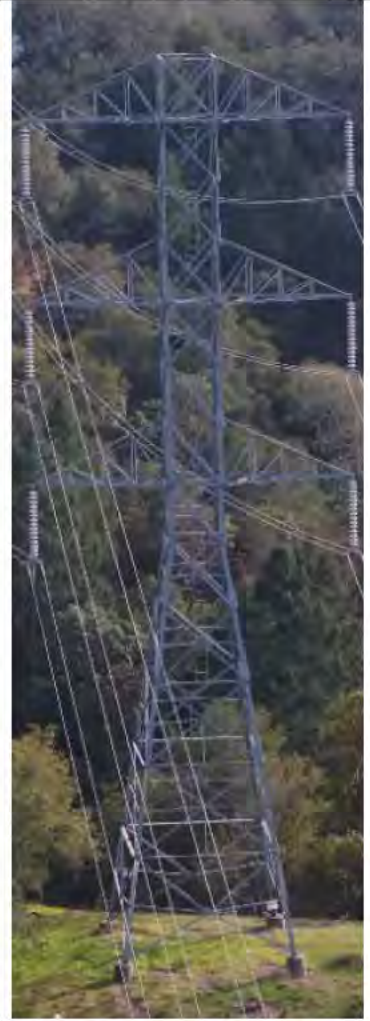
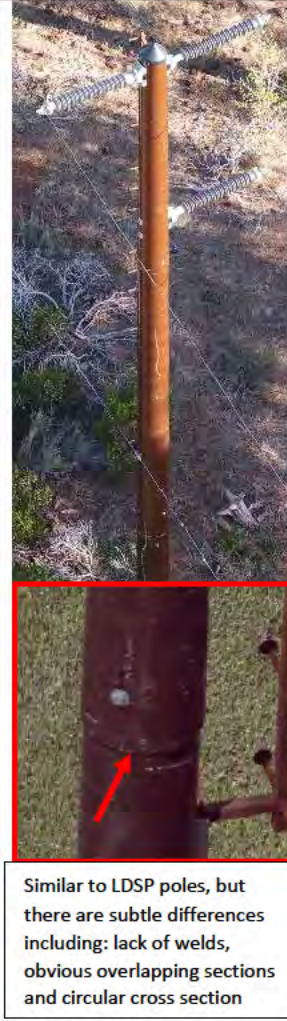
FDA code versus structure type

<p>Wood pole FDA: Wood</p>	<p>Light duty steel pole (LDSP) FDA: Wood</p>	<p>Tubular steel pole (TSP) FDA: Steel</p>	<p>Lattice steel tower FDA: Tower (or Steel if tower not available)</p>	<p>Fiberglass pole FDA: Wood</p>

Note the difference in the base

Figure 2 Breakdown of structure type vs FDA code to use when appropriate. Typically TSPs are built on a concrete foundation.

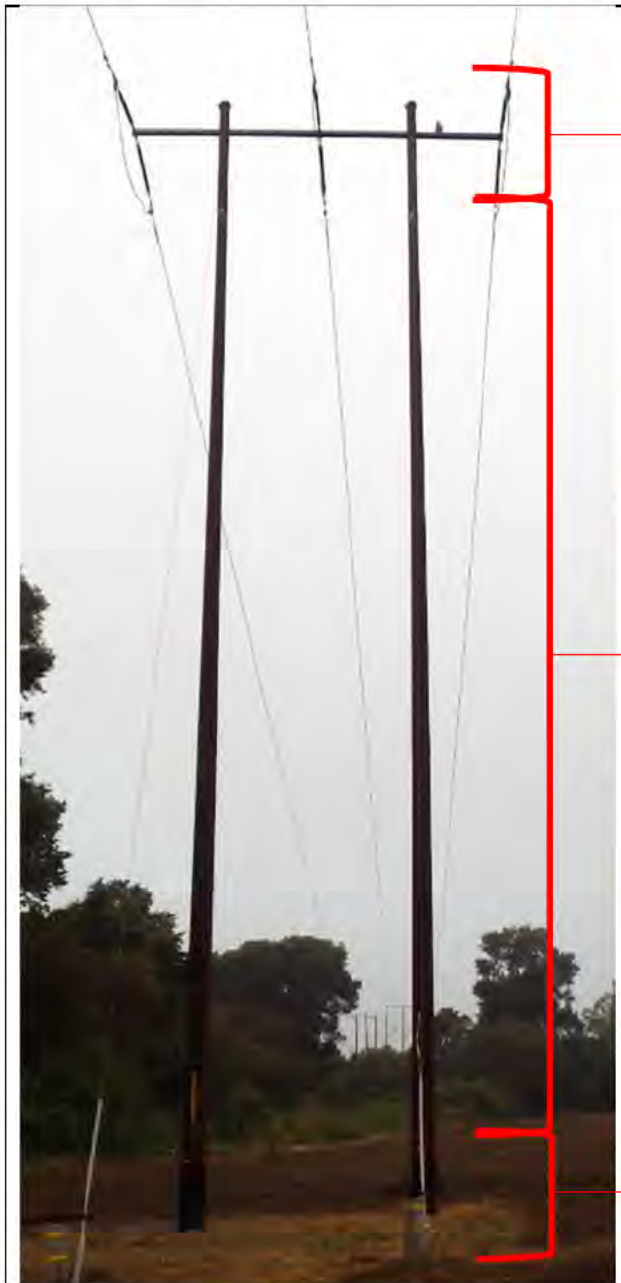
Multi-pole inspections

Sherlock will now serve you “connected” (parent/child structures) structures as one, and unconnected (“A/B/C”) structures one after another. Please inspect each one consecutively. When encountering an issue as described below, please try to adhere to the guidance as strictly as possible. Changes may arise in Sherlock which render these instructions difficult to follow. In those instances, request help from your **IRS**.

Damage at the conductor level that could be considered for the entire structure (e.g. conductor damage, or damage to crossarm) should be assigned to the left pole.

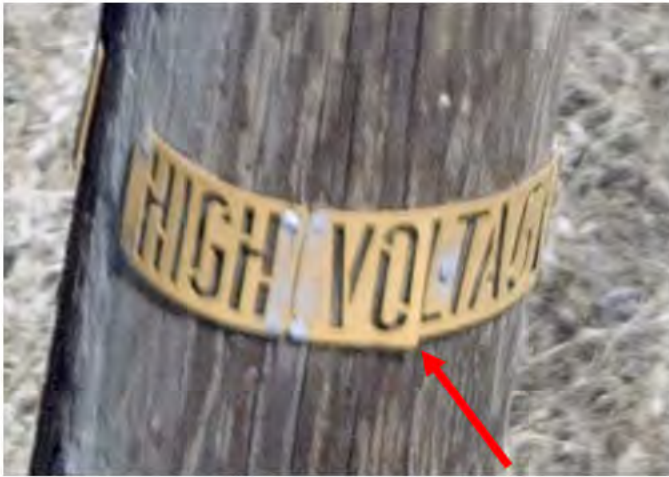
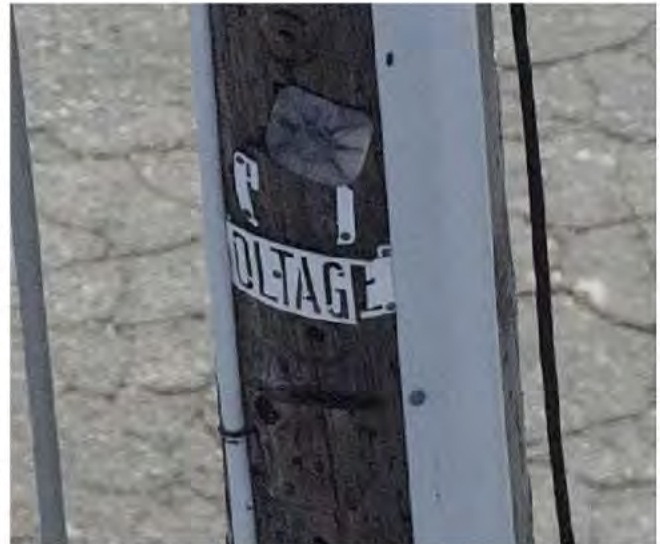
Condition: 1
 Priority: No Notification Required
 FDA: N/A

Condition: 2
 Priority: F
 FDA: Marker (i.e. sign)-Wood|No good/Out of Stdrd|Install

Figure 10 **Cracked high voltage sign (left).** Damaged sign, no longer legible (right).

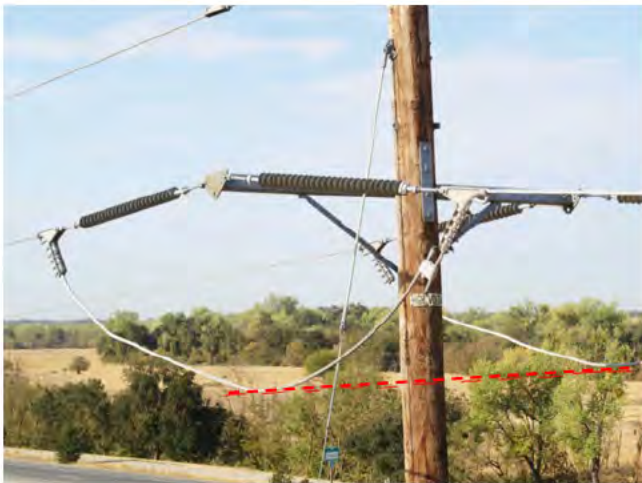
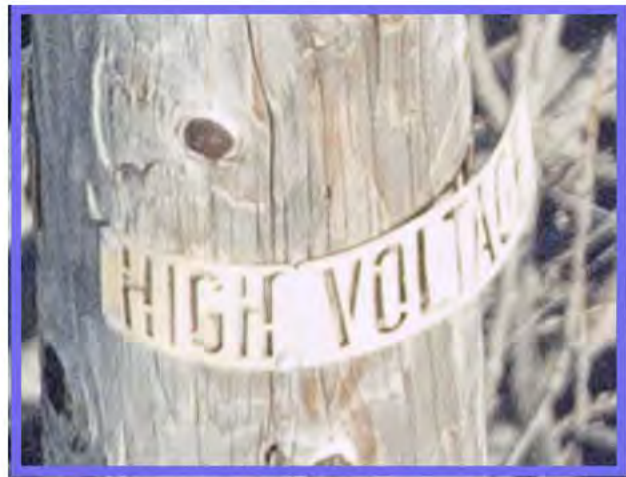
Condition: 2
 Priority: F
 FDA: Marker (i.e. sign)-Wood|No good/Out of Stdrd|Install

Figure 11 High voltage sign is *above* the lowest point of the jumper (left). **Loose high voltage sign (right).**

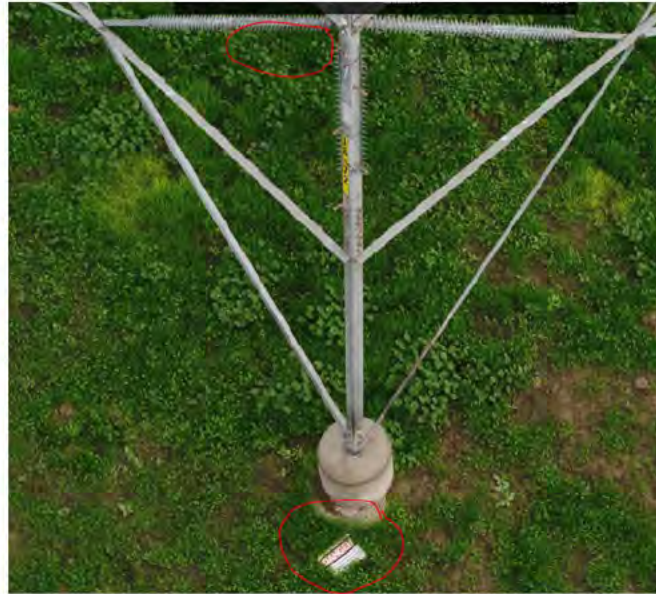
Figure 12

Condition: 2
Priority: F

FDA (1): Marker (i.e. sign)-Steel | No good/Out of Std | Install
 FDA (2): Structure-Wood/Steel | Debris/Nest/etc | Remove

Danger (or HV sign) fallen off of the structure and sitting at bottom. Two tags are necessary – one for the fallen sign and another to replace the missing one.

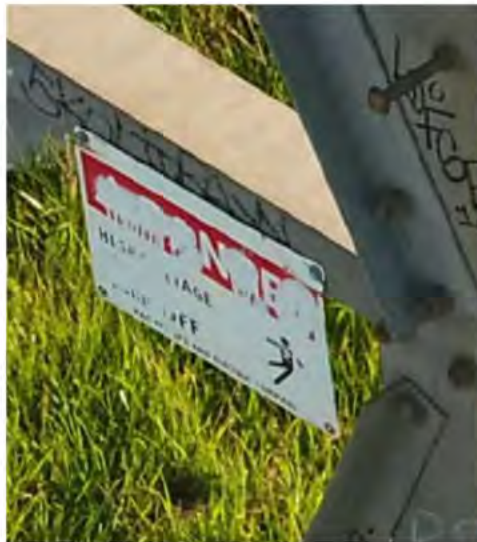
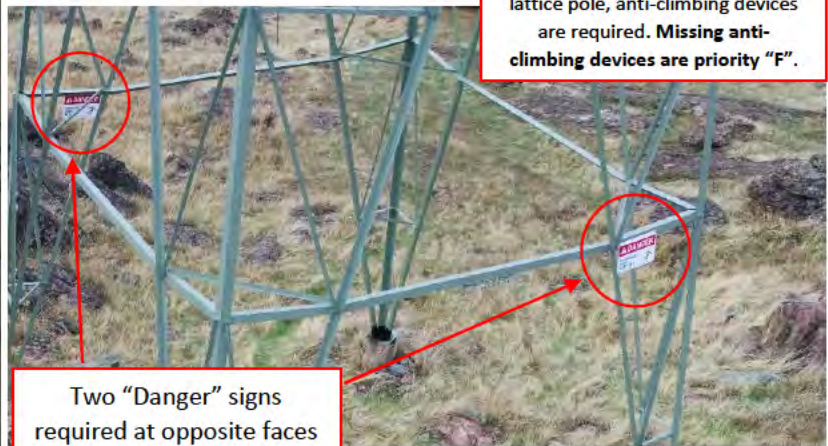
Figure 13

Condition: 2
Priority: F

FDA: Marker (i.e. sign)-Steel | No good/Out of Std | Install

Two "Danger" signs required at opposite faces of the tower

Damaged sign (left). Damage signs can be bullet holes, covered by paint or faded letters. Example of proper high voltage signage for lattice towers (right).

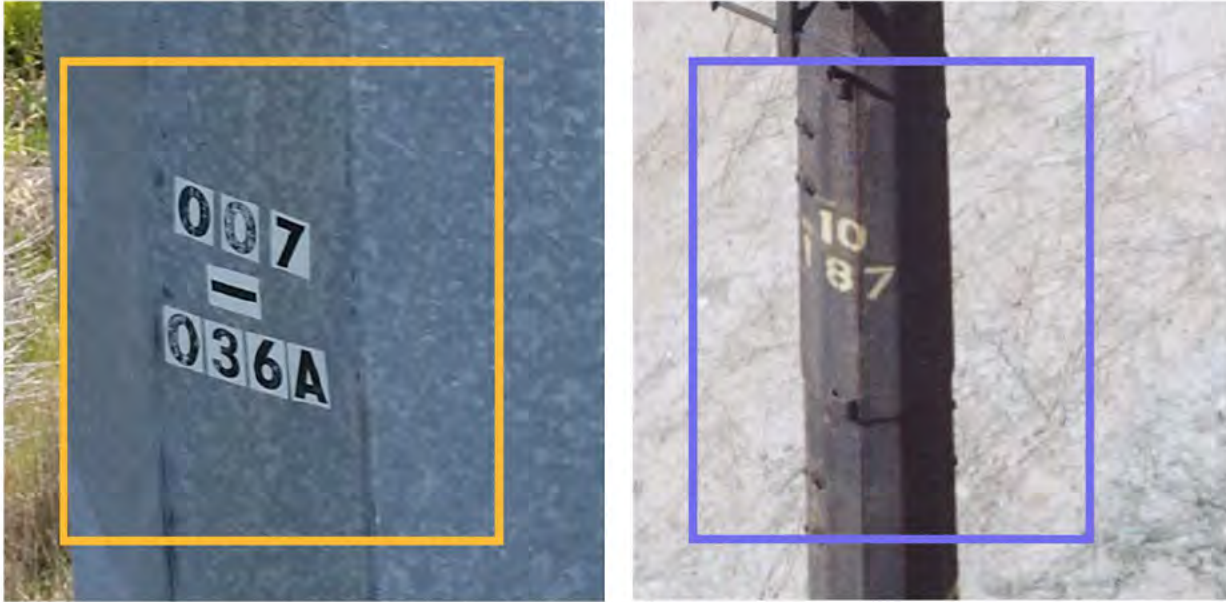
Figure 14

Condition: 2
Priority: F

FDA: Marker (i.e. sign)-Wood/Steel|No good/Out of Stdrd|Install

Structure ID is not to standard, should be yellow and black (left). ID is painted on the structure (right).

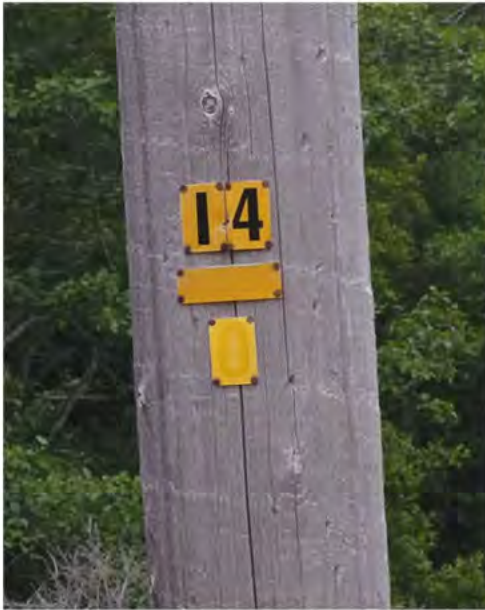
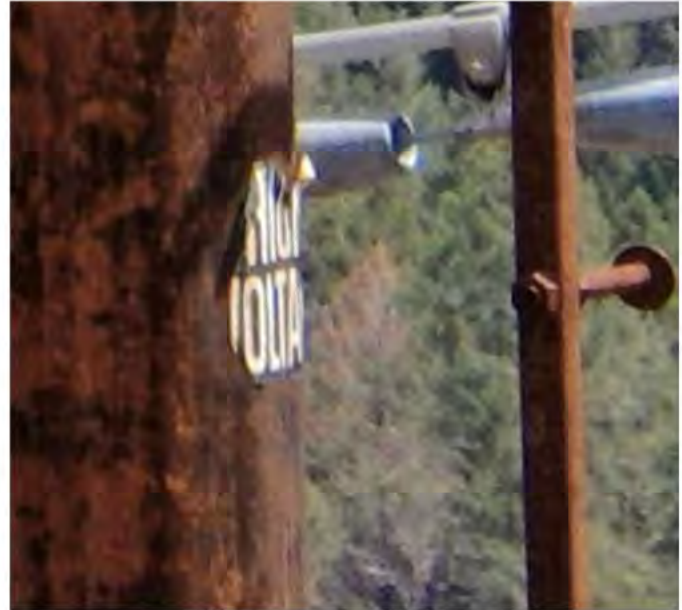
Figure 16

Condition: 2
Priority: F

FDA: Marker (i.e. sign)-Wood/Steel|No good/Out of Stdrd|Install

Faded ID (left). Damaged high voltage sign (right).

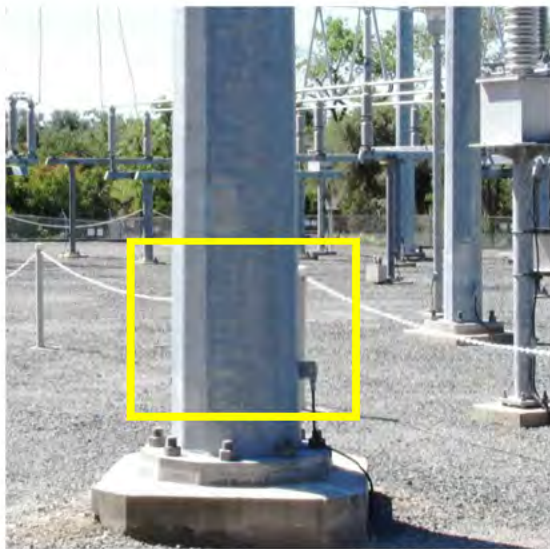
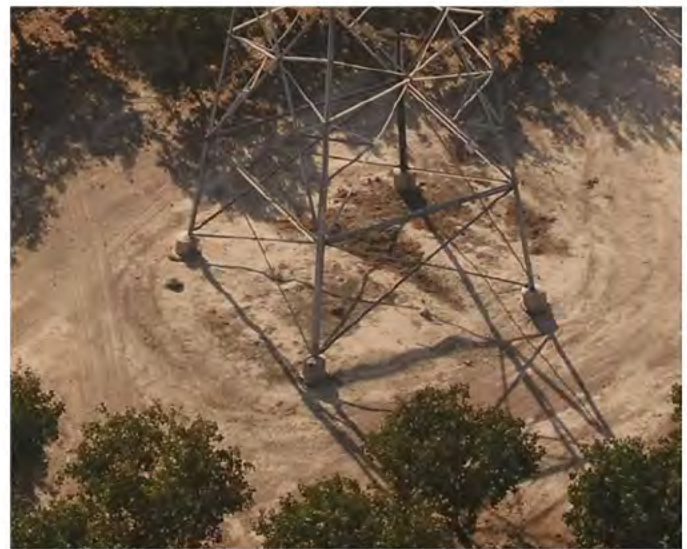
Figure 17

Condition: 2
Priority: F

FDA: Marker (i.e. sign)-Wood/Steel|No good/Out of Stdrd|Install

High visibility strips required inside substations (left). High visibility strips need to be installed on structures located in area with heavy tire tracks (right).

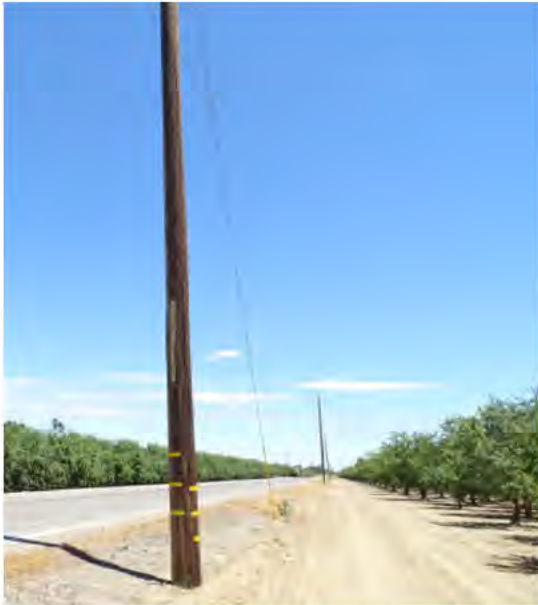
Condition: 1
Priority: No notification required

Condition: 2
Priority: F
FDA: Marker (i.e. sign)-Wood/Steel|No good/Out of Std|Install

Figure 18 High visibility strips required on both street side and agricultural side of pole (left). Visibility strips required 15ft from paved roadways and 6ft from well-travelled trails, driveways, parking lot, etc. that isn't protected by a curb. (per standards in 022168)

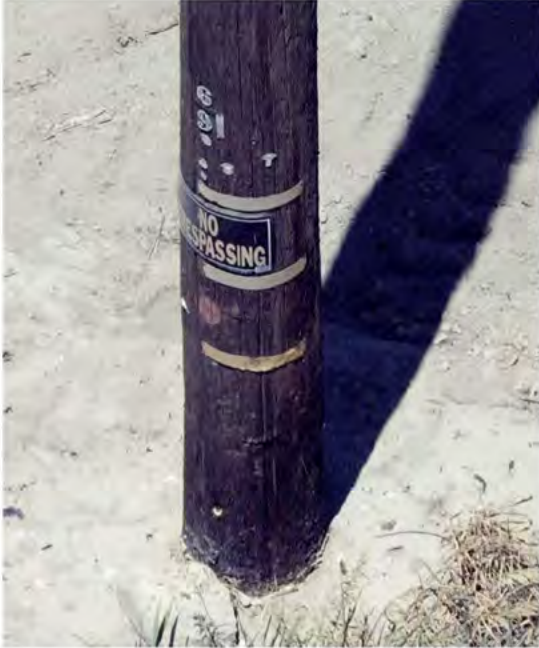
Condition: 2
Priority: F

FDA: Structure-Wood|Debris/Nest/etc|Remove

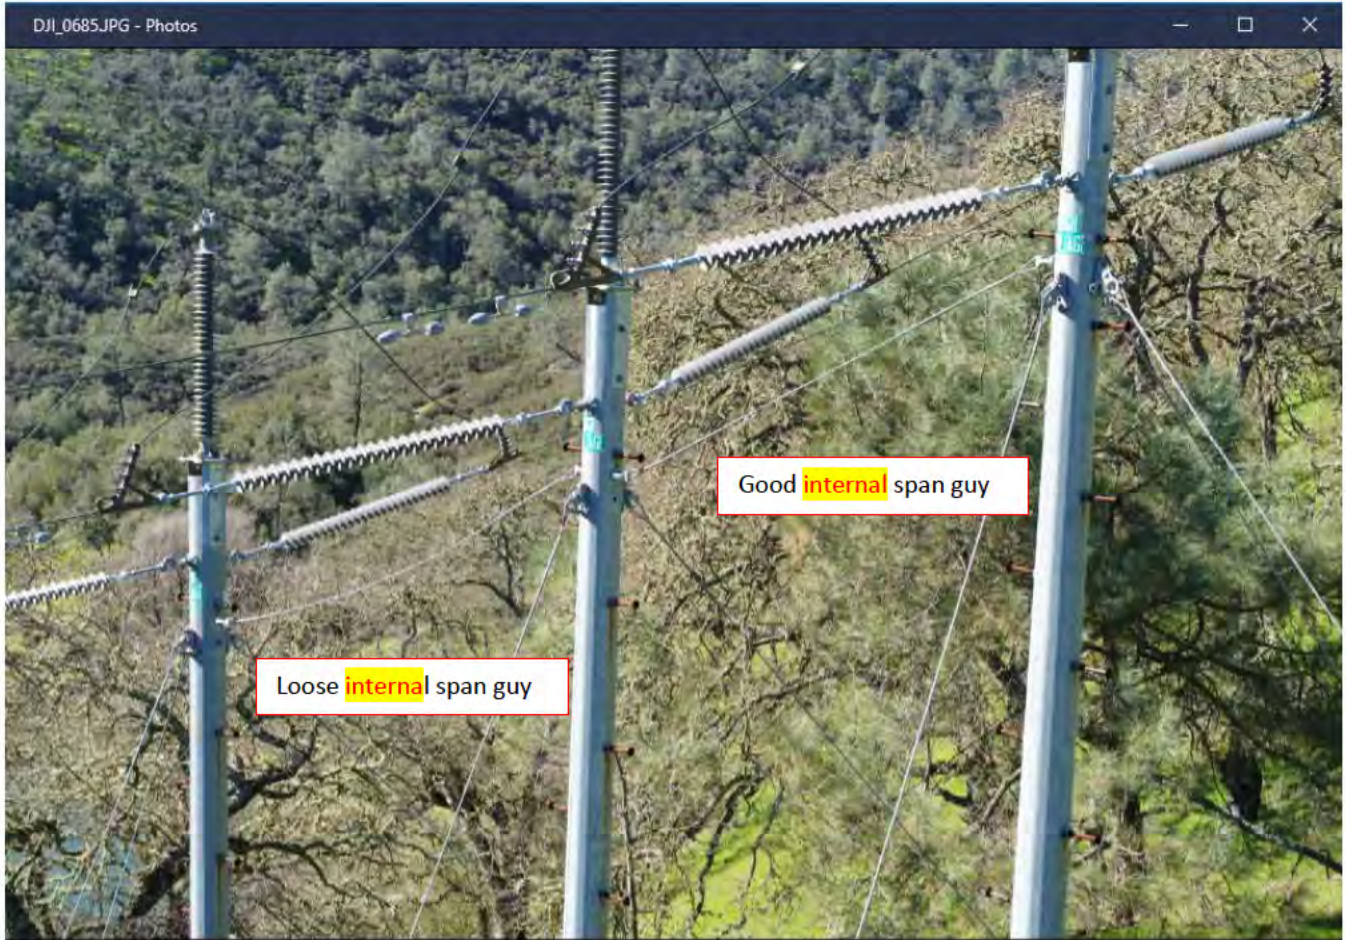
Condition: 3

Priority: E

FDA: Guy Wire-(Wood/Steel) | No Good/Out of Stdrd | Repair

Figure 22 Example of internal span guys (left) loose internal span guys, (right) good internal span guy.

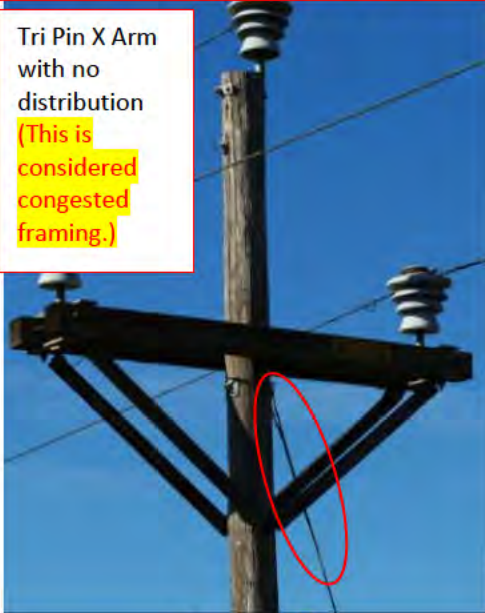
Tri Pin X Arm with no distribution
(This is considered congested framing.)

Condition: 3
Priority: E

Figure 23 Examples of guyed structures with missing fiberglass rod. **If congestion exists at Transmission-level, assign E-priority.**

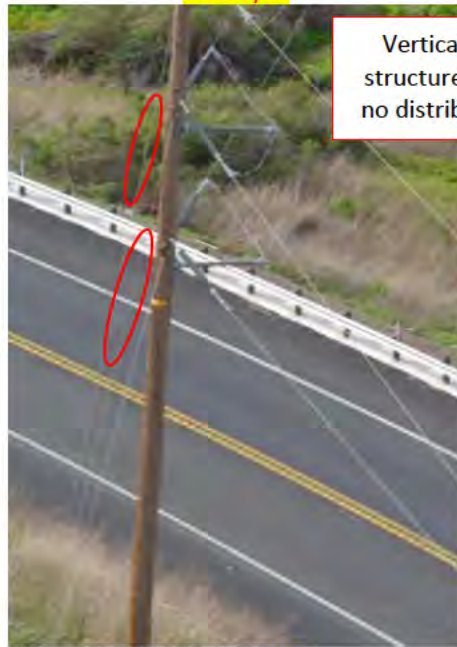
Vertical DE structure with no distribution

Condition: 2
Priority: F

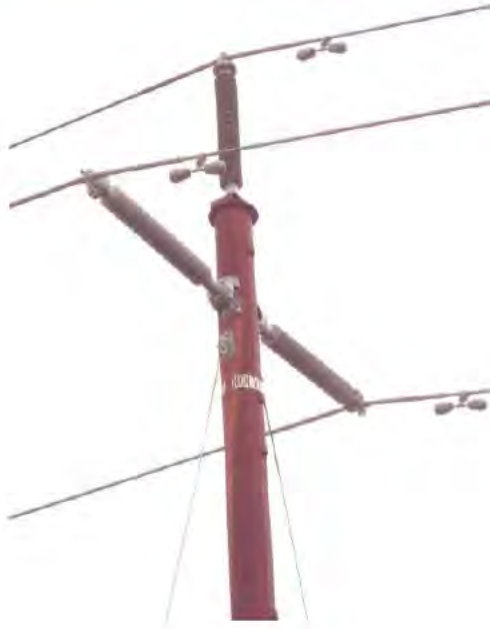
Condition: 1
Priority: No notification required

Condition: 2
Priority: F
FDA: Guy Wire-Wood|No Good/Out of Stdrd|Repair

Figure 24 Guy wires on steel poles (left). **Fiberglass rods without bonding and loose hardware (right).**

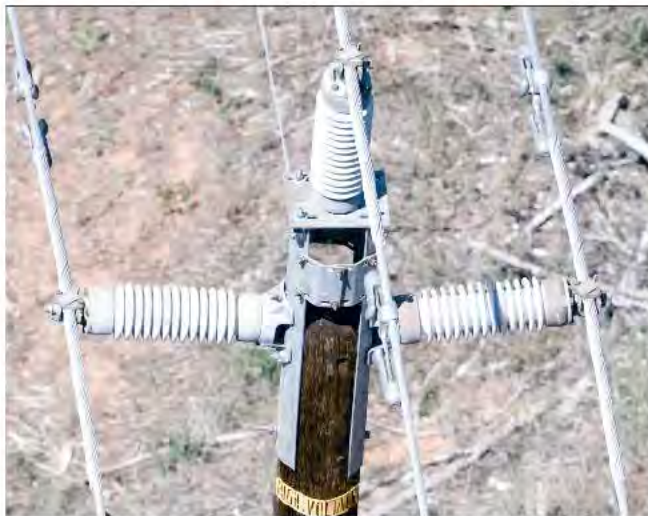
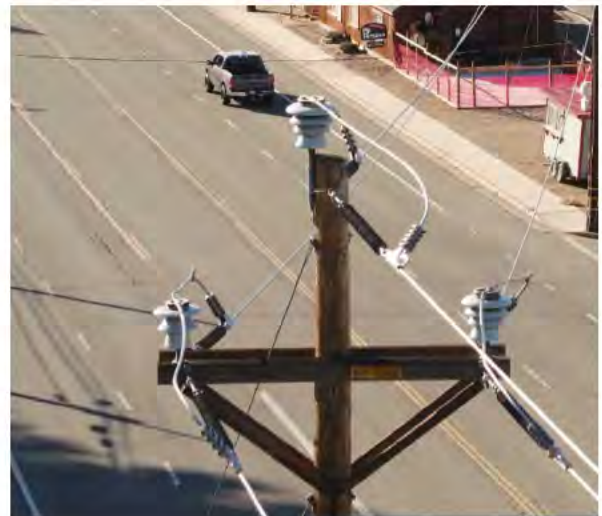
Condition: 1
Priority: None

Condition: 3
Priority: E
FDA: Guy Wire-Wood|No Good/Out of Stdrd|Repair

Figure 25 Structure with all insulators attached to a continuous bracket. This structure does not need bonding, *unless there is a guy in proximity to the hardware (left). Missing fiberglass insulator on guy and a congested configuration (right).*

If a guy is attached 10 feet or more below a hardware attachment, no bonding is necessary, even if a strain insulator is present.

Steel poles with guys that do not enter the distribution's cylinder of proximity **don't** require fiberglass rods. If the guys do enter the cylinder of proximity, follow the same process

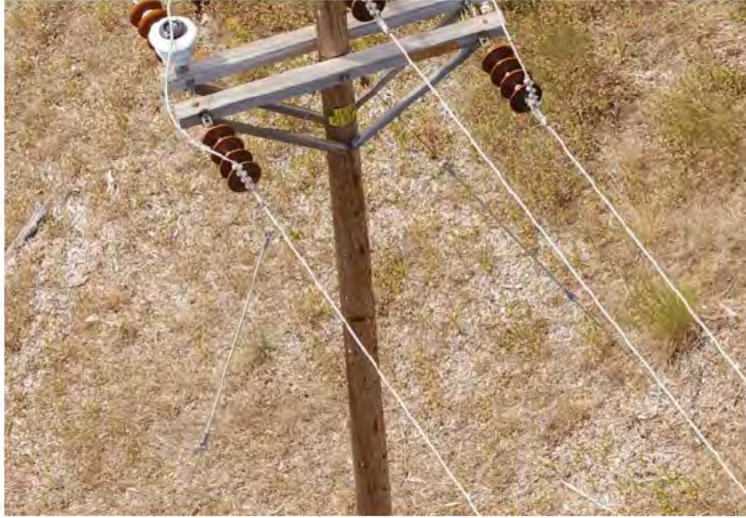
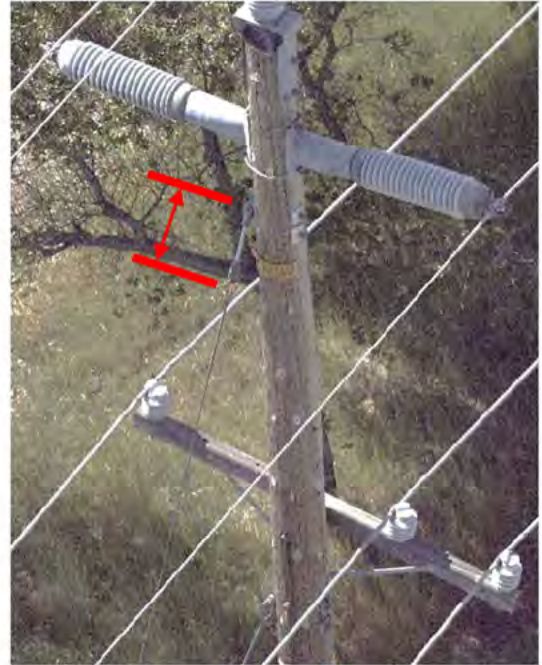
Figure 26

Condition: 2
Priority: F

FDA: Guy Wire-Wood | No Good/Out of Stdrd | Repair

Fiberglass guy insulators installed mid-span on guy wire (left). These should be repaired on an F tag. The standard is to have them installed up against the pole hardware. Short fiberglass guy insulator used on transmission (right). These types of insulators are not acceptable and should be replaced with the longer standard insulators.

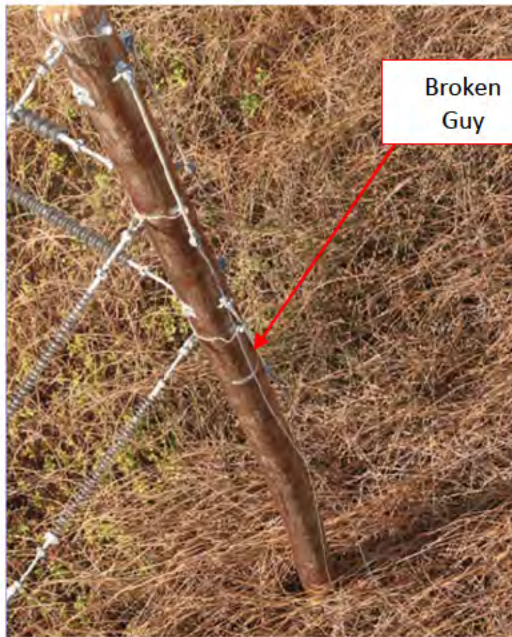
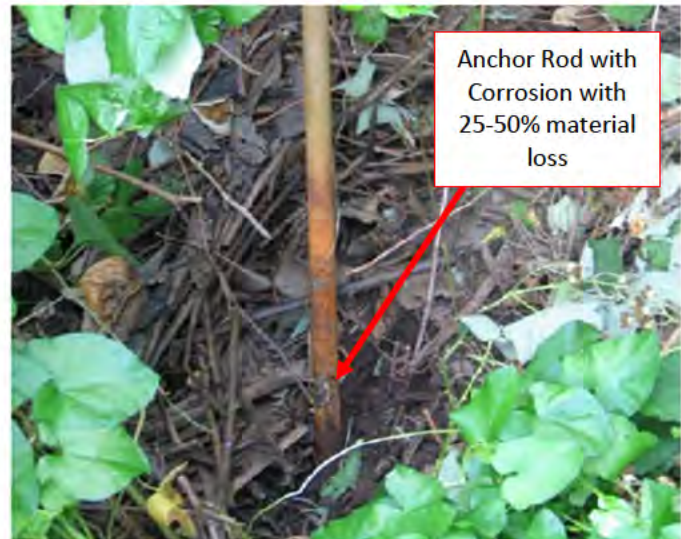
Figure 27

Condition: 5
Priority: A

FDA: Emergency | Storm Related | Repair

Condition: 3
Priority: E

FDA: Anchor-Wood/Steel | No Good/Out of Stdrd | Replace

Broken load bearing guys (left). Corroded anchor rod (right).

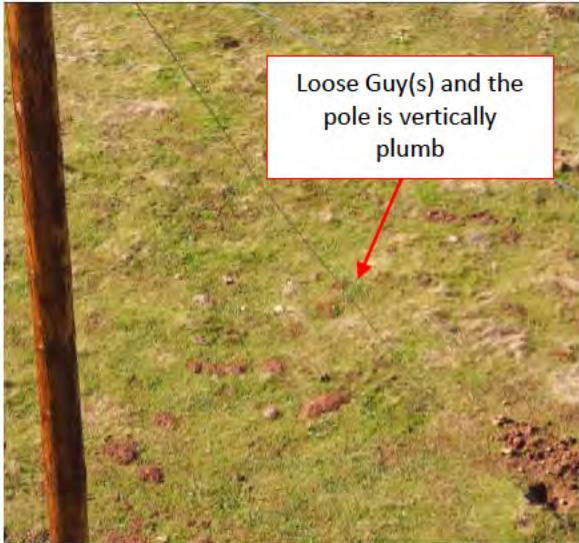
Condition: 3
Priority: E

FDA: Guy Wire-Wood/Steel | No Good/Out of Std | Repair

Figure 28 **Loose guy (left). Loose span guy (right).**

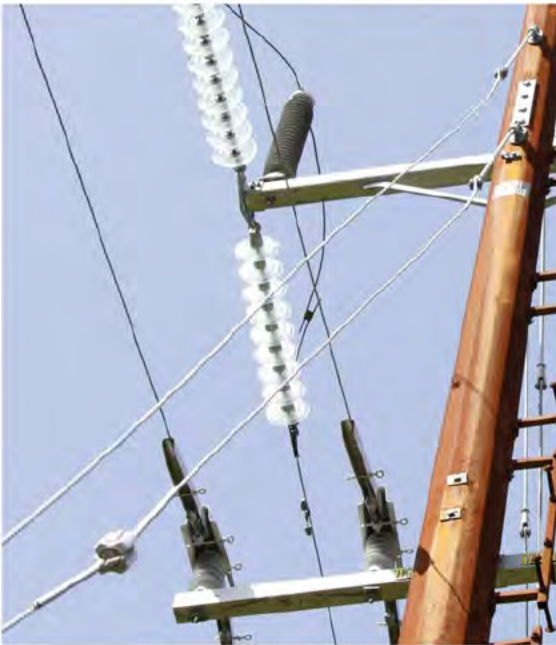
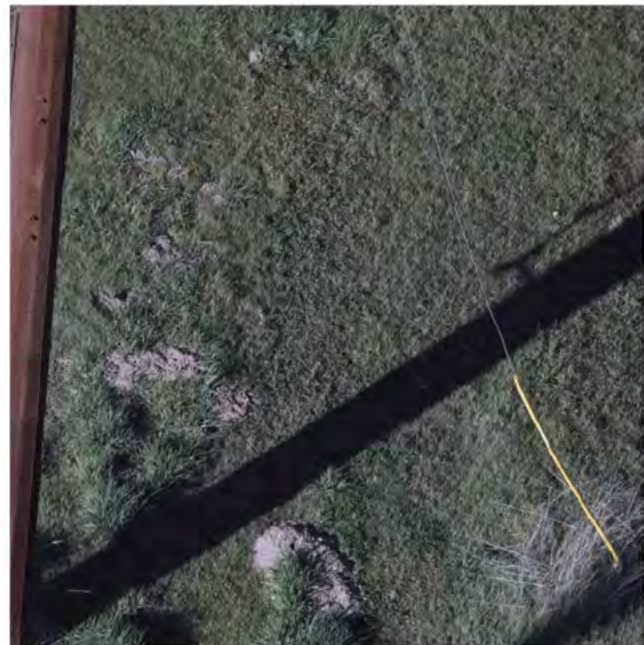
Condition: 3
Priority: E

FDA: Guy Wire- Wood/Steel | No Good/Out of Std | Repair

Figure 29 **Loose guy (left and right).**

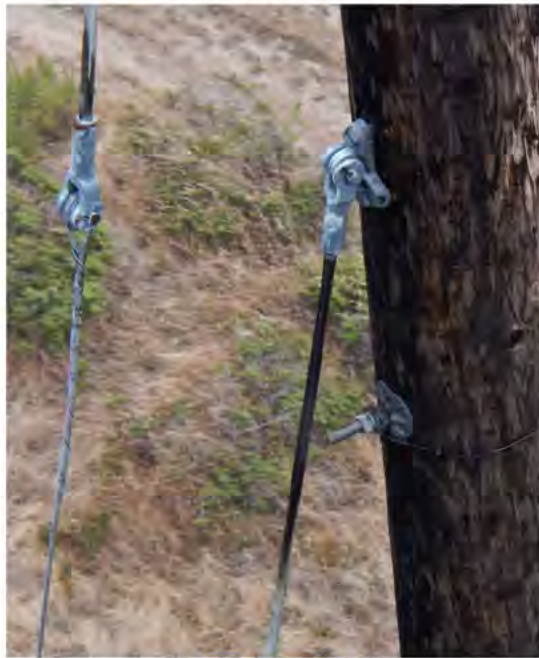
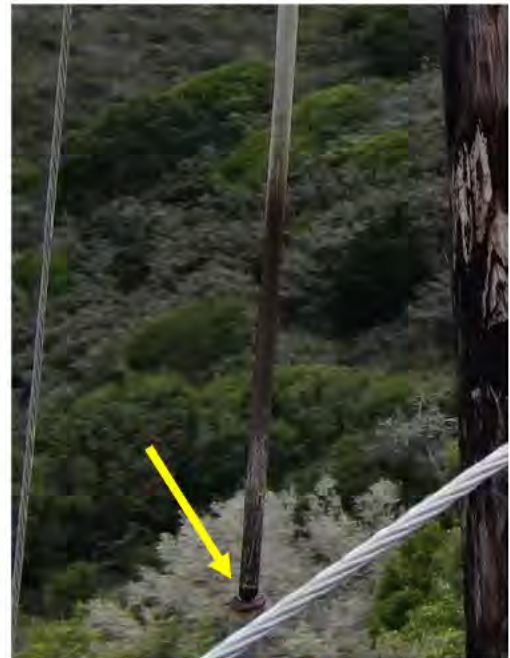
Figure 30

Condition: 3
Priority: E

FDA: Guy Wire-Wood|No Good/Out of Std|Repair

Damage on the fiberglass insulators with signs of tracking (left). Damaged fiberglass insulator to the core due to flash or tracking (right).

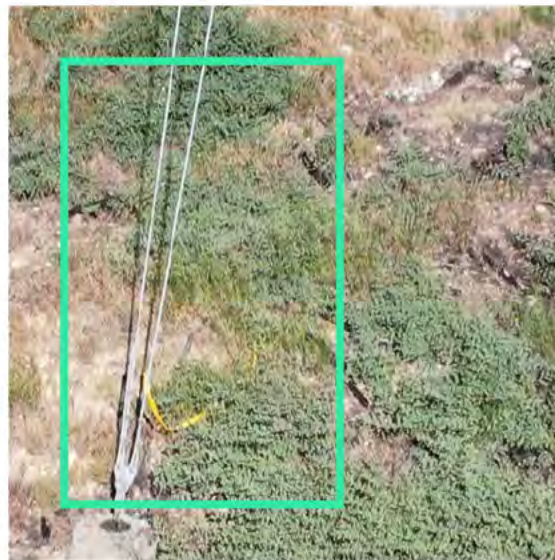
Figure 31

Condition: 2
Priority: F

FDA (1): Guy Wire Mark/Indic- Wood/Steel | No Good/Out of Std|Install
FDA (2): Structure-Wood/Steel|Debris/Nest/etc|Remove

Guy marker has fallen off of the guy wire. Two tags are necessary – one for the fallen marker and another to replace it. (Only one of the guy wires require a marker in this scenario.)

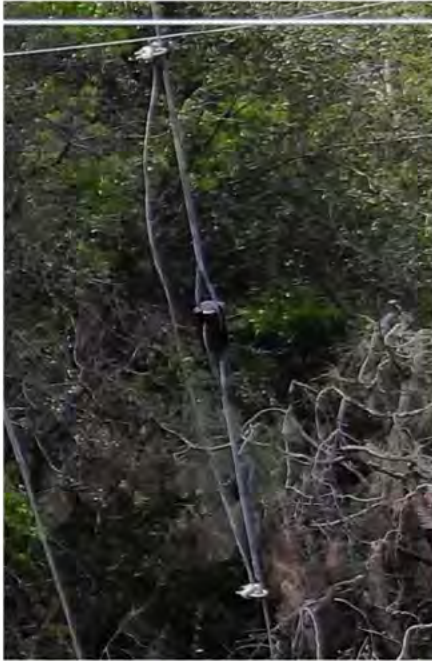
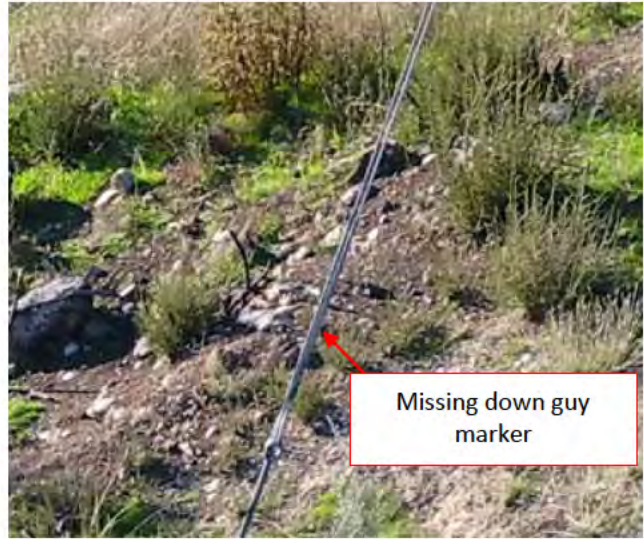
Condition: 3
Priority: E

FDA: Guy Wire-Wood/Steel|No Good/**Out of Stdrd**|Repair

Condition: 2
Priority: F

FDA: Guy Wire Mark/Indic-Wood/Steel| **No Good/Out of Stdrd**|Install

Figure 32 Guy not sectionalized. When evaluating the guy decision tree, this should be treated as 'no 506 bob installed' (left). Missing guy marker (right).

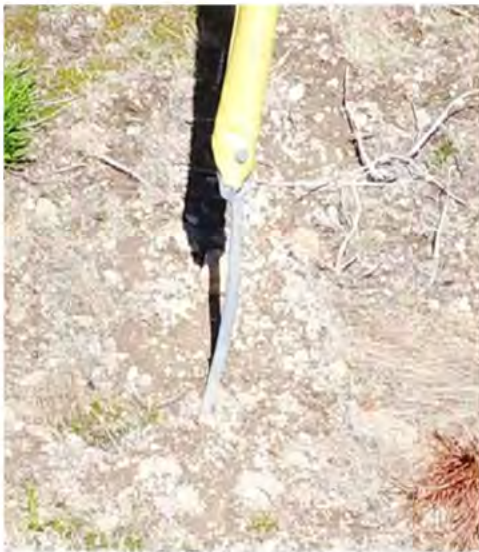
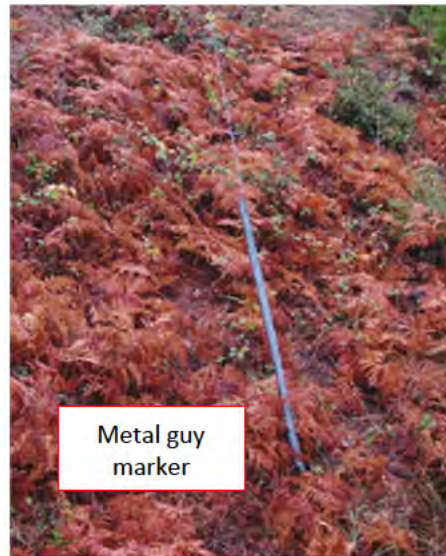
Condition: 3
Priority: E

FDA: Anchor-Wood/Steel|No Good/**Out of Stdrd**|Replace

Condition: 1
Priority: No notification required

Figure 33 Bent anchor rod (left). Metal guy marker – acceptable (right).

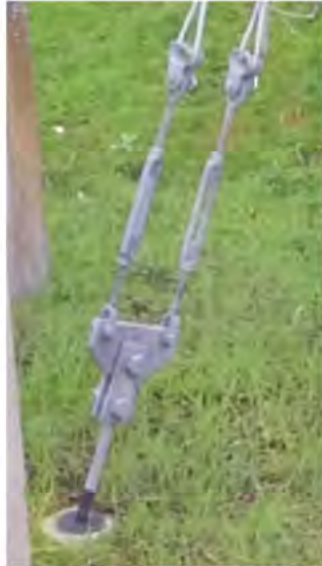
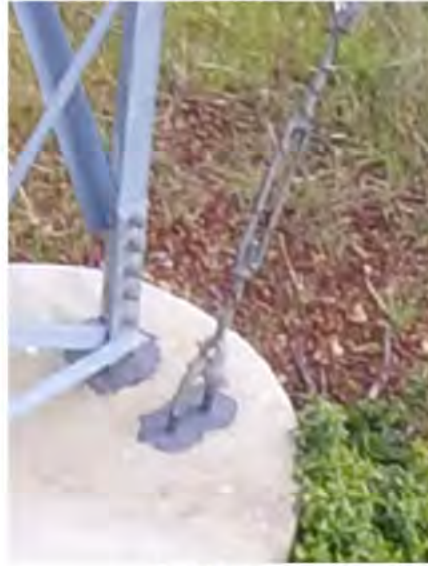
Condition: 1

Priority: No notification required

Figure 35 Example of anchors consisting of “rods” (left), and “loops” (right).

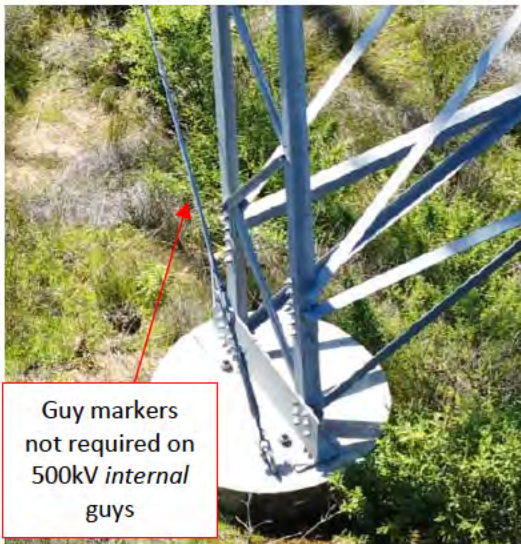
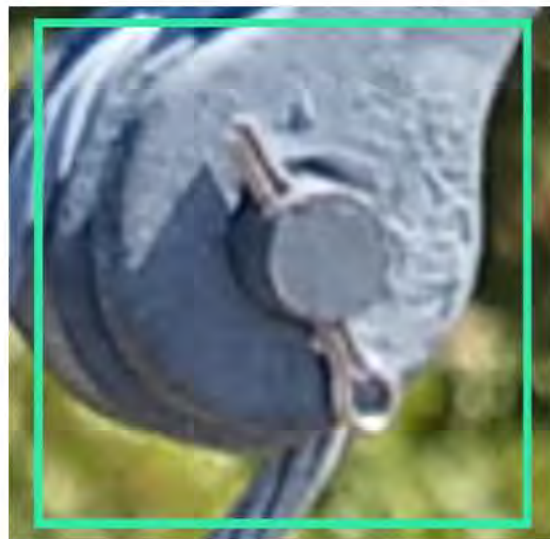
Condition: 1

Priority: No notification required

Condition: 4

Priority: E+

FDA: Guy Wire- Wood/Steel | No good/Out of
Stdrd Repair

Figure 36 Guy wires on 500kV structures (left). Cotter key not fully seated on guy hardware (right).

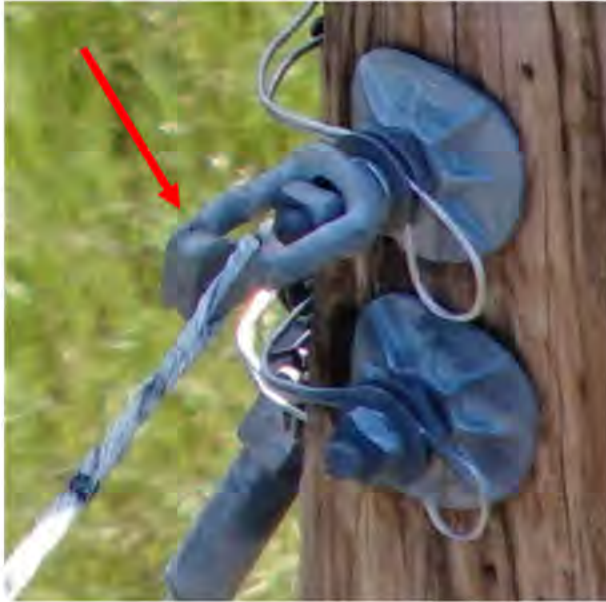
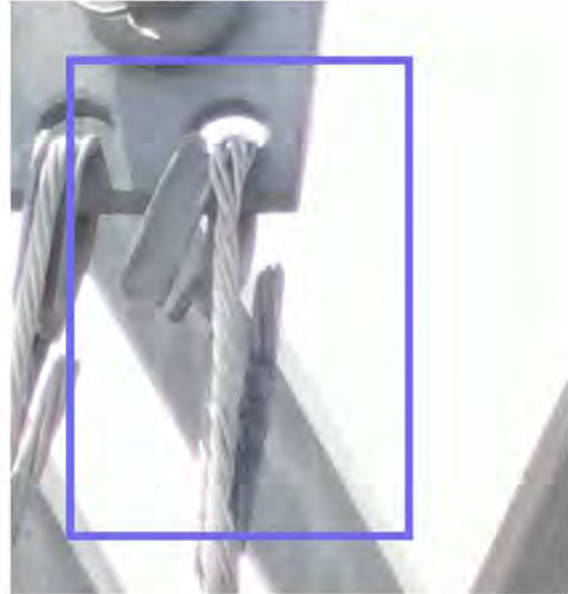
Figure 37

Condition: 3

Priority: E

FDA: **Guy Wire**-Wood/Steel|No Good/**Out of Stdrd**|Repair

Examples of guy preform not in thimble. If there is damage (broken strands) to the preform, assign E+ priority.

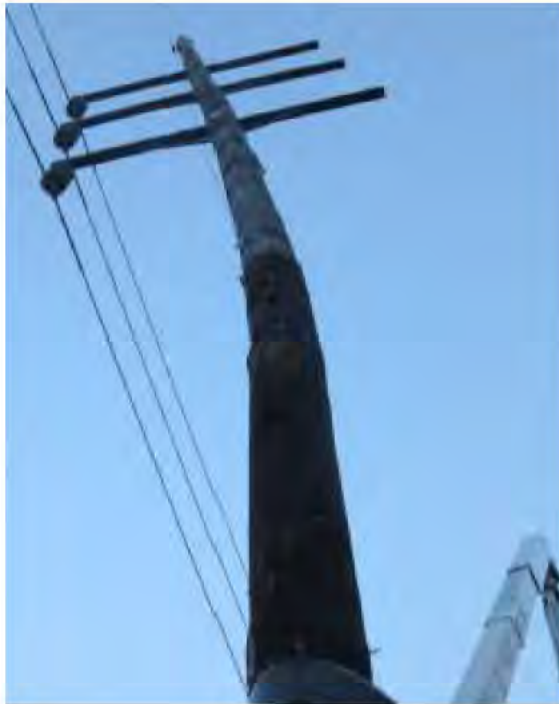
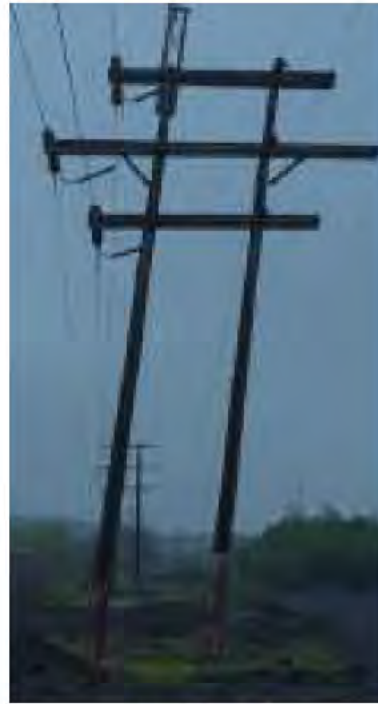
Condition: 4
Priority: **E+**

Figure 39 FDA: Structure-Wood|No Good/**Out of Stdrd** | Replace Excessive pole deflection (left), erosion/soil movement Issues (right).

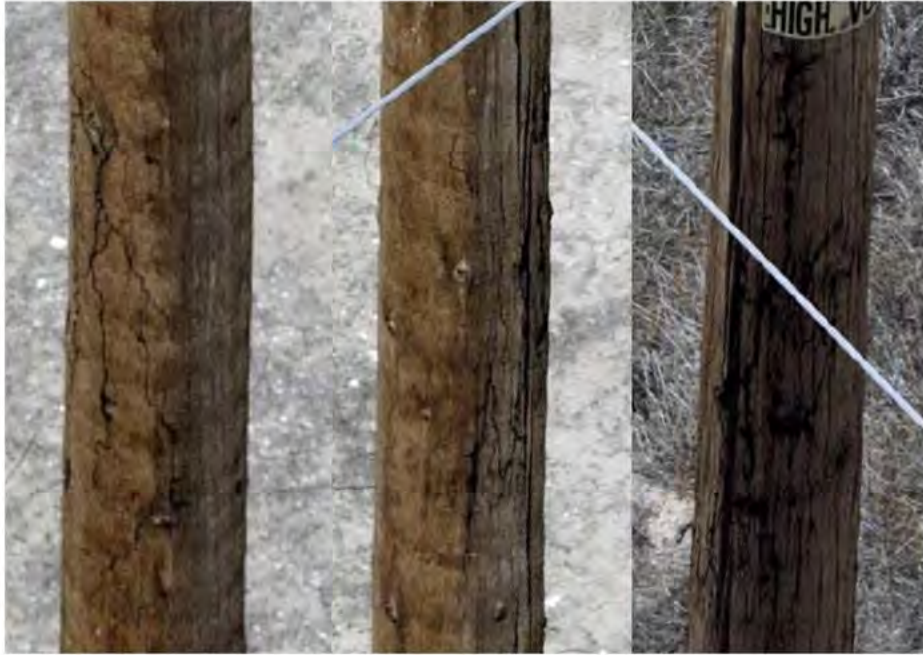
Figure 41

Condition: 5
Priority: A

FDA: Emergency-Wood | Other | Replace

Example of tracking that extends to the ground level, assign emergency tag due to public safety. Find the source of failed insulation/bonding.

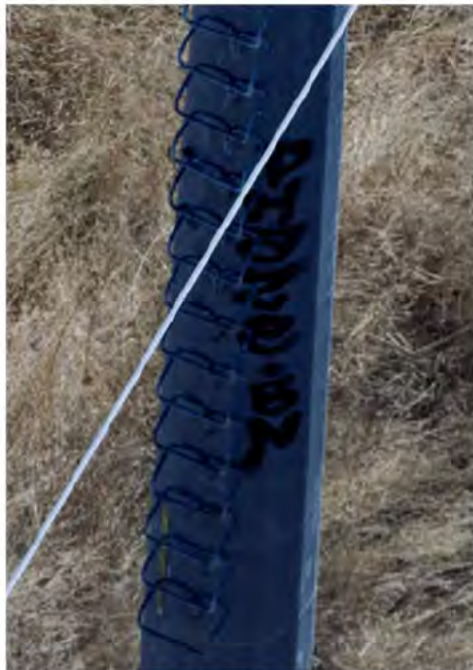
Figure 42

Condition: 5
Priority: A

FDA: Emergency | Storm Related | Repair

Example of unauthorized climbing. Evidence of public activity.

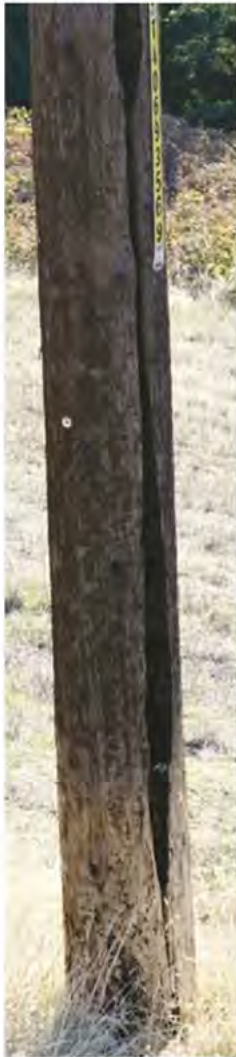
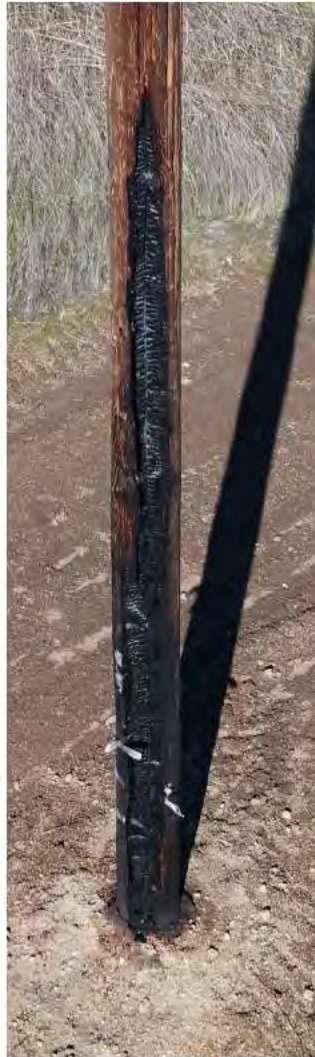
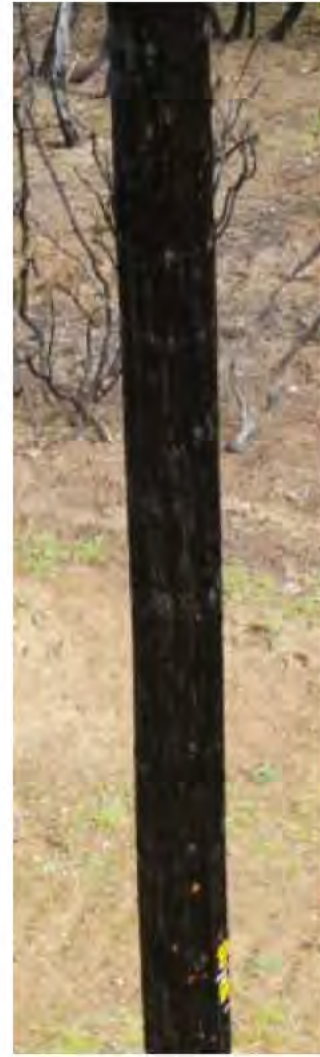
Condition: 4
 Priority: **E+**
 FDA: Structure-Wood|No Good/**Out of Stdrd**| Replace

Condition: 2
 Priority: No notification required

Figure 43 Pole decay/ shell and core rot (left). Burnt pole with significant material loss (center). Burnt pole with minimal material loss (right).

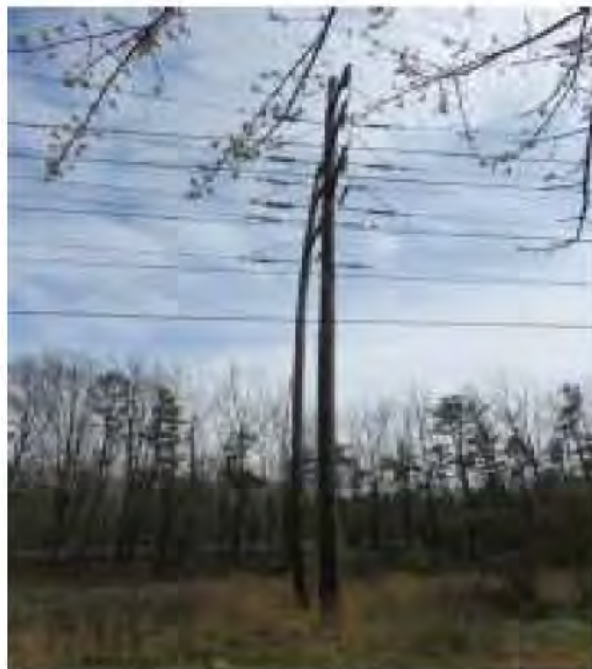
Figure 44

Heavy decay occurring around thru bolts

Condition: 4
Priority: E+

FDA: Structure-Wood|No Good/**Out of Stdrd**| Replace

Condition: 3
Priority: E

Pole cracks/rot with material loss (left). Single pole deflection on H-frame (right).

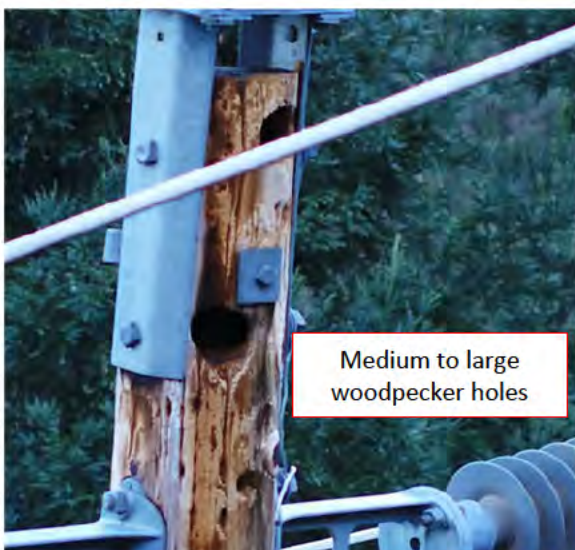
Medium to large woodpecker holes

Condition: 4
Priority: E+

FDA: Structure-wood|No Good/**Out of Stdrd**| Replace

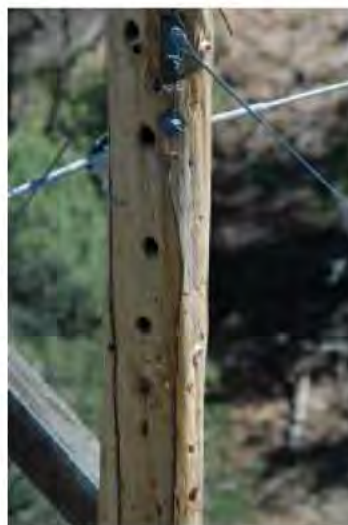
Figure 45

Condition: 2
Priority: F

FDA: Structure-Wood|No Good/**Out of Stdrd**|
Repair

Large woodpecker holes in proximity to hardware (left). Multiple medium woodpecker holes in close proximity to one another.
