AERIAL INSPECTION REVIEW+ TEAM

AIR+ TEAM HANDBOOK

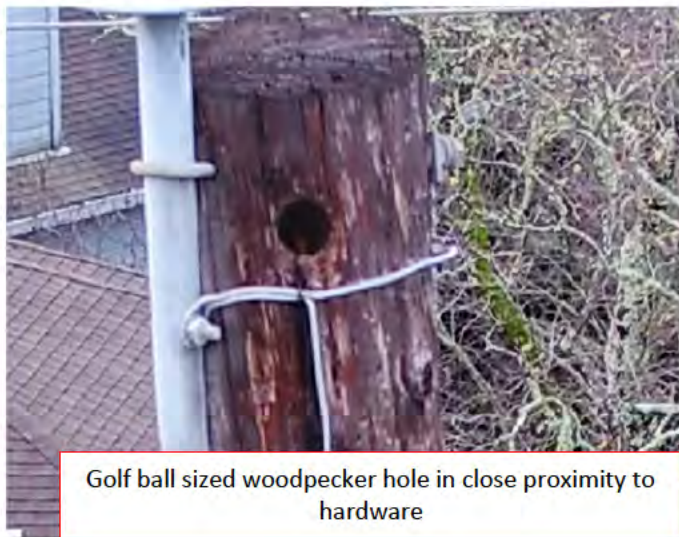
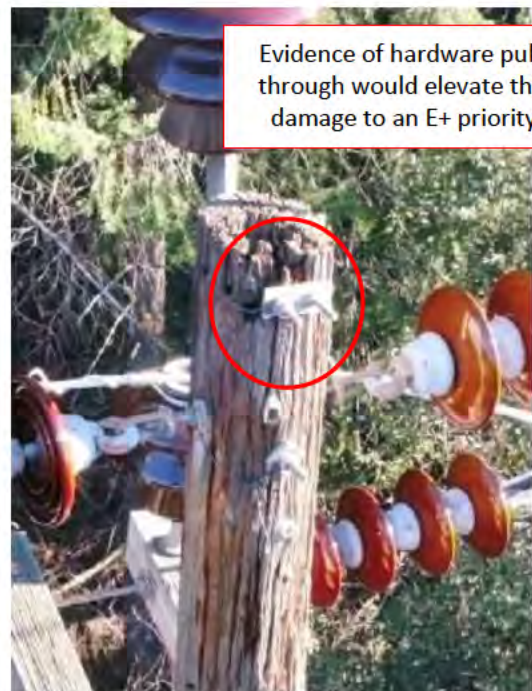
Golf ball sized woodpecker hole in close proximity to hardware

Condition: 2
Priority: F

FDA: Structure-Wood | No Good / Out of Std | Repair

Evidence of hardware pull-through would elevate this damage to an E+ priority

Condition: 3
Priority: E

FDA: Structure-Wood | No Good / Out of Std | Replace

Figure 47 Single medium size woodpecker hole (left), pole top rot (right).

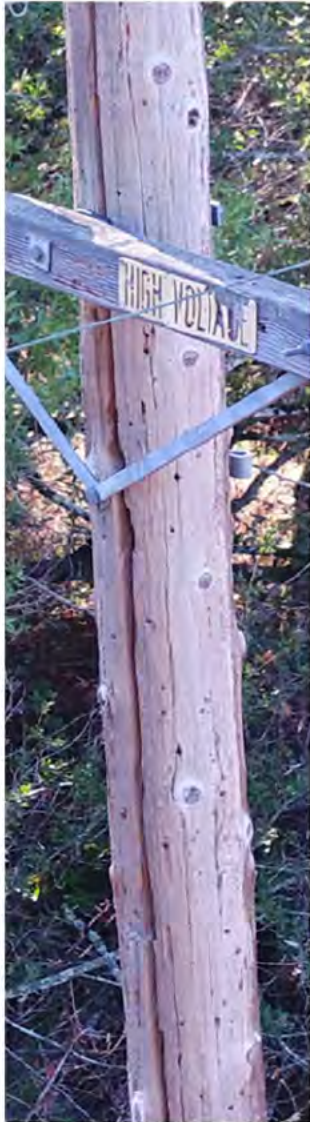
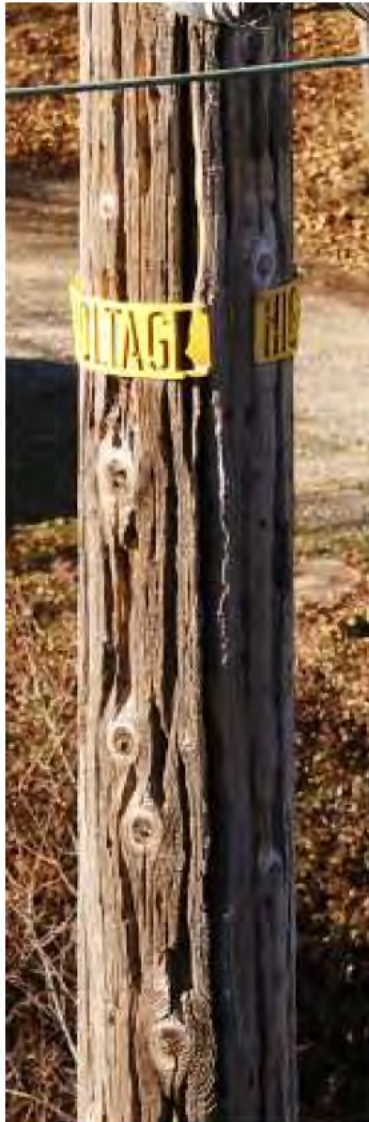
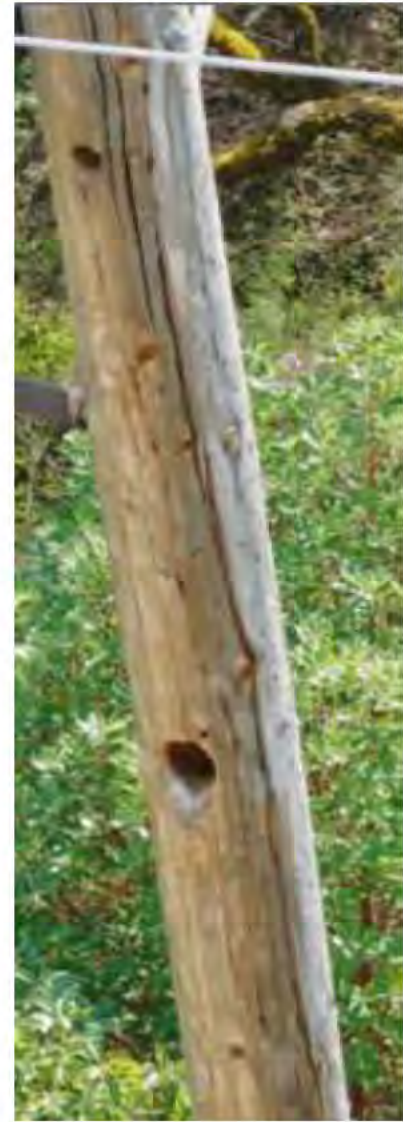
Crack depth	Priority notification
< 4 inches	No notification required
< 50% depth	E Priority
> 50 % depth	E+ Priority

Condition: 4
Priority: **E+**

FDA: Structure-Wood | No Good/**Out of Stdrd** | Replace

Condition: 3
Priority: E

FDA: Structure-Wood | **No Good/Out of Stdrd** | Replace

Figure 48 Wide pole crack with likelihood of penetrating greater than 50% of the pole cross section (left). Shell rot and pole cracks (center). Woodpecker holes in center of pole (right).

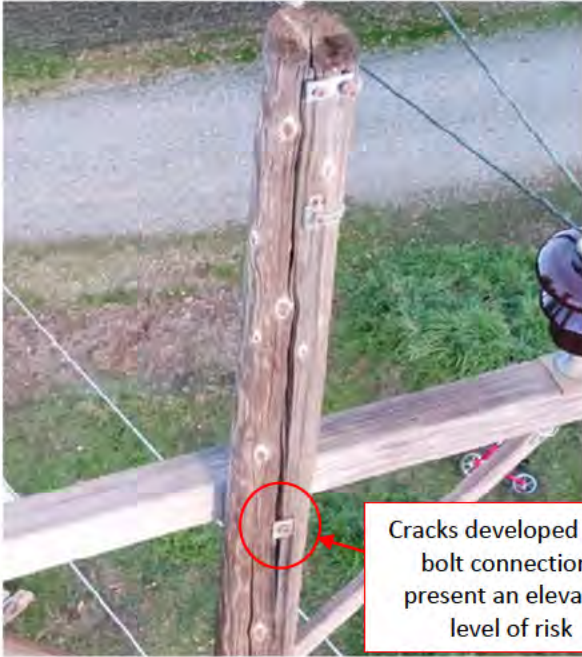
Cracks developed near bolt connections present an elevated level of risk

Condition: 3
Priority: E

Small woodpecker hole isolated from hardware and other damages

Condition: 2
Priority: No notification required

FDA: Structure-Wood | No Good / **Out of Std** | Replace

Figure 49 Wide pole crack penetrating roughly 50% of the pole (left). Single small woodpecker hole (right).

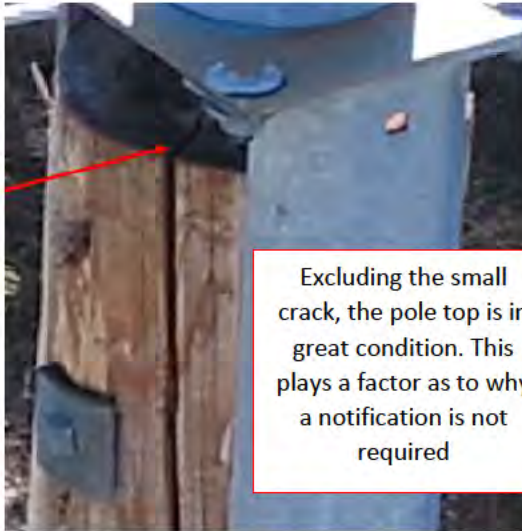
Excluding the small crack, the pole top is in great condition. This plays a factor as to why a notification is not required

Condition: 2
Priority: No Notification Required

Figure 50 Pole top crack. **Hardware that is perpendicular to a crack can serve as anti-split device.**

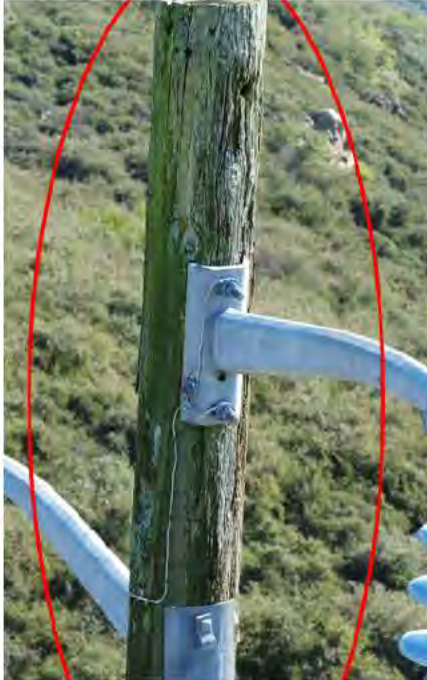
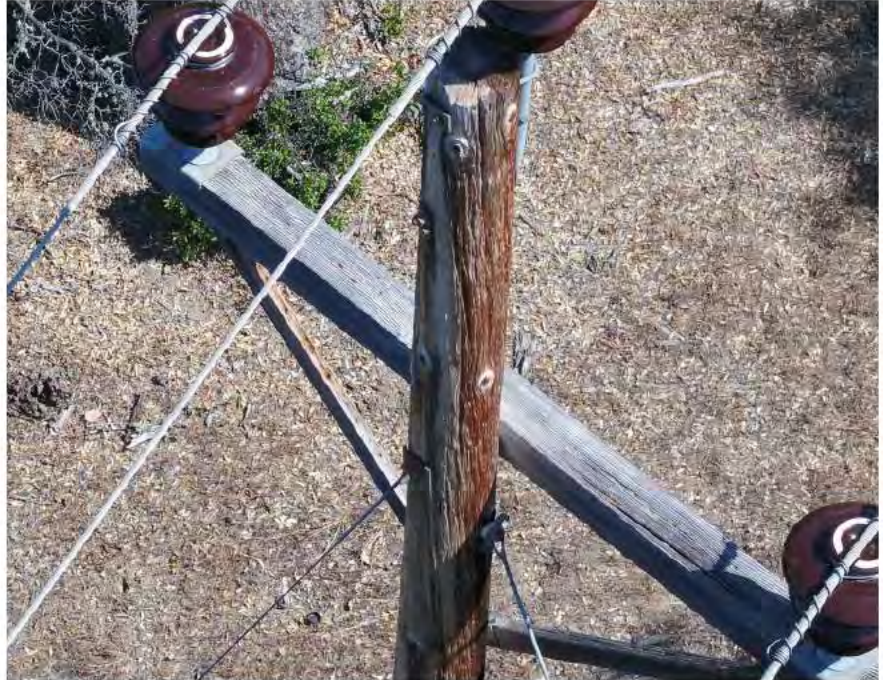
Condition: 2

Priority: No Notification Required

Figure 51 Surface mold (left). Typical pole cracking and shrinking as a result of aging (right).

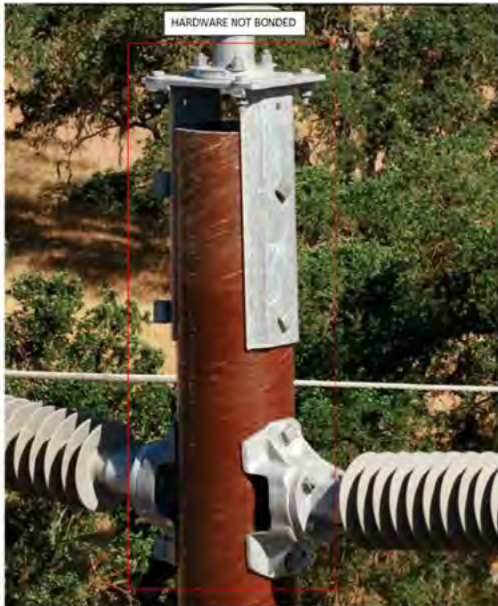
Condition: 2

Priority: F

FDA: Hardware-Wood | No Good/Out of Stdrd | Replace

Condition: 5

Priority: A

FDA: Emergency | Storm Related | Repair

Figure 52 Missing bond wire (left). Broken bond wire with gap <math>< 0.25''</math> (right). Risk of spark requires A priority tag per Table 4.

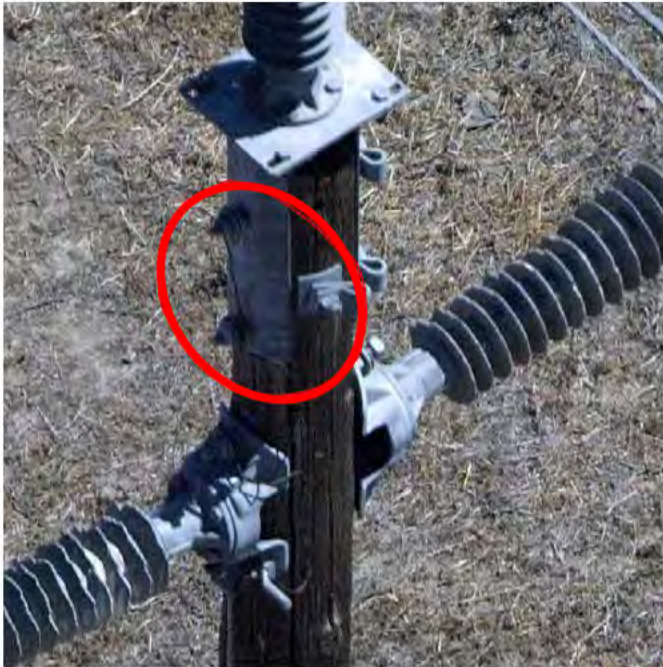
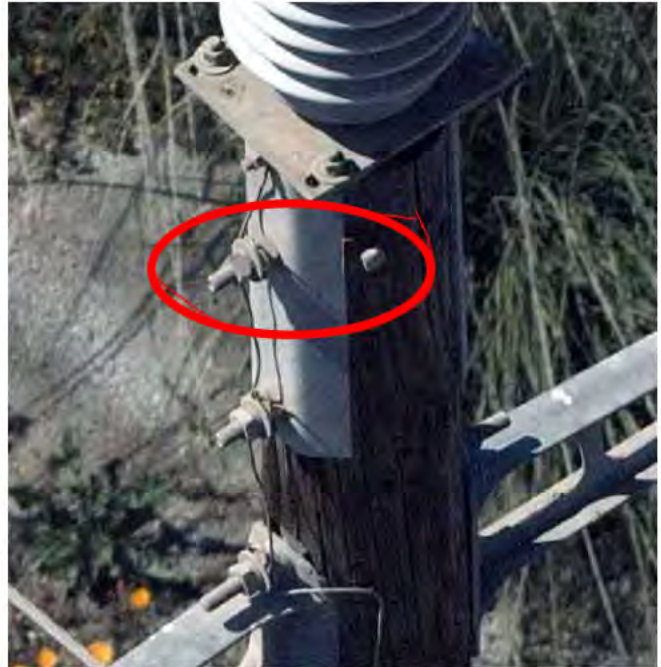
Condition: 2
Priority: F

FDA: Hardware-Wood | No Good/Out of Std | Replace

Split bolt installed within **1-1/2"** of bonded hardware and missing a bonding wire itself. This requires installation of a bonding wire with an **F** priority.

<ul style="list-style-type: none">Updated: EDEP FDA usage, switch number tags, aerial markers, Figure 34 priority, Figure 180 FDA, Figure 224 FDA, Foundation FDA's, Switch 'out of adjustment' guidance, buried secondary members, cold end hardware FDA, climbing racks, steel guy markers, guy bob requirements, Figure 53 priority
--	--	--

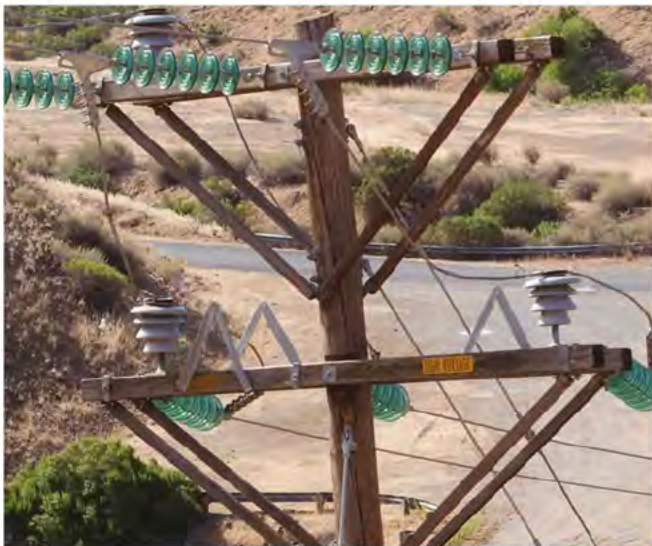
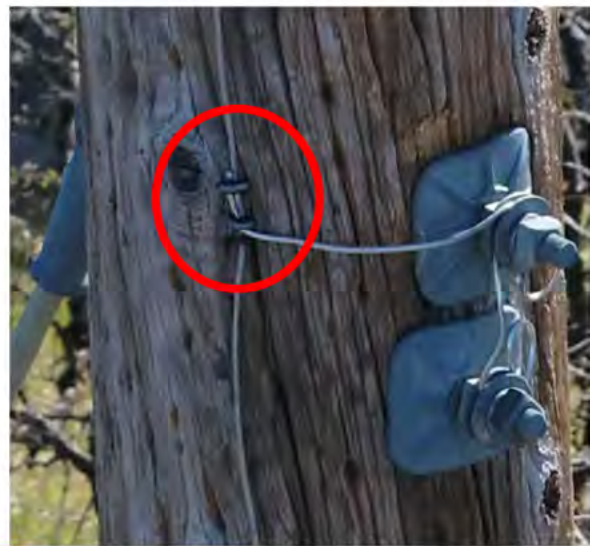
Figure 54

Condition: 3
Priority: E

FDA: Hardware-Wood | No Good/Out of Std | Replace

When transmission framing consisting of multiple X-arms (left), there needs to be a common bond between them. All associated hardware and any hardware within 1-1/2 inches of bonded hardware, needs to be incorporated into the bonding scheme. Staples are not approved to join two sections of bond wire (right). If there is a gap less than $<0.25"$ between them, *this should be sent as a possible emergency tag.*

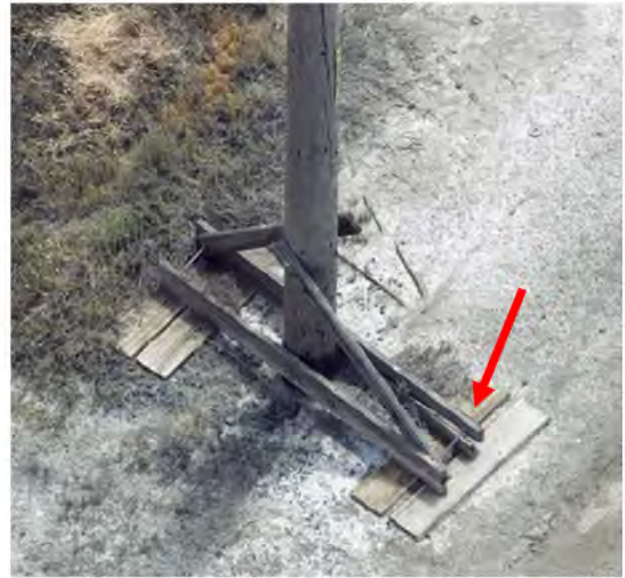
Figure 55

Condition: 3

Priority: E

FDA: Structure-Wood|No Good/Out of Stdrd|Repair

"Mud Sills for Wood Pole Lines" from Document 030109 (left). Damaged mud sill (right). This is also known as a 'bog shoe' or 'swamp brace'.

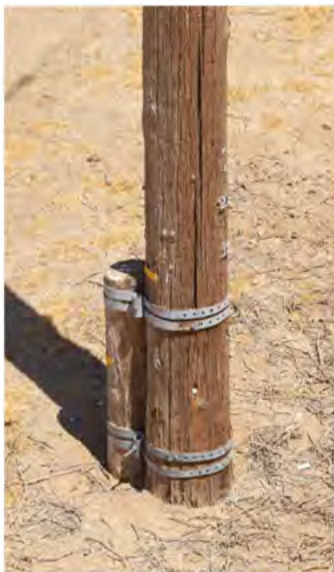
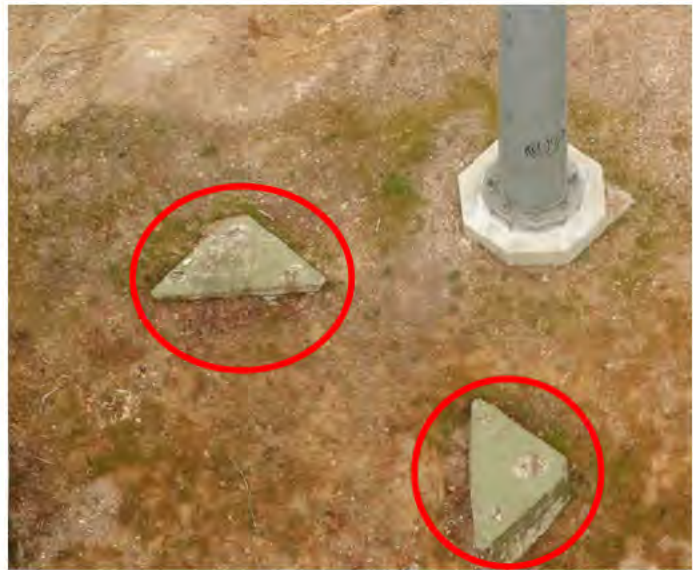
Figure 56

Condition: 3

Priority: E

FDA: Structure-Wood|No Good/Out of Stdrd|Replace

A pole which has been braced by a wood stub (left). Old structure foundation needs to be removed (right).

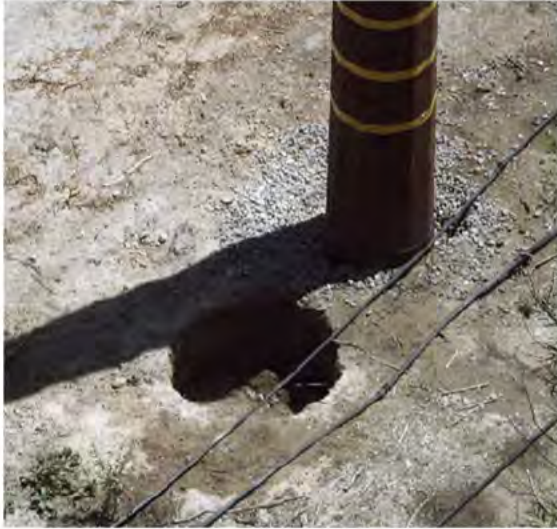
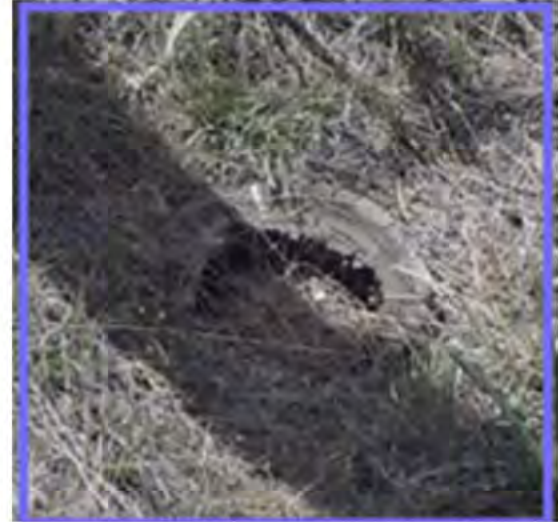
Figure 57

Condition: 2
Priority: F

FDA: Structure-Wood|Debris/Nest/etc|Remove

Soil erosion/medium hole near base of structure (left). If the stub is cut off at ground level and has rotted or started to rot and to form a hole, or if it has the potential to be a tripping hazard, it should be given an F priority, due to risk to humans, as well as livestock and other animals (right).

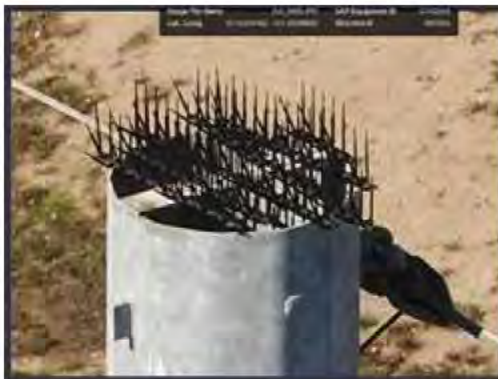
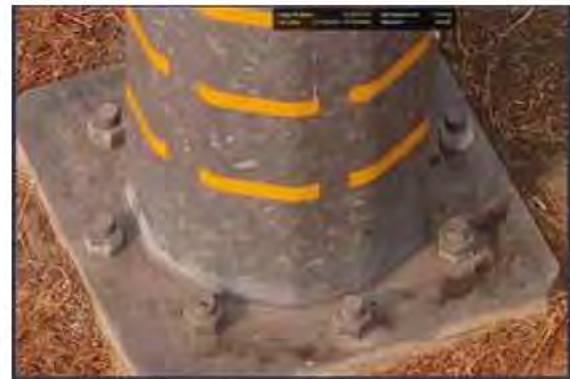
Figure 58

Condition: 3
Priority: E/F

FDA: Structure-Steel|No Good/**Out of Stdrd**|Repair

The above TSP has the top open to the elements. This can cause a buildup of moisture in the interior of the pole. This should be given an F tag. However, if there are signs of rust or corrosion damage at the base of the pole, it can be upgraded to an E.

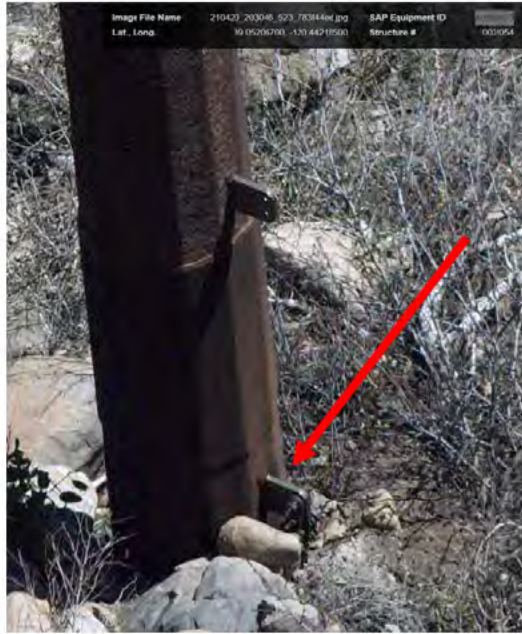
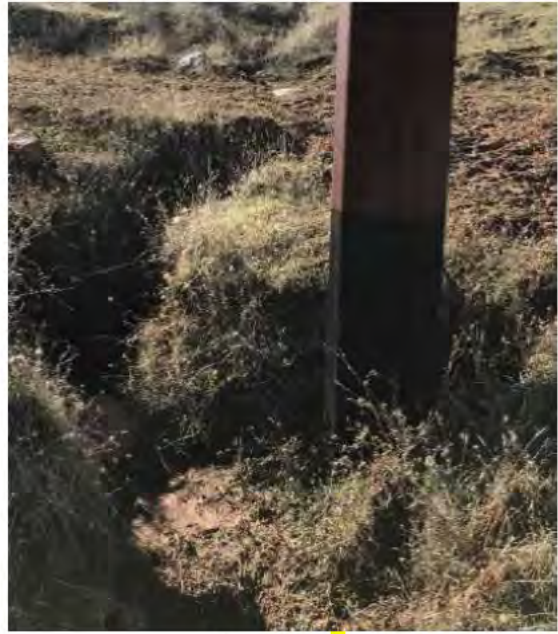
Figure 59

Condition: 3
 Priority: E

FDA: Structure-Wood|No Good/
Out of Stdrd|Repair

These structures should have at least one tab buried (left). Direct buried foundation with soil erosion more than 3 feet (right).

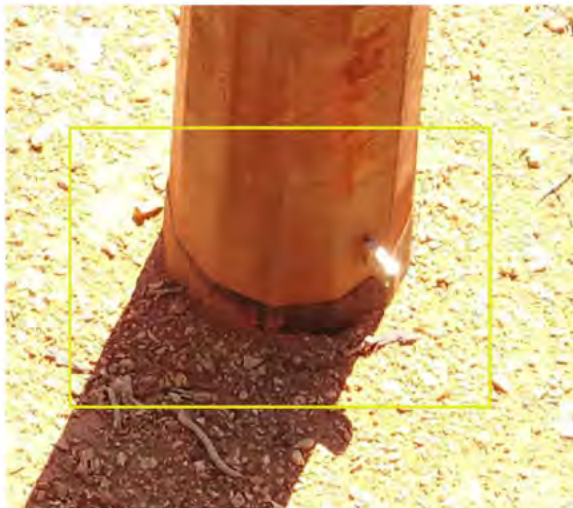
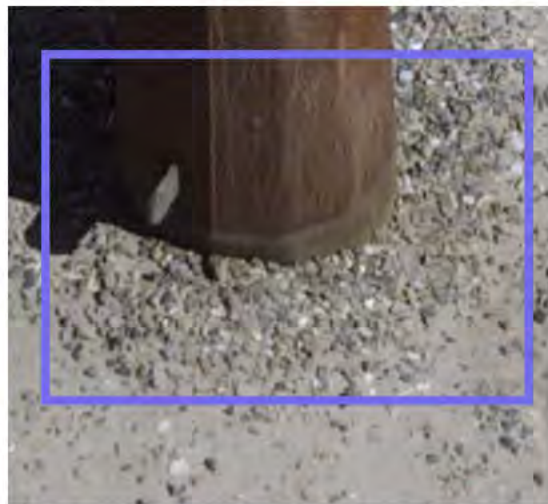
Condition: 3
 Priority: E

FDA: Structure-Wood|No Good/Out of
 Stdrd|Repair

Condition: 1

Priority: No Notification Required
 FDA: N/A

Worn mastic with signs of rust (left). Not all mastic is black, and lighter shades don't necessarily mean there's wear present (right).

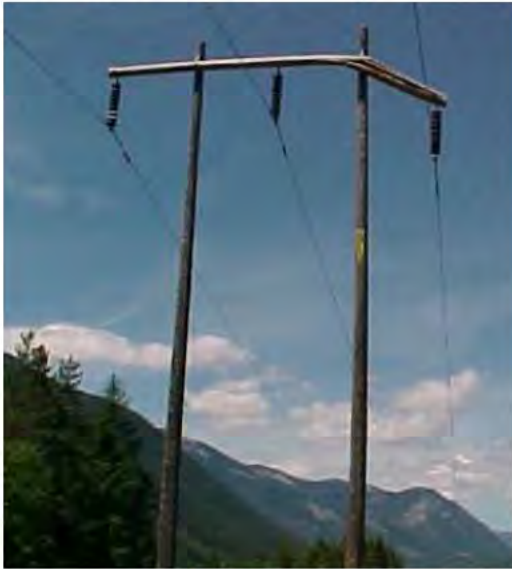
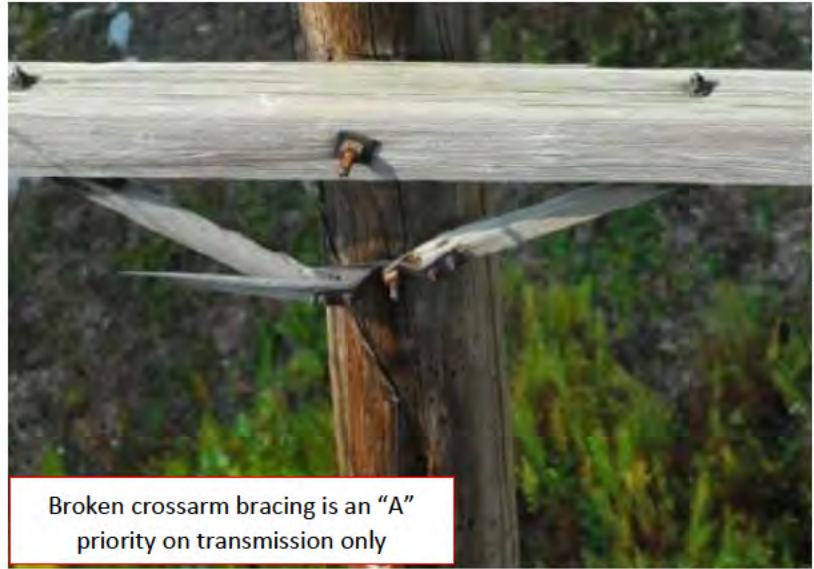
Condition: 5
Priority: A

FDA: Emergency | Other | Replace

Broken crossarm bracing is an "A" priority on transmission only

Figure 61 Failed H-frame crossarm (left). Failed crossarm bracing (right).

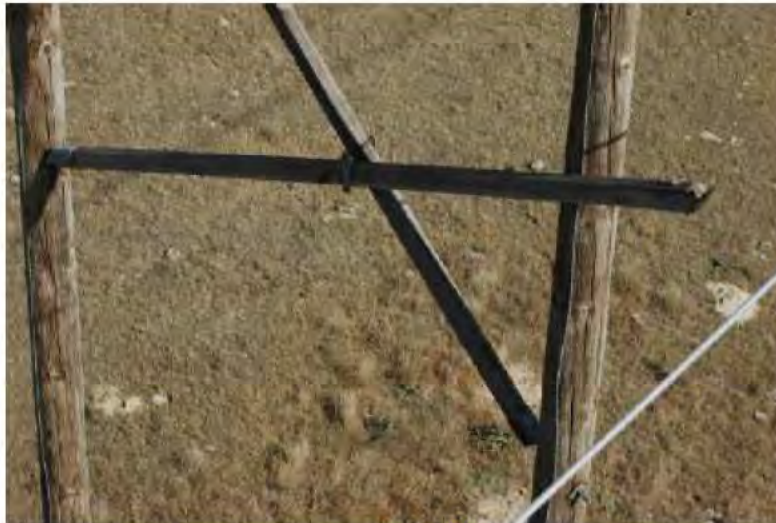
Condition: 4
Priority: E+

FDA: Crossarm-Wood | No Good | Out of Stdrd | Replace

Figure 62 Detached H-frame bracing.

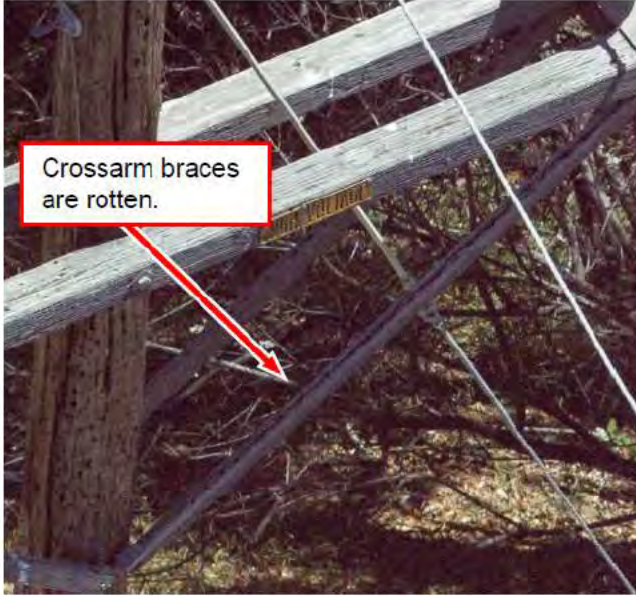
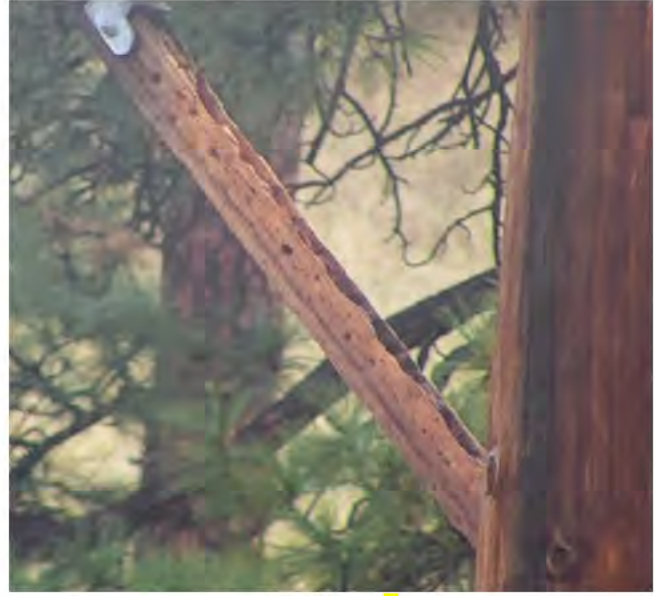
Figure 63

Crossarm braces are rotten.

Condition: 3
Priority: E

FDA: Crossarm-Wood|No Good/**Out of Stdrd**|Repair

Damage to crossarm brace.

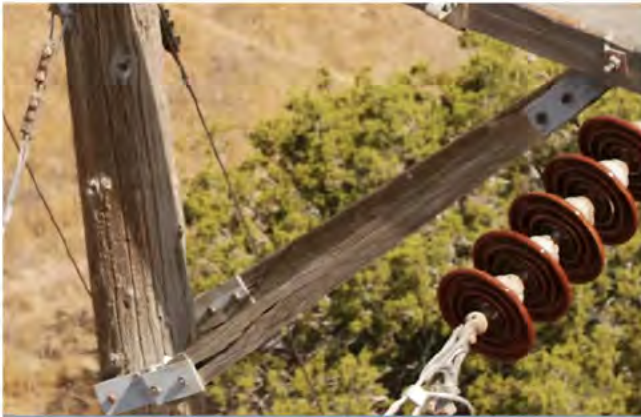
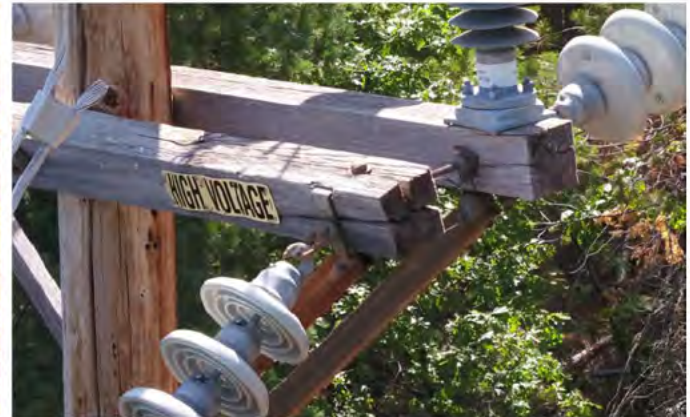
Figure 64

Condition: 4
Priority: E+

FDA: Crossarm-Wood|No Good/**Out of Stdrd**|Repair

Damage to crossarm brace at hardware,

FDA: Crossarm-Wood|No Good/**Out of Stdrd**|Replace

missing bracing (left). Cracked crossarm at hardware (right).

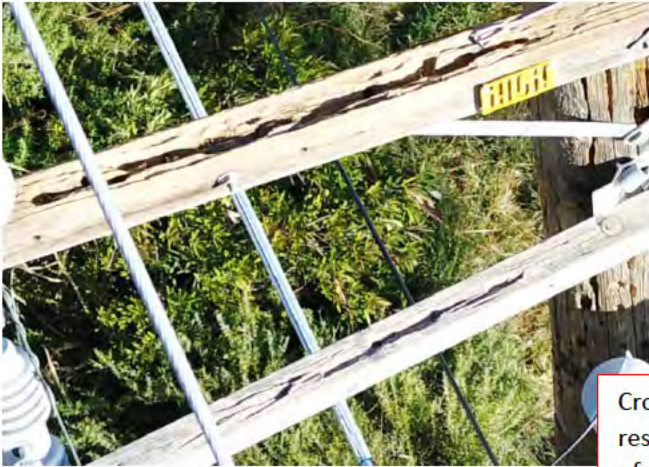
Crossarm decay/rot resulting in 20-50% of cross-sectional material loss

Condition: 4
Priority: E+

Condition: 3
Priority: E

FDA: Crossarm-Wood|No Good/**Out of Stdrd**|Replace

Heavy damage/crossarm rot compromising hardware (left) and moderate damage/crossarm rot (right).

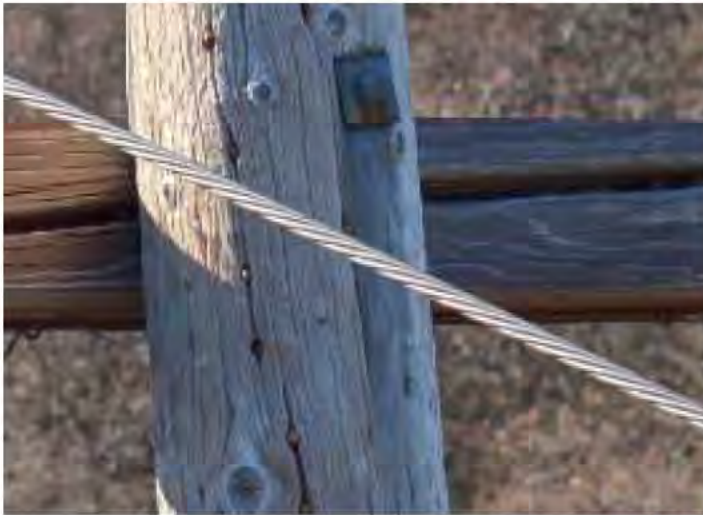
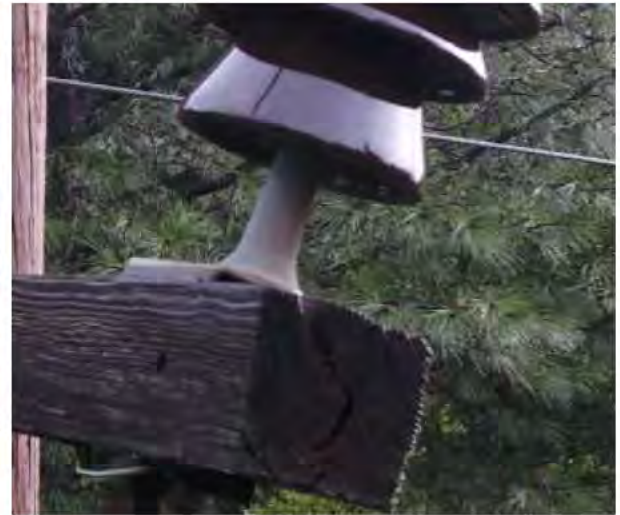
Figure 65

Condition: 3
Priority: E

FDA: Crossarm-Wood|No Good/**Out of Stdrd**|Replace

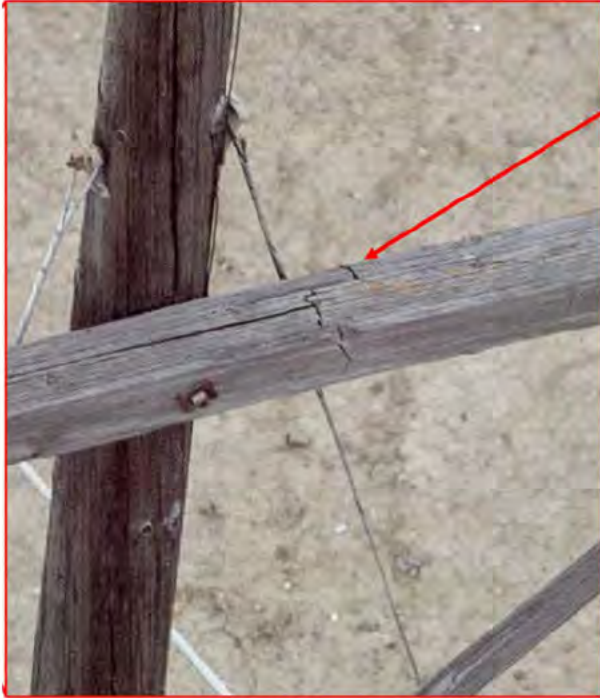
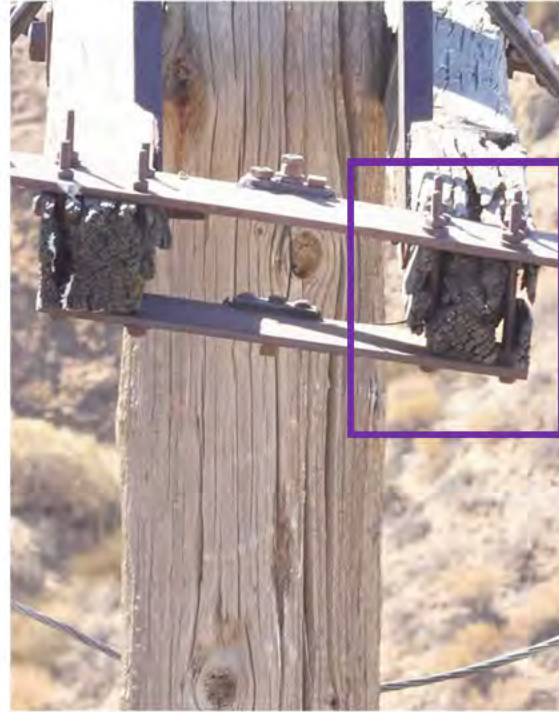
Figure 66

Cracked crossarm (left and right). Note: Field will not repair tri-pin framing, so a “replace” FDA is preferred in this case.

Condition: 5

Priority: A

FDA: Emergency-Wood|Other|Replace

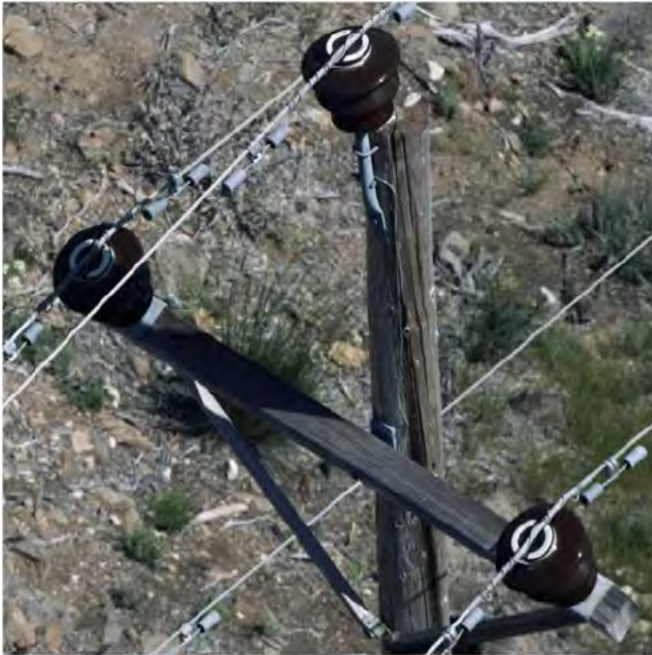
Figure 67 Crossarm cracked >50% (left). **Crossarm cracked/rotten with signs of hardware slippage (right).**

Condition: 3

Priority: E

FDA: Crossarm-Wood|No Good|Out of Stdrd|Replace

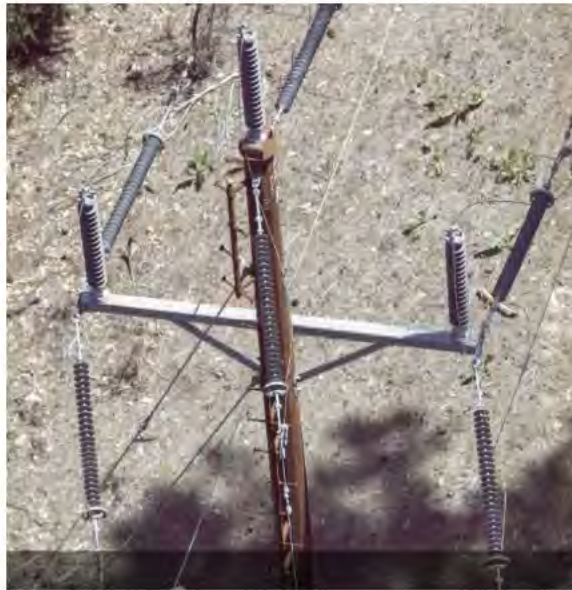
Figure 69

Insufficient crossarm length and insulator sizes can reduce the clearances between conductor and pole or conductor and crossarm to potentially dangerous distances.

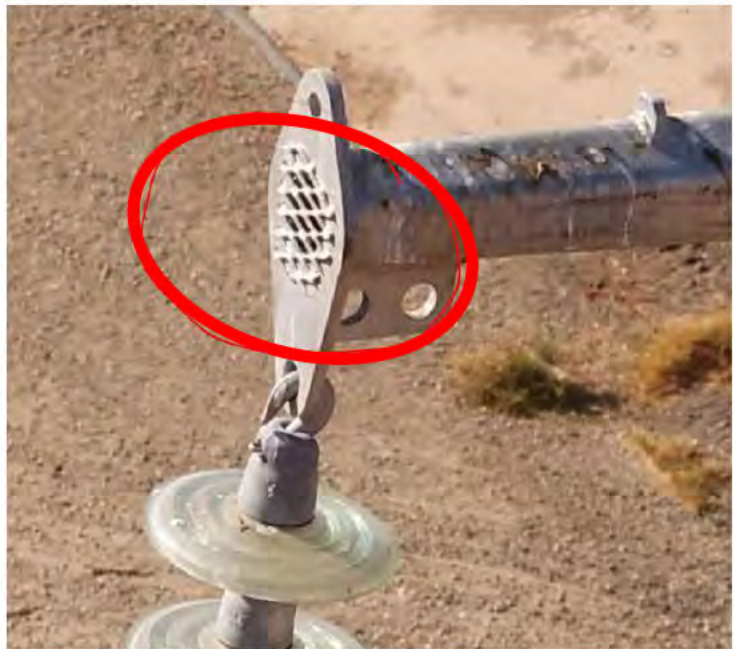
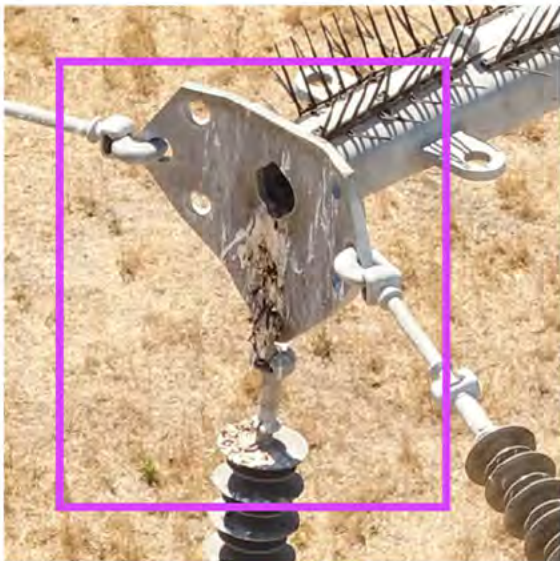
Condition: 3
Priority: E

FDA: Raptor Guard-Wood/Steel|No Good/Out of Std|Install

Figure 71 Damaged raptor guard (left). Poles with open-ended crossarms with evidence of bird activity should be covered as in the photo (right). If not, they should be written up with an F priority tag.

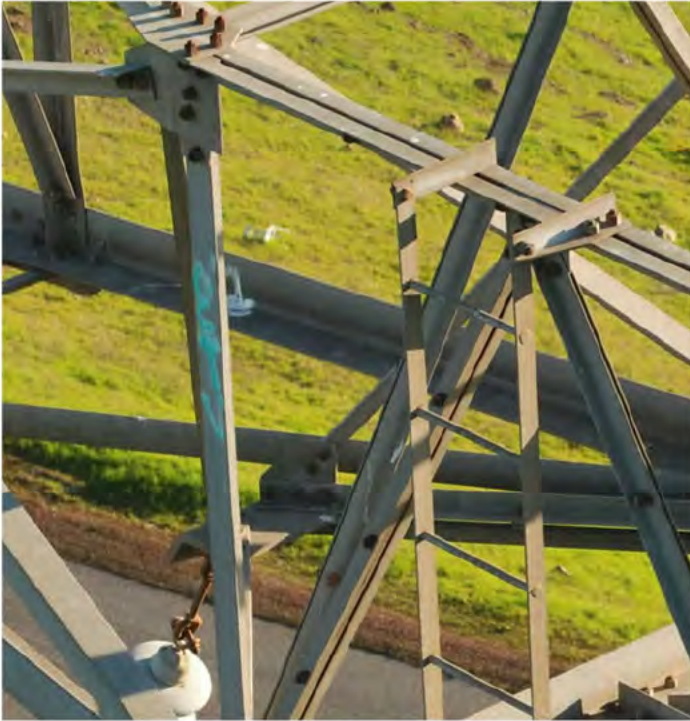
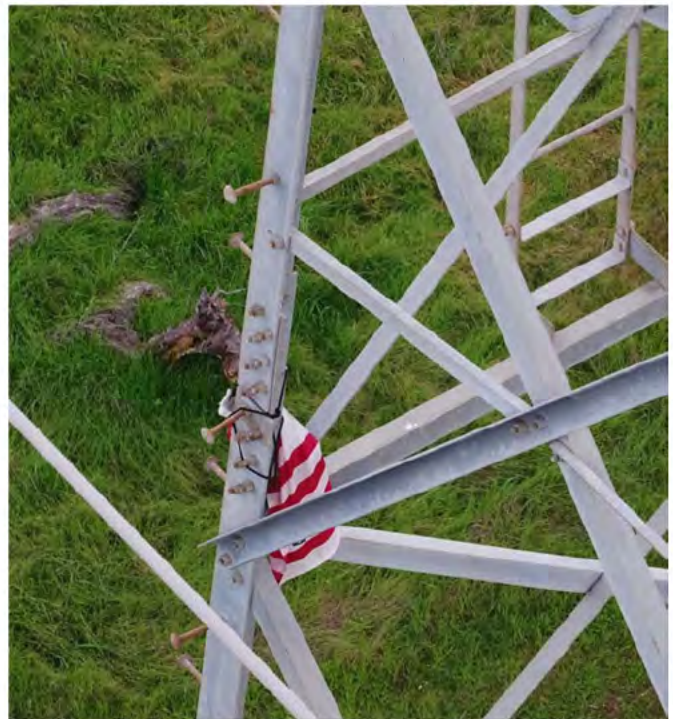
Figure 74

Condition: 5

Priority: A

FDA: Emergency|Storm Related|Repair

Examples of unauthorized climbing. Evidence of public activity.

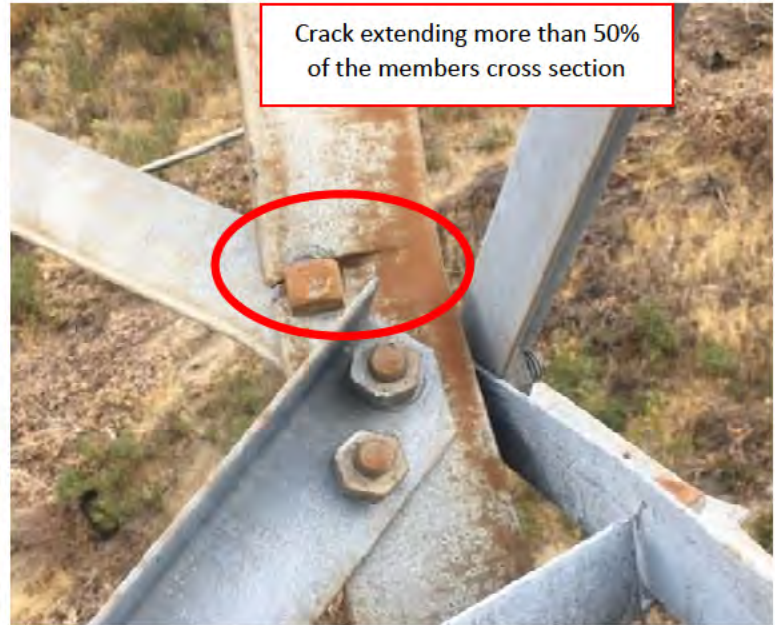
Condition: 5
Priority: A

FDA: Emergency|Storm Related|Repair

Crack extending more than 50% of the members cross section

Figure 77 Severe member rust (left). Cracked crossarm member (right).

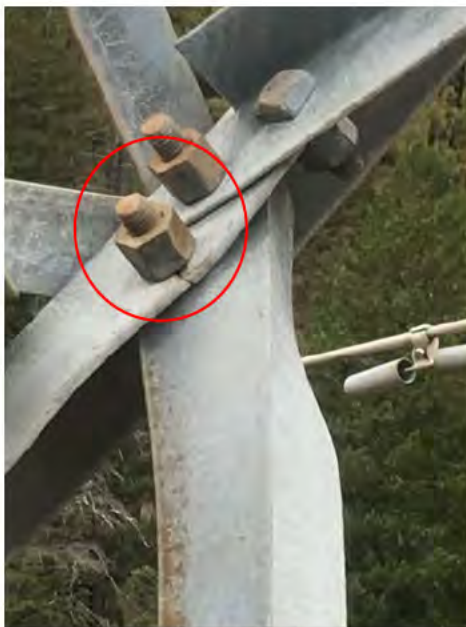
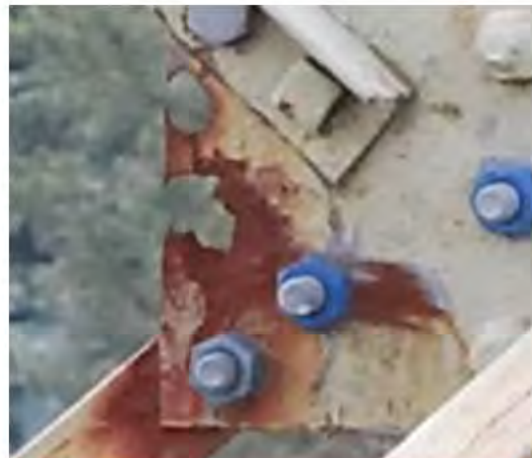
Condition: 4
Priority: E+

FDA: Structure-Tower|No Good/**Out of Std**|Repair

If material loss was occurring directly over the bolts discuss with your IRS for a potential "A" priority

Figure 78 Cracked bolt hole in crossarm (left). Corroded connection plate(right).

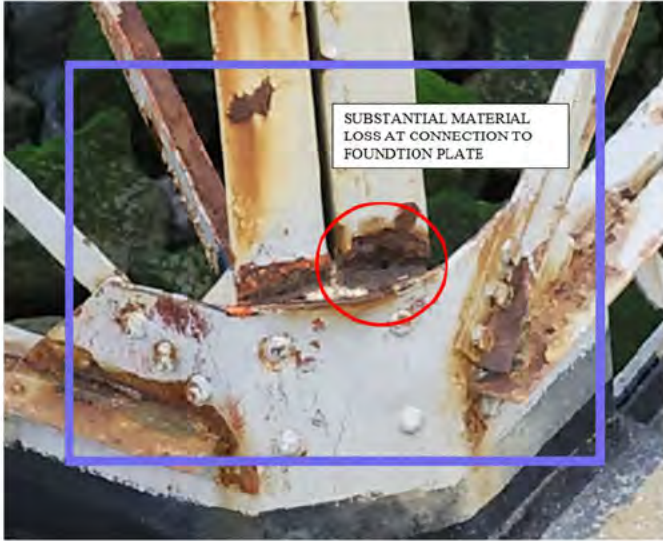
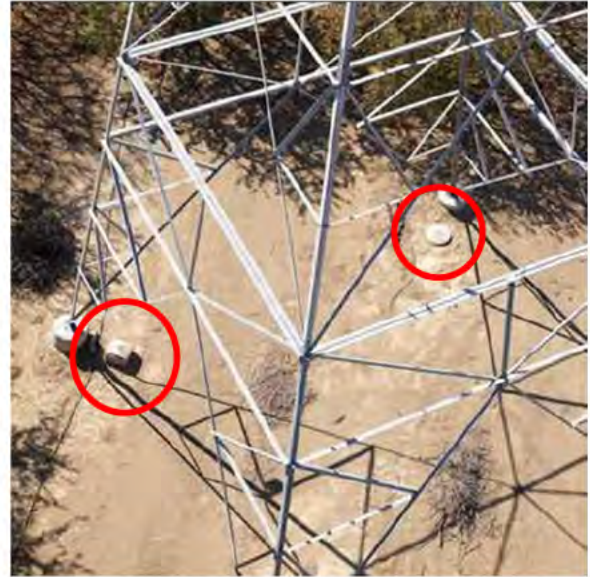
Condition 4
Priority E+

Condition: 2
Priority: F

Critical/main member corrosion with 30-50% material loss (left). Old tower foundation (CIRT to contact civil engineering for action) (right).

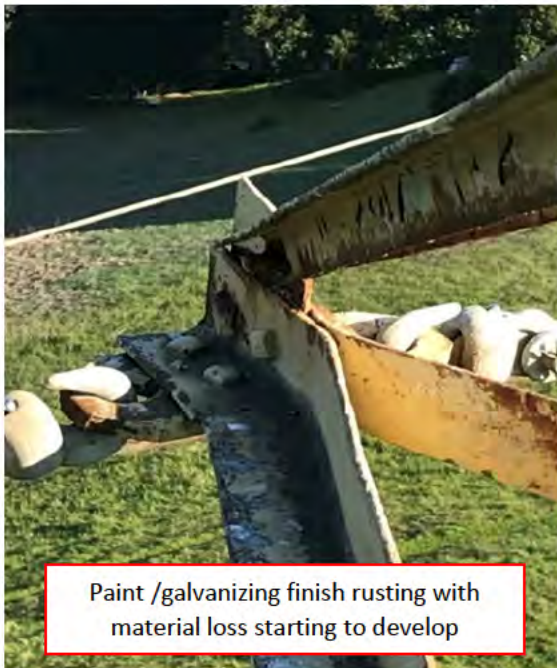
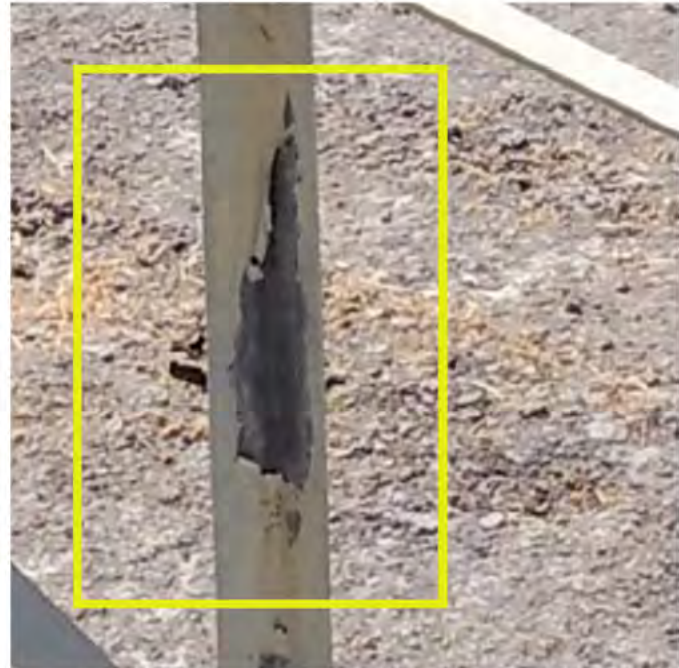
Figure 80

Condition: 2
Priority: F

FDA: Structure-Steel | Paint/Coating | Other

Worn paint/galvanizing finish with material loss starting to develop (left). Worn paint (right).

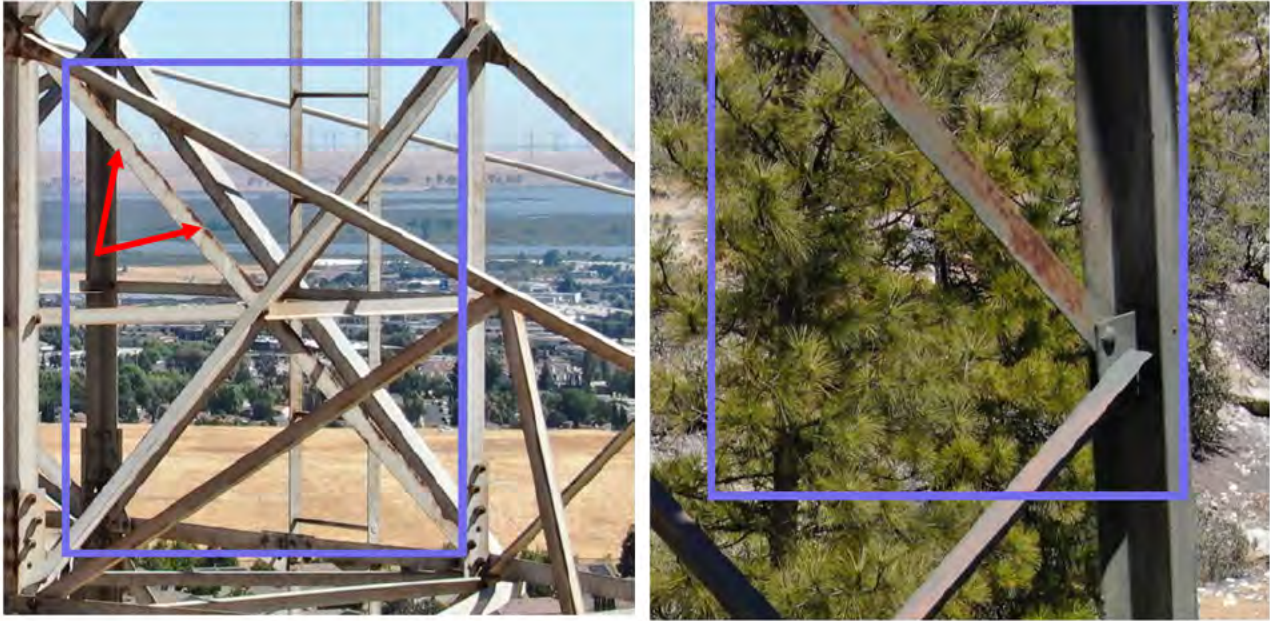
Figure 81

Condition: 2

Priority: F

Examples of spotted dark red rust with some material loss (left). Dark red rust (right).

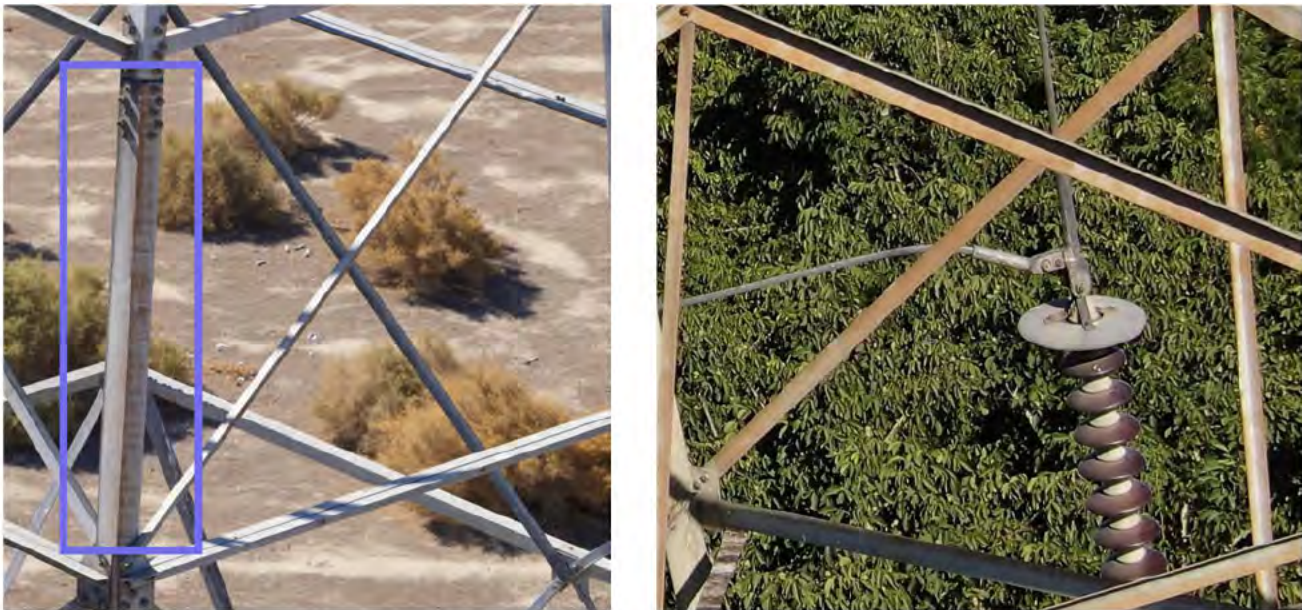
Figure 82

Condition: 1

Priority: No notification required

Examples of minor surface rust with no material loss.

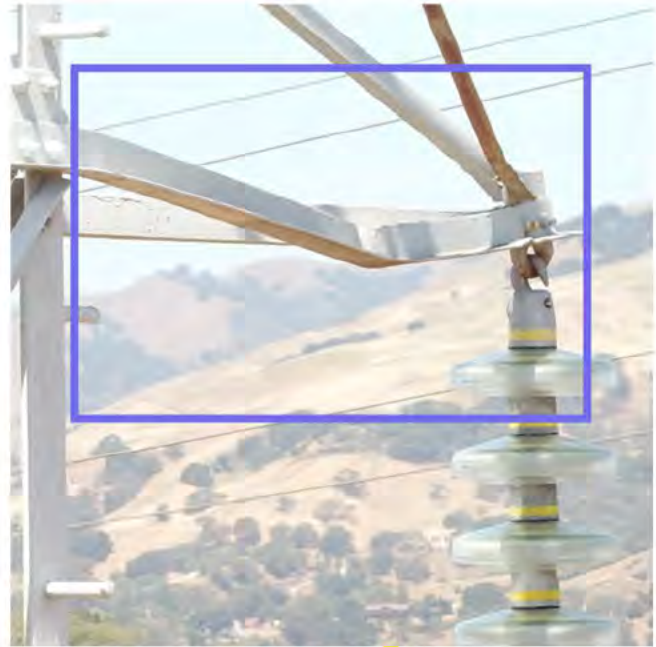
Dark red/brown surface rust covering a majority of the framing members

Condition: 2
Priority: F

Condition: 4
Priority: E+

Figure 83 FDA: Structure-Steel|Paint/Coating|Other **Lattice tower surface rust (left).** FDA: Structure-Tower|No Good/**Out of Stdrd**|Repair **Bent primary member on crossarm (right).** **Any additional bent members on the same crossarm should be considered a possible A priority.**

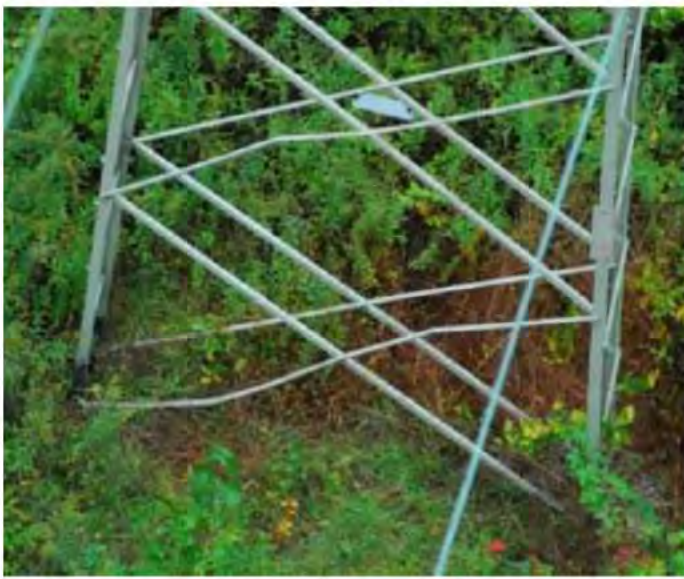
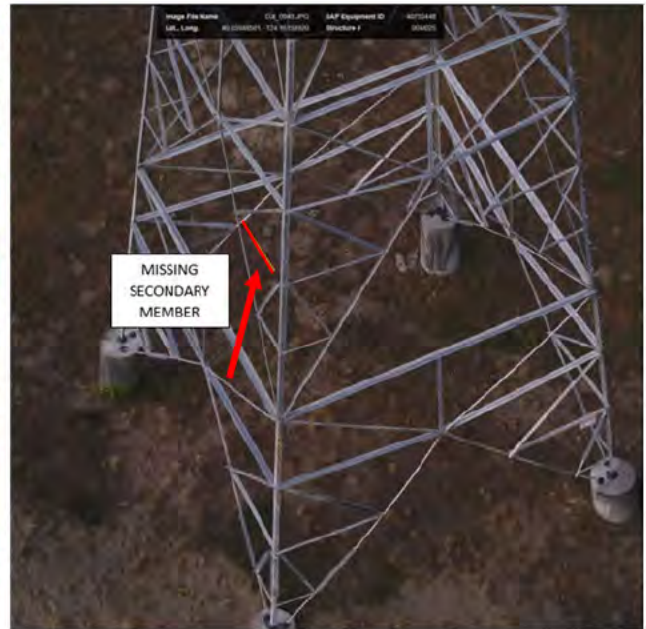
Condition: 4
Priority: E+

Figure 84 FDA: Structure-Tower|No Good/**Out of Stdrd**|Repair **Bent secondary members (multiple) compromising structural integrity (left).** FDA: Structure-Tower|No Good/**Out of Stdrd**|Repair **Missing secondary member (right).** Only noticeable when compared to other locations on the tower.
