AERIAL INSPECTION REVIEW+ TEAM

AIR+ TEAM HANDBOOK

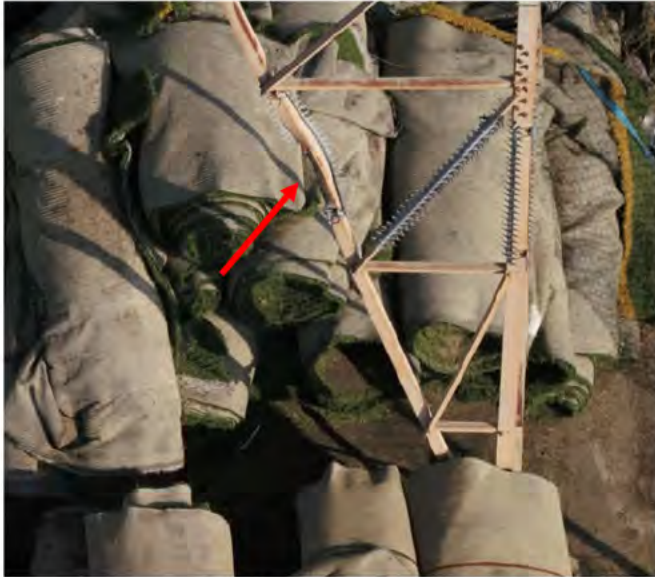
Condition: 4
Priority: E+

FDA: Structure-Tower | No Good/Out of Stdrd | Repair

FDA(1): Structure-Tower | No Good/Out of Stdrd | Repair
FDA(2): Structure-Steel | Debris, Nest, etc. | Remove

Figure 85 Moderate damage to primary member (left). Completely missing secondary member, with buckling members in other locations E+; Debris F-priority (right).

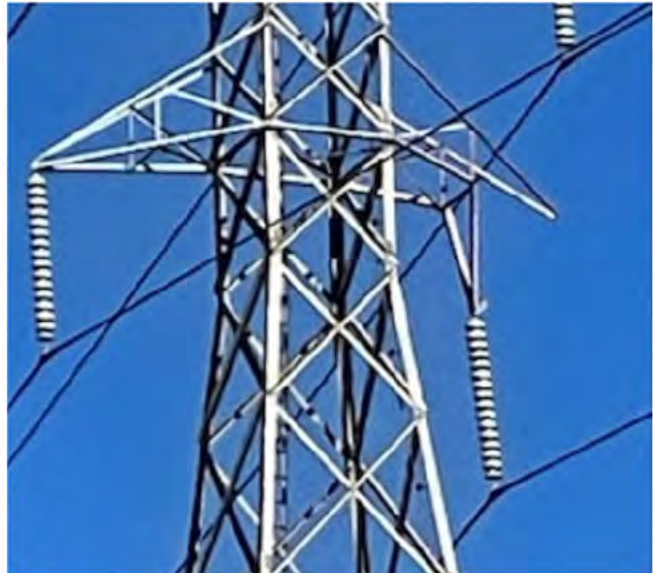
Condition:5
Priority: A

FDA: Emergency-Steel | Other | Replace

Figure 86 Two types of A priority damage on crossarms. One is rusted through with material loss >50%. The other has had a mechanical failure of the crossarm.

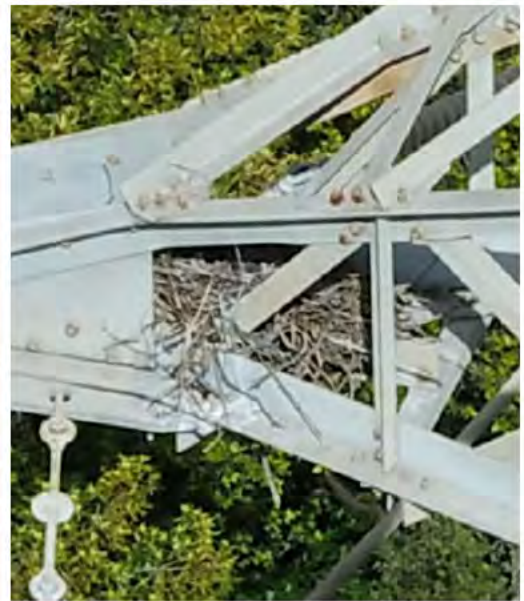
Notifications are only required for large raptor nests above the conductor. Use an "E" priority tag.

Separate from being over the conductor, **if there is evidence of corrosion on the members due to the nest** it would warrant an E notification. Check for nest decay as a potential indicator of moisture.

Condition: 3
 Priority: E
 FDA: Structure-Steel | Debris/Nest/etc | Remove

Figure 88 Large raptor nest and regions that require a nest notification

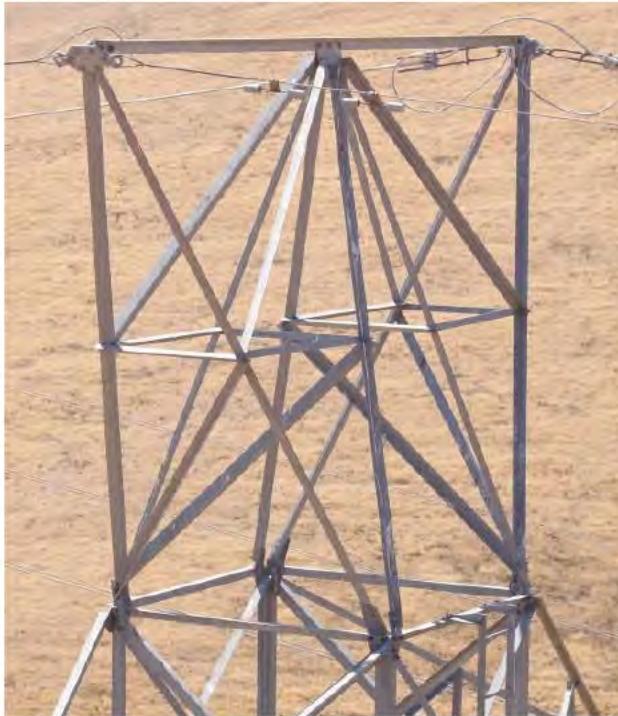
Figure 90

Condition: 2

Priority: F

FDA: Hardware-Tower | No Good/Out of Stdrd | Replace

Climbing steps missing. Steps must be up to level of fiber cable if installed on structure (left). Three or more adjacent (consecutive) steps must be missing to warrant a tag (right).

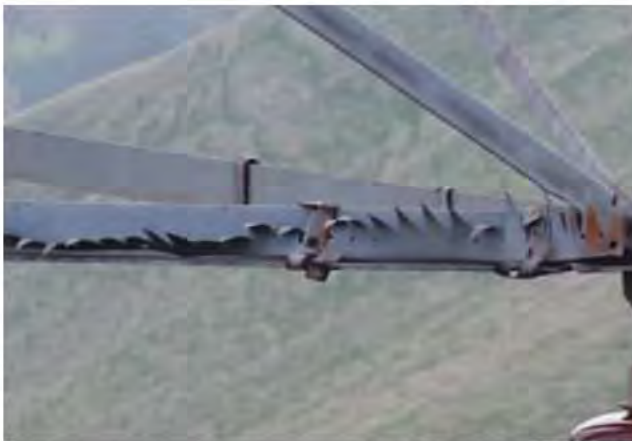
Condition: 1

Priority: No notification required

Damaged raptor guard (left), missing bolts that do not require a notification.

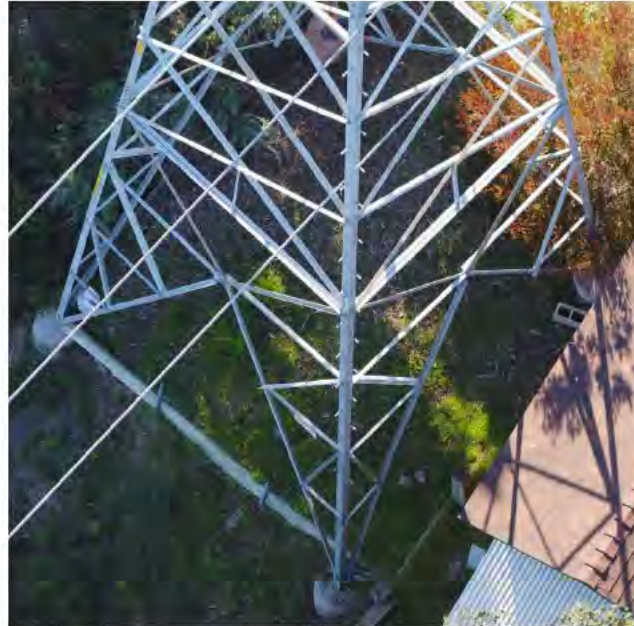
Figure 92

Condition: 2

Priority: F

Structure in obviously populated area that should be equipped with an anti-climbing guard. Use FDA: Structure-Tower|Anti-Climbing Guard|Repair with priority F if guard is present but damaged.

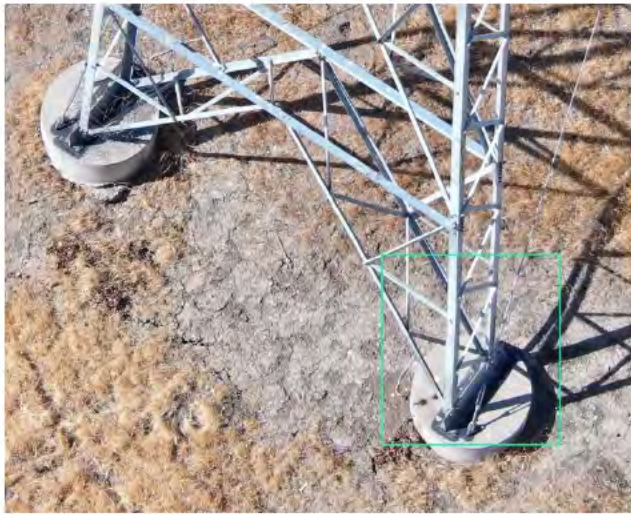
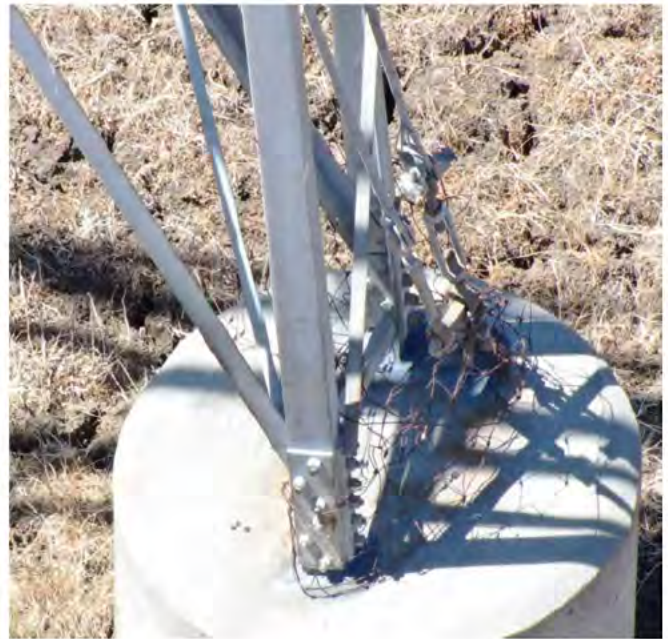
Figure 94

Condition: 3

Priority: E

FDA: Animal Guard-Steel No Good/Out of Stdrd|Repair

If an animal guard is present on the structure or guy turnbuckles but is missing/damaged on one or more of the legs or turnbuckles, write a notification to install animal guard.

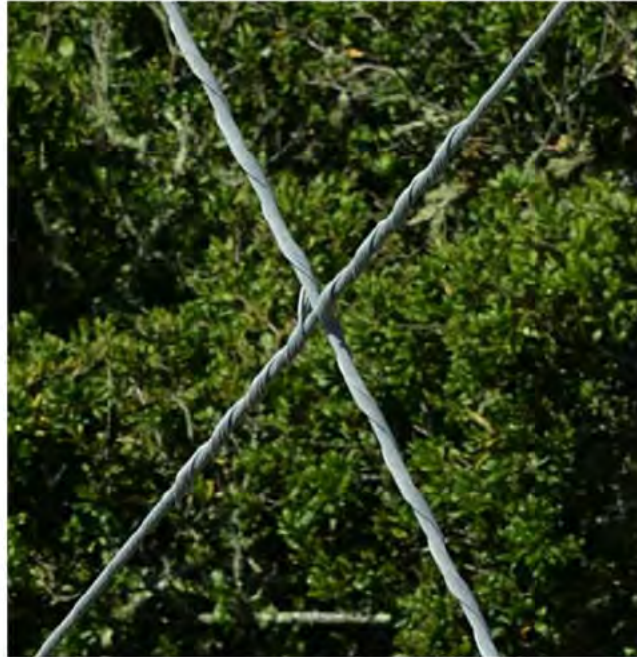
Figure 97

Condition: 1

Priority: No notification required

Correctly installed cross tie.

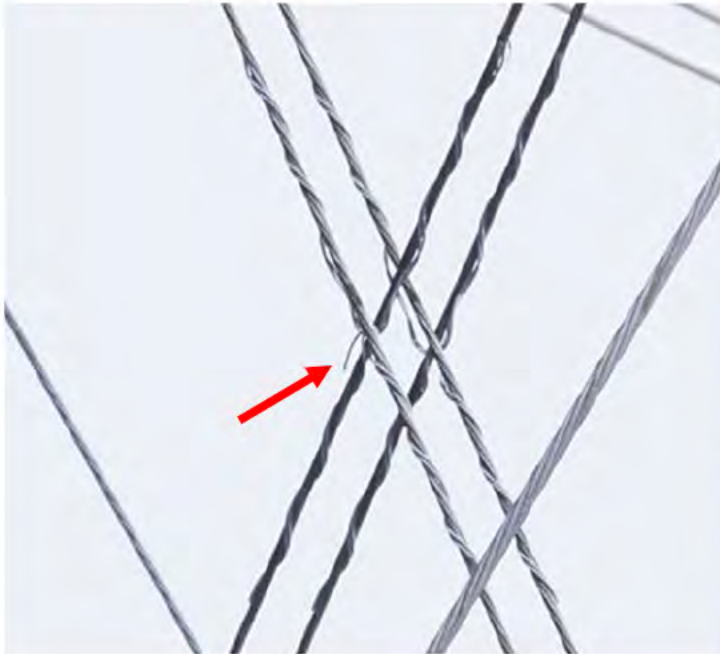
Figure 98

Condition: 3

Priority: E

FDA: Guy Wire-Steel|No Good/Out of Std|Repair

Example of damaged/loose cross tie (left). Non-standard cross tie (right).

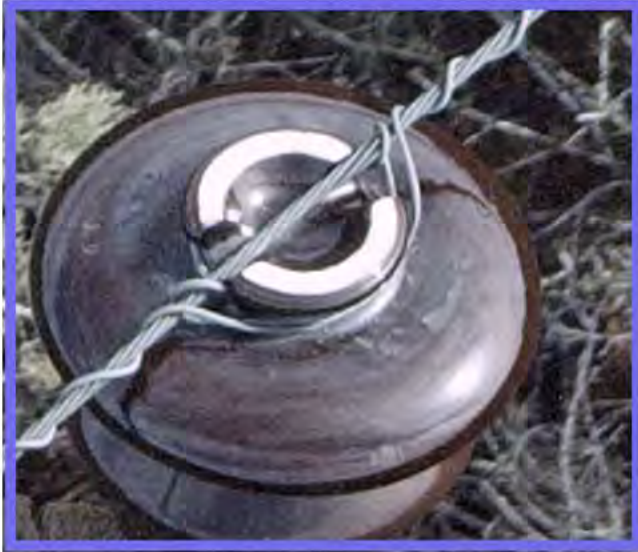
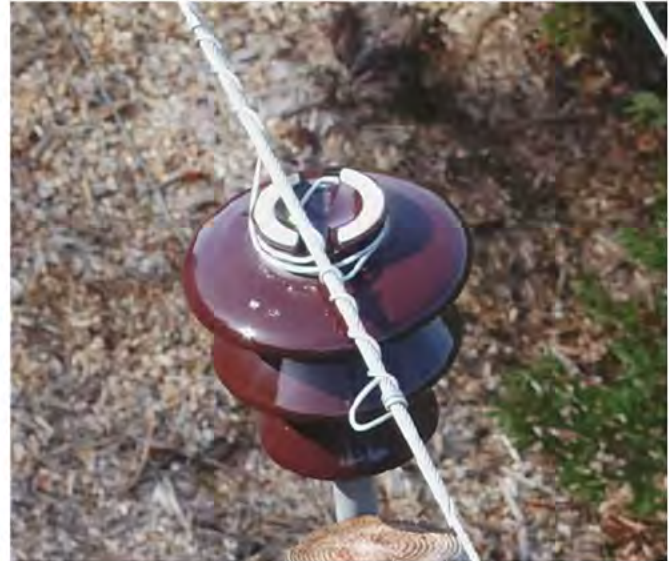
Figure 103

Condition: 3

Priority: E

FDA: Tie Wire-Wood | No Good / Out of Stdrd | Replace

Condition: 5

Priority: A

FDA: Emergency | Storm Related | Repair

Loose tie wire with uplift, conductor still over the biscuit (left). Loose tie wire with uplift and insulator starting to turn (right).

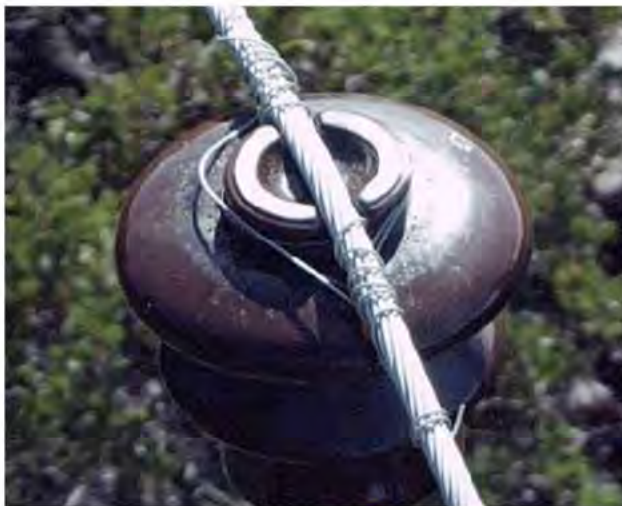
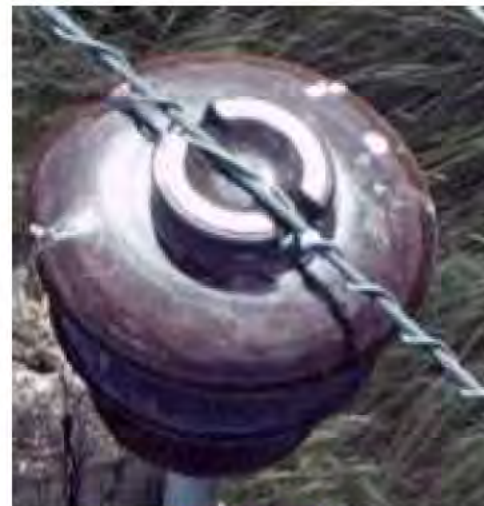
Figure 104

Condition: 3

Priority: E

FDA: Tie Wire-Wood | No Good / Out of Stdrd | Replace

Condition: 1

Priority: N/A

Loose tie wire, conductor seated in the biscuit (left). Fully seated conductor with no issues (right).

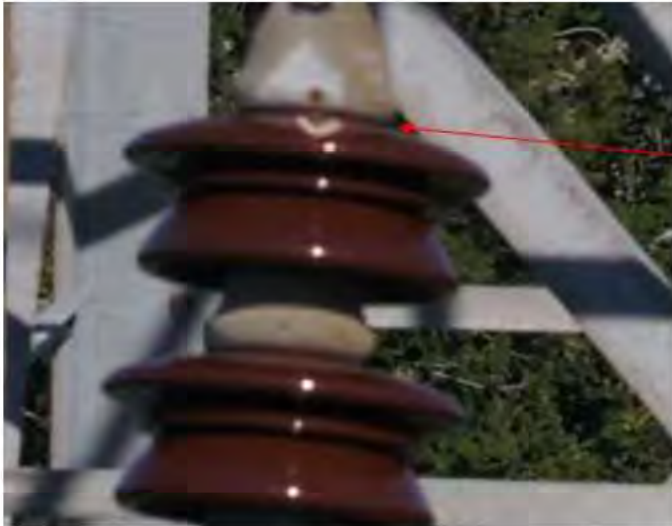
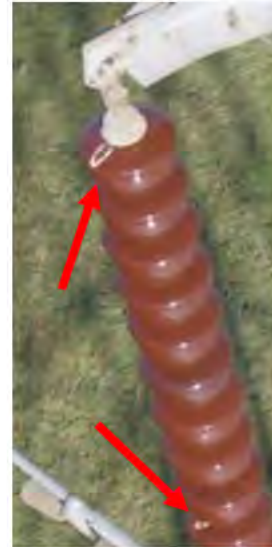
Figure 105

Condition: 4

Priority: E+

FDA (1): Insulator-Steel|No Good/**Out of Std**|Replace

Flashed insulator (left). Multiple flashes on insulator string (right).

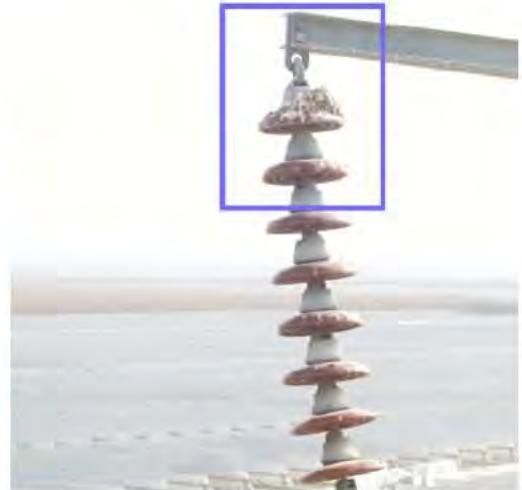
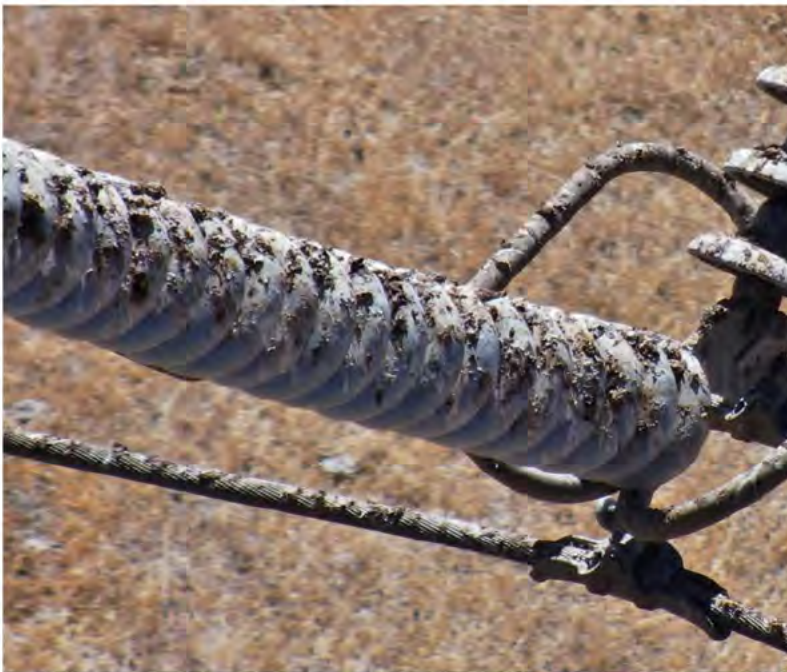
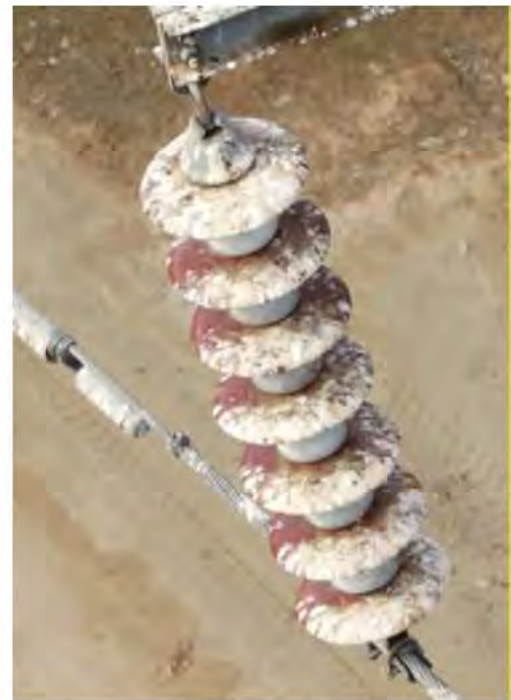
Condition: 2
Priority: F

FDA: Insulator |Contaminated|Ground /Helicopter Wash

Condition: 4
Priority: E+

Figure 107 Examples of a variety of insulator contamination. **Ground wash applies to most wood poles or shorter structures that are accessible by truck. Helicopter wash applies to towers and not easily accessed structures.**

Note: On 500kV only: If a tag is created for contamination of insulators, and no bird guards are present, create a tag for their installation (FDA: Raptor Guard-Steel|Missing|Install) – E priority.

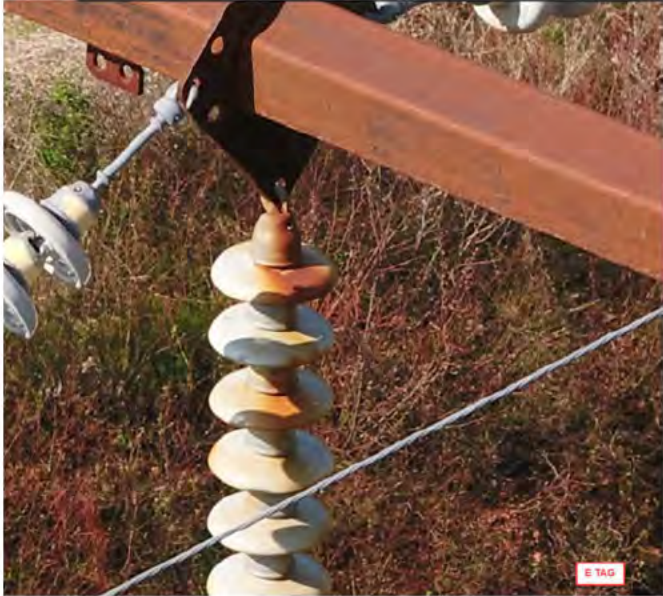
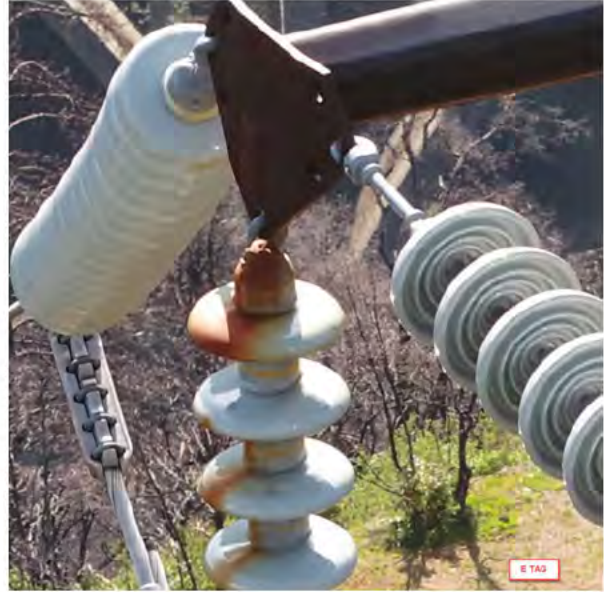
Figure 108

Condition: 3
Priority: E

FDA: **Insulator-Steel(or Wood) | No Good/Out of Stdrd | Replace**
Insulators with staining from corrosion of crossarm. These should be called out for insulator replacement on an E tag. Repair action to be determined by CIRT.

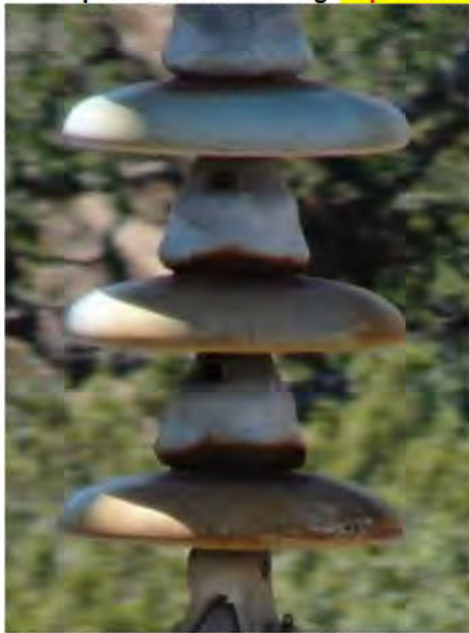
Figure 109

Condition: 3
Priority: E

FDA: Insulator-Wood/Steel | No Good/Out of Stdrd | Replace

FDA: Insulator-Steel | No Good/Out of Stdrd | Replace

Corona damage (left). Corona damage on bells (right). Create an E tag if three or more bells are damaged, but if there is considerable damage or material loss, a tag could be created on an insulator with less than three damaged bells.

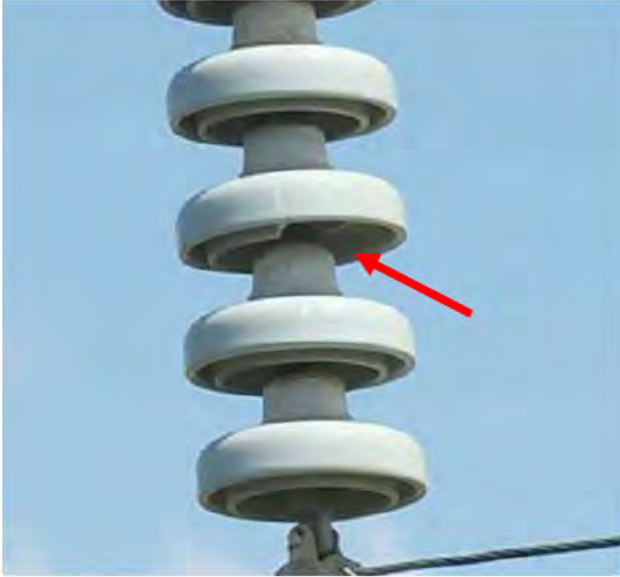
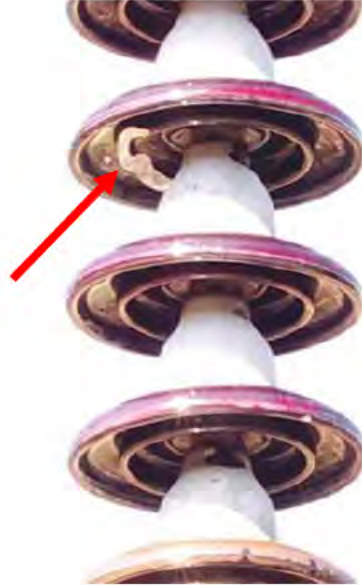
Priority: 3
Priority: E

FDA: Insulator-Wood/Steel|No Good/**Out of Stdrd**|Replace

Figure 110 Insulators with chipped bells larger the **1-1/2 inches** in diameter.

- A crack extends from the chip.
 - The chip is larger than 1-1/2 inches in diameter.
 - The chip is located next to a grouted fitting where it could trap water and freeze.

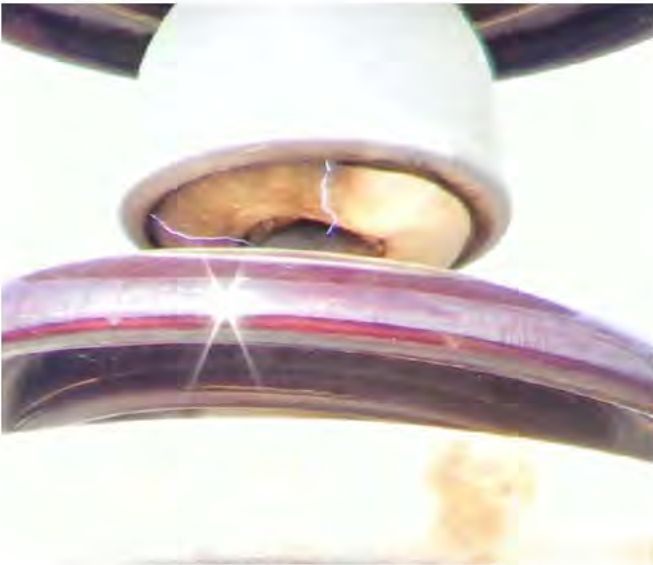
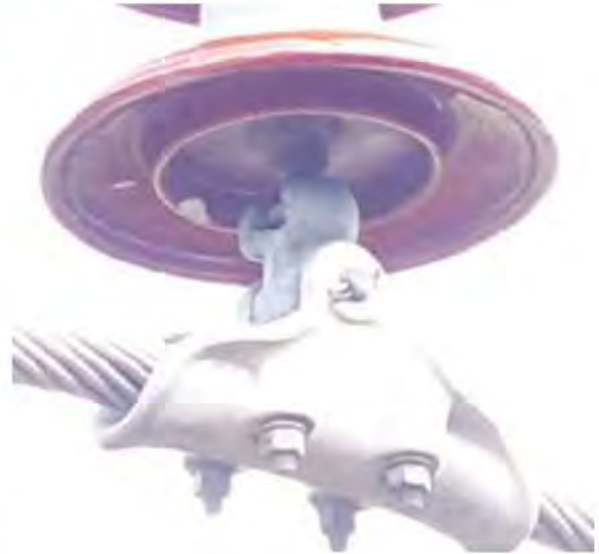
Condition: 5
Priority: A

FDA: Emergency-Wood/Steel|Other|Replace

Condition: **1**
Priority: No notification required

Figure 111 **Separated cap with arcing (left). Insulator with chip less than 1-1/2 inches in diameter (right).**

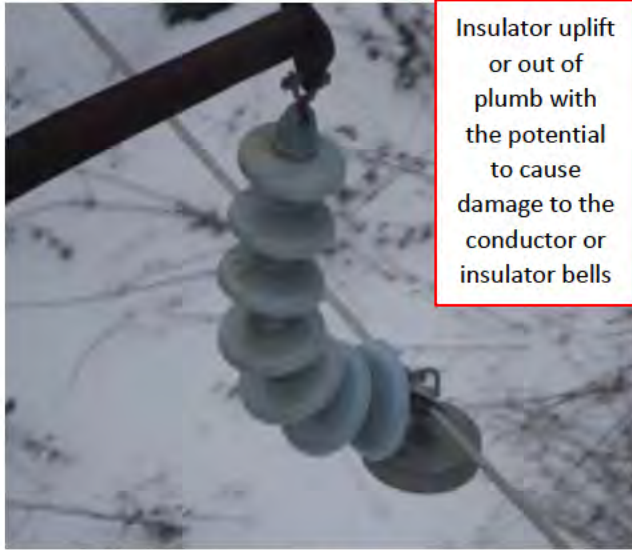
Figure 112 Out of plumb insulators. *Insulators extremely out of plumb require replacement, rather than repair.*

Insulator uplift or out of plumb with the potential to cause damage to the conductor or insulator bells

Condition: 4
Priority: E+

FDA: Insulator-Steel | No Good / **Out of Stdrd** | Replace

For insulators extremely out of plumb, "Replace" is used. For less extreme insulators, "repair" would be appropriate

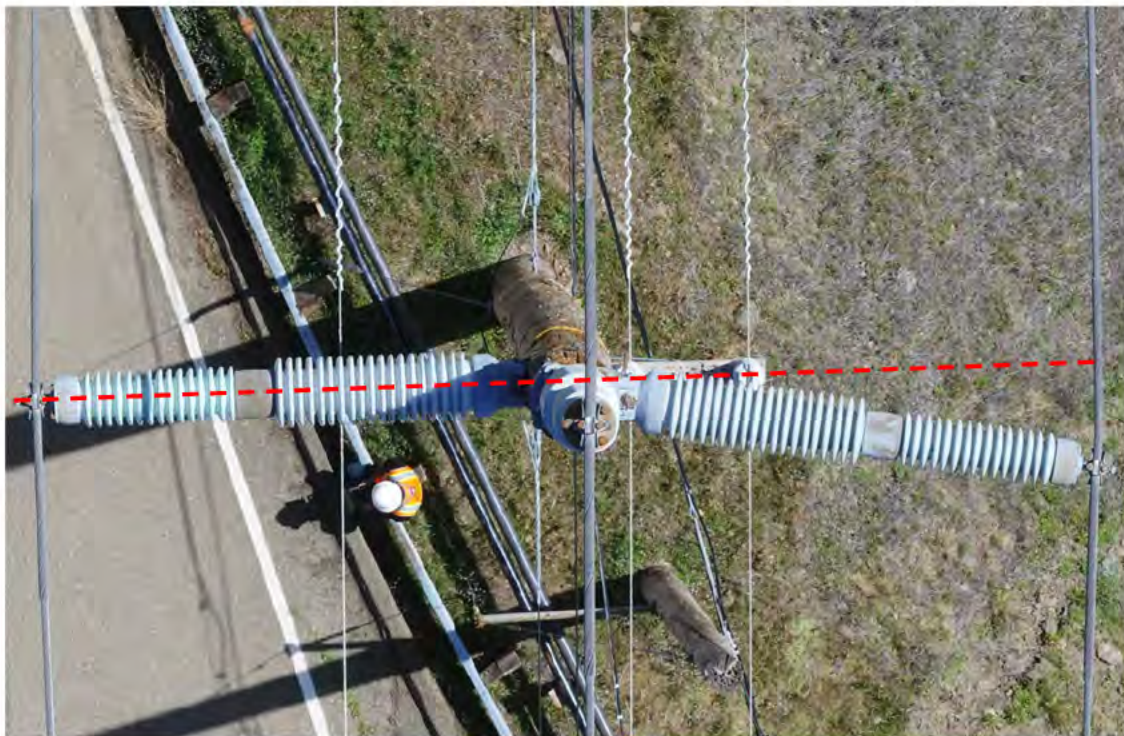
Figure 113 **Out of plumb post insulator >6" not impacting conductor. If the conductor is being impacted, assign E priority.**

Condition: 2
Priority: F

FDA: Insulator-Steel | No Good / **Out of Stdrd** | Repair

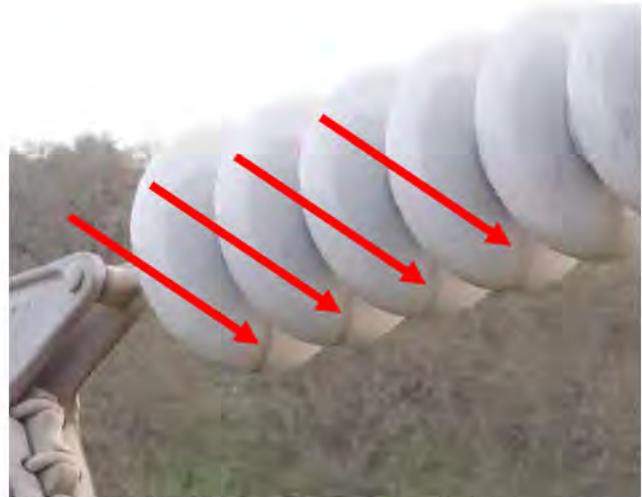
Condition: 3
Priority: E

FDA: Insulator-Wood/Steel|No Good/**Out of Std**|Replace

Condition: **1**
Priority: No notification required

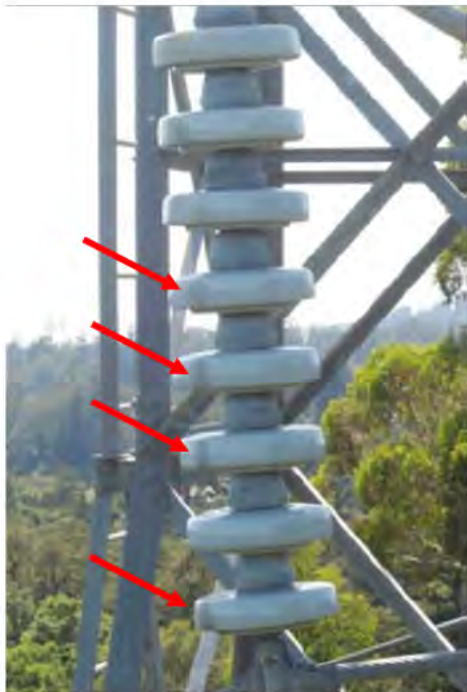
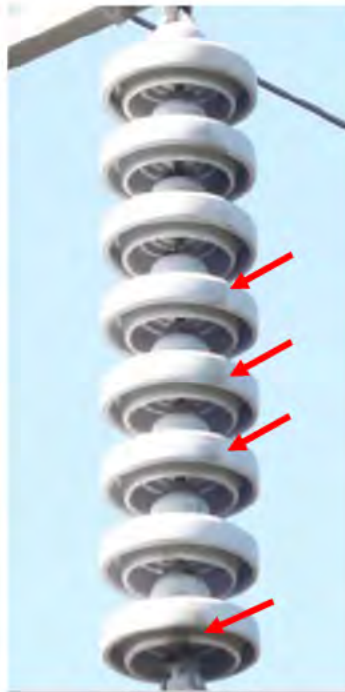
Figure 115

Condition: 3
Priority: E

FDA: Insulator-Wood/Steel|No Good/**Out of Std**|Replace

When tracking is found, use Table 4 in determining the priority of replacing the insulators based on G.O.95. If tracking extends from the cap to the porcelain bell a wash would be need and priority based on G.O.95. If tracking is only on the cap, no wash is required.

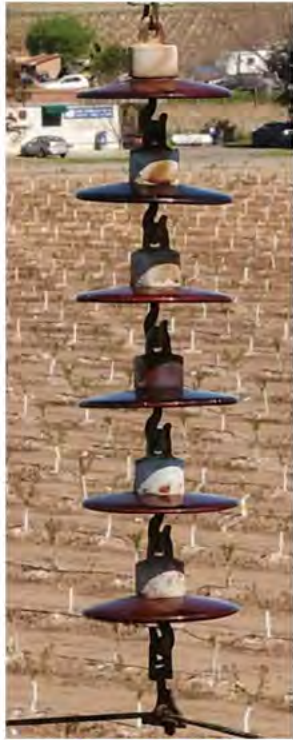
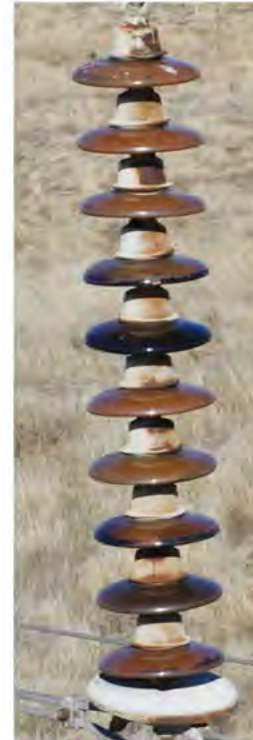
Figure 116 30% rust on caps and insulators are over 50 years old per ETGIS installed date (left). Additional damage could warrant higher priority. Light rust developing with some caps showing signs of dark rust close to 30% of cap (right).

Condition: 3
Priority: E

FDA: Insulator-Wood/Steel|No Good/Out of Std|Replace

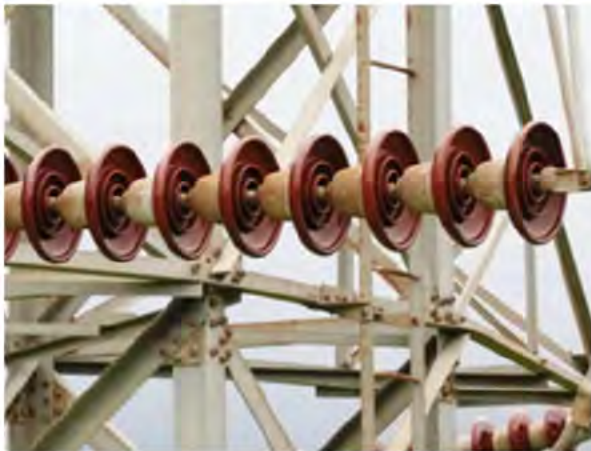
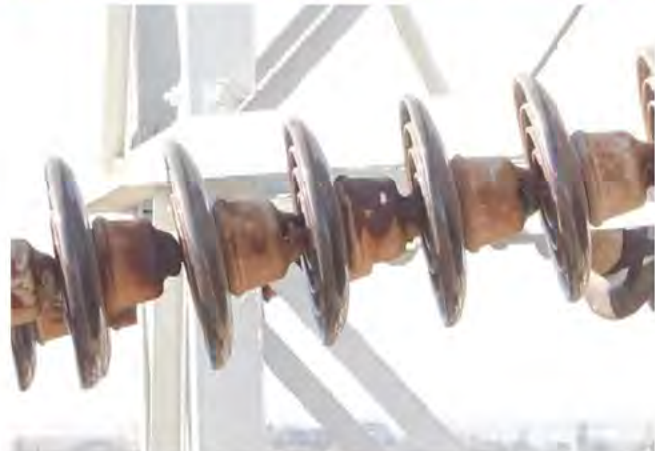
Figure 117 Mild surface rust on insulator caps (left). Dark rust on multiple bells (right).

Condition: 1
Priority: No notification required

Condition: 3
Priority: E

FDA: Insulator-Wood/Steel|No Good/Out of Std|Replace

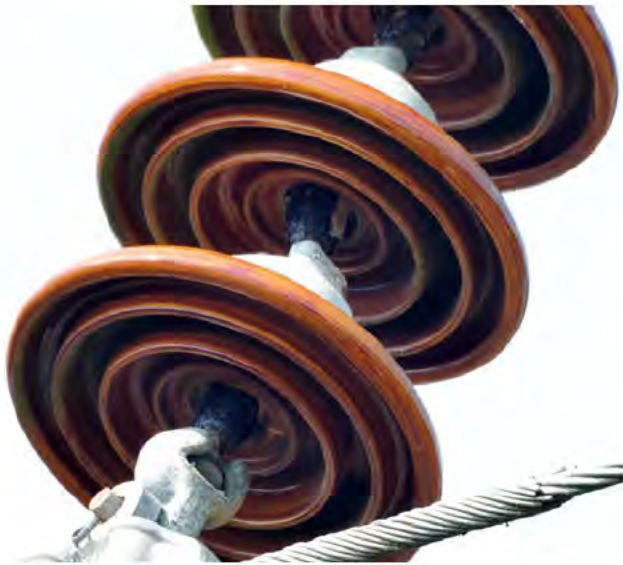
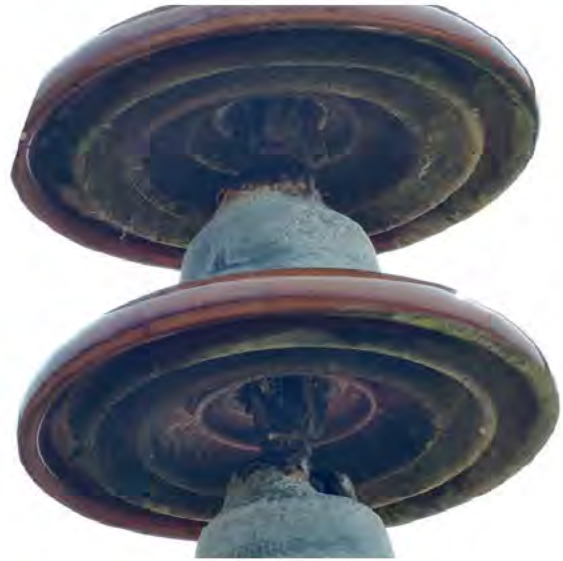
Figure 118 Example of rusted insulator pins (left) that also has a loose cotter key. Example of emergency level rusted insulator pins (right).

Condition: 4
Priority: E+

FDA (1): Insulator-Wood/Steel|No Good/Out of Stdrd|Repair

FDA (2): Insulator-Wood/Steel|No Good/Out of Stdrd|Replace

Condition: 5
Priority: A

FDA: Emergency-Wood/Steel|Other|Replace

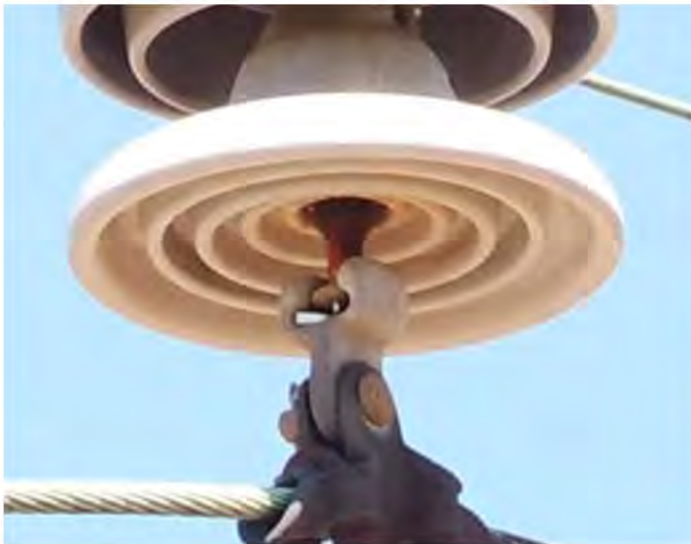
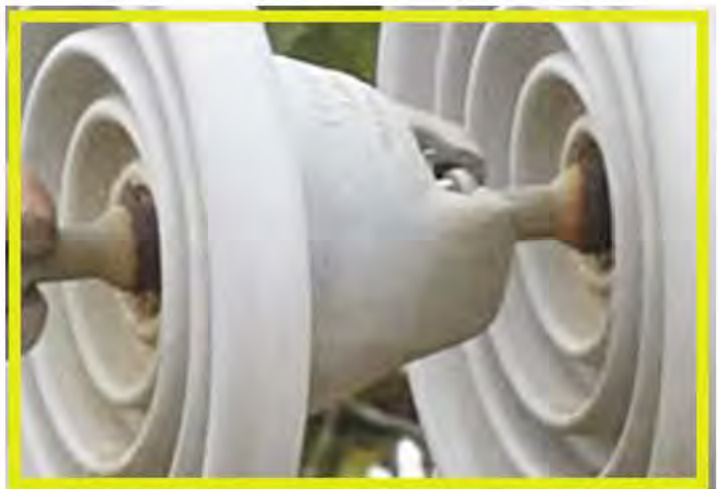
Figure 119 Examples of rusted insulator pins.

Condition: 4
Priority: E+

FDA: Insulator-Wood/Steel|No Good/Out of Stdrd|Replace

Condition: 3
Priority: E

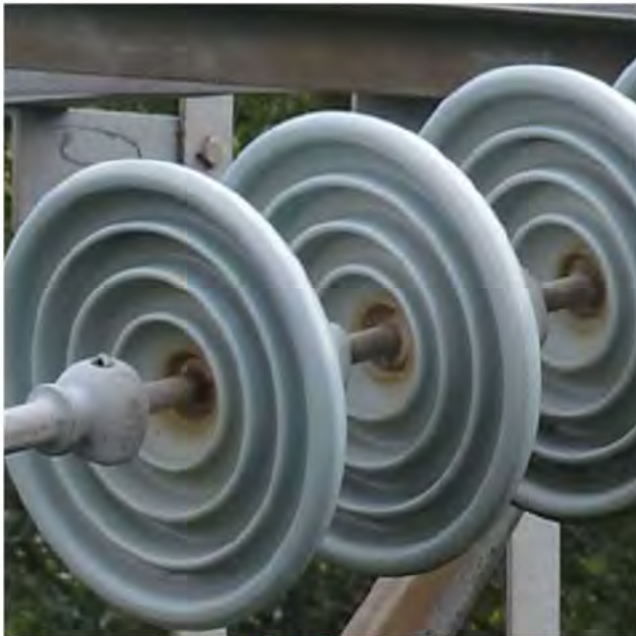
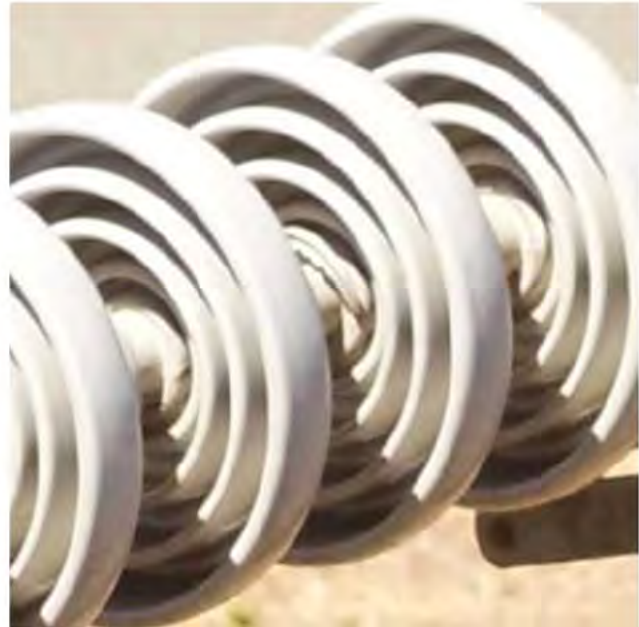
Condition: 3
Priority: E

FDA: Insulator-Wood/Steel|No Good/Out of Std|Replace

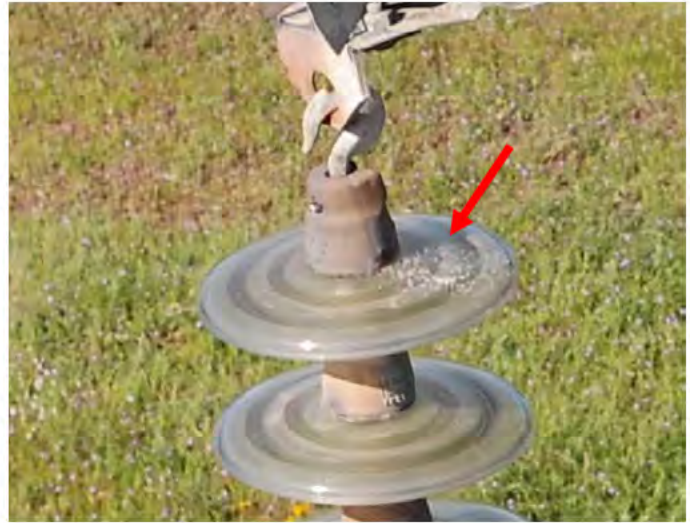
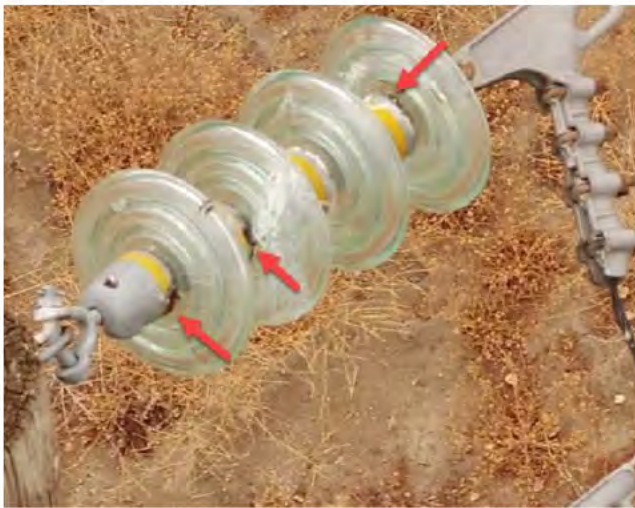
Condition: 3-5

Priority: E-A

FDA: Insulator-Steel | No Good/ **Out of Stdrd** | Replace

Examples of glass insulators that have experienced damage to the glass (in the form of bubbling) and/or major damage to the caps. These insulators should be replaced on a priority based on the number of damaged bells.

Note on glass insulators: If calling for a wash on glass insulators, base priority and condition on the number of bells flashed/remaining.

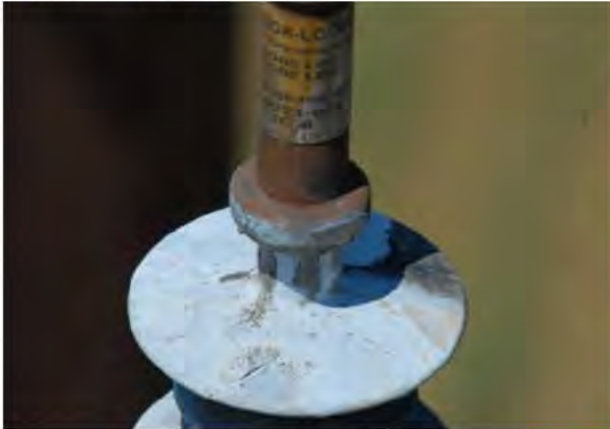
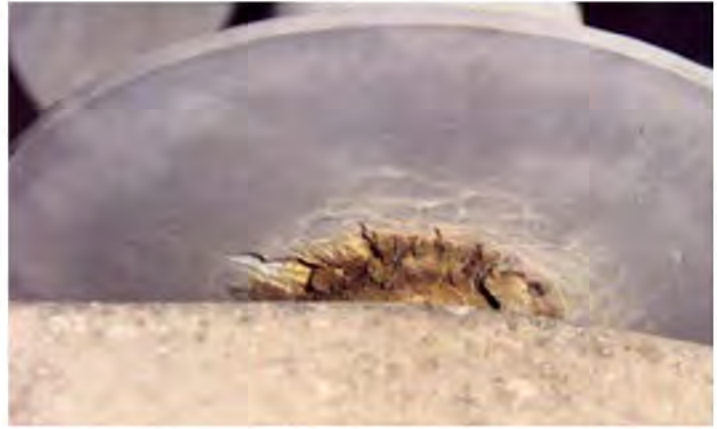
Condition: 4
Priority: E+

FDA: Insulator-Wood|No Good/**Out of Stdrd**|Replace
Figure 124 Insulator chalking (left), corona damage to insulator (right).

FDA: Insulator-Wood|No Good/**Out of Stdrd**|Replace

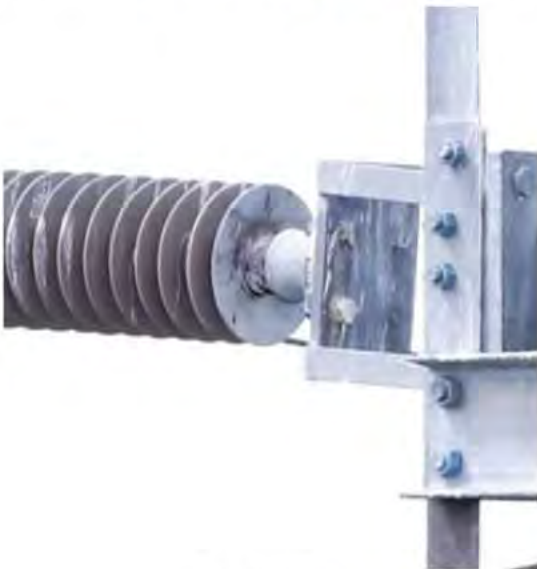
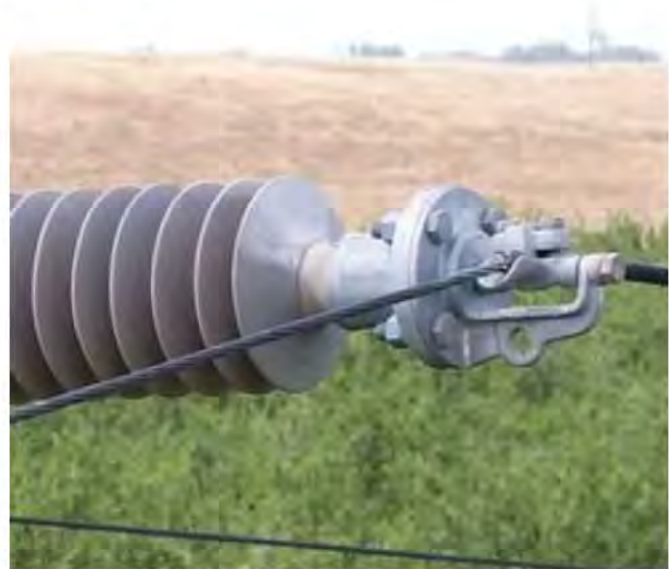
Condition: 3
Priority: E

FDA: Insulator-Steel|No Good/**Out of Stdrd**|Replace
Figure 125 Examples of damage to polymer insulators. Chalking/flashing (left), and flashing (right).

FDA: Insulator-Wood|No Good/**Out of Stdrd**|Replace

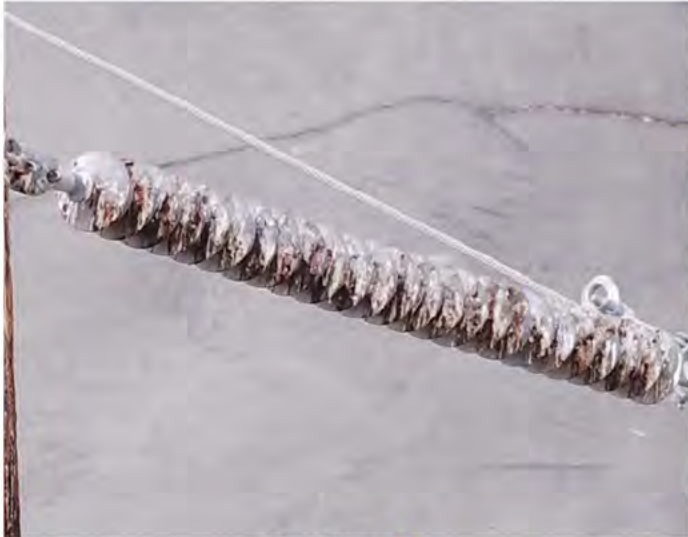
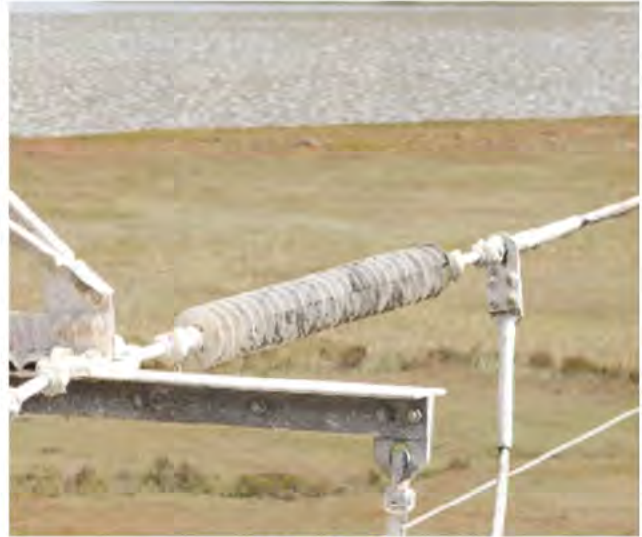
Figure 126

Condition: 4
Priority: E+

FDA: Insulator-Wood/Steel|No Good/Out of Stdrd|Replace

Example of polymer insulator heavily contaminated (left). Heavy contamination (right). Polymer insulators do not get washed, only replaced.

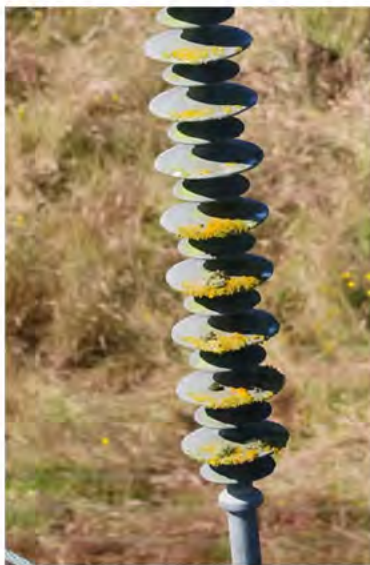
Figure 127

Condition: 2
Priority: F

FDA: Insulator-Wood/Steel|No Good/Out of Stdrd|Replace

Condition: 4
Priority: E+
FDA: Insulator-Wood/Steel|No Good/Out of Stdrd|Replace

Moss (medium) contamination (left). Sheds sliding off and revealing core on polymer insulator (right).

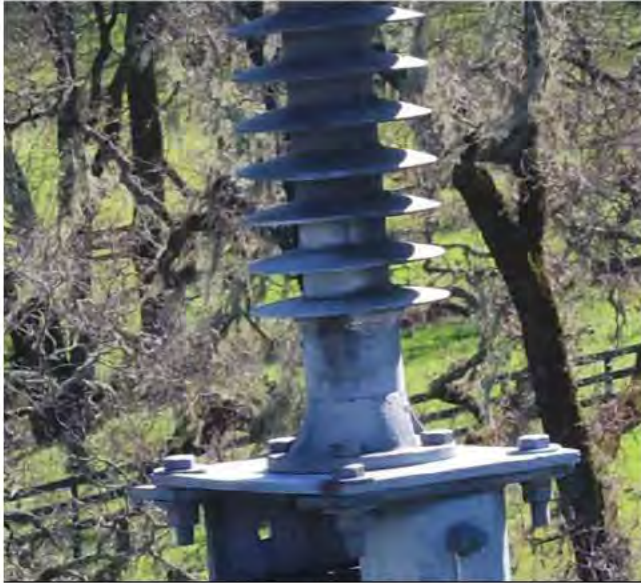
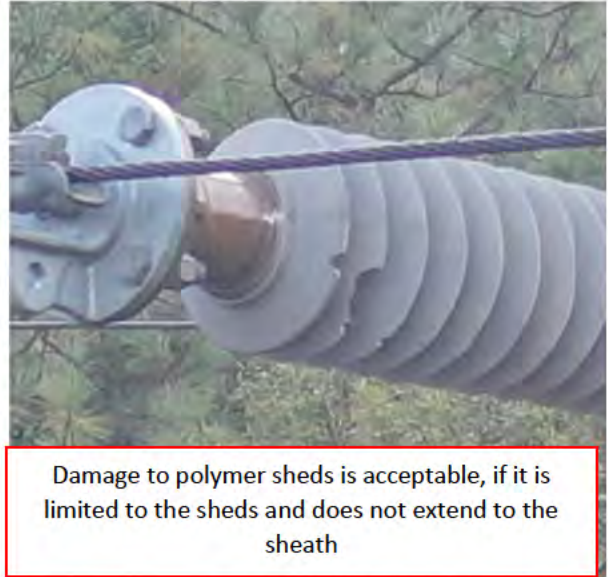
Condition: 4

Priority: E+

FDA: Insulator-Steel|No Good/**Out of Std**|Replace

Damage to polymer sheds is acceptable, if it is limited to the sheds and does not extend to the sheath

Condition: 1

Priority: No notification required

Figure 128 Flashed polymer insulator (left). Minor damage to polymer sheds (right).

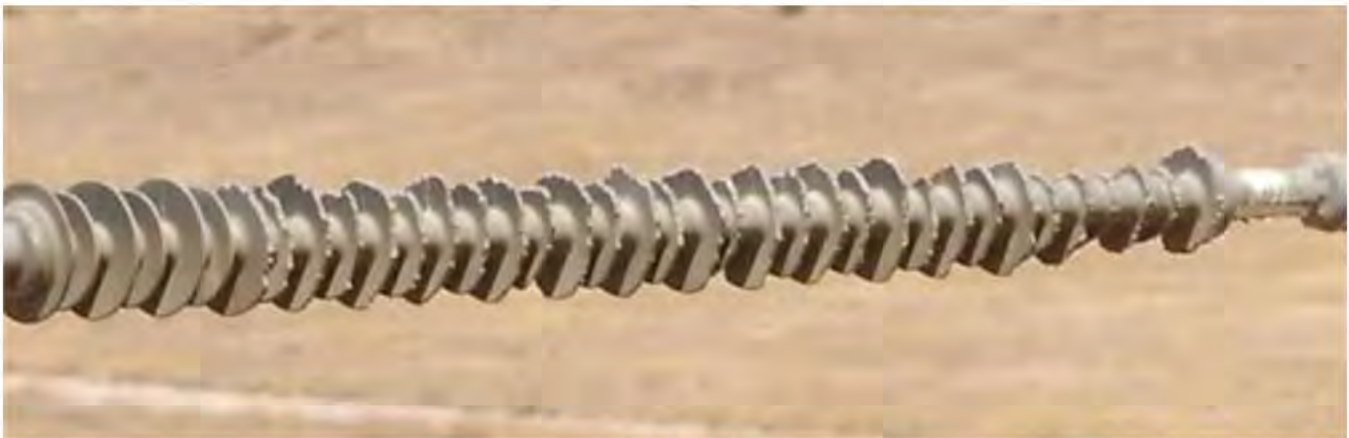
Condition: 3

Priority: E

FDA: Insulator-Steel/Wood|No Good/**Out of Std**|Replace

Figure 129 Severe shed damage on polymer insulators. Under normal circumstances, damage to the sheds of a polymer insulator without damage to the sheath would not require a notification. However, the damage at the far right end is extensive and very close to the sheath. This is a borderline case but an E priority notification would be warranted.

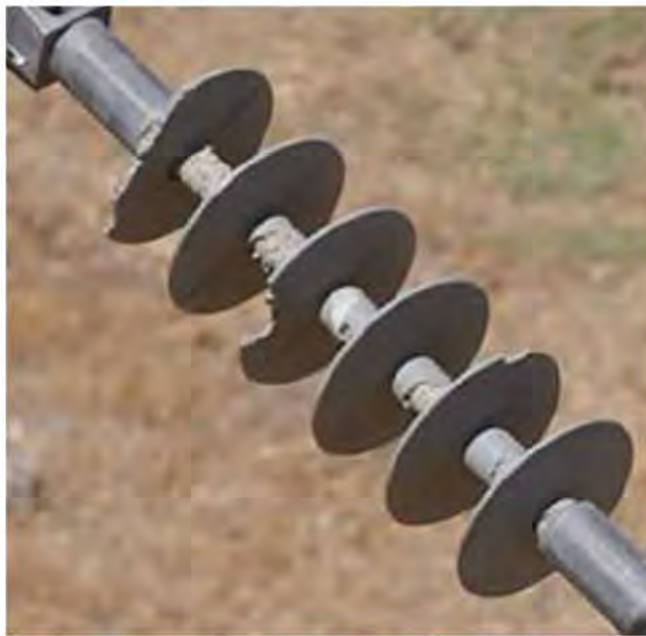
Condition: 5
Priority: A

FDA: **Emergency-Steel/Wood|Other|Replace**

Condition: 4
Priority: **E+**

FDA: Insulator-Steel/Wood|No Good/**Out of Stdrd**|Replace

Figure 130 Insulator damage that could result in an A tag (left). The protective sheath has been broken, which would lead to degradation of the core. **Damage to insulator sheath, not to the core (right).**

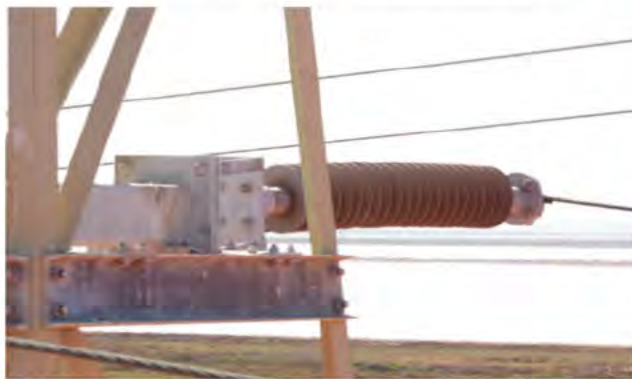
Condition: 3
Priority: E

FDA: Insulator-Steel/Wood|No Good/**Out of Stdrd**|Replace

Figure 131 Bowing polymer post insulators. These should be replaced.

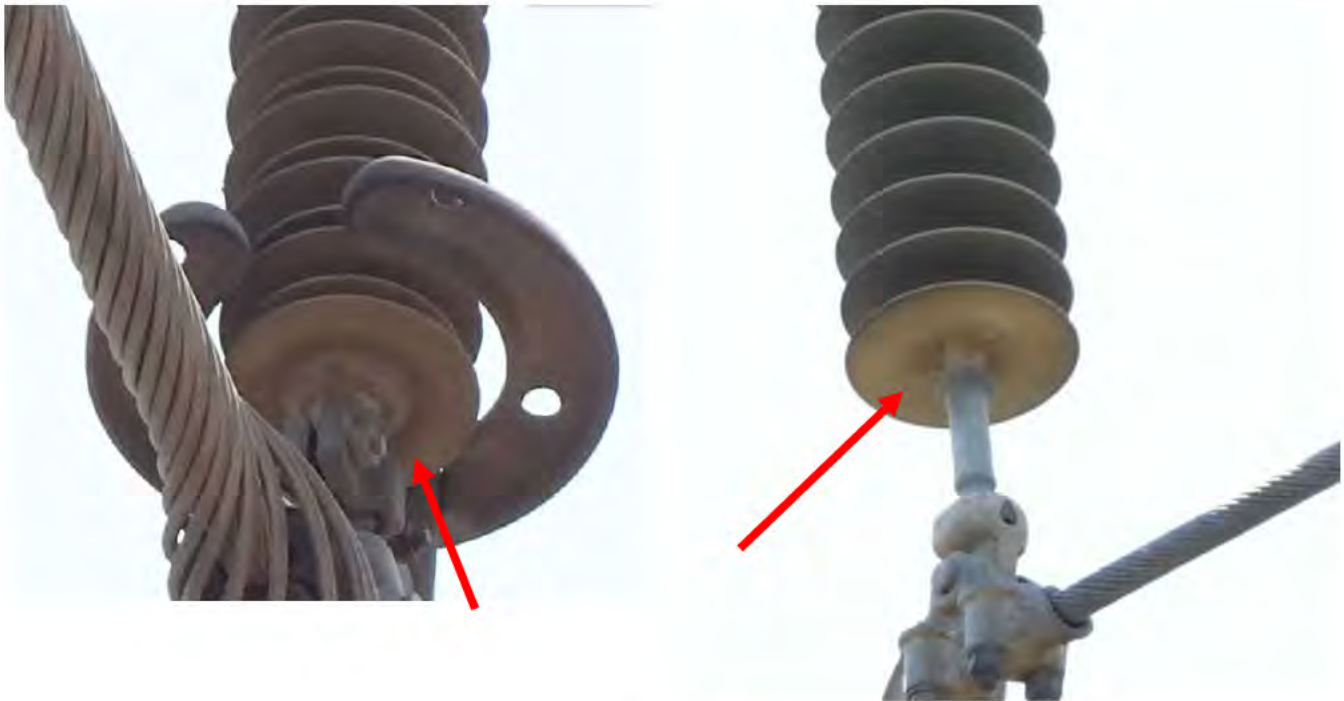
Figure 132

Condition: 3
Priority: E

FDA: Insulator-Wood/Steel|No Good/**Out of Stdrd**|Replace

Examples of corona damage on polymer insulators. The pictured insulators should be replaced with an E tag. **All suspension type polymer insulators from 115kv to 230kv require grading rings.**
