AERIAL INSPECTION REVIEW+ TEAM

AIR+ TEAM HANDBOOK

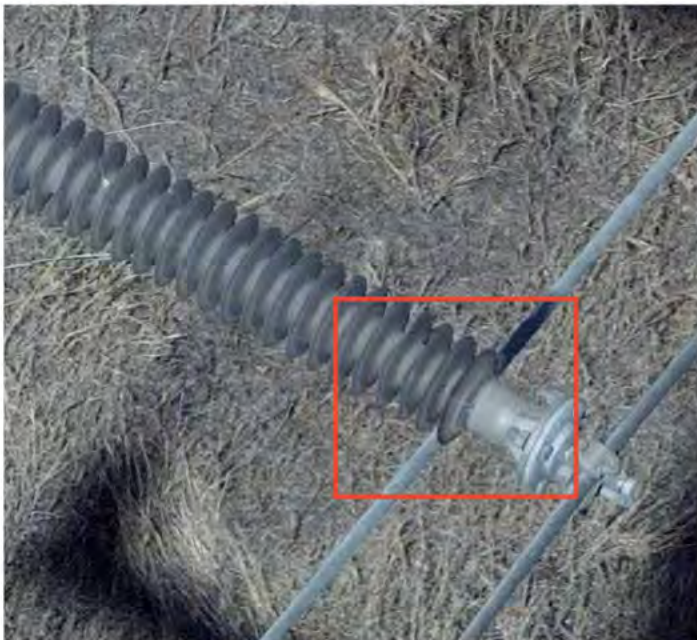
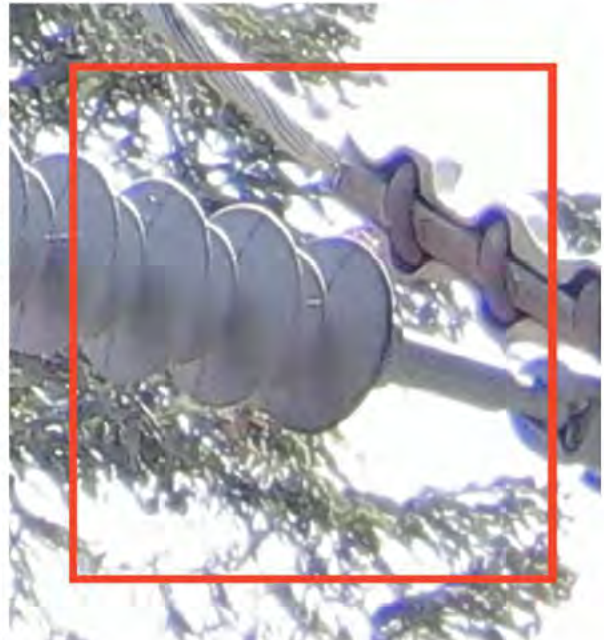
Figure 133

Condition: 3
Priority: E

Examples of corona damage to polymer insulators.

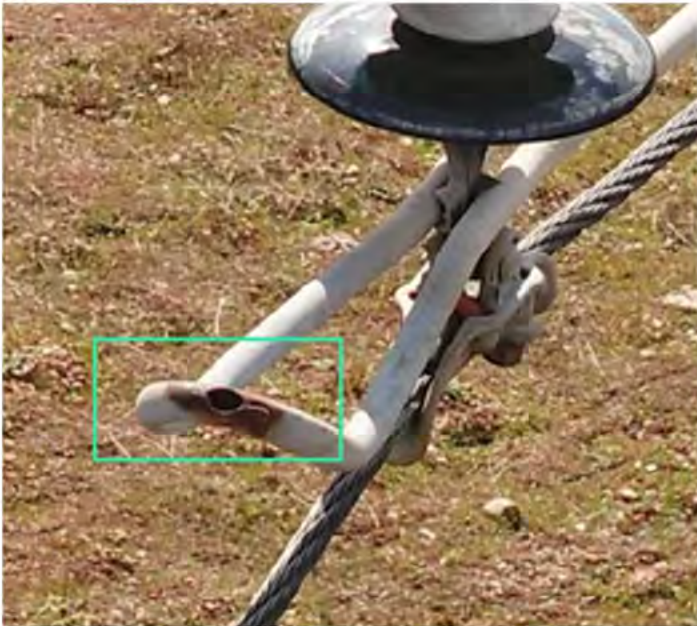
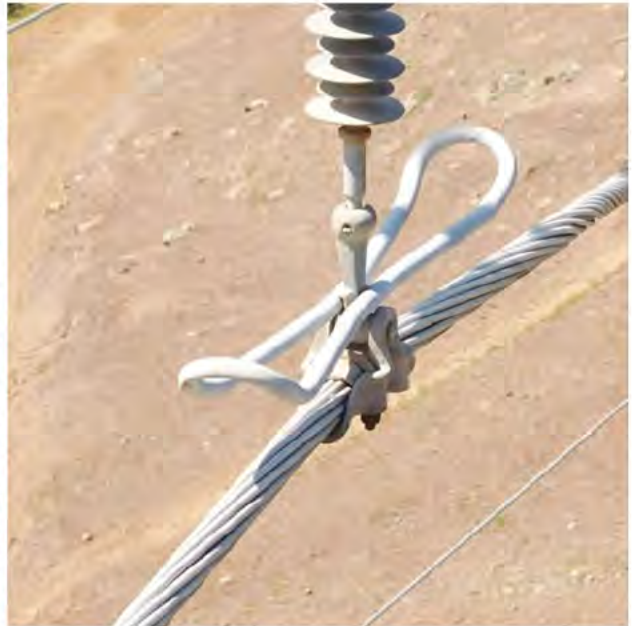
Figure 134

Condition: 3
Priority: E

Damaged corona ring (left). Snowshoe style corona ring with a polymer insulator (right) needs a notification to install the correct style grading ring.

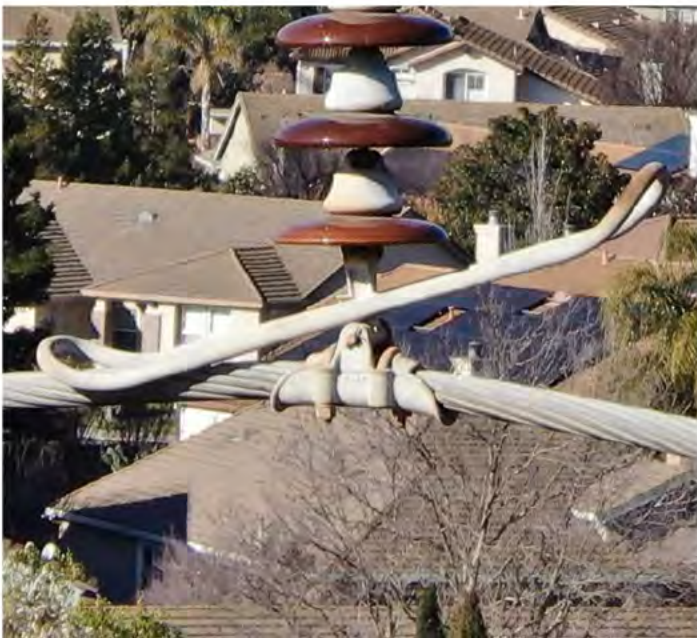
Figure 135

Condition: 3/2
Priority: E/F

A notification is required when the corona ring breaks the top horizontal plane of the conductor or is in contact with the conductor (left). If damage is present, E priority, if no damage present assign F priority.

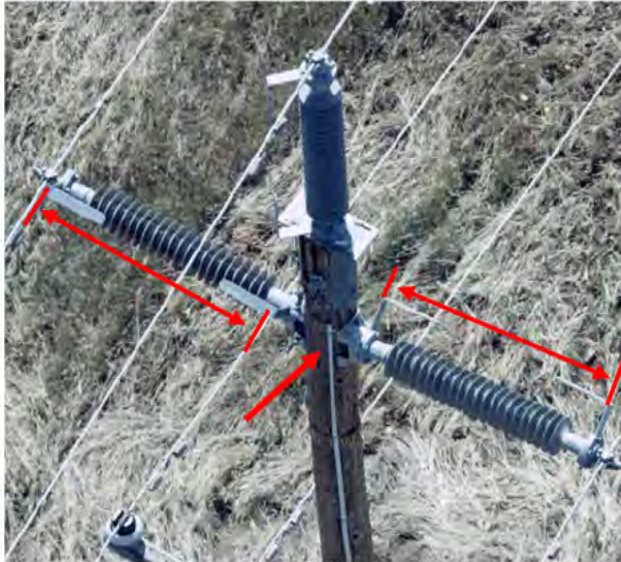
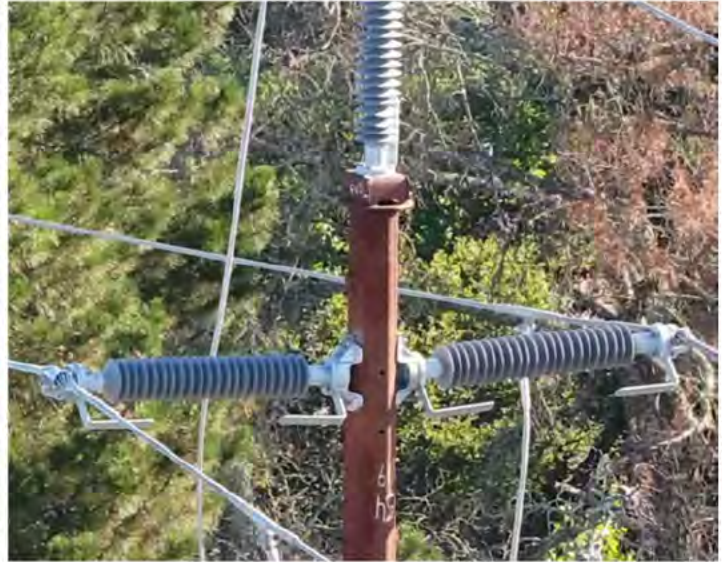
Condition: 3

FDA: Ground wire-Wood/Steel|No Good/**Out of**
Std|Repair

Spill gaps should be installed underneath horizontal insulators to prevent bird contact. IF there is damage to the spill gap, create a notification to repair it (FDA: Insulator-Wood/Steel|No Good/Out of Std|Repair, Priority: E). IF ground wire is not installed or within standards on wood or composite poles, a notification is needed (left). Spill gaps with no grounding issues or damage (right).

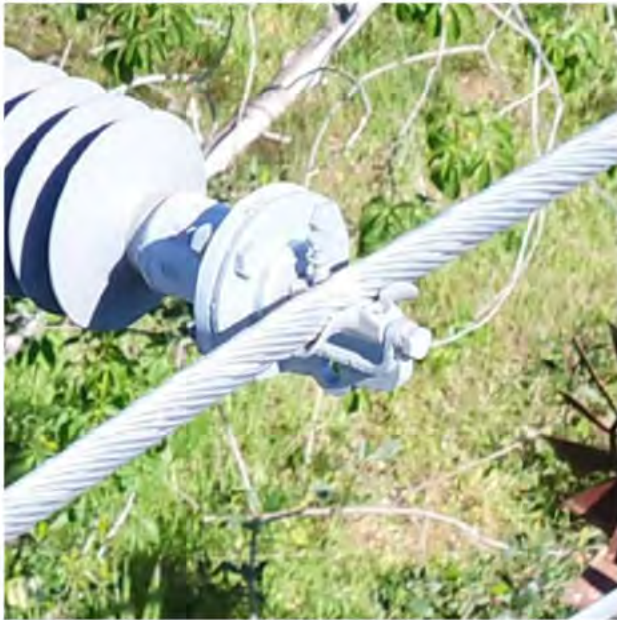
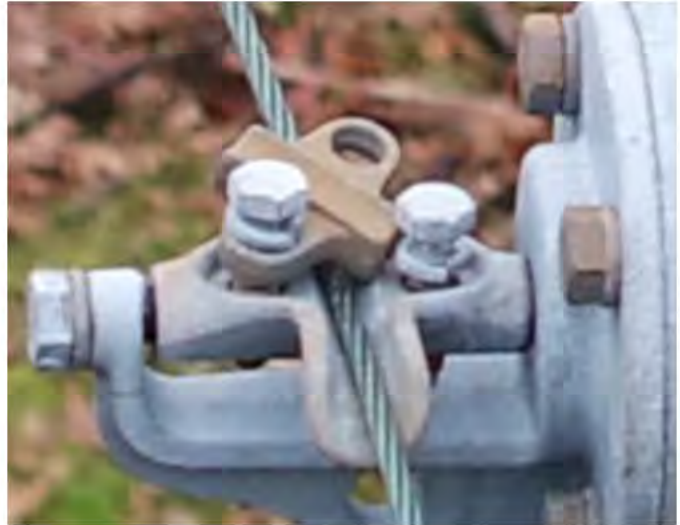
Condition: 5
Priority: A

Condition: 4
Priority: E+

Figure 137 Missing clamp (left). Incorrectly installed trunnion clamp, if elevation has uplift at the location of the clamp consider a possible A priority (right).

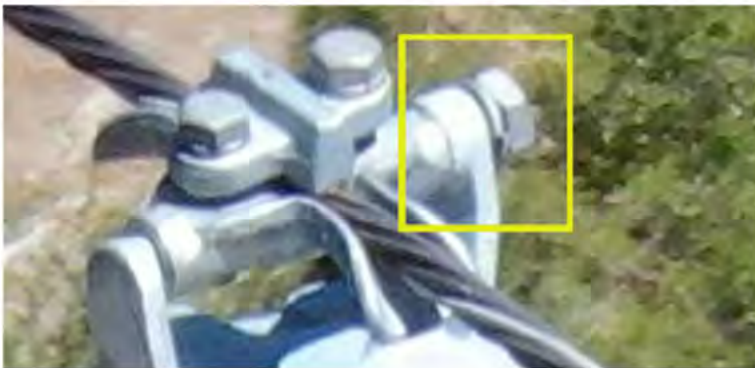
Condition: 2
Priority: F

Figure 138 Examples of loose retainer bolt on trunnion clamp.

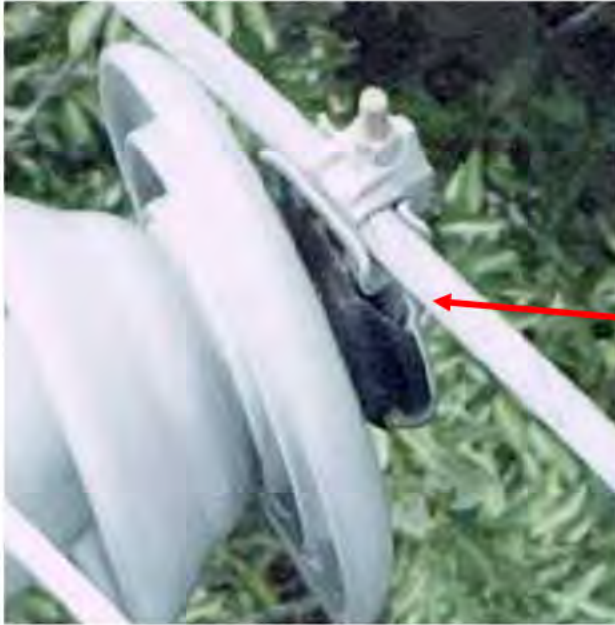
Condition: 5
Priority: A

Figure 139 Broken pin insulator biscuit at connection hardware.

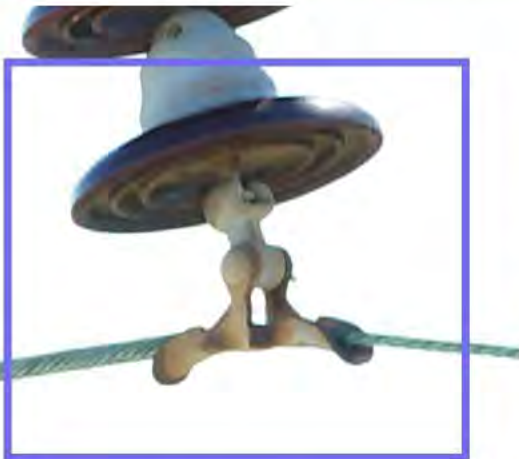
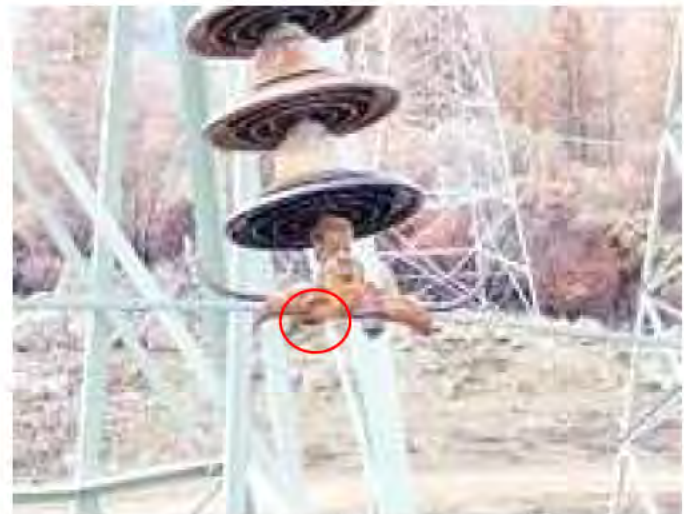
Condition: 3
Priority: E

Figure 140 Missing bolts on suspension shoe (left). Missing bolt on suspension shoe (right).

Deadend framing type with similar damage to bolts/nuts is treated with more caution due to the threat of conductor slipping in the hot-end hardware, which could affect conductor clearance. Suspension framing type doesn't have the same failure modes in this case. Please refer to other examples for deadend framing type damage.

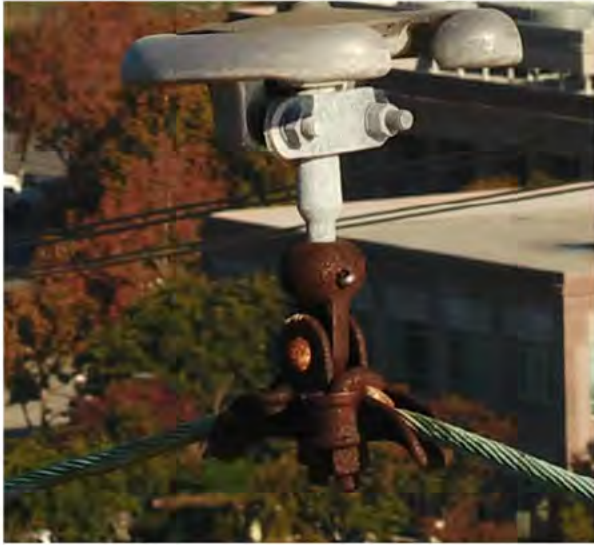
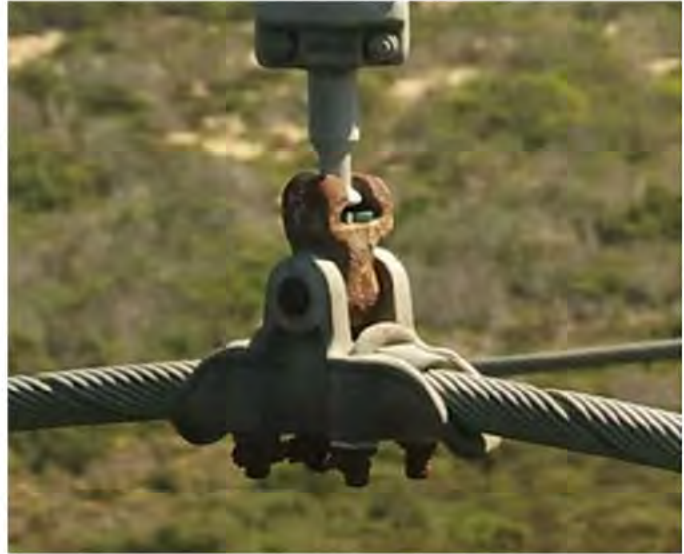
Figure 141

Condition: 1
Priority: No notification required

Condition: 3
Priority: E
FDA: Insulator-Wood/Steel|No Good/**Out of Stdrd**|Repair

Hardware surface rust (left): material loss is not significant enough to warrant an E priority notification. Corroded nuts on suspension shoe (right).

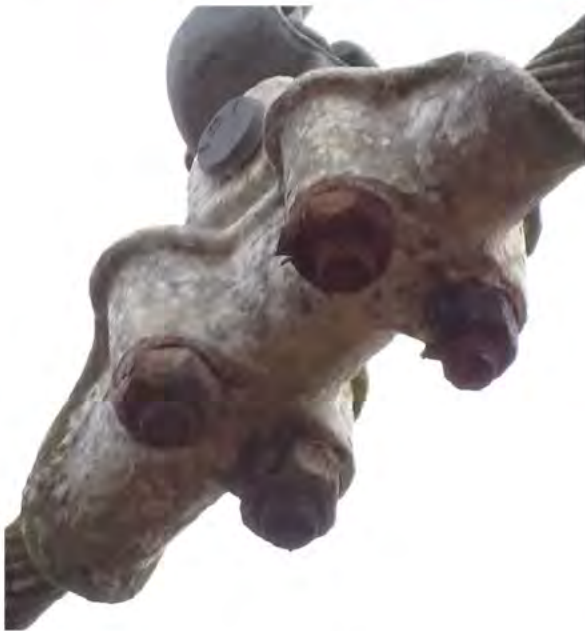
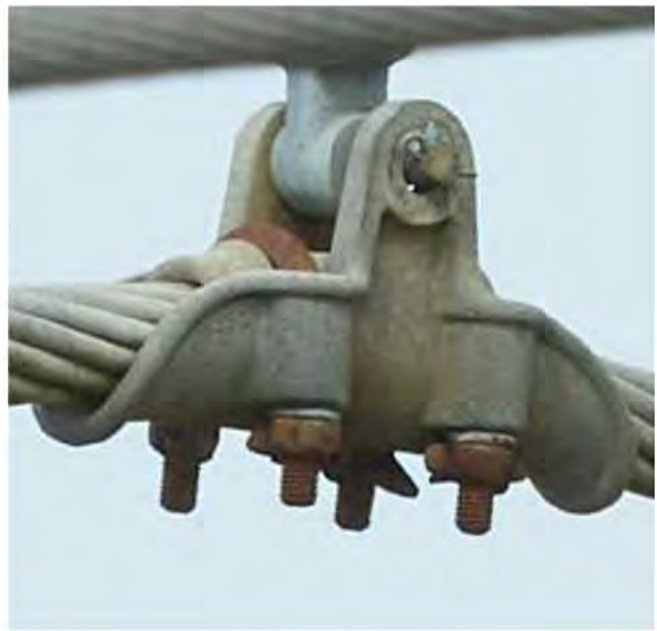
Condition: 3
Priority: E

FDA: Insulator-Wood/Steel|No Good/**Out of Stdrd**|Repair
Figure 142 Corroded shoe hardware

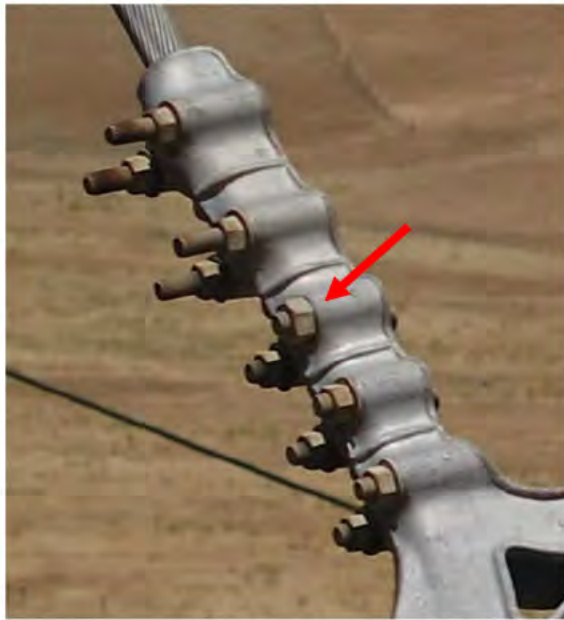
Figure 143

Condition: 3/2
Priority: E/F

Missing a washer on shoe E tag (left). Loose hardware F tag (right).

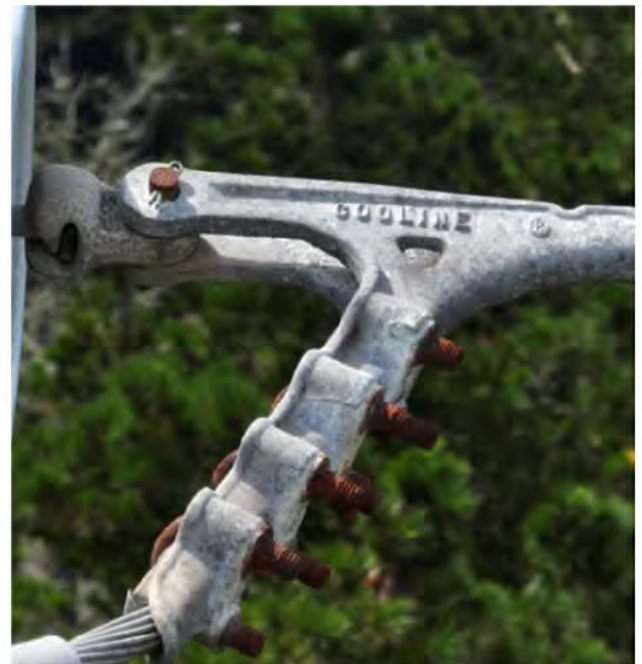
Condition: 4
Priority: **E+**

Damaged nuts 30-50% (left). Damaged nuts more than 50% (right).

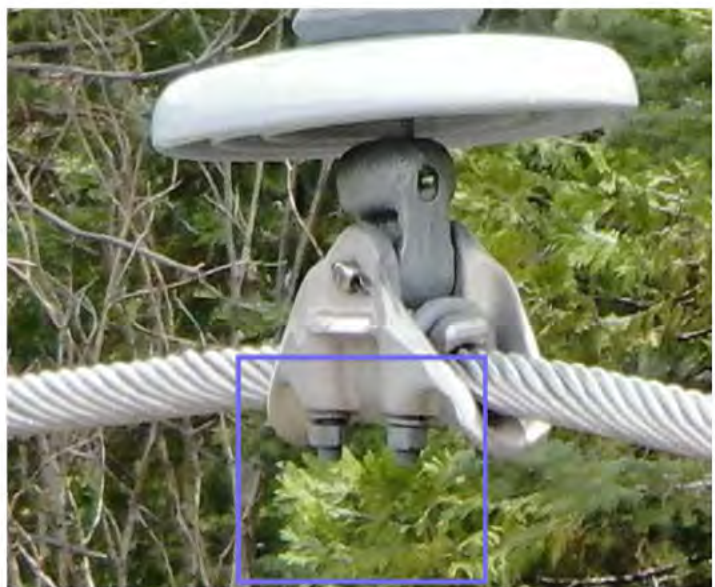
Condition: 2

Figure 146 Examples of suspension shoes with U-Bolts and lock washers are not fully compressed.

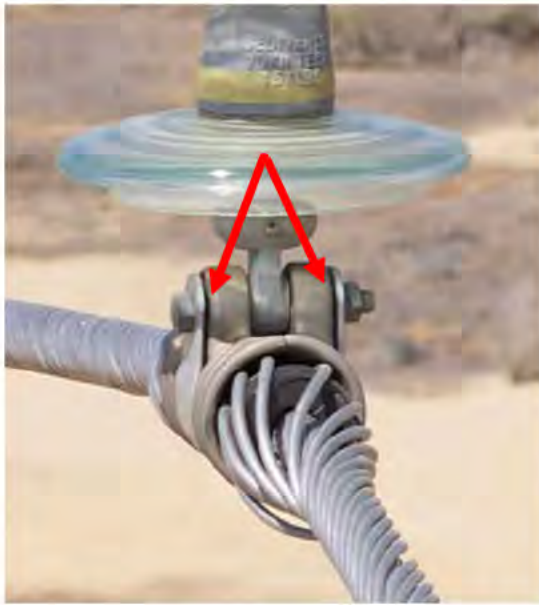
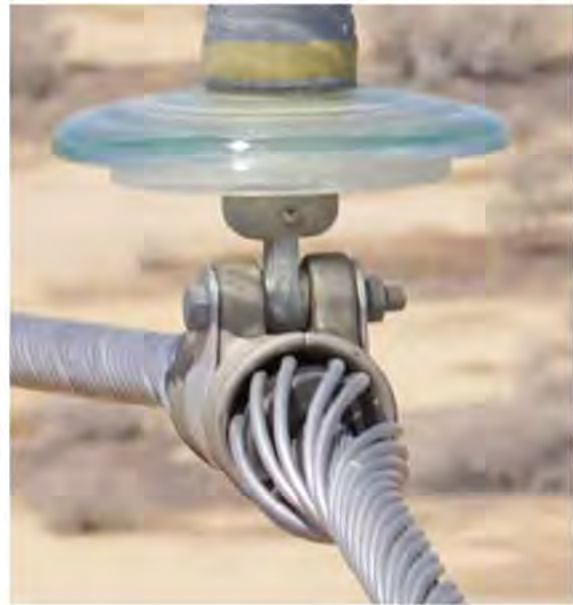
Figure 147

Condition: 2
Priority: F

Condition: 1
Priority: None

Loose hardware on shoe (left). Same style hardware secure (right).

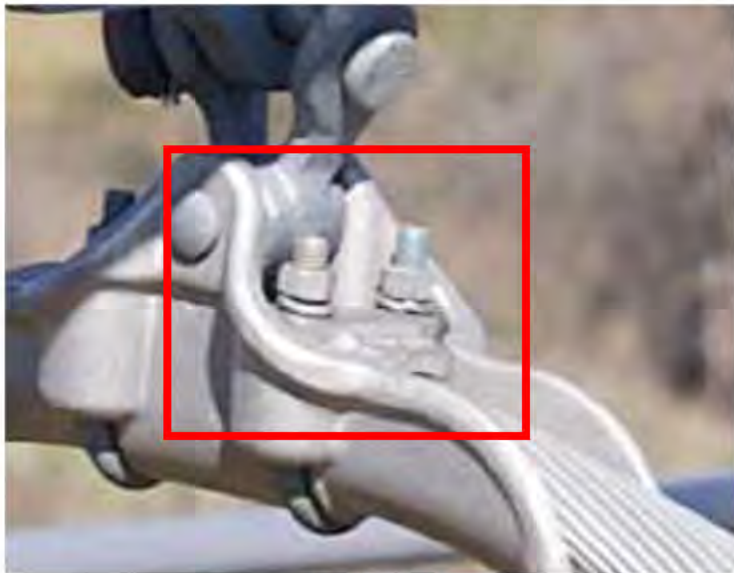
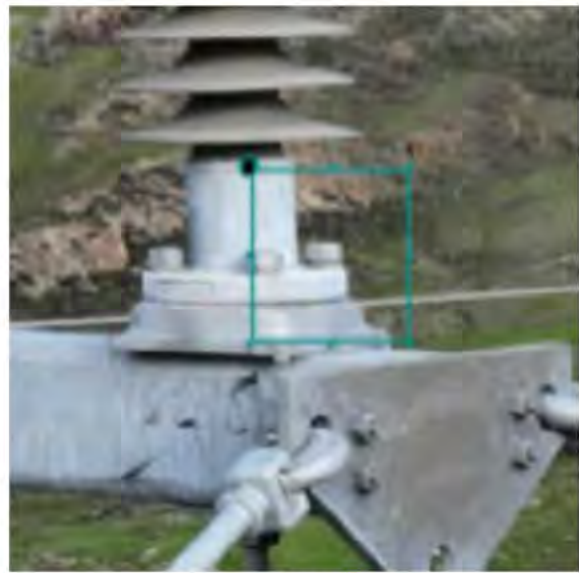
Figure 148

Condition: 2
Priority: F

Loose lock washers on suspension shoe (left). Loose cold end hardware on insulator (right). Notice cold end hardware uses hardware FDA, and hot end hardware uses insulator FDA. Hot end hardware being loose requires a line clearance to perform maintenance, and cold end hardware does not.

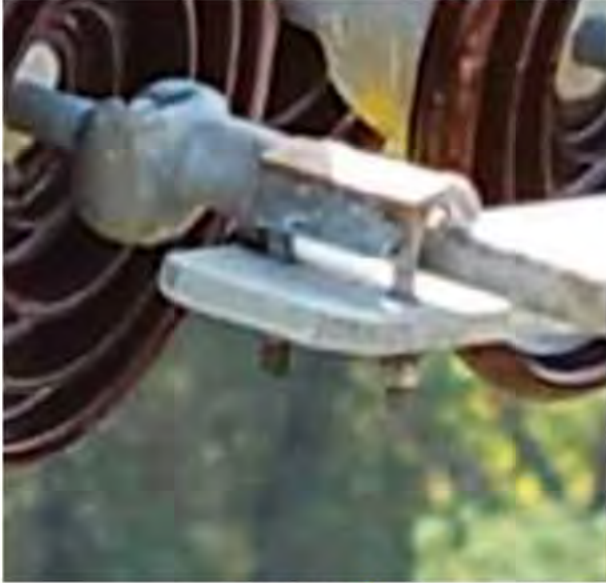
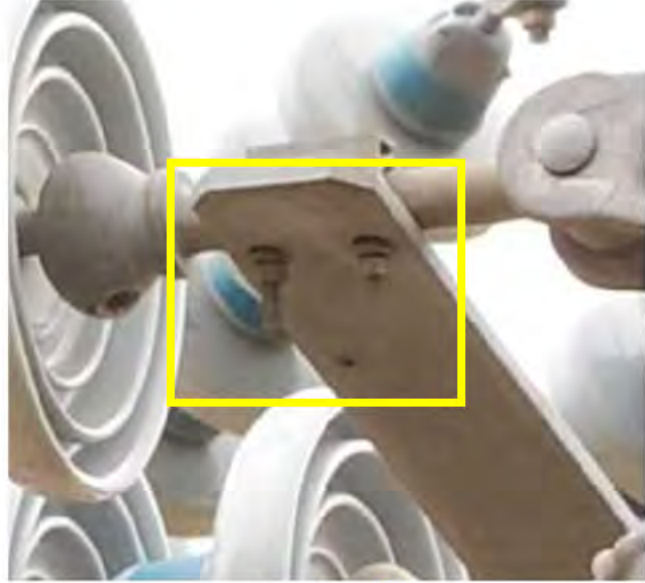
FDA: Insulator-Wood/Steel|No Good/**Out of Stdrd**|Repair
Figure 149 **Loose J-bolts on spacer bar.**

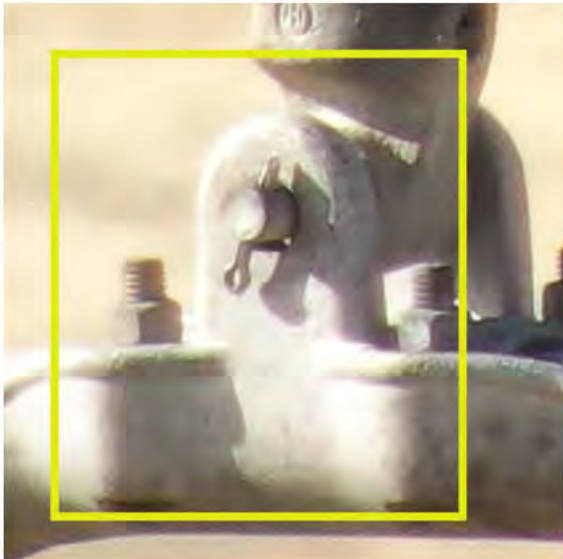
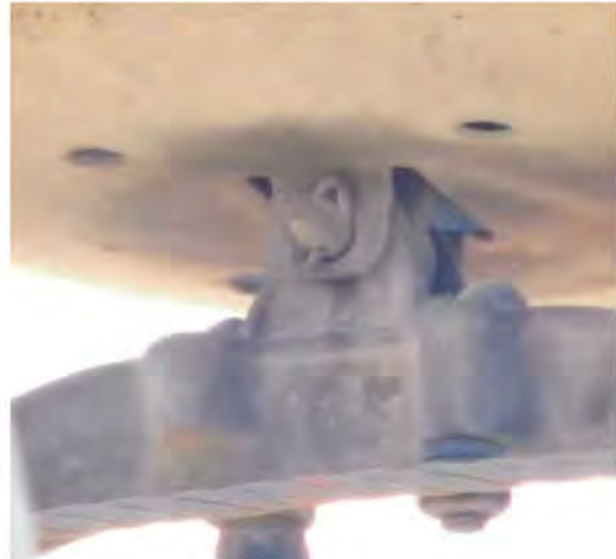
Condition: 4

FDA: Insulator-Wood/Steel|No Good/**Out of Stdrd**|Repair
Figure 150 **A straight type cotter key with no bump and legs not split (left). **Non-standard cotter key (right).****

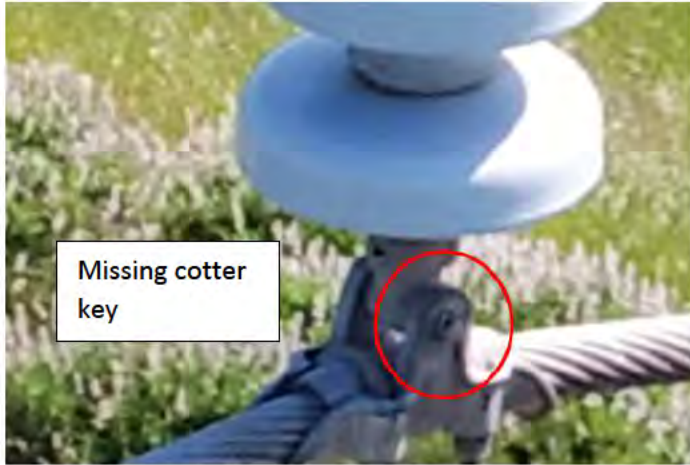
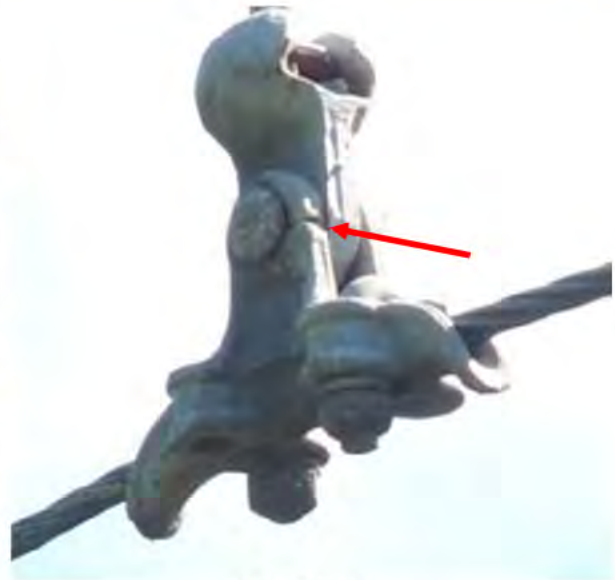
Missing cotter key

Figure 151 Missing cotter key (left). **Cracked shoe (right).**

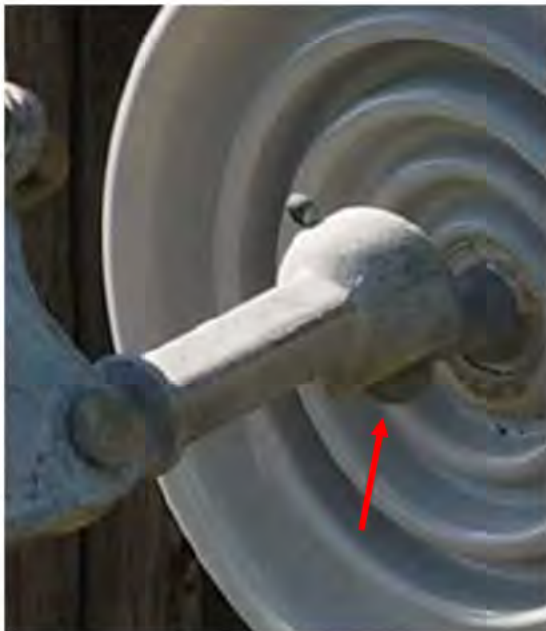
Figure 152 **Example of unseated retainer key and insulator not seated in the socket (left). Unseated retainer key (right).**

Condition: 5
Priority: A

FDA: Emergency|Storm Related|Repair

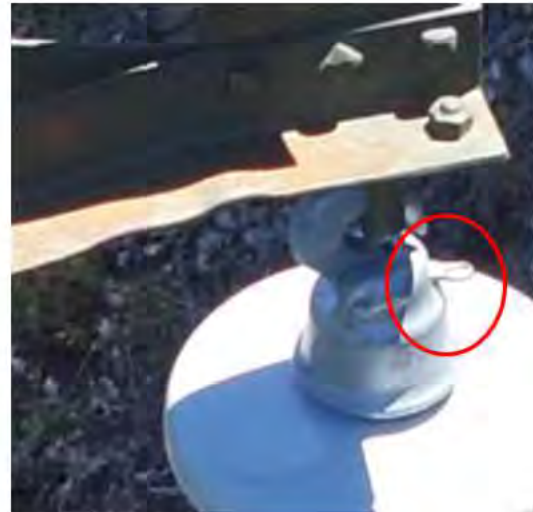
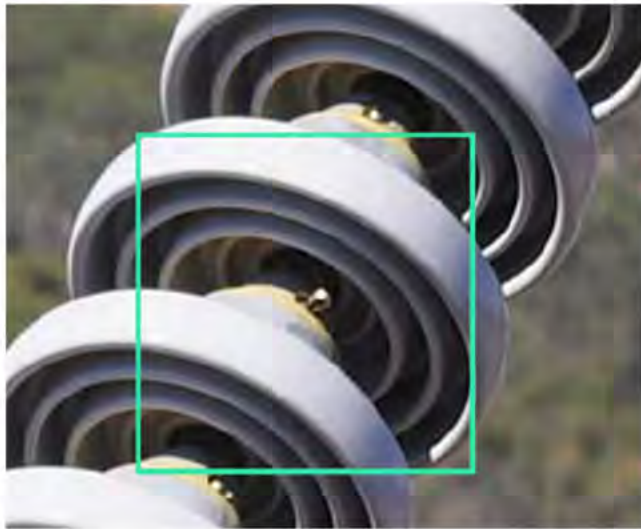
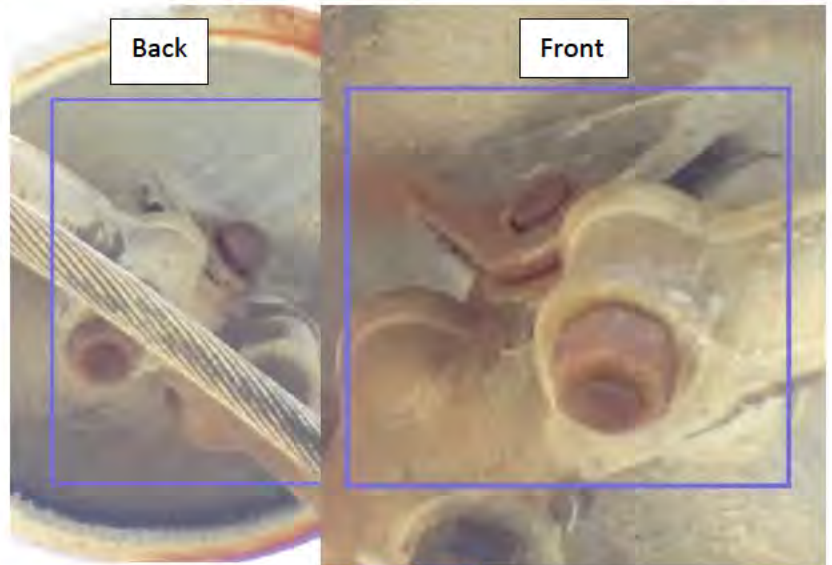
Condition: 4
Priority: E+

FDA: Insulator-Wood/Steel|No Good/**Out of Stdrd**|Repair

Condition: 4

Priority: E+

FDA: Insulator-Wood/Steel|No Good/Out of Std|Repair

Examples of unseated retainer keys (left) missing cotter key, retainer pin backing out yet still seated through hardware (right).

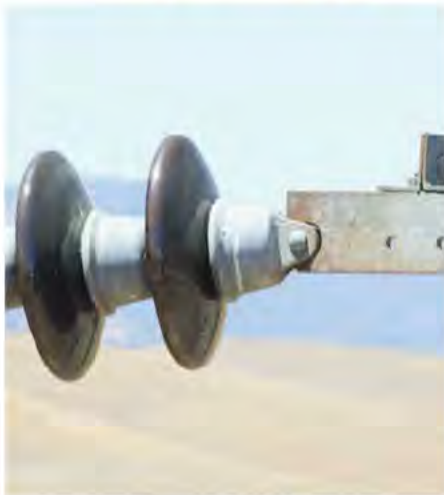
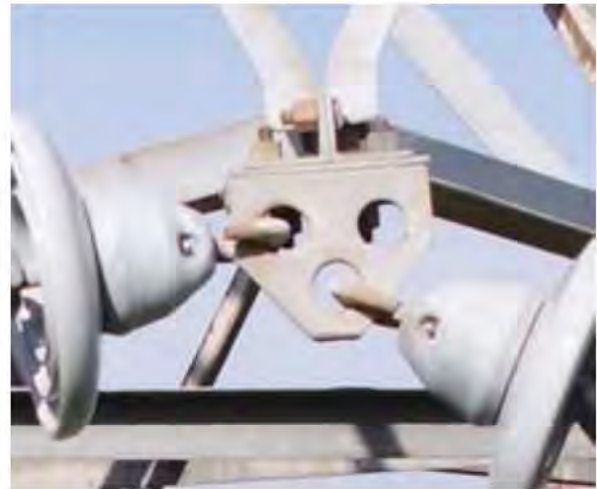
Figure 154

Condition: 3

Priority: E

FDA: Insulator-Steel|No Good/Out of Std|Repair

FDA (1): Insulator-Steel|No Good/Out of Std|Repair

FDA (2): Hardware-Tower|No Good/Out of Std|Replace

Missing cold-end hardware such as c-hook, clevis, shackle, etc (left), and incorrect installation of right insulator string (right). The c-hook installed in the incorrect eye of the hanger plate has created a twist in the hardware/crossarm warranting hardware replace issue.

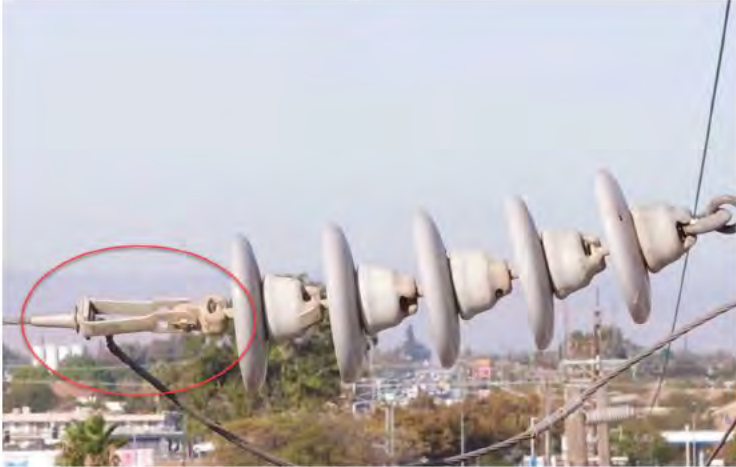
Condition: 4
Priority: E+

FDA: Insulator-Steel/Wood| No Good/**Out of Stdrd**| Repair

Figure 155 Automatic dead-end shoes which should be removed when found.

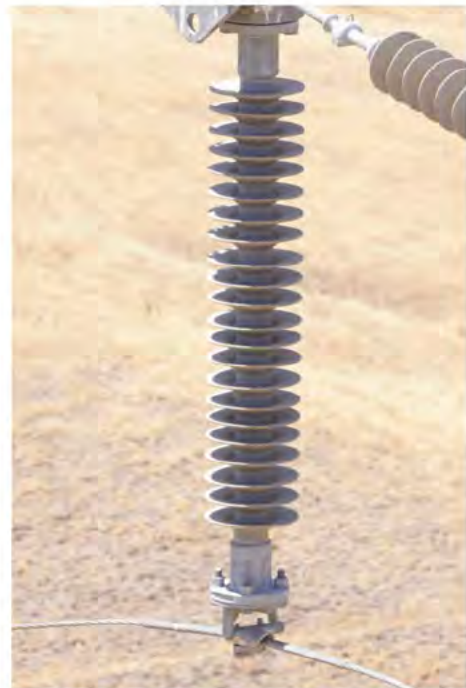
Condition: 2
Priority: F

FDA: Insulator-Steel/Wood| No Good/**Out of Stdrd**| Repair

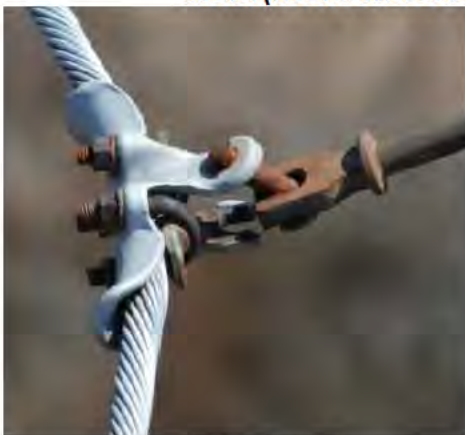
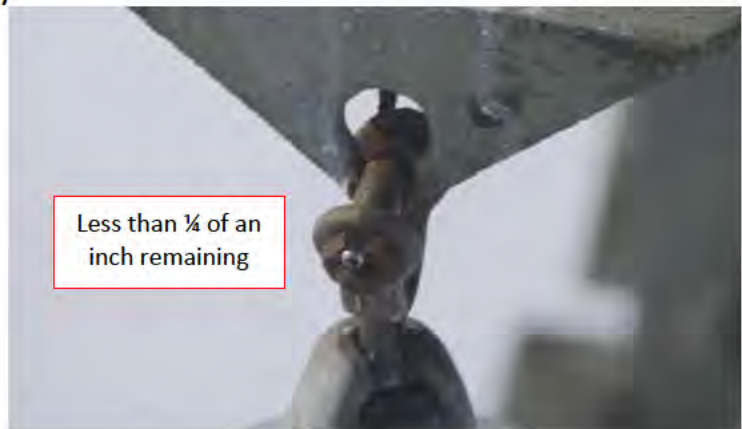
Condition: 5
Priority: A

FDA: Emergency|Storm Related|Repair

FDA (1): Emergency|Storm Related|Repair (Hanger plate)
FDA (2): Emergency **Wood/Steel**|Other|Replace (Insulator)

Figure 158 Sheared connection on the suspension shoe on OPGW/Shield wire (left), worn hanger plate/y-clevis connection (right). Two notifications are made for the right image. One for the hanger plate and one for the insulator hardware. Insulators will almost always be replaced when hanger plates and hardware are replaced.

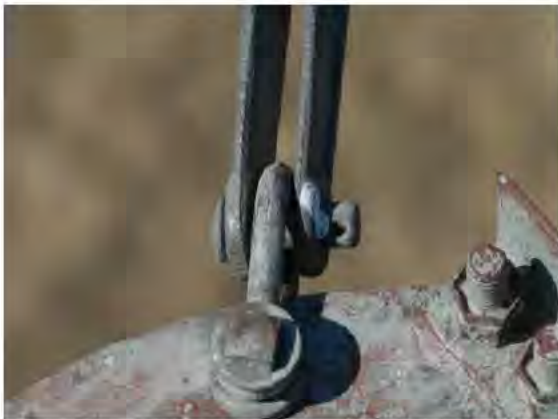
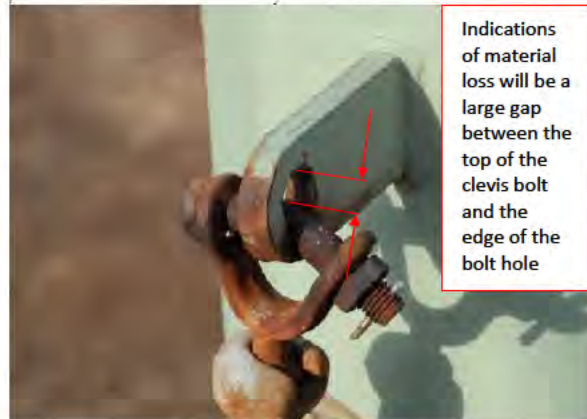
Condition: 4
 Priority: E+
 FDA: Insulator-Steel|No Good/**Out of Std**|Repair

Condition: 4
 Priority: E+
 FDA (1): Hardware-Tower|No Good/**Out of Std**|Replace
 FDA (2): Insulator-Steel|No Good/**Out of Std**|Replace

Figure 160 Missing cotter key (left). Rusted y-clevis (right).

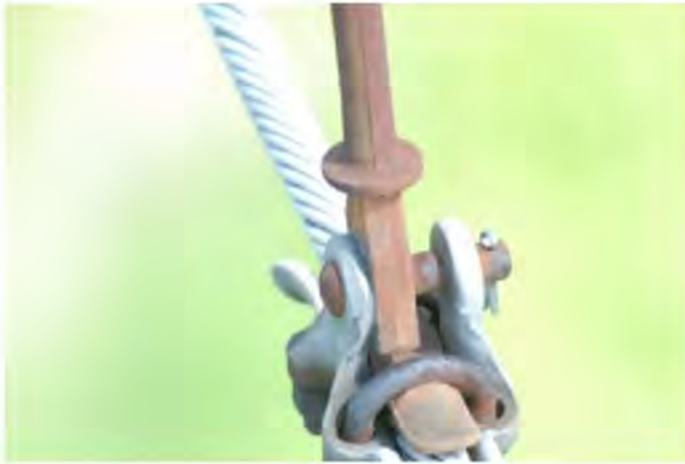
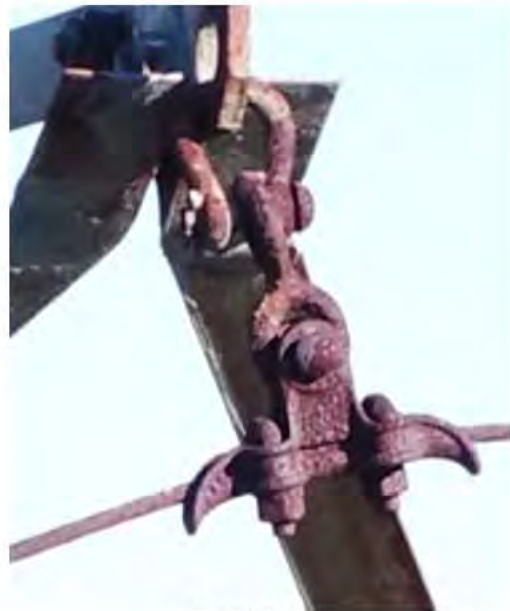
Condition: 1

Priority: No notification required

Figure 161 Minor surface rust (left). Hardware surface rust (right): material loss is not significant enough to warrant an E priority notification.

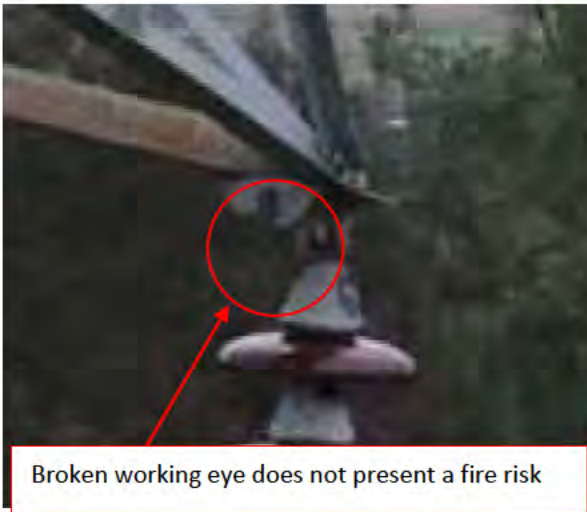
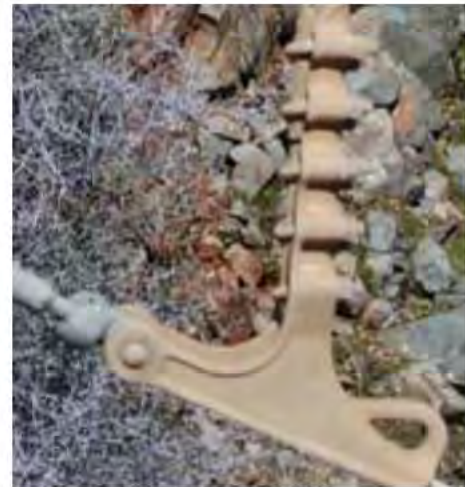
Broken working eye does not present a fire risk

Condition: 1

Priority: No notification required

Figure 162 Broken working eye (left). Minor surface rust (right).

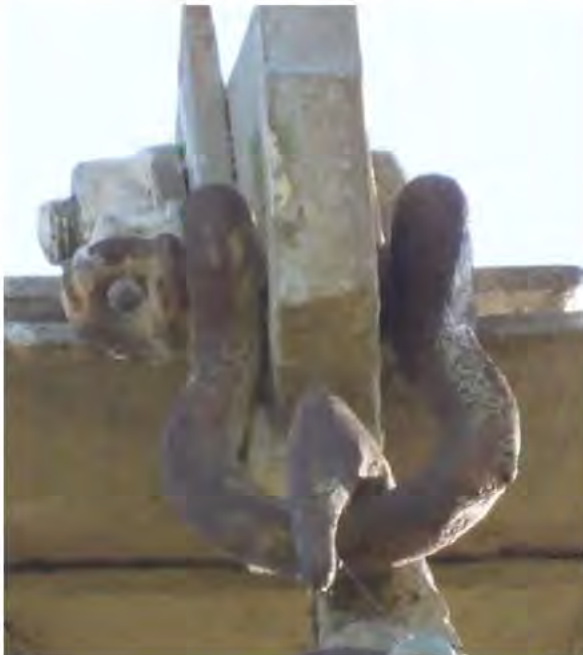
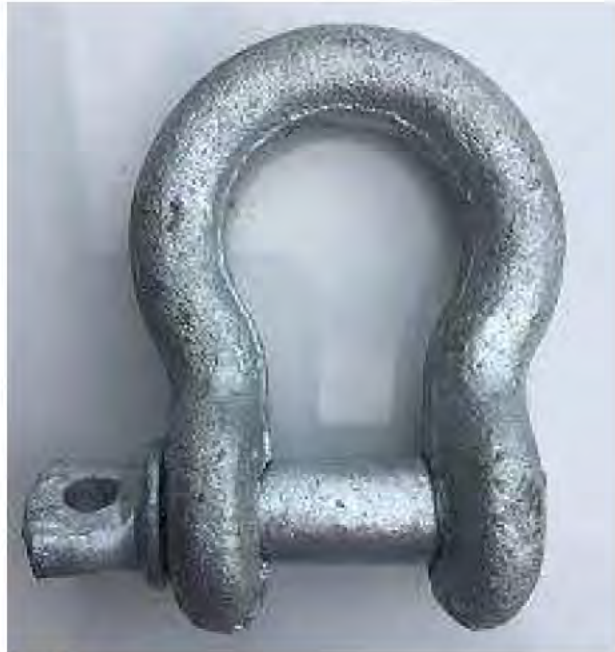
Figure 163

Condition: 3

Priority: E

FDA: Insulator–Wood/Steel|No Good/**Out of Stdrd**|Replace

Working shackle used on structure. Working shackles have pins which screw in, as shown on the right.

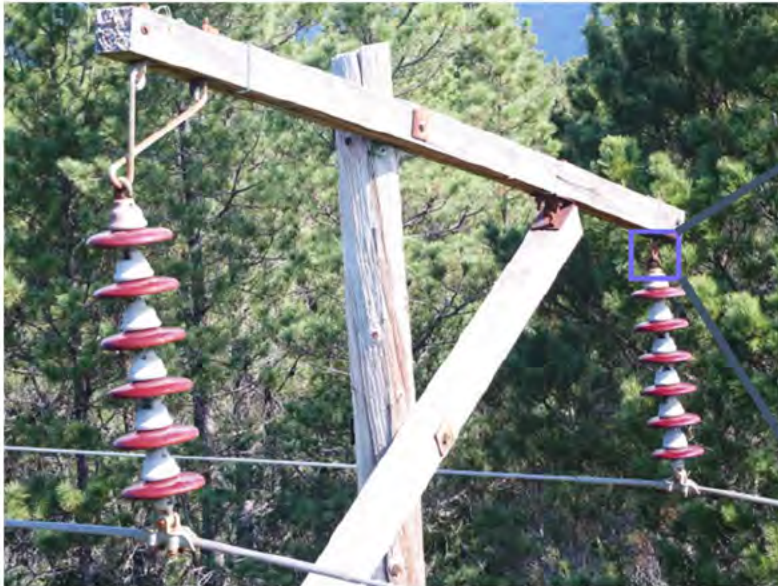
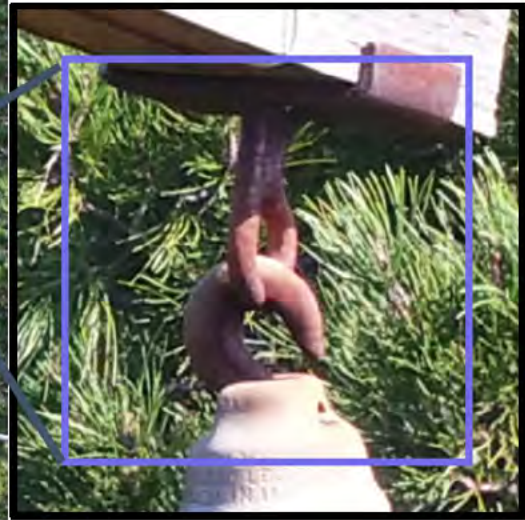
Figure 164

Condition: 5

Priority: A

FDA (1): Emergency|Storm Related|Repair (Hanger plate)

FDA (2): Emergency **Wood/Steel**|Other|Replace (Insulator)

Wear can occur in any configuration, even on wood poles. Always be aware of this when examining cold-end hardware. Replace FDA(2) is appropriate due to insulator age.

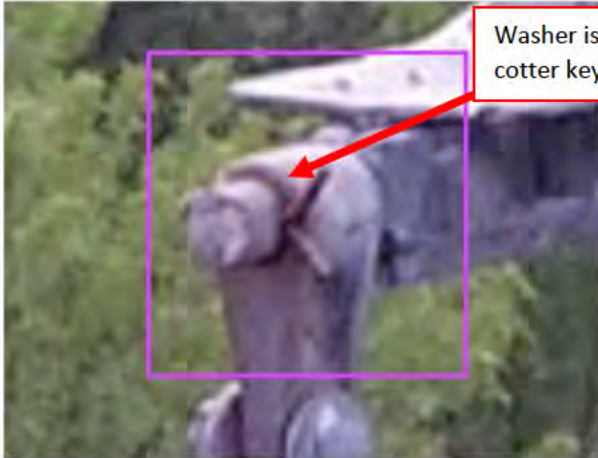
Washer is missing between cotter key and swing plate.

Diagram of configuration to the left. The missing washer is visible.

Condition: 4
Priority: E+

FDA: Hardware-Steel | No Good/Out of Stdrd | Replace

Figure 165 Washer is missing between the swing plate and the cotter key. If the cotter key is damaged or worn, the hardware and conductor can fall. The "Steel" FDA should be used if this takes place on a tower or on a steel pole

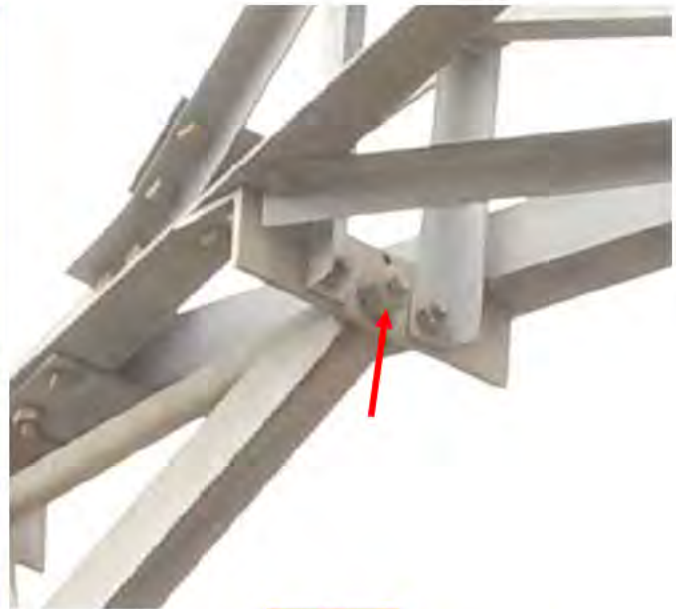
Condition: 4
Priority: E+

FDA: Hardware-Steel | No Good/Out of Stdrd | Replace

Condition: 3
Priority: E

Figure 166 Used wire instead of cotter key (left). Cotter key missing, but nut is present and secure (right).

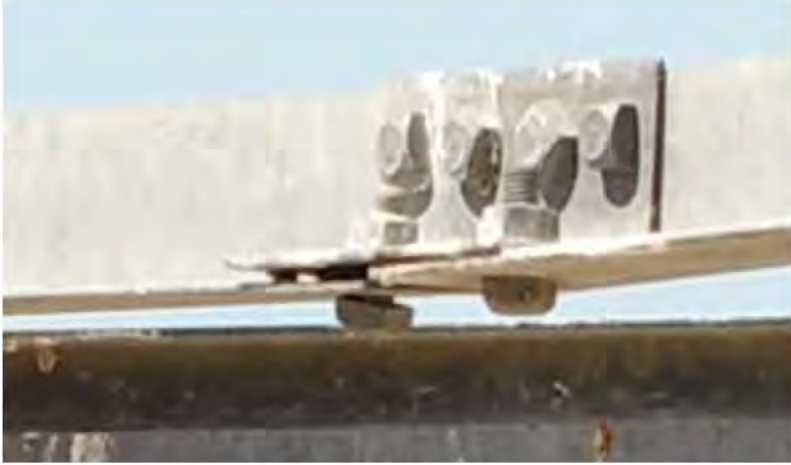
Condition: 2
Priority: F

FDA: Hardware-Tower | No Good/Out of Std | Replace

Figure 167 Loose bolt/nut on tower (left). Example of "punched" bolts (right).

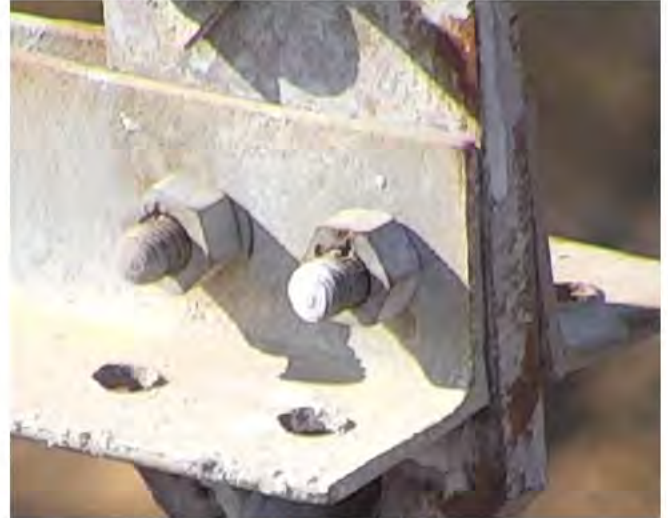
Condition: 1
Priority: No notification required

Condition: 3
Priority: E

FDA: Hardware-Tower | No Good/Out of Std | Replace

Figure 168 Corroded nuts/bolts (left). Consider repainting the tower. Missing bolt in a multi bolt connection Per JA-07 (right) is an E priority due to it being a Primary member connection.

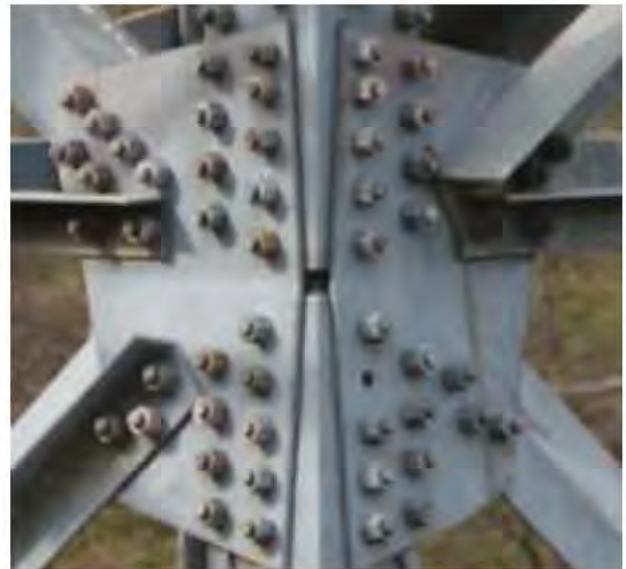
Figure 169

Condition: 3
Priority: E

FDA: Hardware-Tower | No Good/Out of Std | Replace

FDA: Hardware-Tower|No Good/Out of Std|Replace

Pal nuts should be installed on similar hardware, located in similar/matching sections. Example above shows a similar/matching section, same crossarm, opposite ends, (left) has pal nuts and (right) is missing pal nuts. If lock washers/punch marks exist, treat as 'No notification required.'

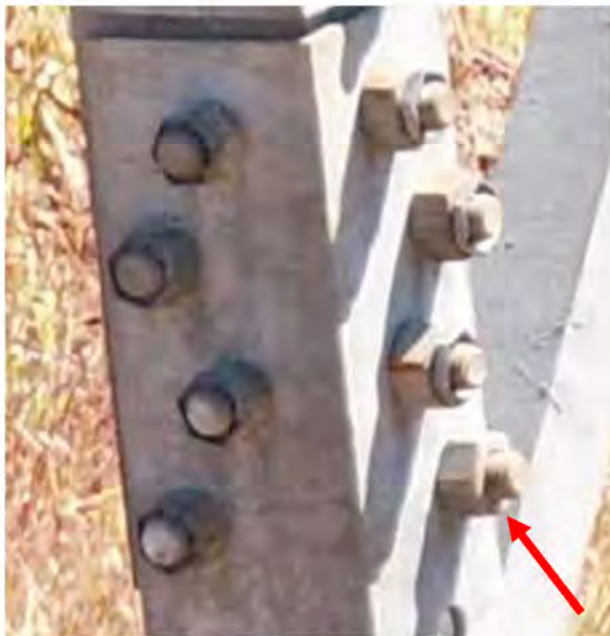
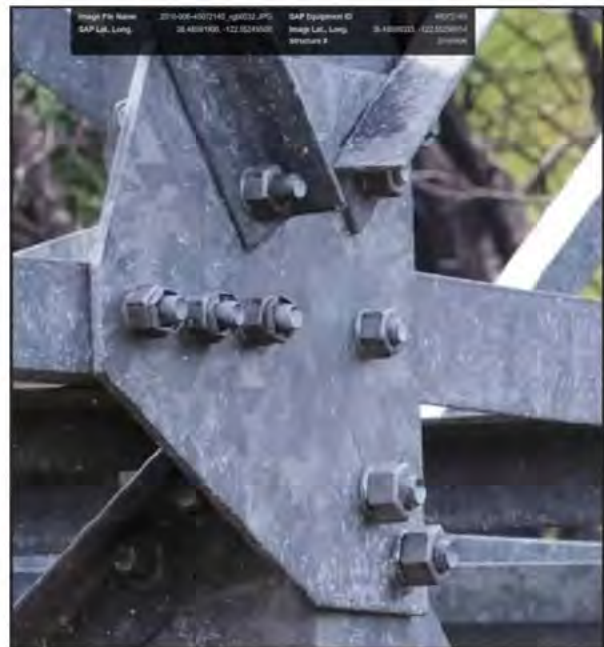
Figure 170

Condition: 3
Priority: E

FDA: Hardware-Tower|No Good/Out of Std|Replace

Missing pal nut (left). Some structure will use different hardware at splice/connection plates, pal nuts and lock washers (right). Each structure can have its own hardware similarities and should be evaluated by comparing adjacent legs or similar/matching sections on the structure.

Condition: 1
Priority: No notification required

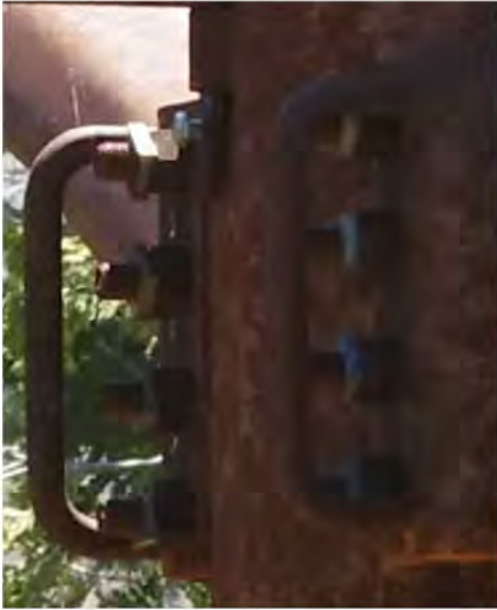
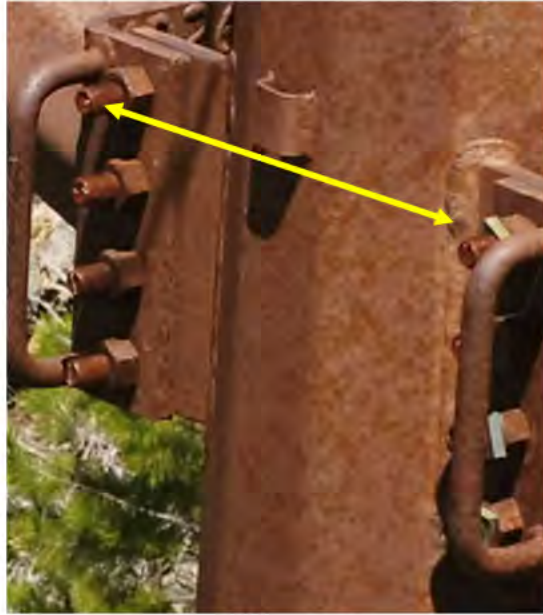
Figure 171

Condition: 3
Priority: E

FDA: Hardware-Wood/Steel|No Good/**Out of Stdrd**|Replace

Missing pal nuts on crossarm. Structure has pal nuts on both crossarms (left) and on the opposite side missing on one crossarm (right).
