AERIAL INSPECTION REVIEW+ TEAM

AIR+ TEAM HANDBOOK

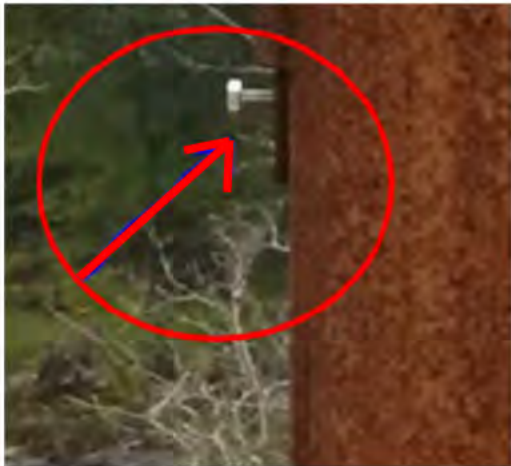
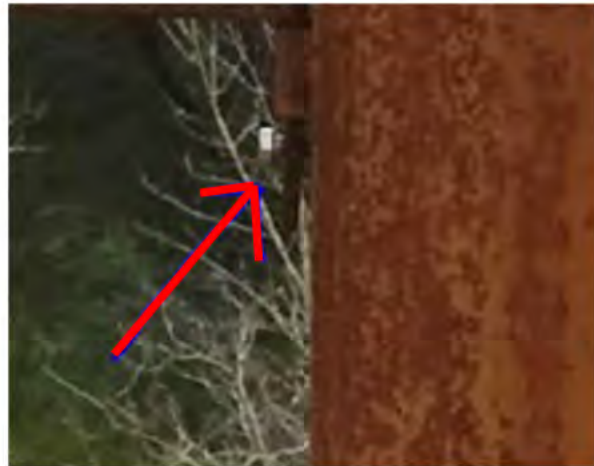
Condition: 2
Priority: F

FDA: Hardware-Wood/Steel|No Good/**Out of Stdrd**|Replace

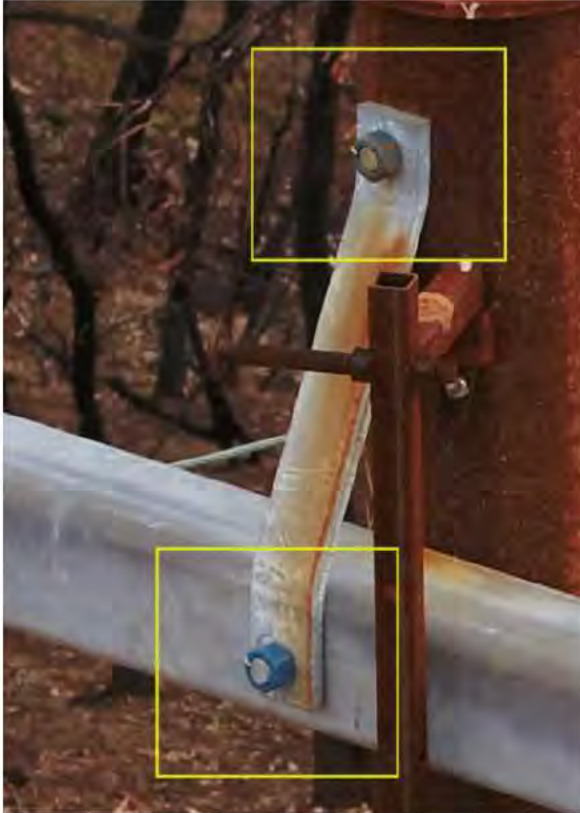
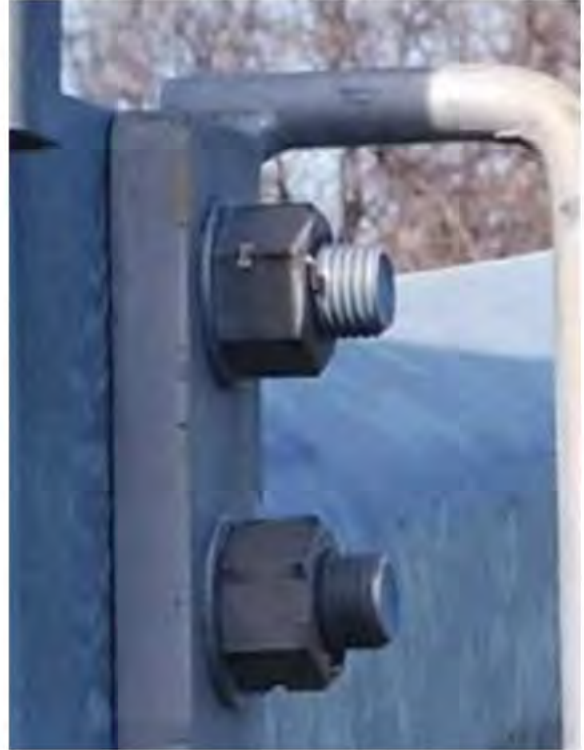
Figure 173

Example of incorrectly installed structural locknut (left). For these nuts to lock, the threads need to protrude past the end of the nut so the ratchet can engage the threads. Correctly installed locknut (right).

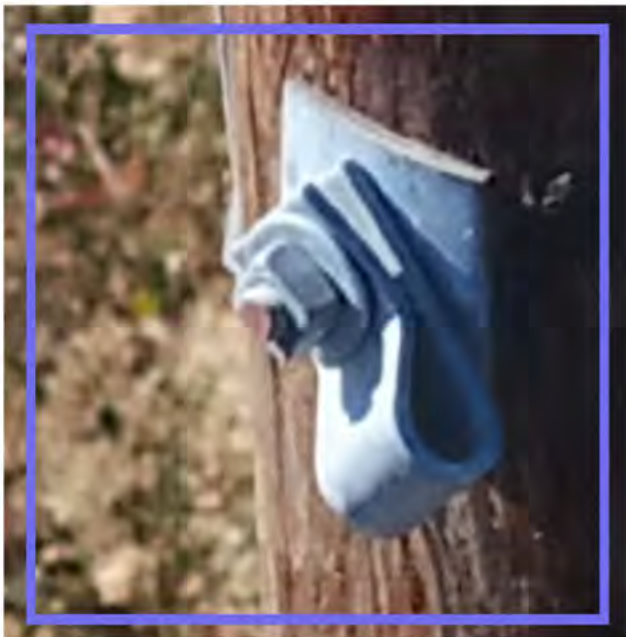
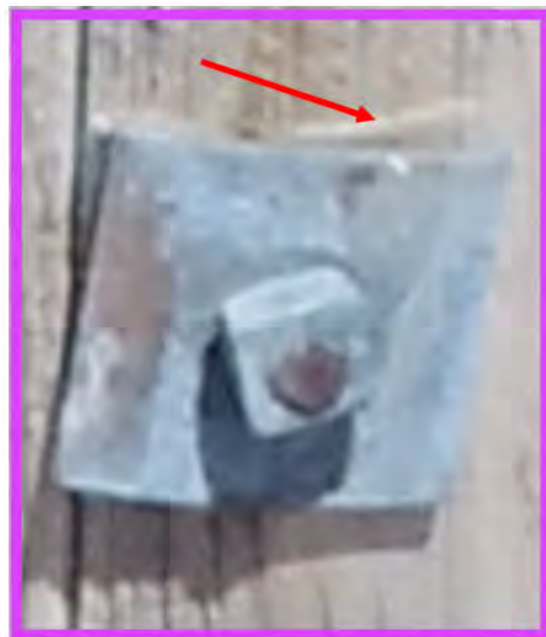
Figure 175 Spring clips are considered loose if the ends are fully separated and not touching at the bend (left). Loose washer, indications on the pole of the washer's original location (right).

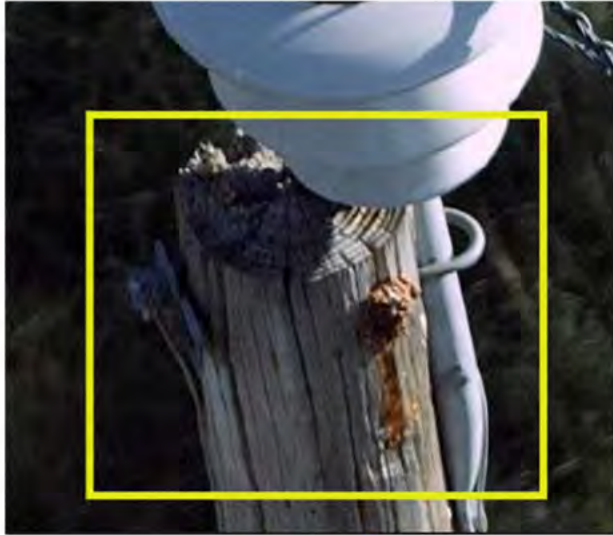
Figure 176 Loose U-bolt holding the insulator to the pole (left). Loose sister eye (right).

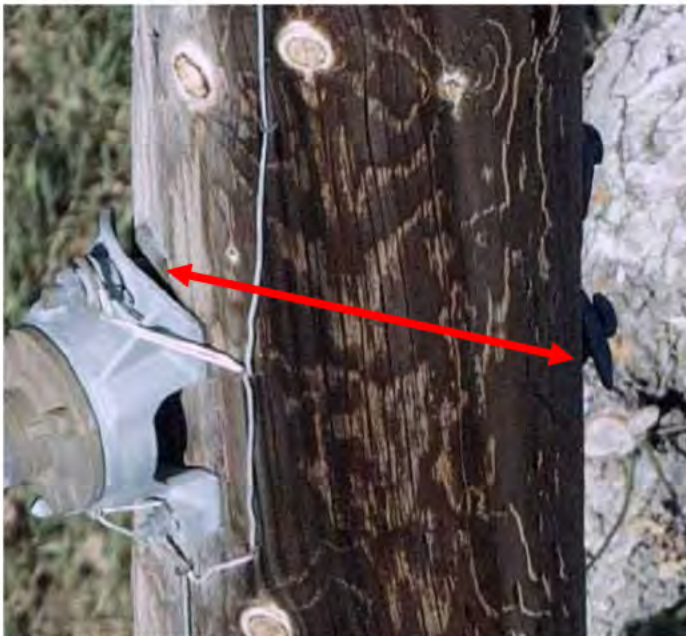
Figure 177 Loose hardware securing the insulator bracket to the pole (left). Bent bolt supporting sister eye (right).

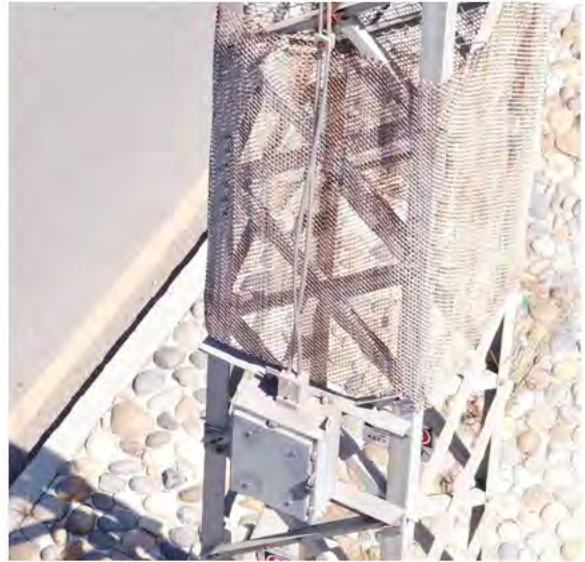
Figure 179 OPGW under anti-climbing guard level, and insulated from structure, public safety risk that requires immediate action. Image on right not grounded at the top of structure.

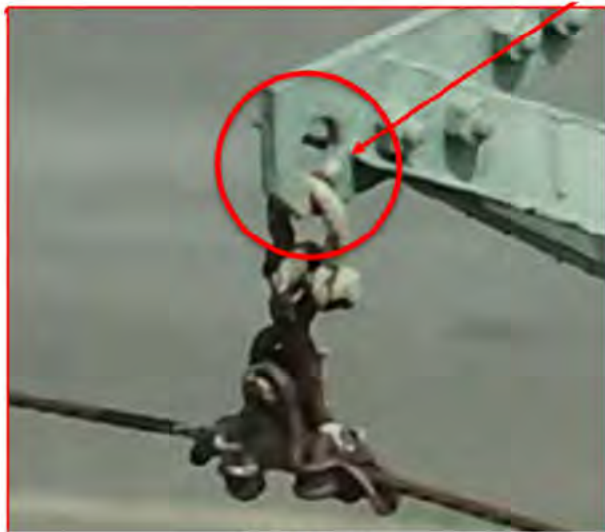
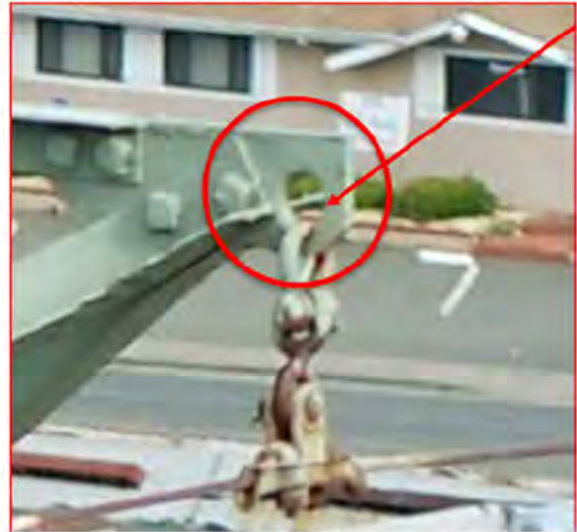
Figure 180 Severe wear (< ¼ inch remaining) in hanger plate (left). Moderate wear (between ½ and ¾ of an inch, right).

<ul style="list-style-type: none">Updated: EDEP FDA usage, switch number tags, aerial markers, Figure 34 priority, Figure 180 FDA, Figure 224 FDA, Foundation FDA's, Switch 'out of adjustment' guidance, buried secondary members, cold end hardware FDA, climbing racks, steel guy markers, guy bob requirements, Figure 53 priority
--	--	--

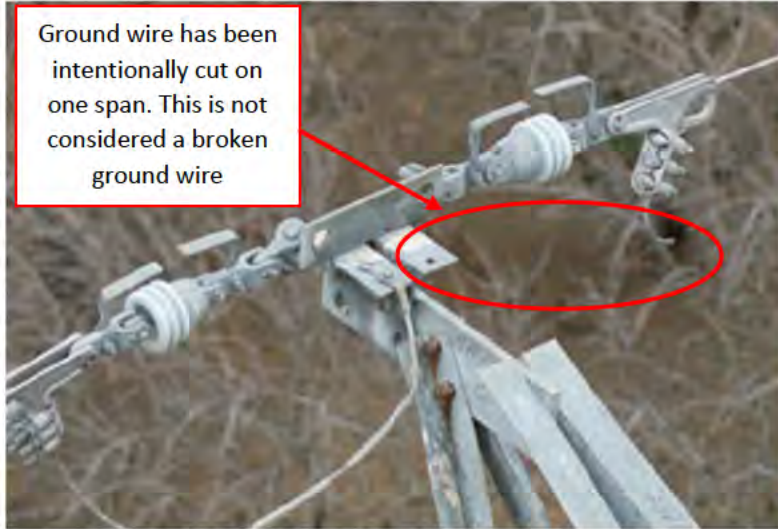
Ground wire has been intentionally cut on one span. This is not considered a broken ground wire

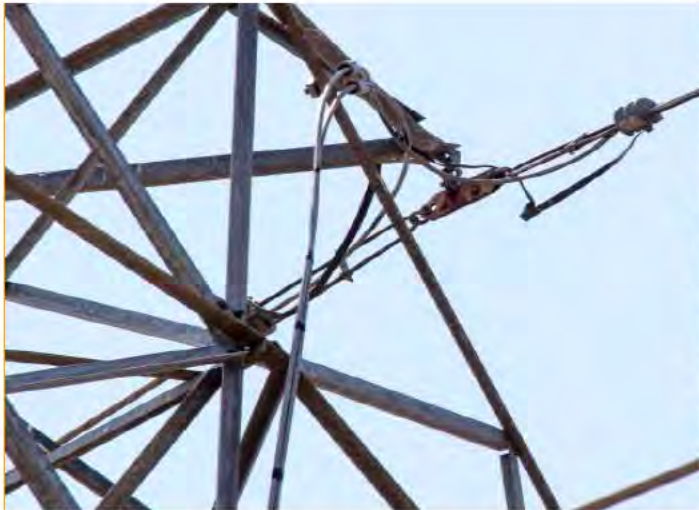
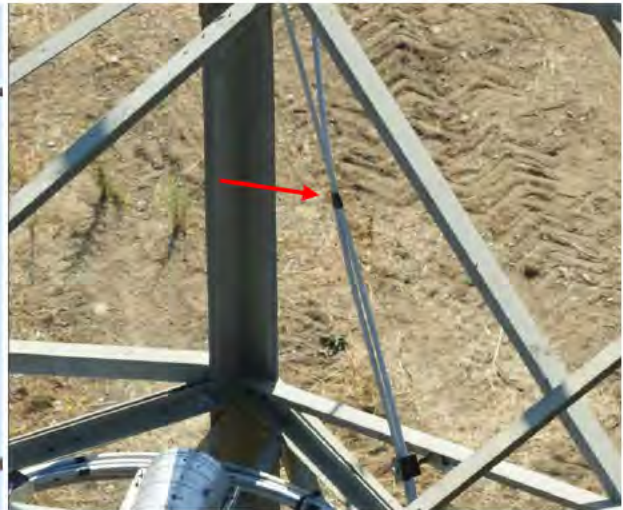
Figure 182

Missing OPGW components. If there is any contact between the wire and the structure, the tag should be upgraded to a **E+** and notes made to reflect this. Both dead ends must be grounded (left). **External contact of OPGW to itself in the downlead to the coil (left).**

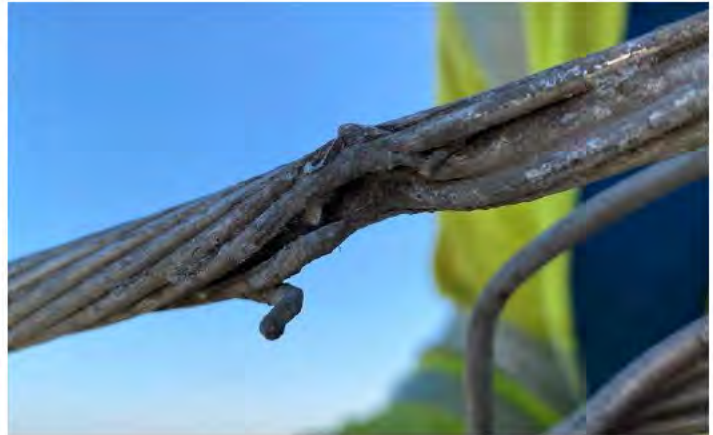
Figure 183

Broken strands (15% to 40%), with the removed cable shown to the right, after repair.

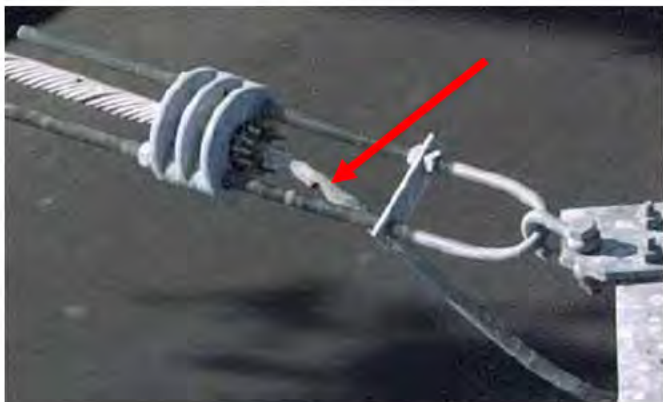
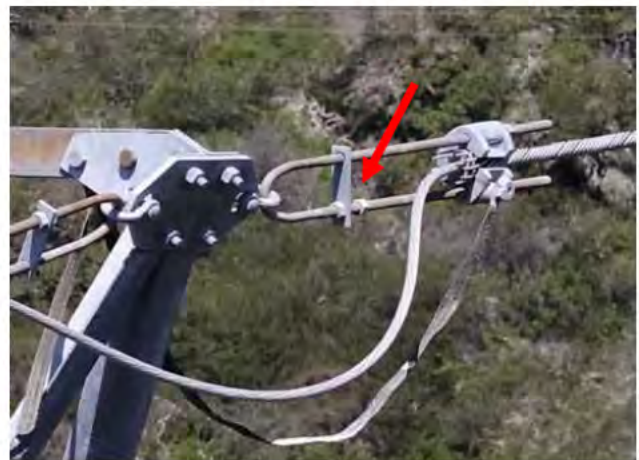
Figure 184

Broken strands on OPGW (left). While the damage was minor and may require an E priority, this was elevated to **E+** priority based on its location between the dead ends. Loose hardware on OPGW spacer (right).

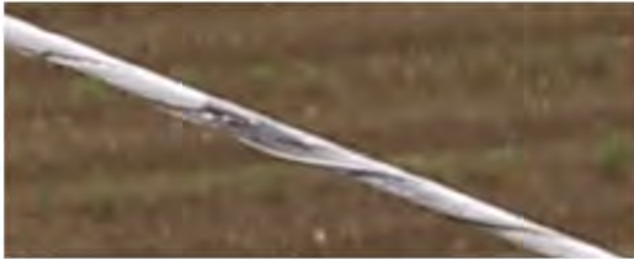
Figure 185 Broken/damaged strands possibly due to corrosion (left). Less than 6" of clearance between OPGW cables (right).

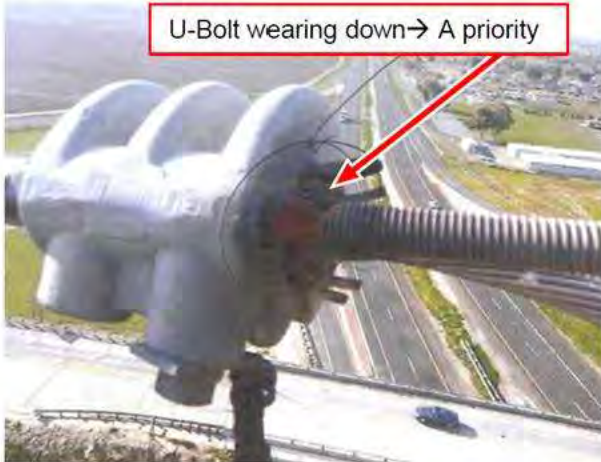
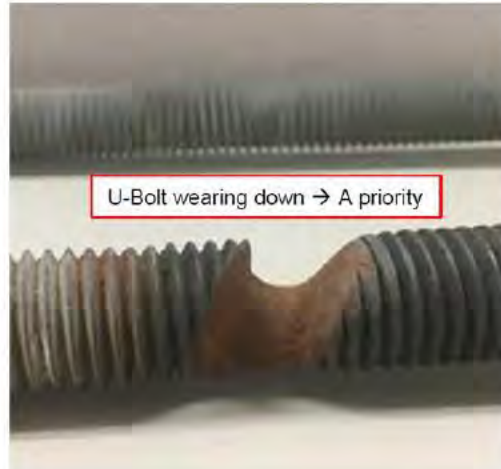
Figure 186 Wear on OPGW hardware in the field (left) and after removal (right).

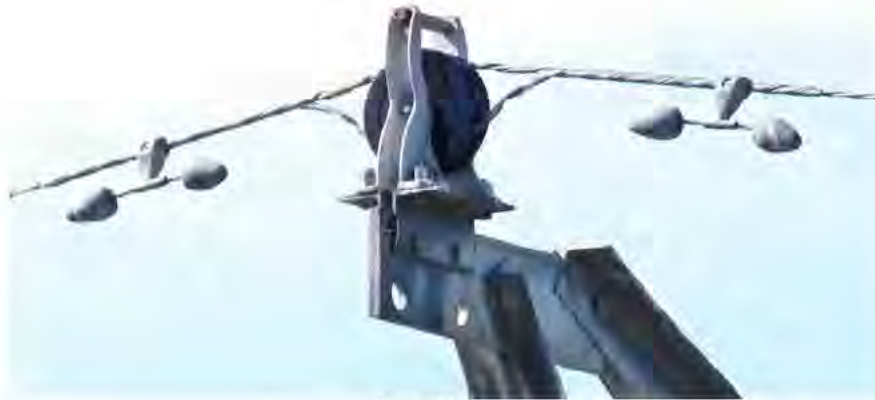
Figure 191 Dampers on shield wire preform are acceptable. **Drawing number 102621 for reference.**

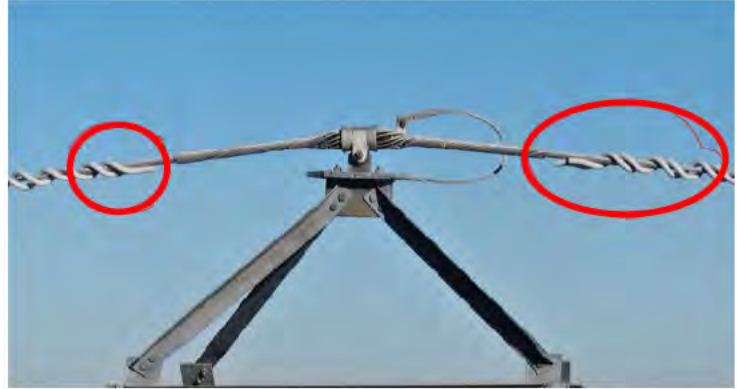
Figure 192

Drawing of acceptable damper placement on OPGW (left). Example of spiral dampers in contact with OPGW **internal** armor rod (right).

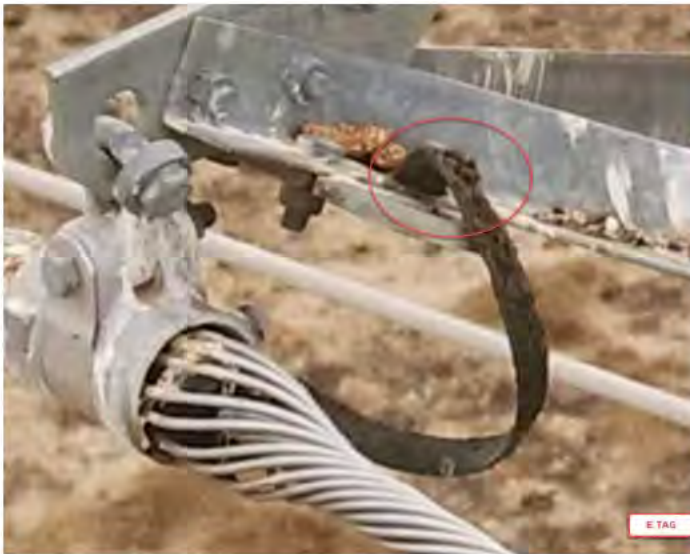
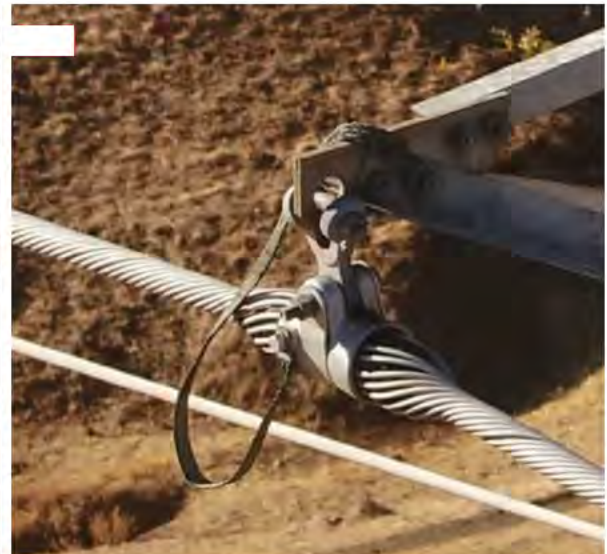
Figure 193

If OPGW ground strap is fraying (left), assign an E tag. If strap is touching the OPGW (right), create a **E+** tag. If a strap is touching the tower, but shows no sign of damage, no tag is necessary.

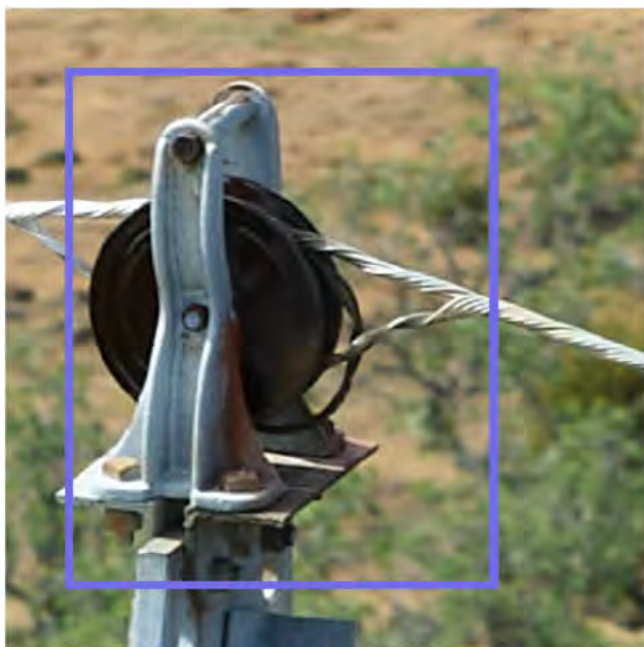
Figure 195 Example of loose shield wire preform (left). Shield wire block cracked (right).

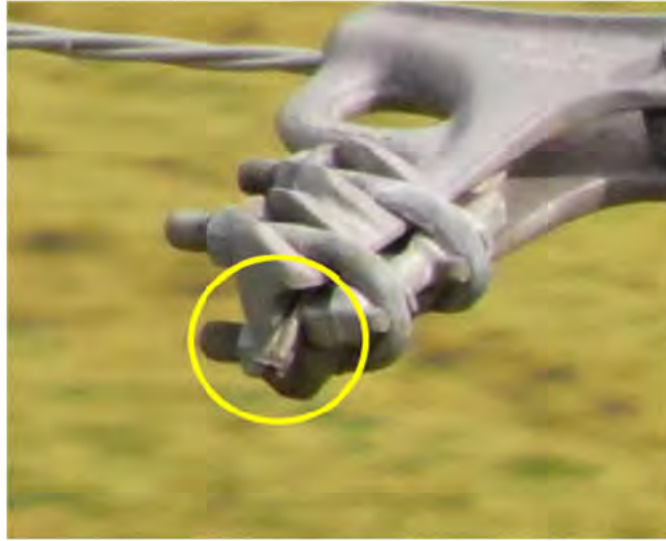
Condition: 1
Priority: No notification required

Figure 196 Tail is outside dead-end clamp.

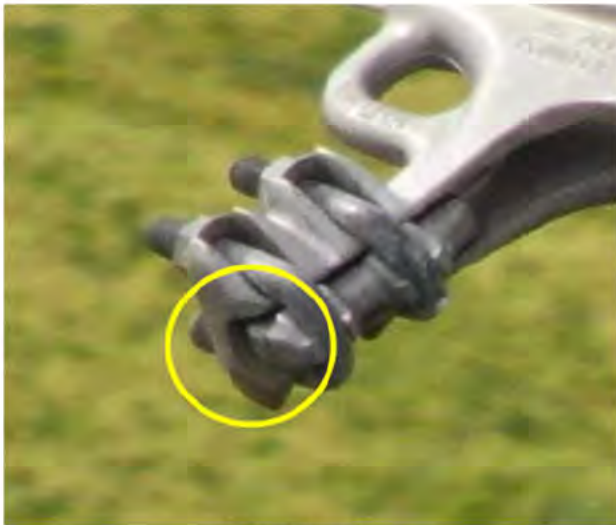
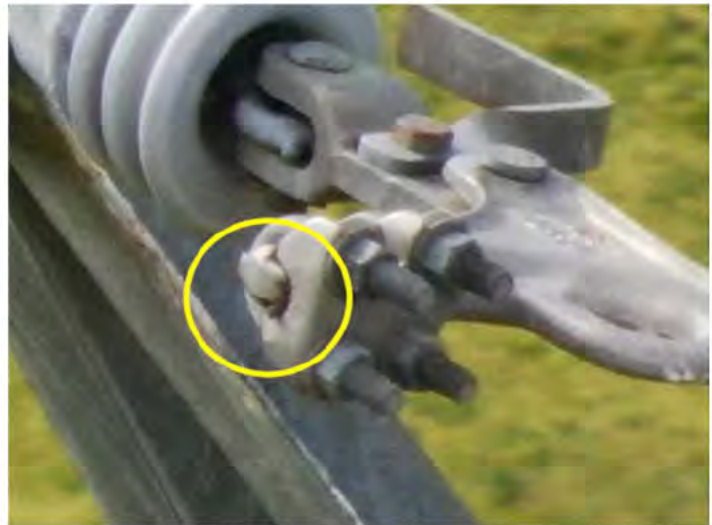
Condition: 5
Priority: A
FDA: Emergency | Storm-related | Repair

Condition: 4
Priority: E+
FDA: Shield Wire/ OPGW-Steel | No Good/Out of Stdrd | Repair

Figure 197 Tail is inside dead-end clamp AND shows evidence of shield wire further receding/slipping (left). Tail is flush with dead-end clamp (right).

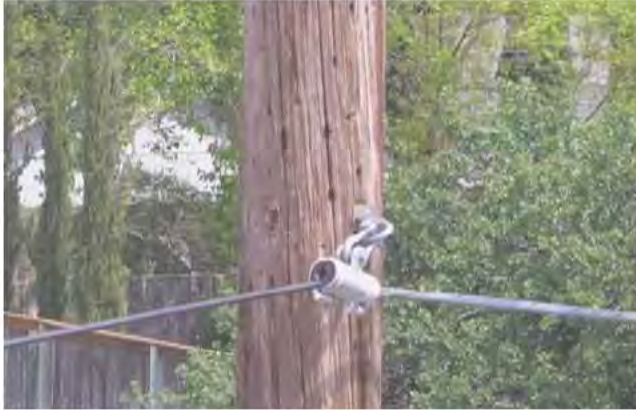
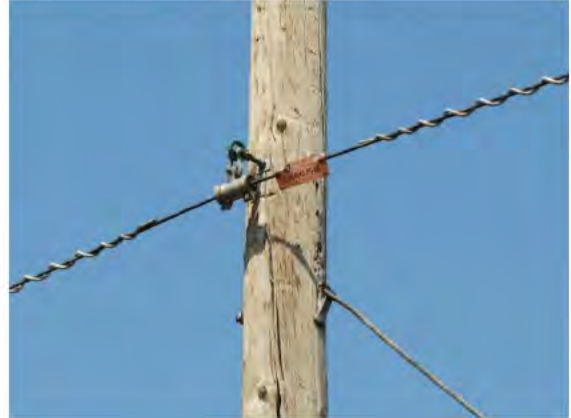
Condition: 4

Priority: E+

FDA: Shield Wire/OPGW-Wood/Steel|No Good/Out of Stdrd|Repair

Figure 198 ADSS twisted at hardware attachment, and armor/reinforcement rod out of position (left). Missing reinforcement rod on ADSS, which requires repair (right).

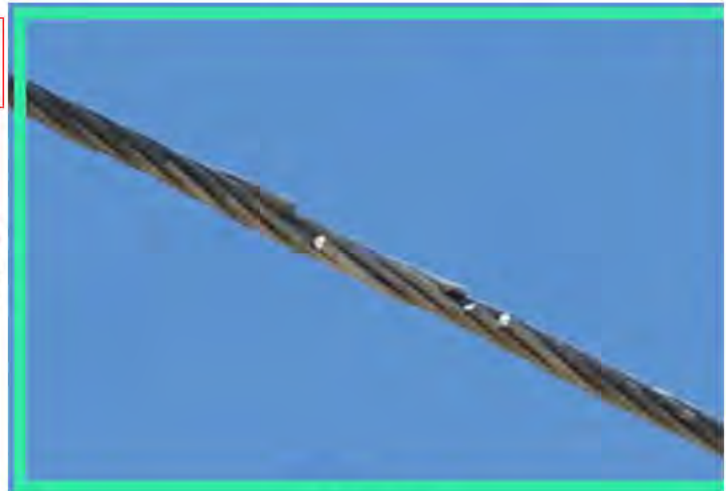
Condition: 5
Priority: A

Figure 200 Gunshot damage (left). Broken conductor, >40% broken strands (right).

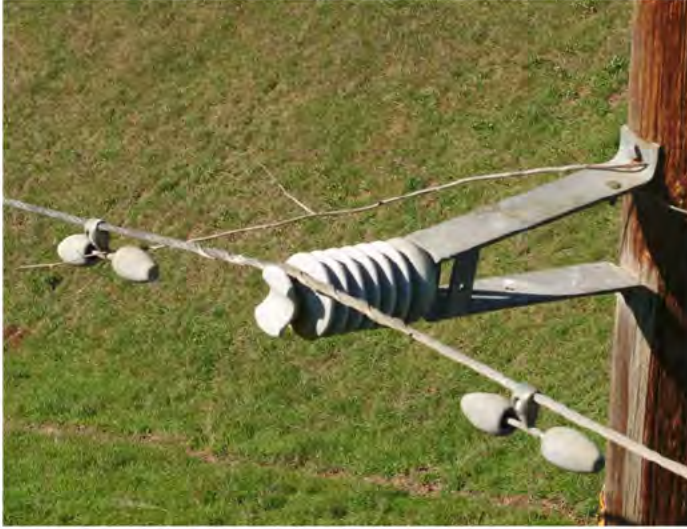
Figure 201

Condition: 5
Priority: A

Example of conductor debris touching energized conductor and bonded hardware. This is an example of T-line operating at distribution voltage, where we inspect per usual besides undersized insulators. (left). Mylar balloon on conductor/overhead fiber (right).

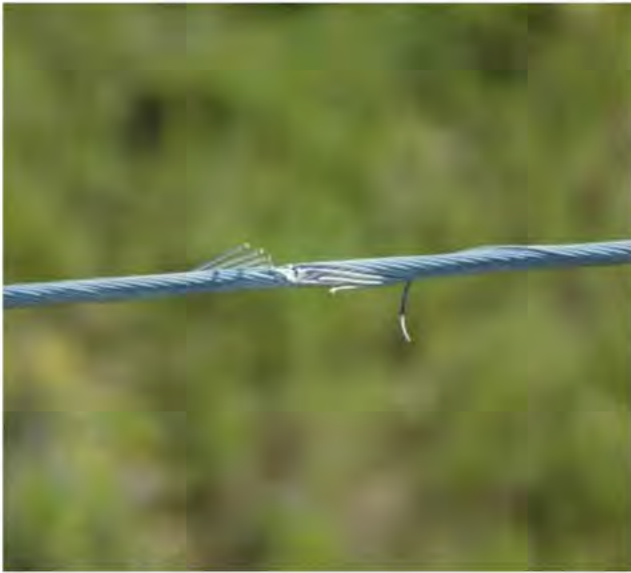
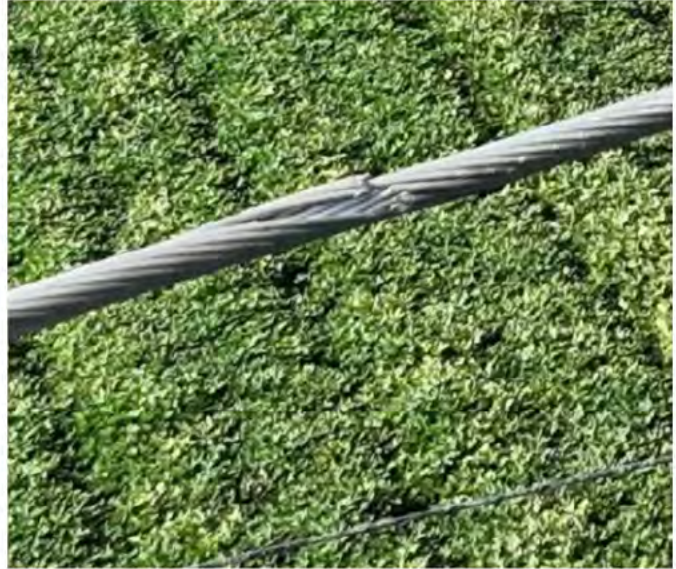
Figure 202

Condition: 3
Priority: E

Examples of conductor damage 5-40%.

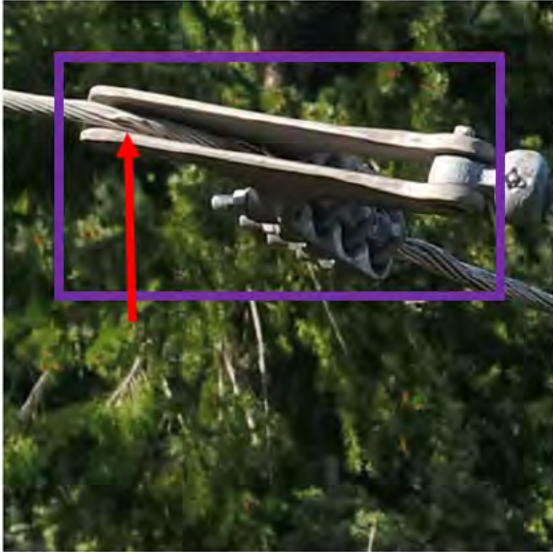
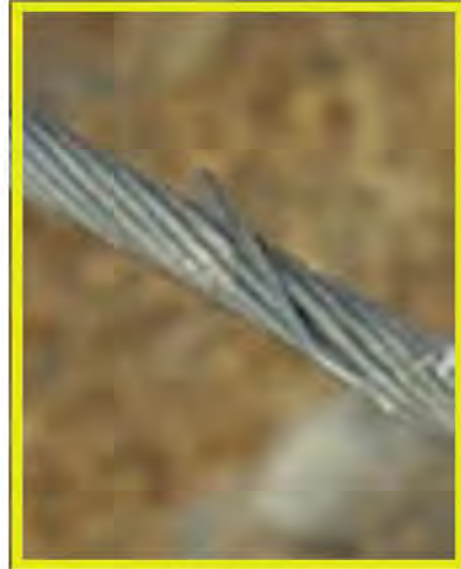
Condition: 3
Priority: E

Condition: 2
Priority: F

Figure 203 **Examples of damaged conductor, 1 strand to 5%. Broken strands up to 5% is an F priority.**

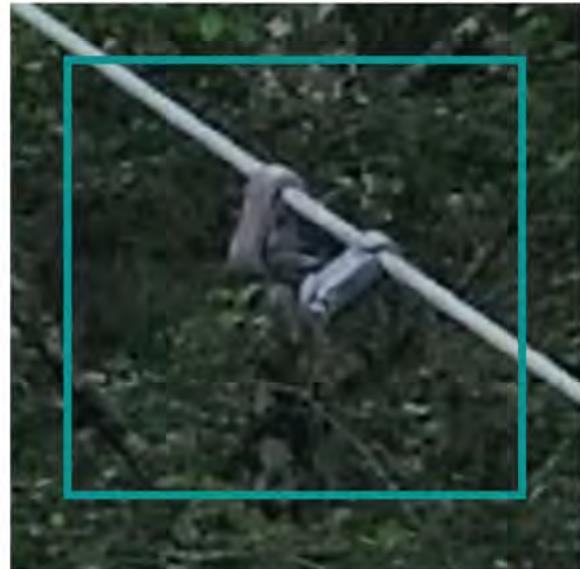
Condition: 2
Priority: F

Figure 204 **Examples of conductor debris. Unused hardware.**

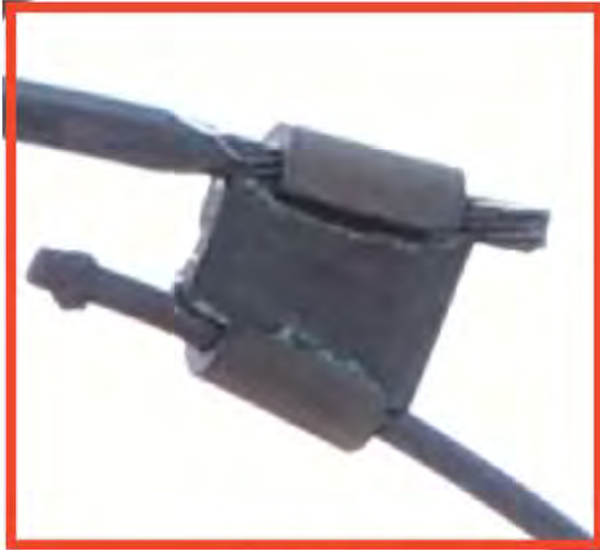
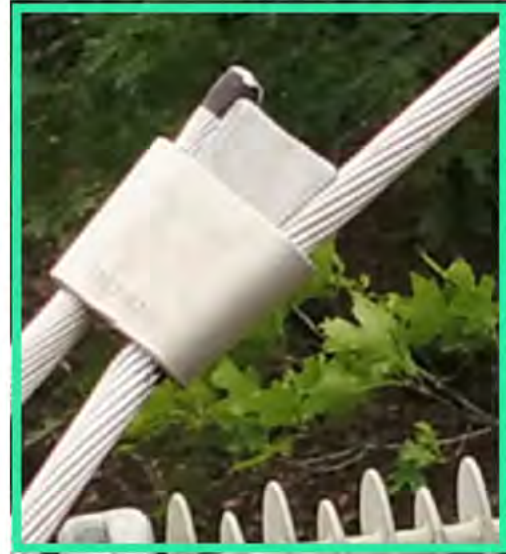
Figure 205

Condition: 5
Priority: A

Connector failure/ hot spot, possibly due to overloading (left). Backed off >50% (right).

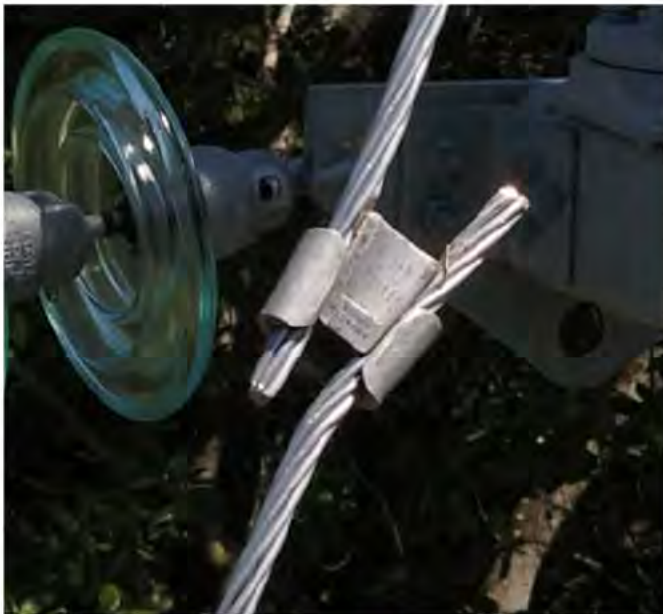
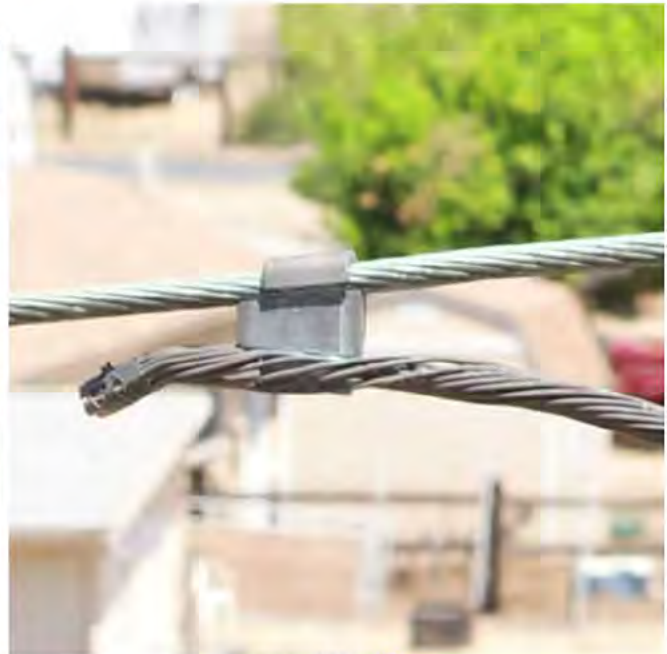
Figure 206

Condition: 4
Priority: E+

Backed off 30-50% or Conductor/Ampact damage(left). Conductor only partially in grasp of the clamp (right). If the connector is on a jumper, use jumper FDA.

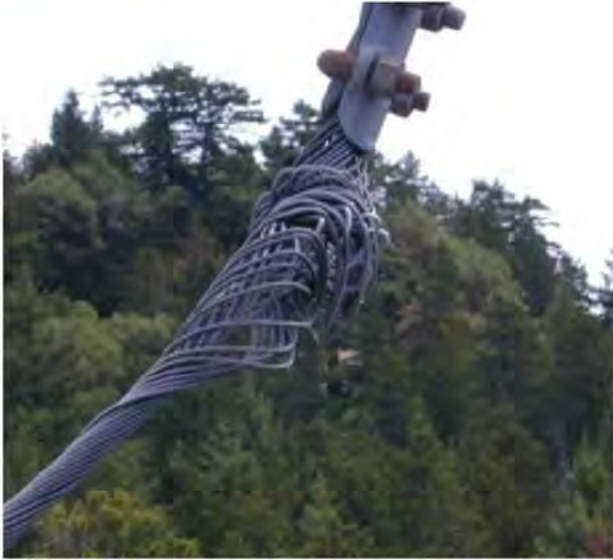
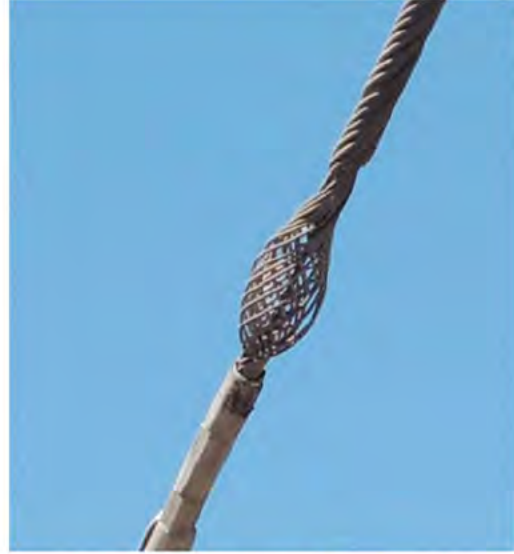
Condition:4
Priority: E+

Figure 207 Examples of conductor strands out-of-lay 5-40%.

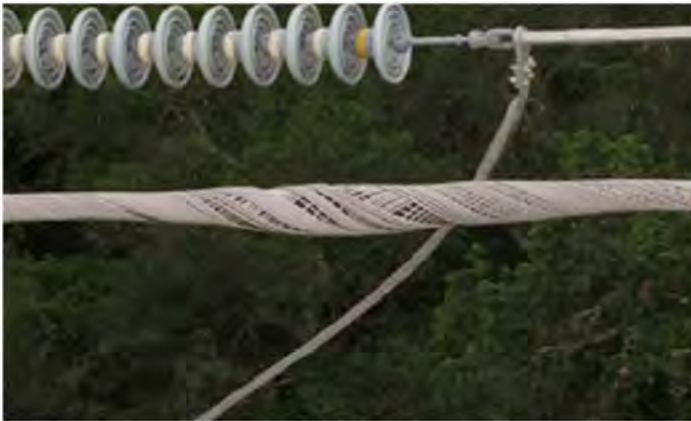
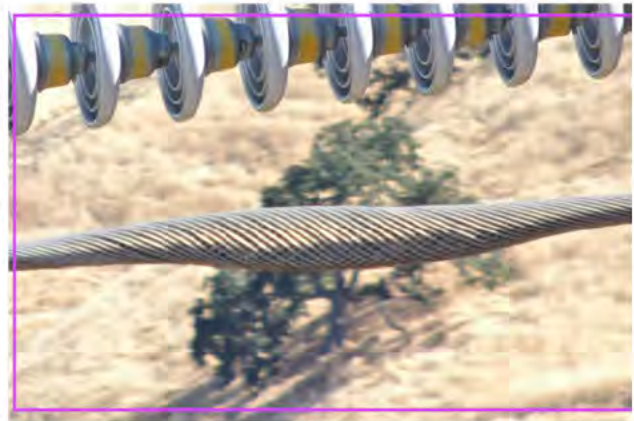
Condition:3
Priority: E

Condition:1
Priority: No notification required

Figure 208 Conductor strands out-of-lay 5-40%. Strands are separated enough to see through to the background (left). Conductor NOT out-of-lay (right).

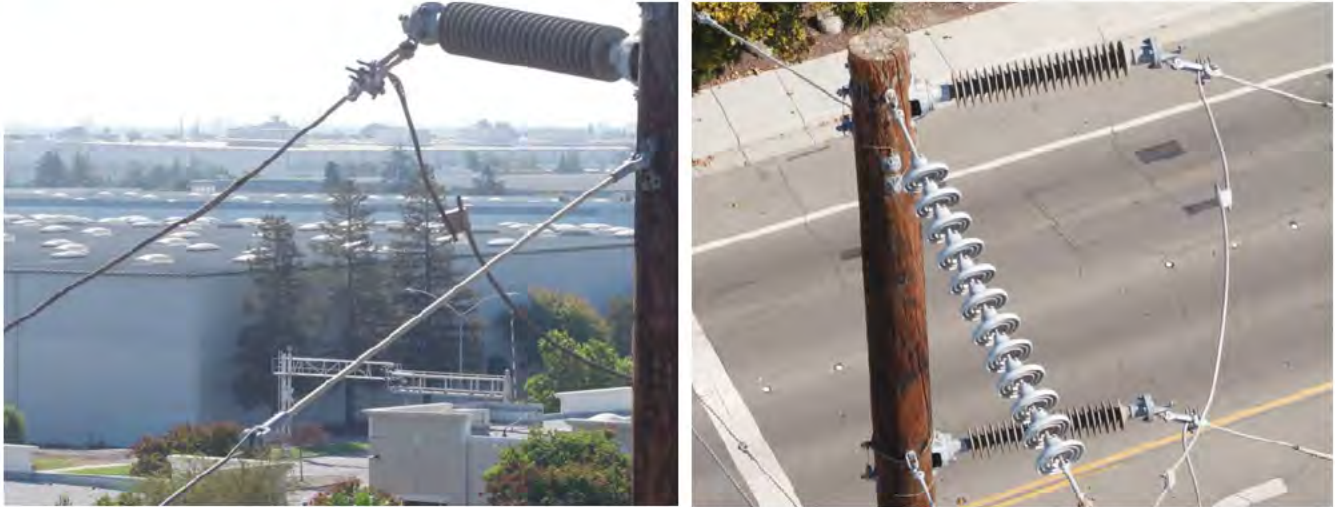
Figure 209

Condition: 1

Example of acceptable splices on non-tension spans. These are acceptable because (1) they are not under tension, (2) they are on short spans (jumpers), and (3) they don't have down-guys backing the load.

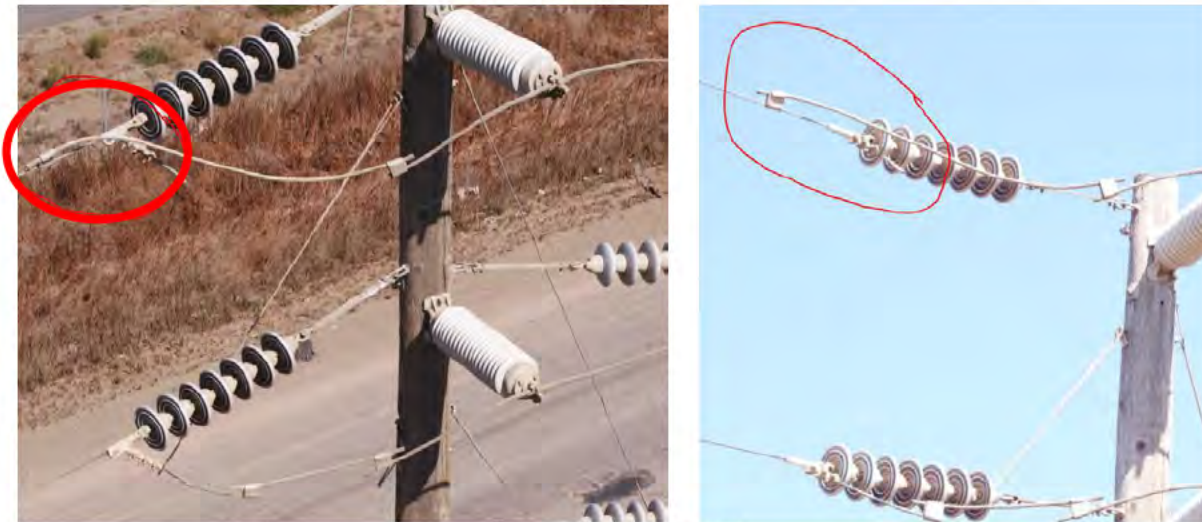
Figure 210

Condition: 3

Priority: E

Jumper connections should be connected to the non-tension side of the shoe. Configuration should be repaired with an E priority notification.

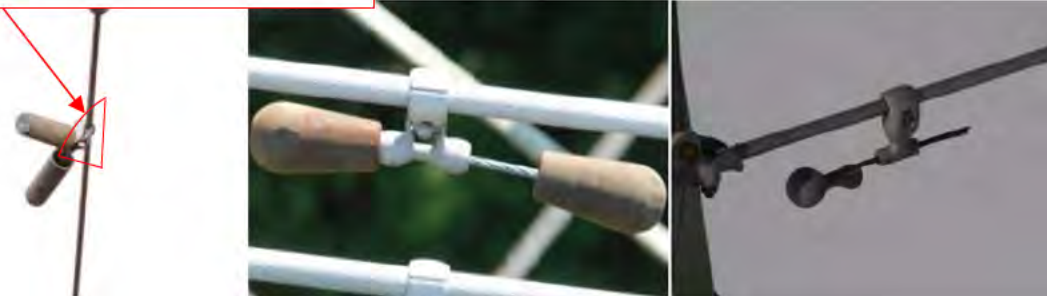
Condition: 3

Priority: **E**

Figure 212 Damaged dampers (left, center, right).

Bent dampers are only considered a notification if they are bent at or more than 45degs away from the conductor

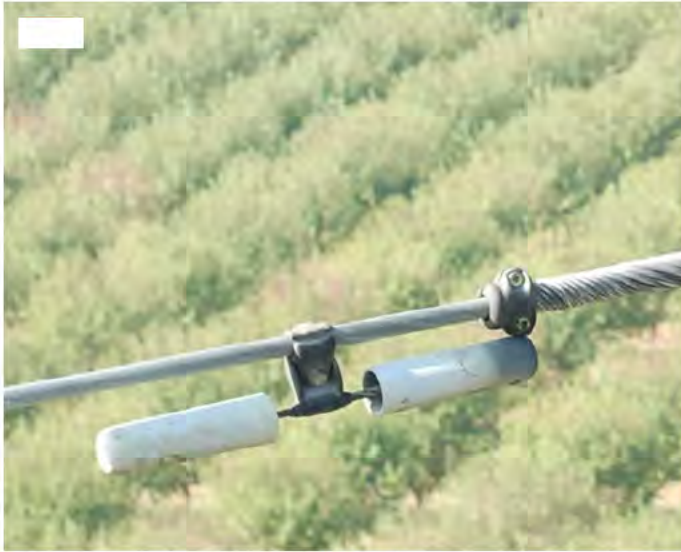
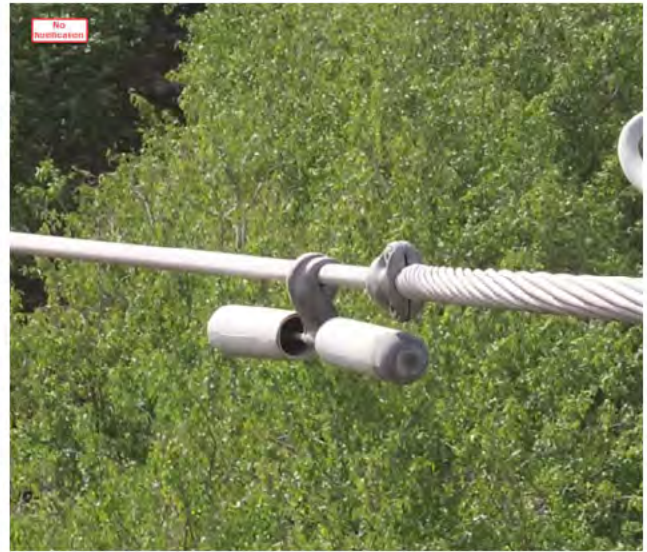
Condition: 3

Condition: 1

Figure 214 Damper weight in contact with armor rod clamps require a **E** priority notification (left). If no contact, no tag is necessary (right).

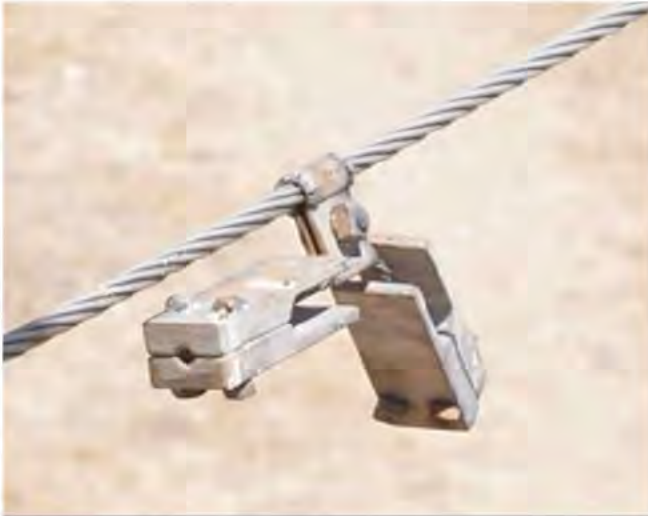
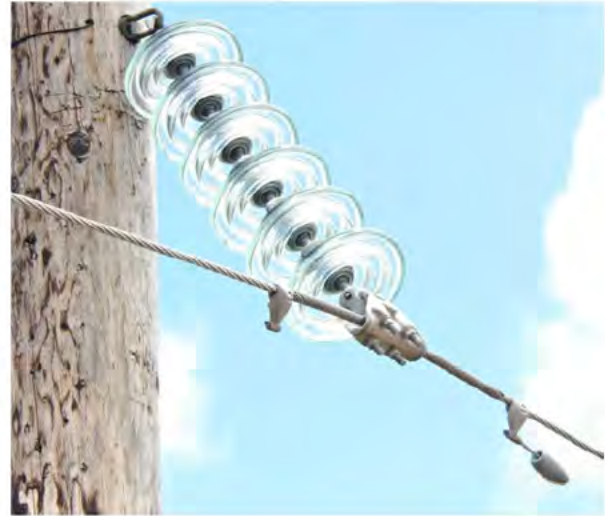
Condition: 3

Figure 215 Bent damper more than 45° (left). Damaged dampers (right).

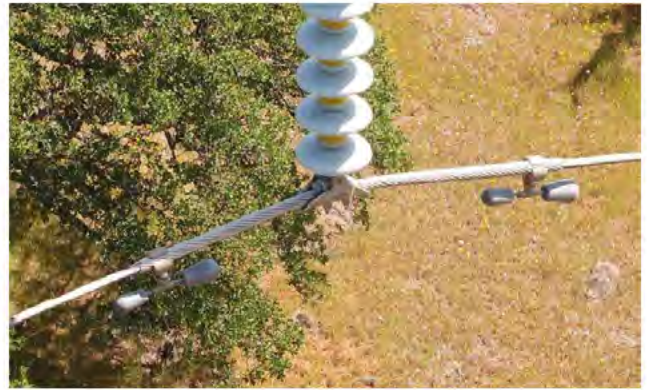
Figure 216

Condition: 1
Priority: No notification required

Dampers on suspension armor rod are acceptable

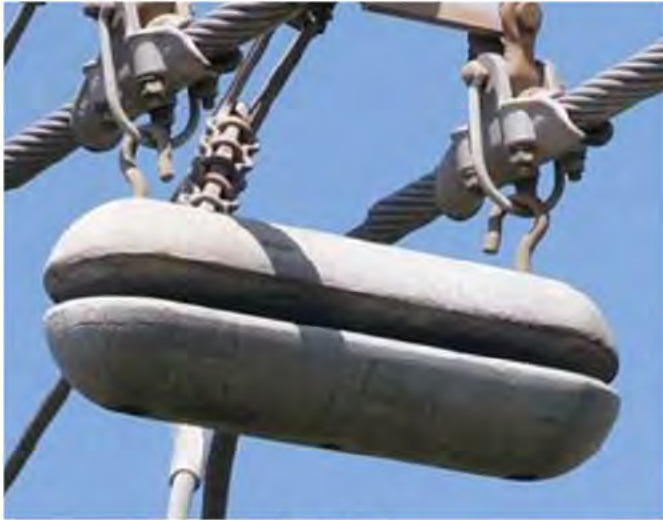
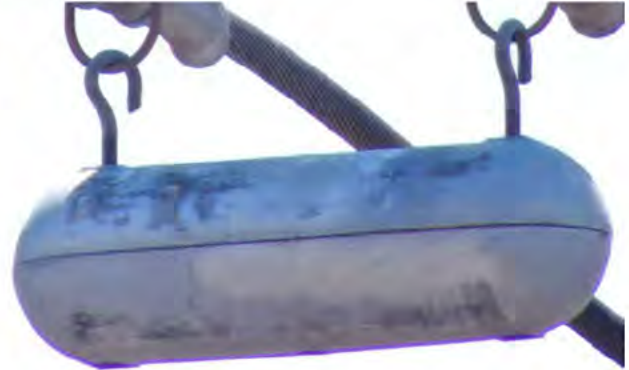
Condition: 3
Priority: **E**

Condition: 1
Priority: No notification required

Figure 217 Separation between weight (left). Weight is tight, no tag is necessary (right).

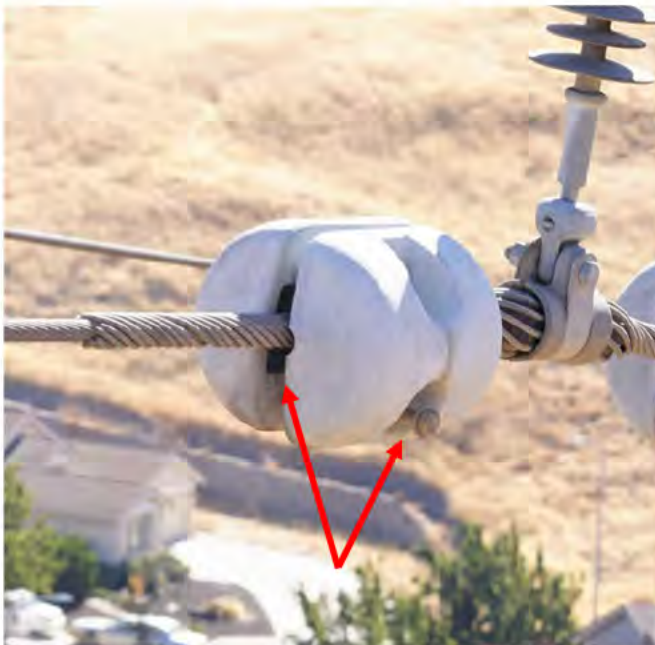
Condition: 3
Priority: **E**

Figure 218 Weight has loose hardware and separation from the armor rod (left). Weight is tight to the armor rod, no tag is necessary (right).

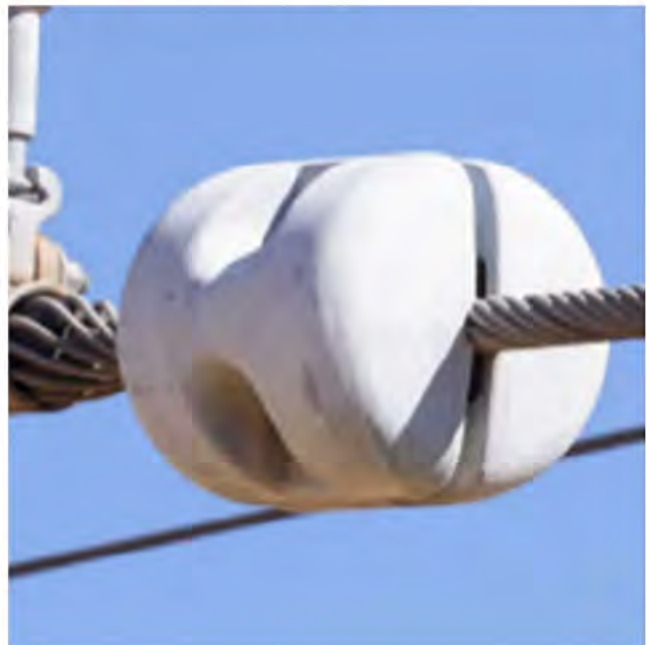
Condition: 1
Priority: No notification required

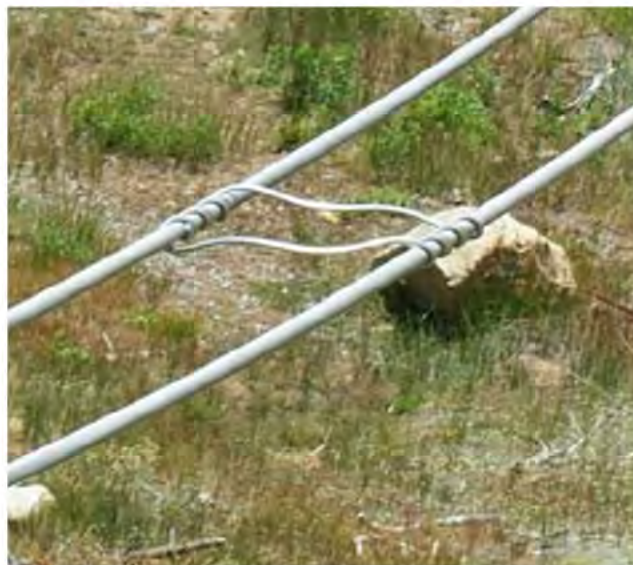
Condition: 1

Priority: No notification required

Figure 219 Spacer is tight on the conductor (left). Pre-form style spacers are acceptable as long as they aren't damaged or broken (right).

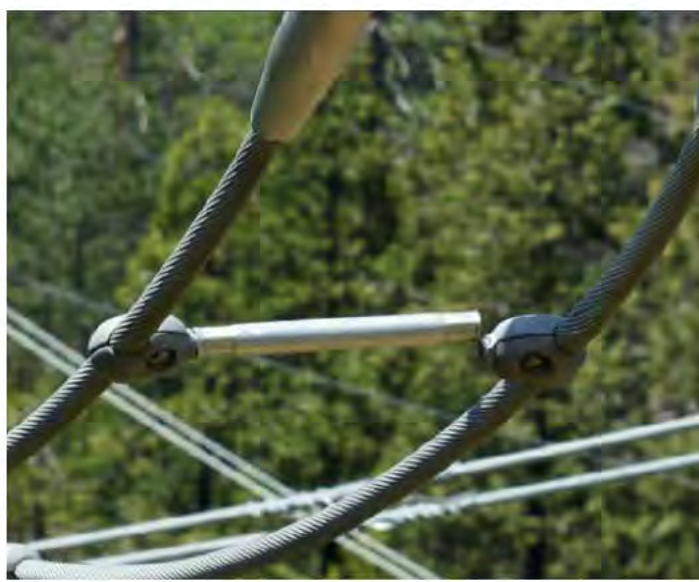
Condition: 3

Priority: E

FDA: Spacer- Wood/Steel|No Good/Out of Stdrd|Replace

Figure 220 Example of damaged spacers. Loose spacer (left) and broken spacer (right).

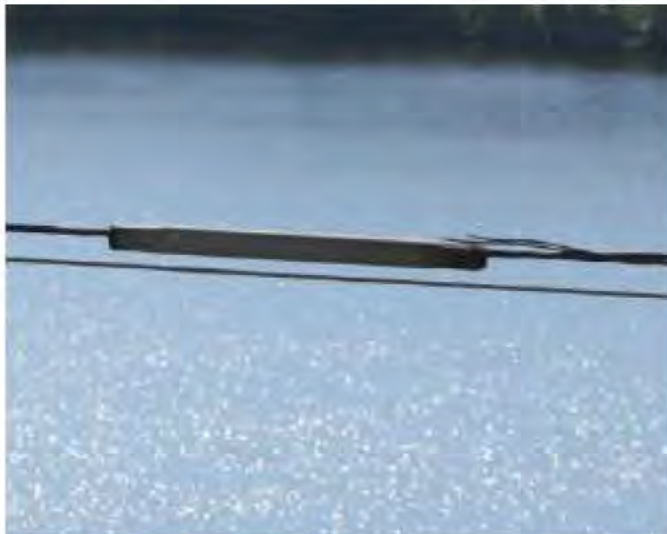
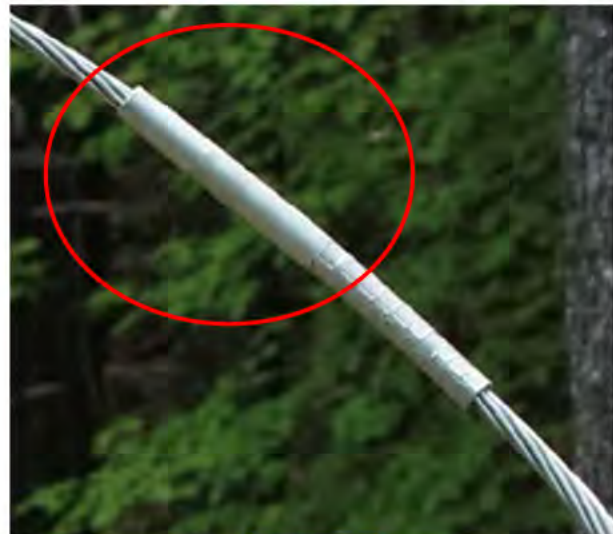
Condition: 5
Priority: A

FDA: Emergency | Storm Related | Repair

Figure 221 Failed splice (left). Splice is not compressed on one side (right).
