AERIAL INSPECTION REVIEW+ TEAM

AIR+ TEAM HANDBOOK

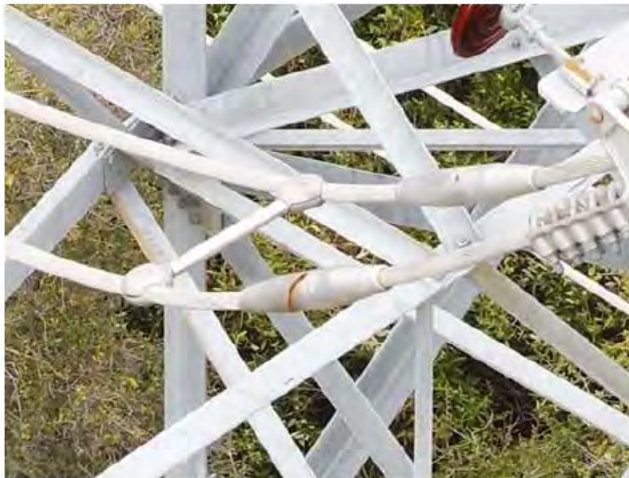
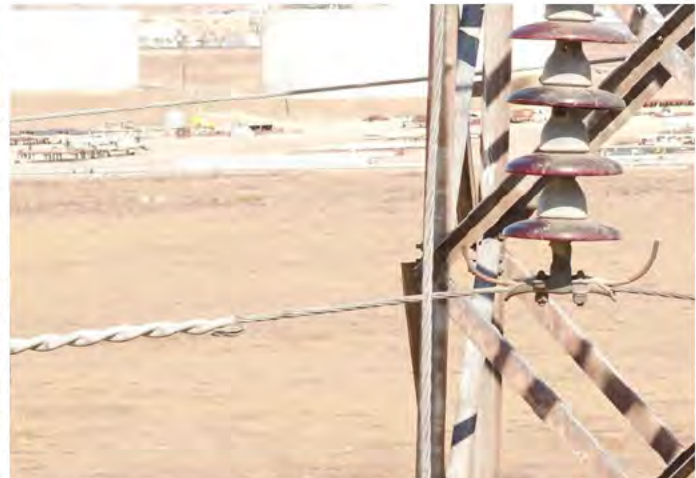
Condition: 1
Priority: No notification required
FDA: N/A

Condition: 3
Priority: E

FDA: Splice-Steel/Wood | No Good/Out of Stdrd | Replace

Figure 222 Implosion splice which is showing signs of interior corrosion with steel plug. No notification unless you notice crack in the housing or further issues (left). Splice within two feet of attachment (right).

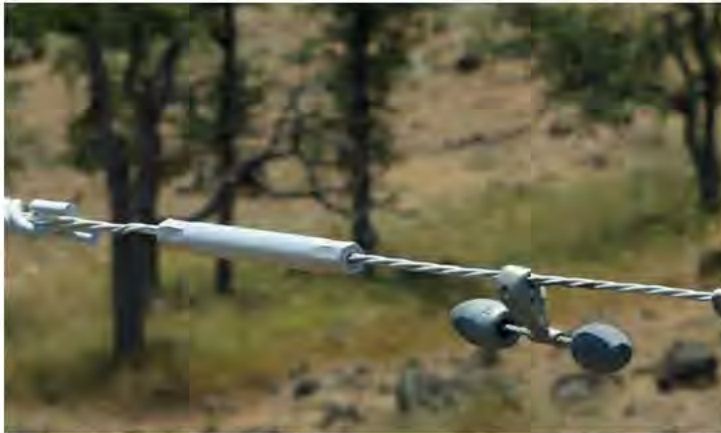
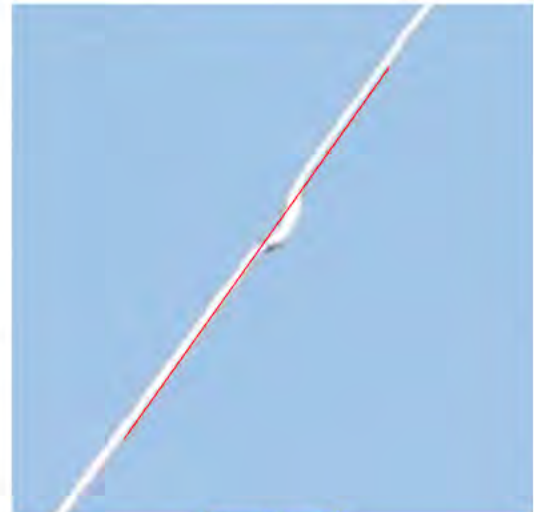
Condition: 3
Priority: E

FDA: Splice-Wood/Steel|No Good/Out of Stdrd|Repair

Figure 223 Compression splice with only compression marks on the ends (left). Bent compression splice "Banana", splice is bent above the top of the conductor line (right).

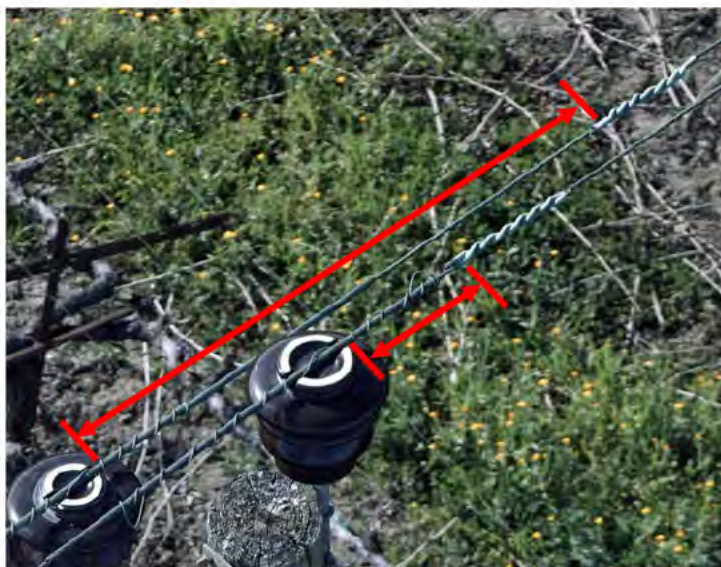
Condition: 3
Priority: E

FDA (1): Splice-Wood/Steel|No Good/Out of Stdrd|Repair
FDA (2): Splice-Wood/Steel|No Good/Out of Stdrd|Replace

Figure 224 For this structure two notification are needed. One to repair the splice $>2'$ - $<10'$ and one to replace the splice $<2'$ (left). Automatic splice outside of 10 feet (right). *Splice issues are not affected by the existence of dampers, please refer to damper section when inspecting for the damage of which.*

<ul style="list-style-type: none">Updated: EDEP FDA usage, switch number tags, aerial markers, Figure 34 priority, Figure 180 FDA, Figure 224 FDA, Foundation FDA's, Switch 'out of adjustment' guidance, buried secondary members, cold end hardware FDA, climbing racks, steel guy markers, guy bob requirements, Figure 53 priority
--	--	--

The use of automatic splices at any location on the conductor requires a notification. Automatic splices within 10' of the conductor clamp is considered a "E" notification. If the splice is 10' or more from the clamp it should be priority "E". See the guy wire section for automatic splices on guy wires.

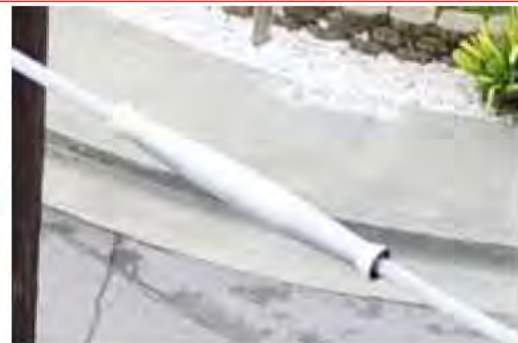
Condition: 3
Priority: E

FDA: Splice-Wood/Steel|No Good/Out of Stdrd|Replace

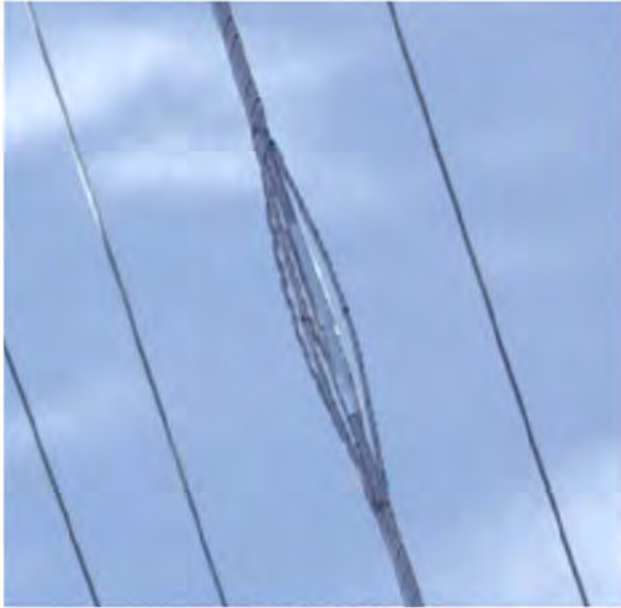
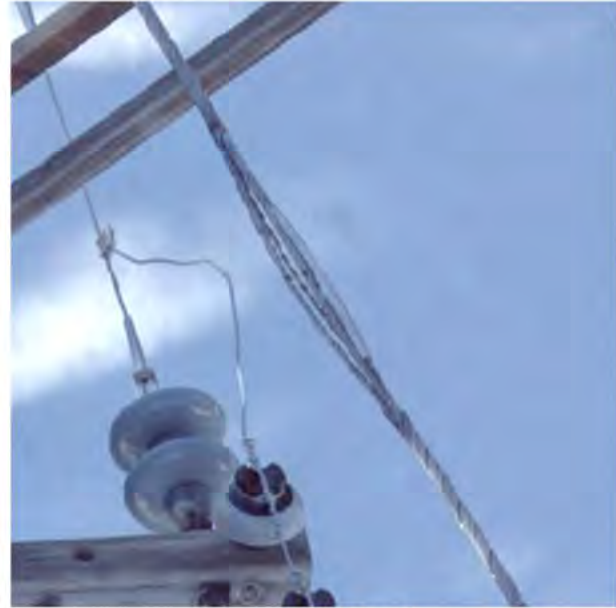
Condition: 1
Priority: No notification required

Figure 225 Examples of shunted splices. Splices that have been shunted, automatic or otherwise, are not a problem, unless there is damage to the splice itself.

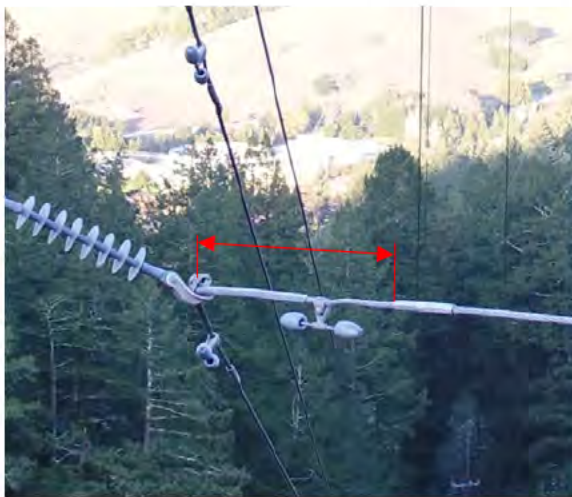
Condition: 3
Priority: E

FDA: Splice-Wood/Steel|No Good/**Out of**
Std|Repair

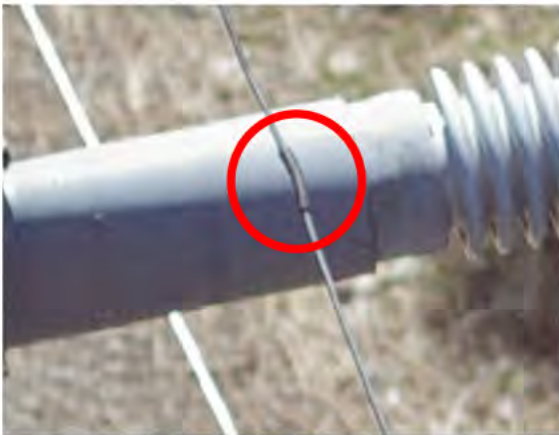
Condition: 3

Priority: E

FDA: Splice-Wood | No Good/Out of Std | Replace

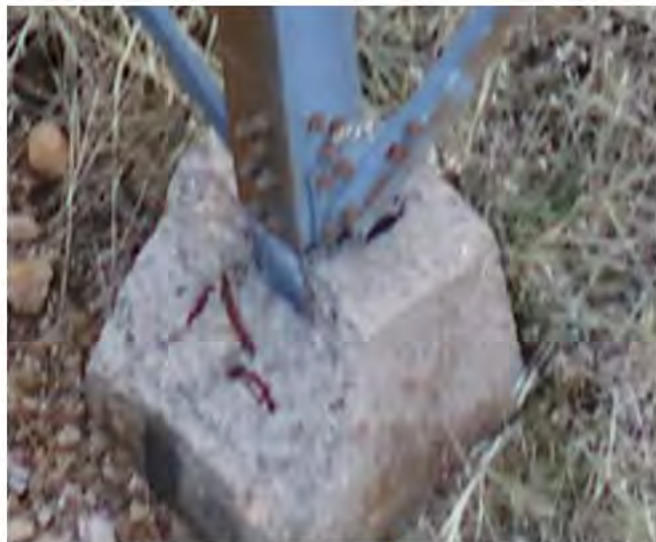
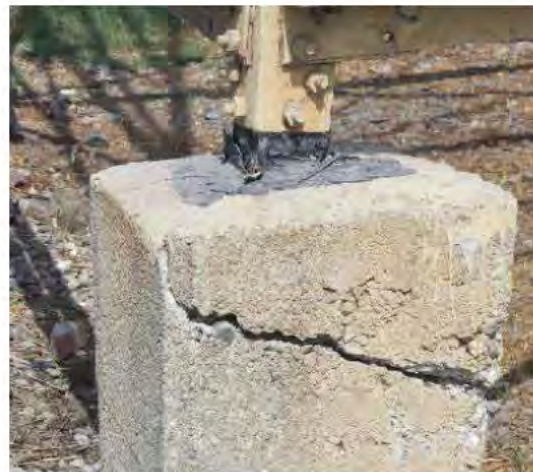
Condition: 3

Priority: E

FDA: Foundation/Concrete-Tower | No Good/Out of Std | Repair

Condition: 4

Priority: E+

Figure 228 Rebar exposed with > 50% material loss (left). Foundation crack exceeding 1/2" in width AND extended to the stub (right).

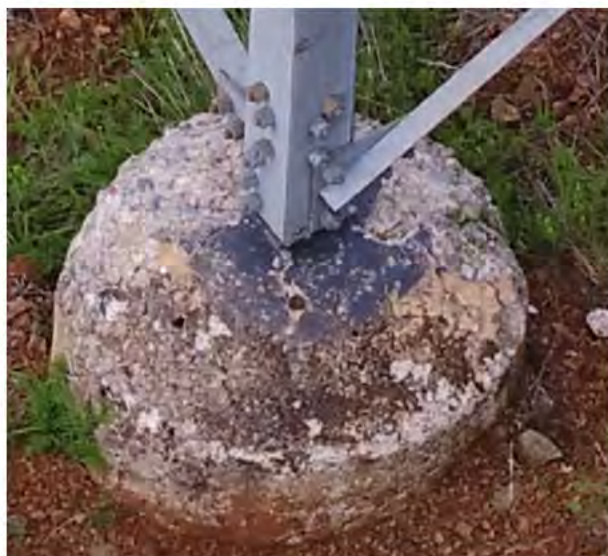
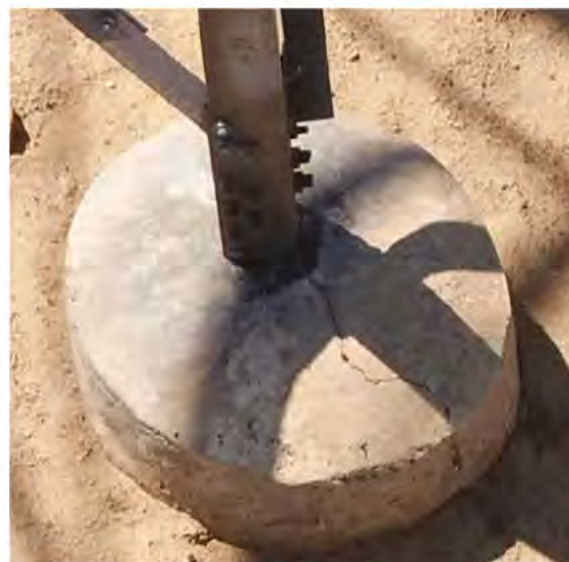
Condition: 3

Priority: E

FDA: Foundation/Concrete-Tower | No Good/Out of Std | Repair

Condition: 2

Priority: F

Figure 229 Moderate foundational damage (left). Foundation crack between 1/16" and 1/2" in width (right).

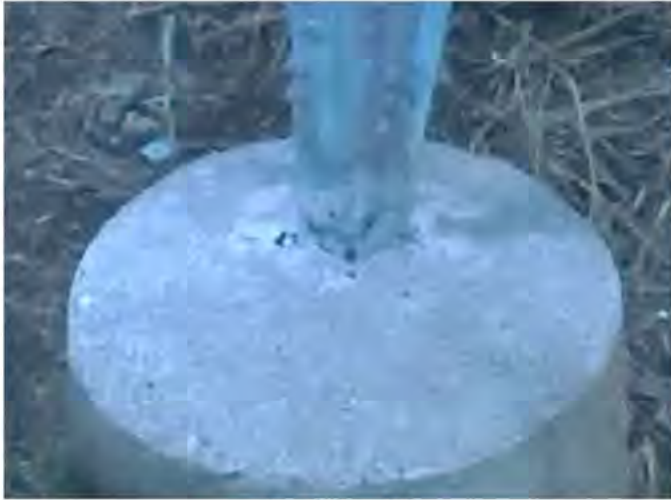
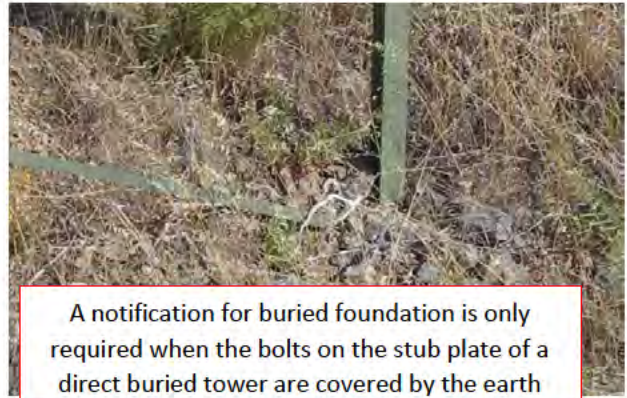
Condition: 1/2

Priority: None (outside of cont. dist)/F (in cont. dist.)

FDA: Foundation/Concrete-Tower | No Good/Out of Std | Repair

A notification for buried foundation is only required when the bolts on the stub plate of a direct buried tower are covered by the earth

Condition: 2

FDA(1): Foundation/Concrete-Tower | No Good/Out of Std | Repair

FDA(2): Structure-Tower | No Good/Out of Std | Repair

Stub in concrete not sealed (left), buried steel stubs **and buried secondary members** (right). If a structure has previously had mastic which has worn away, it should be given an F. However, the structure to the left has not, so its priority is based on if it is in a contamination district or not (see below).

Cracks less than 1/16"	Cracks between 1/16" and 1/2"
Not in corrosion district	Mastic never applied	No notification required	F
	Mastic was present, now worn	No notification required	F
In corrosion district	Mastic never applied	F	F
	Mastic was present, now worn	F	F

Table 7: Breakdown of priorities for mastic based on corrosion district, previously applied mastic, and the presence of cracks. This table is only intended as guidance for mastic issues. For a more detailed breakdown of damage to foundations, see [TD-1001M-JA12](#).

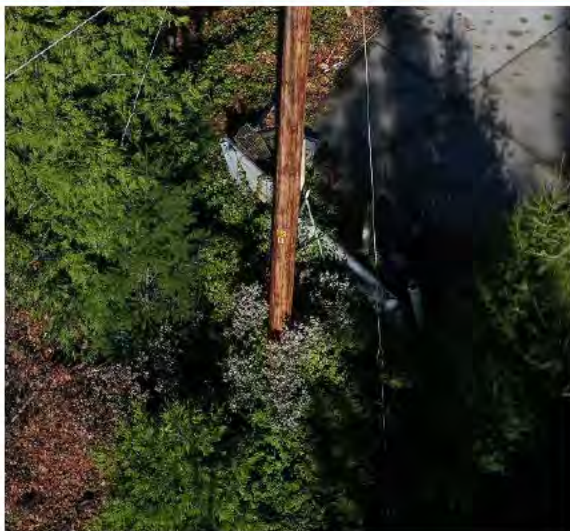
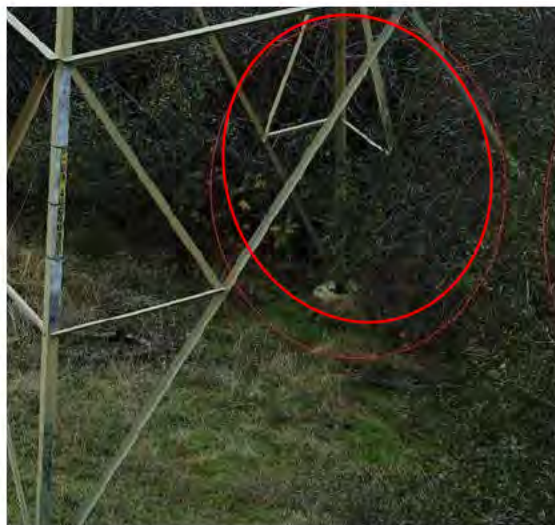
Condition: 3
Priority: E

FDA: Vegetation | Overgrown | Remove

Figure 231 **Vegetation around base of pole, warranting removal.**

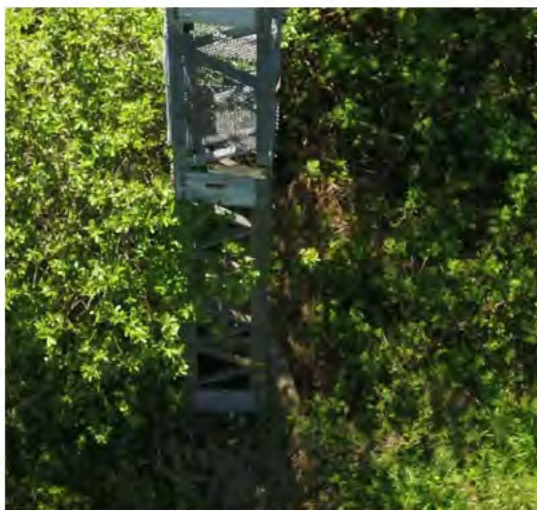
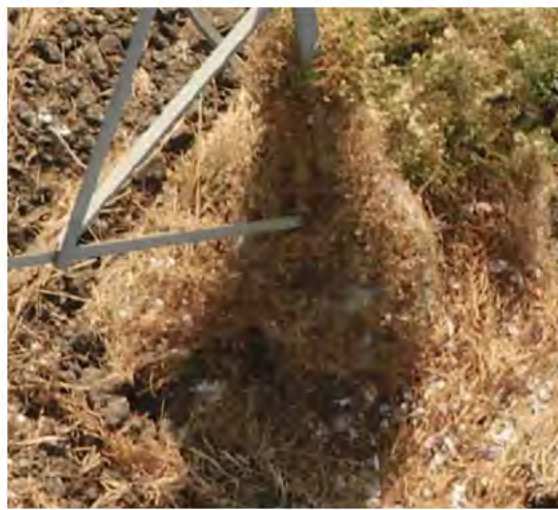
Condition: 3
Priority: E

FDA: Vegetation | Overgrown | Remove

Figure 232 **In general, only “woody” vegetation warrants a notification. “Woody” vegetation is vegetation that cannot be removed with a weed-eater or lawn mower. The vegetation on the left would be considered “woody” while the vegetation on the right would not. Vegetation on the right obstructs the visibility of the foundation.**

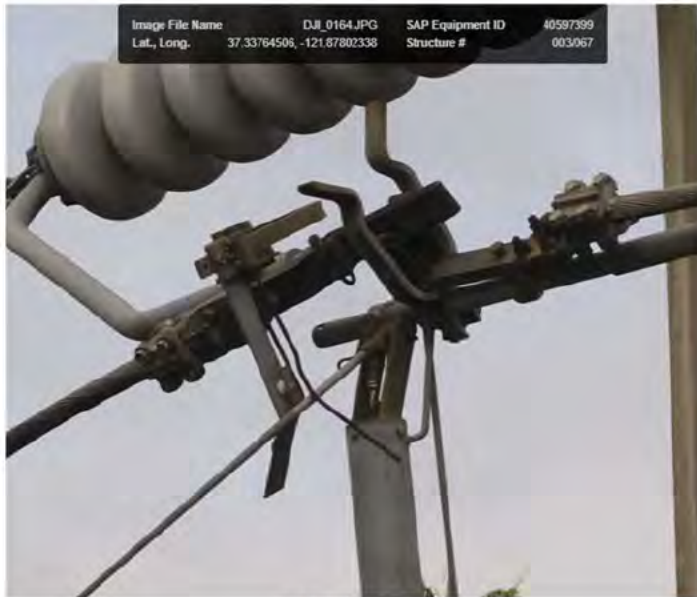
Condition: 5
Priority: A

FDA: Emergency-Steel(wood) | Other | Replace

Condition: 3
Priority: E

FDA: Switch-Steel | Out of Adjustment | Repair (Steel option)
FDA: Switch-Wood | No Good/Out of Stdrd | Repair (Wood option)

Condition: 4
Priority: E+

FDA: Switch-wood | No Good/Out of Stdrd | Repair

FDA: Switch | Out of adjustment | Repair

Figure 234 Switch out of adjustment and load break device not fully seated (upper left). Switch handle not bonded to platform (upper right). Missing and broken whip on fully seated switch (bottom left). Switch blade not seated (bottom right).

Out of Adjustment: When a switch is not FULLY seated with contacts, use E+ priority. When a switch is not operable, (switch not fully seated and load break mechanism not seated/captured), use A priority.

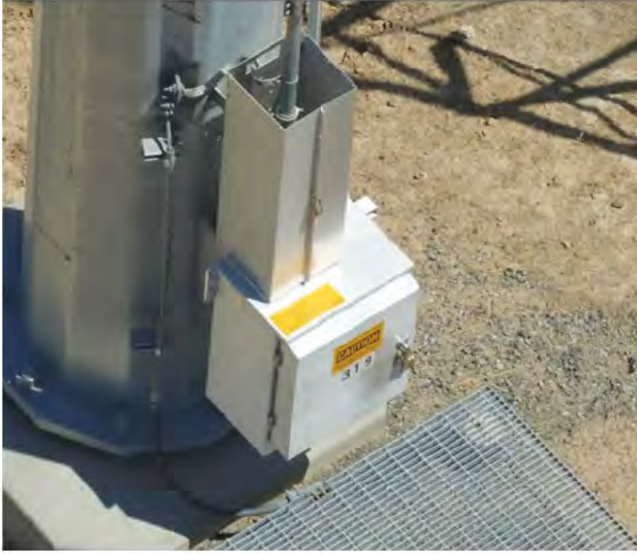
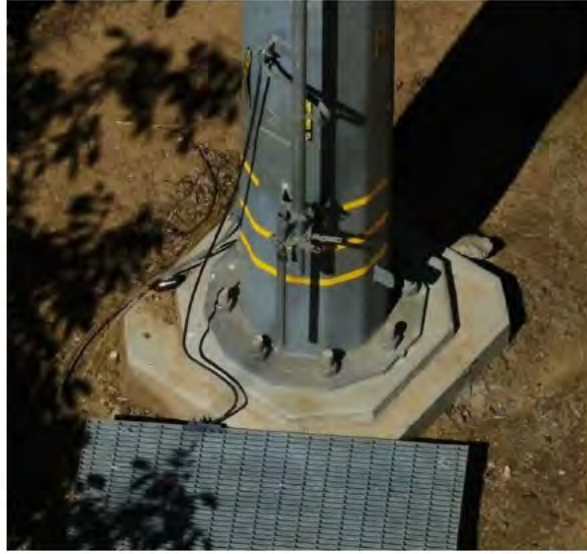
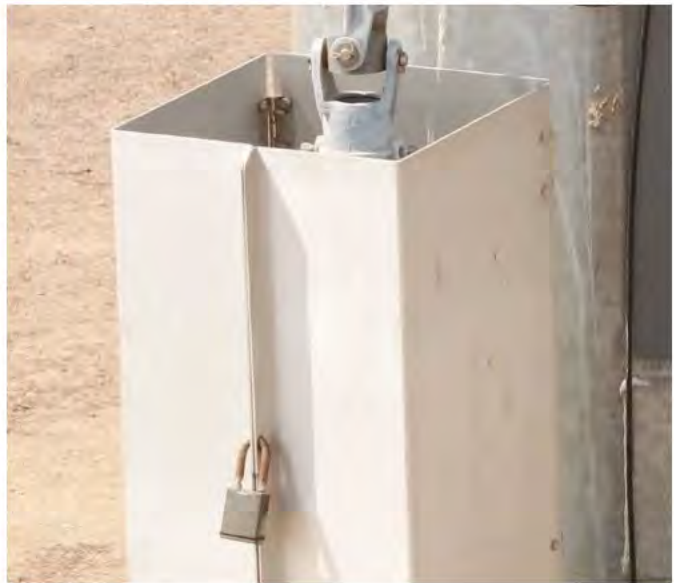
Condition: 1
Priority: **No notification required**

Condition: **3**
Priority: **E**
FDA: Switch-Steel|Out of Adjustment|Repair

Switches properly grounded (upper left and upper right). Platform improperly grounded, no direct connection between handle and platform (bottom left). **Unlocked shroud doesn't qualify as a non-conformance** (bottom right).

8.1	01/30/2023	<ul style="list-style-type: none"> • Figure 235 – right image change to condition 1, no notification required • Figure 46 – right example FDA corrected • Figure 23 – left image example corrected priority per JA13 pg16

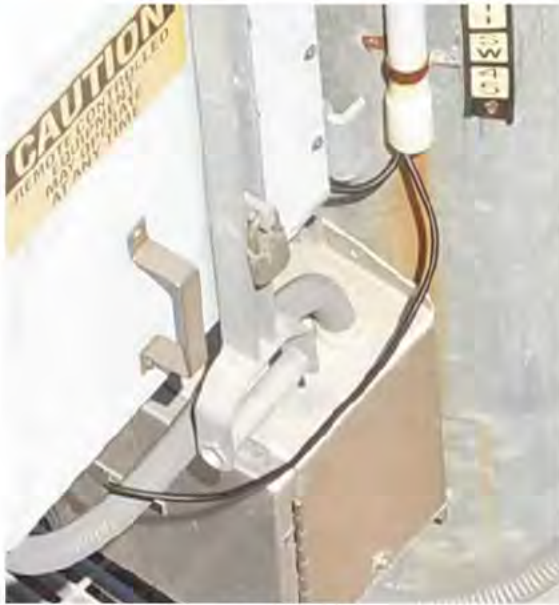
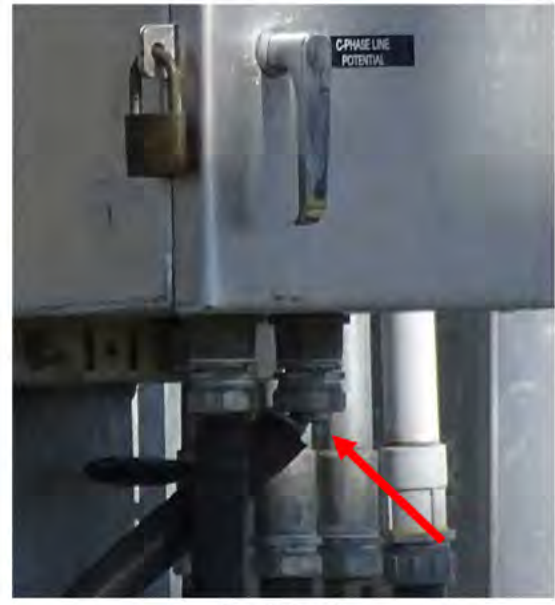
Condition: 5
Priority: A

FDA: Emergency | Storm Related | Repair

Figure 236 Examples of exposed switch control wiring at ground level.

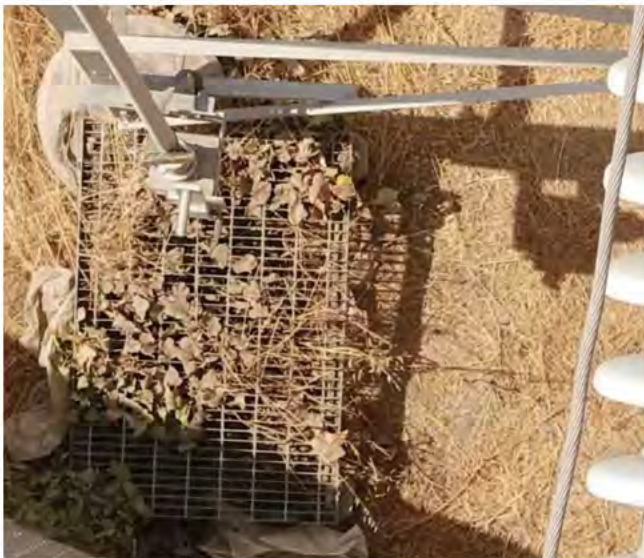
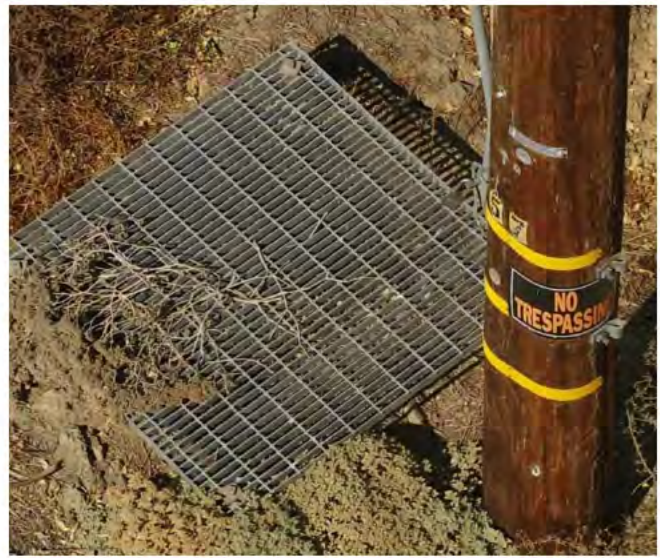
Condition: 3
Priority: E

FDA: Vegetation | Overgrown | Remove

Figure 237 Generally, any vegetation encroaching on a switch platform warrants an E tag, regardless of the thickness. Grass or weeds should still call for an E tag.

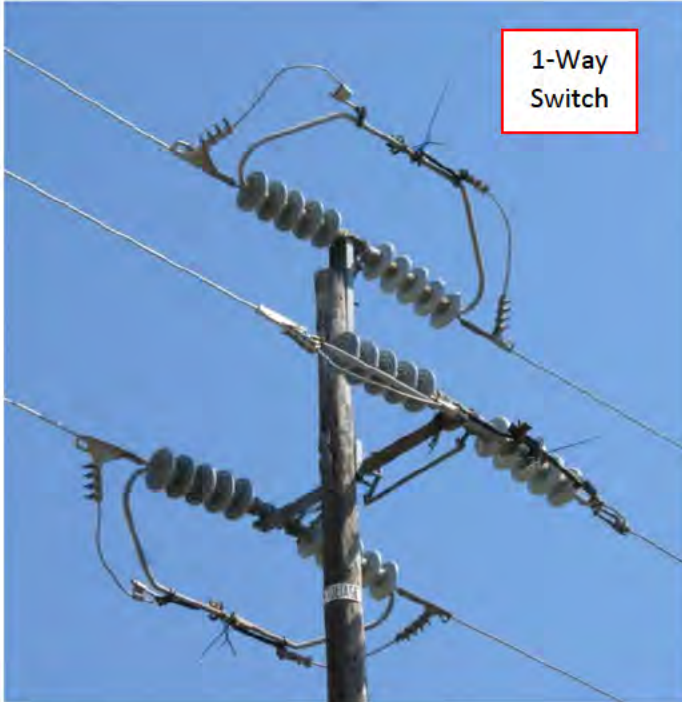
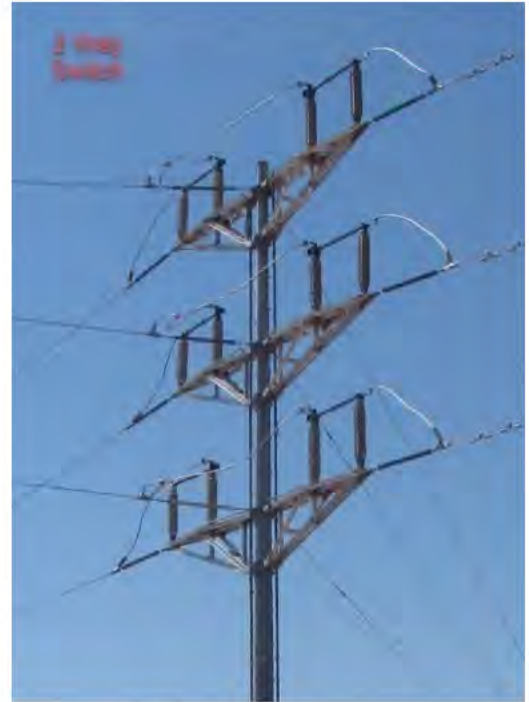
For the purposes of the inspection form, the answer to “How many switches are present?” and “Number of switches” should be as follows: Each individual set of switches counts as one. Therefore, a 1-Way switch counts as 1, a 2-Way switch counts as 2 and a 3-Way switch counts as 3.

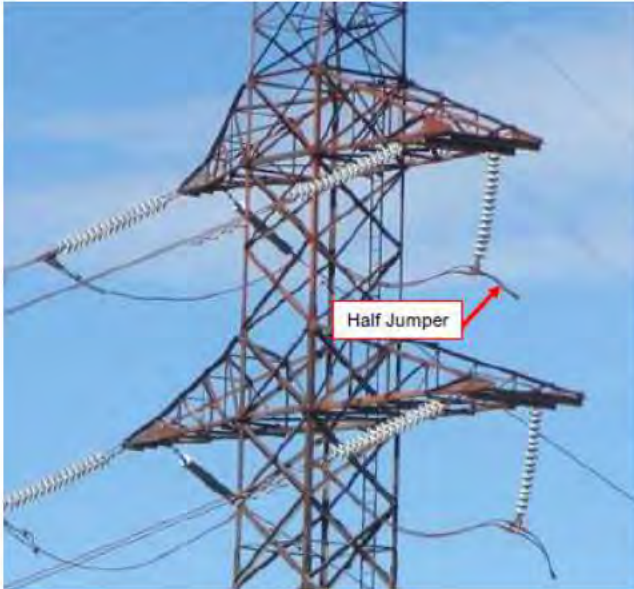
Condition: 5
Priority: A

FDA: Emergency | Storm related | Repair

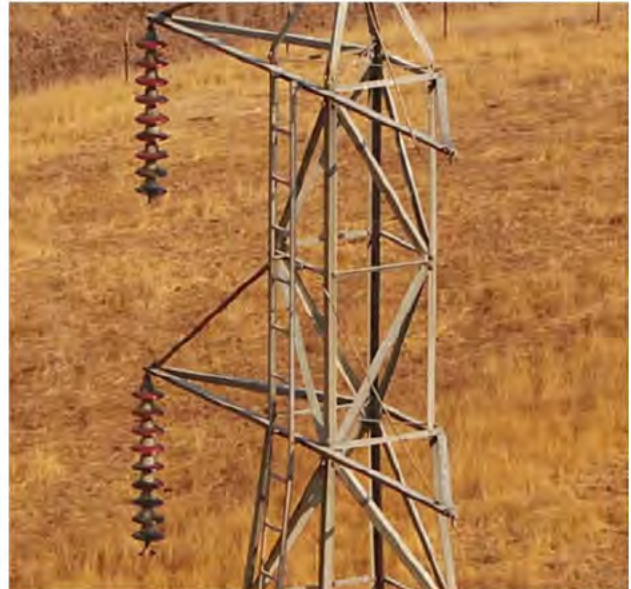
Condition: 3
Priority: E

FDA: Structure-Steel | Debris | Remove

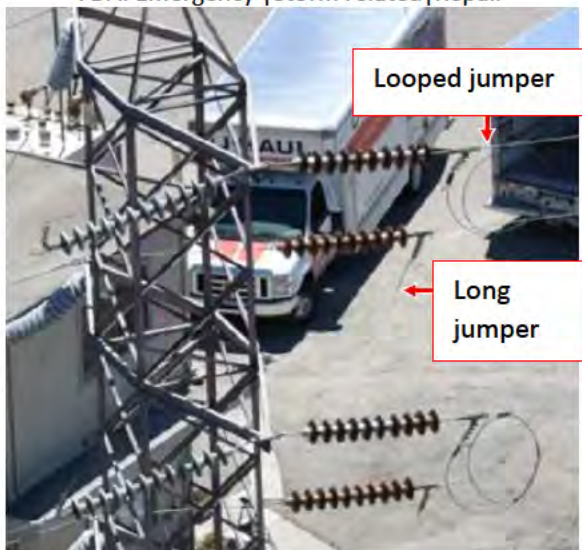
Condition: 2
Priority: F

FDA: Structure-Steel | Debris | Remove

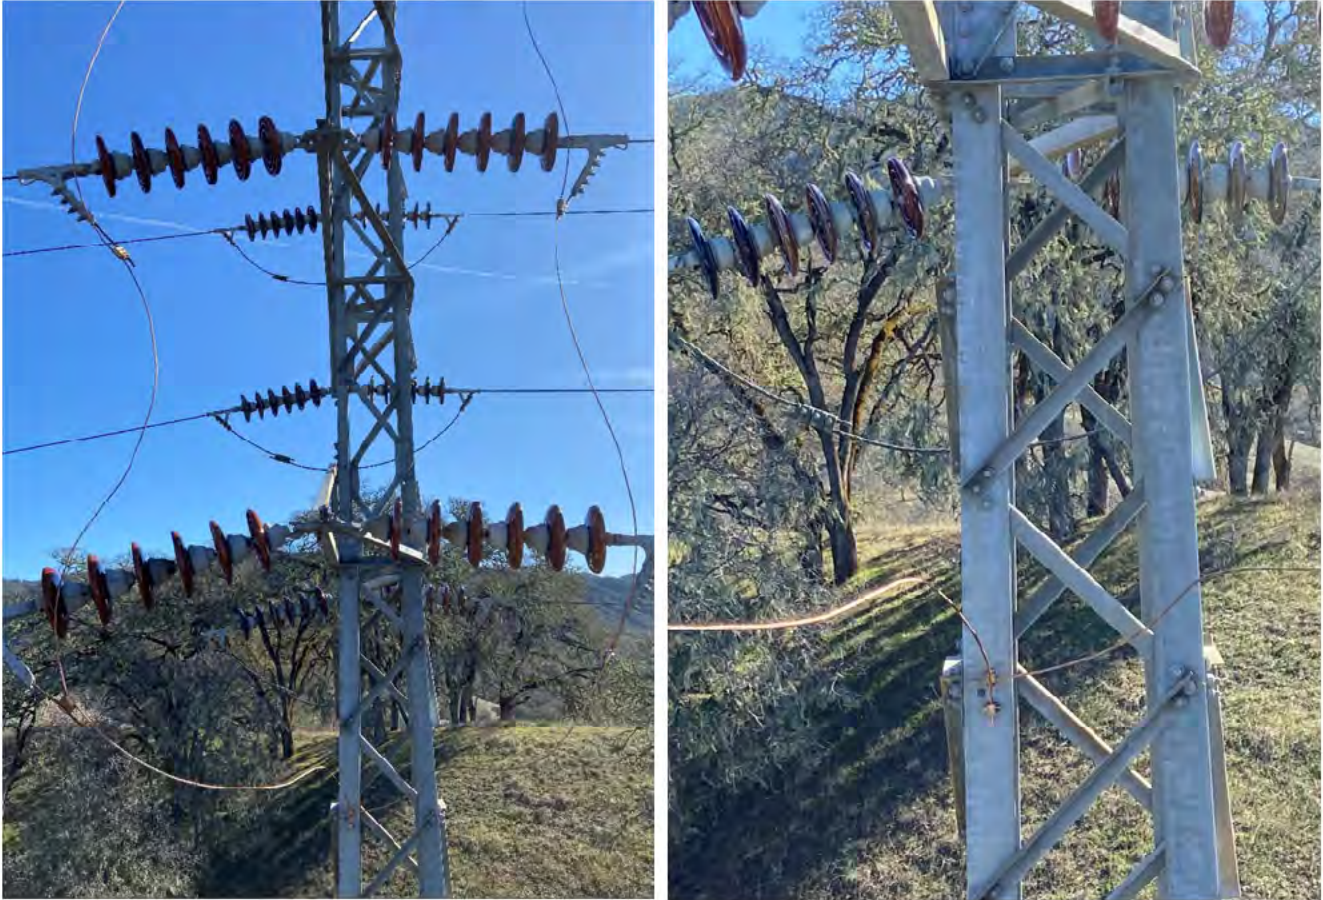
Grounded idle facilities

Condition: 1

Priority: No notification required
