**CALIFORNIA UNDERGROUND FACILITIES SAFE EXCAVATION BOARD
INVESTIGATION DIVISION
INVESTIGATION REPORT**

CASE No.: D230130001

INCIDENT: Failure to provide electronic positive response

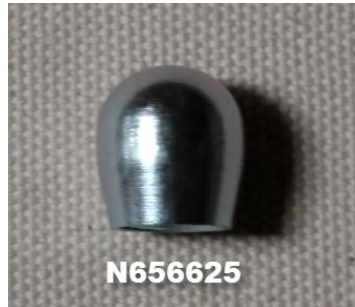
FIGURE 2

- 4.3.5. Make sure the metal ball on the end of the bar probe is present and securely fastened to the probe. An Impacto Bar that either has no metal ball or a no longer rounded ball can cause unintentional damage to underground substructures and can affect the tool's proper operation. Replacement balls are available to order through local storerooms (N656625). See **Figure 2** below.

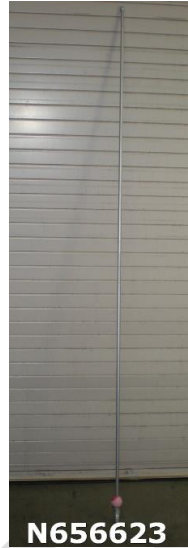
FIGURE 4

- 4.3.7. If desired, a longer 72-inch metal probe is available for order. Order the optional size through the local storeroom (**N656623**). See **Figure 4** below.

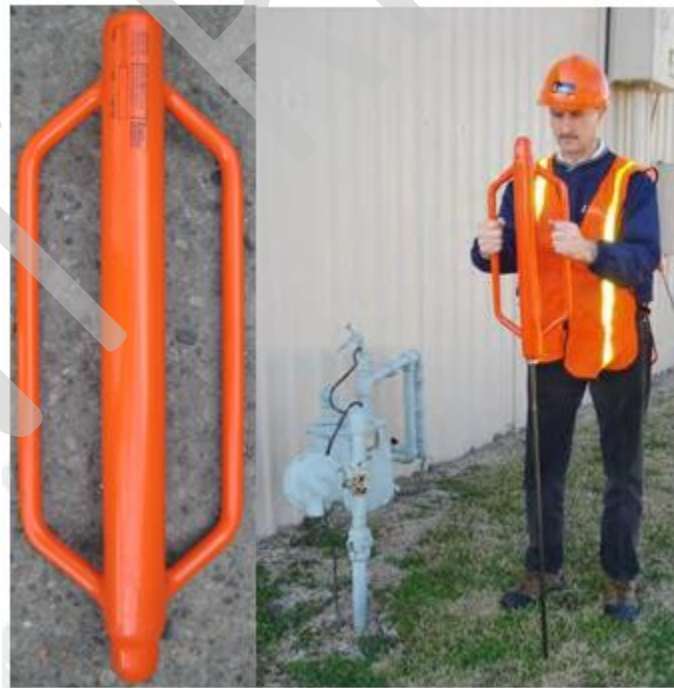
FIGURE 5

- 4.6.1. To alleviate stress on the body from repetitive action, such as large areas requiring multiple bar holes, or in hard surfaces, or hard road base, a two-handled Angle Fin Impacto Bar handle is a substitute for the single-handle model. See **Figure 5**.

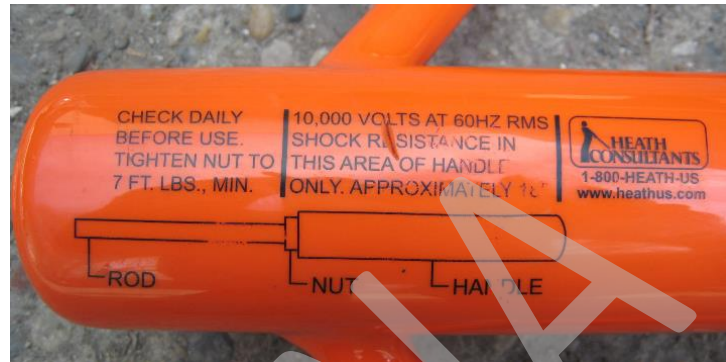
FIGURE 8

- Replace the handle if the rod and piston assembly does not move freely or you hear loose pieces.
- The Guide nut is securely threaded into the handle. See the diagram in **Figure 8** for the location of the nut.
