Burbank Water and Power

# WILDFIRE MITIGATION PLAN

2024

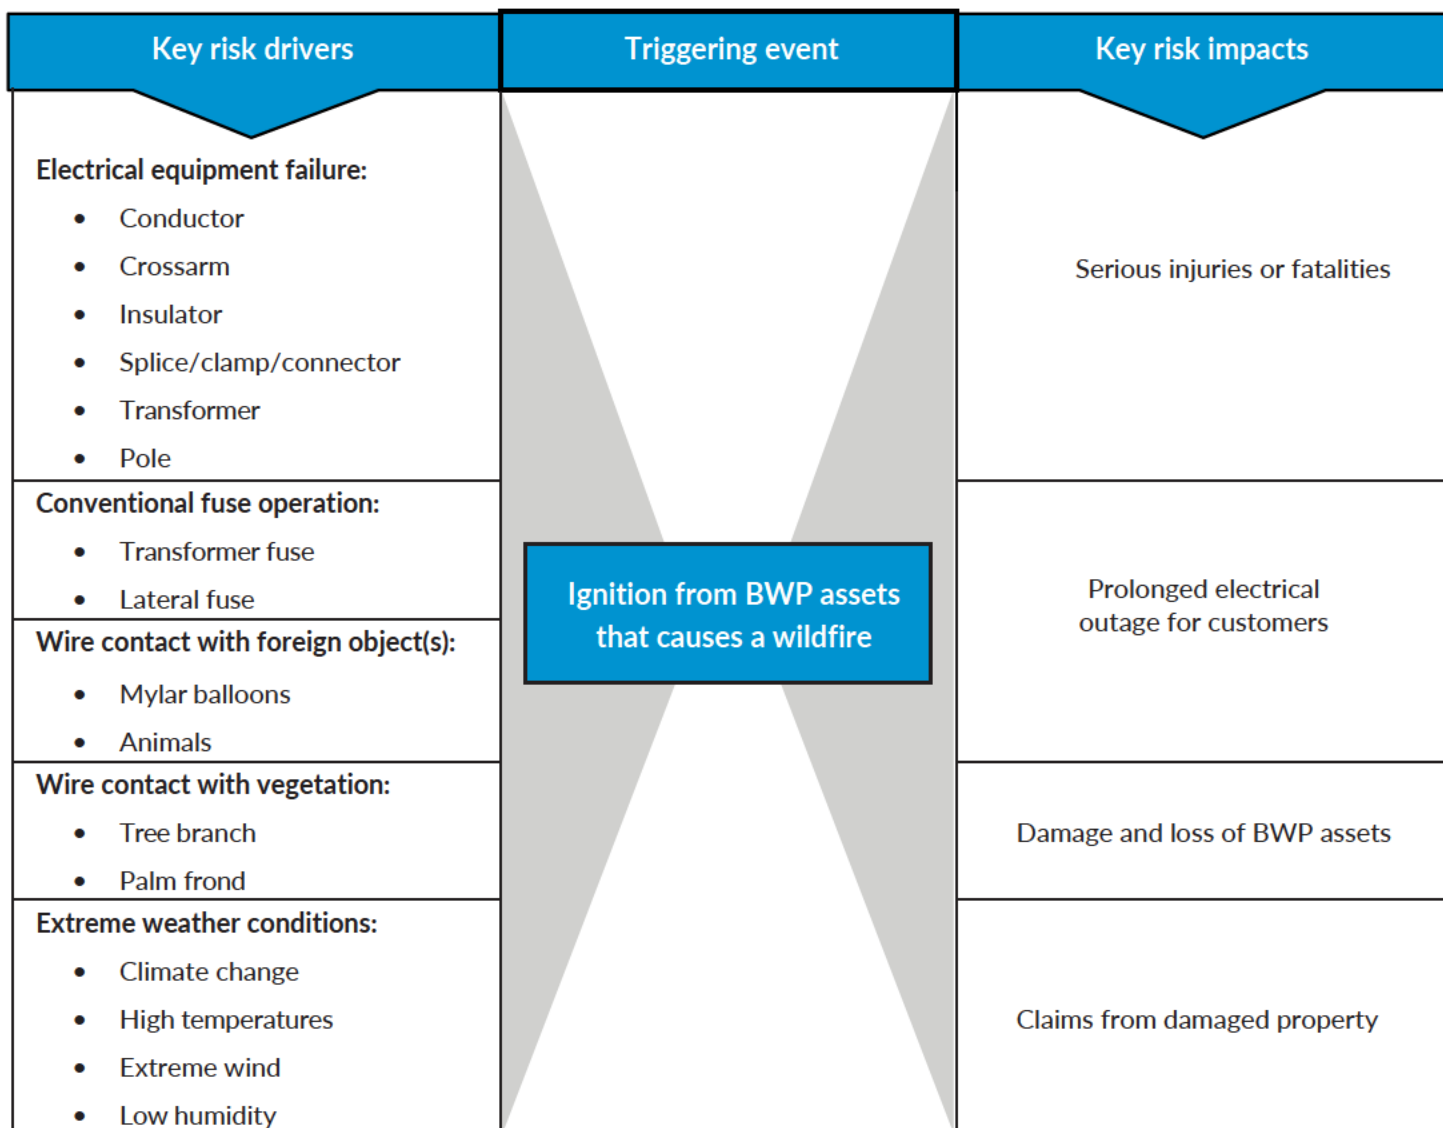
Figure 3 - BWP's wildfire risk bowtie

The risk of a vegetation ignition and potential for an uncontrollable wildfire caused by BWP electrical facilities is related to the type of vegetation (fuel bed) within its vicinity, the local/regional weather patterns, and the potential for a failure of BWP's equipment. For example, areas that include uninterrupted, natural (unmaintained) vegetation present a risk of ignition from ongoing operational activities or equipment failures. When the area also includes weather conditions that result in periodic high wind and low humidity, the wildfire risk is significantly enhanced. Both of these weather conditions can occur in BWP's Tier 2 HFTD area. A bow tie analysis was conducted to identify these risk drivers as well as their potential resulting impacts. Figure 3 provides the risk bow tie diagram, which summarizes the assessment process.

Risk drivers are important to identify because they are the primary ways in which BWP electrical facilities could result in a catastrophic wildfire. The center of the bow tie chart is the triggering event, which is an ignition caused by a BWP asset resulting in a catastrophic wildfire. During the wildfire threat assessment, five categories were identified as potential drivers for causing fire ignitions:

If one of the risk drivers listed above were to occur, resulting in a wildfire ignition caused by BWP electrical facilities, there could be potential consequences for BWP as presented on Figure 3.
