## NOTICE OF DATA INACCURACY

# INSPECTION REPORT

Electrical Corporation:	San Diego Gas & Electric Company
Report Number:	PAD_SDGE_SIS_20260408_0959
Date of Inspection:	April 08, 2026
City and/or County of Inspection:	Valley Center, San Diego County
Inspector:	Samuel Isaiah
WMP Year Inspected:	2025
Quarterly Data Report (QDR) Referenced:	Quarter 3 (Q3)
Inspection Selection:	Energy Safety viewed the contents of the Q3 QDR and performed an analysis that resulted in the selection of the WMP initiatives and locations referenced in this report.
Relevant WMP Initiative(s):	8.1.4.6 – Lightning Arrester Removal and Replacement (WMP.550)
Inspection Purpose:	Assess the accuracy of San Diego Gas & Electric Company’s QDR data, completeness of its work, and performance of WMP requirements.

## WMP Inspection Data Inaccuracies

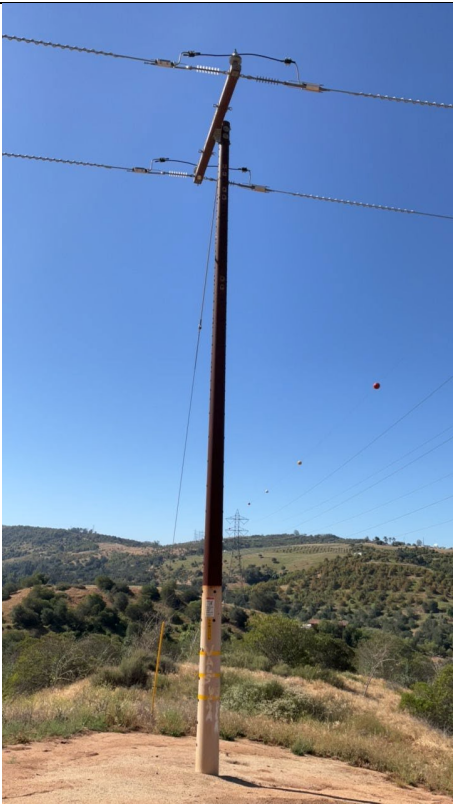
A photograph showing a tall wooden utility pole with multiple cross-arms and power lines. The pole is situated in a dry, hilly landscape under a clear blue sky.

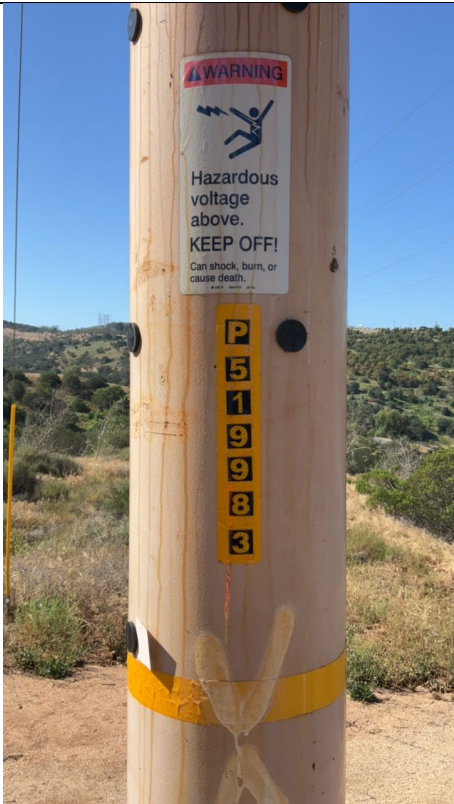
A close-up photograph of the utility pole. It features a white warning sign with a lightning bolt icon and the text: "WARNING Hazardous voltage above. KEEP OFF! Can shock, burn, or cause death." Below the sign is a yellow vertical label with the structure ID "P519983" and a yellow horizontal band at the bottom.
<p><b>General Image1:</b> Overall structure</p>	<p><b>General Image2:</b> Structure ID</p>

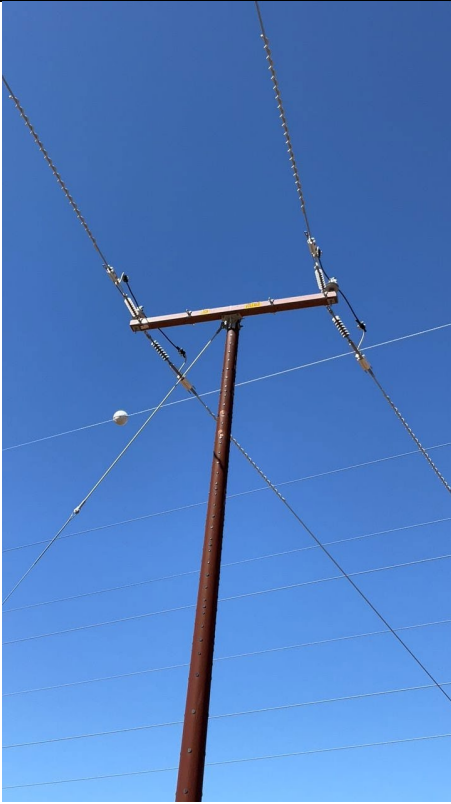
On Pole ID P519983, Grid Hardening ID 300000596492\_P519983\_92431 at Valley Center, CA, 92082, 33.329414, -117.104047, the inspector observed that covered conductor was installed, but no lightning arresters were replaced (or upgraded) at the reported pole. The inspector's observation is documented in Data Inaccuracy 1 photographs, which are attached to this report as Exhibit A. Photo numbers Asset Image 1 and Asset Image 2 depict that no lightning arresters were replaced or upgraded on the pole.

**Asset Image 1:** Lighting arresters not present

Within 30 days from the issuance date of this NODI, SDG&E should provide a response advising Energy Safety of corrective actions taken or planned to remedy the identified data inaccuracy or inaccuracies.

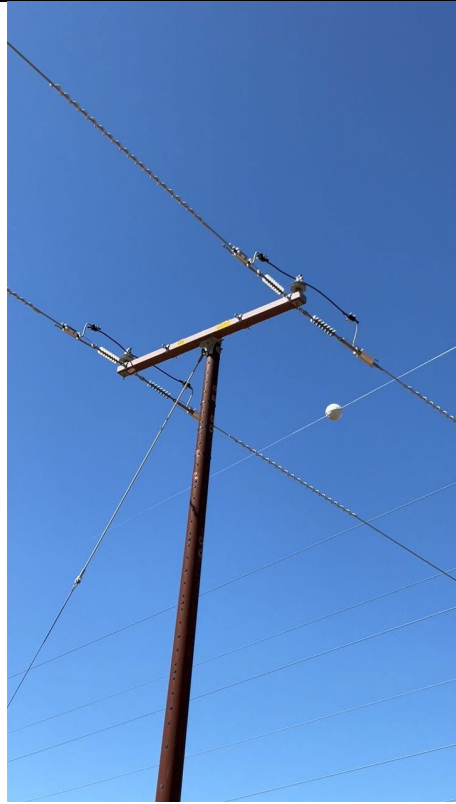
**Asset Image 2:** Lighting arresters not present
