## **NOTICE OF DATA INACCURACY**

## INSPECTION REPORT

Electrical Corporation:	Pacific Gas and Electric Company
Report Number:	PAD_PGE_BKA_20251105_1239
Date of Inspection:	November 5, 2025
City and/or County of Inspection:	Cool, El Dorado County
Inspector:	Babak Kaviani
WMP Year Inspected:	2025
Quarterly Data Report (QDR) Referenced:	Quarter 2 (Q2)
Inspection Selection:	Energy Safety viewed the contents of the Q2 QDR and performed an analysis that resulted in the selection of the WMP initiatives and locations referenced in this report.
Relevant WMP Initiative(s):	8.1.2.1 – Covered Conductor Installation – Distribution
Inspection Purpose:	Assess the accuracy of Pacific Gas and Electric Company’s QDR data, completeness of its work, and performance of WMP requirements.

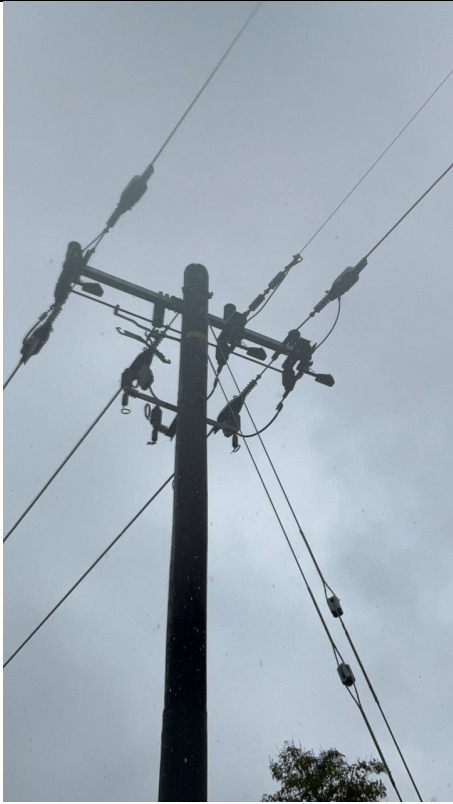
On Pole ID 121901742, Grid Hardening ID 35305310 at Mile 4.1 State Hwy 193 E, Cool, CA, 95614, USA, 38.8989112519005, -120.947950005085, the inspector observed no covered conductor installation on the middle phase on the west side of the pole. The inspector's observation is documented in Data Inaccuracy 1 photographs, which are attached to this report as Exhibit A.

1. PG&E reported in the 2025 Q2 QDR that work on WMP initiative 8.1.2.1 – Covered Conductor Installation – Distribution was completed at this location.
2. The inspector did not observe covered conductor installation on the middle phase on the west side of the Pole ID 121901742.
3. The inspector observed bare conductor on the middle phase on the west side of the Pole ID 121901742.

**IA1Img1:** Close up view of pole 121901742 showing a bare conductor on the west side of the middle phase

Within 30 days from the issuance date of this NODI, PG&E should provide a response advising Energy Safety of corrective actions taken or planned to remedy the identified data inaccuracy or inaccuracies.

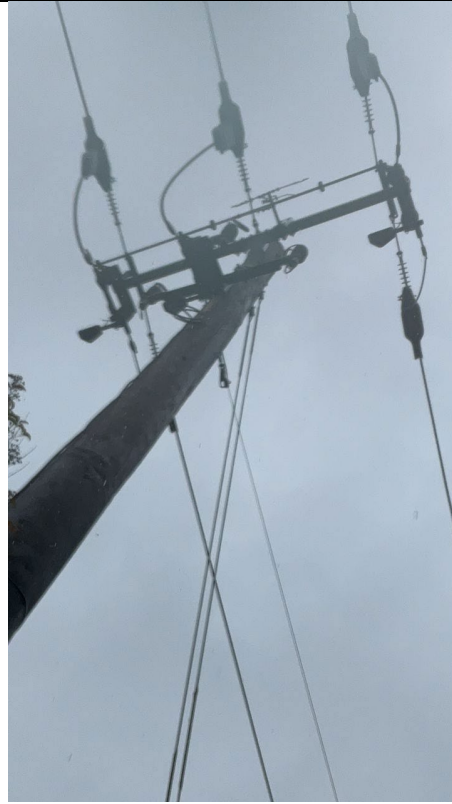
**IA1Img2:** Close up view of pole 121901742 showing a bare conductor on the west side of the middle phase
