## **NOTICE OF NON-PERFORMANCE**

# INSPECTION REPORT

Electrical Corporation:	Pacific Gas and Electric Company
Report Number:	PAD_PGE_RMA_20260225_1347
Inspector:	Romeo Marroquin Ajcac
WMP Year Inspected:	2025
Quarterly Data Report (QDR) Referenced:	Quarter 3 (Q3)
Inspection Selection:	Energy Safety viewed the contents of the Q3 QDR and performed an analysis that resulted in the selection of the WMP initiatives and locations referenced in this report.
Relevant WMP Initiative(s):	8.1.2.10.5 - Non-Exempt Expulsion Fuses
Date of Inspection:	February 25, 2026
City and/or County of Inspection:	Angwin, Napa County
Inspection Purpose:	Assess the accuracy of Pacific Gas and Electric Company’s QDR data, completeness of its work, and performance of WMP requirements.

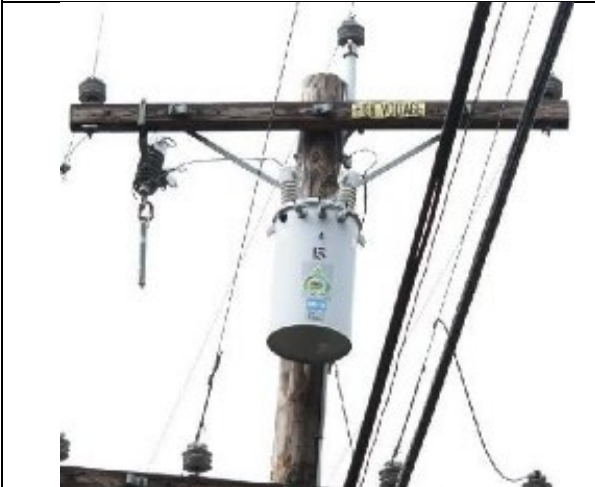
In the 2025 Q3 Quarterly Data Report submission, PG&E reported that work on WMP initiative 8.1.2.10.5 – Non-Exempt Expulsion Fuses was completed at Pole ID 110500257, Grid Hardening ID 31742800 at 1-91 Cold Springs Rd, Angwin, CA, 94508, USA, 38.5649660898935, -122.439116400552. At this location, the inspector observed that an exempt fuse was left in the open position in its cutout. The inspector's observation is documented in Deficiency 1 photographs, which are attachments to this report. Photo numbers IA1Img1 and IA1Img2 depict an exempt fuse in the open position in its cutout.

1. The inspector observed an exempt fuse in the open position in its cutout.

**IA1mg1:** Exempt fuse in the open position in its cutout.

Deficiency 1. Energy Safety observed that in implementing 2025 WMP initiative 8.1.2.10.5 – Non-Exempt Expulsion Fuses, PG&E failed to complete the installation of non-exempt expulsion fuses on Pole ID 110500257, Grid Hardening ID 31742800 at coordinates 38.5649660898935, -122.439116400552. Energy Safety considers this non-performance to be in the Minor risk category. PG&E must complete a corrective action for this deficiency by 12 months of this notice.

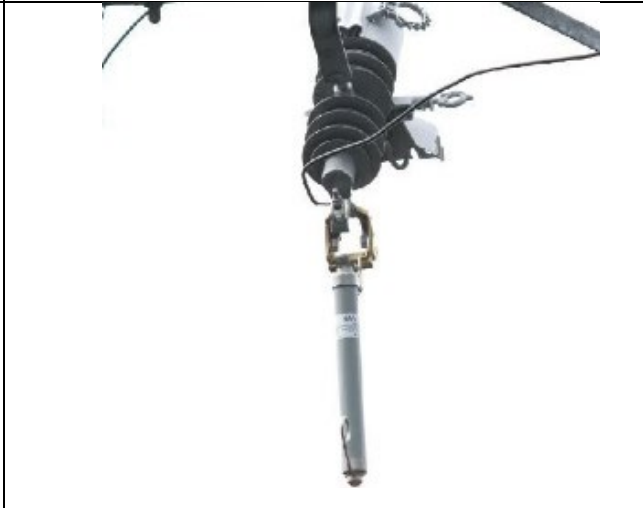
**IA1mg2:** Exempt fuse in the open position in its cutout (close view).
