**CALIFORNIA UNDERGROUND SAFETY BOARD
INVESTIGATION DIVISION**

INVESTIGATION REPORT

Case No.: N243261302

On November 20, 2024, Solar Central, Inc. was installing an electrical grounding rod with a hammer without first contacting the regional notification center and damaged a ½" plastic natural gas facility. Upon the escape of gas from the subsurface installation, Solar Central, Inc. did not call 911 emergency services to report it. No one was injured and no equipment, other than the ½" plastic natural gas facility, was damaged.

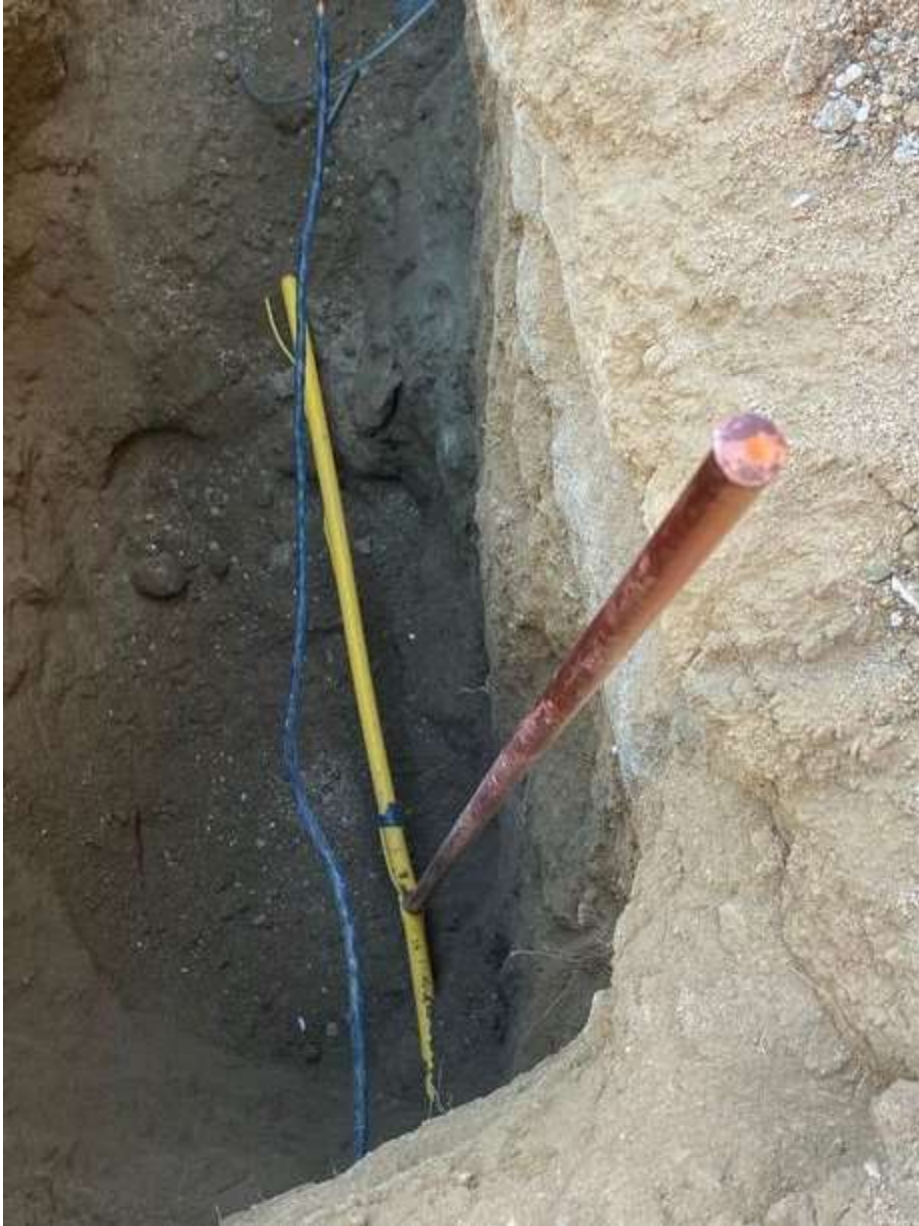
Provide any other relevant information about the damage on 11/20/2024.
Solar Central INC was installing ground rod in the process Solar Central INC truck .5 plastic gas service while excavating with no USA ticket.

Gas service was punctured with ground rod.
