April 17, 2025

Patrick Doherty
Program Manager | Compliance Assurance Division
Office of Energy Infrastructure Safety
715 P Street, 20th Floor
Sacramento, CA 95814

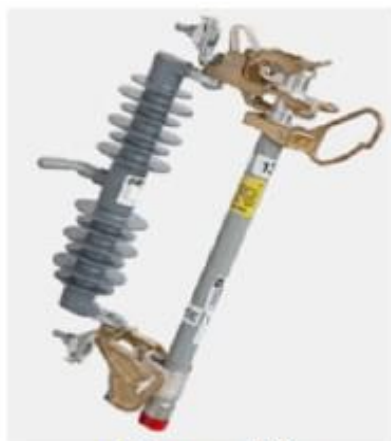
The exempt fuses are shown hanging on the poles steps and conform to PG&E guidance document 15225 (1.C.1) for care and handling of Type E Power fuses. As shown in Image 1 and Image 2 below, both the Part63H cutout and the Type E Power Fuse have distinct features that distinguish them from Part 44H cutouts and the non-exempt universal fuses they can accept. Part63H cutouts are noticeably larger than Part 44H cutouts and the Type E Power Fuses have an oblong ring to support installation and removal. Another identification characteristic is the cap installed on the bottom of the fuse and the absence of a visible fuse element exiting the fuse holder.
