June 9, 2025

Patrick Doherty, Compliance Program Manager
Compliance Assurance Division
Office of Energy Infrastructure Safety
California Natural Resources Agency
715 P Street 20th Floor
Sacramento, CA 95814

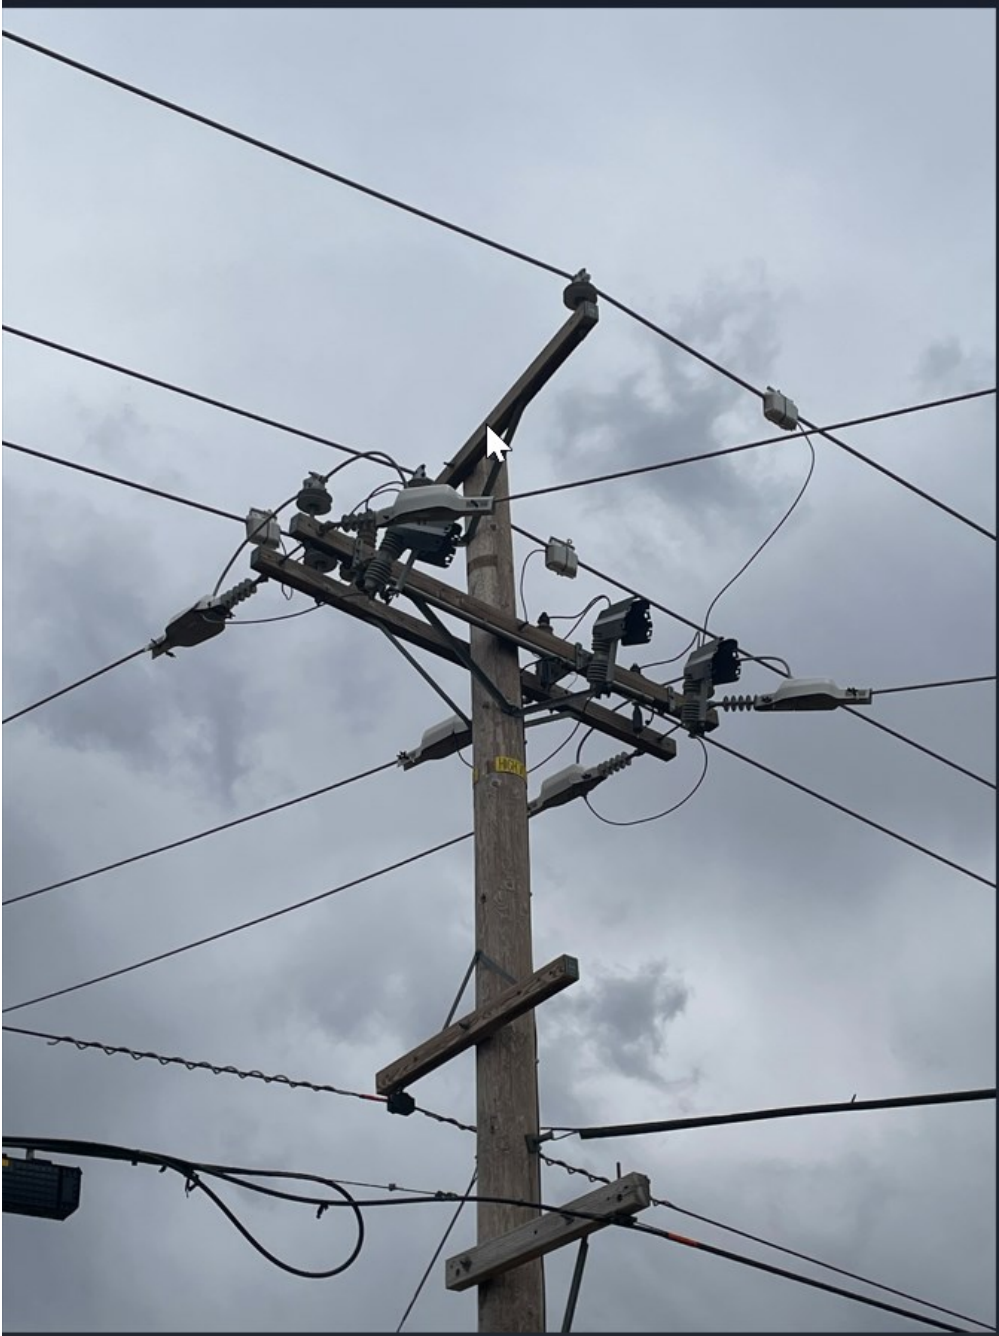
Please find photo evidence below from SCE's June 3, 2025, inspection showing the wildlife cover in its secured condition.
